DOE/NV--1530

Post-Closure Report for Closed
*Resource Conservation and
Recovery Act* Corrective Action
Units, Nevada National Security
Site, Nevada

For Fiscal Year 2014
(October 2013–September 2014)

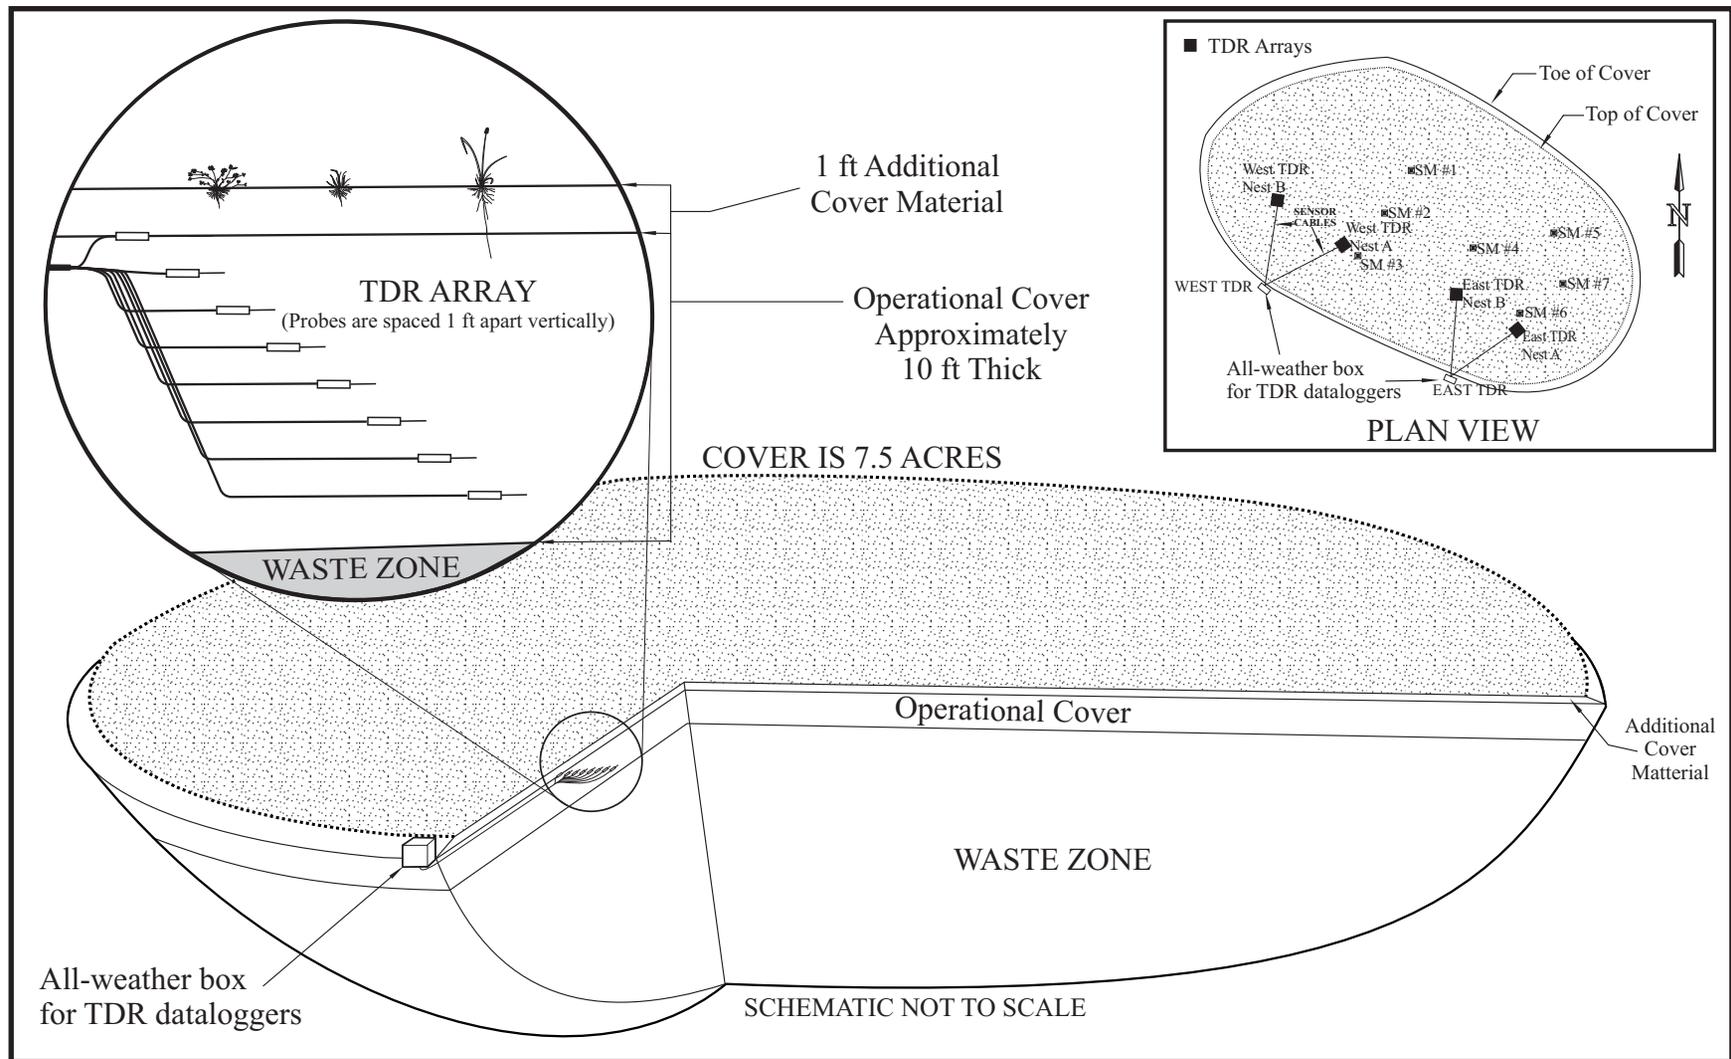
FIGURE 1
CORRECTIVE ACTION UNIT 110 TIME DOMAIN REFLECTOMETRY LOCATIONS

The CAU 110 cover is designed to prevent infiltration into the disposal unit. The cover performance is monitored using Time Domain Reflectometry (TDR) soil water content sensors buried within the waste cover. The TDR probes are buried at depths of 1 to 8 ft below ground surface at 1-ft intervals. The TDR probes are installed at a distance of 165 ft from the edge of the cover. Arrays of eight probes are positioned at four locations across the cover. Figure 1 illustrates the locations of TDR probes on the cover. Moisture content data from the TDR probes are recorded on a daily basis and stored on a data logger. The data are transmitted via radio frequency and downloaded on a quarterly basis.

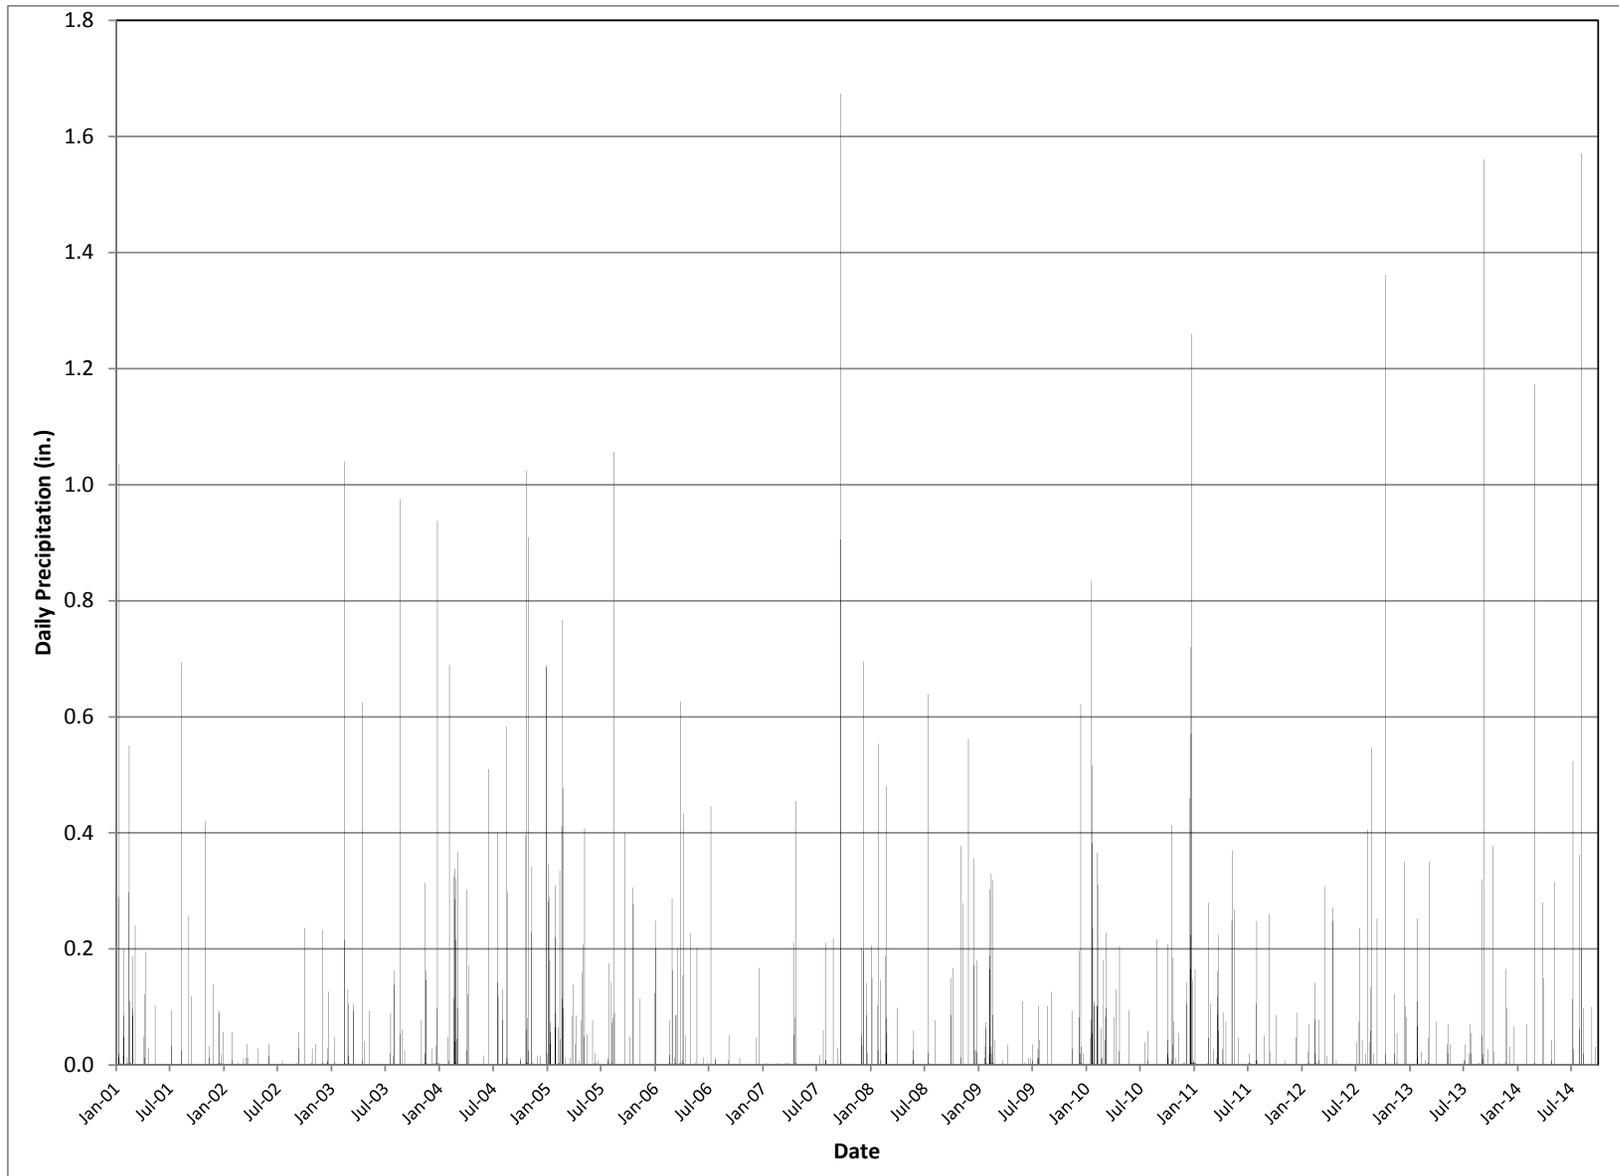
FIGURE 2. PRECIPITATION DATA FOR METEOROLOGICAL STATION BUSTER JANGLE Y

Precipitation data were collected from meteorological station Buster Jangle Y, located approximately 3 miles northwest of CAU 110. The precipitation data are presented in Figure 2. Graphs of the TDR-derived soil moisture content profiles, combined with the daily precipitation values, are presented in Figures 3 through 6.

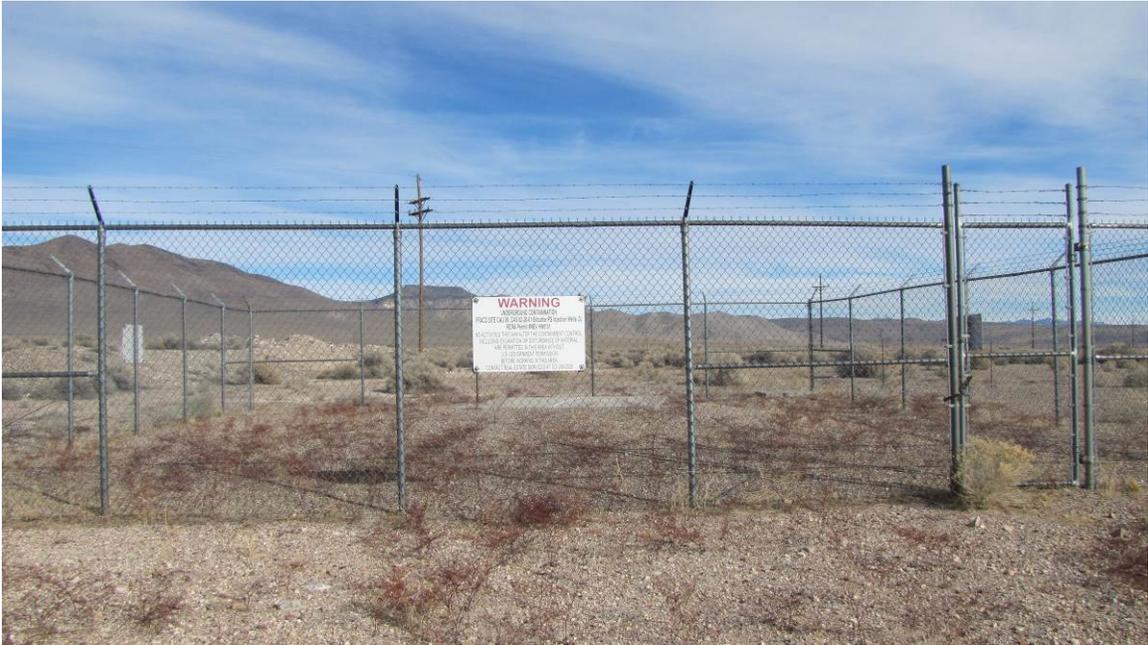
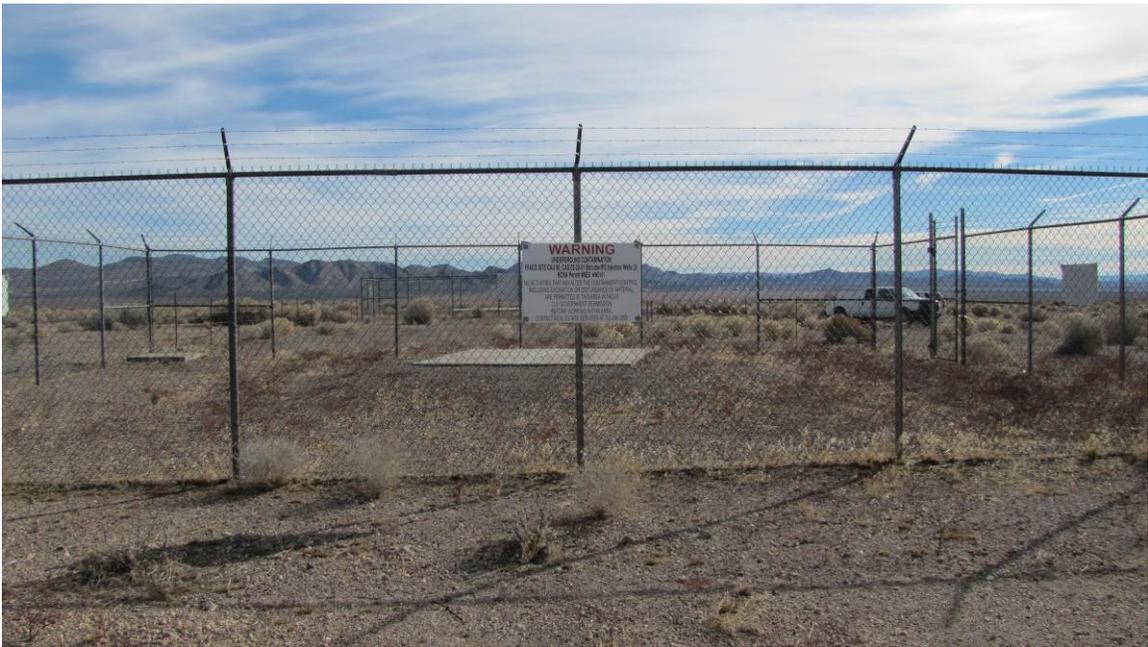
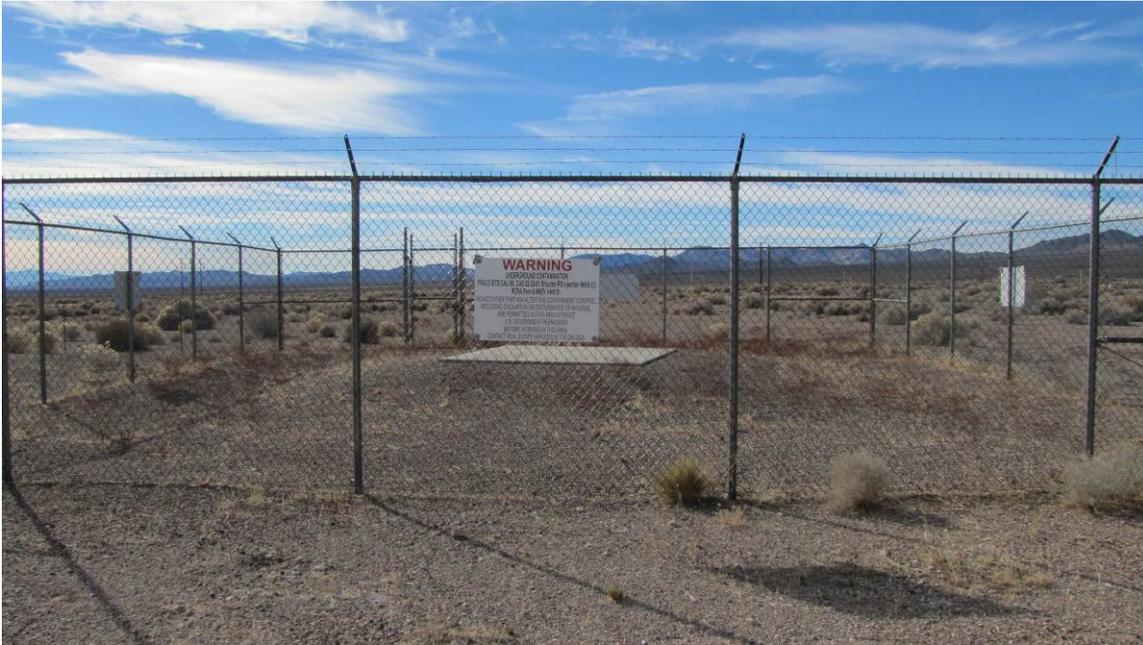
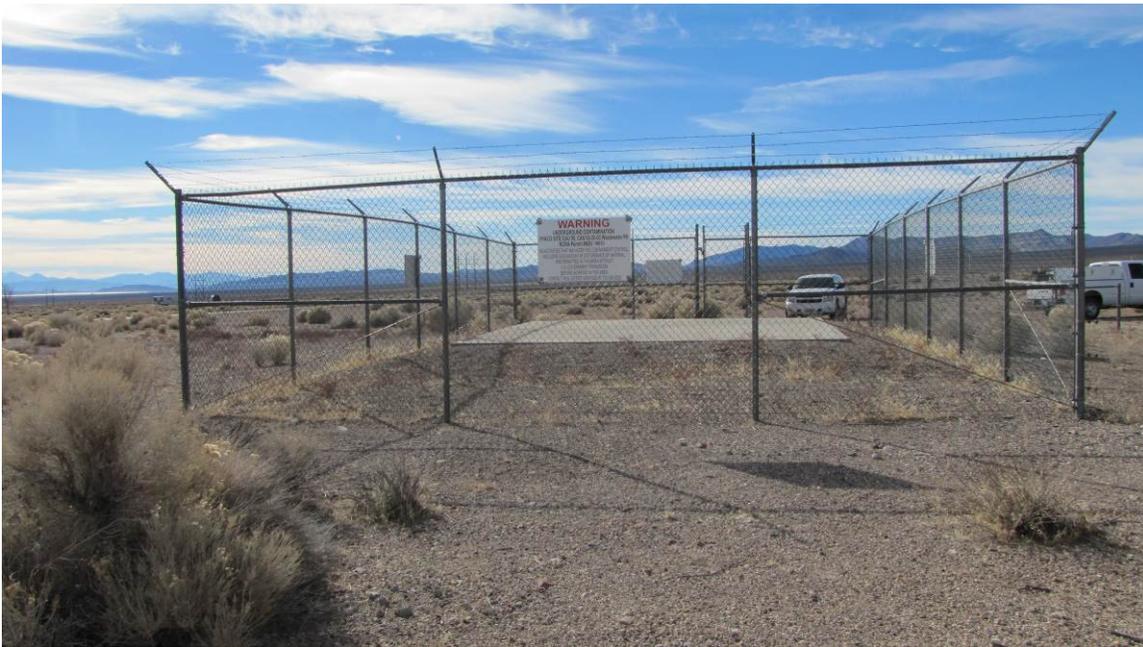
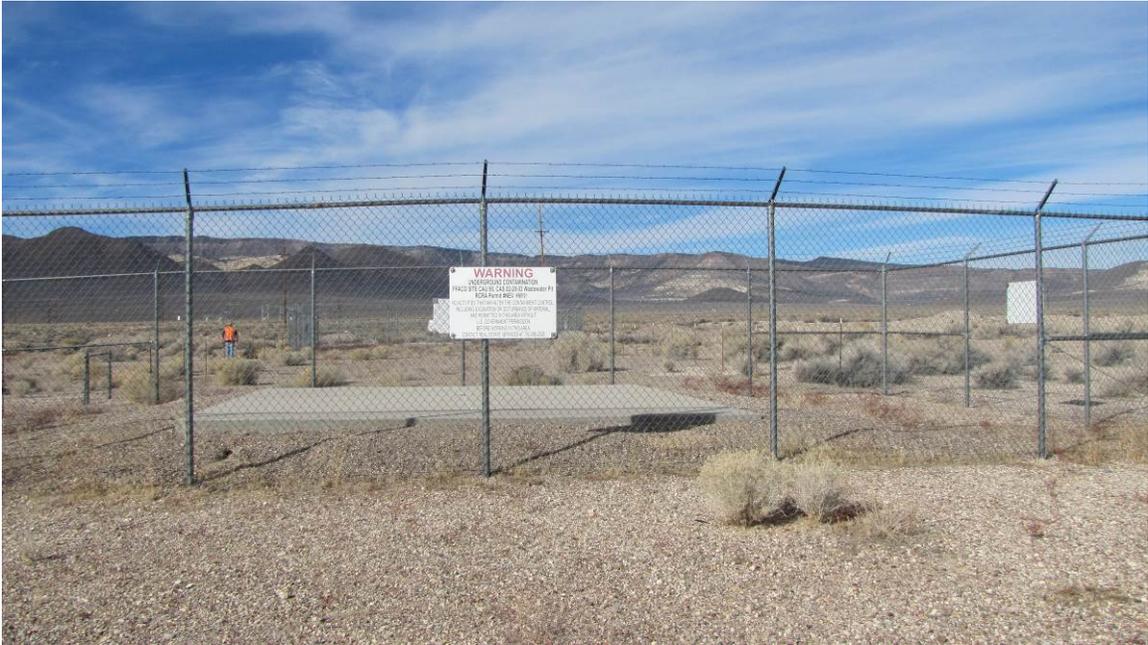
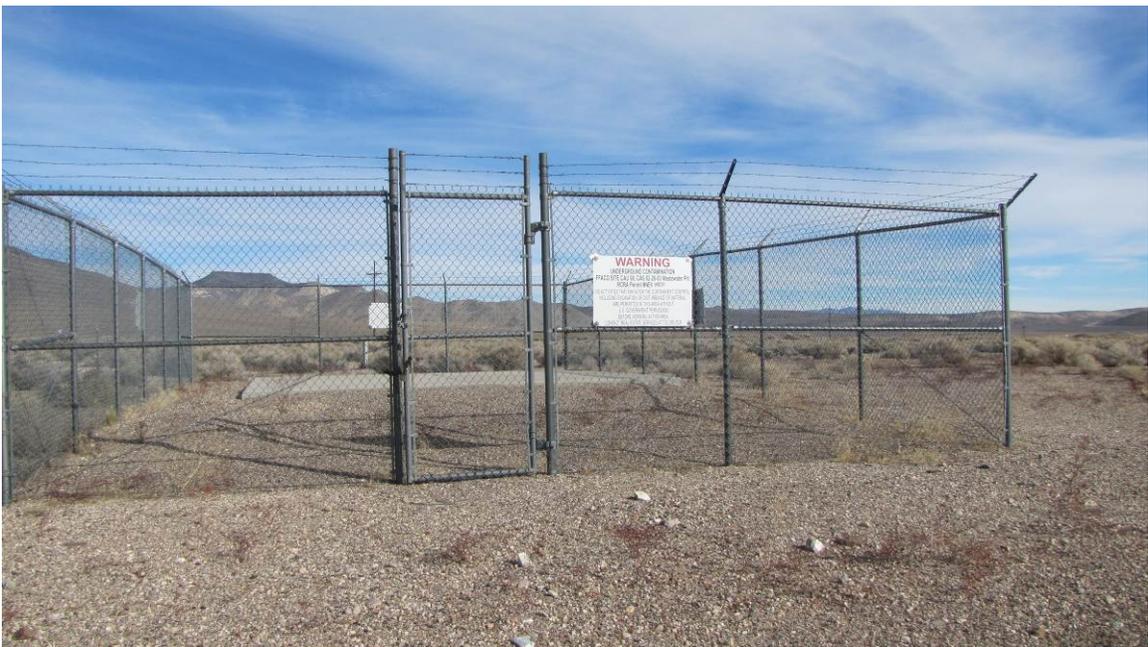
The first semiannual inspection was performed on December 16, 2013. The gate and locks required maintenance, small animal burrows were present, and vegetation was present on the covers. No other issues were observed. Maintenance was completed on January 22, 2014.

Photograph 1: CAU 90, West Unit Facing North, 12/16/2013

Photograph 2: CAU 90, West Unit Facing East, 12/16/2013

Photograph 3: CAU 90, West Unit Facing South, 12/16/2013

Photograph 4: CAU 90, East Unit Facing South, 12/16/2013

Photograph 5: CAU 90, East Unit Facing West, 12/16/2013

Photograph 6: CAU 90, East Unit Facing North, 12/16/2013

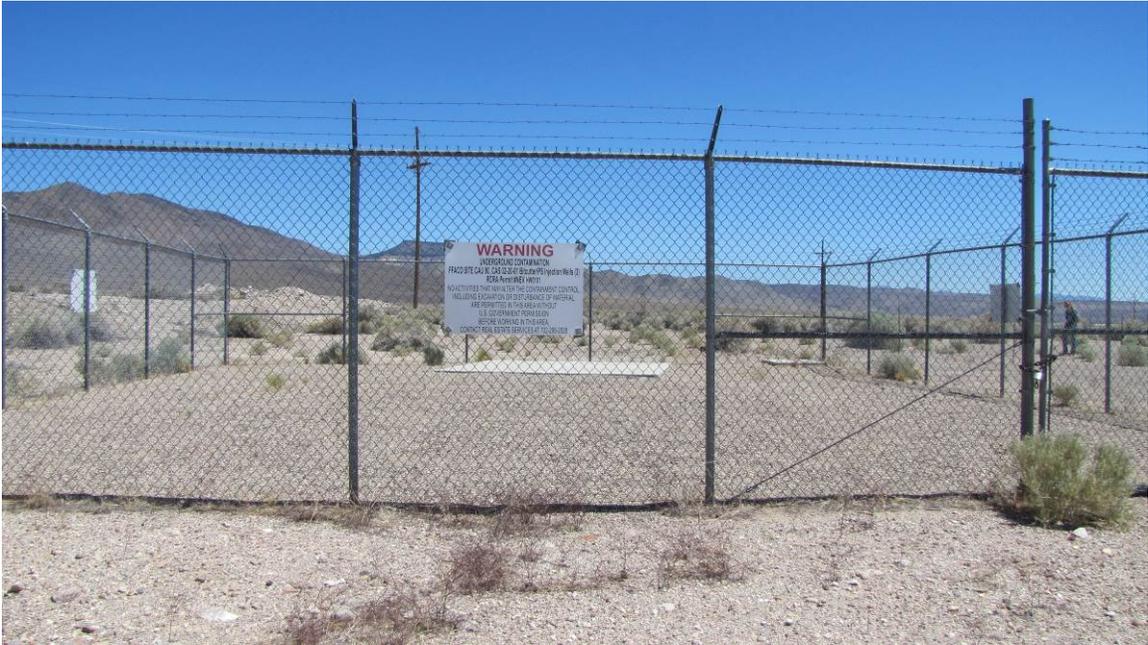
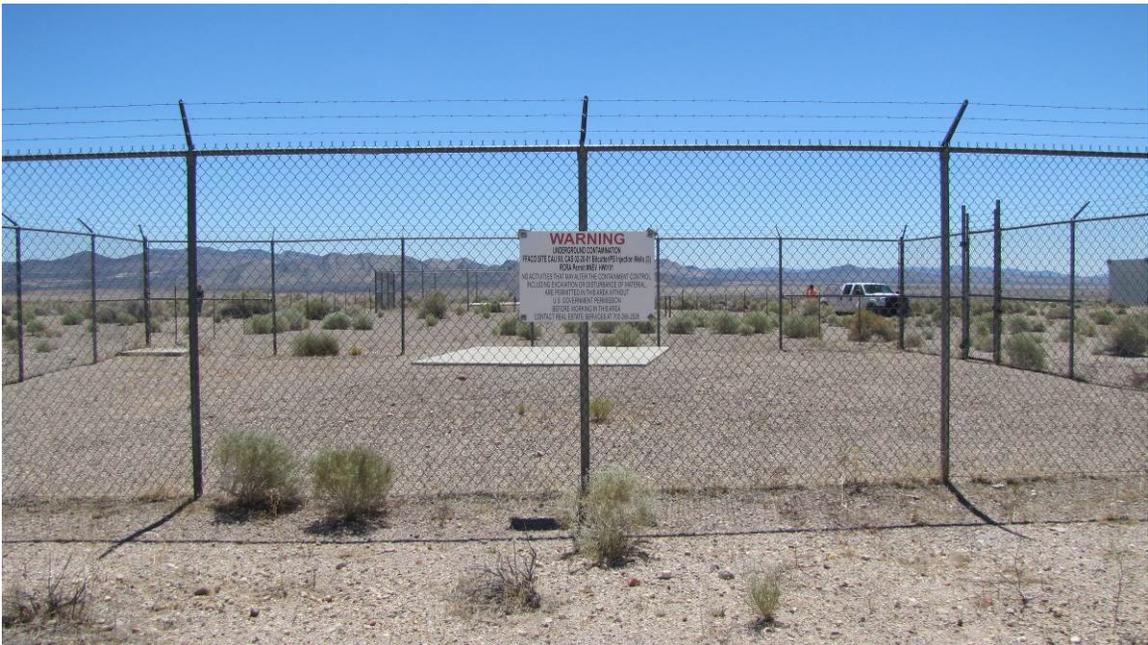
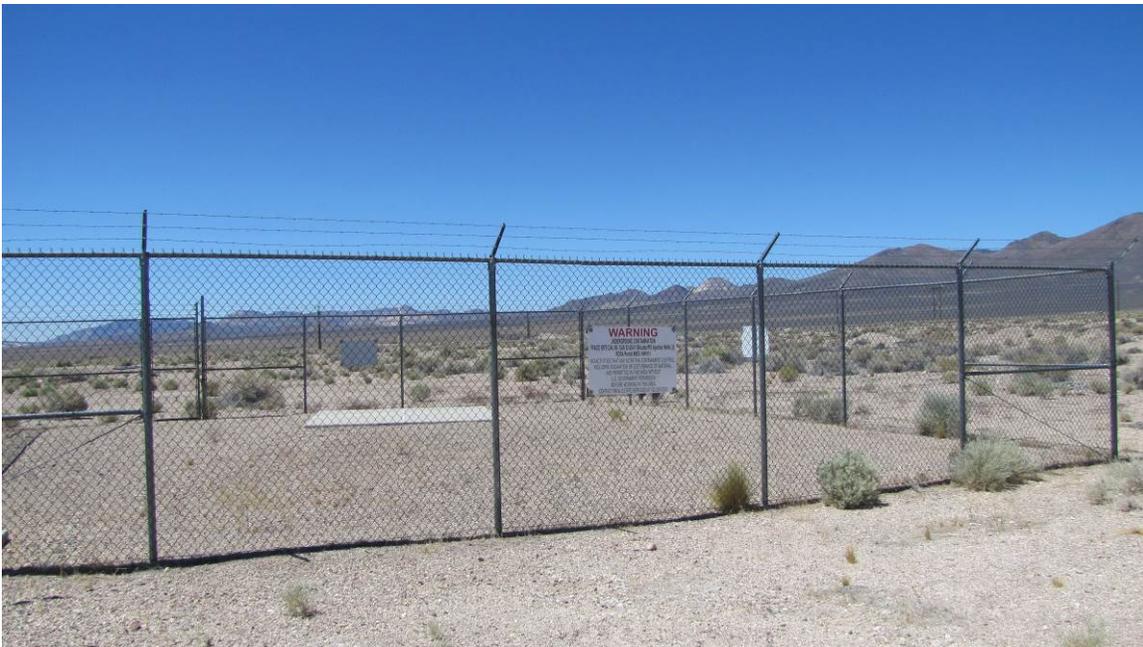
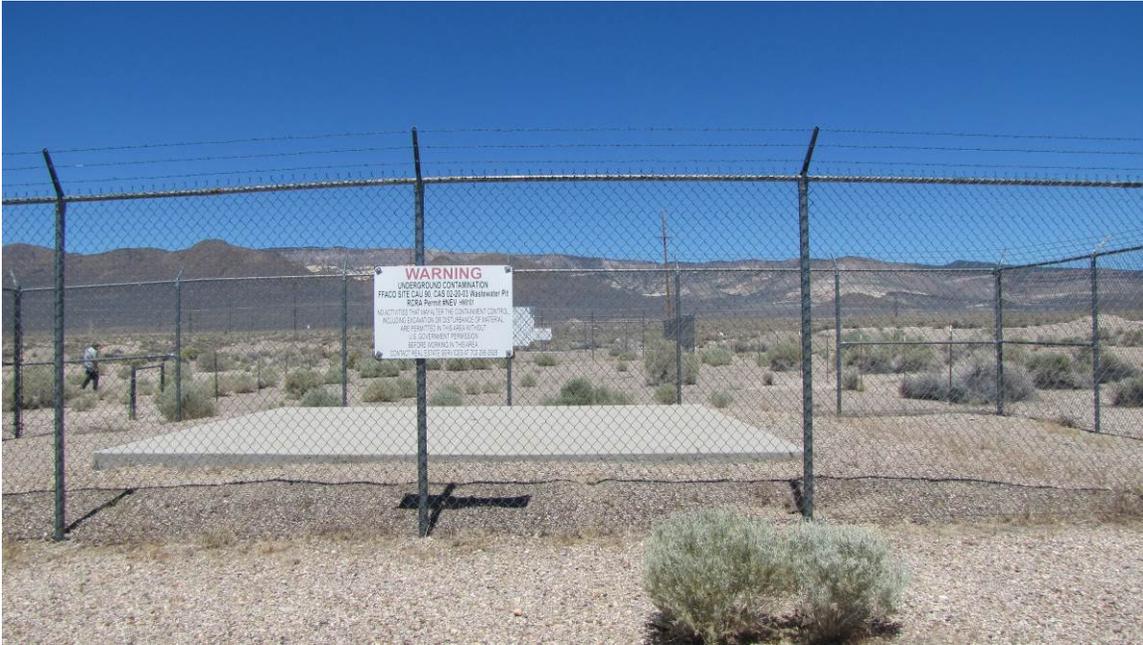
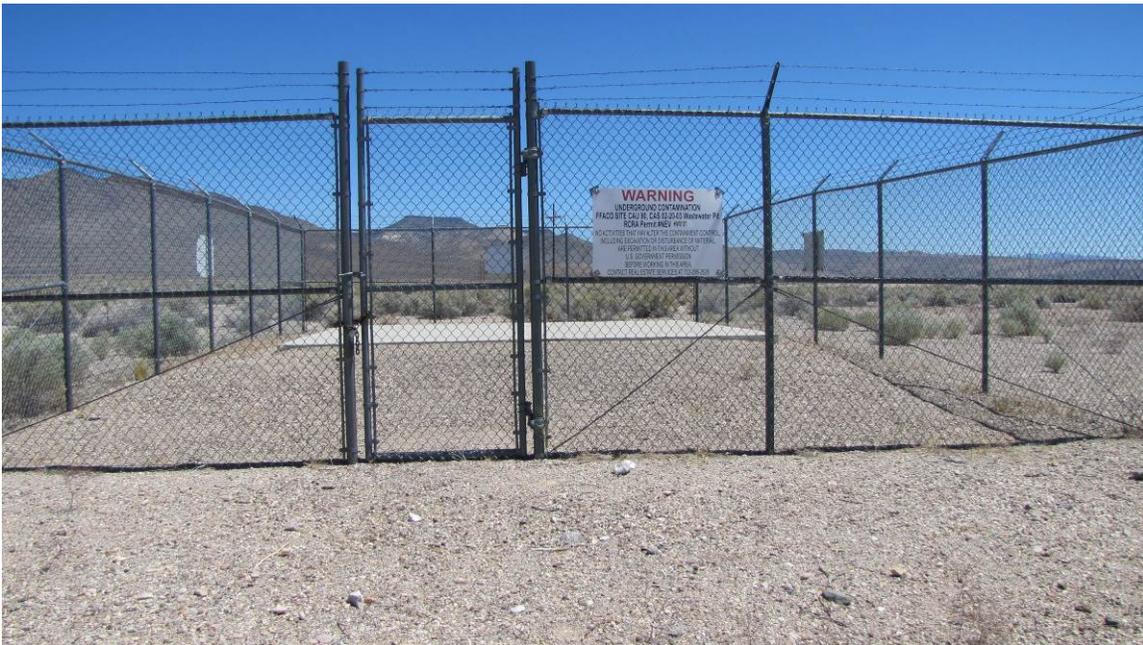
The second semiannual inspection was performed on June 18, 2014. Minor vegetation was present that did not require removal. No maintenance or repairs were required.

Photograph 7: CAU 90, West Unit Facing North, 06/18/2014

Photograph 8: CAU 90, West Unit Facing East, 06/18/2014

Photograph 9: CAU 90, West Unit Facing South, 06/18/2014

Photograph 11: CAU 90, East Unit Facing West, 06/18/2014

Photograph 12: CAU 90, East Unit Facing North, 06/18/2014

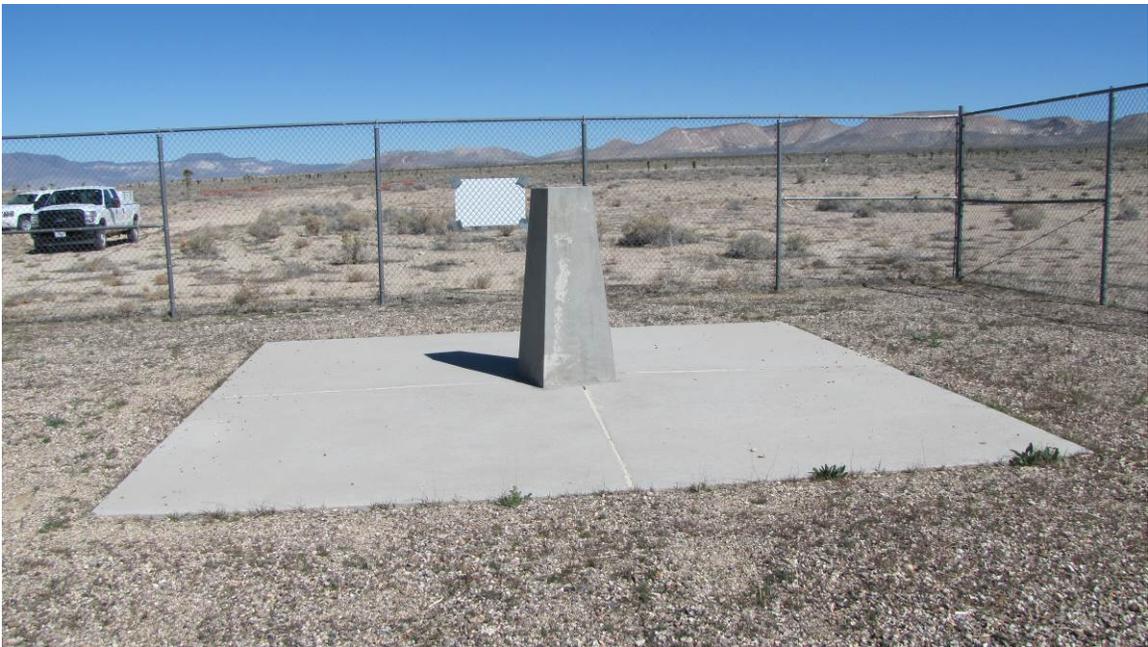
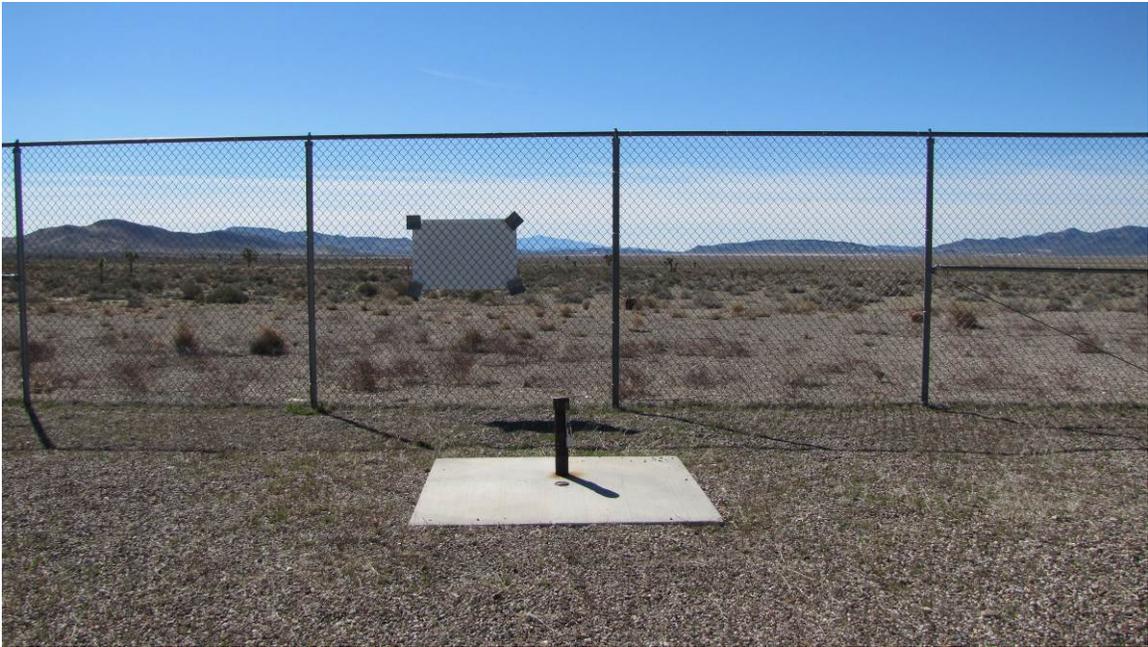
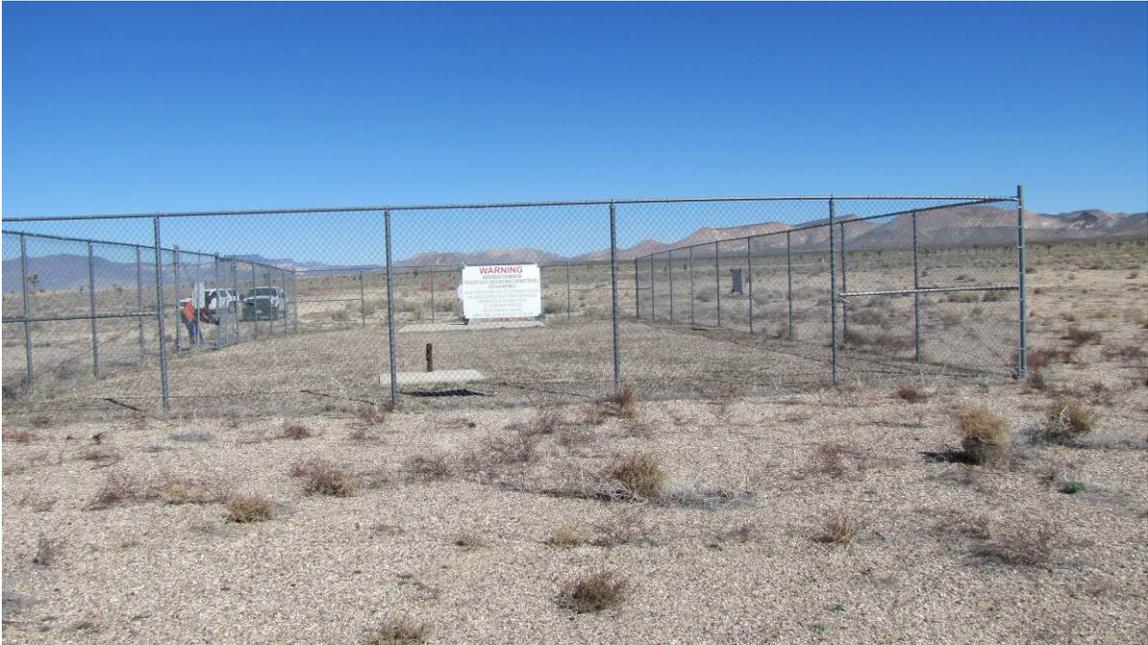
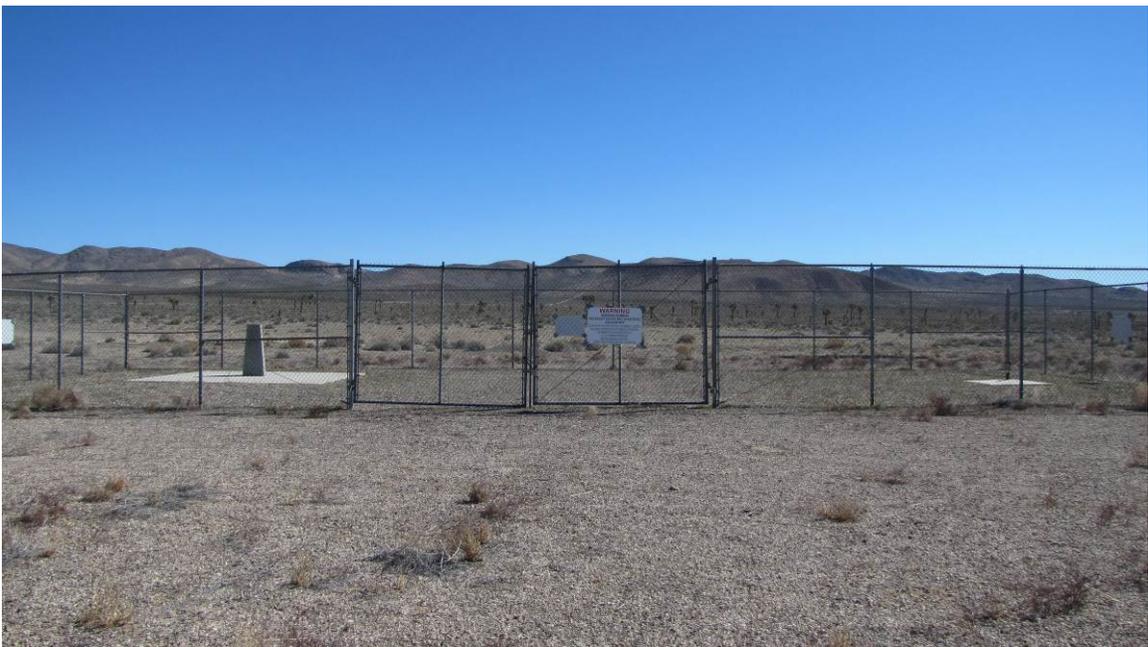
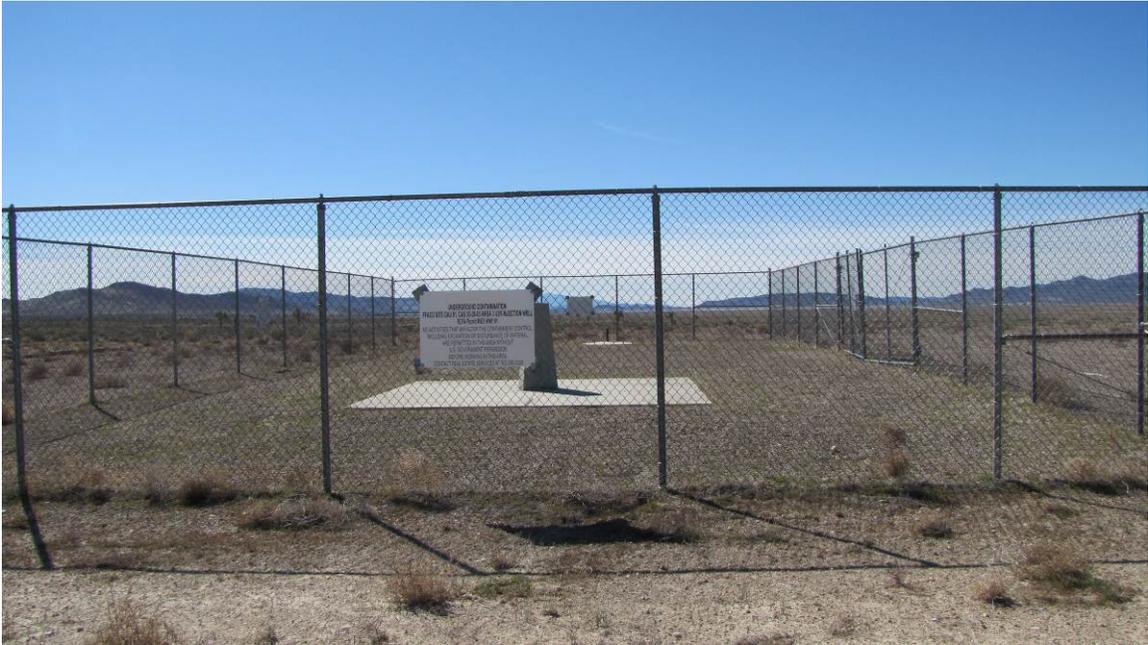
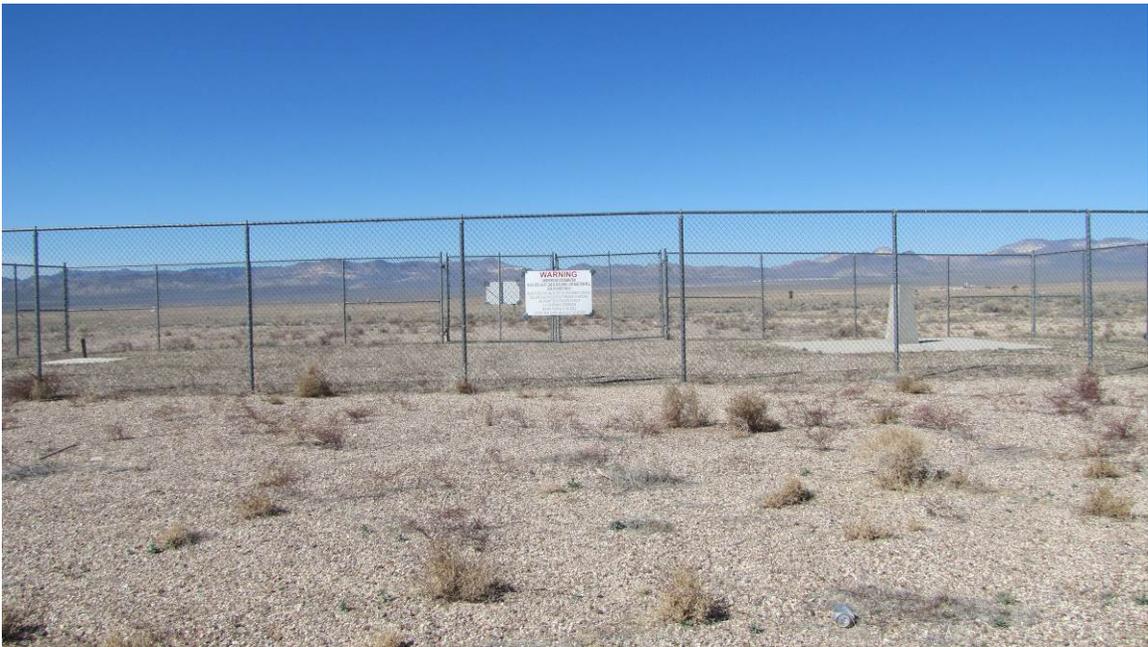
Vegetation observed in September 2013 was removed on October 15, 2013. The first semiannual inspection was performed on March 11, 2014. The red "WARNING" text on one sign was faded, and vegetation was present on the cover. No other issues were observed. Maintenance was completed on April 12, 2014.

Photograph 13: CAU 91, Inside Facing North, 03/11/2014

Photograph 15: CAU 91, Inside Facing South, 03/11/2014

Photograph 17: CAU 91, Outside Facing North, 03/11/2014

Photograph 18: CAU 91, Outside Facing East, 03/11/2014

Photograph 19: CAU 91, Outside Facing South, 03/11/2014

Photograph 20: CAU 91, Outside Facing West, 03/11/2014

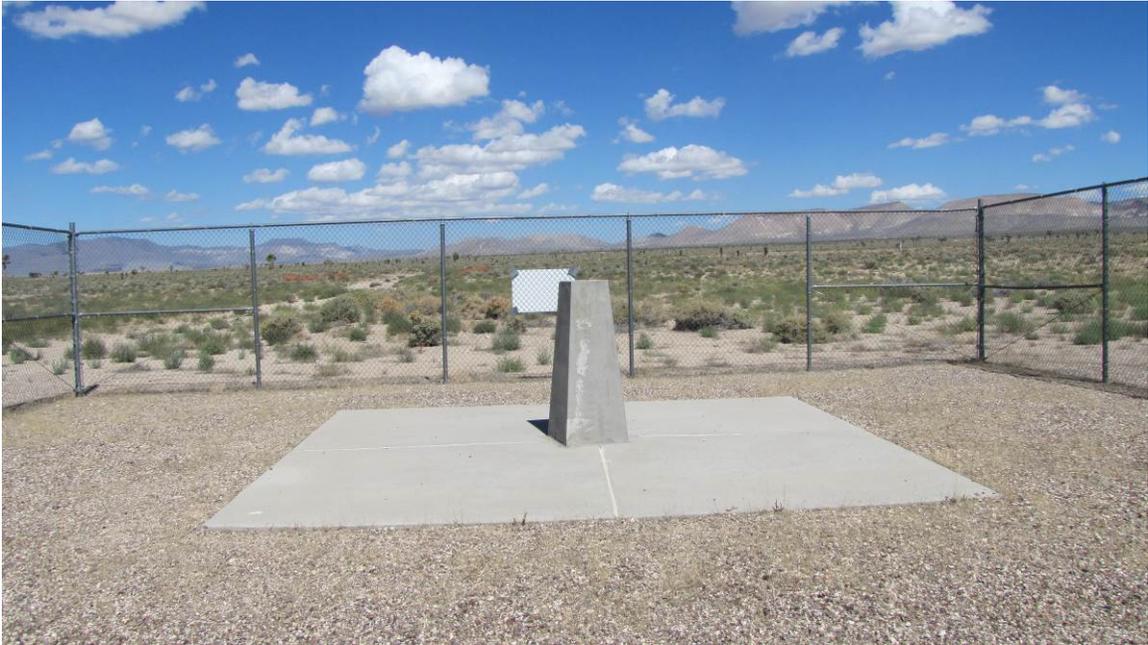
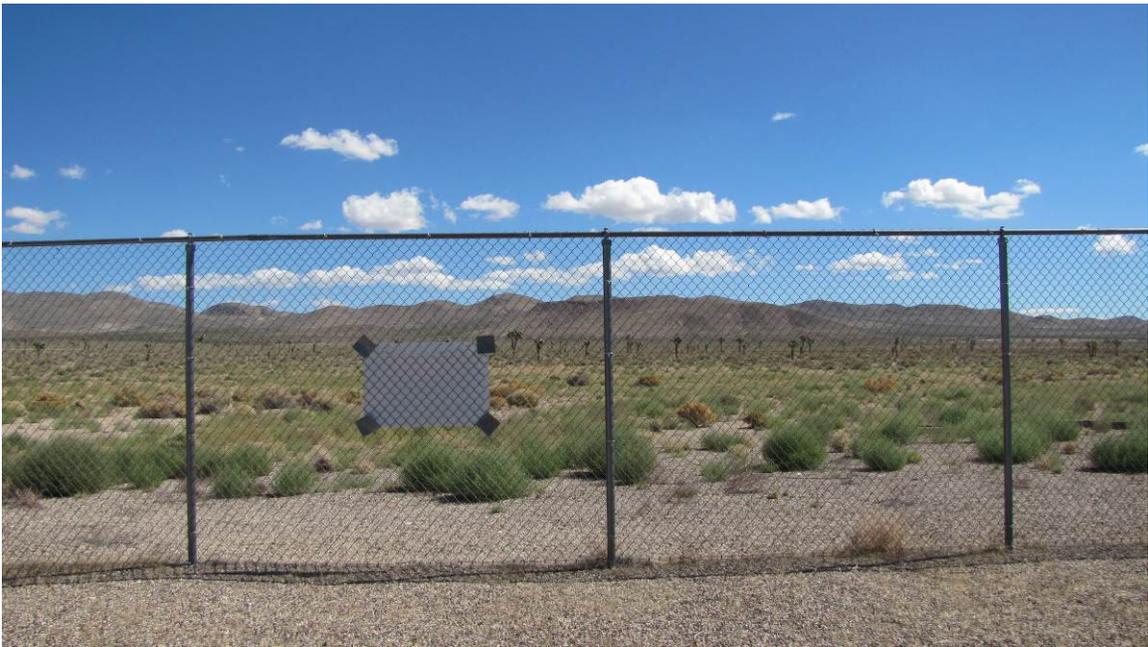
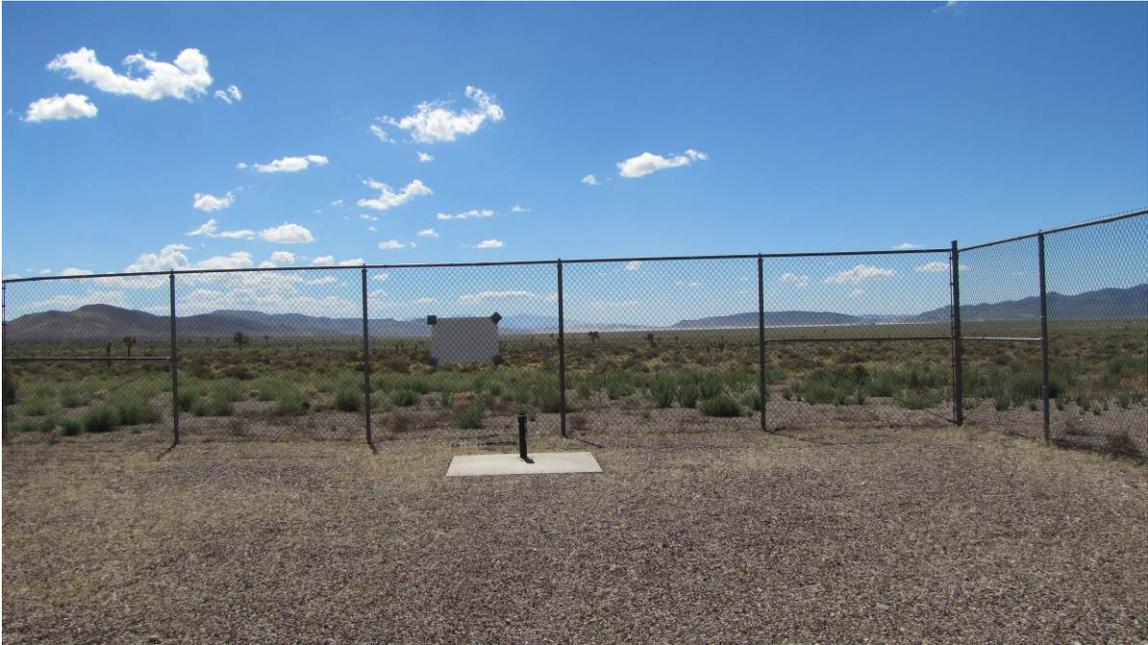
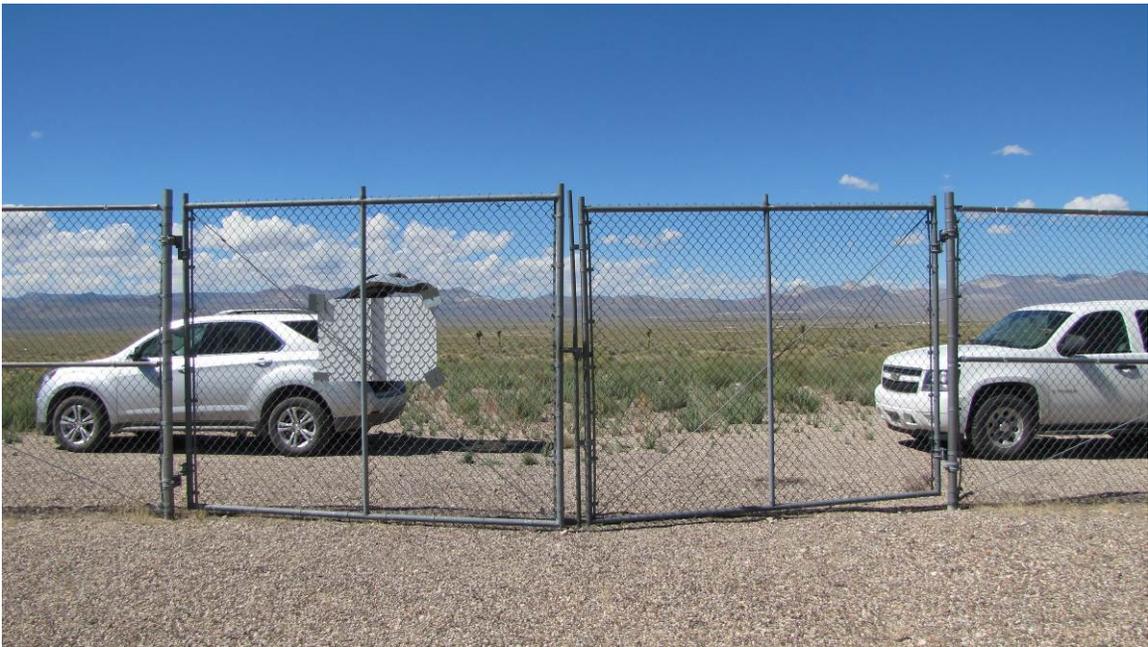
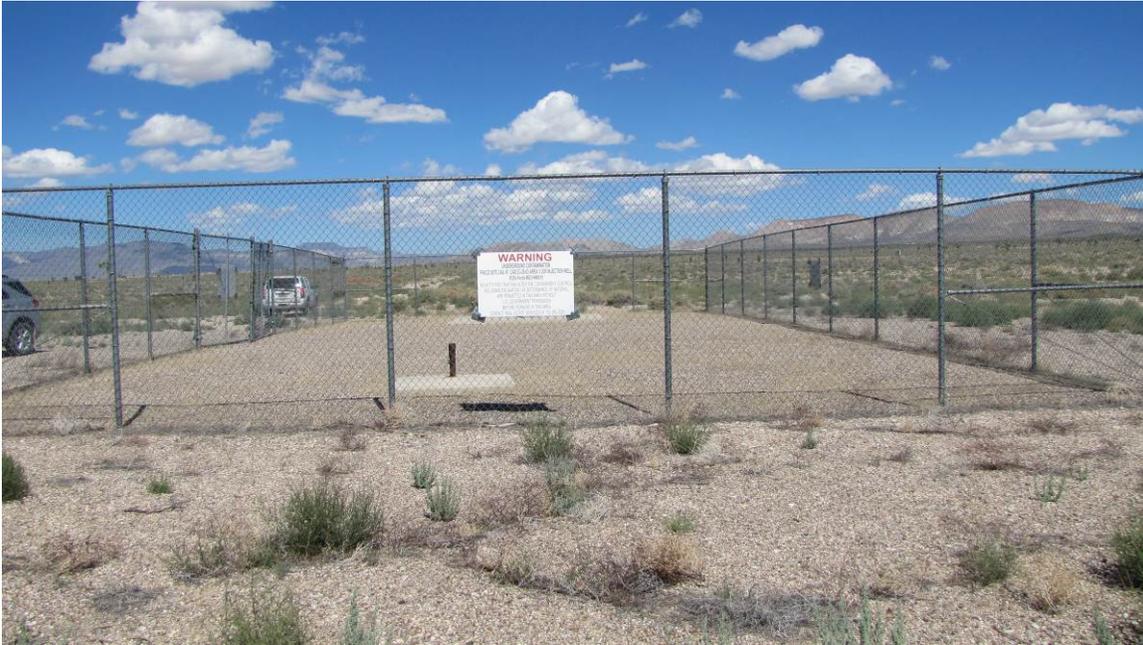
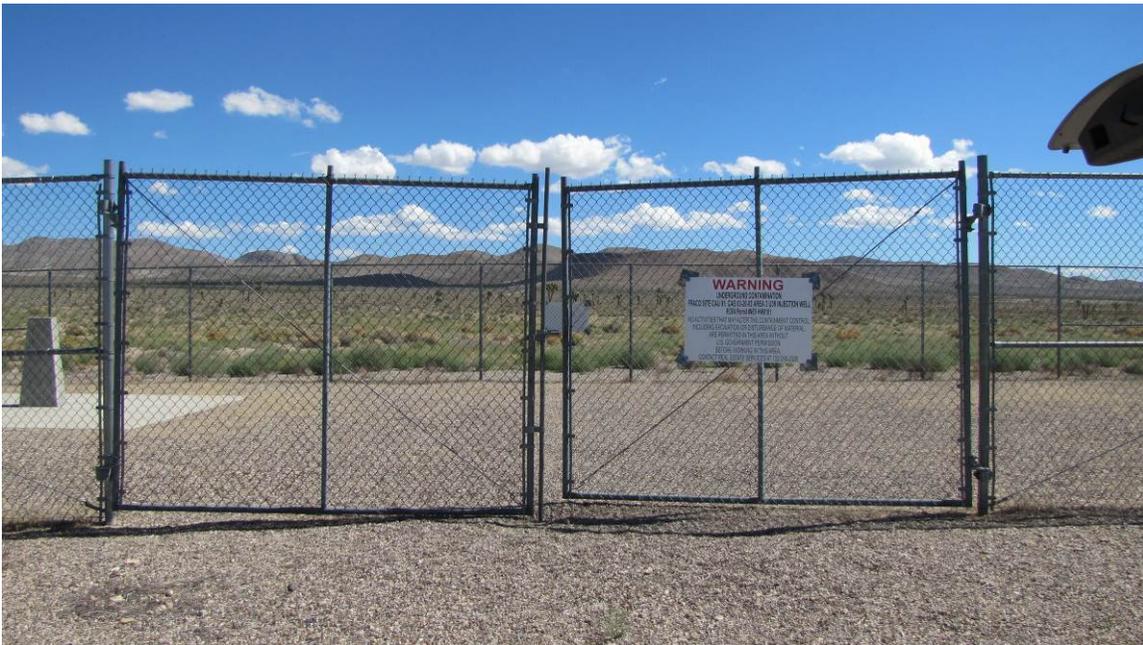
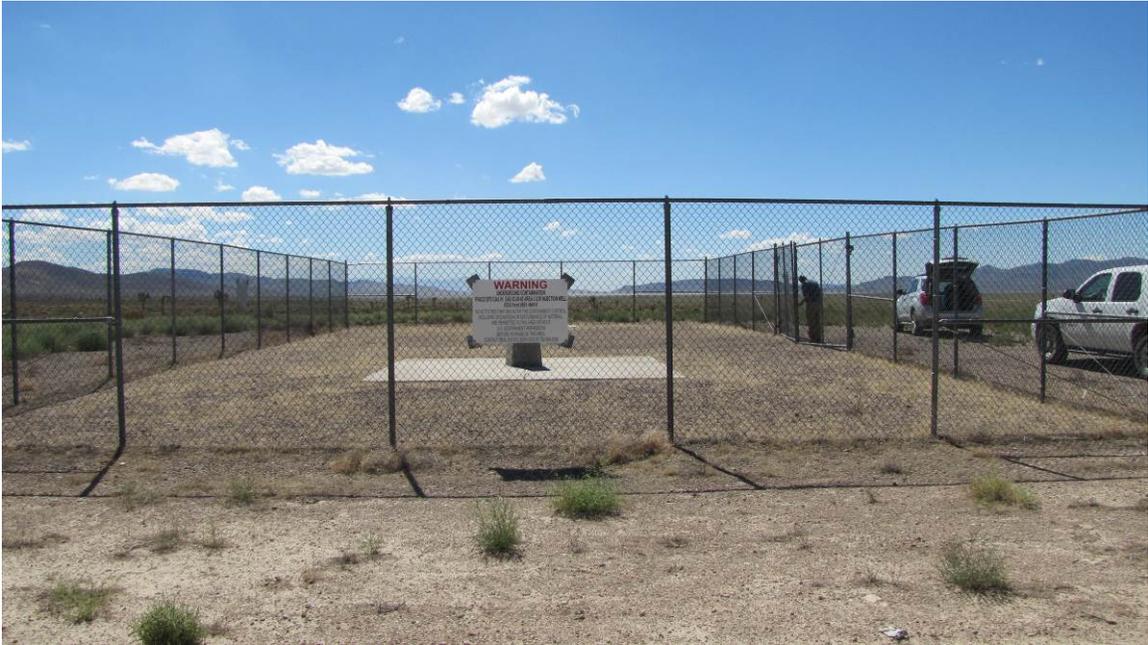
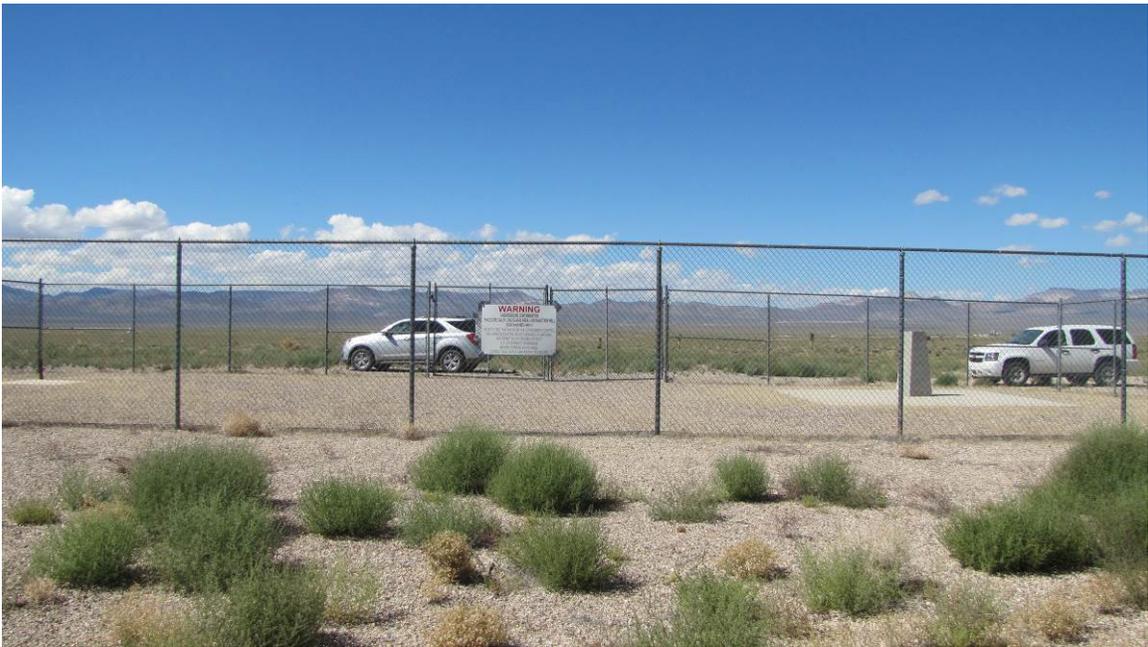
The second semiannual inspection was performed on September 25, 2014. The red "WARNING" text on one sign was faded. A new "WARNING" sticker was placed on the sign during the inspection. No other issues were observed.

Photograph 21: CAU 91, Inside Facing North, 09/25/2014

Photograph 22: CAU 91, Inside Facing East, 09/25/2014

Photograph 23: CAU 91, Inside Facing South, 09/25/2014

Photograph 24: CAU 91, Inside Facing West, 09/25/2014

Photograph 25: CAU 91, Outside Facing North, 09/25/2014

Photograph 26: CAU 91, Outside Facing East, 09/25/2014

Photograph 27: CAU 91, Outside Facing South, 09/25/2014

Photograph 28: CAU 91, Outside Facing West, 09/25/2014
