DOE/NV--1530

Post-Closure Report for Closed
*Resource Conservation and
Recovery Act* Corrective Action
Units, Nevada National Security
Site, Nevada

For Fiscal Year 2014
(October 2013–September 2014)

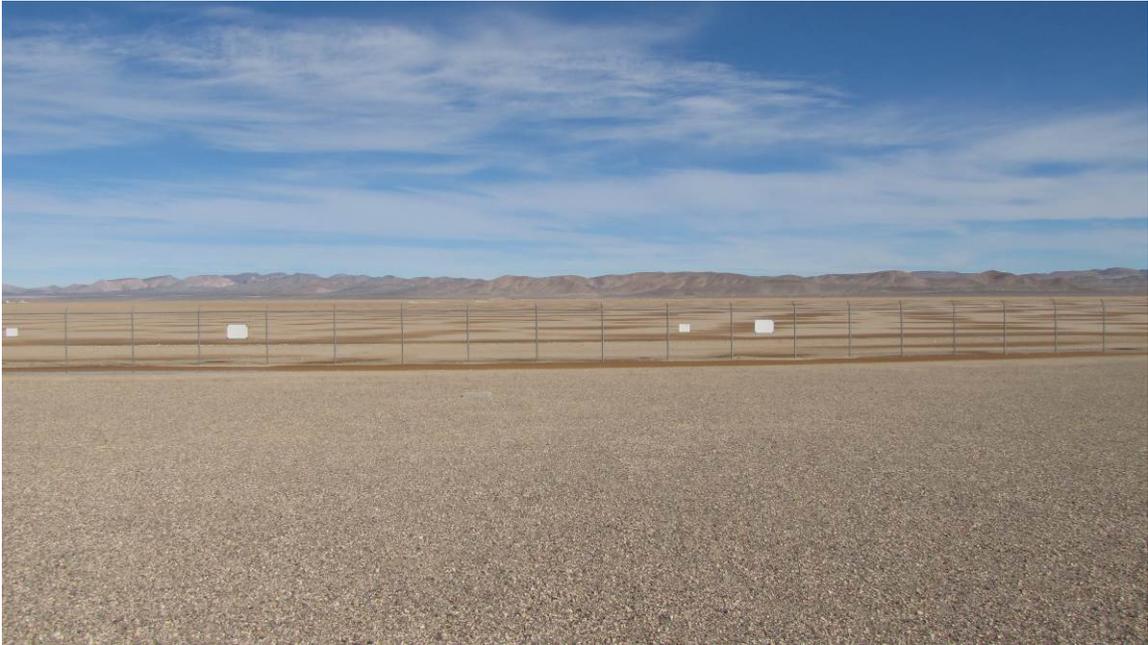
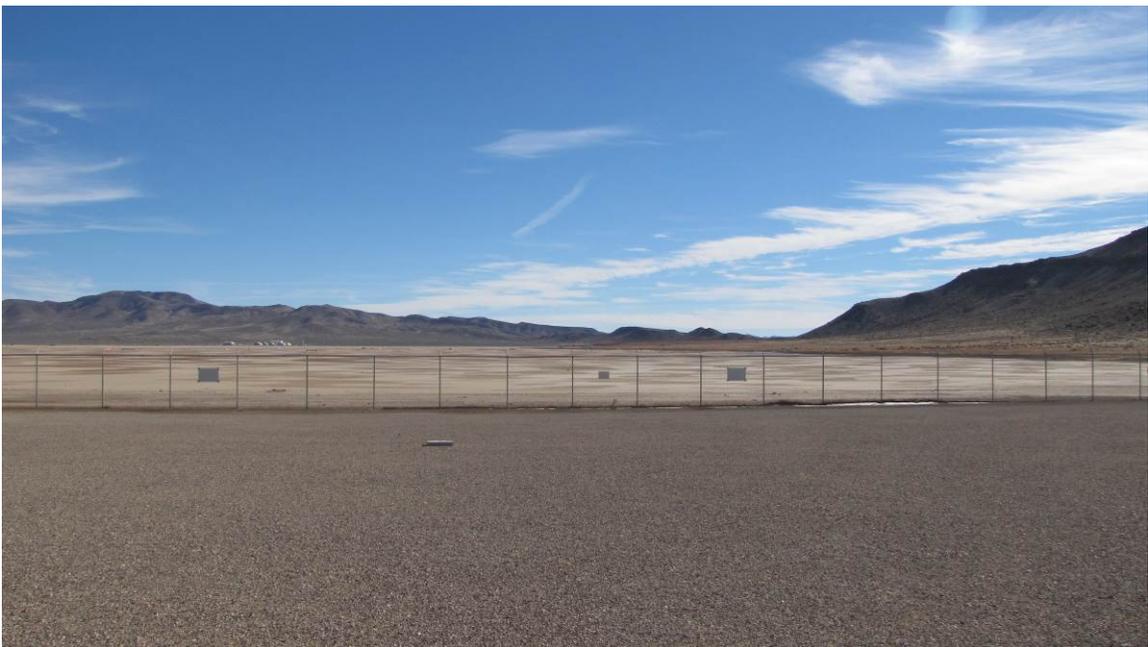
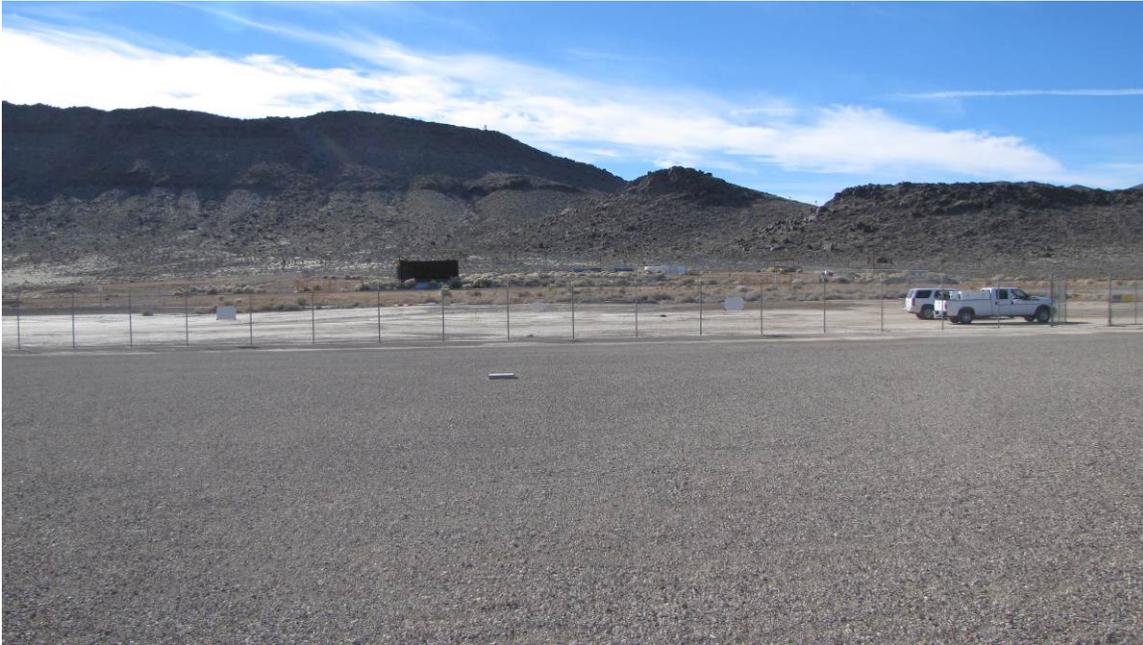
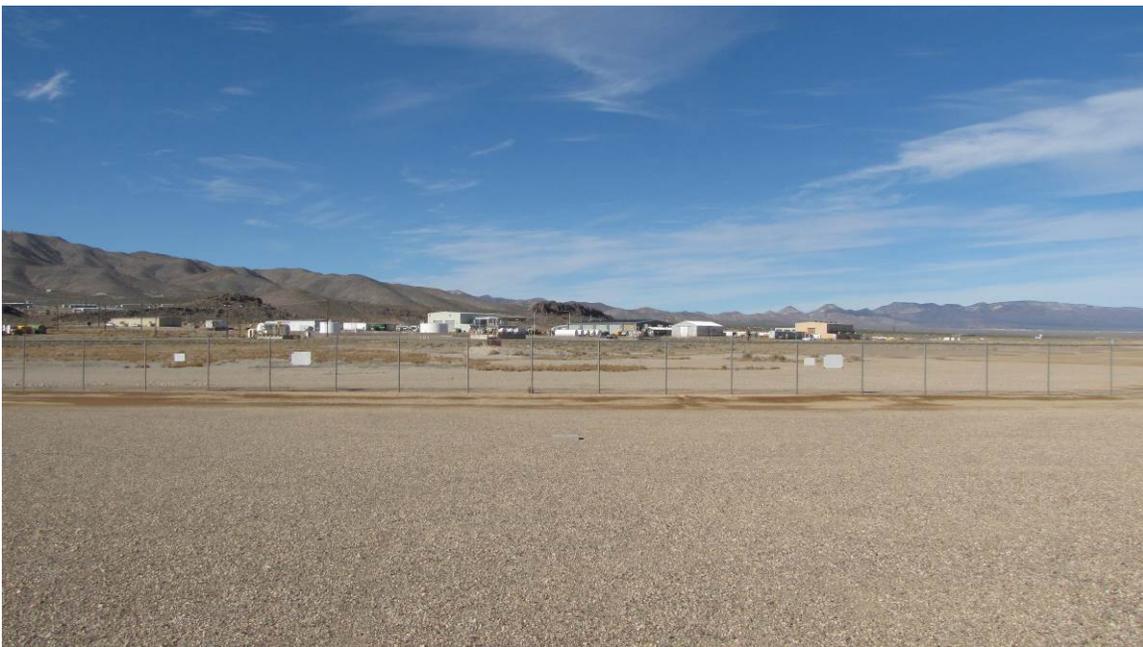
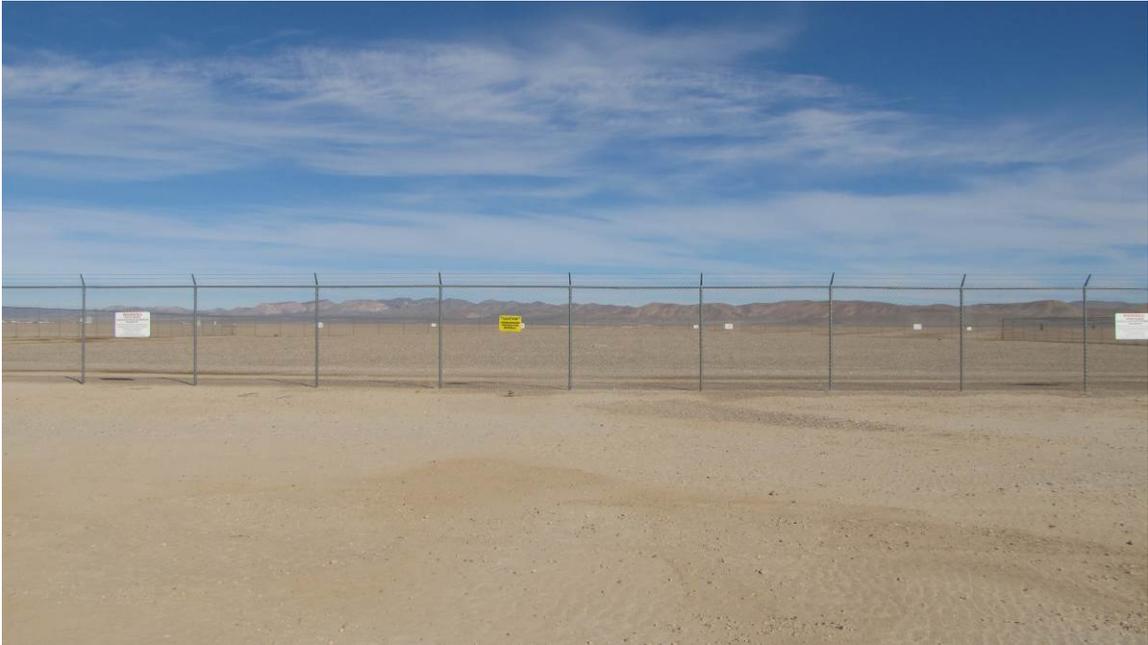
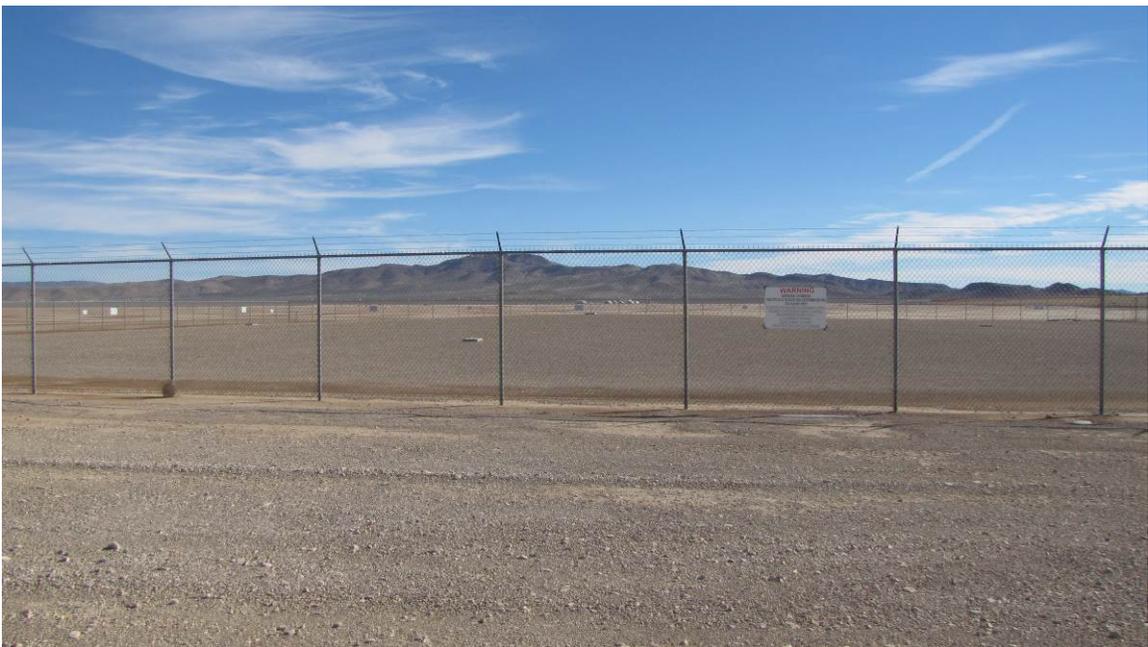
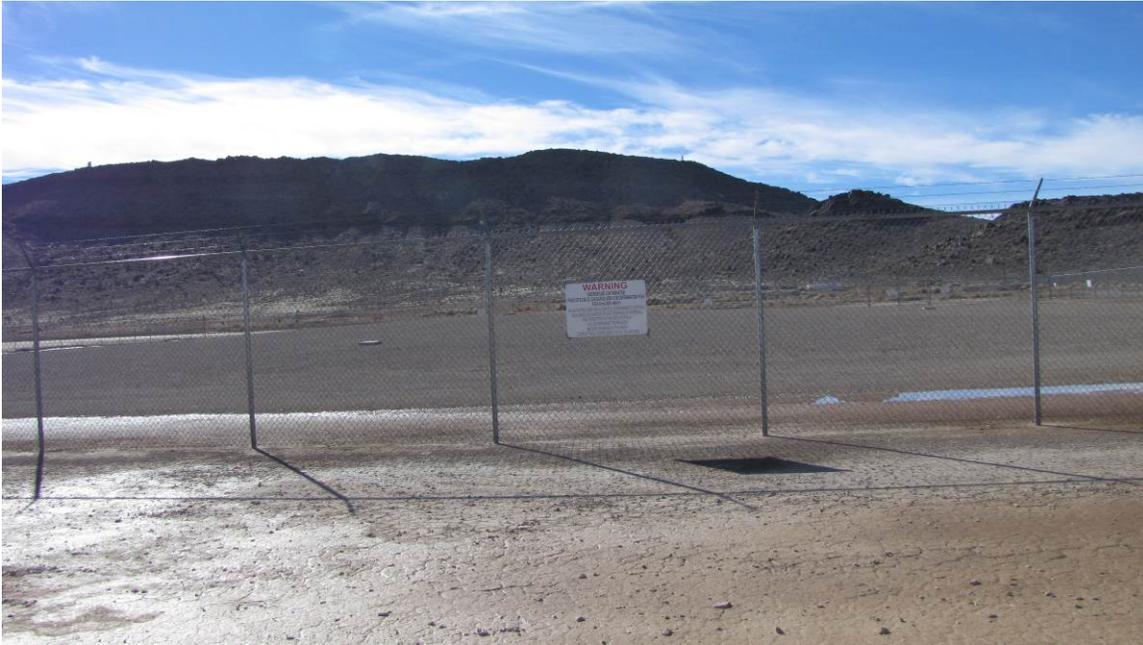
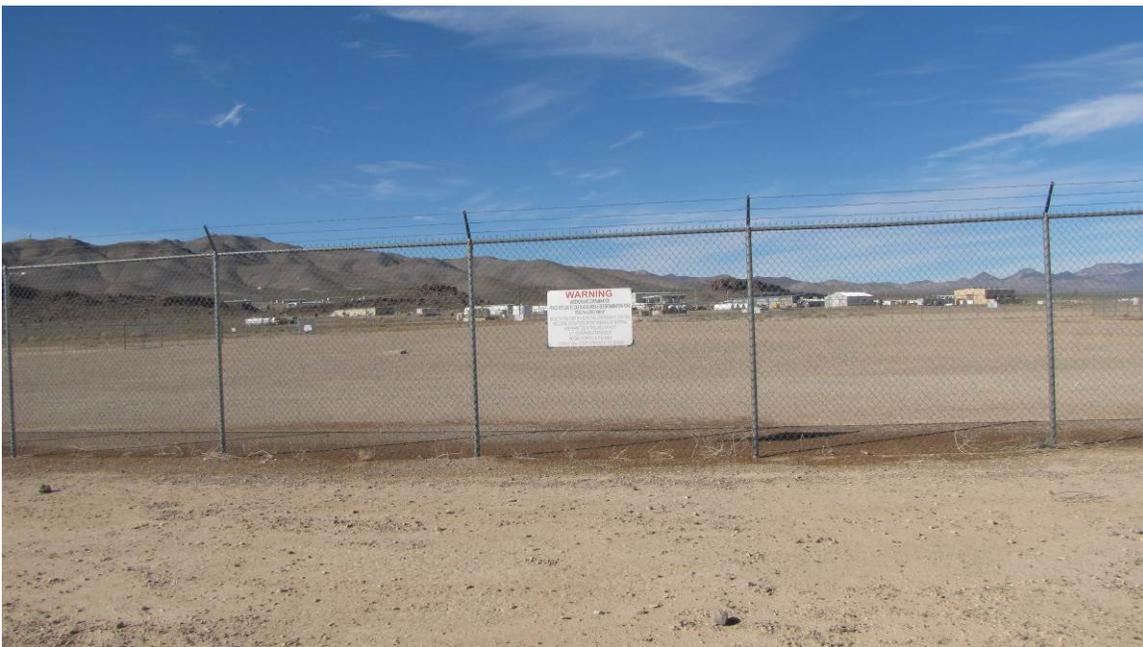
The first quarterly inspection was performed on December 16, 2013. A small amount of standing water that did not require corrective action was observed along the fence. Two areas of minor erosion were observed under the west fence. No other issues were observed. Erosion repair was completed on January 22, 2014.

Photograph 29: CAU 92, Inside Facing North, 12/16/2013

Photograph 30: CAU 92, Inside Facing East, 12/16/2013

Photograph 31: CAU 92, Inside Facing South, 12/16/2013

Photograph 32: CAU 92, Inside Facing West, 12/16/2013

Photograph 33: CAU 92, Outside Facing North, 12/16/2013

Photograph 34: CAU 92, Outside Facing East, 12/16/2013

Photograph 35: CAU 92, Outside Facing South, 12/16/2013

Photograph 36: CAU 92, Outside Facing West, 12/16/2013

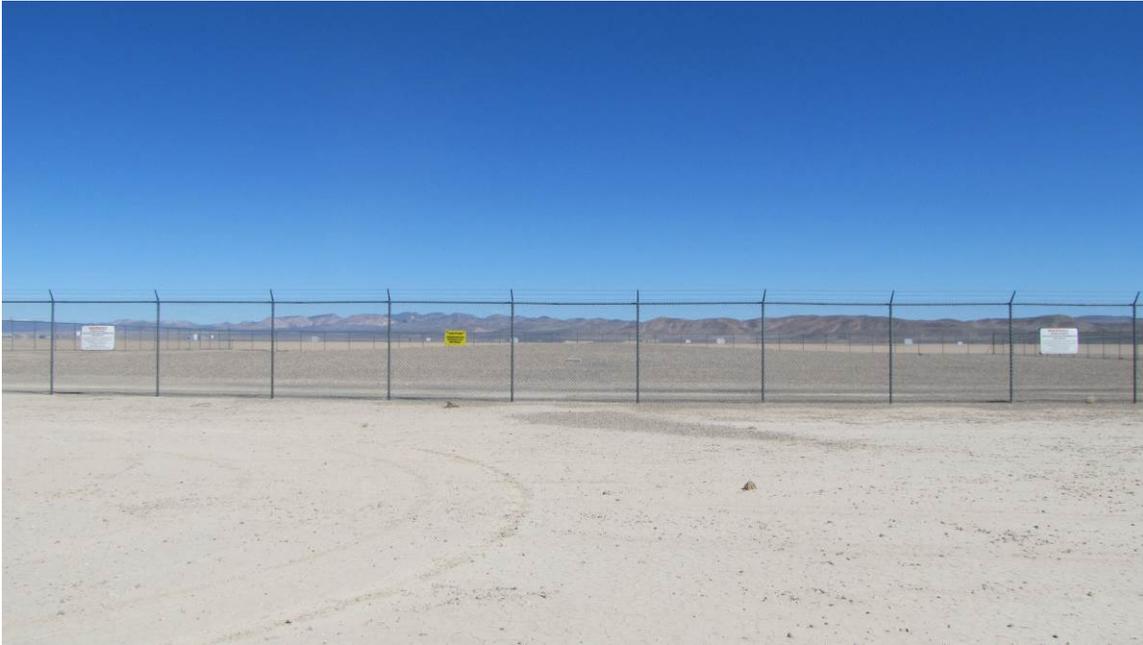
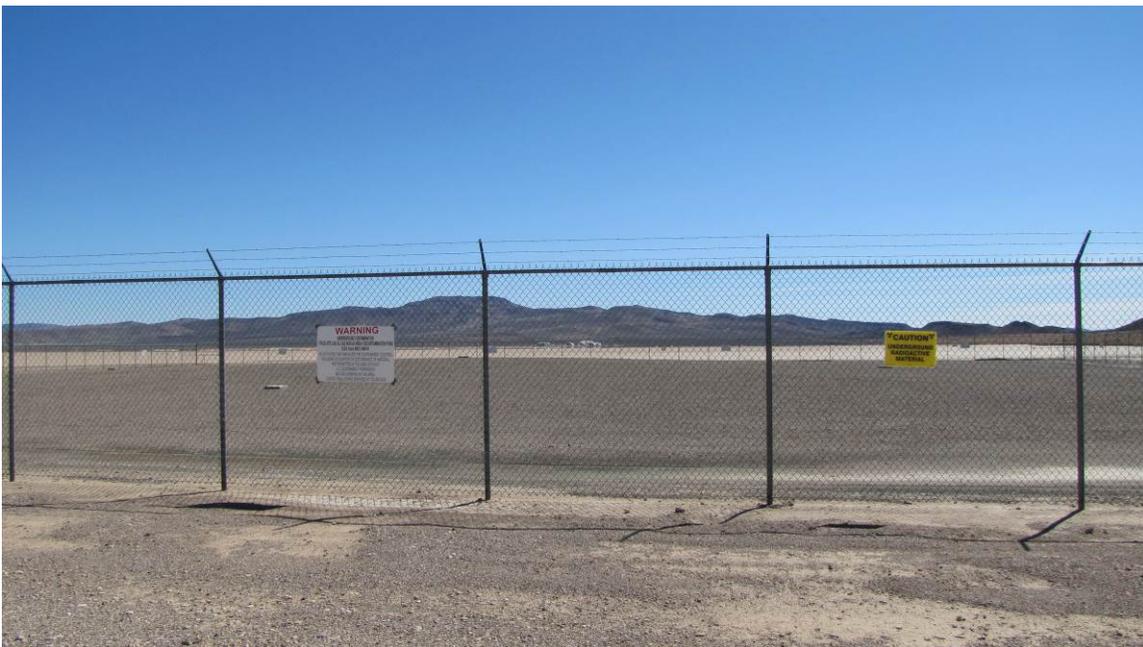
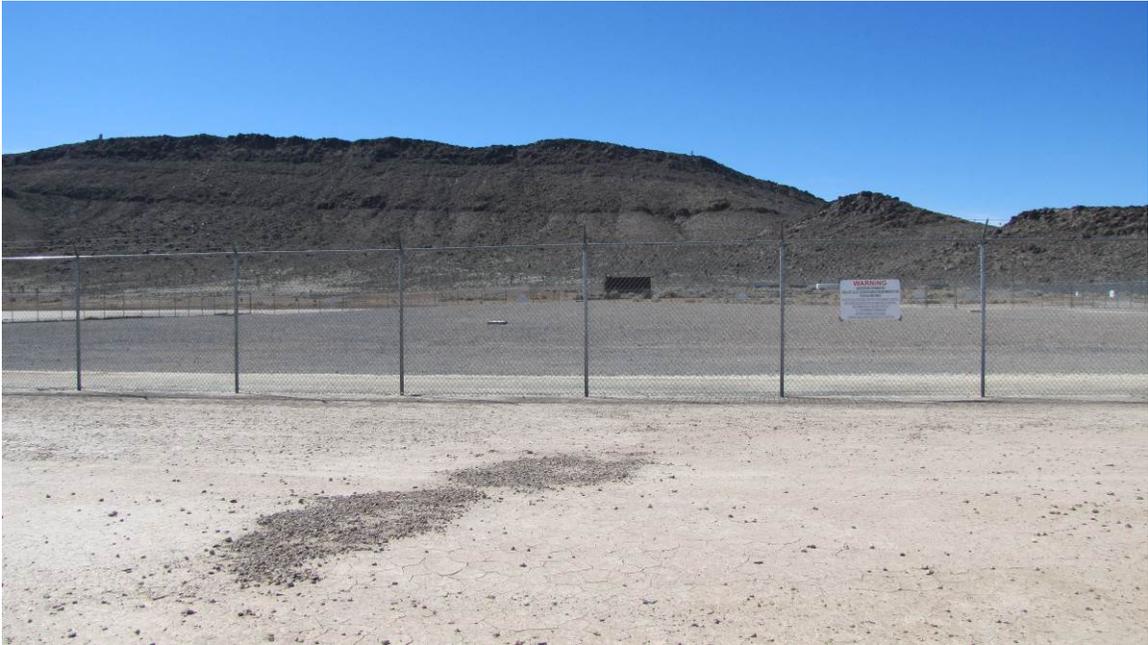
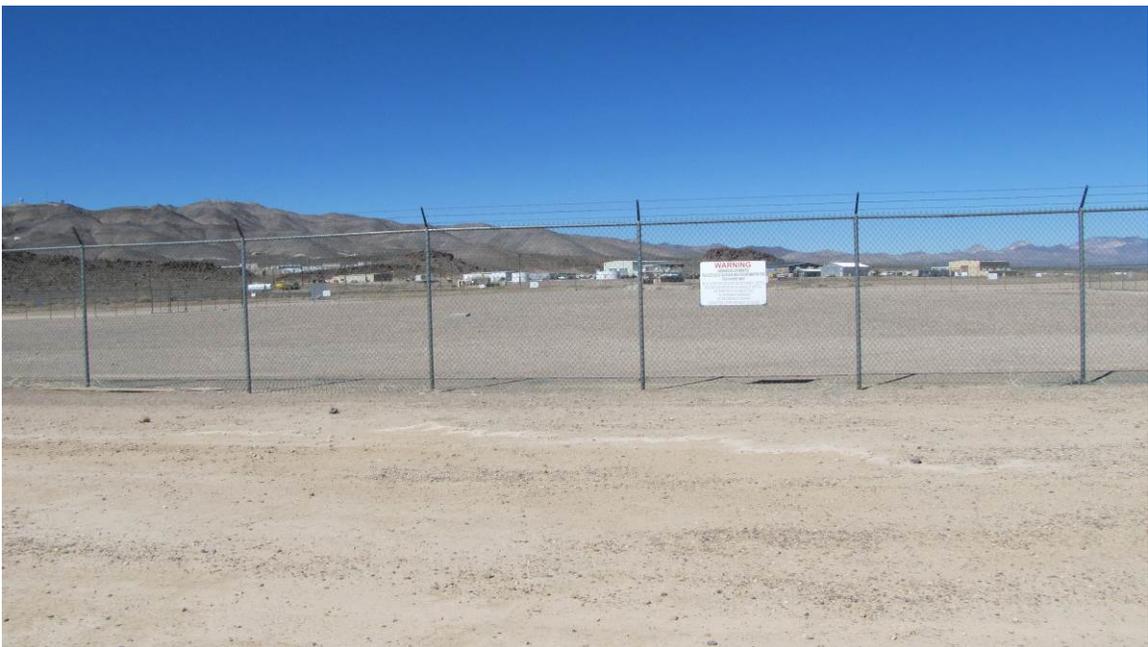
On February 28, 2014, 0.77 in. of precipitation was recorded. An inspection was conducted on March 3, 2014. This inspection was for both the precipitation event and the second quarterly inspection. No issues were observed. No maintenance or repairs were required.

Photograph 37: CAU 92, Outside Facing North, 03/03/2014

Photograph 38: CAU 92, Outside Facing East, 03/03/2014

Photograph 39: CAU 92, Outside Facing South, 03/03/2014

Photograph 40: CAU 92, Outside Facing West, 03/03/2014
