# Wyandotte Neighborhood Stabilization Program: Retrofit of Two Homes

A. Lukachko, A. Grin, and D. Bergey  
*Building Science Corporation*

April 2013

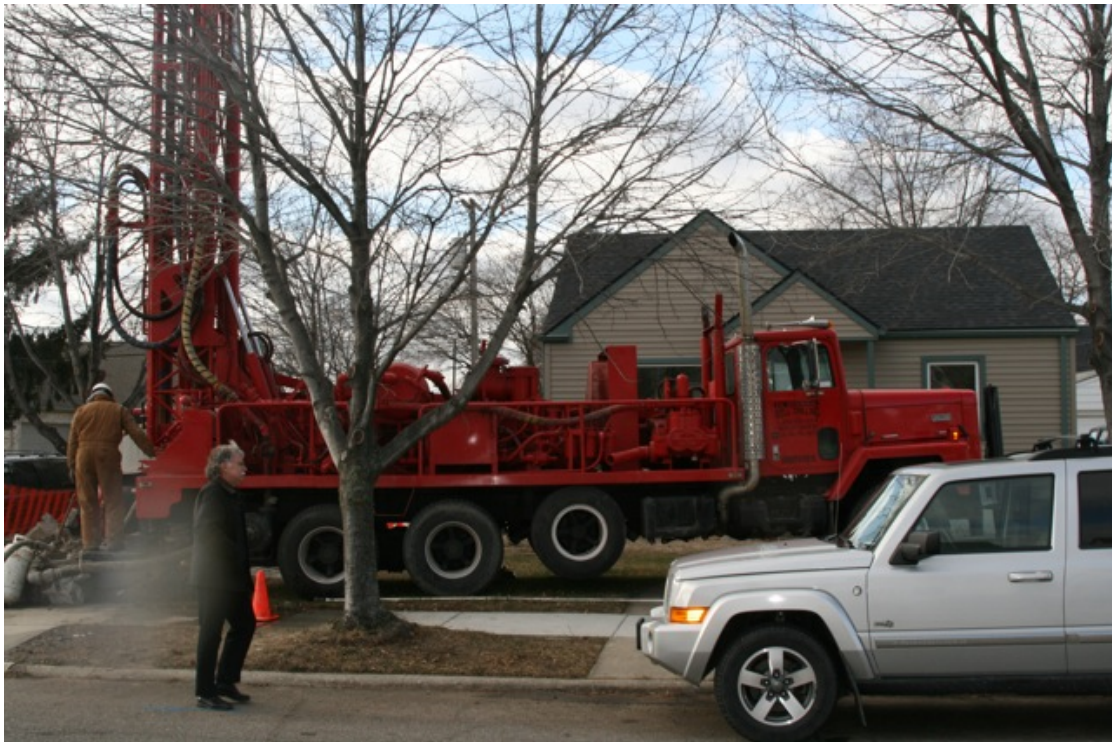
**Figure 6. Photograph of a well operation for a GSHP system in the NSP2 neighborhood**

As part of the project, the City of Wyandotte will drill vertical boreholes (see Figure 6) at each NSP2 project property in the City-owned portion of the front yard. These wells are estimated to support GSHP units totaling 6-8 tons. The expectation is that although each well will initially be connected to only one NSP2 house, in the long term, Wyandotte Municipal Services will connect two or three houses to each well and possibly join the wells together to create a district GSHP system. The utility will lease the heat exchanger back to the house occupants. In this way, the per-house cost of the system is reduced, and the cost is amortized over a longer period than most homebuyers or builders can accommodate. A more complete discussion of costs is provided in the following section. The energy efficiency of each NSP2 project is important because the load on the well will determine whether one or two additional houses can be added to the well. The City of Wyandotte has agreed to handle the long-term collection of energy use data for these homes and is interested in the possibility of engaging the National Renewable Energy Laboratory (NREL) to monitor the district GSHP system.

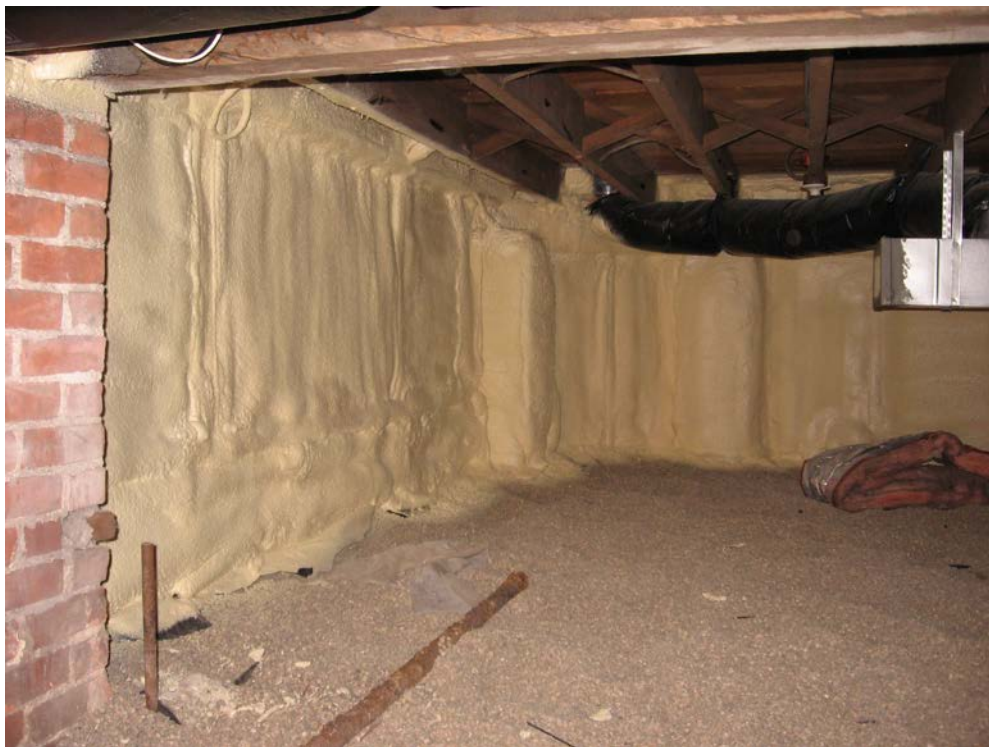
**Figure 13. Spray foam installation in conditioned crawlspace at Cedar 1**

The foundation existing pre-retrofit at Cedar 1 was a combination of an uninsulated basement accessed from the exterior at the rear of the house, and an un-insulated, vented crawlspace at the front of the house. The strategy for the crawlspace was to seal, insulate, and condition this area as a conditioned crawlspace. A polyethylene sheet was placed on top of the ground and overlapped by the spray foam as a complete air barrier.

spray foam was completed. BSC has recommended that insulation of the basement walls be completed prior to final testing of the house.

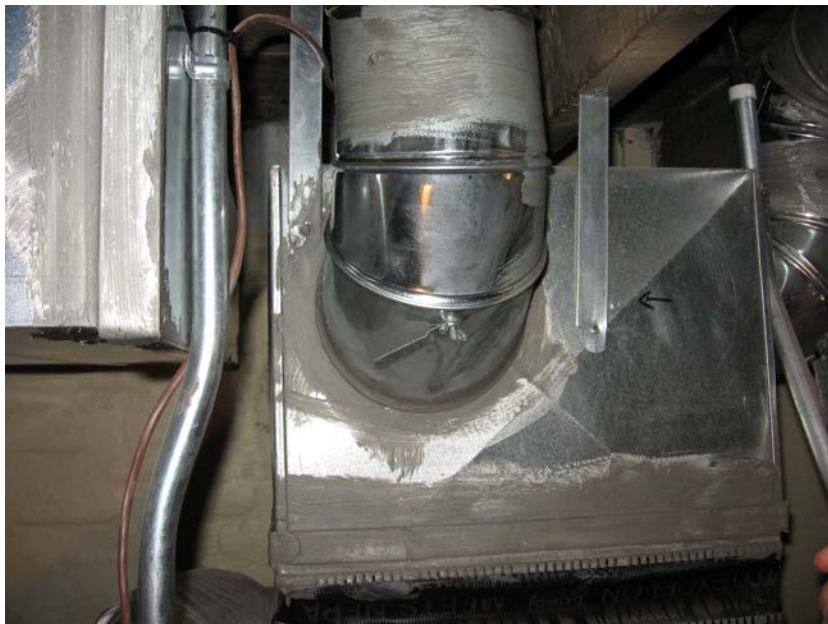
Figure 14. Typical ductwork sealing at takeoff from trunk; elbow to the site is sealed

The HVAC equipment—a GSHP, hot water tank, and air handler—were installed and commissioned by the installer in Cedar 1 but not Cedar 2 at the time of this report. As specified, all ductwork joints and seals have been sealed with mastic (see Figure 14 below). Pressure testing of the ductwork system has not been completed. All ductwork has been installed inside the thermal enclosure as specified.

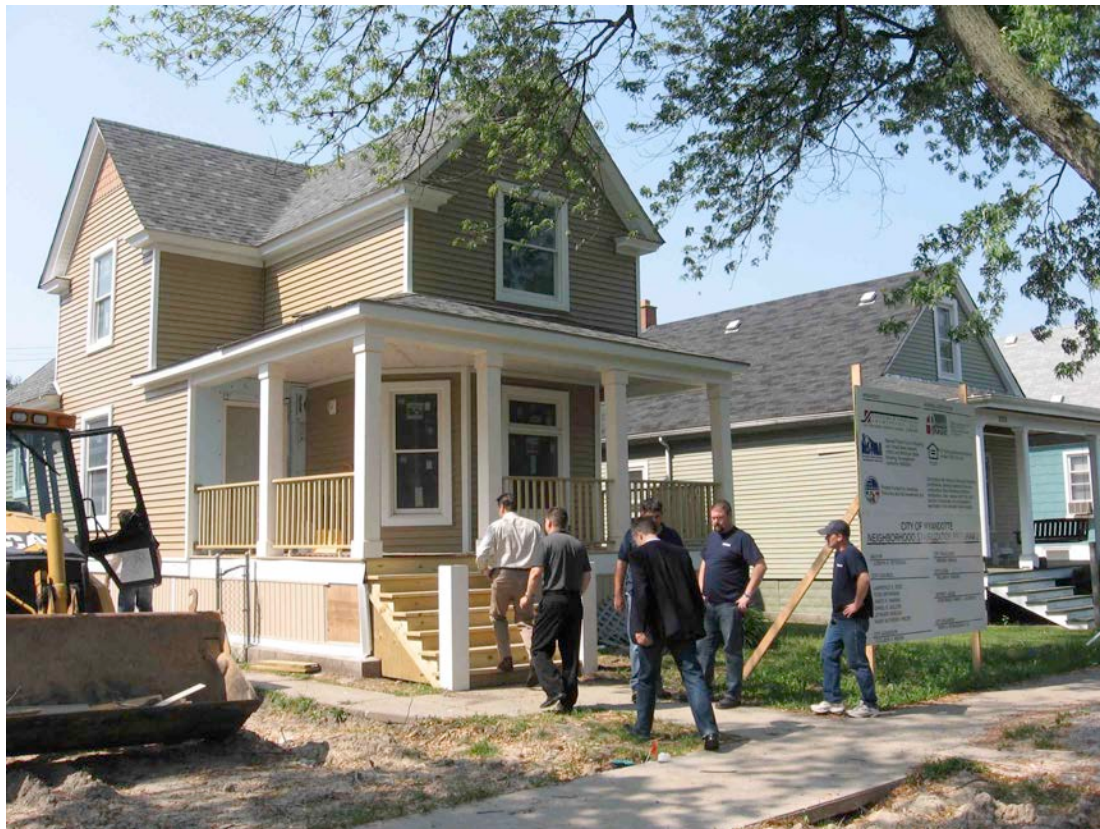
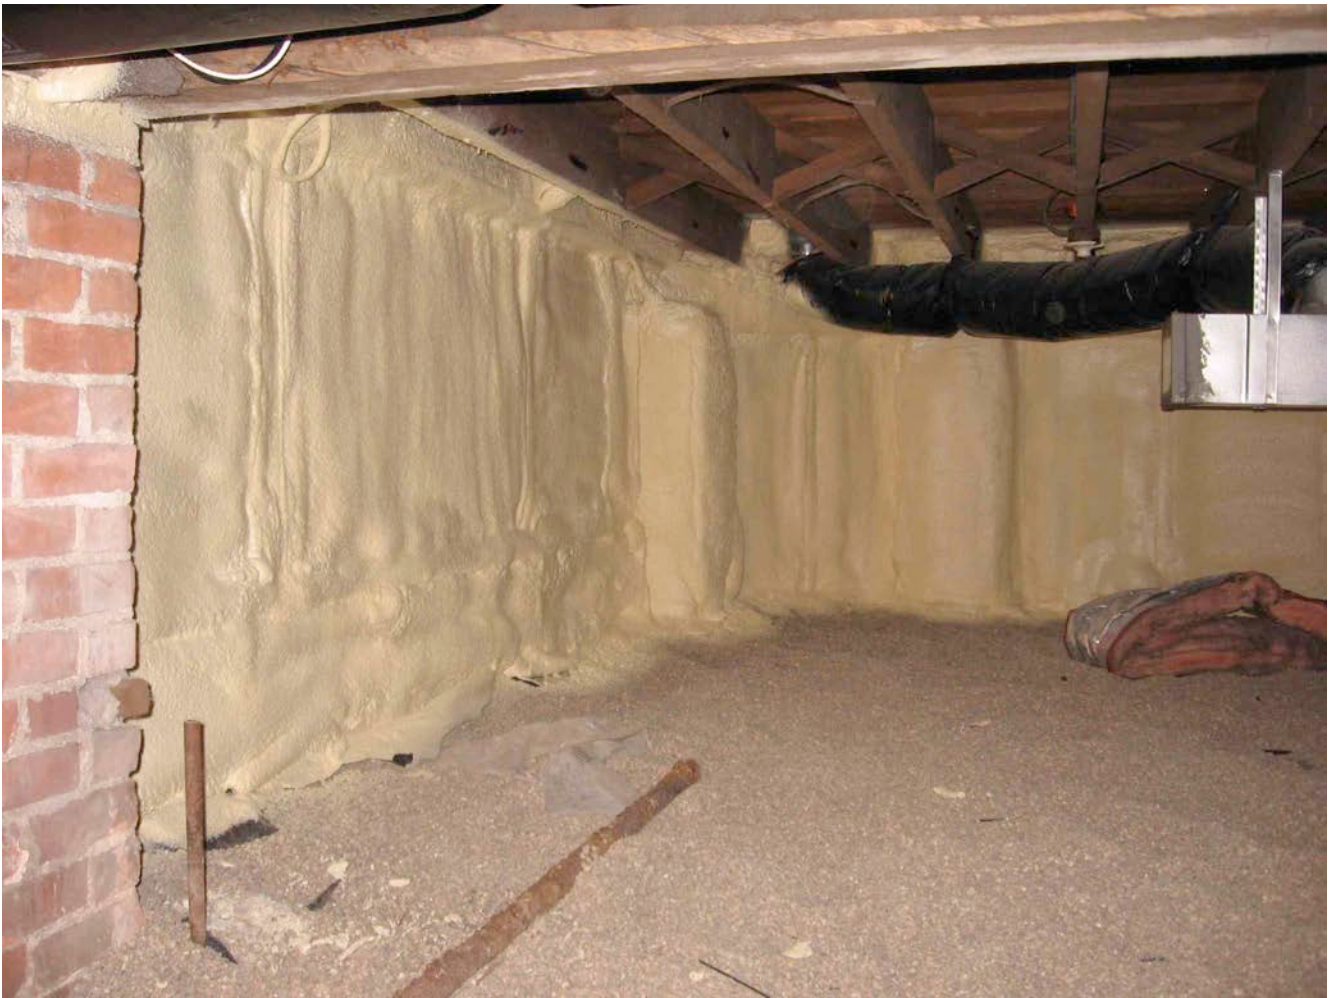
### 213 CEDAR STREET

This is a Bid Pack 1 retrofit project. Briefly, the house was gutted and refinished on the inside – full depth ccSPF in stud cavities. New mechanical including GSHP. The crawlspace was covered to a conditioned crawlspace. The attic was insulated as a conditioned attic. The roofing was new and left as found. The building was reclad with 1" of XPS and new vinyl. This house is ready for us to test on June 27 but we do not have pre-retrofit data on this house because construction was started during our funding gap.

There is a sheet of polyethylene under the pea gravel.

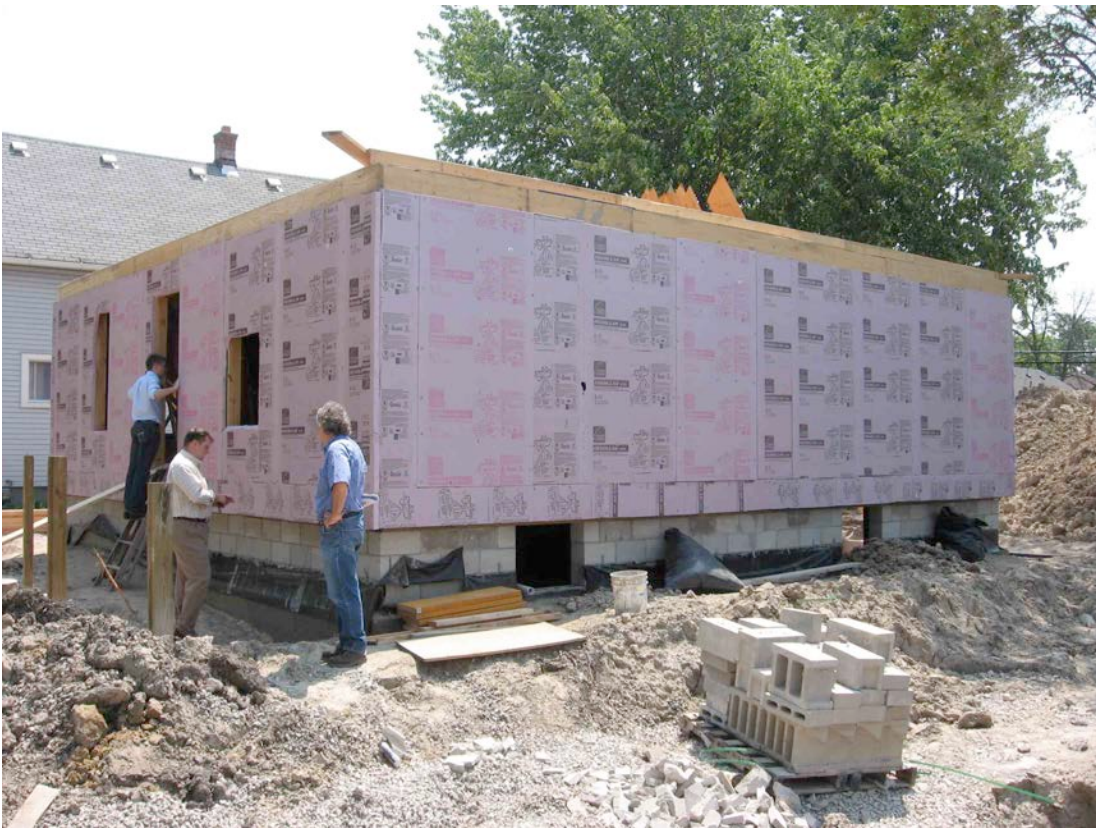
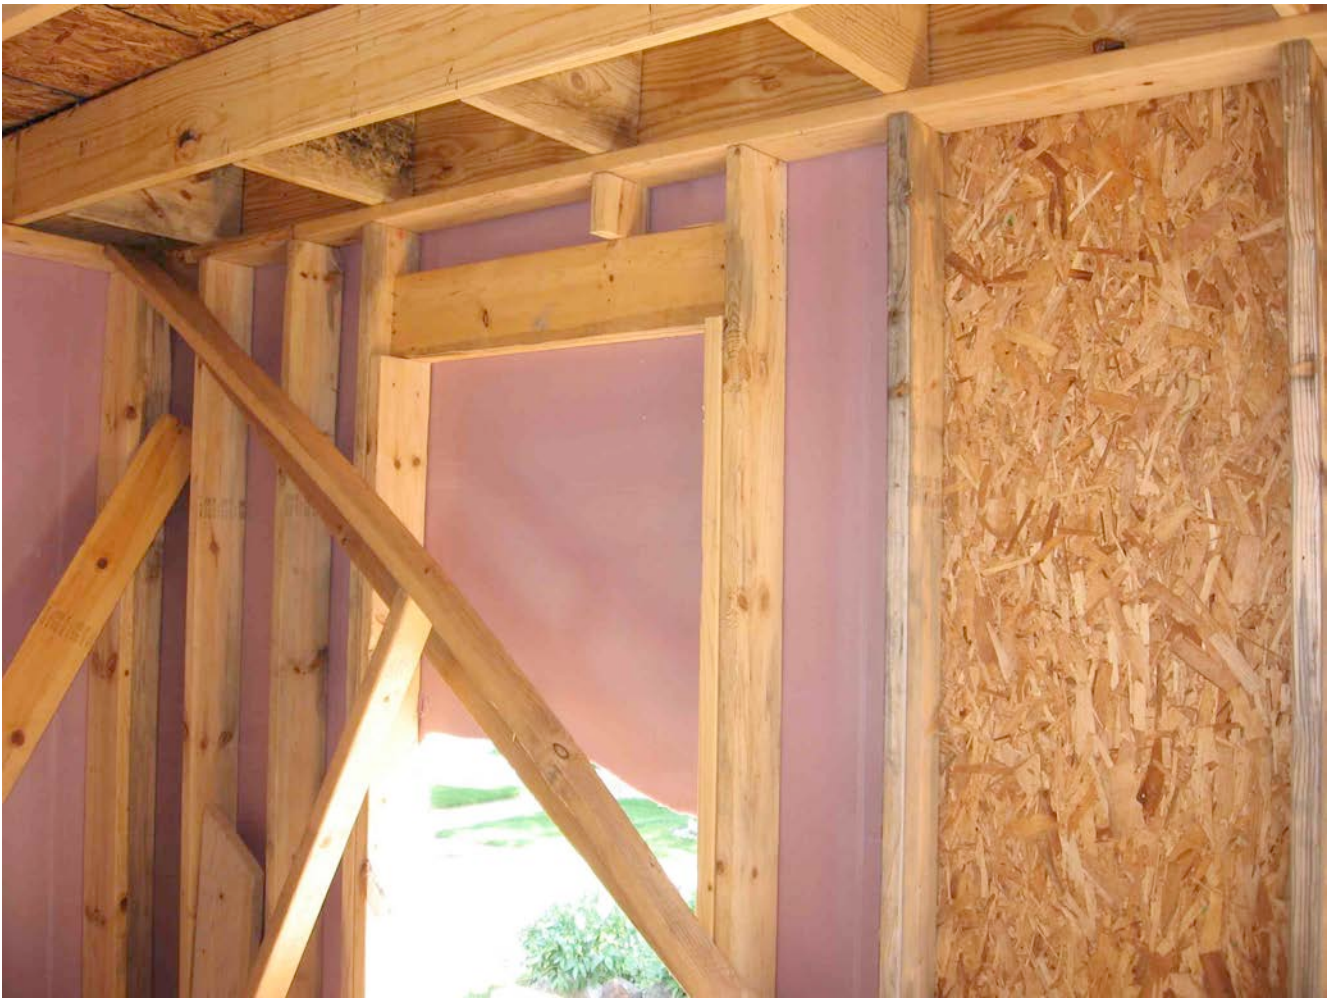
#### 247 & 257 WALNUT STREET

These are the first two new houses in the NSP2 project. There were a number of changes made to the framing on the first one. Framing of the second house should be smoother. The above-grade portion of the basement foundation wall will be finished with brick and insulated with Thermax on the interior. 2" XPS as insulating sheathing and 3-4" ccSPF on the interior.

The window opening framing will be corrected. They were having some issues with alignment of the framing between walls and floors. This has been largely corrected by the architect. The meeting on-site included the GC, the framing crew, the lumber supplier, the mason, the architects and the City project manager. We talked through all of the details and gave them some guidance on corrections that need to be made. Aaron will issue a brief report to the architect with photos to help them with their site review. A major issue was that no framing drawings were produced. We discussed the value of this and it seems that everyone now understands what level of planning is required for these houses.

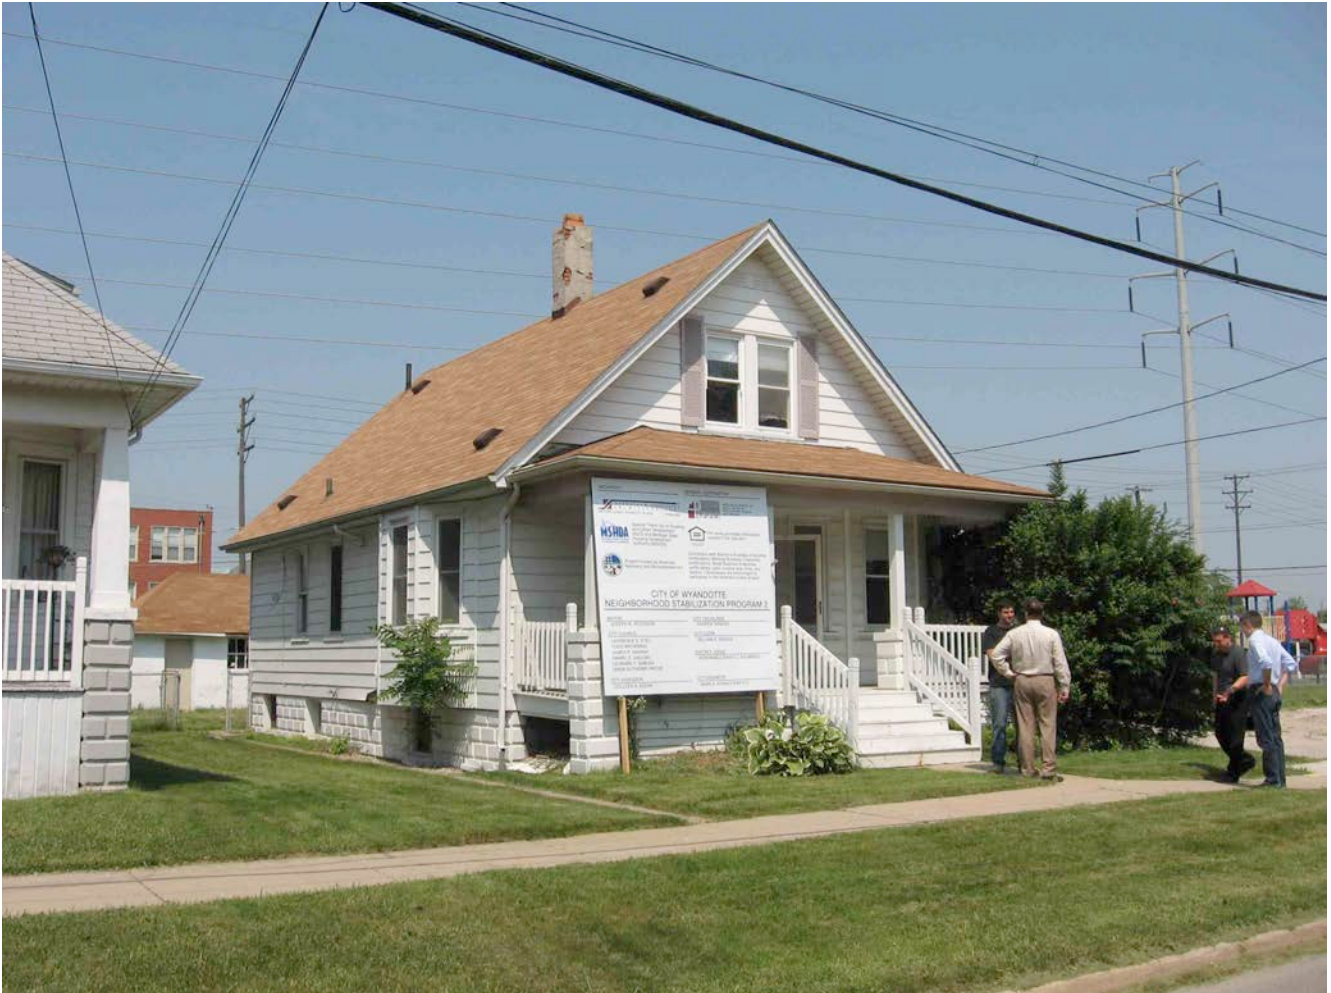
This house has been assigned as part of Bid Pack 2, which was awarded to the builder who is completing work on the first houses mentioned in this report. This house will be a full rebuild from the interior with minor repairs to the exterior cladding. The basement has obvious water intrusion issues and the City is considering both trenching the exterior to install damproofing and replacing the concrete floor slab to install insulation and a capillary break.

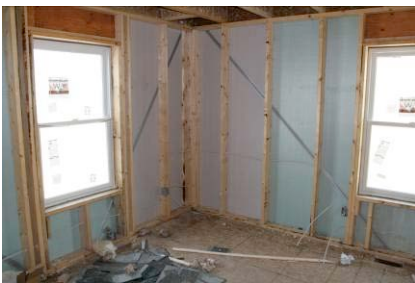
During the August 22<sup>nd</sup> visit the framing of 456 Vinewood was reviewed. It was found that a new structural sheathing product was being used on this home. The structural OSB sheathing appears to have been replaced with Dow SIS although this could not be confirmed as the labeled side of the product is covered on the outside.

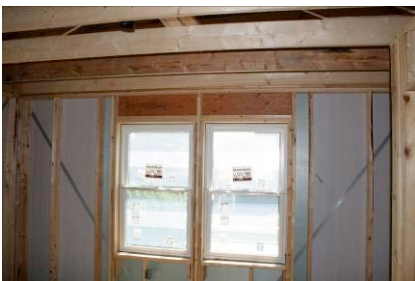
In terms of advanced framing the learning curve for this builder is evident on this home as very little was found in terms of deficiencies. The main deficiency found was the unnecessary installation of relatively heavy-duty manufactured headers above windows in non-load bearing walls. This was found on both the front and back of the house where it appears these walls are in gables and are non-load bearing. The removal of these headers has the potential to reduce construction costs. These findings were discussed with Tony Pizzo of Pizzo Construction. These findings will be discussed with Sarnacki Architects.

2011-08-22 – Unnecessary header above a window in a non-load bearing wall

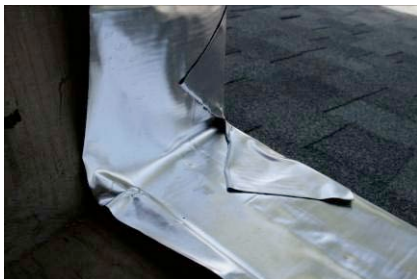
A window on the second floor had not been installed yet allowing a review of the sub-sill flashing. Care must be taken to ensure reversed flashings, gaps, or fish mouths do not occur. Shown in the photo below, a gap has been left in the corner flashing of the sub-sill flashing. This has the potential to direct water on the subsill flashing behind the insulating sheathing which is intended to be the drainage plane. This has the potential to cause moisture related damage to the structural sheathing.

2011-08-28 – Gap in corner flashing

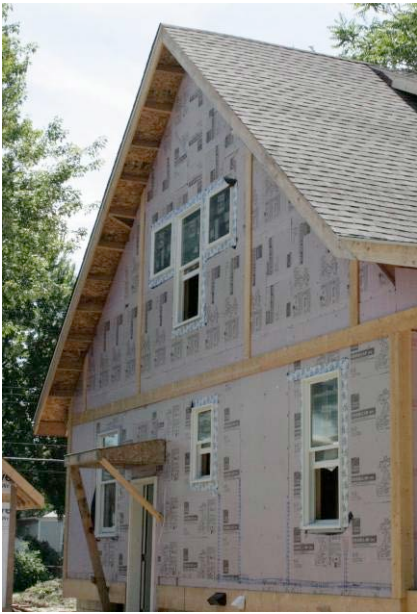
Water management details at the windows need some improvement - flashing was observed to be sealing the bottom of the window, rather than being drained. It was recommended that the flashing across the bottom of the window be slit or removed completely. BSC also recommended back dams on window openings. As recommended the flashing across the bottom of the window was removed in most areas. The east facing windows of the home on the first and second floor still require that the flashings along the bottoms of the windows be removed. There also areas within the field of the wall where the joints between the sheets of XPS must be sealed as the primary drainage plane. The windows above the front porch also require attention to repair the flashings.

Areas where flashings below the windows need to be removed

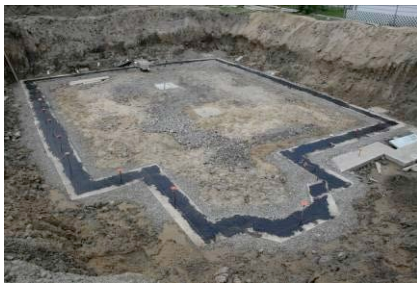
2011-08-22 – Footings complete with capillary break

During the August 22<sup>nd</sup> site visit it was found that the footings were complete for this house. A capillary break was adequately installed in the form of a roller applied product.

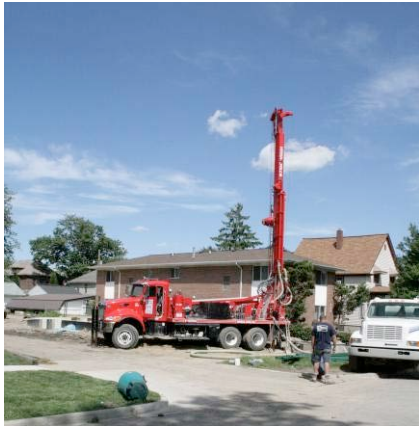
2011-08-22 – Drilling of the geothermal wells in progress

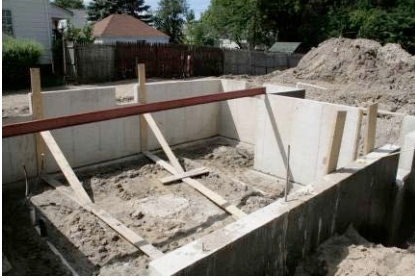
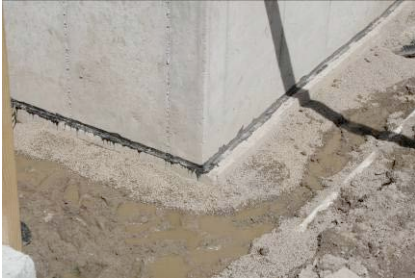
2011-08-22 – Foundation and basement floor complete. It appears that the capillary break was not properly installed between the footing and the foundation.

During the August 22<sup>nd</sup> site visit it was found that the poured foundation was complete for this house. Exterior damproofing was complete but it appeared that the footing capillary break was improperly installed at the inside joint between the footing and the foundation rather than between the footing and the foundation before the foundation was poured. The crack appears to be due to the fact that the foundation was back filled before the floor of the house was installed and, as reported by Ralph Hope, before shoring was installed.

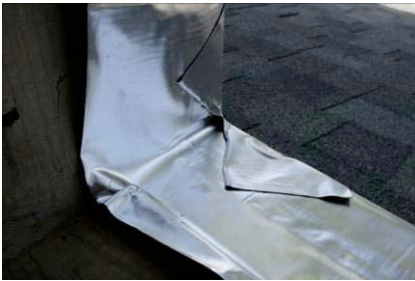
A window on the second floor had not been installed yet allowing a review of the sub-sill flashing. Care must be taken to ensure reversed flashings, gaps, or fish mouths do not occur. Shown in the photo below, a gap has been left in the corner flashing of the sub-sill flashing. This has the potential to direct water on the subsill flashing behind the insulating sheathing which is intended to be the drainage plane. This has the potential to cause moisture related damage to the structural sheathing.

2011-08-28 – Gap in corner flashing

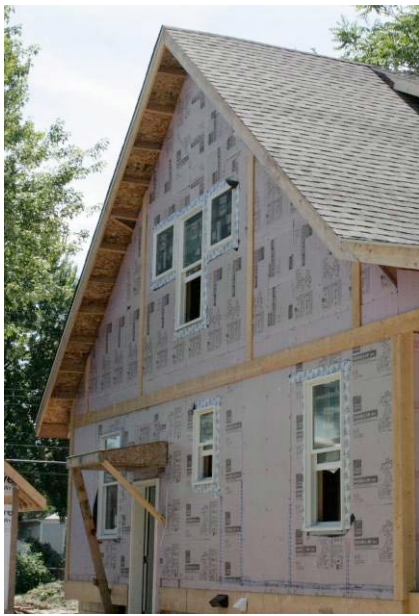
Water management details at the windows need some improvement - flashing was observed to be sealing the bottom of the window, rather than being drained. It was recommended that the flashing across the bottom of the window be slit or removed completely. BSC also recommended back dams on window openings. As recommended the flashing across the bottom of the window was removed in most areas. The east facing windows of the home on the first and second floor still require that the flashings along the bottoms of the windows be removed. There also areas within the field of the wall where the joints between the sheets of XPS must be sealed as the primary drainage plane. The windows above the front porch also require attention to repair the flashings.

Areas where flashings below the windows need to be removed

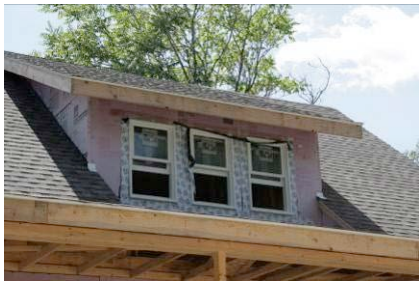
Windows above front porch requiring remediation

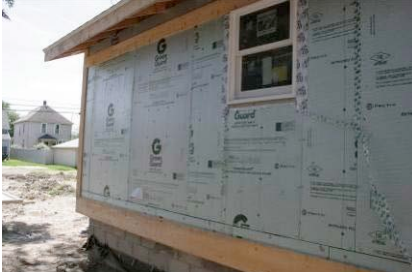
| 257 Walnut | |
|---|---|
| | <p>Failing and completely missing tape</p> |

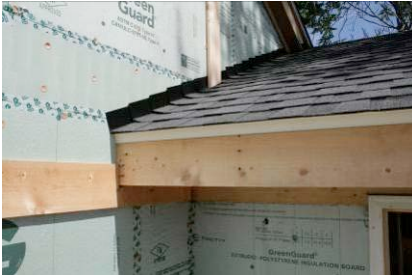
| 257 Walnut | |
|---|---|
| | <p>Step flashing requiring integration to the drainage plane. Details to finish this flashing with a regletted cap flashing and tape can be found at:</p> <p><a href="http://www.buildingscience.com/documents/information-sheets/common-flashing-details/files/bsc_info_303_common_flashing.pdf">http://www.buildingscience.com/documents/information-sheets/common-flashing-details/files/bsc_info_303_common_flashing.pdf</a></p> |

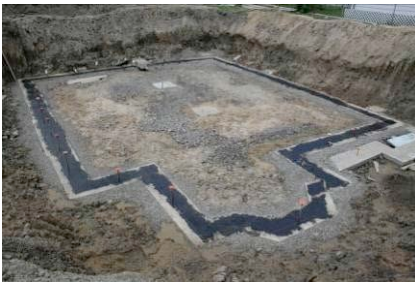
#### 2446 8th Street (South, west side of the road)

2011-08-22 – Footings complete with capillary break  
2011-10-06 – Foundation complete, nothing else to report

During the August 22<sup>nd</sup> site visit it was found that the footings were complete for this house. A capillary break was adequately installed in the form of a roller applied product. It was observed during the October visit that the foundation for this house was installed.

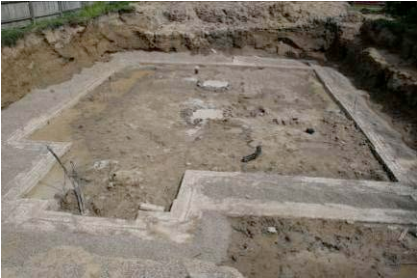
| 2325 8th Street (North, east side of the road) | |

| 2325 8th Street (North, east side of the road) | |
|---|---|
| | <p>2011-08-22 – Footings complete missing capillary break</p> <p>2011-10-06 – Foundation complete, nothing else to report</p> |

During the August 22<sup>nd</sup> site visit it was found that the footings were complete for this house. A capillary break not installed for this footing. This information was relayed to Ralph Hope for remediation. It was observed during the October visit that the foundation for this house was installed.

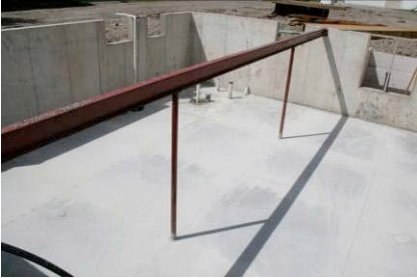
| 234 Chestnut | |

| 234 Chestnut | |
|---|---|
| | <p>2011-08-22 – Foundation and basement floor complete. The status of the capillary break is unknown</p> <p>2011-10-06 – Site not visited during this trip</p> |

During the August 22<sup>nd</sup> site visit it was found that the poured foundation was complete for this house. Exterior dampproofing was complete but it could not be determined if a footing capillary break was installed as the basement slab was already poured. This site was not visited during the October site visits.

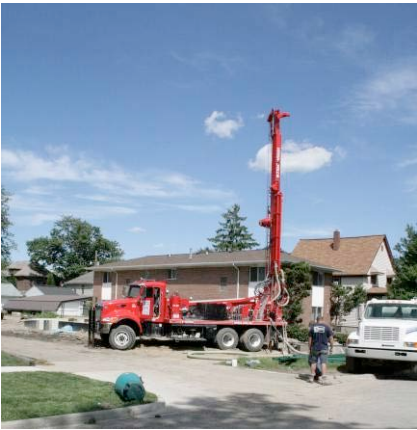
| 234 Chestnut | |
|---|---|
| | <p>2011-08-22 – Drilling of the geothermal wells in progress</p> |

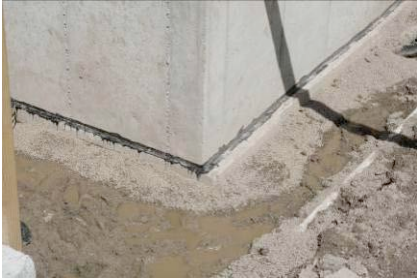
2011-08-22 – Foundation and basement floor complete. It appears that the capillary break was not properly installed between the footing and the foundation.

During the August 22<sup>nd</sup> site visit it was found that the poured foundation was complete for this house. Exterior dampproofing was complete but it appeared that the footing capillary break was improperly installed at the inside joint between the footing and the foundation rather than between the footing and the foundation before the foundation was poured. The crack appears to be due to the fact that the foundation was back filled before the floor of the house was installed and, as reported by Ralph Hope, before shoring was installed.

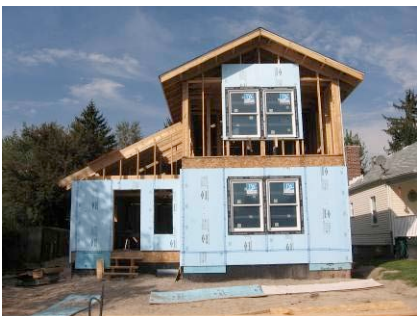
2011-10-06 – Framing substantially complete. Insulated sheathing was removed in locations to determine fastening pattern for SIS.

During the October site visit this site seemed to be in a state of disassembly and repair. Sections of roofing were left uninstalled. Areas of the exterior insulation and SIS had been removed while the electrical and mechanical was at rough-in.

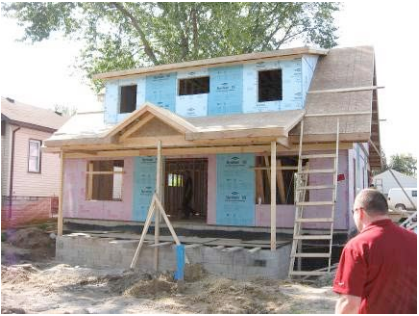
| 2250 Cora Street | |

| 2250 Cora Street | |
|---|---|
| | 2011-10-06 – Foundation complete, framing nearing completion. |

During the October site visit this house was found to be nearing framing completion. This was a first try for the framer on-site and overall there were very few issues with the home. Some design issues were determined on-site, but do not require major repair. 1" of exterior insulation is used on this home because the design created for this home was developed during the initial design process with the city of Wyandotte when it was unclear how much funding would be available for energy saving upgrades. During the construction process it was found that the construction would be significantly simplified and increase the available headroom on the second floor if the two planned dormers became one large dormer as shown in the photo above. This framing package is the first completed that has a hung main floor framing system to minimize the rise of the first floor from grade allowing this unit to be fully wheelchair accessible.

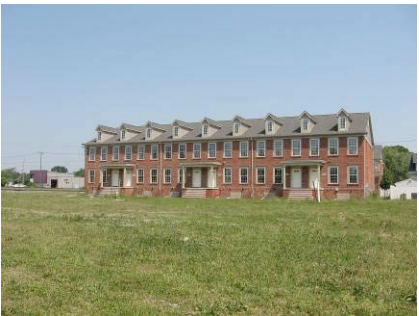
| Vinewood Condos | |

| Vinewood Condos | |
|---|---|
| | 2011-10-06 – Preliminary walk through completed of units without drywall or insulation. Blower door test completed of a single interior unit which was substantially complete. |

A finished blower door test was completed on October 6th. The results of this blower door test showed an estimated leakage rate of 1803 CFM at 50Pa. This correlates to an approximate 5 ACH at 50Pa. Areas of leakage found included the window to window rough framing where it appears no sealant is provided and interior partitions on the second floor which connect to the attic space. The windows should be sealed with low expansion foam while the partitions intersecting the attic space should be sealed with closed cell spray foam from the attic side. It is likely that the rim joists are also sources of leakage, but to seal this area would require removal of interior drywall to properly seal.
