# Field Testing of an Unvented Roof with Fibrous Insulation, Tiles, and Vapor Diffusion Venting

K. Ueno and J. W. Lstiburek  
*Building Science Corporation*

February 2016

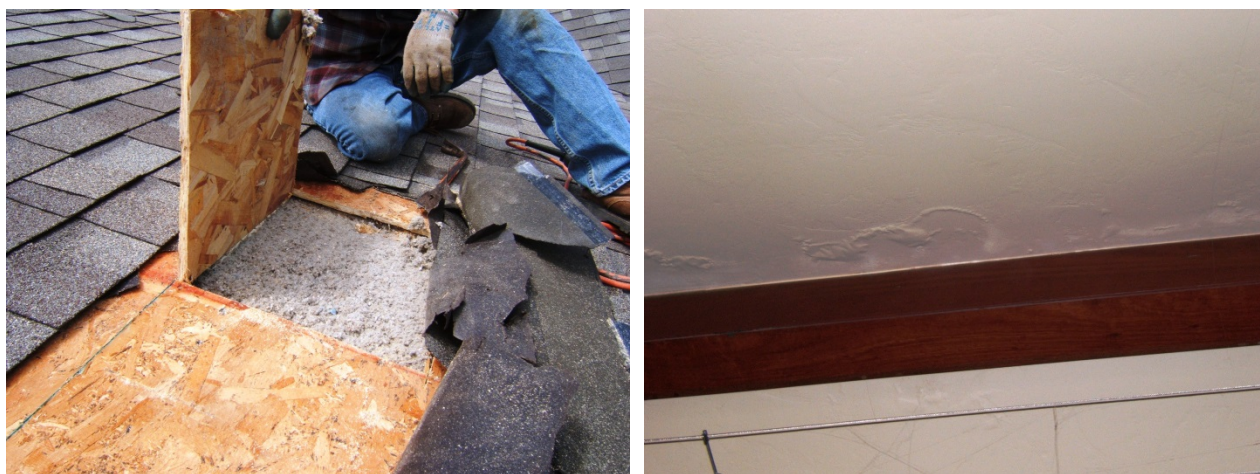
**Figure 12. Dry sheathing lower at roof (left); interior ridge conditions (right)**

These issues arose soon after construction (during the first winter); the problems were manifested as paint blistering at the interior gypsum wallboard (GWB) near the roof (Figure 12, right), because the accumulated condensation dripped. The issue was definitely localized at the ridge of the roof; disassembly at a lower section of the roof showed dry sheathing conditions (Figure 12, left). Air barrier imperfections at the interior GWB (especially at the ridge board interruption) were contributing factors.

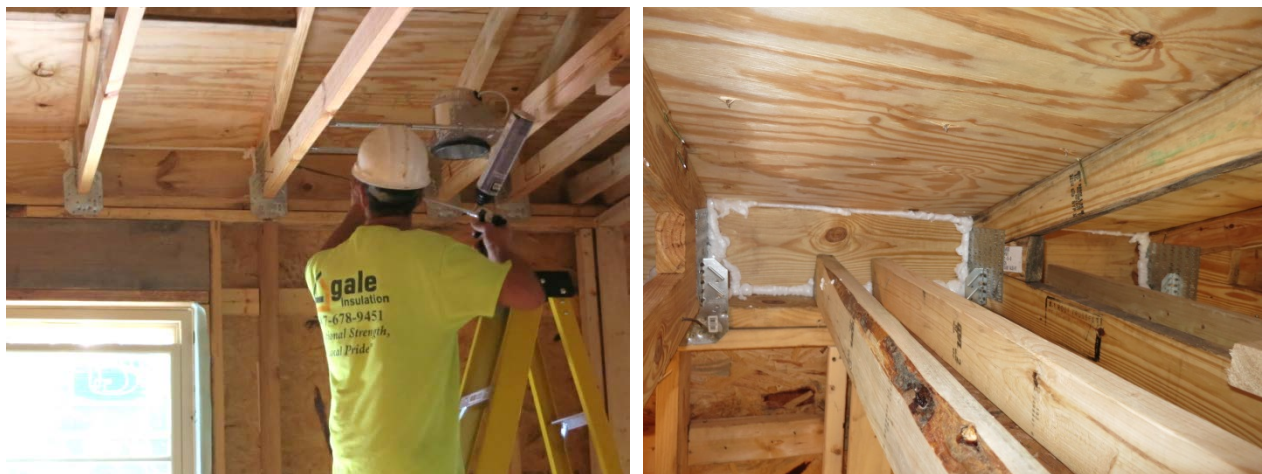
**Figure 19. Air sealing roof-to-wall connection; note 2x blocking and single-component foam**

At the roof-wall (eave/overhang) interface, the air barrier connection was made using 2x wood blocking between the wall top plate and roof sheathing; gaps were filled with single-component urethane foam (Figure 19). Two-component SPF was used at this connection in other projects, which would have provided more effective coverage and air sealing and possibly more resistance to long-term movement.

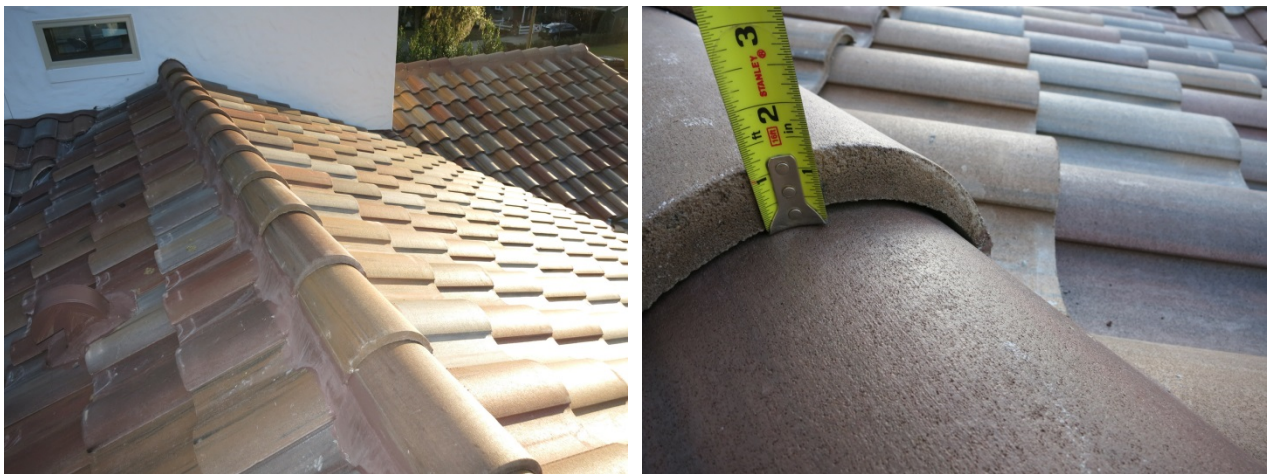
**Figure 26. Completed roof ridge tile geometry (left); gaps in ridge tile (right)**

At the ridge metal channel (Figure 25 right), some type of open-weave mortar mesh was placed between the metal and the roof tile to ensure an open air channel for lateral airflow. Air flows under the roof tiles and exits through the gaps between the ridge tiles.

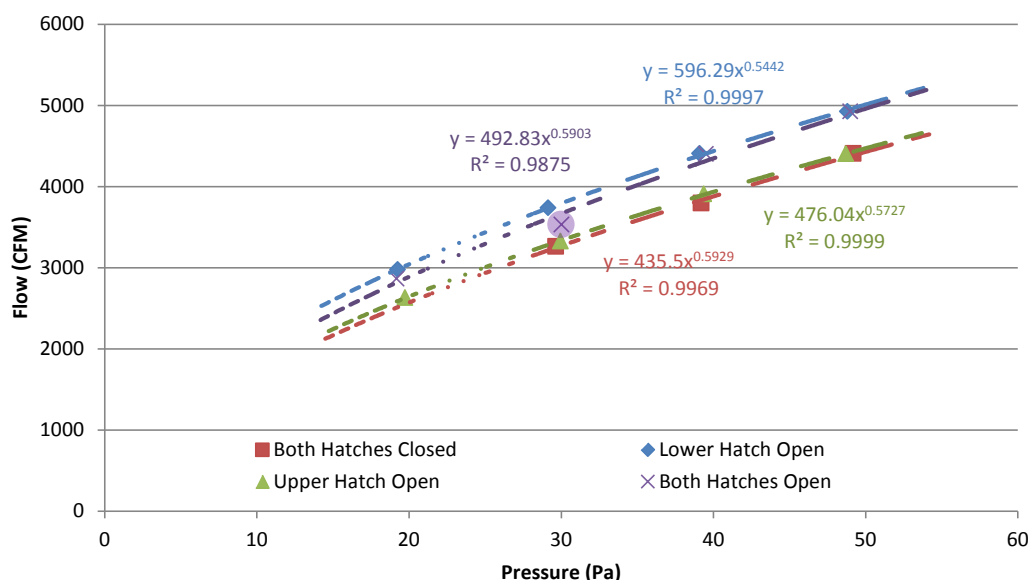
**Figure 35. Hatch open/hatch closed multipoint testing with curve fits**

The results of the four multipoint tests are shown in Figure 35; the exponential curve fits were used to calculate C (coefficient) and n (exponent) values.

The final test (both hatches open) was first calculated to be more airtight than the one hatch open test (an unreasonable result). However, after removing an outlier data point (highlighted in Figure 35, “select data” in Table 3), the results of the two tests were almost identical.

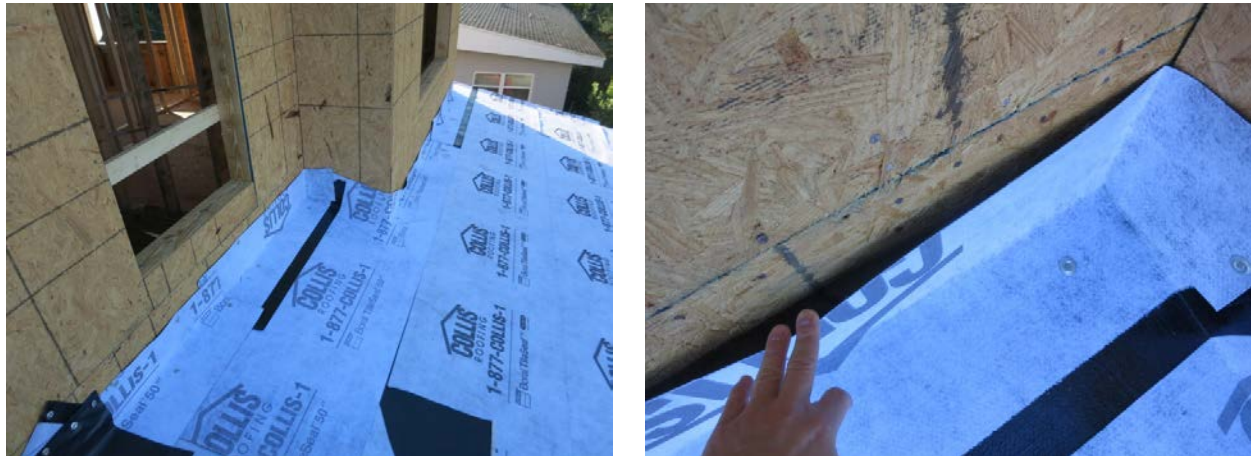
**Figure 46. Construction image of roof-wall interface self-adhered membrane (Location E)**

The presence of roof-wall leakage was originally puzzling, given the use of a self-adhered roof membrane that laps onto the wall sheathing. However, examination of construction photos (taken at Location E; Figure 46) showed that membrane adhesion to the vertical wall surface was not consistent; gaps and openings sometimes occurred. Although this detail would provide excellent service for rain control (assuming shingle lapping of the house wrap onto the roof membrane), it was apparently not sufficient for air barrier detailing.

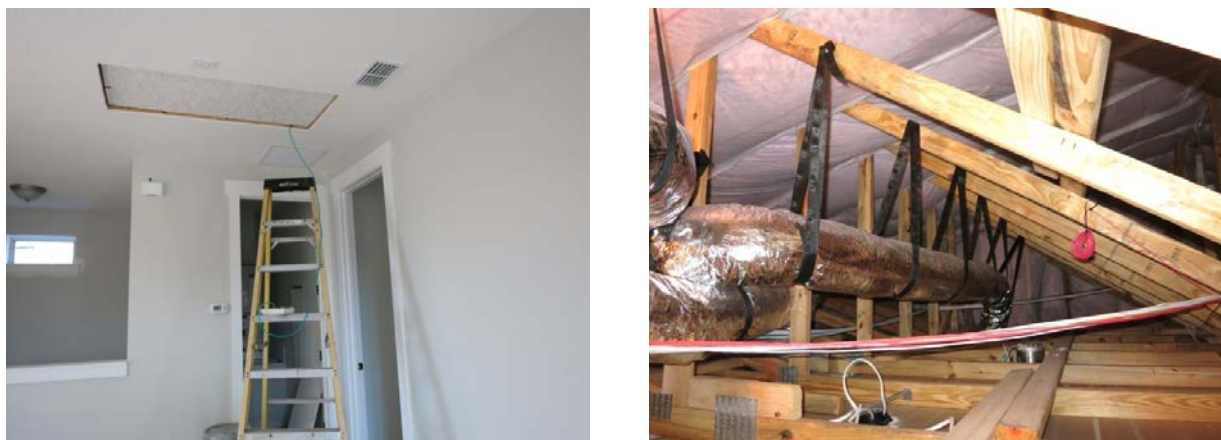
**Figure 47. Upper attic  $\Delta P$  measurement (left); ductwork located in upper attic (right)**

The baseline (fan off) measurements of attic pressure (with respect to the main space) varied from 0 Pa to  $-0.1$  Pa. The measurements after turning on the air handling unit were essentially unchanged (0 Pa typical), indicating that any pressurization or depressurization caused by air handling unit operation in this house is minor.

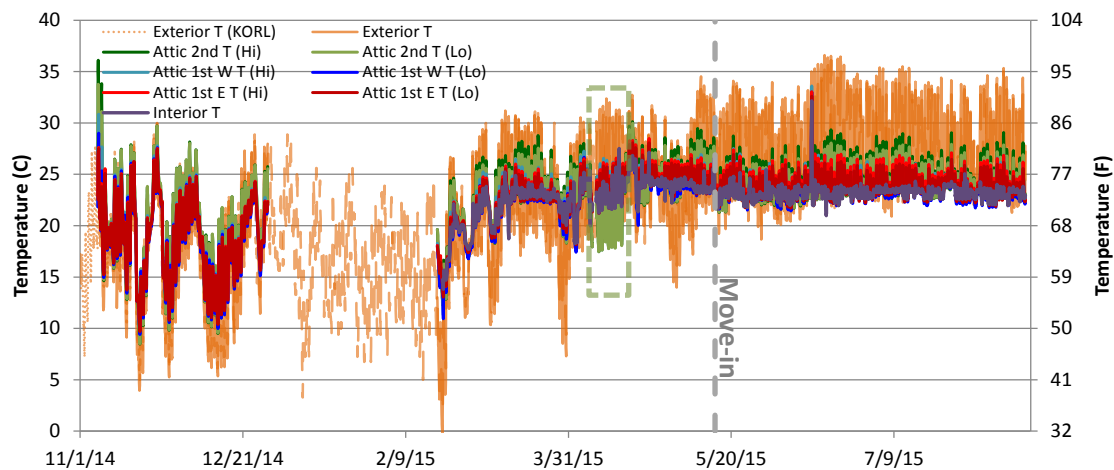
**Figure 48. Exterior, attic, and main conditioned space temperatures**

There was a temperature anomaly in April 2015, when the second-floor attic (“Attic 2<sup>nd</sup> T”) temperatures dropped to near-ambient conditions (highlighted in green in Figure 48). This was ascribed to painting work with open windows and an open attic hatch (per the site supervisor).

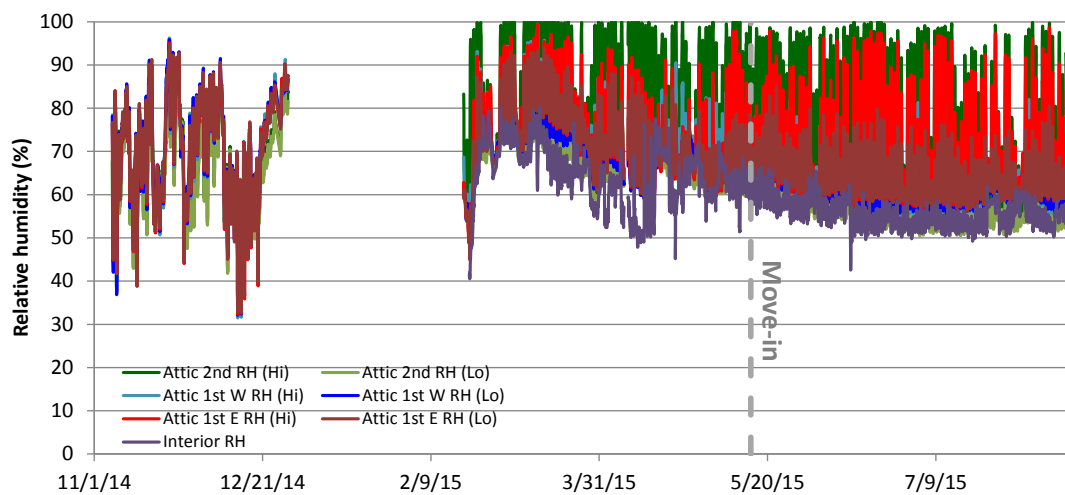
**Figure 51. Attic and main conditioned space RH**

Interior RH is plotted in Figure 51; after the data gap (post mid-February 2015). Attic RHs oscillate between very high (90%–100%) and lower (75%–80%) levels on a diurnal cycle. This period includes conditioned and unconditioned periods; the thermostat was apparently set for cooling only, and the system was operated intermittently (see interior temperatures in Figure 48). After the cooling system was put in operation, interior space RH dropped slowly over time (from roughly 70% to 50%–60%). However, attic peak RHs still cycled up to the 90%–100% range.

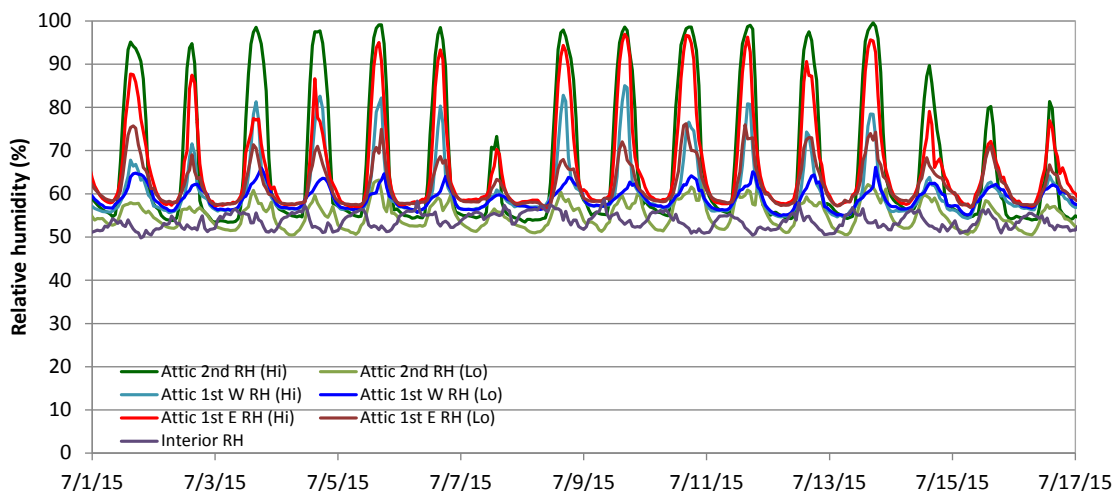
**Figure 52. Attic and main conditioned space RH, July 2015 detail**

A detail of July RH data (Figure 52) shows that interior RHs are well controlled (50%–60%), but several attic sensors have daily peaks up to 90%–100% RH. The highest RH readings are associated with sensors capturing the upper one-third of attic air conditions (Hi sensors). In contrast, lower one-third (Lo) sensors have less pronounced peaks. These patterns are discussed further below.

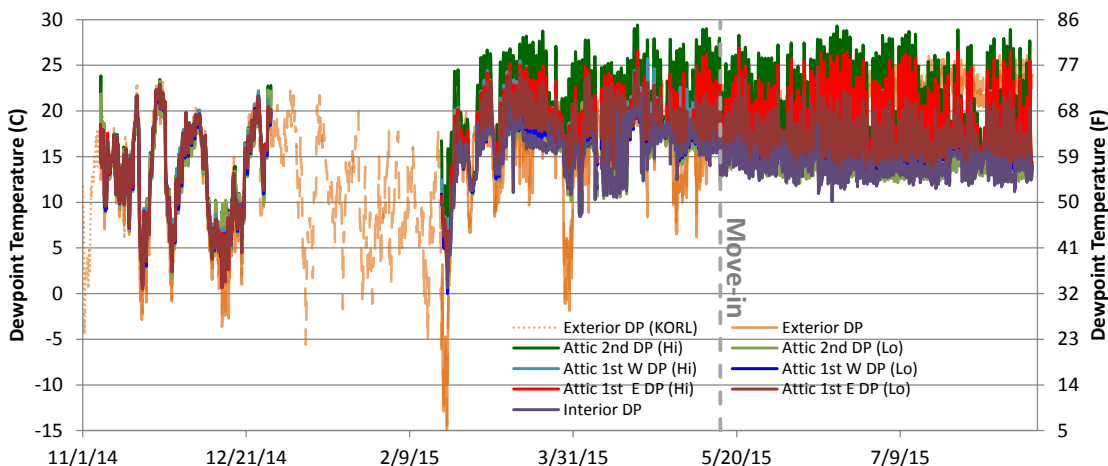
**Figure 53. Exterior, attic, and main conditioned space dew point temperatures**

Further insight can be gleaned by plotting moisture conditions in terms of absolute air moisture content (dew point), which removes temperature-RH effects, and allows comparisons with outdoor conditions (Figure 53). The initial data (pre-January 2015) show identical conditions between interior and exterior dew points; after resumption of data collection (February 2015), interior dew points are higher than exterior. The site supervisor confirmed that drywall mudding and interior painting occurred during the missing data period (i.e., construction moisture created interior moisture loads). Similar to RH plots, interior conditions are drier than attic conditions and show a gradual decline over the cooling season.

Overall, the boundary condition measurements show that the upper/second-floor attic has the highest risk of cold-weather condensation issues, because it has the highest dew points (air moisture content) from construction moisture. This is consistent with the upper/second-floor attic being (a) a relatively airtight and (b) located at the top of the conditioned space (i.e., moisture

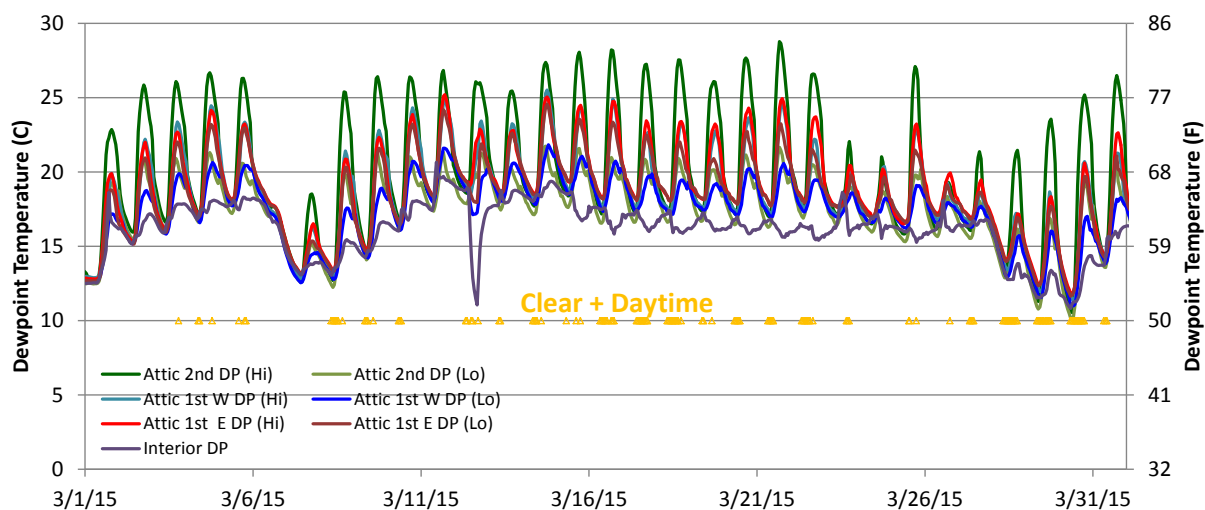
**Figure 54. Attic and main space dew point temperatures (March 2015) with sky conditions**

A close-up of March 2015 dew point data is shown in Figure 54: interior dew points exhibit a diurnal cycle; the peaks in these data are typically at 5–6 p.m., which is a rough match to sunset.

The diurnal moisture cycling also highlights differences between the three attic locations; the highest dew points are seen at attic 2<sup>nd</sup> (high). In any given high/low pairing, the high measurement has a higher dew point. These observations are consistent with moisture stratification and buoyancy within the attics, as described by Lstiburek (2014). The high dew points in the second-floor attic are due to a combination of greater airtightness (as measured previously), and location at the highest point of the conditioned space. The dew points of attic 1<sup>st</sup> west (W) are the lowest and show little stratification (high/low difference). It is the shortest attic, with only 19 in. between the high and low sensors. Interior dew points are the driest, because this space receives direct space conditioning (and therefore dehumidification during cooling).

The diurnal cycles are not consistent day to day; some days have much more pronounced dew point spikes. Weather data (from KORL) were plotted with marker points on hours with “Clear” sky conditions during daylight hours (“Clear + Daytime”; gold dots) in Figure 54. This figure shows days with minimal dew point spikes were typically overcast conditions (e.g., March 24 and March 25). This is consistent with dew point rise being caused by moisture driven out of the roof sheathing by solar gain and temperature rise.

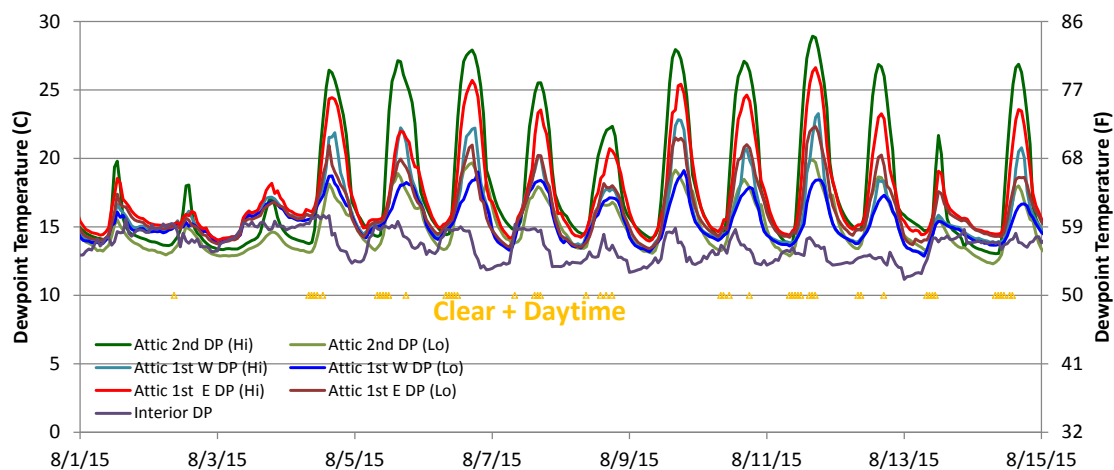
**Figure 55. Attic and main space dew point temperatures (August 2015) with sky conditions**

This pattern is also seen in summertime data, such as an August excerpt (Figure 55). Large dew point spikes typically coincided with clear daytime conditions. The same relative attic dew point patterns are seen. The effect of solar gain could also be gauged by plotting roof sheathing temperature.

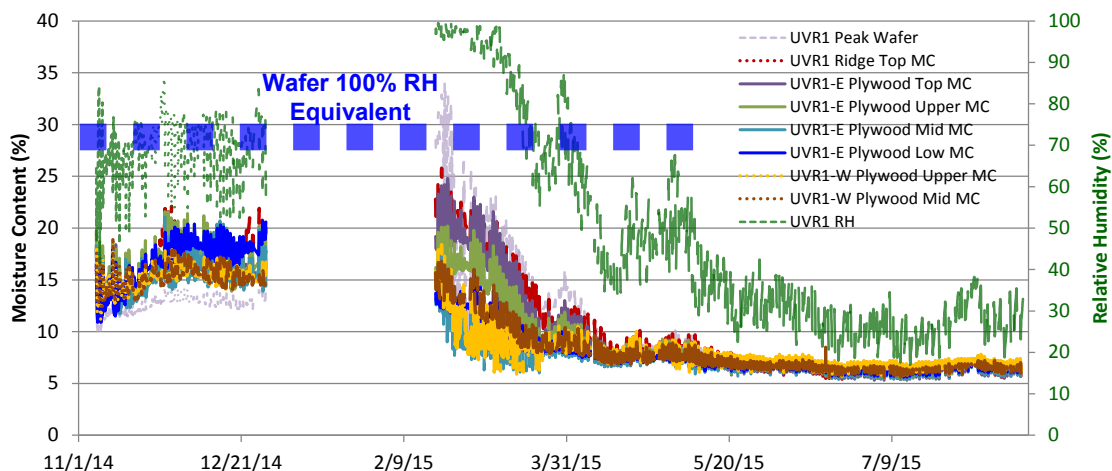
**Figure 59. Unvented roof (UVR1) MC and RH measurements (second-floor attic)**

Prior to the data gap (with low interior moisture conditions), wood MCs remained mostly below 20% with corresponding RHs. But after the gap (high interior moisture), significant moisture accumulation occurred at the ridge. This is indicated by wood MCs near the ridge in the 20%–25% range, wafer measurements higher than 30% MC, and ridge RH in the 95%–100% range. These high moisture conditions correlate with some of the coldest days of the winter (Figure 48). As outdoor temperatures increased, all these MCs fell. By early May 2015, all wood MCs were lower than 10% (completely safe range), and RHs were in the 30%–50% range. Dry conditions were seen throughout the remainder of the summer.

The ridge wafer measurements can be related to qualitative moisture conditions. In a previous calibration (Ueno and Straube 2008), the wafer sensors came to equilibrium with 100% RH conditions (air in a closed container over water) at 28%–30% MC (blue dotted line in Figure 59). However, immersing the sensors in liquid water increased their MC to the 40%–45% range. Therefore, measurements higher than the 100% RH-equivalent range (28%–30%) may have indicated liquid water condensation, and higher than 40% strongly indicated liquid water wetting. The measurements in the unvented roof showed possible condensation followed by drying in the springtime.

The ridge top MCs (red dotted data) are among the driest in the diffusion vent roofs but one of the wettest in the unvented roof (Figure 59). This is consistent with interior-sourced moisture accumulation at the ridge (in UVR1) versus high localized drying directly under the permeable roof membrane (in DVR1/2/3).

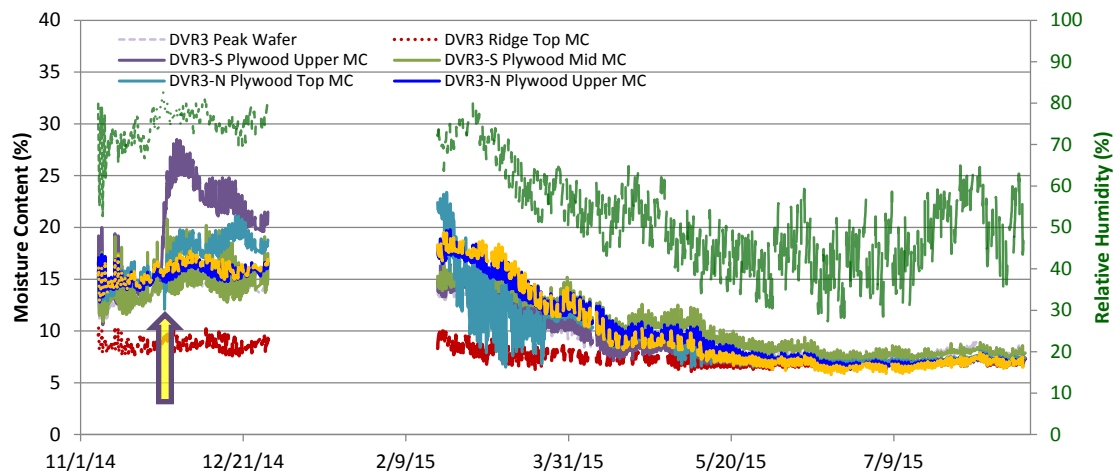
**Figure 62. Diffusion vent ridge (DVR3) MC and RH measurements (lower/first-floor attic)**

One anomaly was seen at the south plywood upper MC of DVR3 (yellow/purple arrow in Figure 62): MC jumped suddenly in late November 2014; the moisture then dried to safe levels in the spring. This is suspected to be rain leakage; a thunderstorm in the weather data coincided with the jump. However, MC jumps (i.e., further water leakage) did not recur.

*One possible roof leak was seen at the south plywood upper MC of DVR3 in November 2014; a sudden jump in MC occurred that later dried. This jump coincided with thunderstorm activity. However, no further wetting was seen in the data. Results from this sensor will be tracked over time.*

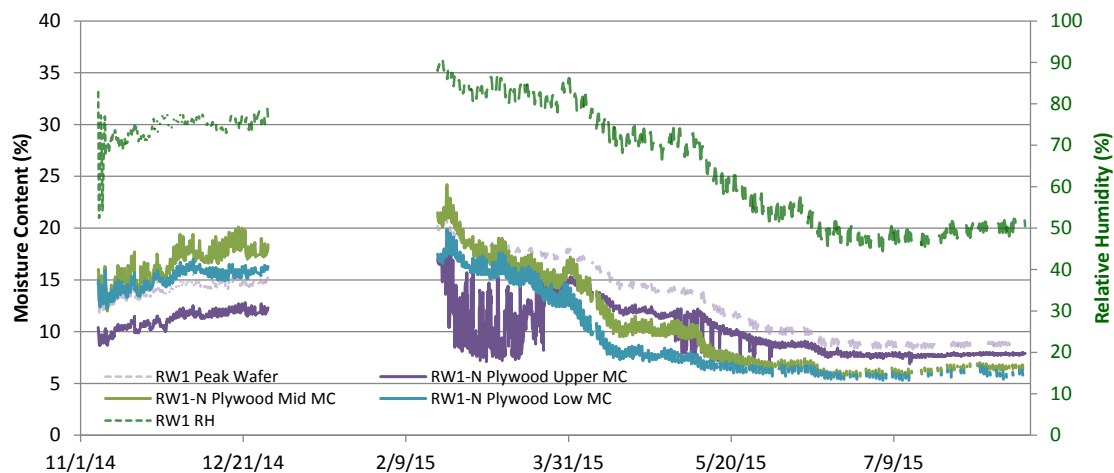
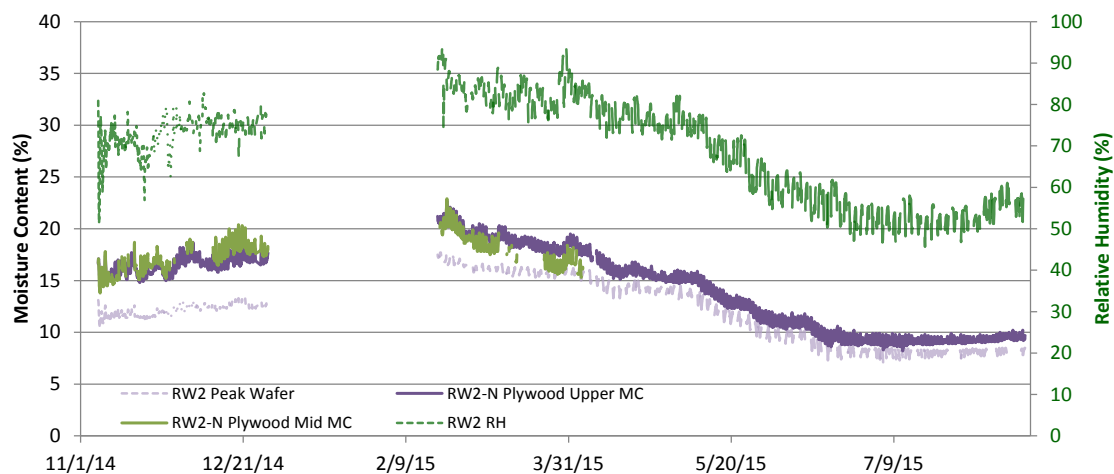
MC and RH measurements for the roof-wall interfaces are plotted in Figure 65 (RW1, significant downhill roof area below) and Figure 66 (RW2, minimal downhill roof area below). Both are located in the lower attic. The roof-wall conditions are measured because this location has no diffusion vents, but it is the top termination of rafter bays (and therefore has the potential for moisture accumulation). The difference in downhill area was that moisture adsorption and desorption from the sheathing may affect the degree of moisture accumulation at the ridge.

Similar patterns were seen of higher wood MCs after the data gap, which then dried in the spring. However, absolute values of MCs were higher more than 20% higher than the previous diffusion vent measurements. This might be ascribed to either the geometry (no diffusion vent) or possibly shading issues (discussed in Section 4.8.3). Similarly, RH levels were slightly higher than previous diffusion vent measurements.

No clear differentiation was seen between the two measurements, which would indicate the effect of downhill contributory roof area. RW1 shows a clear pattern of vertical moisture stratification in the springtime MC measurements.

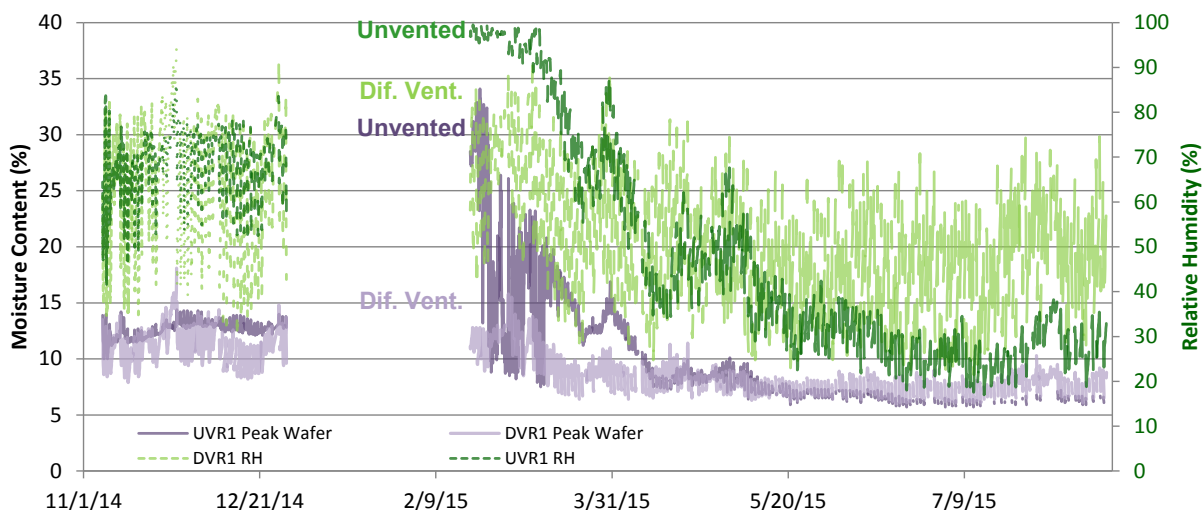
**Figure 67. Comparison of unvented (UVR1) and diffusion vent (DVR1) ridge wafer MC and RH**

Before the data gap (early winter 2014), the two roofs were comparable; the unvented roof had slightly higher moisture levels. After the data gap (winter–spring 2015), after interior moisture loading and cold outdoor temperatures, the two roofs showed a marked difference. The wafer sensor indicated possible condensation risks in the unvented roof with long periods of high RH (95%–100%). The diffusion vent roof stayed drier; only a few winter hours exceeded 80% RH, and wafer measurements were well in the safe range (lower than 15% MC).

As outdoor temperatures increased, the unvented roof dried rapidly. This is consistent with a vapor-impermeable exterior layer (self-adhered membrane) and a strong temperature gradient, which drove moisture downward and thus dried the roof. The diffusion vent roof also showed a drying pattern during the spring, but RHs remained slightly higher in the spring and summer. This is because the diffusion vent allowed vapor communication with the exterior, which was at a higher dew point than the interior.

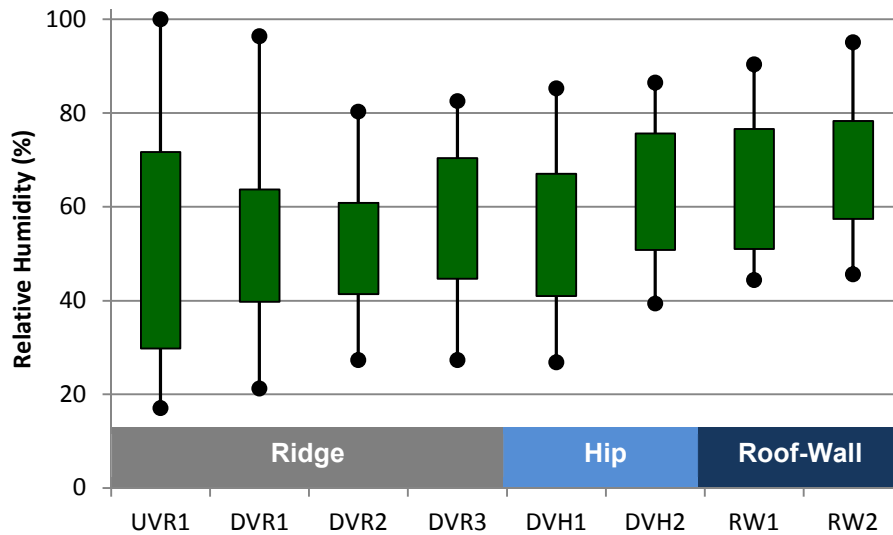
**Figure 68. Box/whisker plot of roof peak RH measurements**

Figure 68 shows the distribution of ridge RH measurements; the unvented roof (UVR1) is the only one that reaches 100% RH. The diffusion vent roofs are demonstrably drier than the unvented roof. Most of the roofs have hours that exceed 80% RH; however, given the discontinuity (gap) in the data, an ASHRAE 160 analysis (ASHRAE 2009, 2011) does not provide useful information based on a 30-day rolling average.

Therefore, the number of hours exceeding 80% RH is shown in Table 8: it includes the number of hours and the percentage of the total recording period higher than 80% RH. It shows that most diffusion vent ridges had minimal (0%–3%) time higher than 80% RH, while the unvented roof had significant (13%) time higher than that level. However, several roofs (DVH2, RW1, and RW2) had extended periods higher than 80% RH; they also had distributions on the high end of the scale (Figure 68). The reason for this behavior is covered in more detail below.

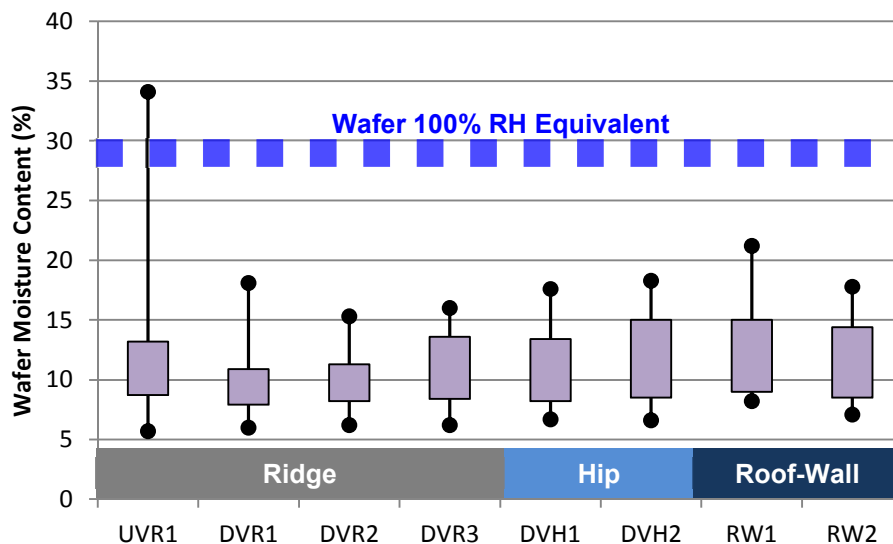
**Figure 69. Box/whisker plot of roof peak wafer MC measurements**

However, the unvented roof is clearly differentiated; periods of wafer measurements exceed the 100% RH-equivalent (28%–30% MC) level. All other roofs have MCs well in the safe range

(almost all lower than 20%). But again, roofs DVH2, RW1, and RW2 are noticeable outliers with higher moisture levels.

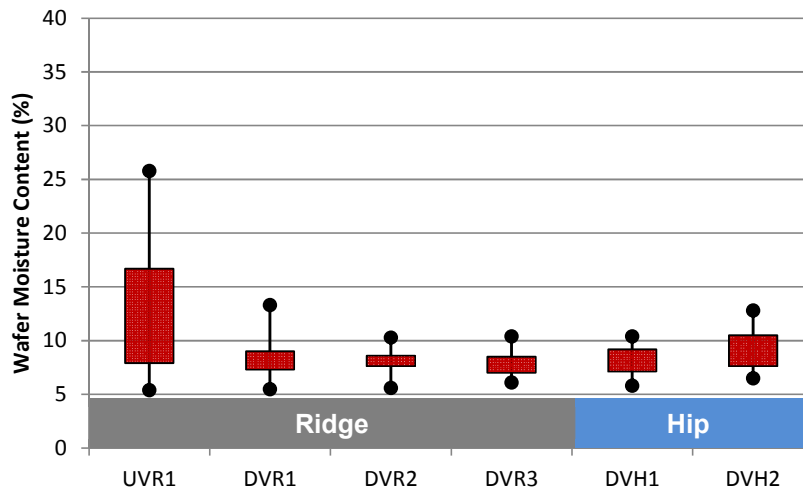
**Figure 70. Box/whisker plot of ridge top wood MC measurements**

Earlier plots demonstrated that the wood ridge at the ridge and hips was the driest location of the diffusion vent roofs, but the dampest in the unvented roof. This is shown in the box and whisker plot in Figure 70. It demonstrates the localized drying available at the ridge of the diffusion vent roof compared to the moisture accumulation (lack of drying) at the unvented roof. The unvented roof had peak MCs higher than 25%.

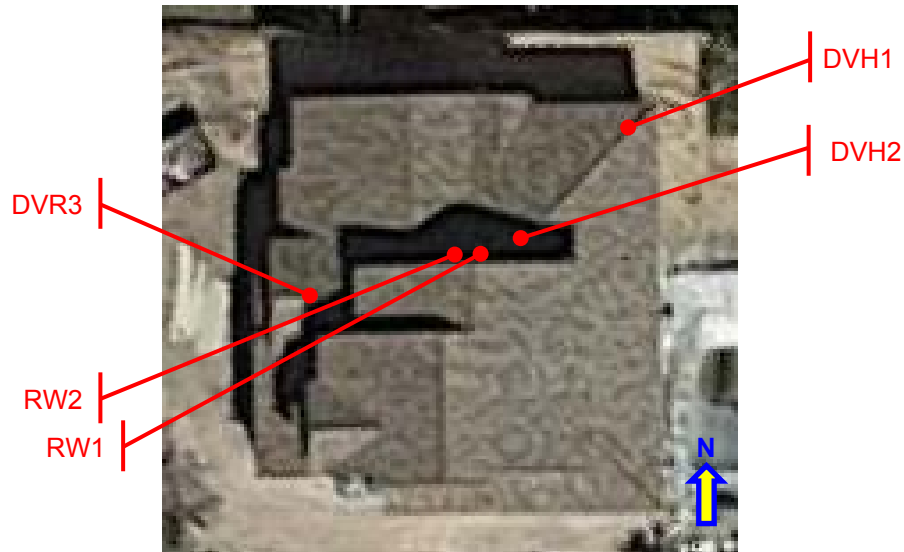
**Figure 71. Overhead view of roof shading with key sensor locations**

One possible explanation for moisture conditions at DVH2, RW1, and RW2 is the shading patterns created by the building (Figure 71).

The lower diffusion vent hip measurement (DVH1) is fully exposed to the sun, while the upper measurement (DVH2) is shaded by the adjacent second story and roof. The roof-wall interfaces (RW1 and RW2) lie directly north of the wall in shadow. DVR3 (diffusion vent at the front of the house) is shaded for part of the day (morning), depending on the season and sun position. All these observations are consistent with higher RHs and MCs seen at RW1, RW2, and DVH2.
