# Public Housing: A Tailored Approach to Energy Retrofits

J. Dentz, F. Conlin, D. Podorson, K. Alaigh,  
and T. Davis

February 2016

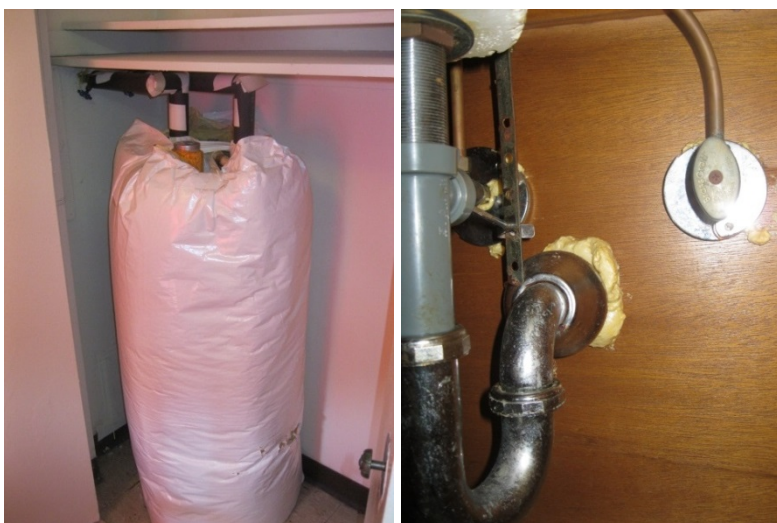
**Figure 3. Electric storage water tank with insulation wrap (left); foamed plumbing penetrations (right) at IHA**

IHA staff members were trained on the protocols during a 3-hour on-site training session. After the training, they implemented the protocols in each unit that was undergoing turnover (Figure 3 and Figure 4). ARIES conducted before and after inspections and tests of five units, including the training unit, to measure implementation effectiveness and estimate costs.

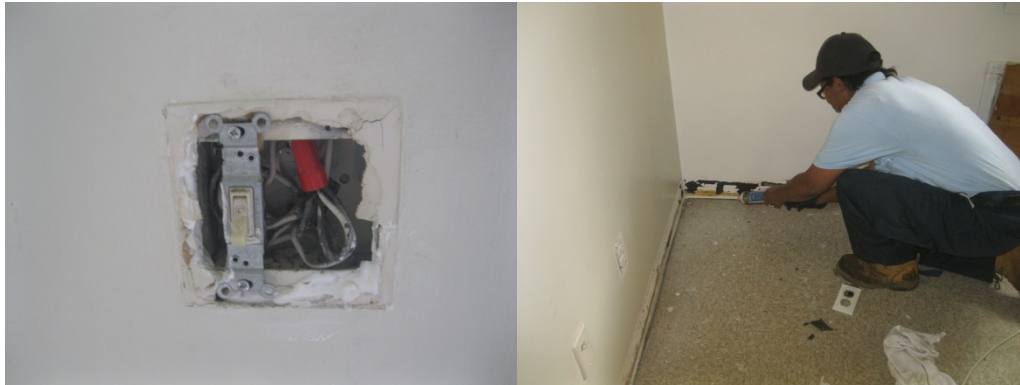
**Figure 16. Newly caulked electrical outlet (left); caulking around base molding (right) at NHA**

NHA staff was trained in the protocols in a 3-hour on-site training session at the King Kennedy unit. Most of the protocols were implemented immediately after the training (Figure 16 and Figure 17); some additional items, such as removing vinyl coves to seal bottom plates, were implemented after the session. ARIES conducted pre- and post-implementation testing to measure implementation effectiveness and estimate costs.
