Excess Fluxes and Defluxers: High Reliability Electronics Risk

Rochelle Piatt, Kim Archuleta and Walter Olson - Dept. 1832, Coatings and Surface Engineering

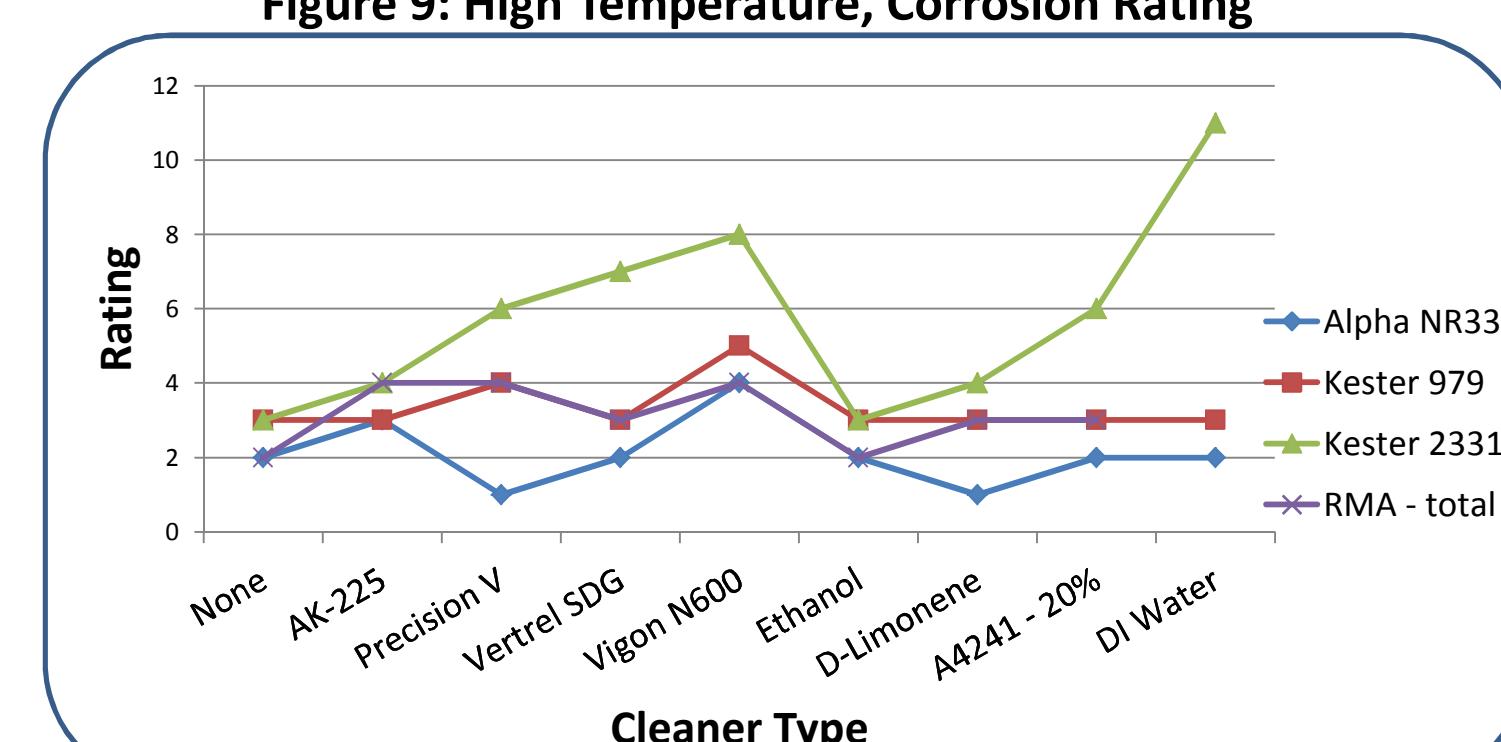
Figure 9: High Temperature, Corrosion Rating

Figures 1 - 4 show samples for the best and worst rated fluxes and cleaning agents for each temperature group for Case 1; fluxes are in Red and defluxers in Blue. Rating results are plotted for easy comparison in Figures 9 and 10.

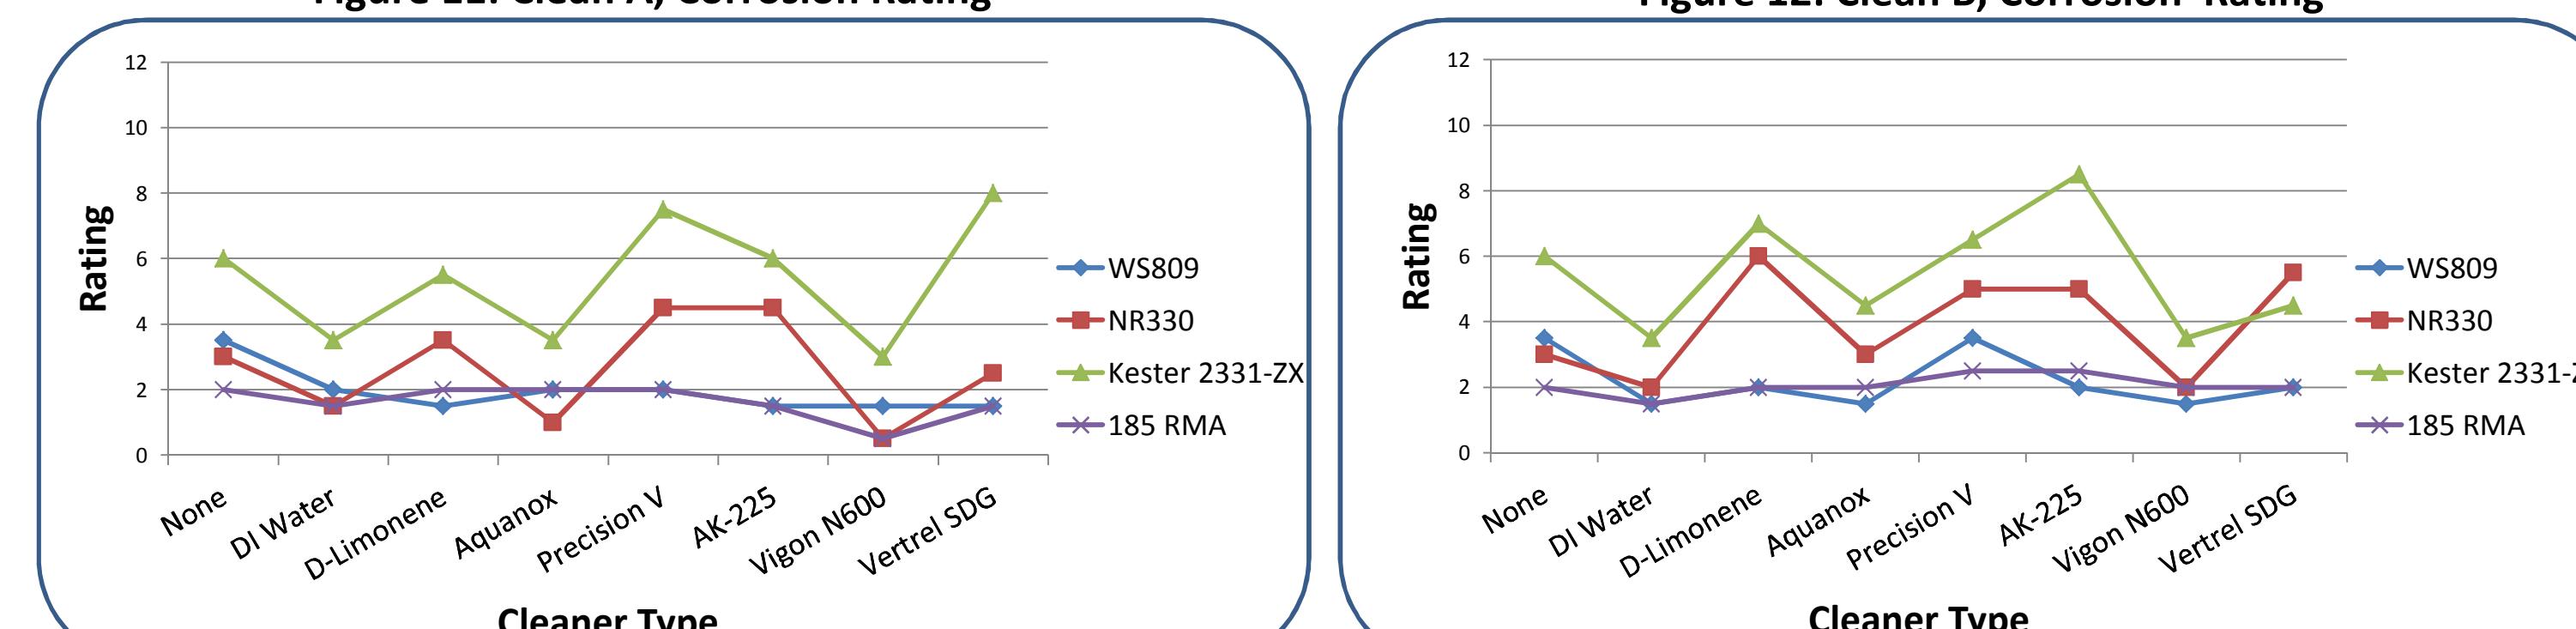
Figure 12: Clean B, Corrosion Rating

In Case 1, where no removal of flux or rinsing of defluxer was attempted, the most corrosion appeared with Aquanox 4241 and Vigon N600. In Case 2, when cleaning with rinsing, most corrosion occurred with the vapor defluxers. The performance of the vapor defluxers in Case 2 may be due to lack of physical pre-clean, or insufficient time spent in the vapor. The poor performance of the aqueous defluxers in Case 1 may be due to insufficient or no rinsing. Further study of cleaning efficacy and determining optimal clean/rinse time and method will be the third case in this study of fluxes and flux cleaning agents. The results of these first two cases demonstrate the need for appropriate cleaning and rinsing to achieve low corrosion risk.
