15th International ASTM/ESIS Symposium on Fatigue and Fracture Mechanics  
(40th National Symposium on Fatigue and Fracture Mechanics)  
May 20-22, 2015, Anaheim, CA

### *Cracking in a Flame-Sprayed Epoxy*

### **Abstract Summary**

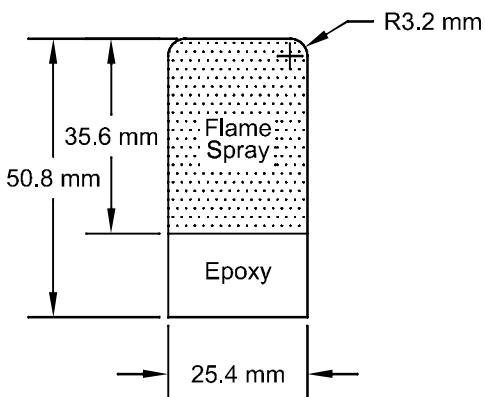
Epoxy cylinders were flame-sprayed and temperature-cycled to isolate conditions that could lead to cracking. Each cylinder was built according to the drawing in Figure 3. The edges of the cylinders that were covered in flame spray were given a 3.2 mm radius to prevent the stress singularity of a sharp corner. A portion of the cylinder was left without flame spray to minimize handling of the coating. The flame spray was applied to the epoxy cylinders at room temperature. describes the flame spray process that resulted in an approximately 0.1 mm coating of metal.

Figure 3: A drawing of the flame-sprayed epoxy cylinders used in the experiments.
