Failure and Repair of the Mach 5 Heater for Sandia's Hypersonic Wind Tunnel

**Engineering Sciences Center
Sandia National Laboratories
Albuquerque, NM, U.S.A.**

**STA1 105th Meeting
14-16 May, 2006
St. Paul, MN**

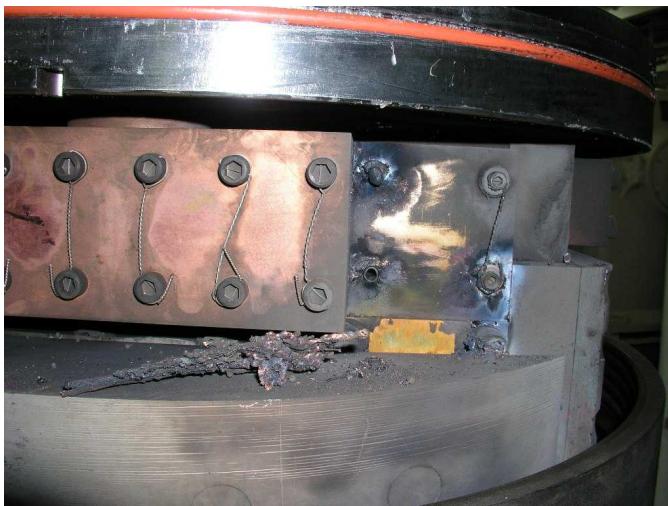
We found marks from electrical scorching, residue of slagged metals, and melted and deformed bolt heads.

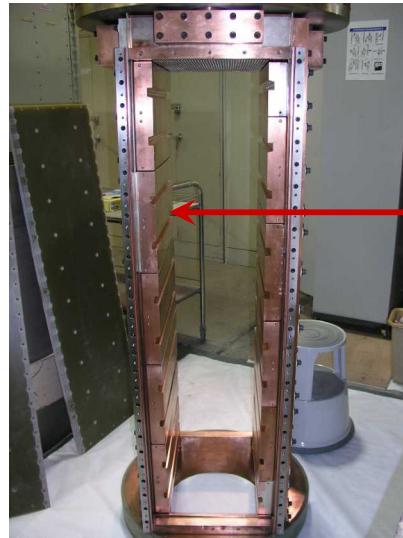
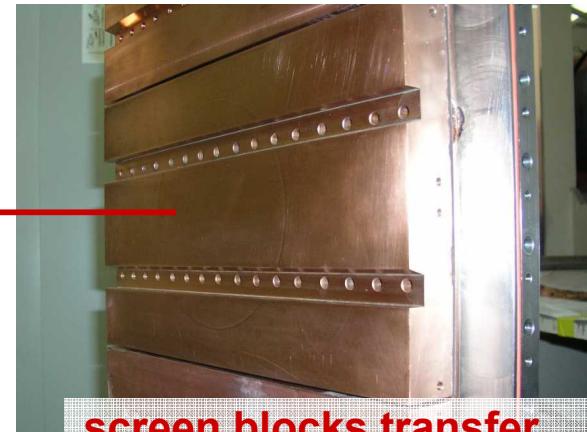
screen blocks transfer power from the bus bars to the nichrome screens

A straightforward example is the replacement of the screen blocks

- Made from zirconium copper
 - Not available in large sizes from a credible vendor
- Modern equivalent is GlidCop
 - High electrical and thermal conductivity
 - Good high-temperature strength
 - Also high cost

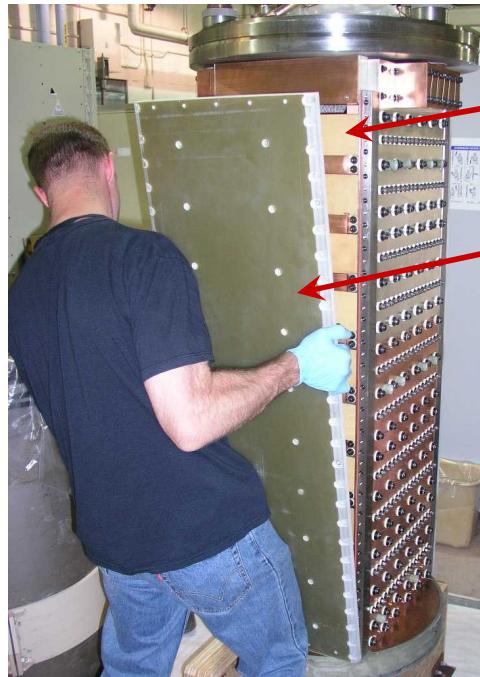
Locating a substitute for the side panels was not straightforward

- Made from Scotchply 1007, a glass fiber composite
- Once made by 3M, but now discontinued
- Portions of Scotchply product line sold to Cytec corporation
- Neither 3M nor Cytec have material information on the 1007 product
- Eventually, we found a retired 3M engineer with the relevant information in his basement
- Many potential replacements do not have known flexural strength properties at elevated temperatures

gold-coated glass panels reflect radiated heat back into the flow

side panels hold the glass in position

A reasonable substitute for our application is G11 glass-epoxy resin

- Temperature rating and strength properties lower than Scotchply 1007
- However, the heater was designed for use with a Mach 3.5 nozzle that was never constructed
 - We can de-rate the necessary strength

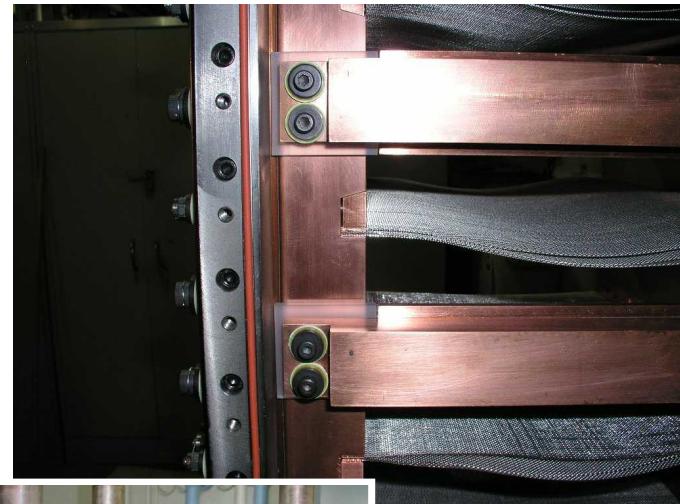
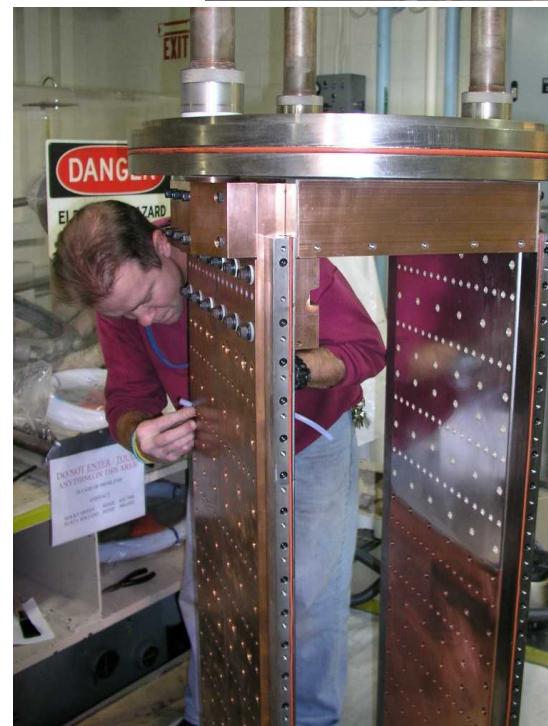
Lots of trouble making it all fit together

- Deformation of hardware over ~30 years
- Undetected discrepancies between drawings and hardware
