Title: Learning Team Review 2016-0001 Installing Outlets for Programmatic Equipment

Learning Team Review 2016-0001

Installing Outlets for Programmatic Equipment

Brief Description of Event:

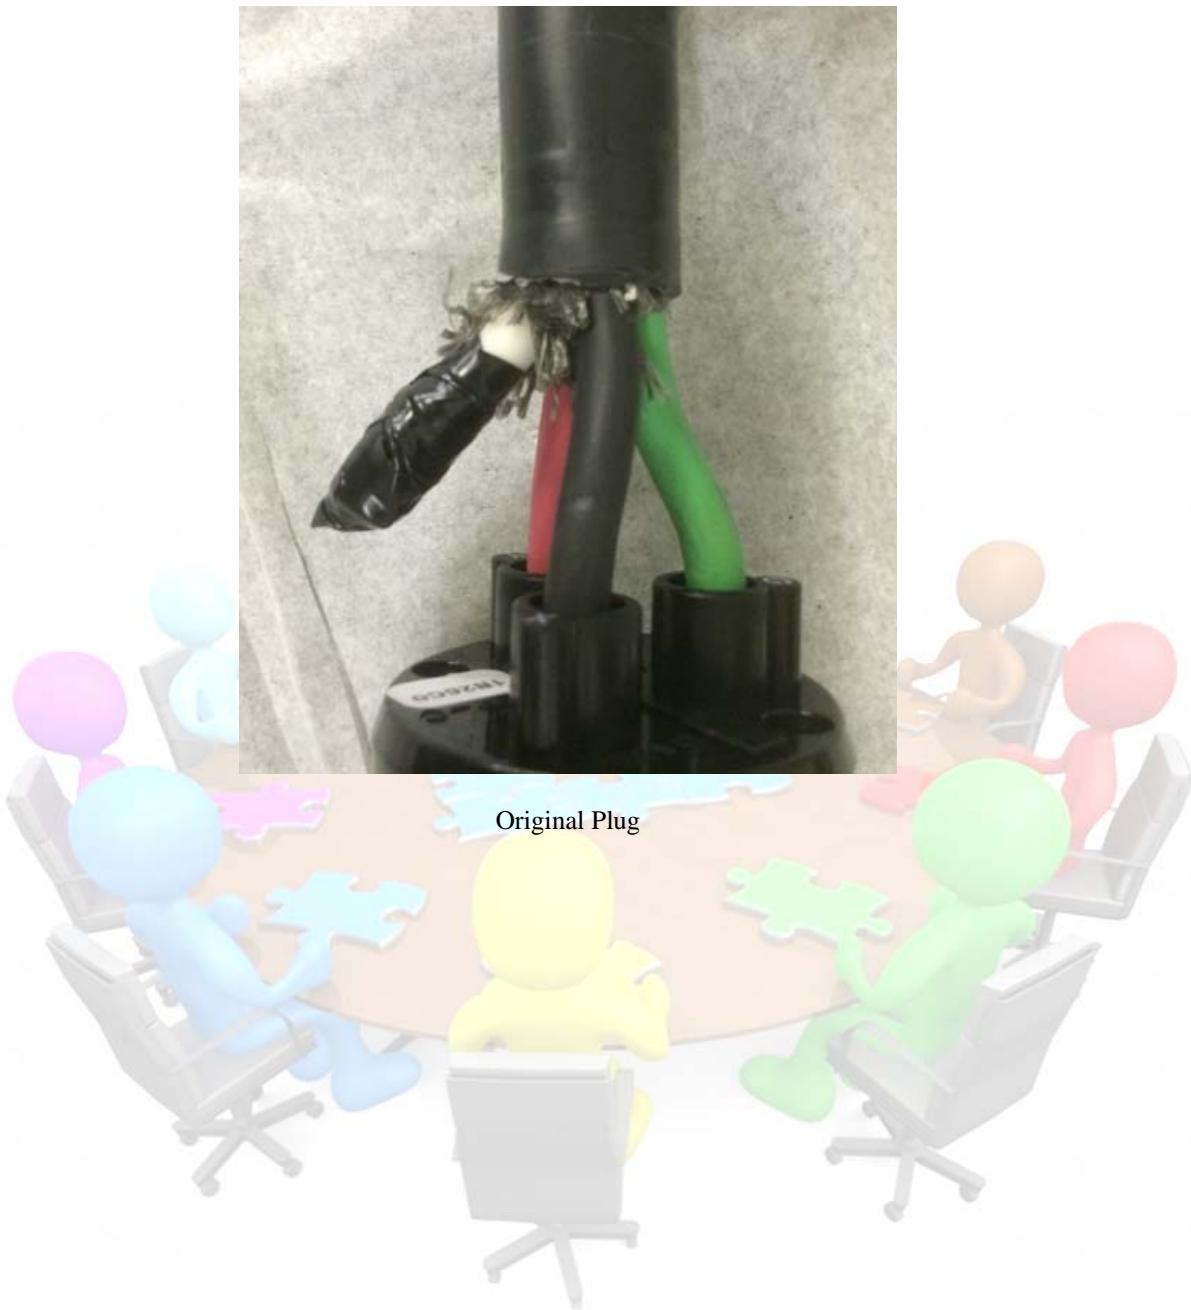
Note: Dead leg is a white conductor wrapped in blue tape. Was originally placed in center hot terminal to recreate original wiring.
