LAWRENCE
LIVERMORE
NATIONAL
LABORATORY

LLNL-TR-715377

Rotary Valve FY 2016 Highlights

December 16, 2016

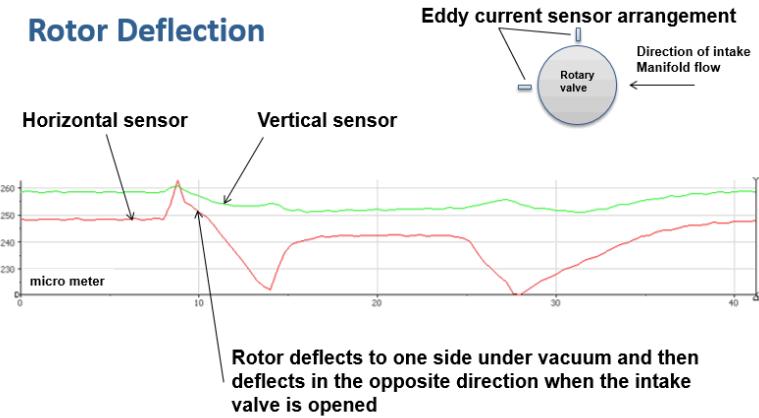
The rotor in the RV moves back and forth as first the intake manifold valve is opened, and then the beamline valve is opened and closed as shown in bottom plot of Figure 8.

Figure 8: Rotor deflection at 40 psi when the beamline and intake valves are opened.

We plan to reduce the rotor motion by installing an insert on the argon side of the RV so that an opposing argon gas can help and steady the motion of the rotor as the helium intake valve is

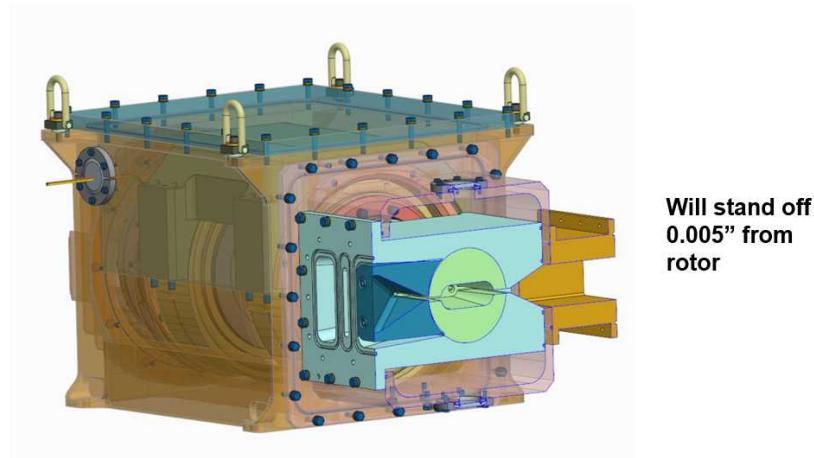
Argon Insert

Figure 9: Argon insert.

opened. Figure 9 shows the insert that was designed and fabricated this fiscal year.

Reducing the motion of the rotor will give us confidence in increasing the helium intake manifold pressures without driving the rotor into its enclosure. The higher intake pressures will most likely be needed to combat the reduction in beam port or slot pressure that come with trying to pull a vacuum in the beamline as is shown in Figure 7.
