Post-Closure Report for Closed *Resource Conservation and Recovery Act* Corrective Action Units, Nevada National Security Site, Nevada

For Calendar Year 2016

**POST-CLOSURE REPORT FOR CLOSED
RESOURCE CONSERVATION AND RECOVERY ACT
CORRECTIVE ACTION UNITS,
NEVADA NATIONAL SECURITY SITE, NEVADA
FOR CALENDAR YEAR 2016**

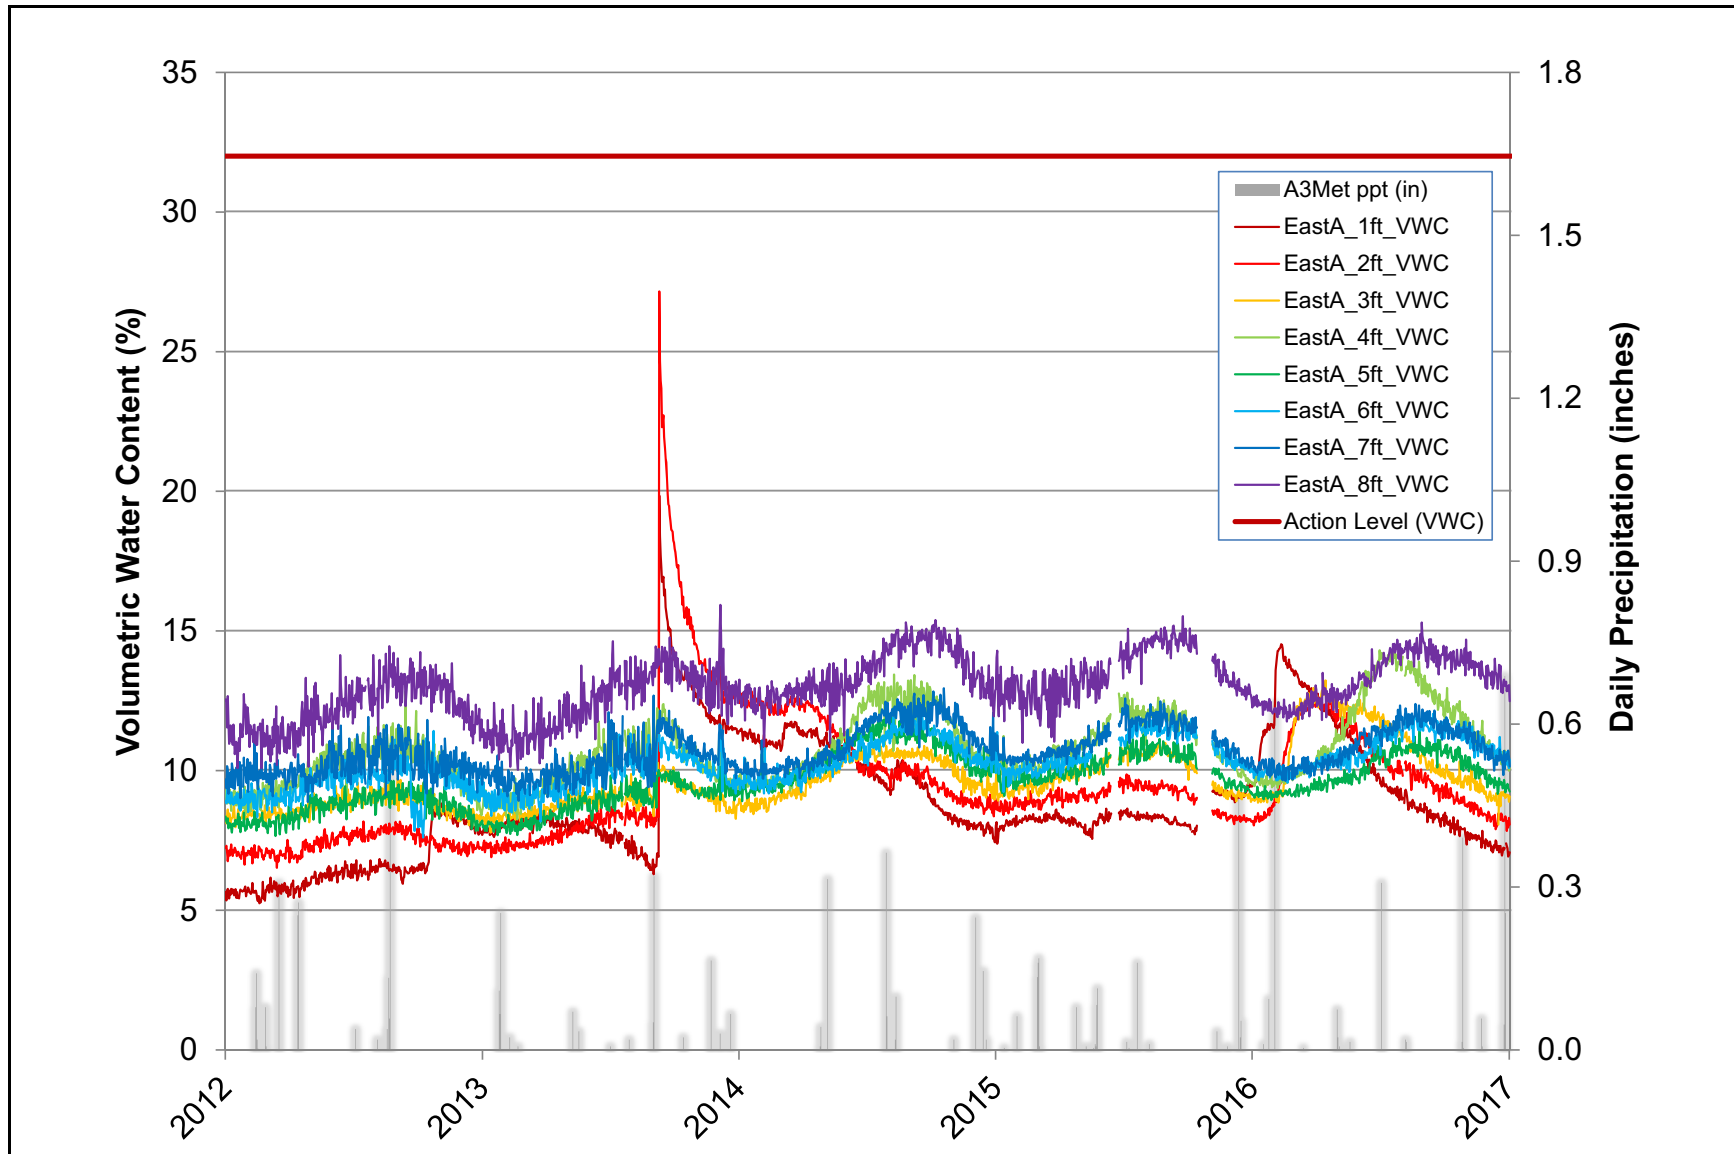
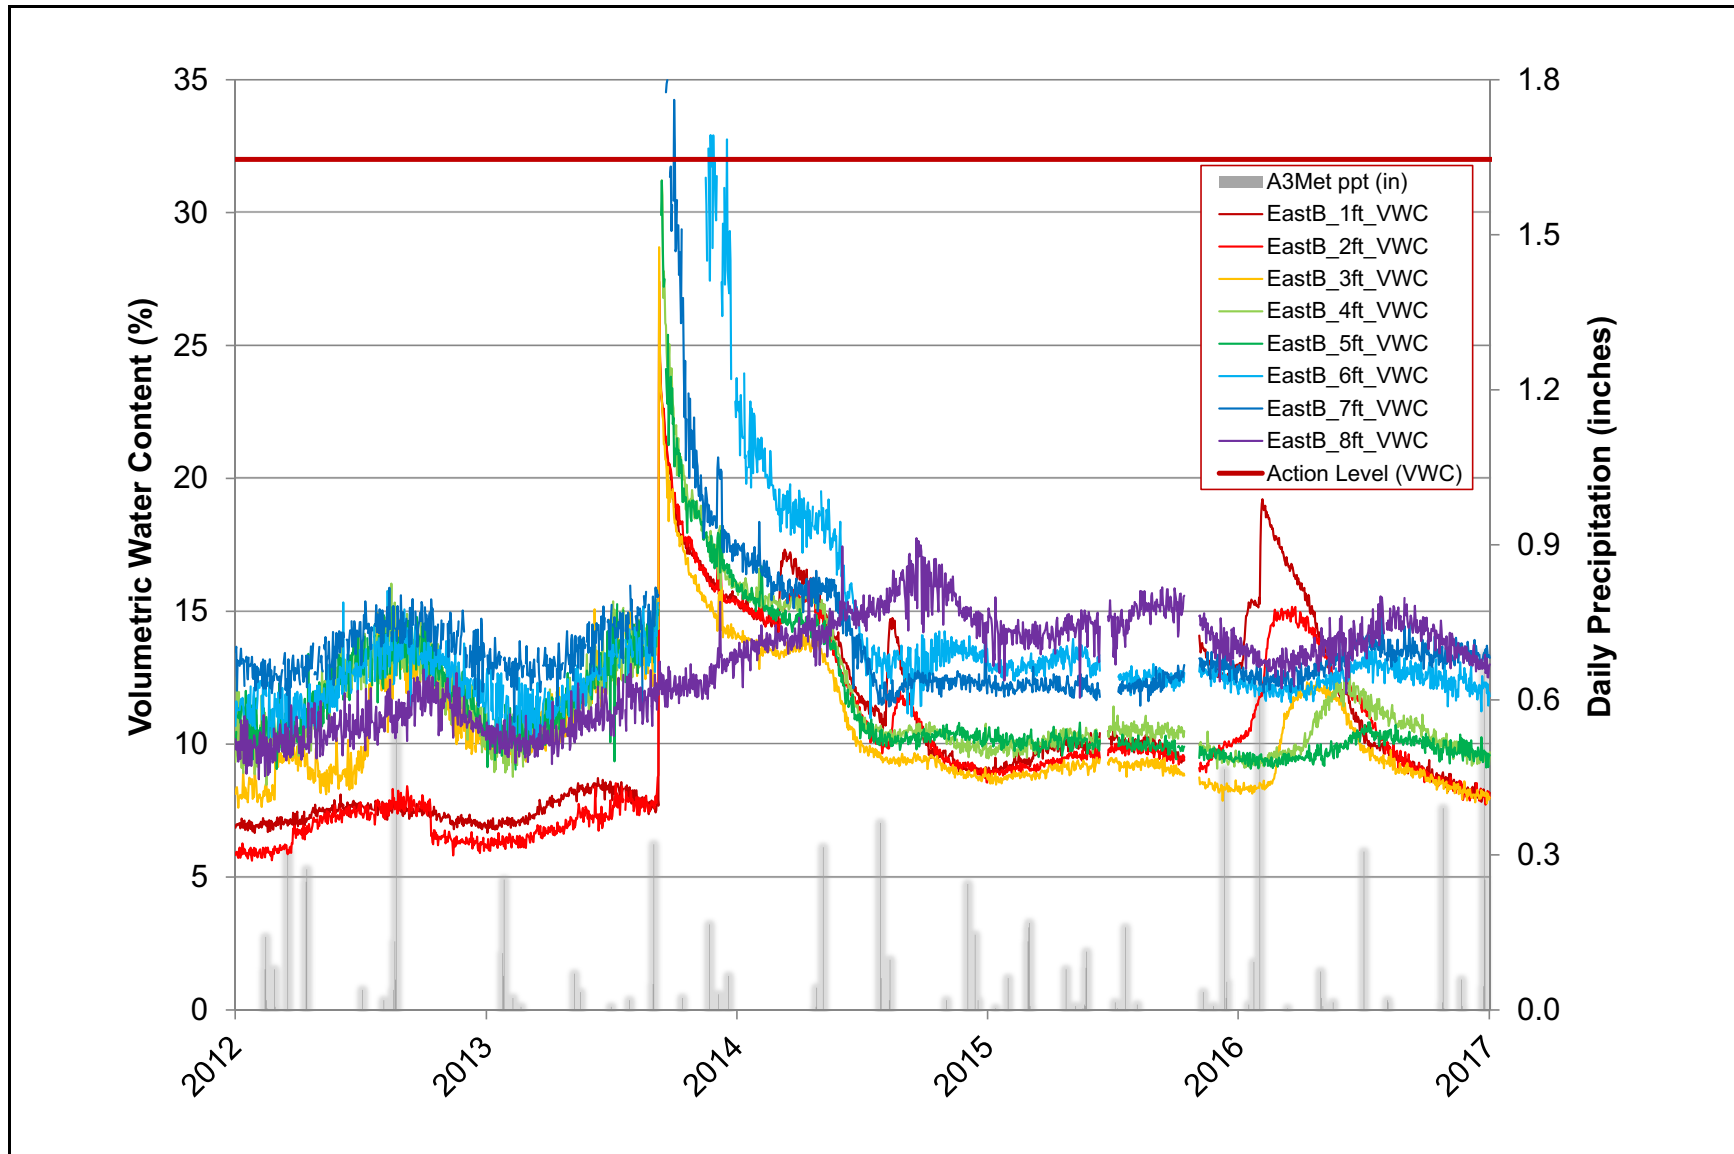
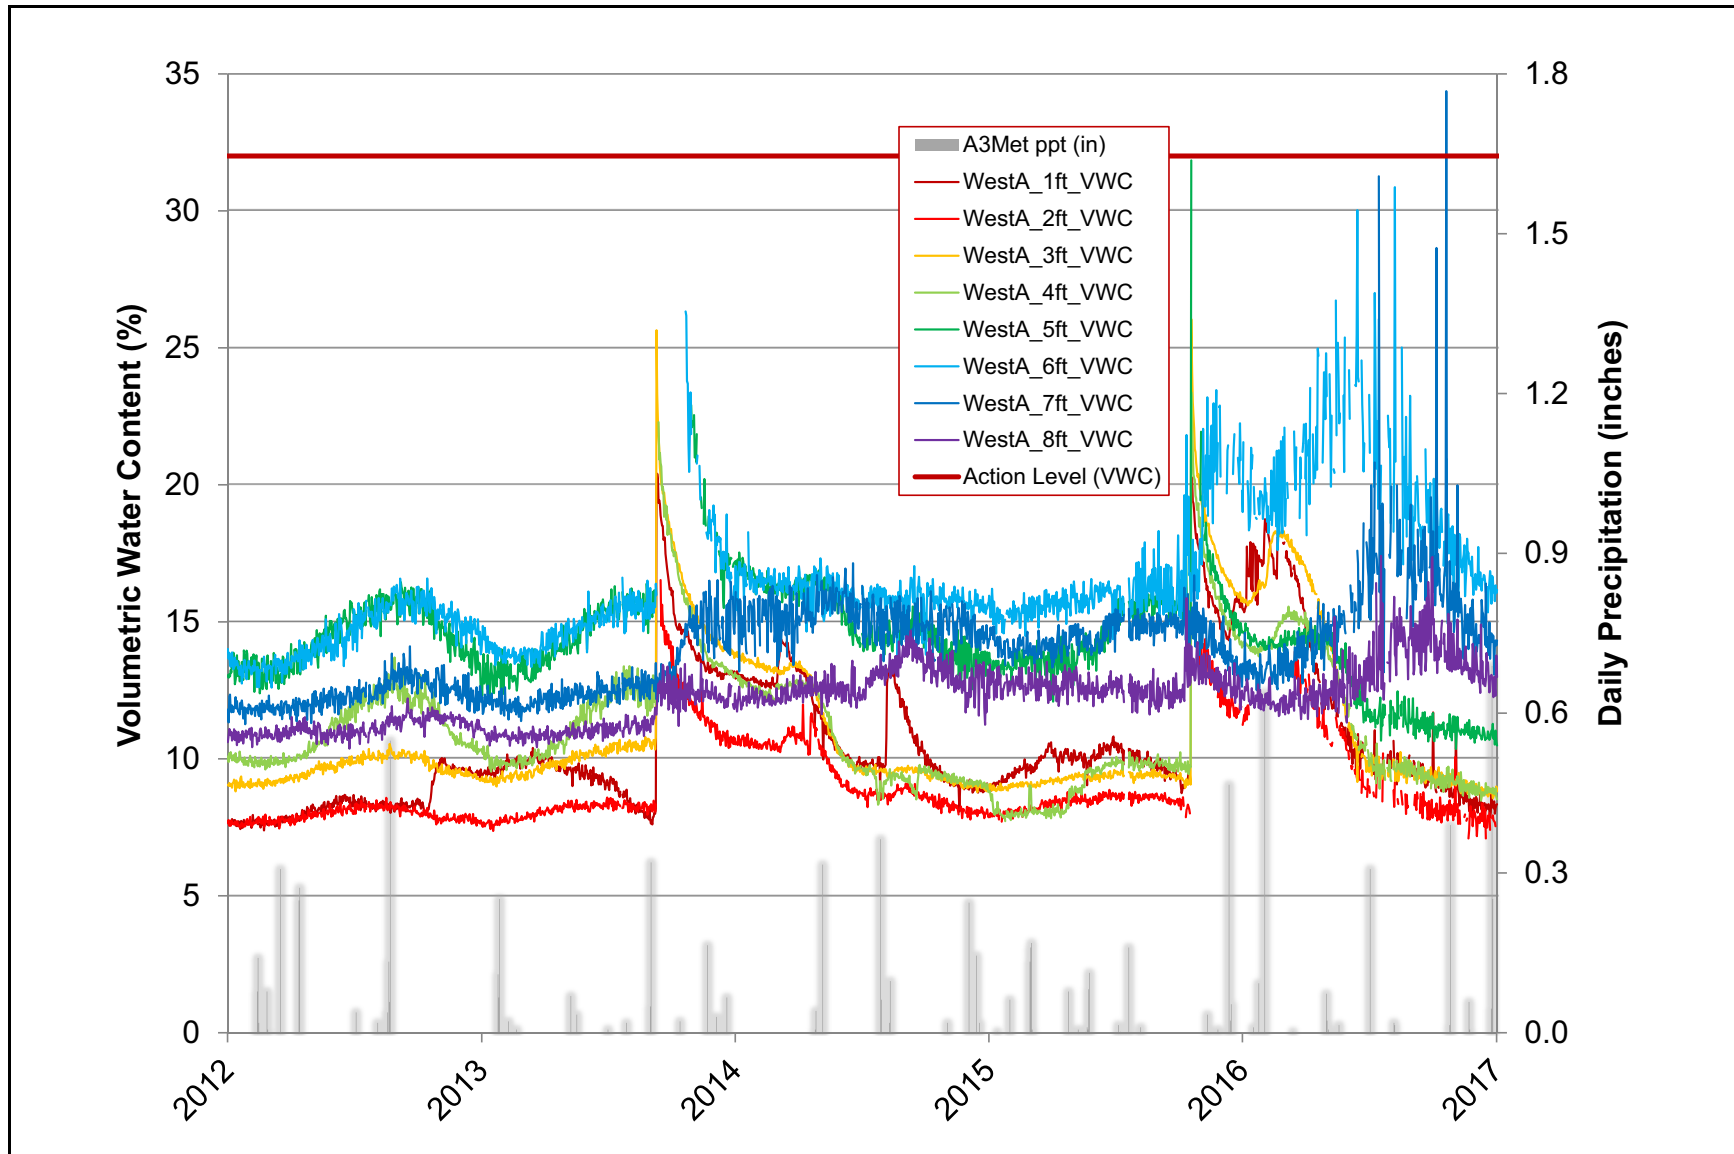
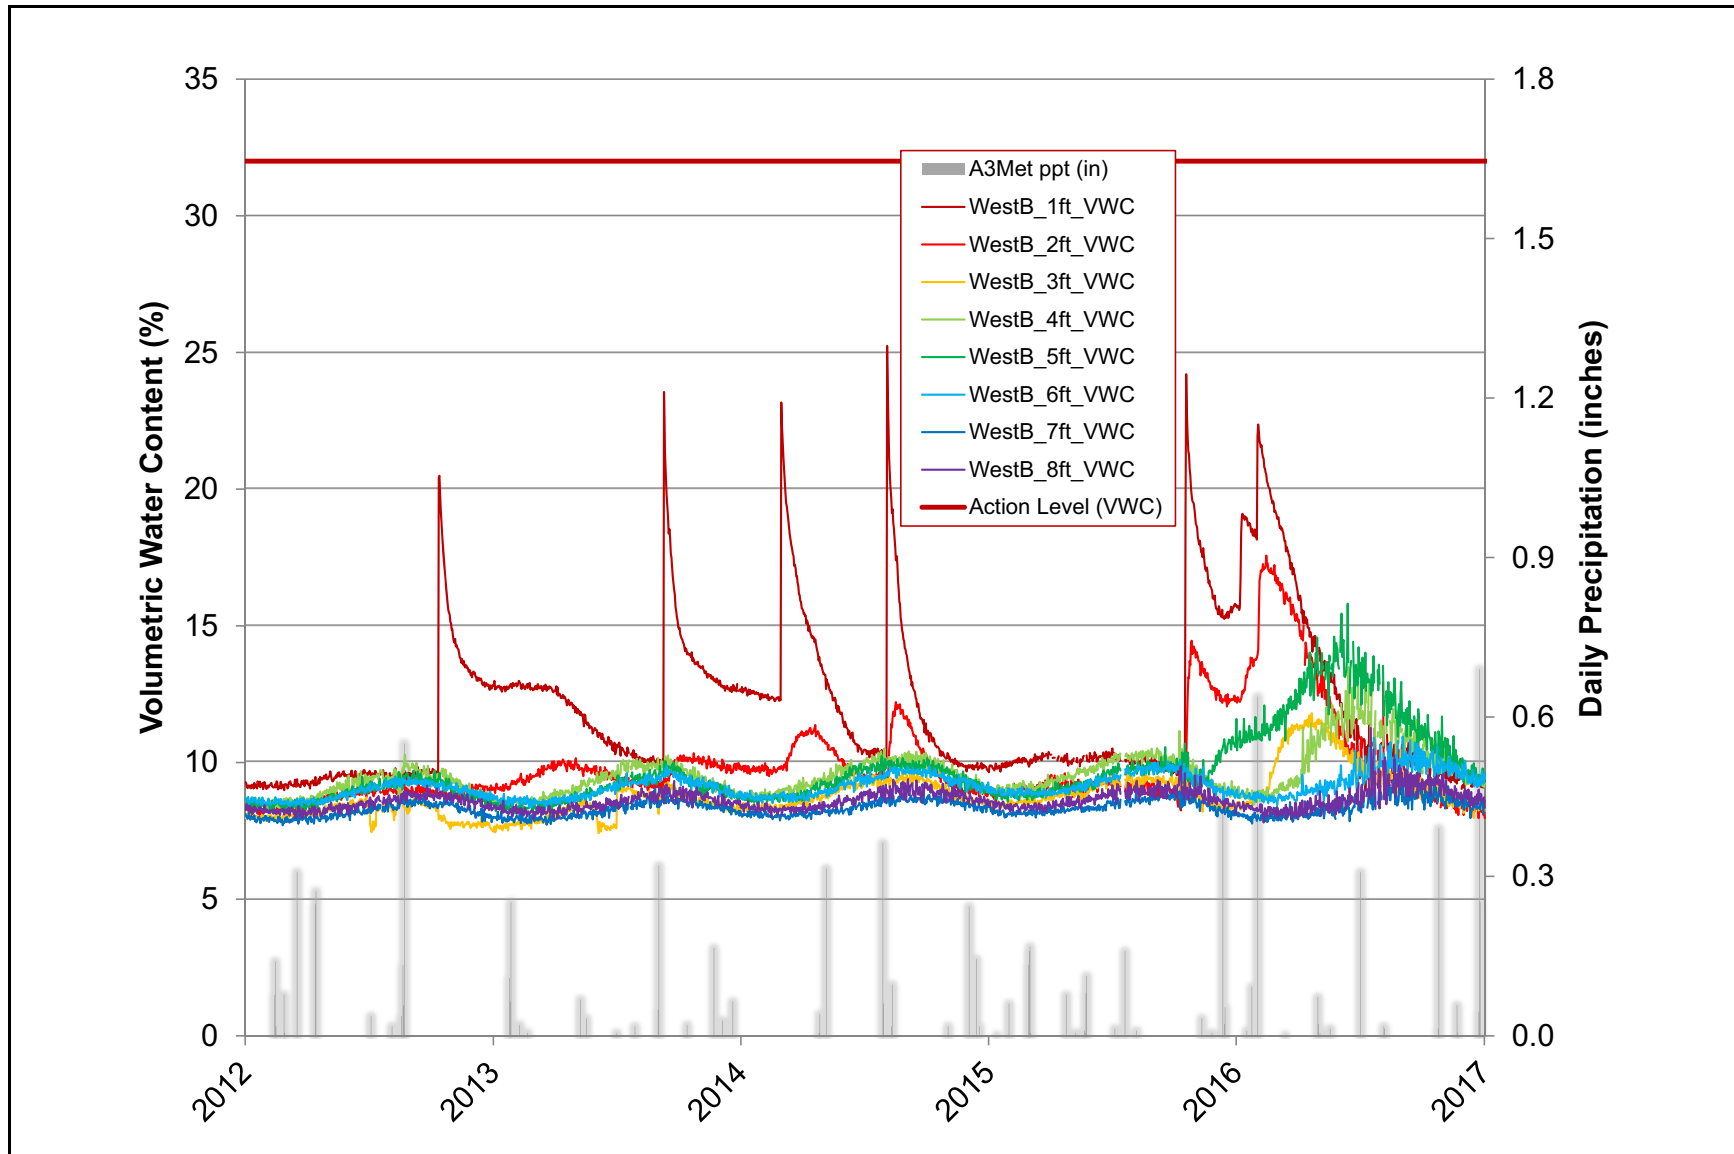
Soil moisture results obtained to date indicate that the CAU 110 cover is functioning as designed. Shallow soil moisture content is variable and dependent on precipitation events and the ability of shallow root systems and evapotranspiration to remove moisture from the soil. The ability of these systems to remove moisture can be locally inhibited if animal burrowing and grazing on plants affects the root systems; therefore, animal burrows are routinely backfilled, and small mammals are occasionally trapped and relocated from the cover to limit this damage.

Soil moisture contents for the TDR nests at depth are generally between 9 and 15 percent volumetric moisture content, depending on the location of the nest. Some locations show greater annual variability in moisture content; however, each location appears to have equilibrated to a consistent state for that location.

The action level (32 percent) is illustrated in [Figures 3-3](#) through [3-6](#). The action level was not exceeded over any six-month period.

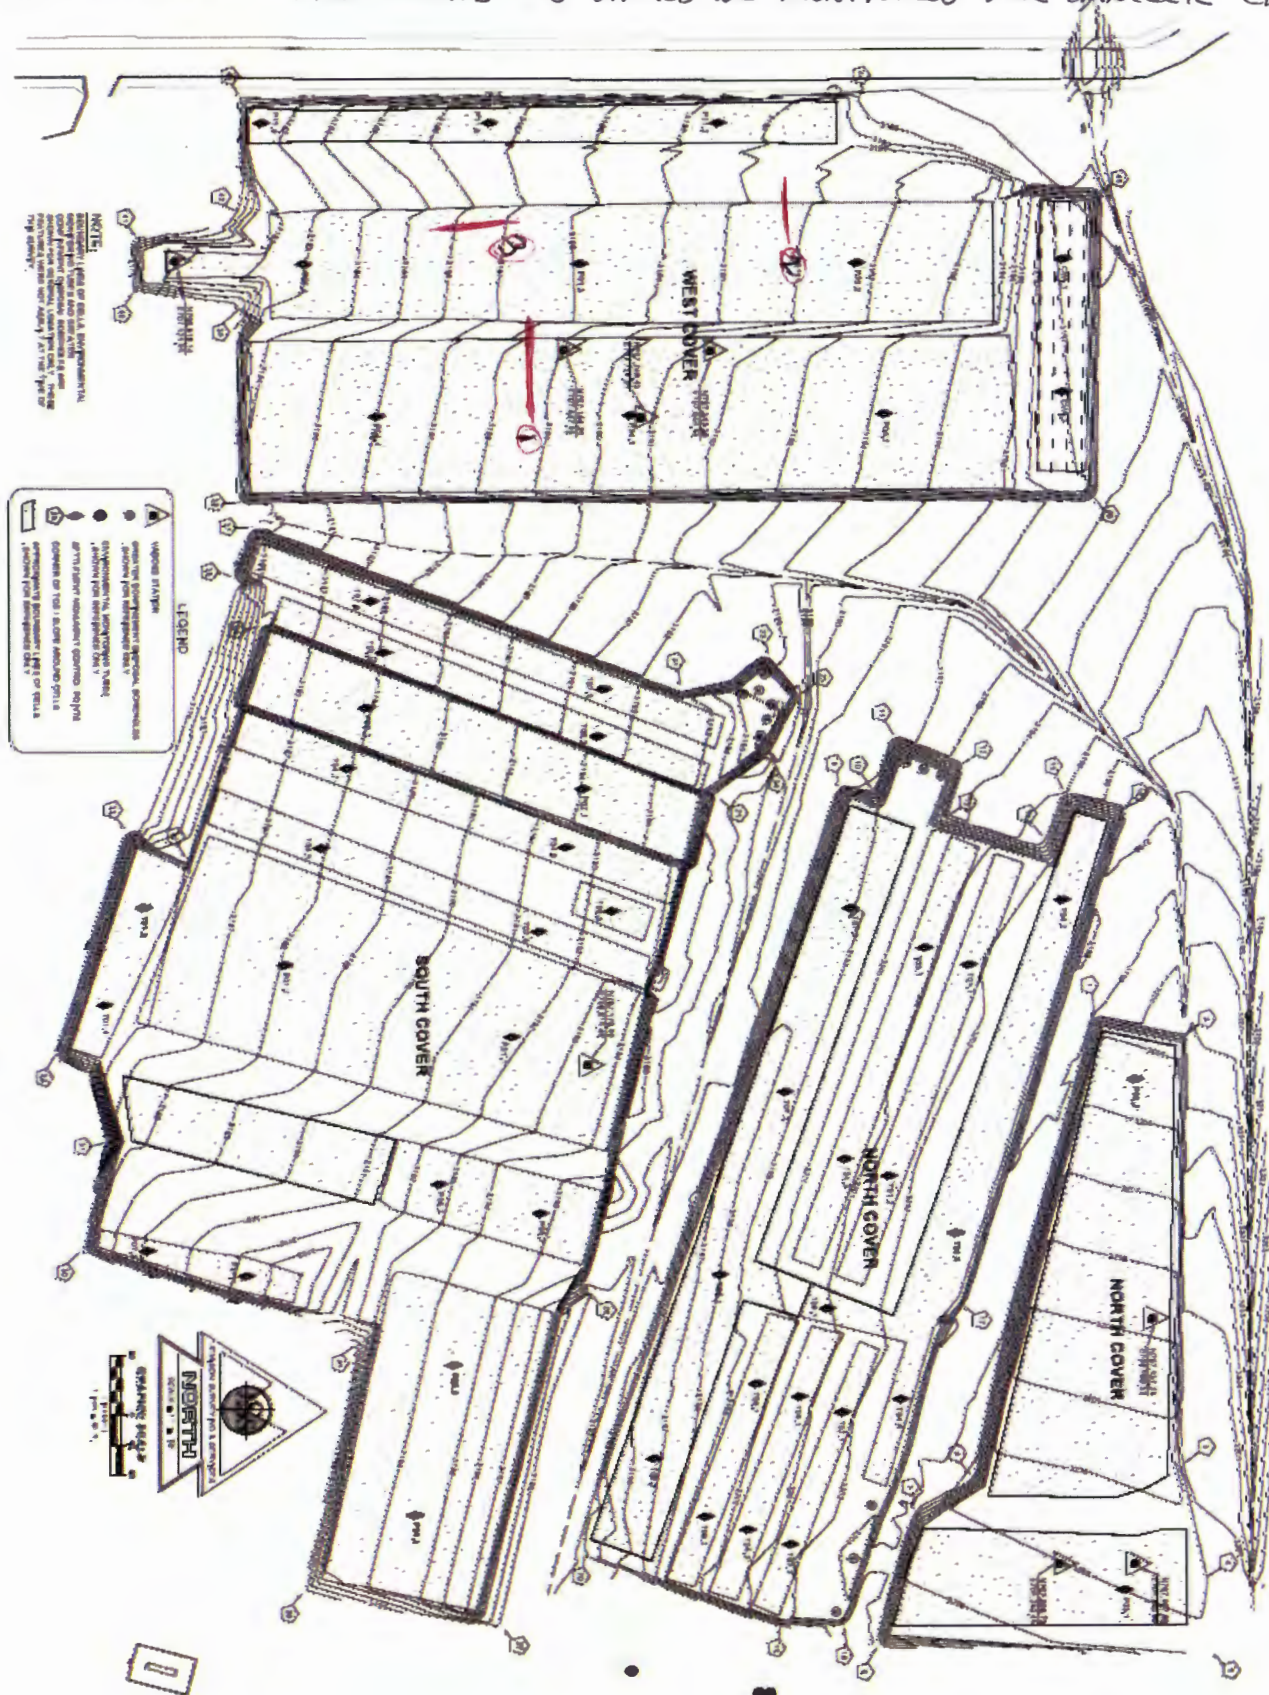
CAU 111. CAS 05-21-01

ALL 3 LOCATIONS ARE CRACKS > 1m LONG & 15 cm DEEP
AREA AROUND #3 SHOULD BE MONITORED FOR SMALLER CRACKS

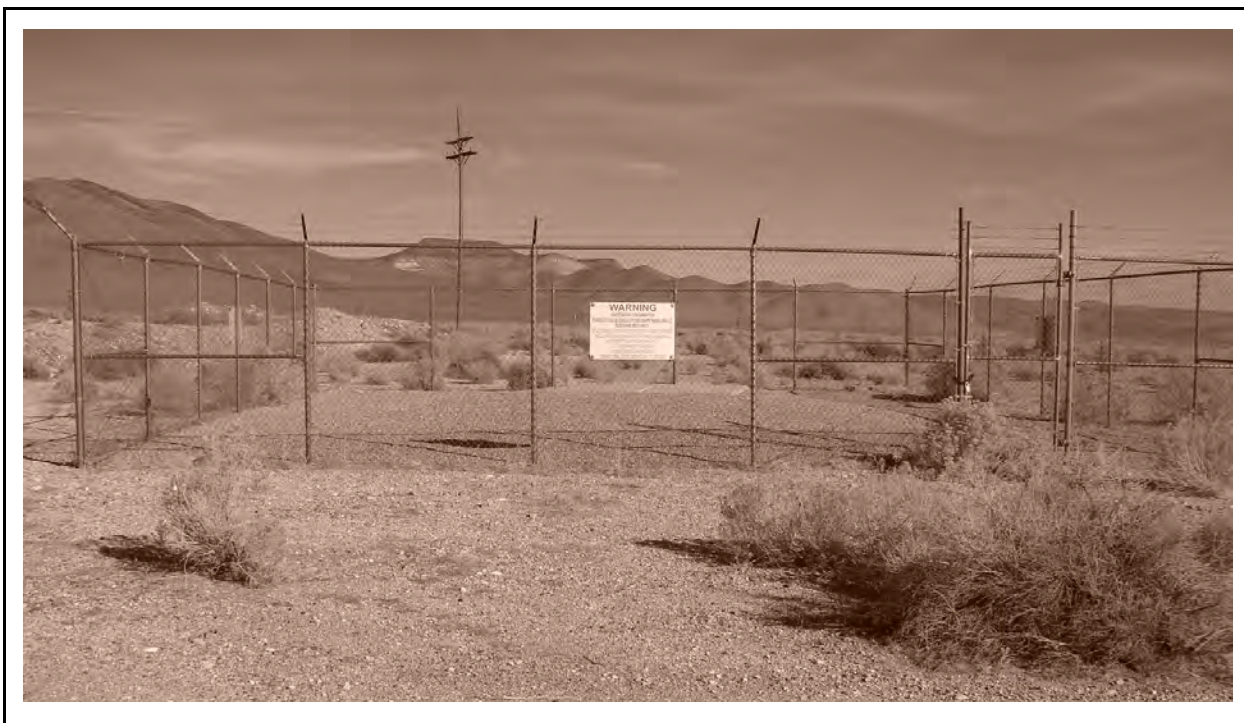
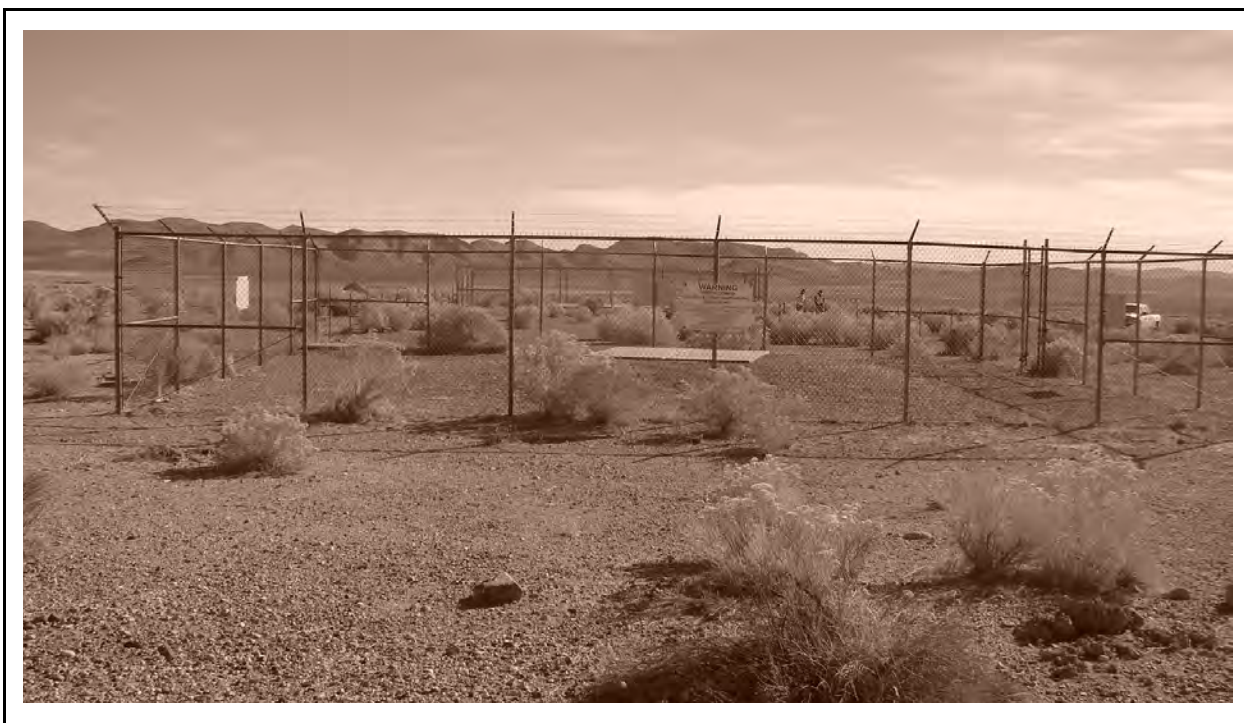
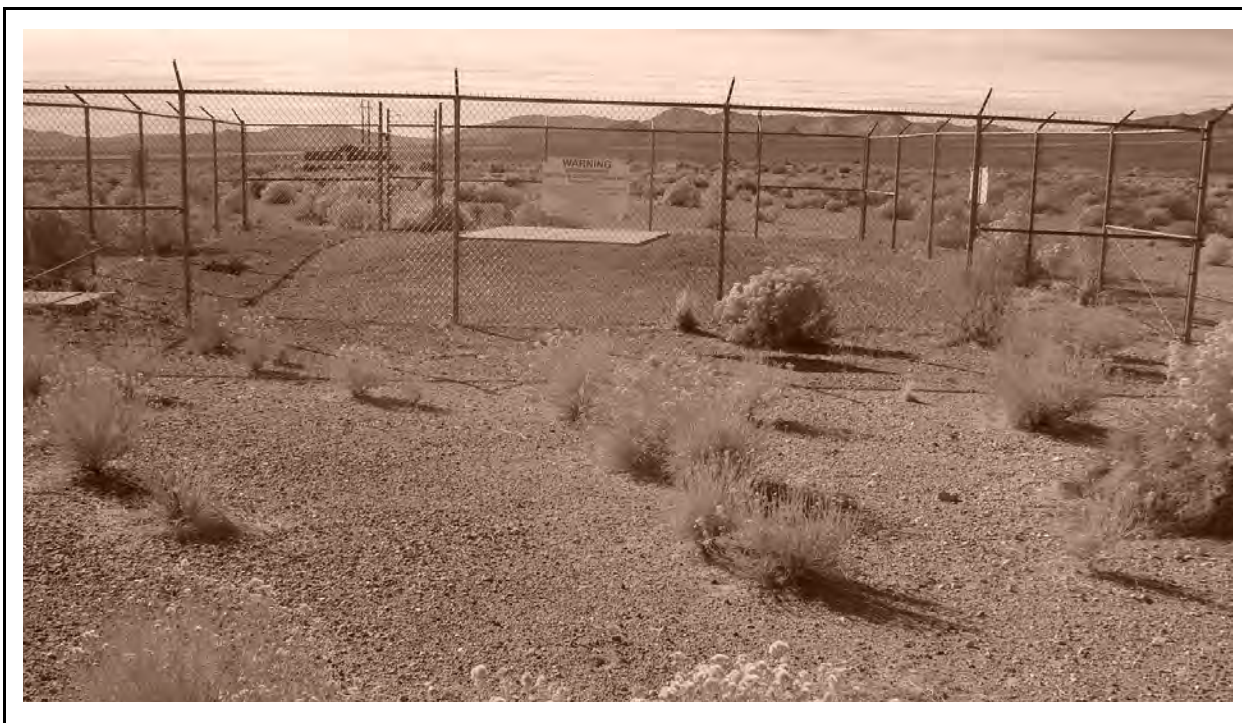
An annual inspection was performed on December 8, 2016. The site was visually inspected, and findings were recorded via checklists and photographs. No problems were observed, and no maintenance or repairs were required at either CAS (02-20-01, Bitcutter/PS Inj. Wells (3) (RCRA); or 02-20-03, Wastewater Pit). All maintenance and restoration actions were made in accordance with the permit.

Figure B-7
Photograph 7: CAU 90, CAS 02-20-01, Facing North (12/08/2016)

Figure B-8
Photograph 8: CAU 90, CAS 02-20-01, Facing East (12/08/2016)

Figure B-9
Photograph 9: CAU 90, CAS 02-20-01, Facing South (12/08/2016)
