Fukushima Forensics: Combustible Gas Effects

April 28-29, Washington, DC

Nathan Andrews (SNL) and Wilson Laungdilok (Fauske
and Associates)

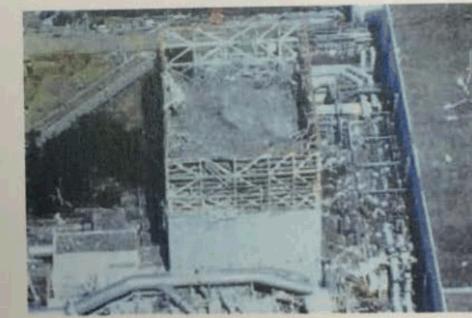
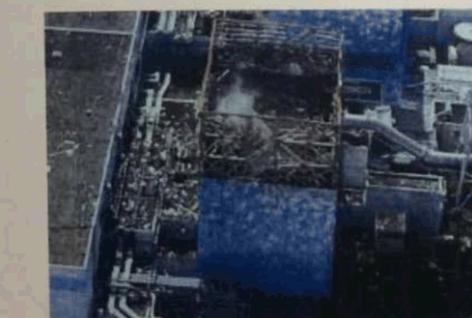
1F1 End State

- Damage following explosion
- Shows all four sides of the building

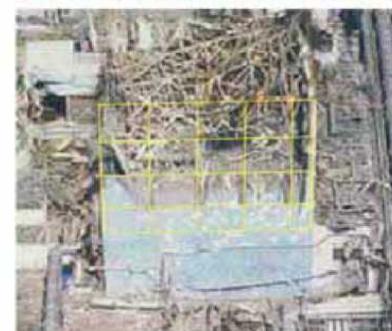
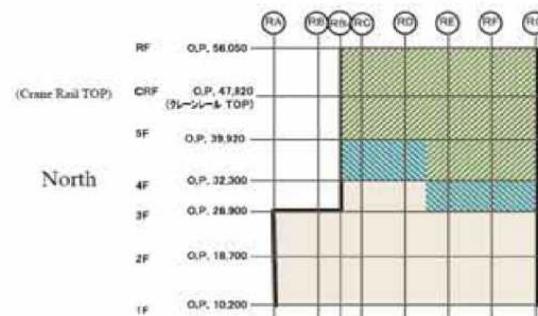
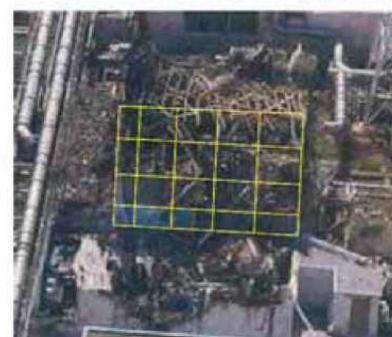
1F3 End State

- Damage following explosion
- Shows all four sides of the building

- **The damage to the 1F3 building was more extensive compared to damage incurred at 1F1 and 1F4.**
 - To what extent was the damage caused by the energetic explosion as a consequence of drywell head seal failure at high PCV pressure and temperature is a question to be answered.

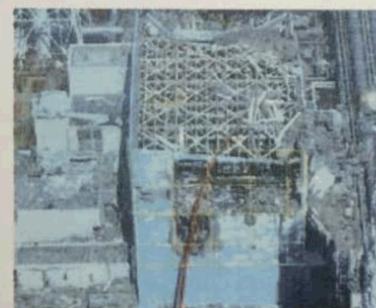
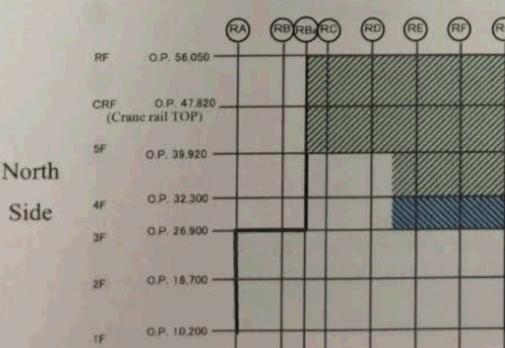
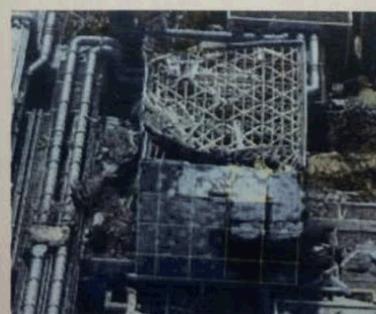
1F4 End State

- Damage following explosion
- Shows all four sides of the building

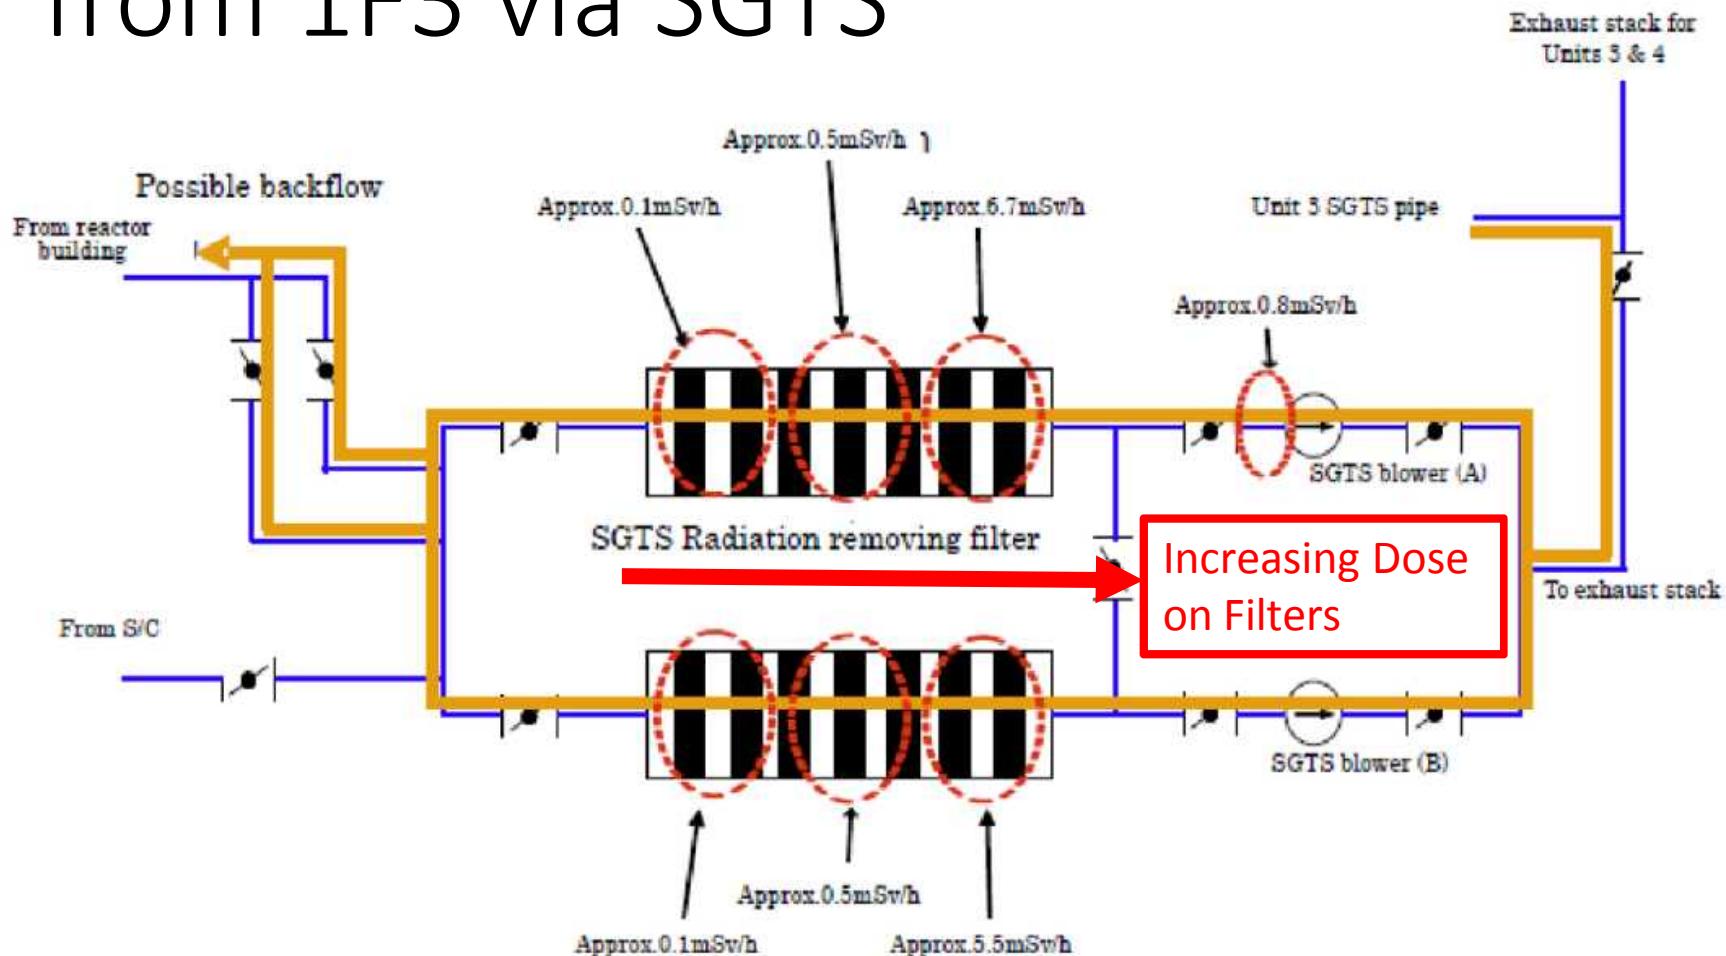
Transfer of H₂ to 1F4 from 1F3 via SGTS

Results of measurement of amount of radiation in Unit 4 SGTS
(conducted on August 25, 2011)
