**ART End User Applications**  
**Task 2.04.19.06**  
**Supercritical Transformational Electric Power (STEP)**

**Milestone Report**

***Resolving Turbine Degradation***

S-CO<sub>2</sub> Materials Development  
Work Package: AT-17SN190602 (STEP – 2)  
Level 3 Milestone Report: M3AT-17SN1906024

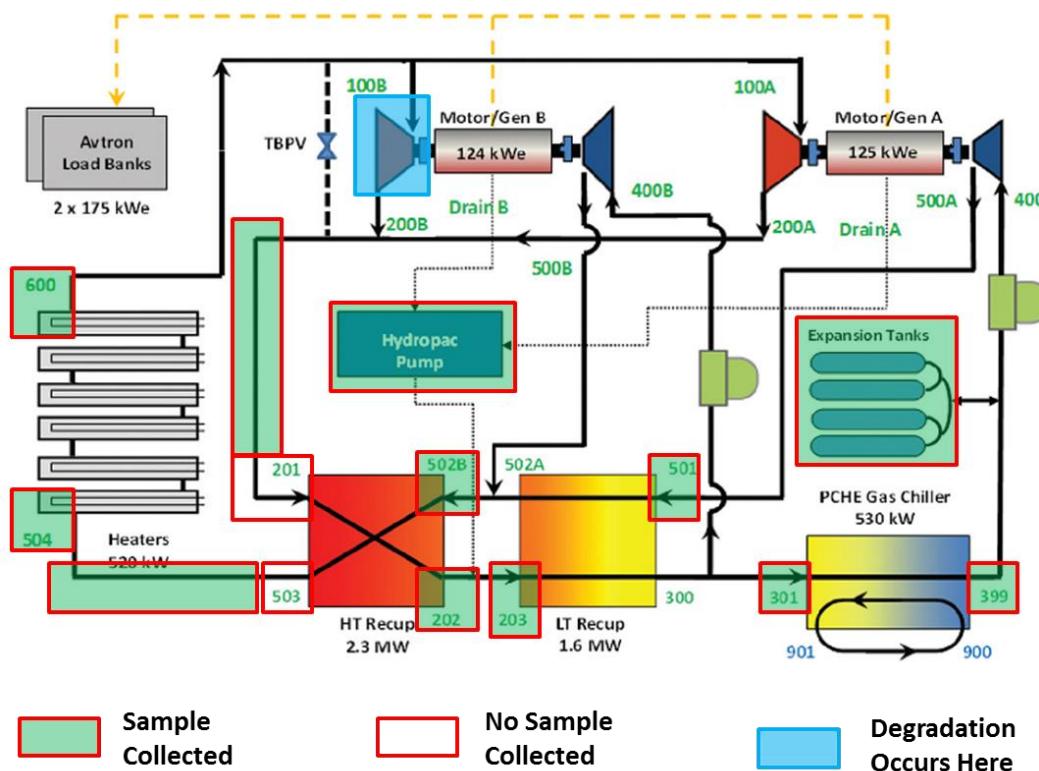
Figure 11 shows a diagram of the test loop that includes locations where foreign material was identified and collected. Images were taken for 22 total samples of foreign material collected from the test loop using the SEM. Also, some chemical information for these particles was collected using EDS. Supplementing these analyses was a more in-depth chemical analysis for four of the powders, using x-ray diffraction (XRD).

Following these inspections, the main focus areas were the expansion (or inventory) tanks, high temperature recuperator (HT Recup), heaters, and sections of piping running between Motor/Gen B (TAC B) and both the heaters and HT Recup. These are areas where significant foreign material debris was identified, and it may be leading to turbine degradation during operation of the test loop.

**Figure 11: Diagram of the Sandia SCO2 test loop, including locations where foreign material were identified and collected.**

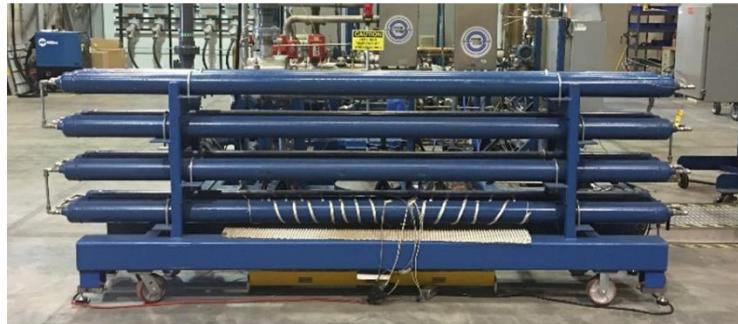
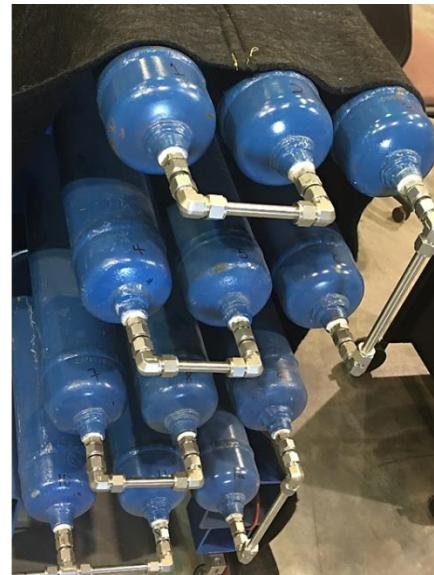
Within the design of the test loop, gas flows into the expansion tanks from the Hydropac pump and flows out from the expansion tanks back into the test loop near the HT Recup inlet at 502A. Several images of the expansion tanks are shown in Figure 12. The tanks are made of carbon steel, and all twelve of them are connected in series, with gas entering one end of a tank and exiting through the other. Gas from the Hydropac pump flows into tank 1, and then continues through each tank until it exits tank 12, back to the loop.

The borescope inspection of the tank interiors revealed a significant quantity of foreign material. A few images of the debris are shown in Figure 13. Visually, it resembled a mixture of metal shavings, glass fibers (likely fiber glass insulation), and metal oxidation product that had spalled from the interior cylinder walls. Samples of foreign material were extracted from each of the tanks, providing for a full characterization of its constituents. An SEM image of this foreign material is shown in Figure 14. EDS of this material revealed that it had a predominantly Fe-O chemistry, indicating that the debris was likely a combination of carbon steel shavings (Fe) and oxidation product ( $Fe_2O_3$ ).

Leading up to this inspection, it was hypothesized that these tanks contained metal oxidation product debris that was flowing into the loop and causing turbine degradation. This was thought to result from prior hydro-testing that was done in these tanks. Following the inspection, it was evident that this hypothesis may indeed be true, as foreign material in support of it was found within the tanks. However, for this hypothesis to be confirmed the presence of  $Fe_2O_3$ , without chromium, needed to be present in the main part of the  $sCO_2$  system (to be discussed later).

**Figure 12: Expansion (or inventory) tanks.**

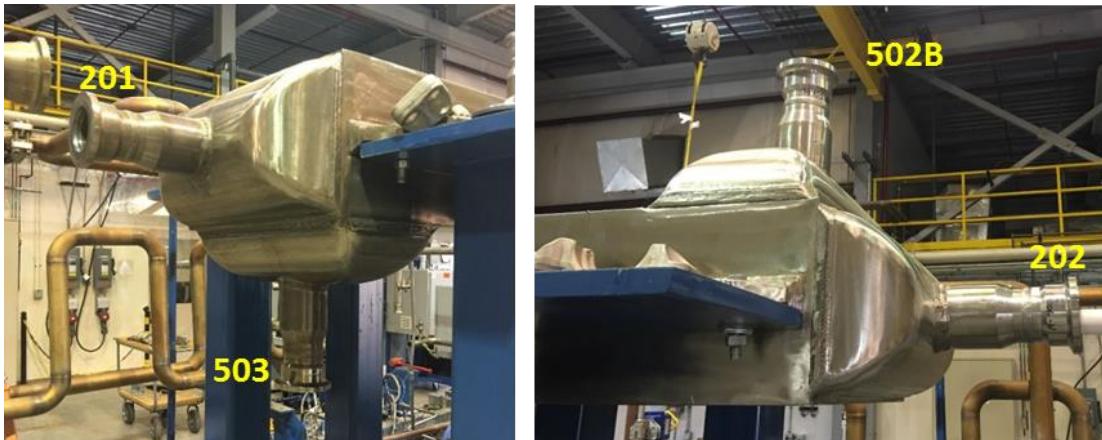
The HT Recup has four separate manifolds directing CO<sub>2</sub> flow across its channels. An image of the HT Recup is shown in Figure 15. After exiting the turbine, hot CO<sub>2</sub> enters the HT Recup at manifold 201, and exits at manifold 202. Flowing in the opposite direction, cool CO<sub>2</sub> enters at manifold 502B and exits at manifold 503. Each manifold was inspected using the borescope. Images of the fluid flow channels within each manifold are shown in Figure 16. Fluid flow channels at manifolds 201, 502B, and 503 appeared clean, and free from surface contamination or corrosion product. In the case of manifold 202, there was a surface film (contamination or corrosion product) covering the fluid flow channel surface. Foreign material was collected from within manifolds at 502B and 202, while none was found in the other two manifolds. It is unclear why just the one surface was contaminated while the others were clean, or why two of the manifolds contained debris while the others did not.

Figure 15: Figure 42. HT Recuperator showing the four manifolds.

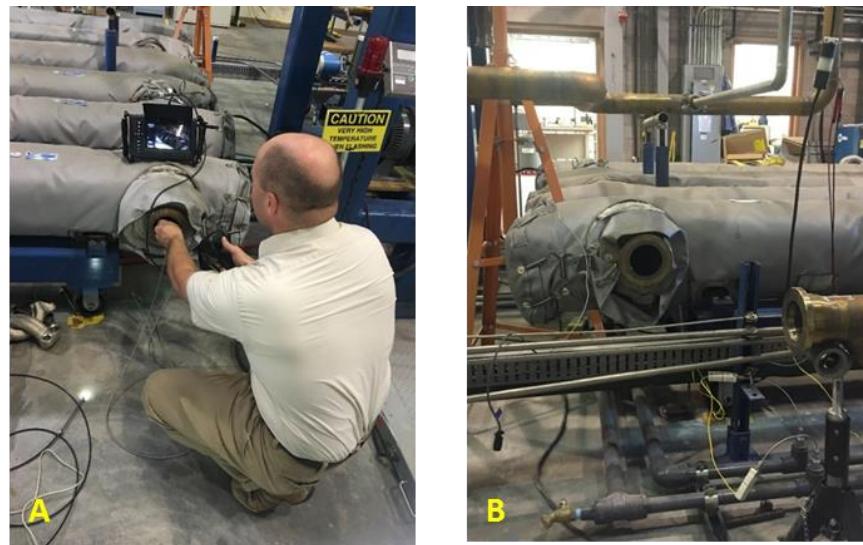
Referring back to the loop diagram in Figure 11, the inlet is shown as 504, while the outlet from the heater is shown as 600. Images of these two locations are shown in Figure 18. Interior photos of each are shown in Figure 19. The areas of the heaters that could be inspected using the borescope appeared to have some oxidation, but overall were relatively clean. The exception to this was an area near the entrance to the heaters that had a rather large pile of debris. An image of this debris is shown in Figure 20. A sample was extracted from the heater for analysis. An SEM image of this material is shown in Figure 21. Similarly to the material from the HT Recup, the material appears to be predominantly stainless steel shavings along with a few oxide particles, an indication that carbon steel inventory tanks may not be the source of particulate contamination.

Figure 18: Inlet (A) and outlet (B) for the SCO<sub>2</sub> test loop heaters.

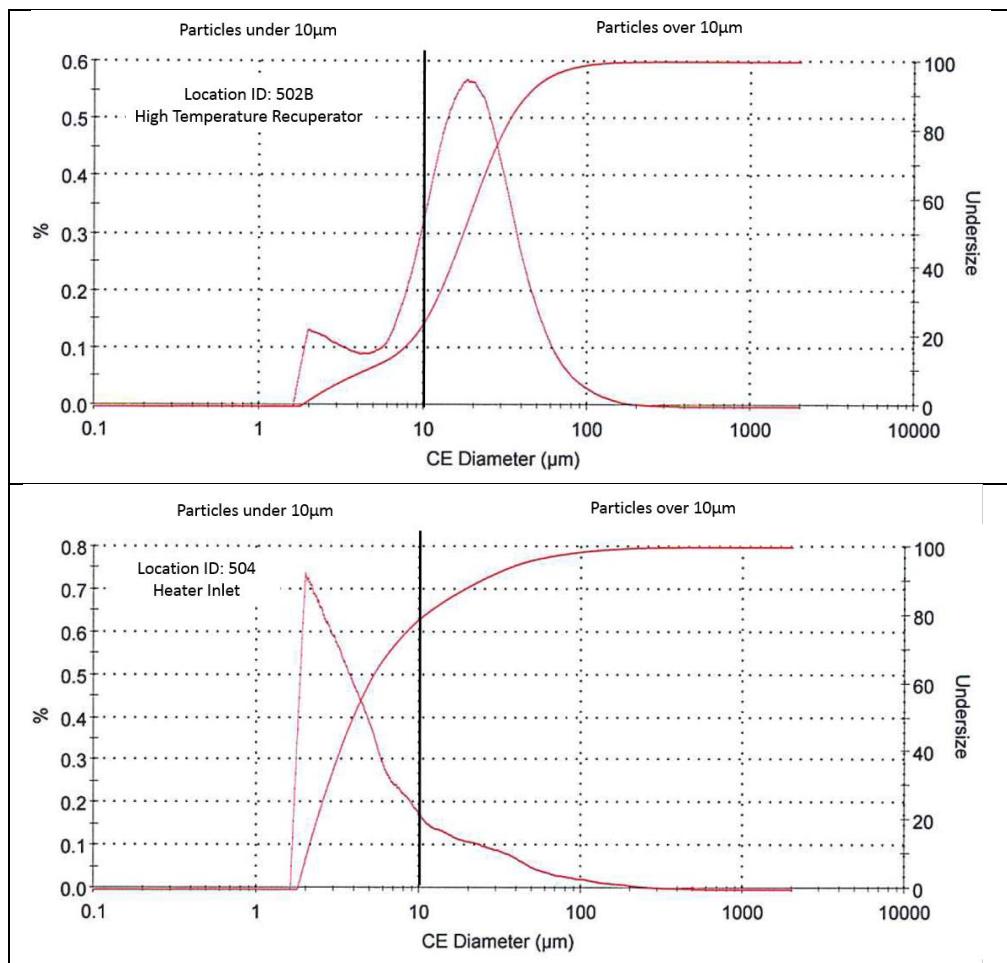
Two locations were investigated; the inlet to the primary gas heater (location 504) and the inlet to the HT recuperator (location 502B). Based on the results there are clear trends in particle size vs. location. Image analysis results are provided for size distribution, aspect ratio (AR), and circularity with a snapshot of results in Table 2 and Figure 26.

**Figure 26: Particle distribution for both locations investigated. Line indicates minimum available 10 $\mu\text{m}$  filter size available.**

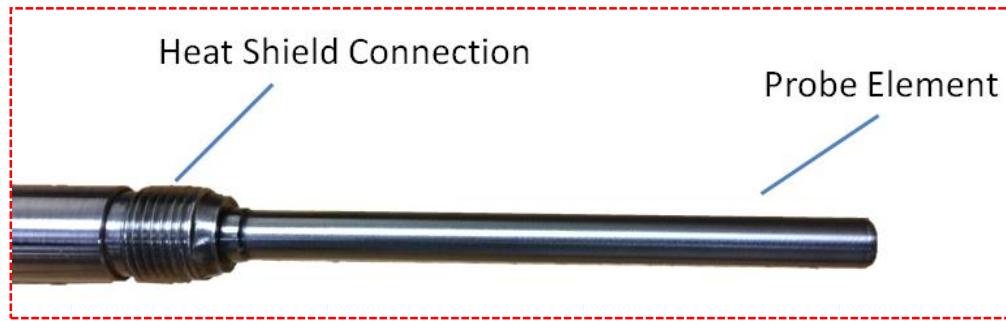
Probe and data acquisition were purchased from Metal Samples® shown in Figure 29. The probe was made custom for the temperature range in question and part of this test series has been to assess the robustness of the probe element. This probe consists of two resistor elements (Figure 30): the probe element, exposed to environment, and reference, which is hermetically sealed. Relative ratio of resistances account in internal temperature adjustment, thus the returned value indicates true metal loss.

Figure 29: Photo of 316L ER device with heat shield removed. Reference element internal to the device.

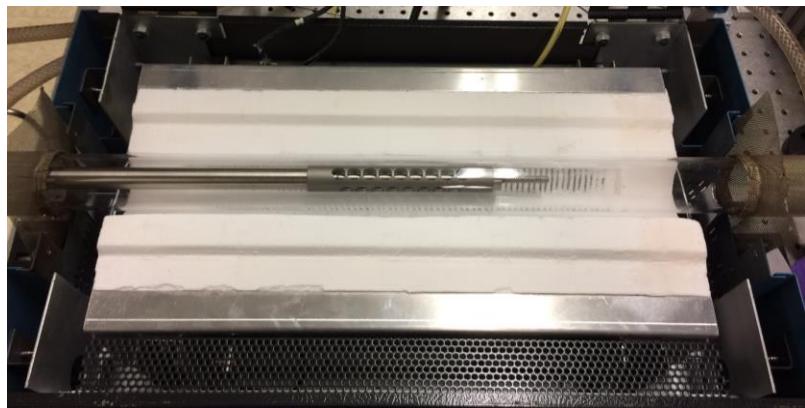
Figure 31 is a photograph of the corrosion probe installed in a quartz tube furnace. Shake down tests were performed in this arrangement at various temperatures and at isothermal conditions (650°C) in Argon and CO<sub>2</sub> over the course of 1.5 months.

Figure 31: Probe, with heat shield, installed in quartz tube furnace

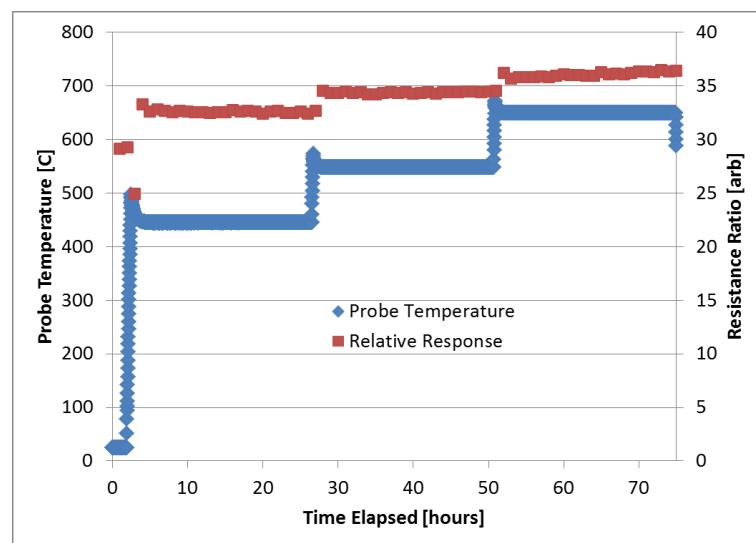
Thermal ramps and holds were performed (Figure 32) and the relative response of the probe (red symbols) indicate that as temperature increased so did the corrosion rate. Each isothermal hold lasted 24 hours. Initial values on these tests were not reported as values were high due to the initial oxidation of the probe and we felt they were not representative of the actual behavior.

Figure 32: Thermal ramp and holds at three temperatures (CO<sub>2</sub> cover gas)

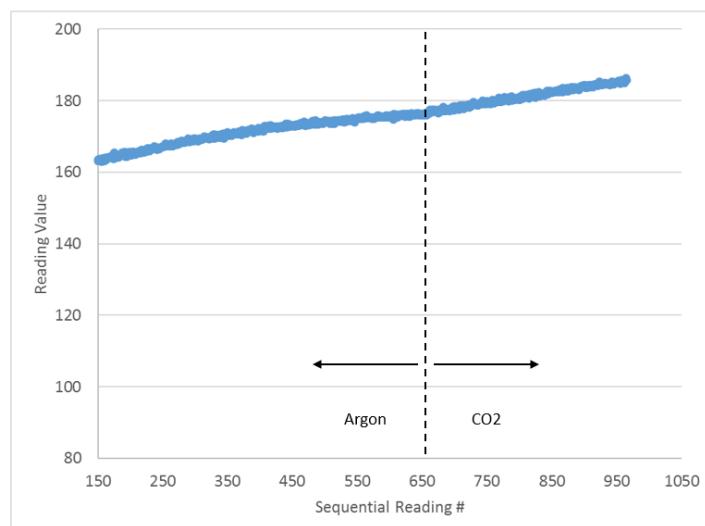
An isothermal experiment, Figure 33, indicated a clear change in corrosion rate when gas was changed from Argon (minimally corrosive) to CO<sub>2</sub>. Argon was the cover gas for 20 days, while CO<sub>2</sub> was the cover gas for only 14 days. The resistance response was linear during the CO<sub>2</sub> exposure, and exhibited more severe corrosion (as expected) vs. Argon. More testing is needed, but qualitatively the probe is performing as expected at representative operating temperatures.

Figure 33: Inflection change indicates change in corrosion rate. ~15% increase in slope when CO<sub>2</sub> was introduced (isothermal 650°C)
