An Evaluation of Prototype Circuit Boards  
Assembled with a Sn-Ag-Bi Solder<sup>1</sup>

P.T. Vianco  
J.A. Rejent

Sandia National Laboratories  
Albuquerque, NM

### Abstract

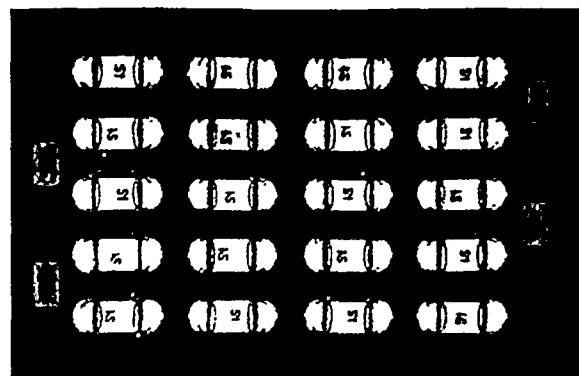
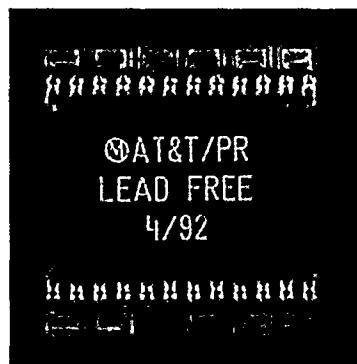
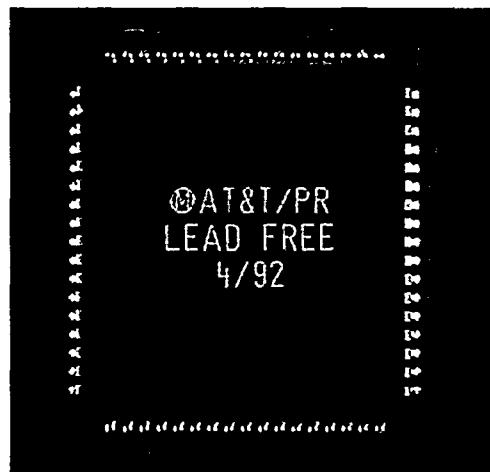
The Sn-Ag-Bi solder exhibited excellent solderability on both the circuit board pads and package I/Os as is evident in the photographs in Fig. 5 showing each of the package types after assembly. Shown in Fig. 6 are SEM micrographs of the chip capacitor, SOIC, and PLCC solder joints along with optical micrographs of cross sections of the respective joints. In the SEM photographs, the black patches on the solder joints were flux residues; recall that a no-clean flux was used in the paste to assemble the test vehicles. There was no significant void ("blow hole") formation in the joint fillets. The absence of voids from the solder joints as well as excellent wettability of all substrate surfaces was confirmed by the cross sectional views. Also, microstructural features such as  $\text{Ag}_3\text{Sn}$  particle distribution within the solder were consistent amongst the three solder joint types. Finally, the alignment between the package I/O and the underlying circuit board pad was excellent. The absence of significant solderability defects, voids, or poor package alignment as well as a consistent microstructure confirm the uniformity of the solder joints between the packages. Such consistent, defect free solder joints are required in order to establish reliable trends of interconnect aging from the thermal cycling experiments.

Fig. 5 Photographs of views of each of the package types on the test vehicle after assembly: (a) chip capacitors, (b) SOIC, and (c) PLCC.

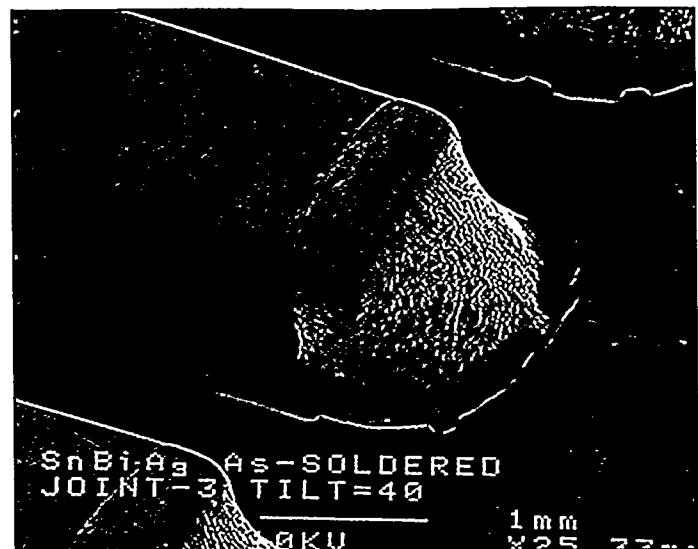
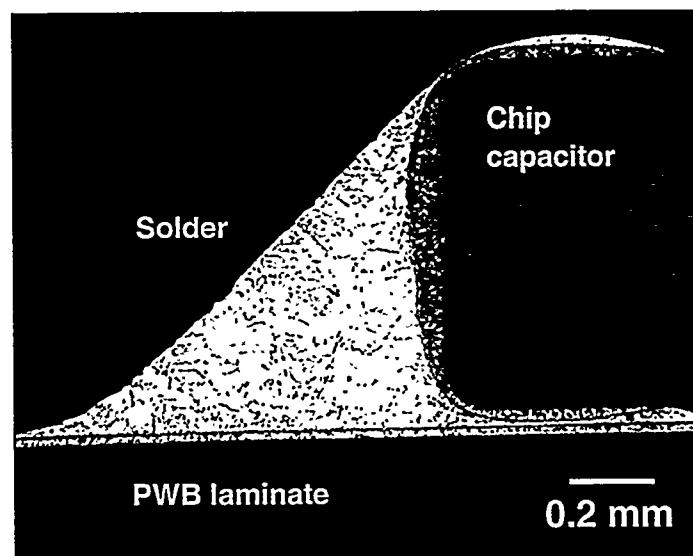
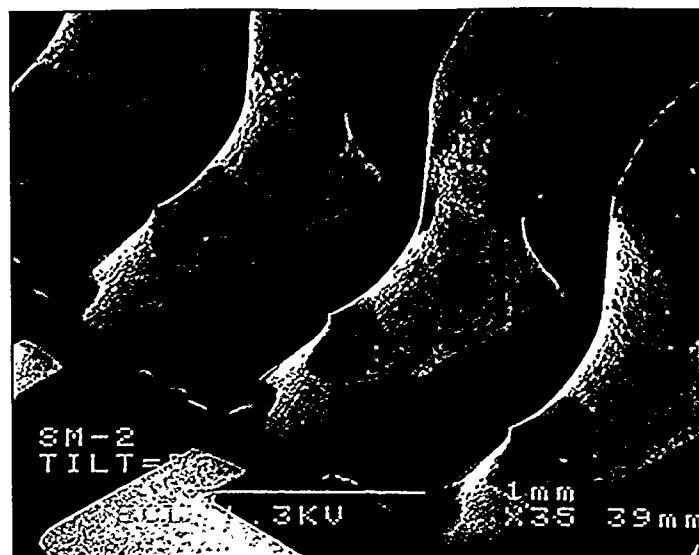
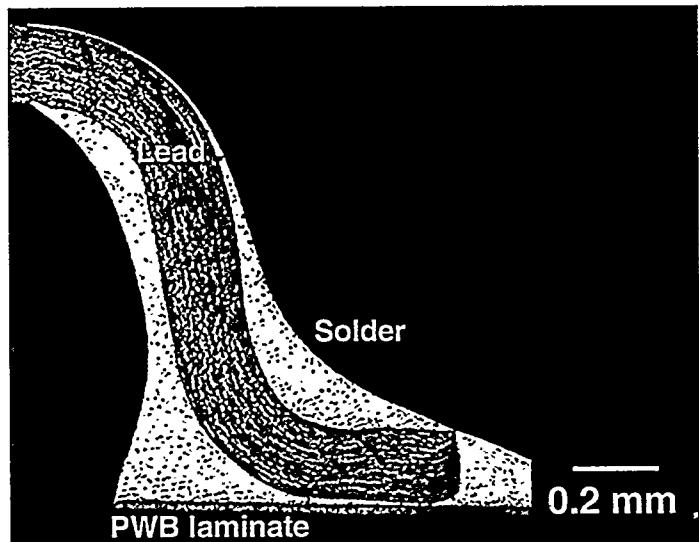
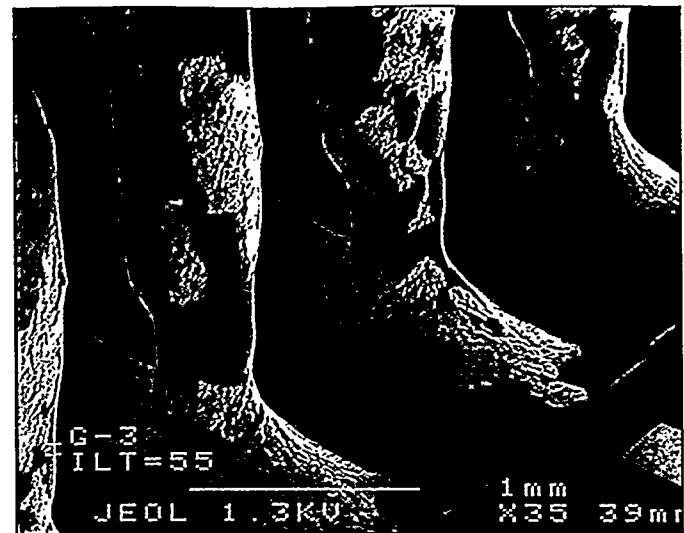
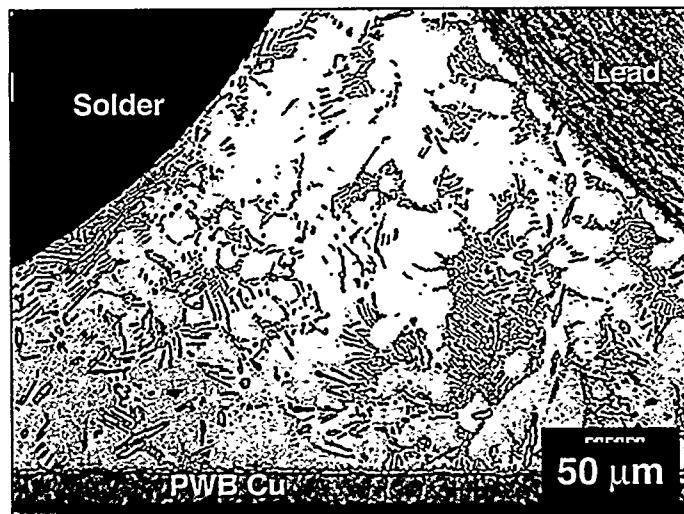
Fig. 6 SEM photographs and cross sectional optical micrographs are presented of the three solder joint configurations: (a, b) chip capacitor; (c, d) SOIC gull wing; and (e, f) PLCC J-lead. (*con't*)

Fig. 6 SEM photographs and cross sectional optical micrographs are presented of the three solder joint configurations: (a, b) chip capacitor; (c, d) SOIC gull wing; and (e, f) PLCC J-lead.

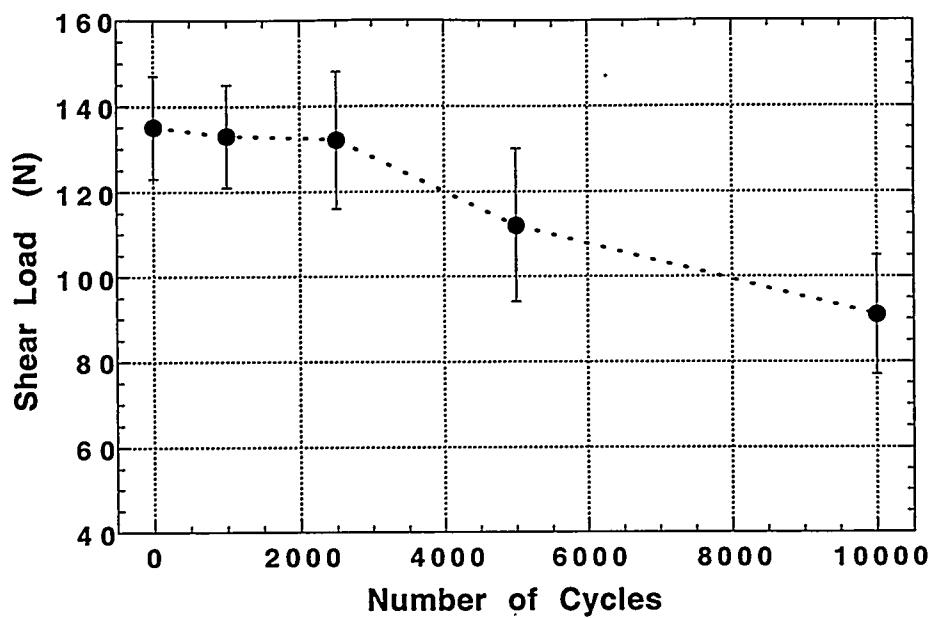
The shear strength values as a function of the number of thermal cycles for the chip capacitor solder joints, are shown in Fig. 18. It is observed that the very high, as-fabricated strength (0 cycles) of 135 N did not change significantly when the parts were subjected to 1000 and 2500 thermal cycles. The mean strength began to decrease with 5000 and 10,000 cycles. It should be noted that the strength level after 10,000 cycles, 92 N, is higher than that of similar Sn-Pb solder joints without thermal cycling (87 N). Therefore, the Sn-Ag-Bi chip capacitor solder joints retained adequate strength after 10,000 thermal cycles.

The shear strength (Fig. 18) and fracture morphology information (Fig. 19) can be correlated as follows. As noted above, the fracture path propagated in both the solder and the chip capacitor structure over the range of thermal cycle conditions. The shear strength exhibited a decline at 5000 and 10,000 cycles. Assuming that the adhesion strength between the metallization and the capacitor was not affected by the thermal cycling conditions, then the drop in strength was due to a decrease in load-bearing area at the solder/termination interface (top of region "A"). Further growth of the fillet tip cracks shown in Figs. 11 (5000 thermal cycles) and 15 (10,000 thermal cycles) was the likely cause for the drop in shear strength of the solder joints.

Fig. 18 Shear strength as a function of the number of thermal cycles for the chip capacitor solder joints.

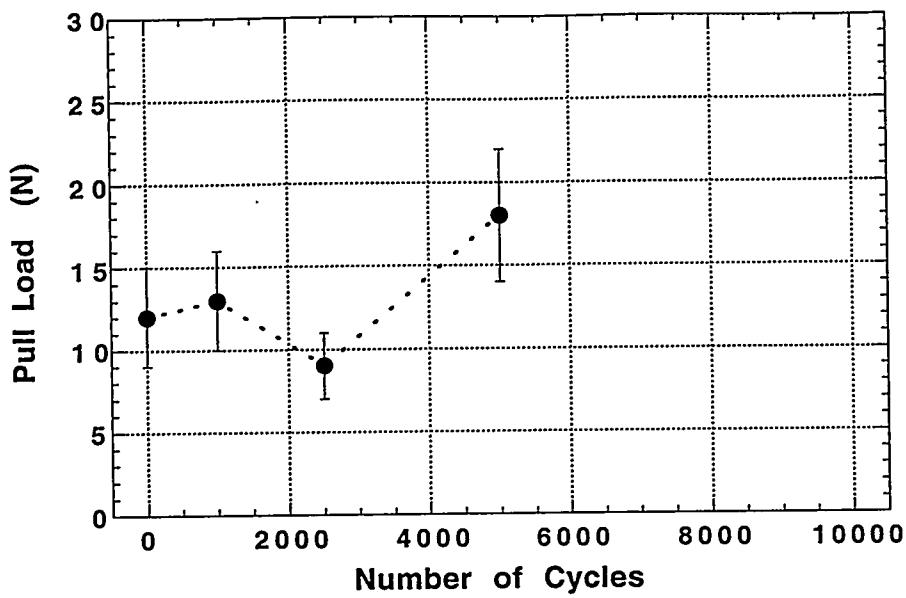
The pull strength of the J-leads on the 68 I/O PLCC packages was determined as a function of thermal cycling; those data appear in Fig. 20. No pull tests were performed on the J-leads of PLCC packages exposed to 10,000 thermal cycles. The data show that the cycling environment had no consistent effect on the solder joint strength. Therefore, the surface and fillet cracks observed in the metallographic cross sections appear to have been inconsequential to the overall mechanical integrity of the J-lead solder joints. The strength levels in Fig. 20 can be compared against that for similar solder joints made with the traditional Sn-Pb solder - 12 N (as-fabricated condition). Therefore, the Sn-Ag-Bi solder retained strength levels that are comparable with those of Sn-Pb solder, even after the former has been thermally cycled.

Fig. 20 Pull strength as a function of the number of thermal cycles for the J-lead solder joints on the PLCC package.
