**North Slope of Alaska ARM Facilities**  
**Monthly Status Update**  
**Sandia National Labs**

**June 2017**

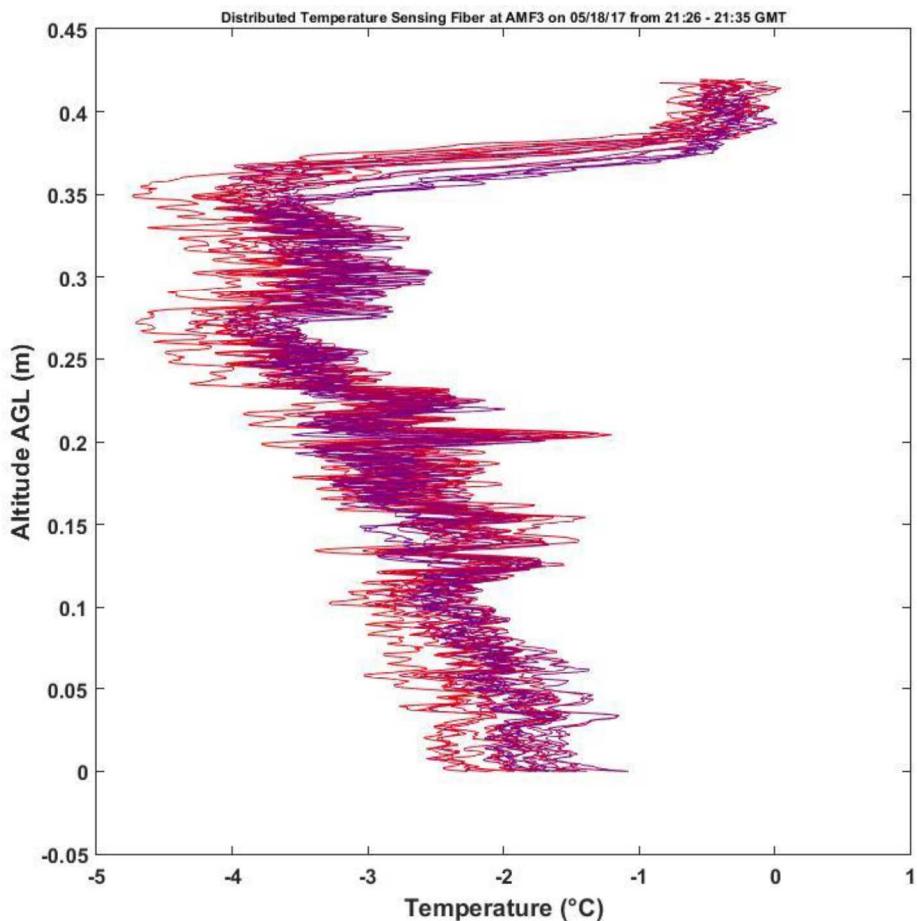
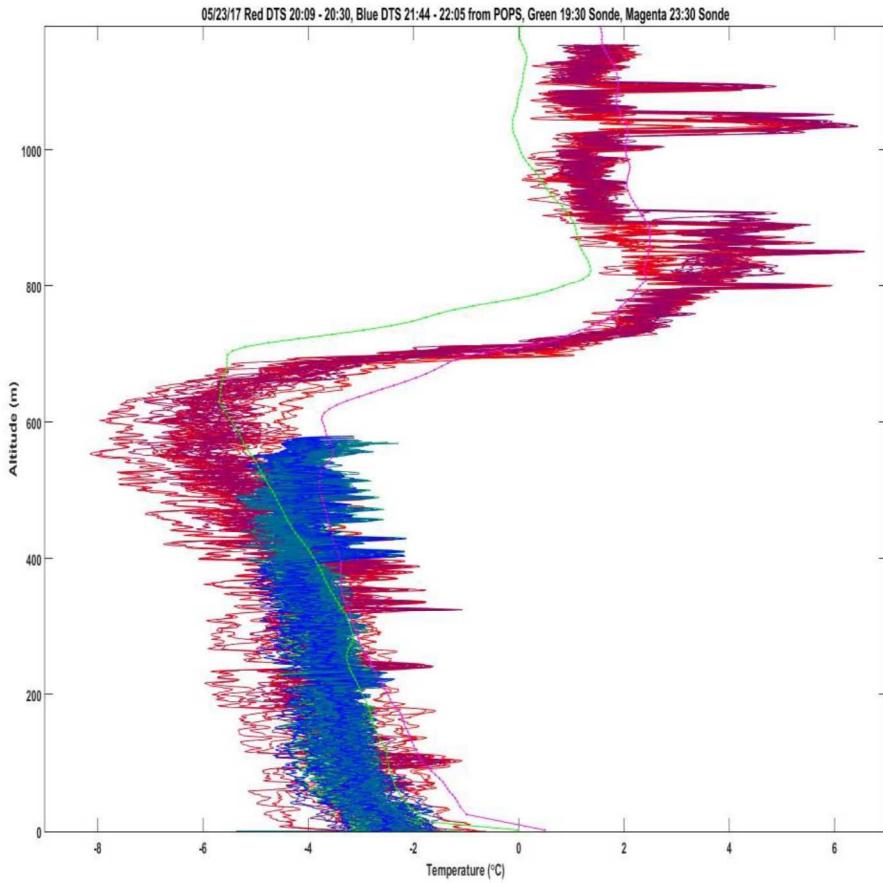
DTS data were analyzed from the May 2017 TBS campaign. It was determined that the silicon oil used in the DTS calibration baths for the first time in May 2017 did not perform as well as the ice and water baths previously used. Much of the May 2017 DTS data was invalid due to poor calibration. It was also noted that the internal DTS battery was dead. The manufacturer requires the unit to be returned in order for this battery to be changed. An increase in noise in the DTS data was also noted in the May 2017 campaign. The DTS unit was returned to the UK for warranty service and maintenance to address these issues. It will be returned by 8/1 for the next scheduled TBS campaign at the AMF3.

DTS measurements were attempted through the fiber optic rotary joint in May 2017. Although measurements were successful when tested in Albuquerque, the temperature measurements through the rotary joint were obviously incorrect in Oliktok. After discussions with the manufacturer the supposed cause is a buildup of the fluid within the fiber optic rotary joint on the internal optics, caused by the relatively high power of the DTS laser. The rotary joint has been returned for exchange to a model that does not use fluid, which will be used in August.
