WINCO-1153

## **CORROSION IN ICPP FUEL STORAGE BASINS**

**W. J. Dirk**

**September 1993**

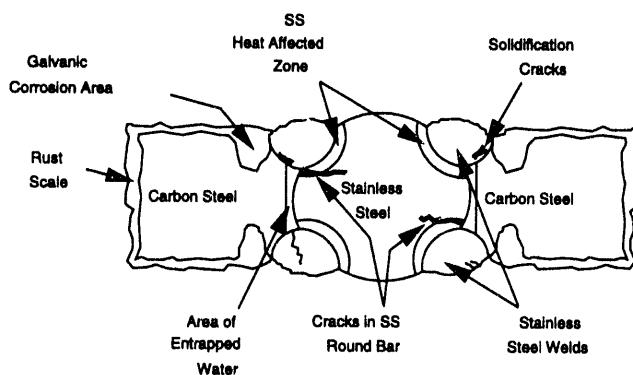
Figure 15 - Cross Section of Single Hook

The second type of hanger was constructed of a 1/2-inch thick by 2-inch-wide carbon steel bar with a 5/8 inch Type 304 stainless steel eye piece welded in a notch cut into the end of the bar (Figure 13). The carbon steel had been previously galvanized to increase the service life, however, there was very little zinc galvanizing left. Ultrasonic thickness measurements made on the carbon steel bar showed a general thickness loss of 0.106 inches after 24 years exposure to the basin water. The area where the stainless steel rod was welded into the carbon steel bar showed evidence of attack in the heat affected zone parallel to the weld. This is indicative of galvanic attack. This hanger was sectioned and metallographically examined. Figure 14 shows a description of where the hanger was sectioned and Figure 15 shows a representation of the sectioned piece. The cross section of the hanger (Figure 14-B) shows incomplete penetration of the weld resulting in a crevice on both sides of the stainless steel rod. This crevice was filled with corrosion product and allowed chloride ions from the basin water to concentrate. Figure 16 shows an example of chloride stress corrosion
