SAND93-2453 • UC-235
Unlimited Release
Printed January 1994

Operational Experience and Evaluation of a Dual-Element Stretched-Membrane Heliostat

John W. Strachan and Jake Van Der Geest

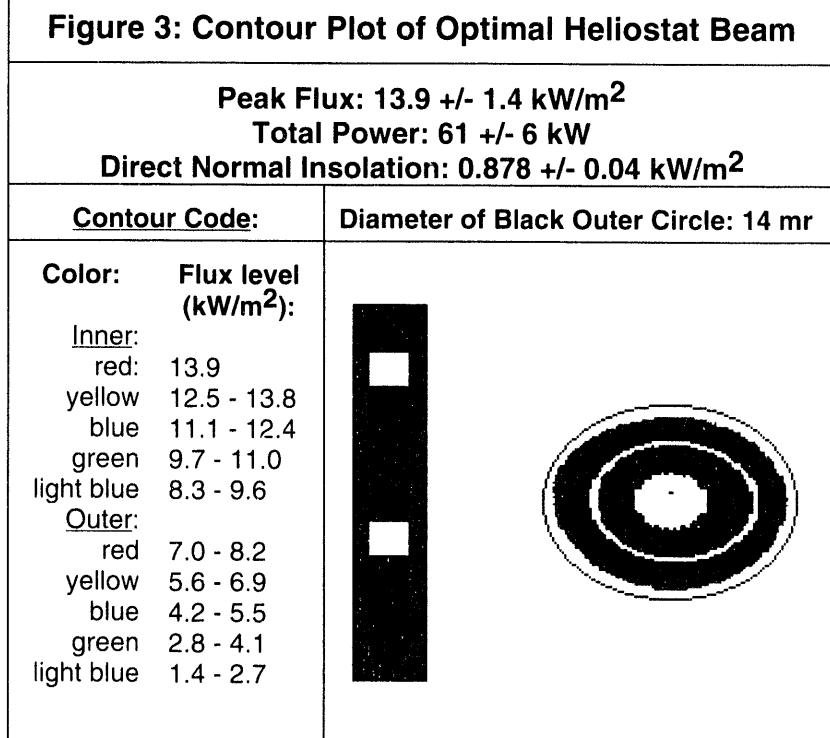
Figure 3: Contour Plot of Optimal Heliostat Beam

graphically in Figure 3 with a contour plot which maps the flux distribution of the collector beam. This image was taken several days after the mirror modules had been recanted so that we could obtain data on the heliostat performance in a condition of zero mirror canting error.⁸ With the two modules' beams fully overlapped, the peak flux in the beam was $13.8 (+/- 1.4)$ kW/m², the beam's total power was $61 (+/- 6)$ kW. All flux in the beam having an intensity equal to or greater than 10% of the peak flux was contained within a circle (the black circle shown in the figure) having a diameter of 14 mr. (For comparison purposes, the nominal angular size of the sun itself is 9.3 mr). Given the insolation level at the time of this measurement (0.878 kW/m²), the normalized power produced by the heliostat was 69 kW which is 0.71 kW per square meter of collection area. This single BCS flux map exemplifies, perhaps, the best optical performance of the heliostat since the beams of the two modules are tightly overlapped. The balance of the beam quality evaluation was done with the modules in their original canted condition, and the results of are presented below.
