Predicting the Reliability of Package-on-Package-Package (PoPoP) Interconnections Based on Accelerated Aging Experiments and Computational Modeling

P. Vianco, J. Rejent, M. Grazier, B. McKenzie, A. Kilgo, and M. Neilsen,

Sandia National Laboratories*
Albuquerque, NM 87185

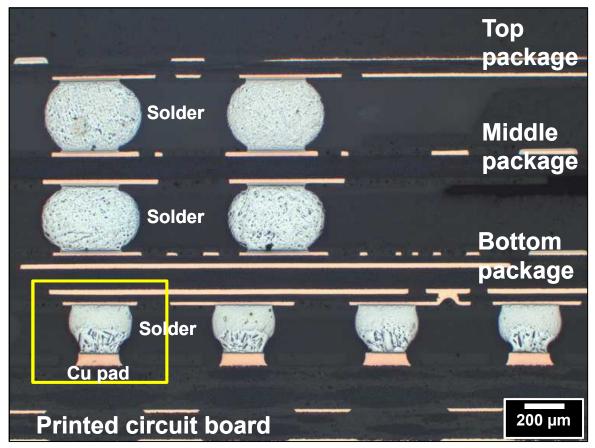
S/N05: as-fabricated; underfill, middle and bottom gaps

- An objective of the backwards compatible test vehicles was to assess the TMF of the inhomogeneous microstructure.
- This microstructure was observed on only one (1) test vehicle.

Excessive voids and cracks were not observed in any joints.

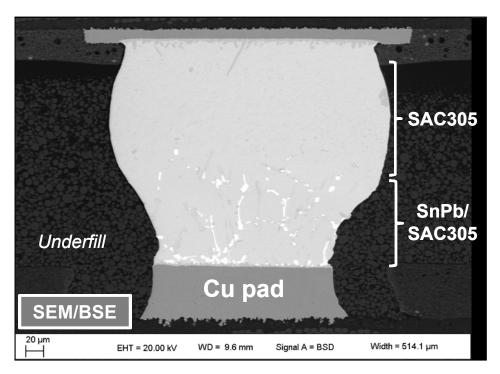
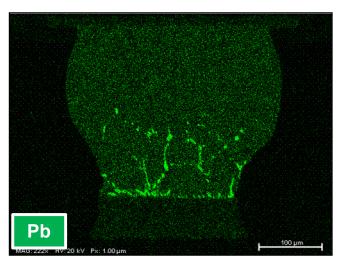
Energy dispersive x-ray (EDX) analysis indicate that both the Pb-rich and Ag₃Sn phases are distributed nonhomogeneously in the "mixed" Sn-Pb/SAC 305" region.

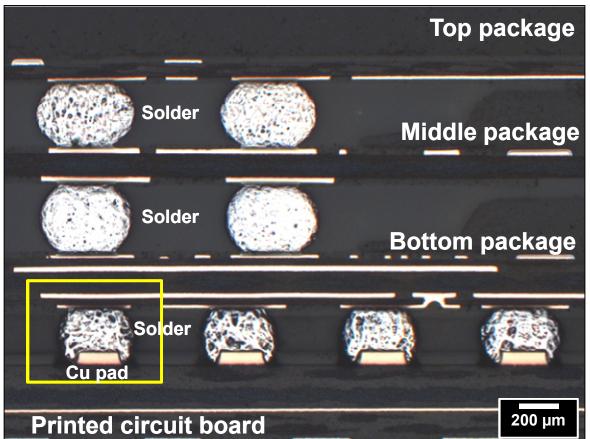
S/N07: as-fabricated; underfill, middle gap

The remaining, backwards compatible test vehicles exhibited homogeneous distributions of Pb-rich phase in the solder joints.

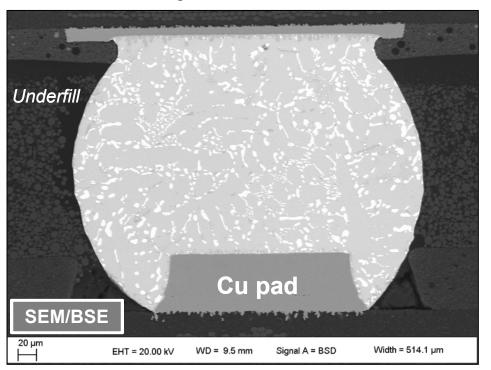
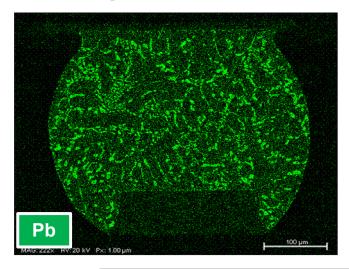
Although the Ag₃Sn particles were not uniformly distributed across the entire joint, this trend did not affect TMF performance.

A direct correlation was not observed between the Pb-rich and Ag₃Sn phases within either the homogeneous or the inhomogeneous microstructures.

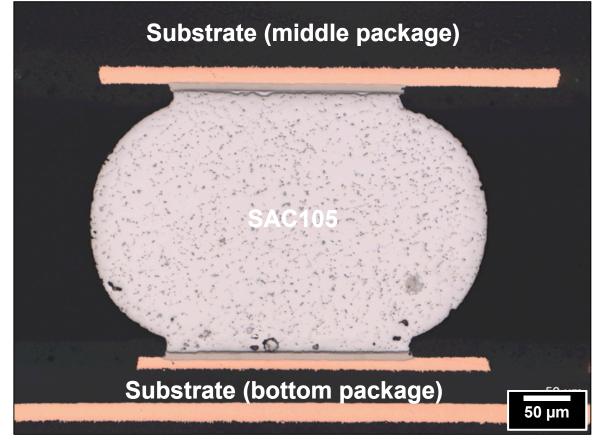
S/N05: as-fabricated; underfill, middle and bottom gaps

The microstructure analysis also confirmed the excellent integrity of the SAC105 solder joints that attached middle package to the bottom package ...

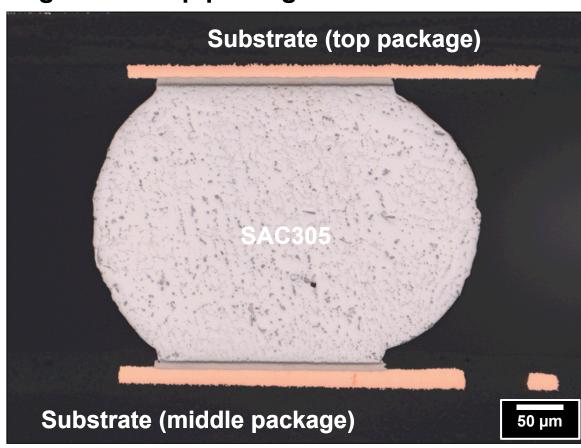
S/N05: as-fabricated; underfill, middle and bottom gaps

... as well as SAC305 interconnections that joined the middle package to the top package.

Recall that the middle and top solder joints had undergone two soldering steps: initial stack reflow and subsequent, solder reflow.

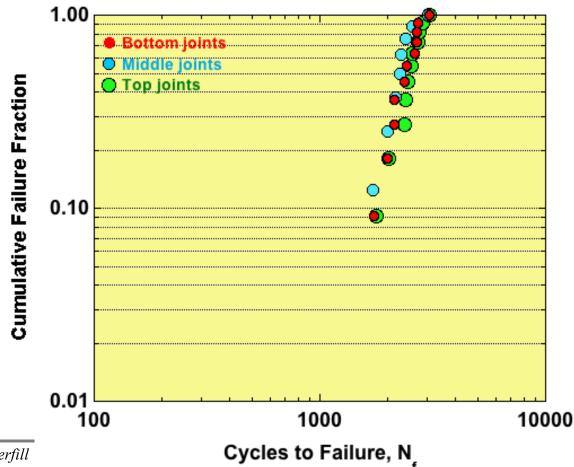
S/N22 and S/N23: Mixed SnPb/SAC305; No underfill

Mixed SnPb/SAC305 bottom joints; no underfill: The 2P Weibull data indicated that all three solder joints had nearly identical behaviors despite the different solder compositions.

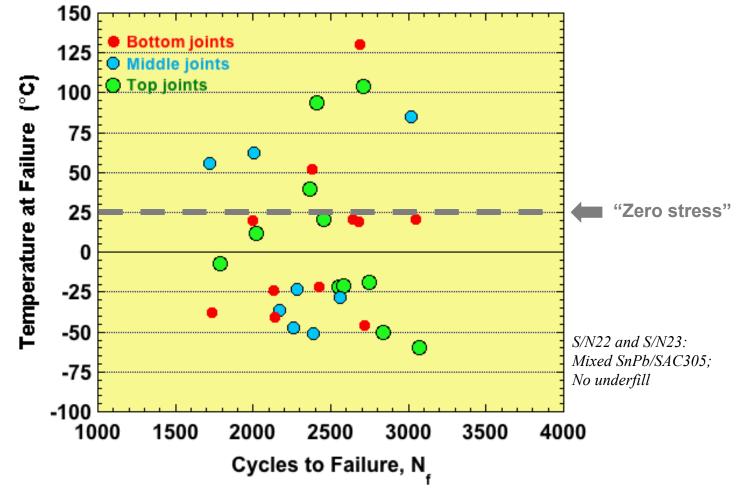
Mixed SnPb/SAC305 bottom joints; no underfill: The data show a slight preference for failures to occur at low temperatures.

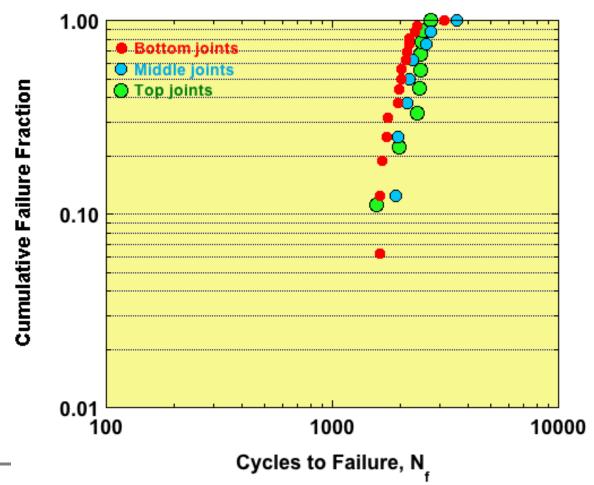
S/N44 and S/N45: 100% SAC305; No underfill

100% SAC305 bottom joints; no underfill: The 2P Weibull data show that the TMF was more distinct vis-a-vis the three solder joint types.

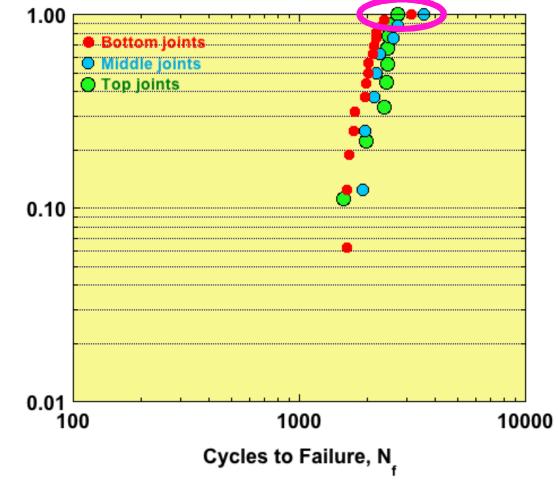
S/N44 and S/N45: 100% SAC305; No underfill

• 100% SAC305 bottom joints; no underfill: The outliers that caused the small β terms for the middle and bottom joints occurred at the high-cycle counts rather than the typical, "early failures".

Middle joints, censored: $\eta = 2400 \pm 500$ cycles $\beta = 8.2 \pm 4.7$

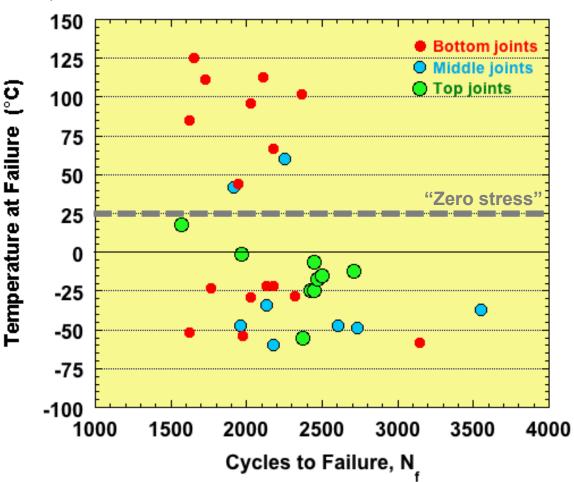
- 100% SAC305 bottom joints; no underfill:
 - The top and middle solder joints showed the same, slight preference for failure towards the low temperatures.
 - The bottom joints exhibited failures at the high and low temperatures to relatively a similar degree.

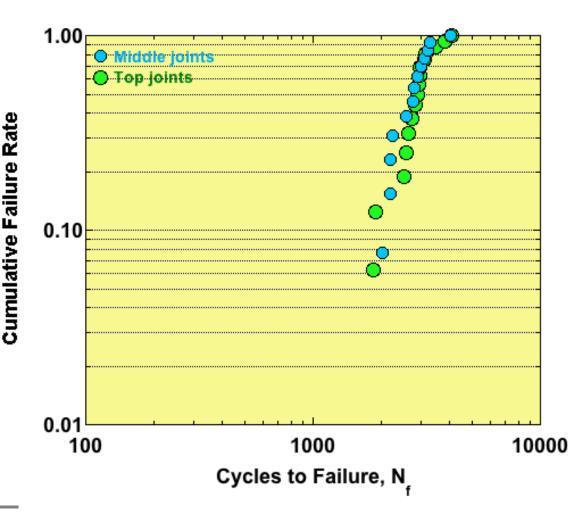
Failure data were collected only for the middle joints and top joints because the bottom joints "outlived" the other joints.

Bottom joints (N = 1): n = 4506 cycles

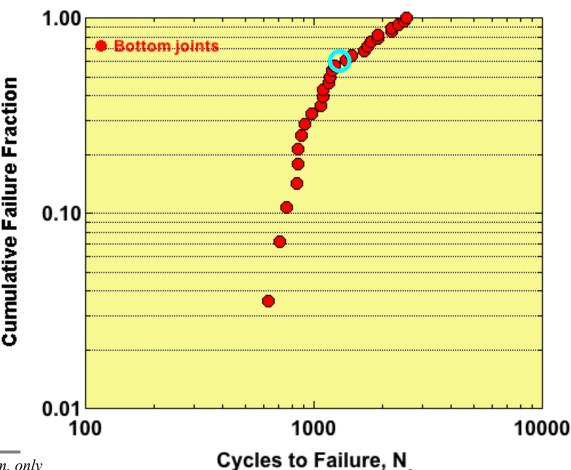
S/N33 and S/N36: 100% SAC305; Underfill, bottom, only

- 100% SAC305 bottom joints; Underfill, bottom gap, only:
- The bottom solder joints were the life-limiting interconnections.
 - 2P Weibull failure statistics are shown for the bottom joints.

- The interconnections had a relatively low η value very wide failure distribution (low β).
- A "knee" is observed at a cumulative failure fraction (CFF) ≈ 0.6, or 1300 cycles.

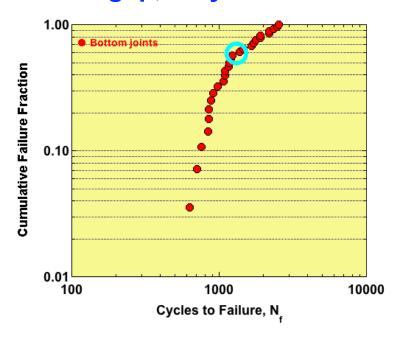
- 100% SAC305 bottom joints; Underfill, bottom gap, only:
- A "knee" CFF plot suggests that the solder joint TMF is governed by two failure mechanisms.
- The 2P Weibull failure statistics were recalculated, assuming that there were two populations:

- The "high-η" mechanism must avoid the "low-η" mechanism.
- Since both failure regimes had similar populations, it is inferred that any solder joint has roughly an equal chance of failing under either mechanism.

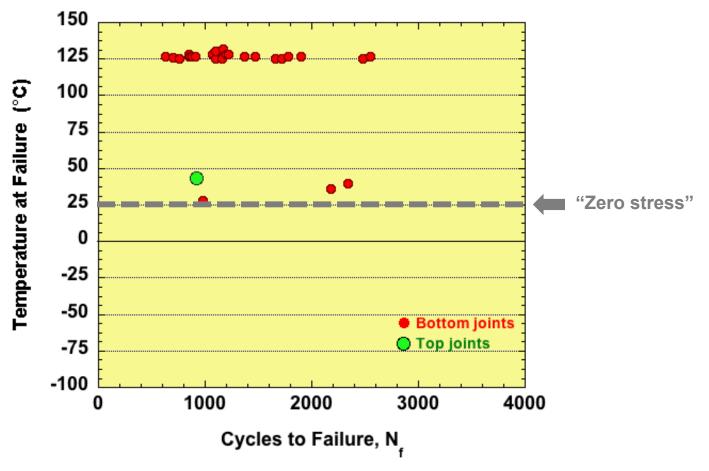
- 100% SAC305 bottom joints; Underfill, bottom gap, only:
- The temperature-at-failure data indicate that tensile stresses due to underfill thermal expansion affected bottom solder joint TMF.
