DOE/NV--1594

**Post-Closure Report for Closed  
Resource Conservation and Recovery  
Act Corrective Action Units, Nevada  
National Security Site, Nevada**

**For Calendar Year 2017**

May 2018

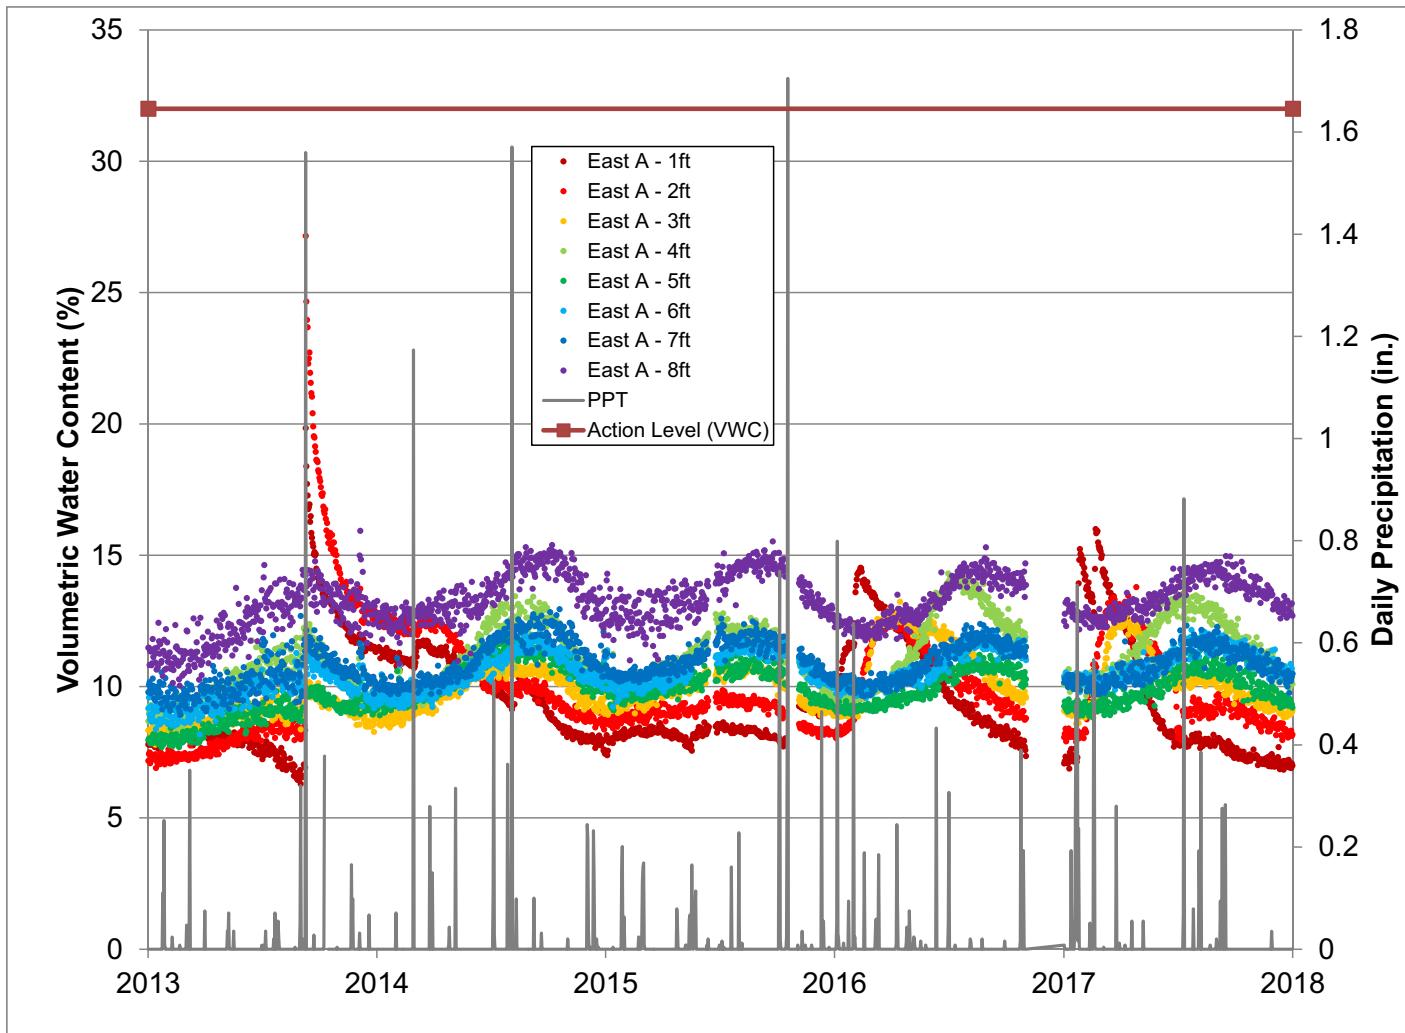
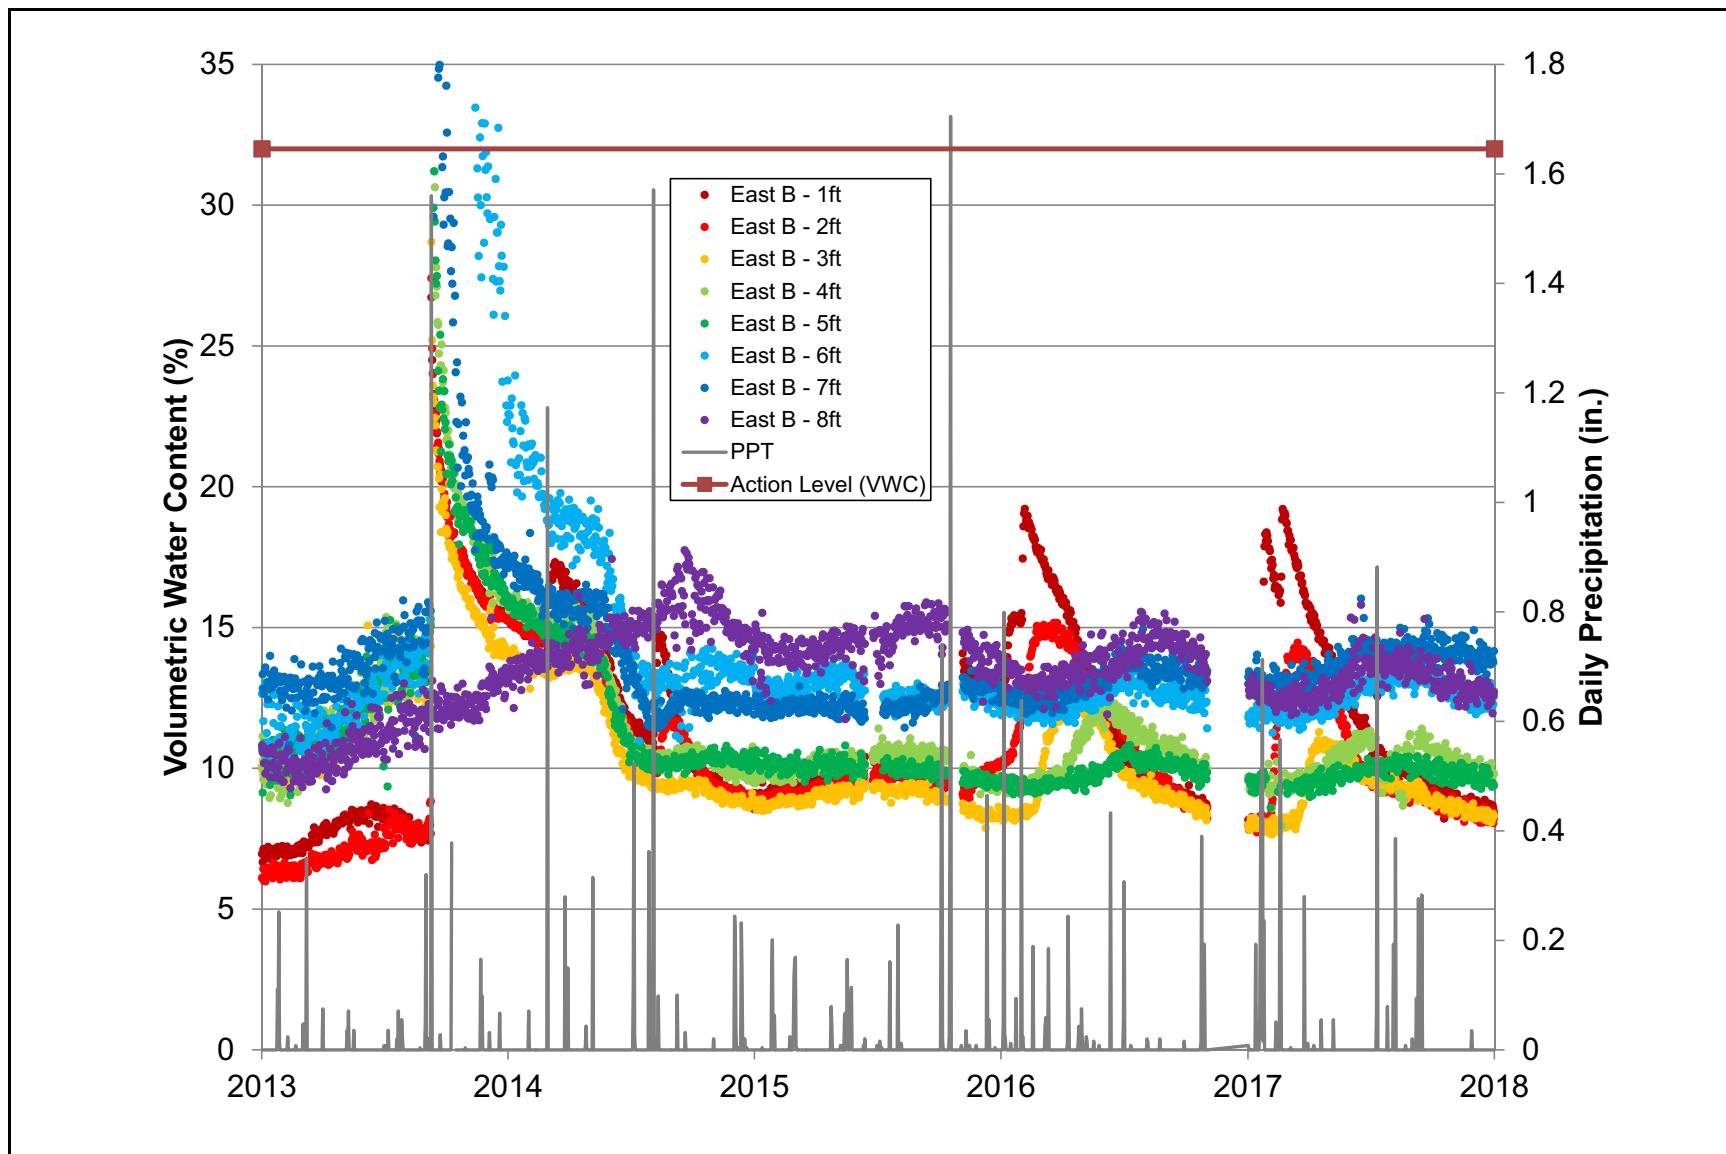
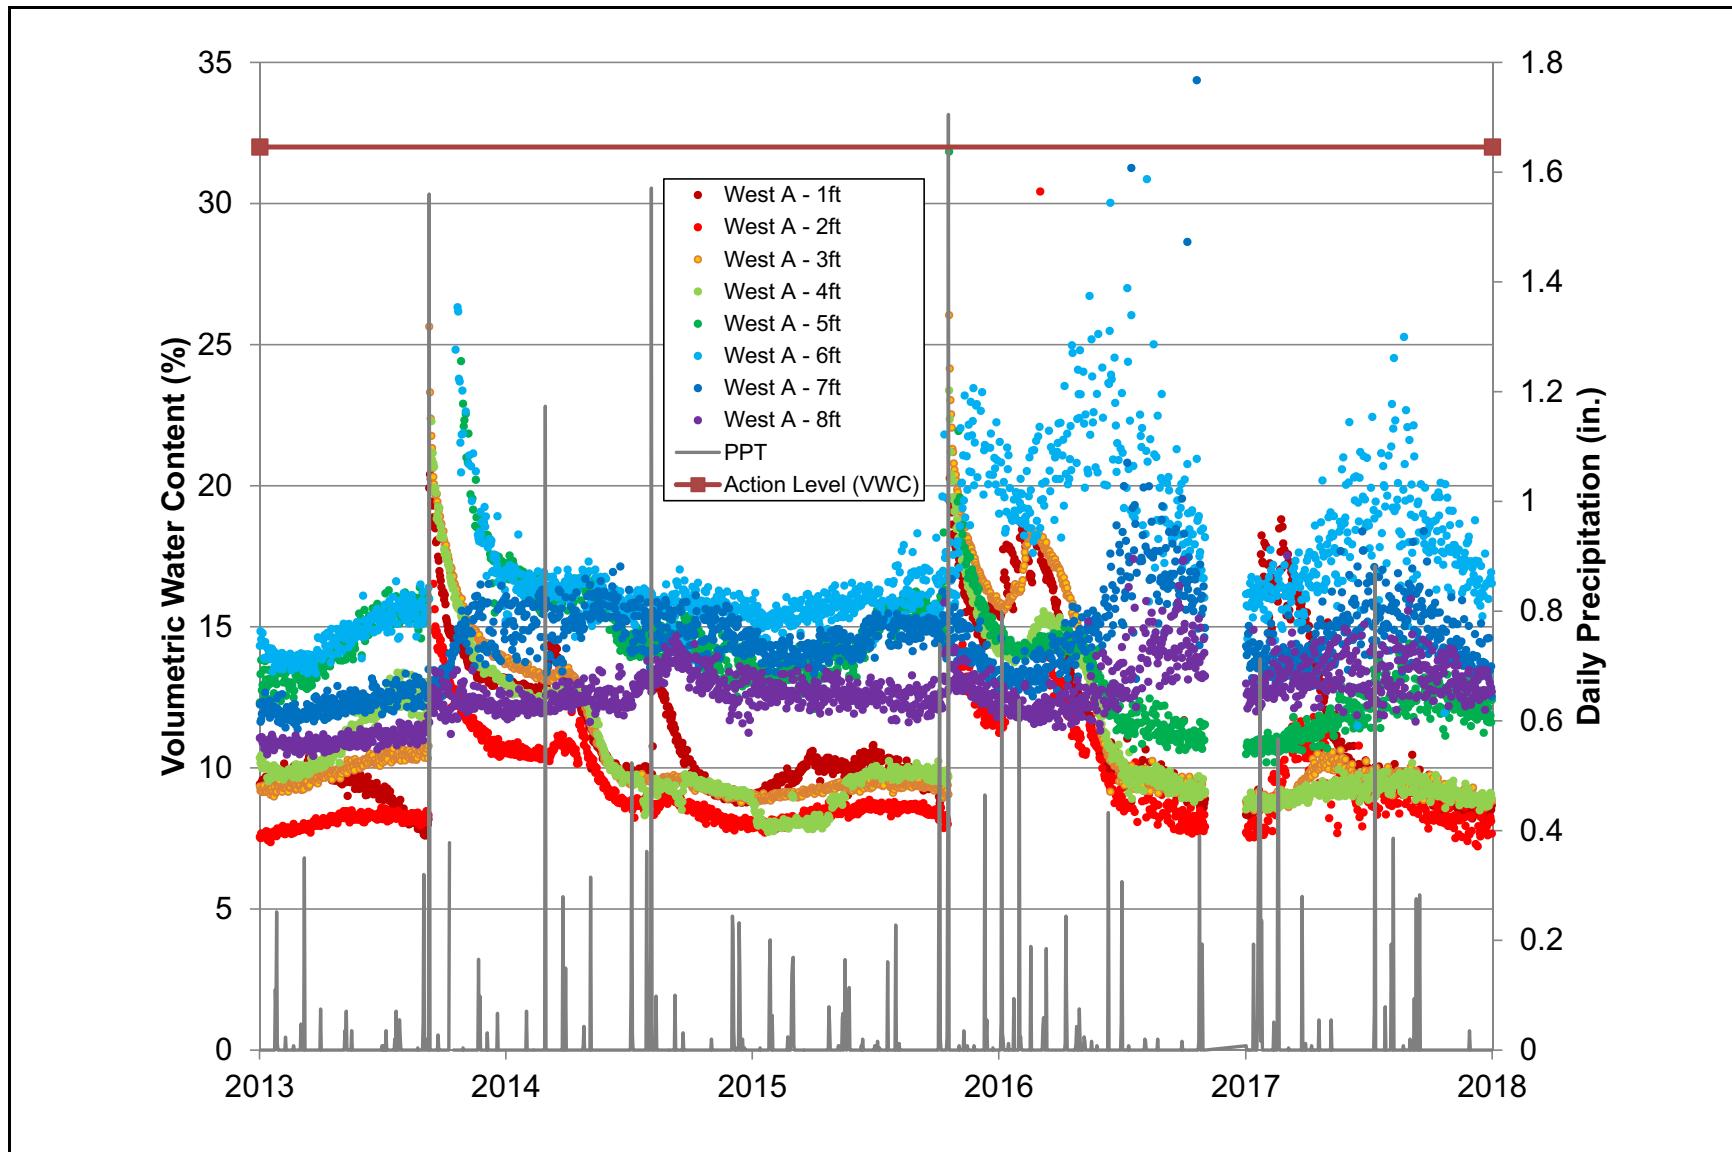
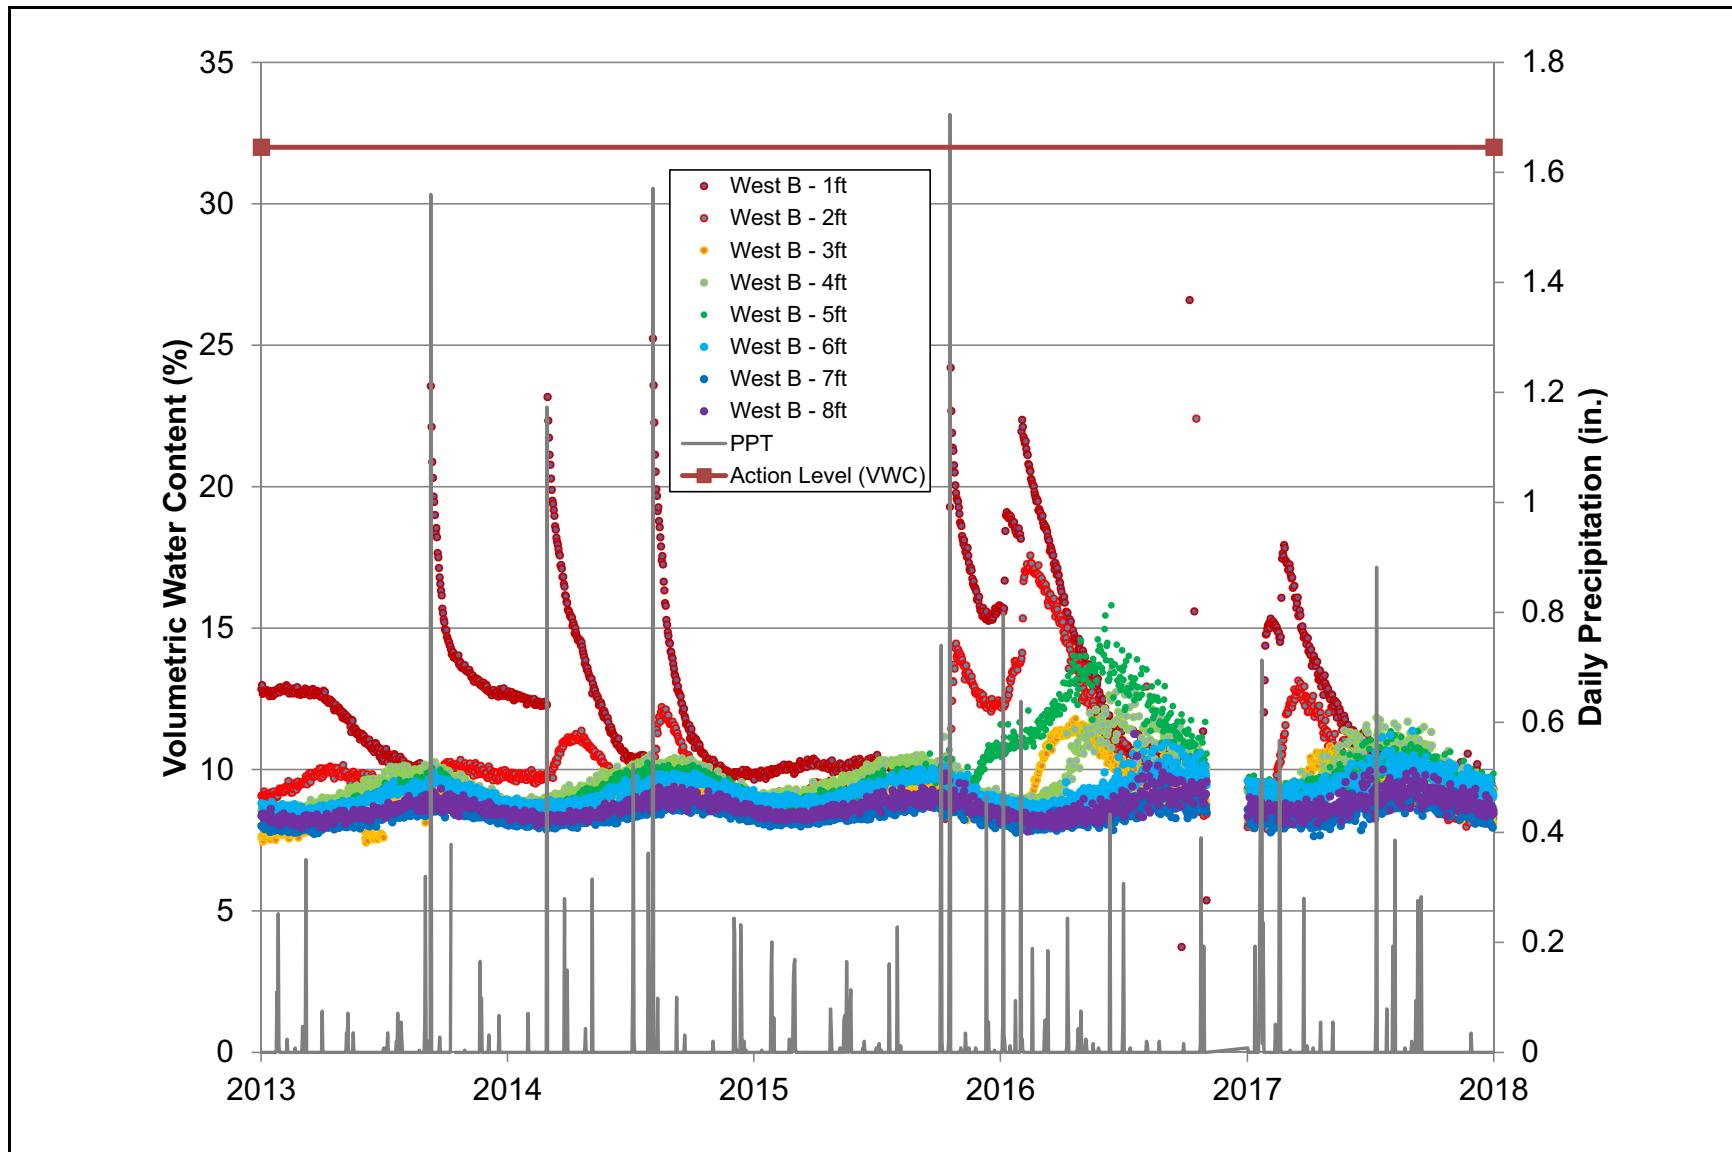
Soil VWC for the TDR nests at depth is generally between 7 and 17 percent VWC, depending on the location of the nest. Some locations show greater annual variability in VWC; however, each location appears to have equilibrated to a consistent state for that location.

The action level is illustrated in Figures 4-3 through 4-6. The action level was not exceeded.

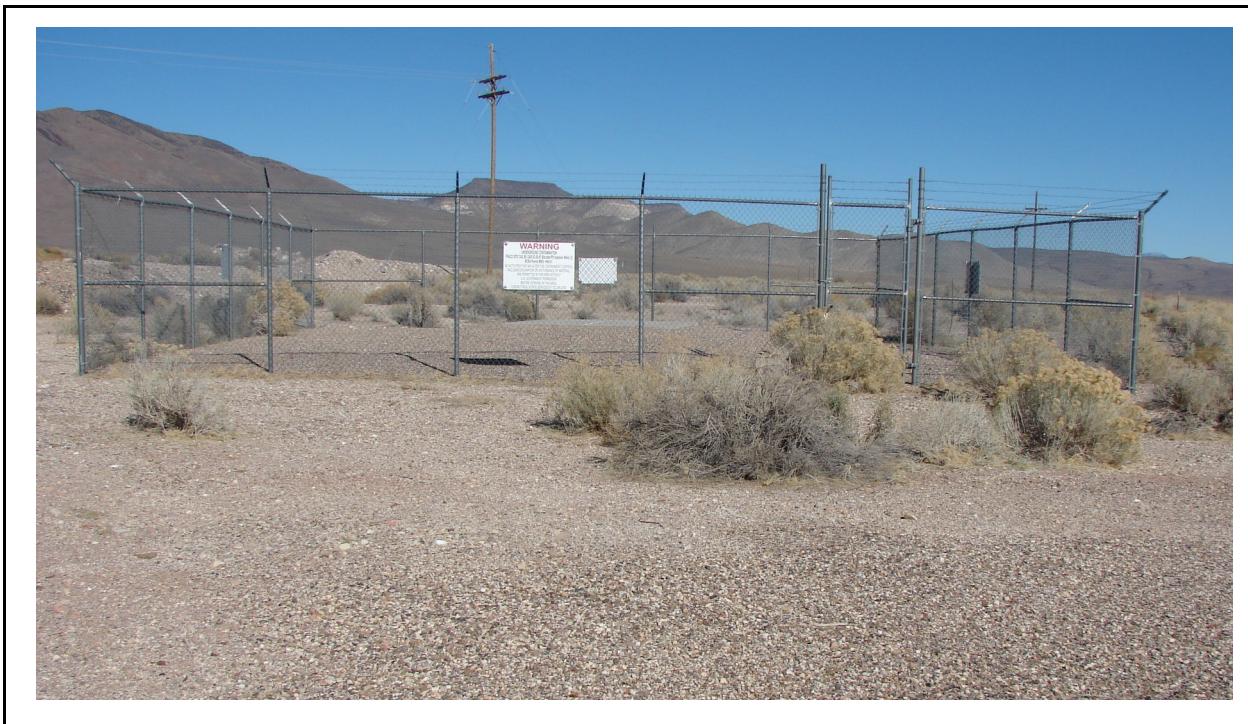
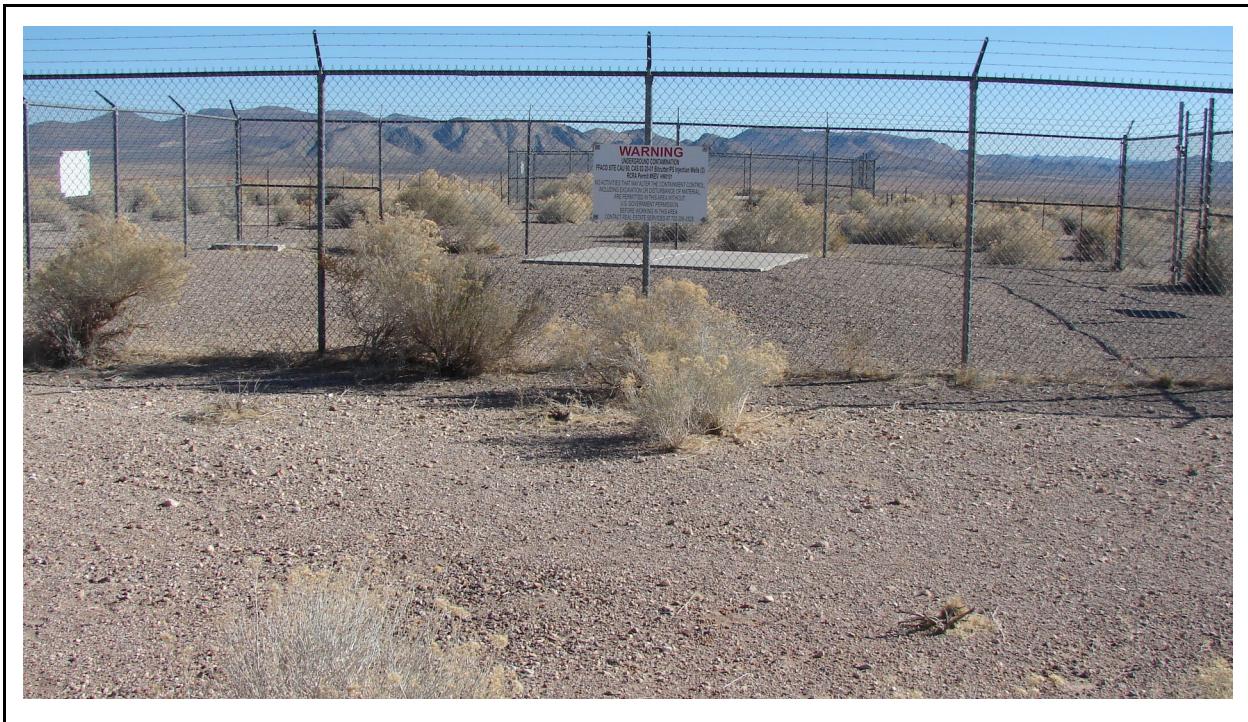
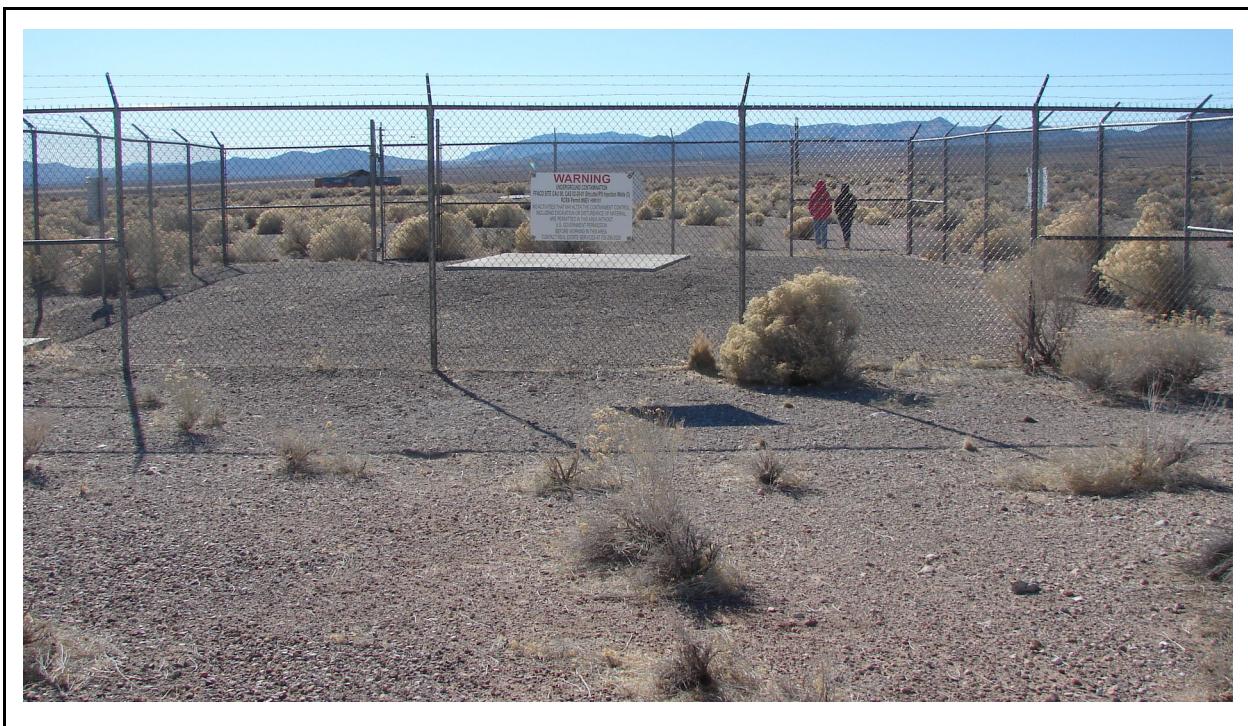
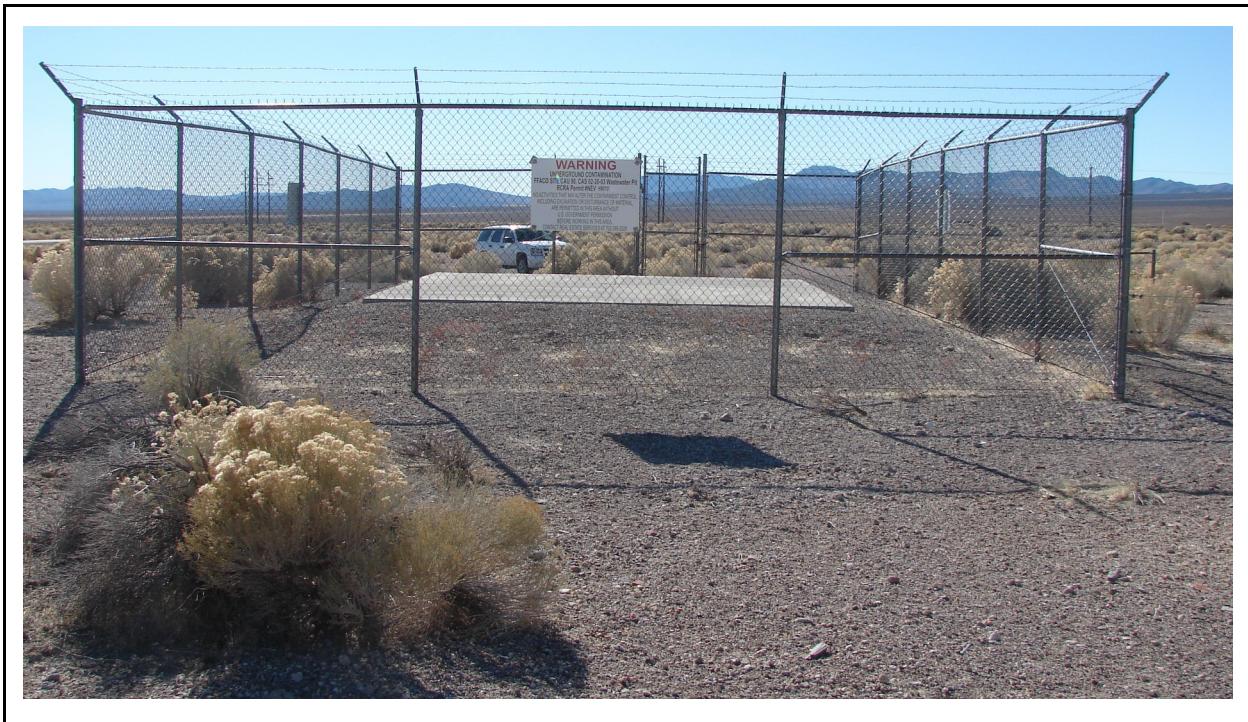
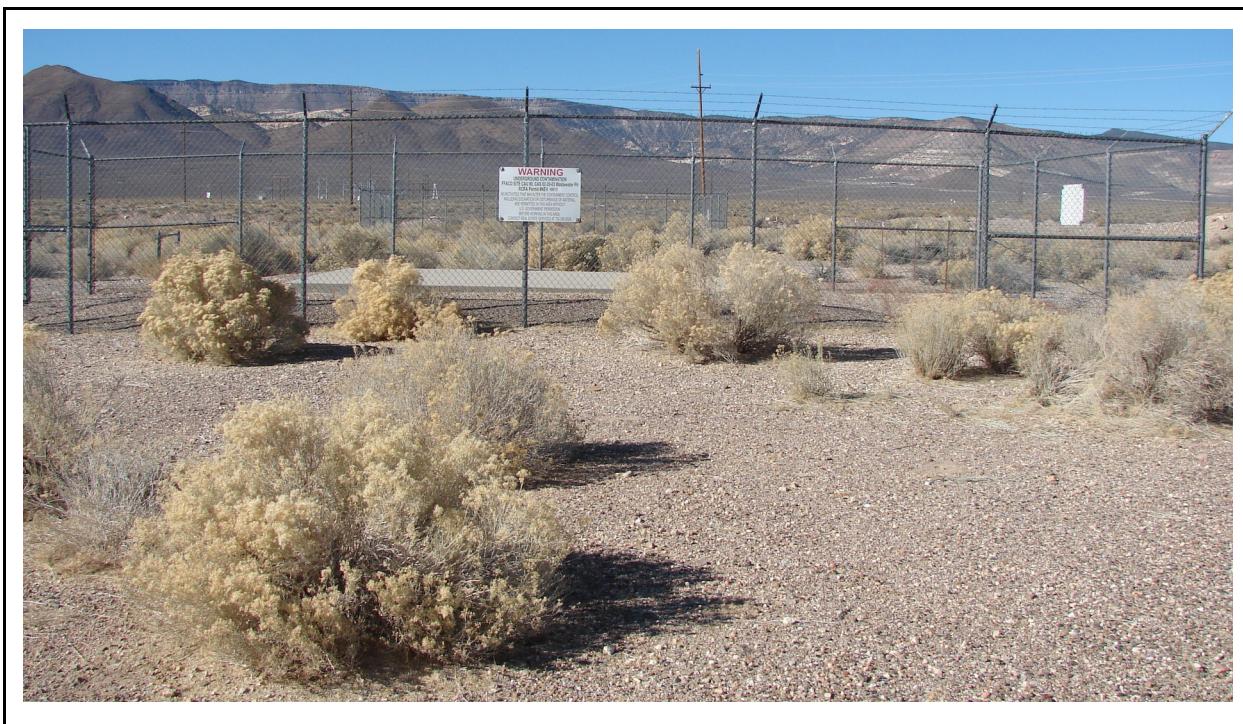
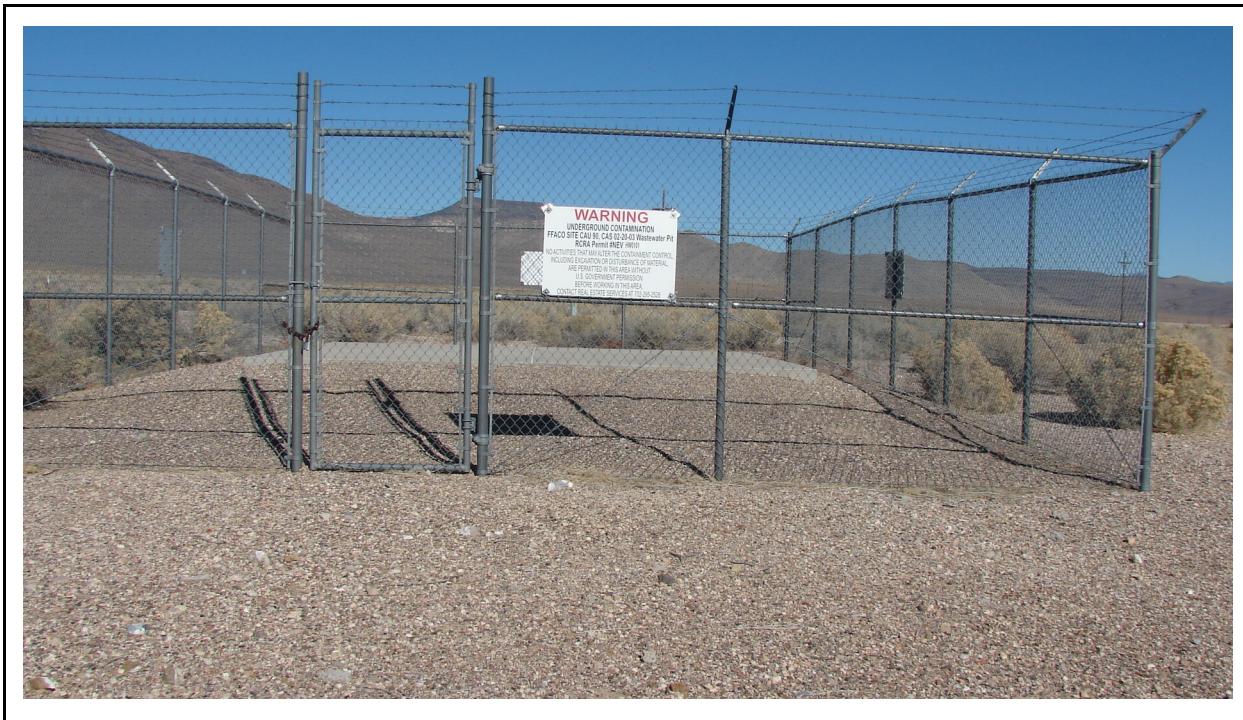
The annual inspection was performed on December 5, 2017. All permit controls were in place, and no maintenance or repairs were required.

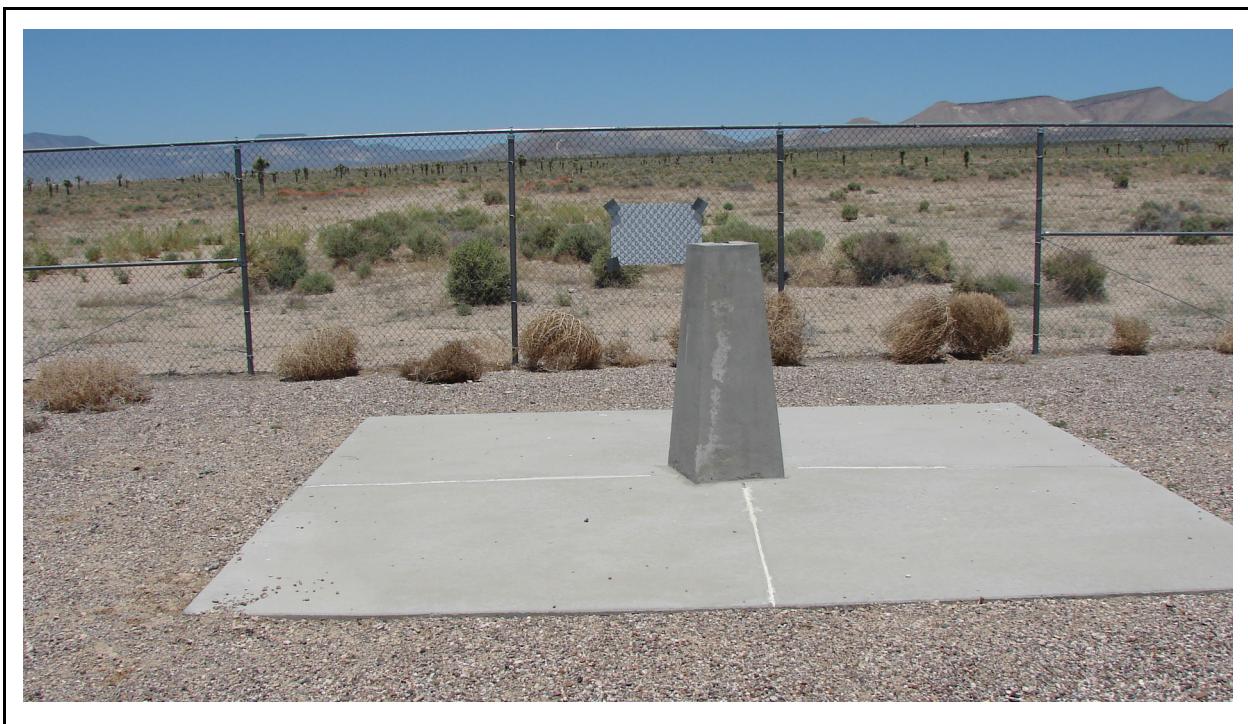
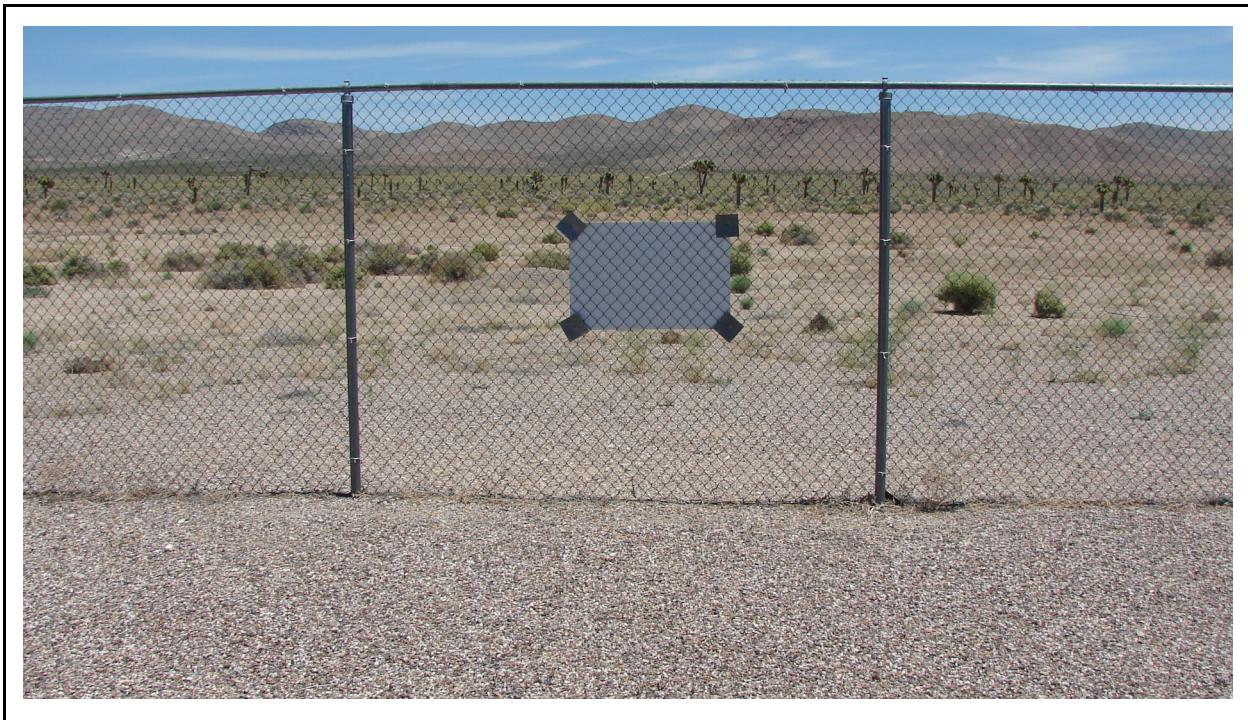
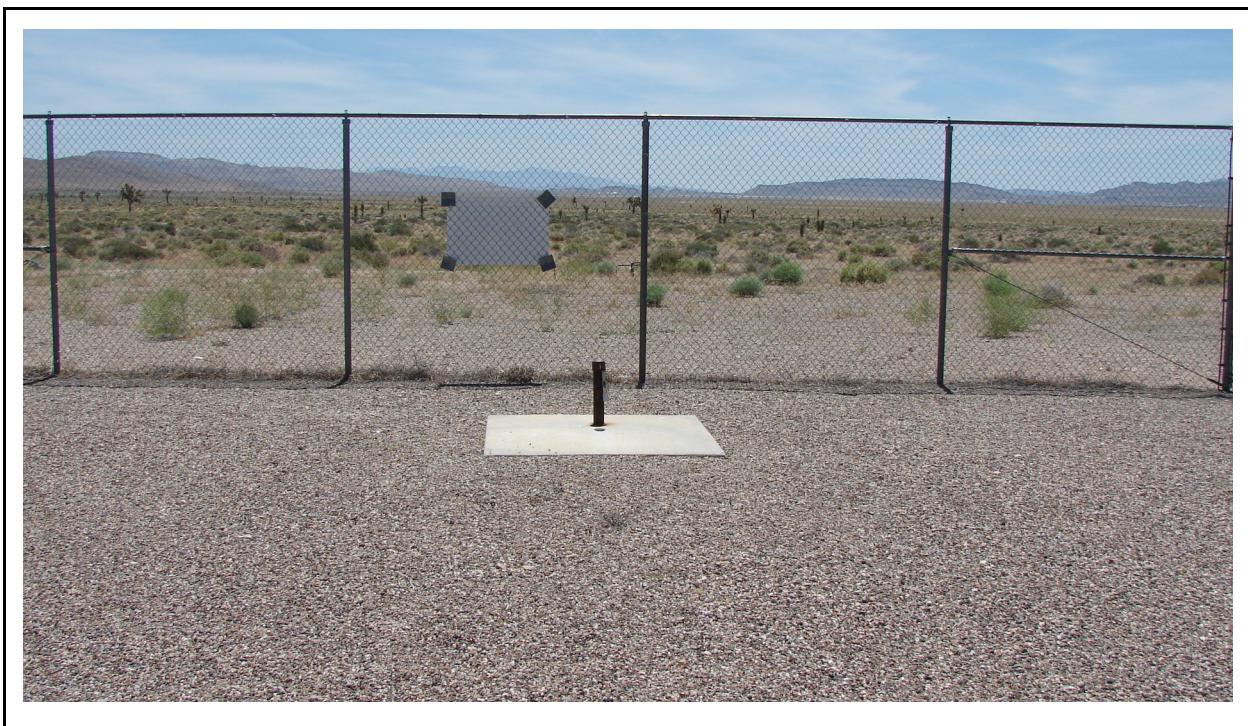
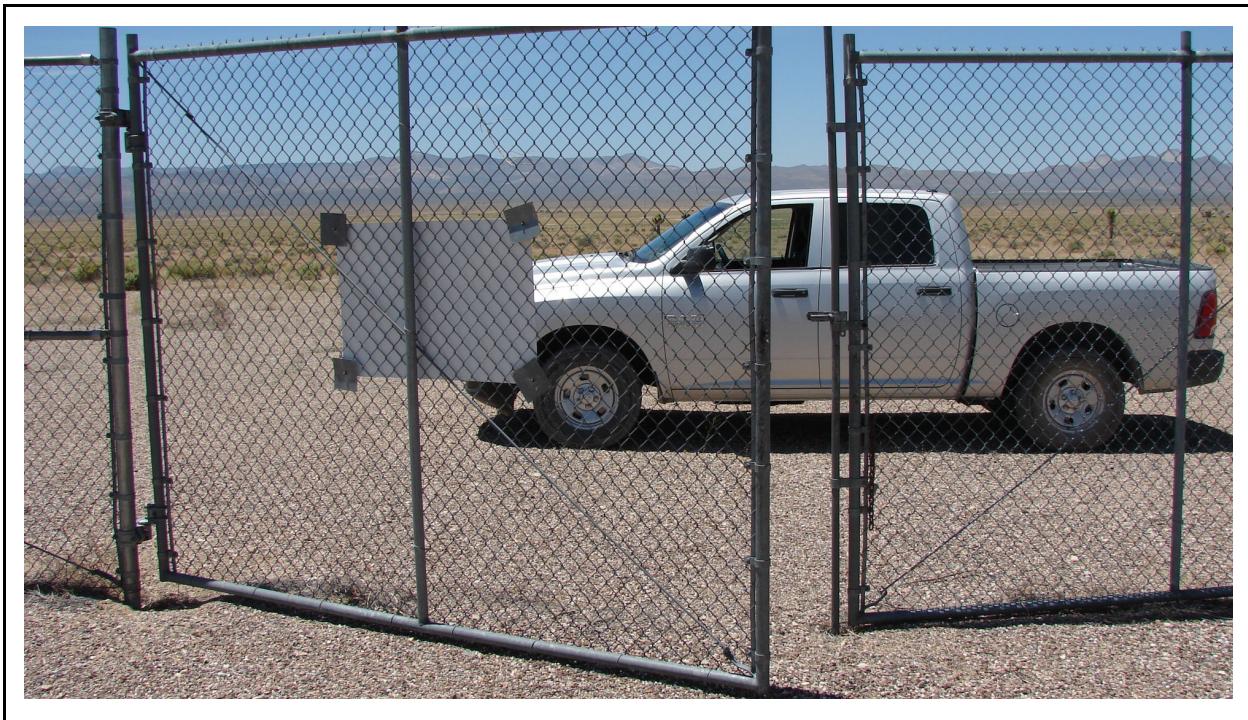
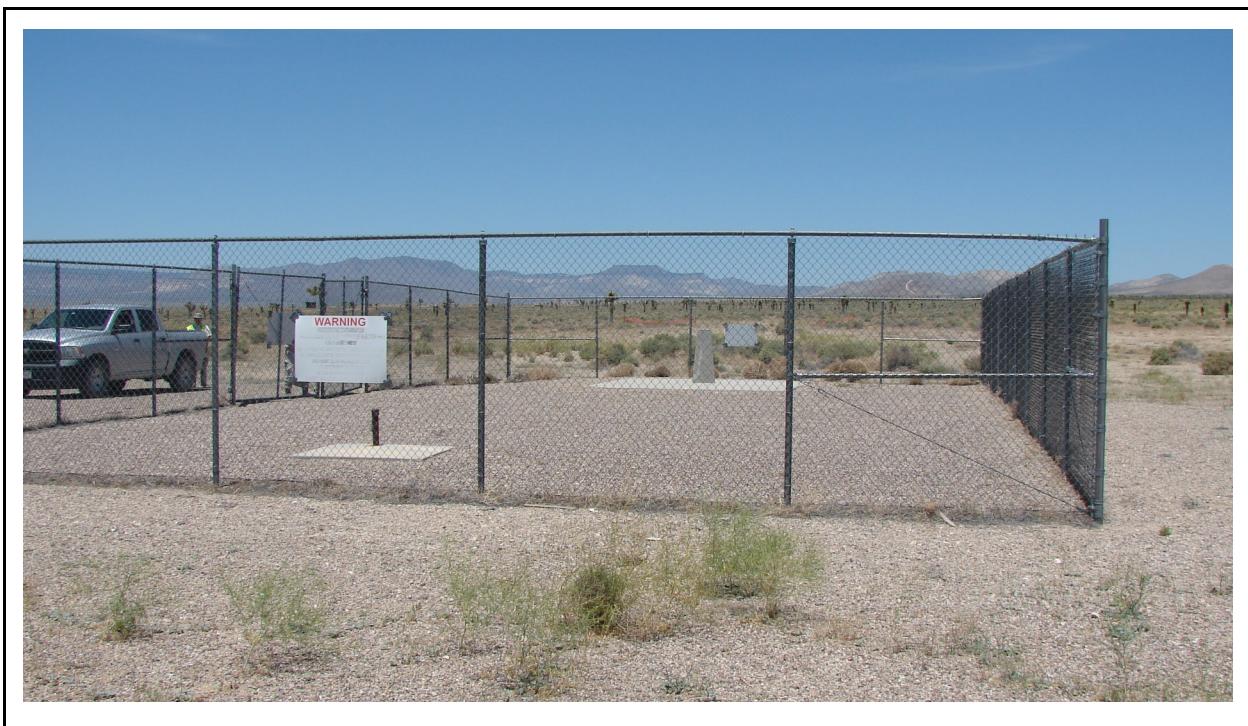
The annual inspection was performed on June 7, 2017. Two use restriction (UR) signs had fading black lettering, and weeds were observed within the compound. All other permit controls were in place.

Weeds were removed and herbicide was applied on September 5, 2017, and the UR signs were replaced on September 6, 2017.
