Radiation Effects on Teflon Wires

LeRoy Whinnery, Alexis Abelow, Wei-Yang Lu, Karla Reyes, Donald Ward, Dustin Murtagh, Zachary Meinelt, Nathalie Le Galloudec, Al Ver Berkmoes, Raymond Friddle

Problem

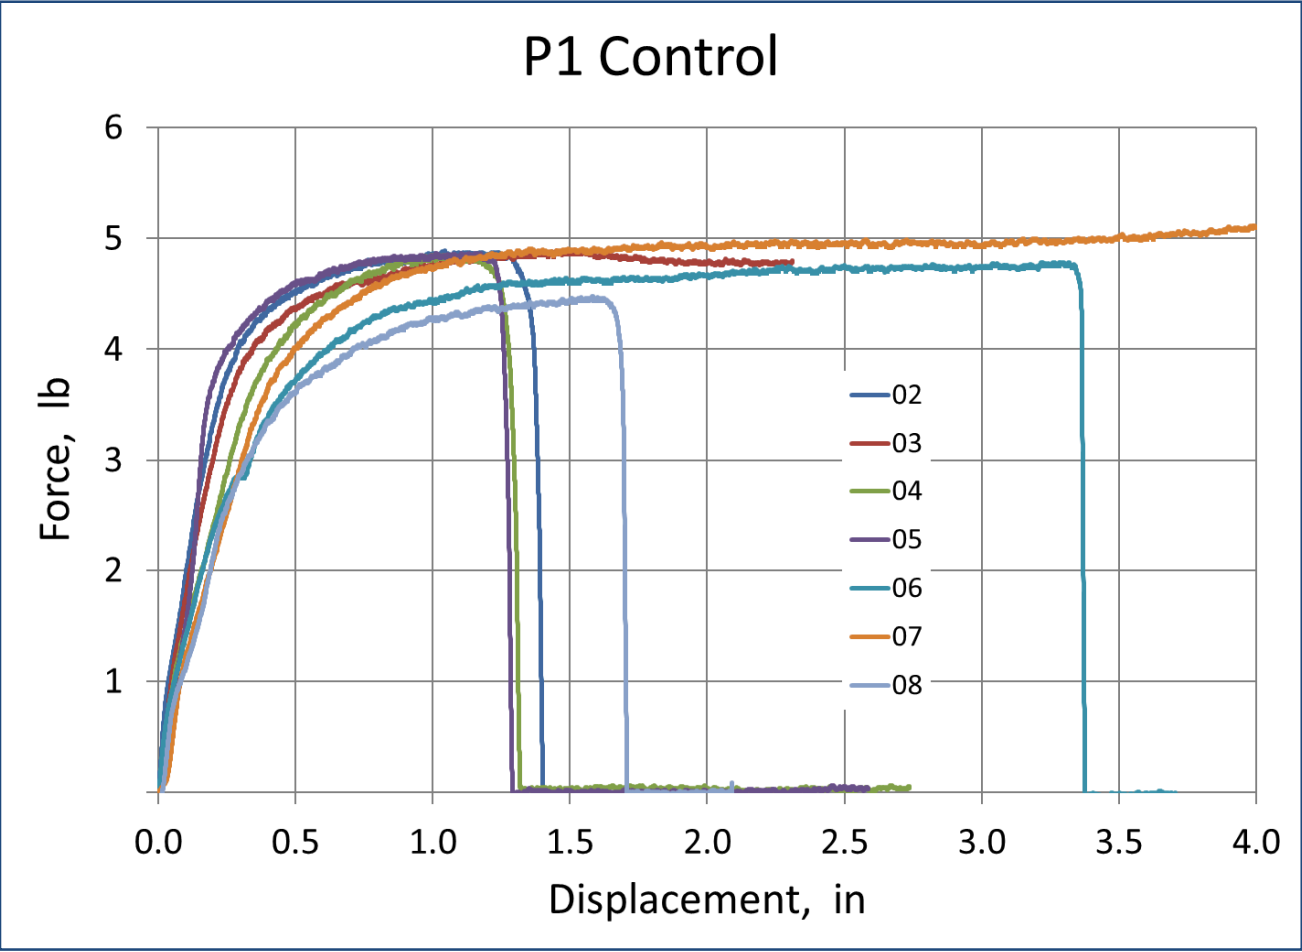
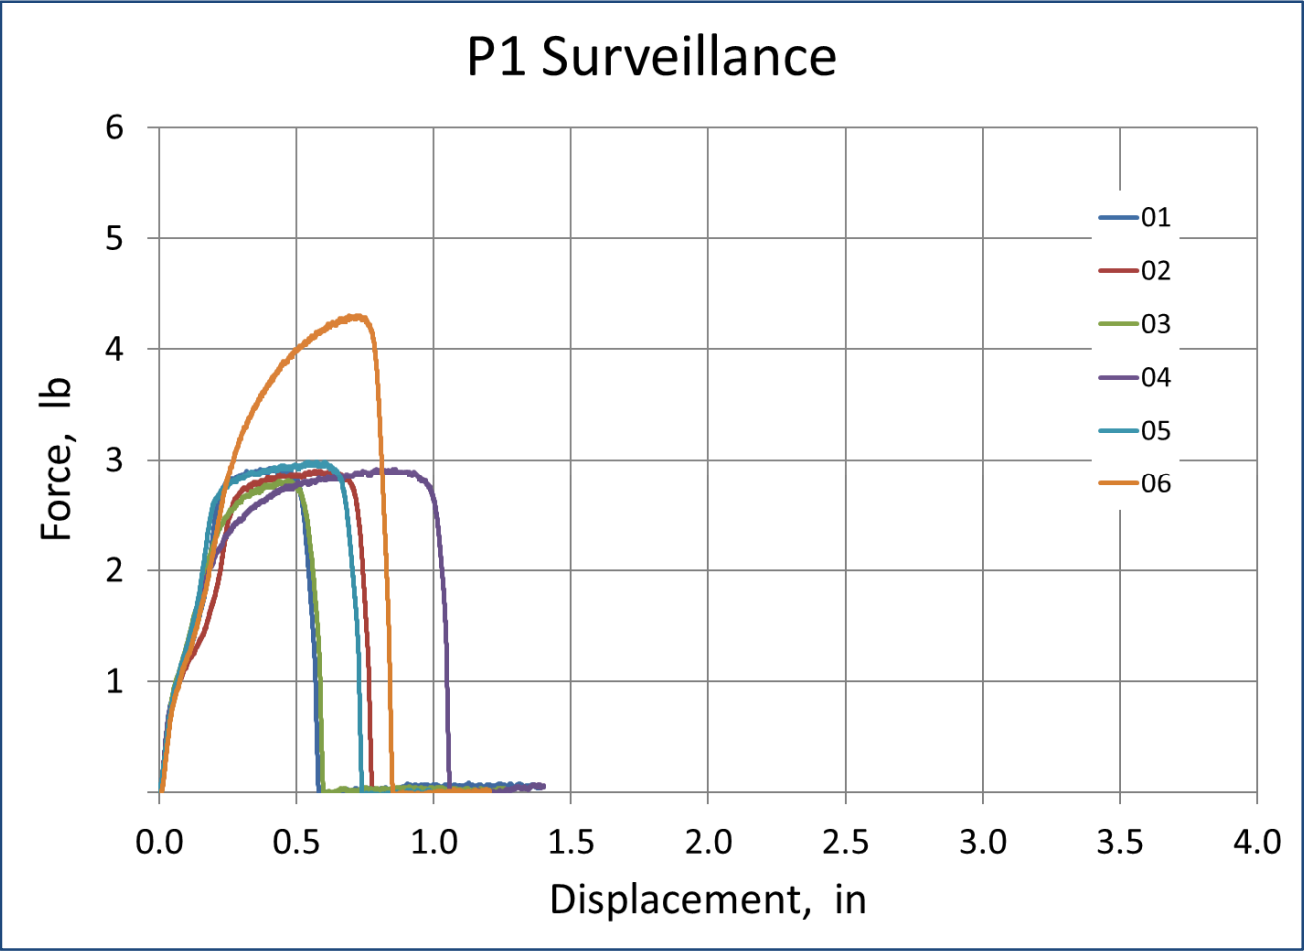
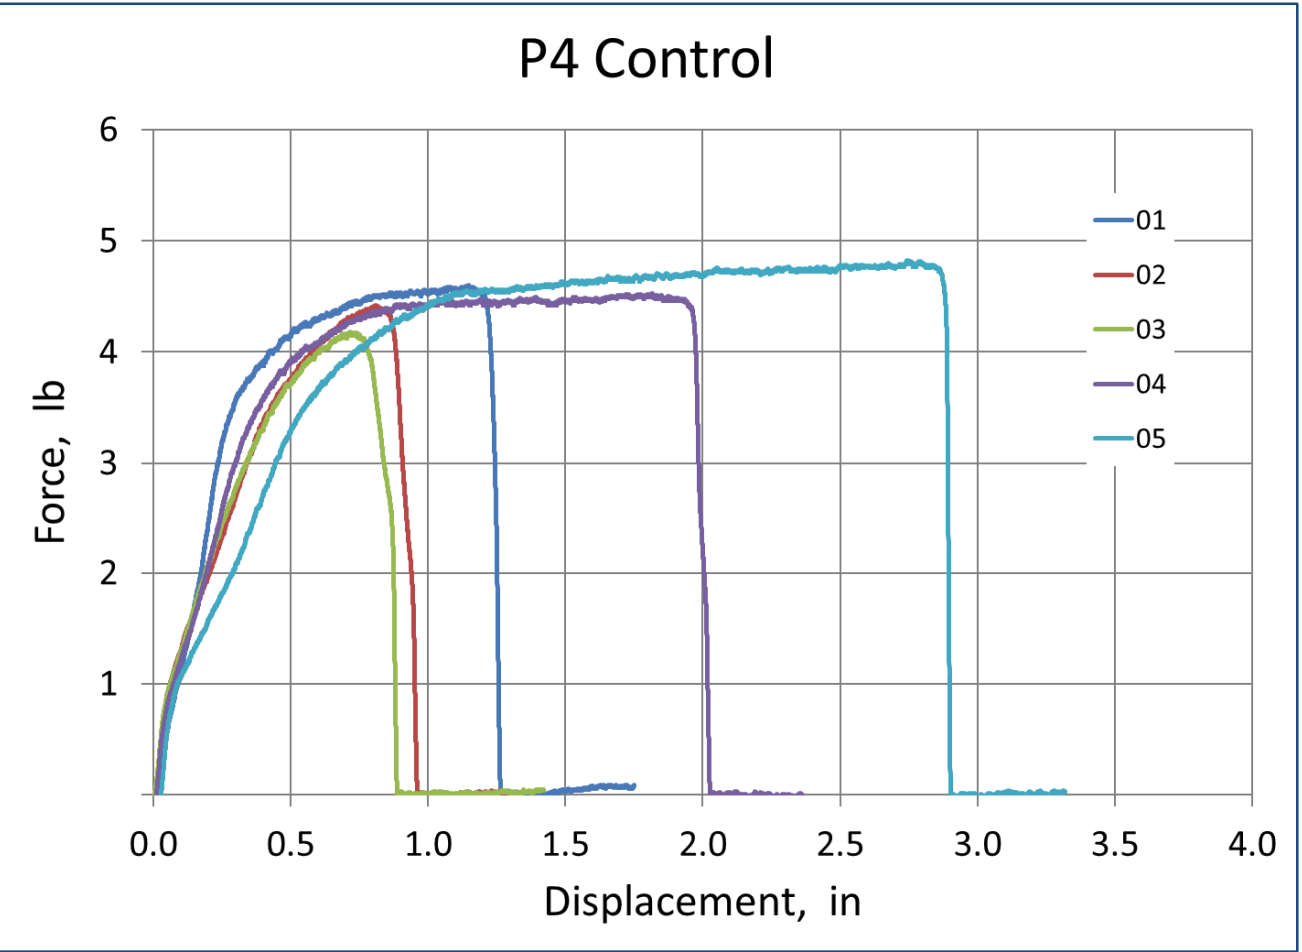
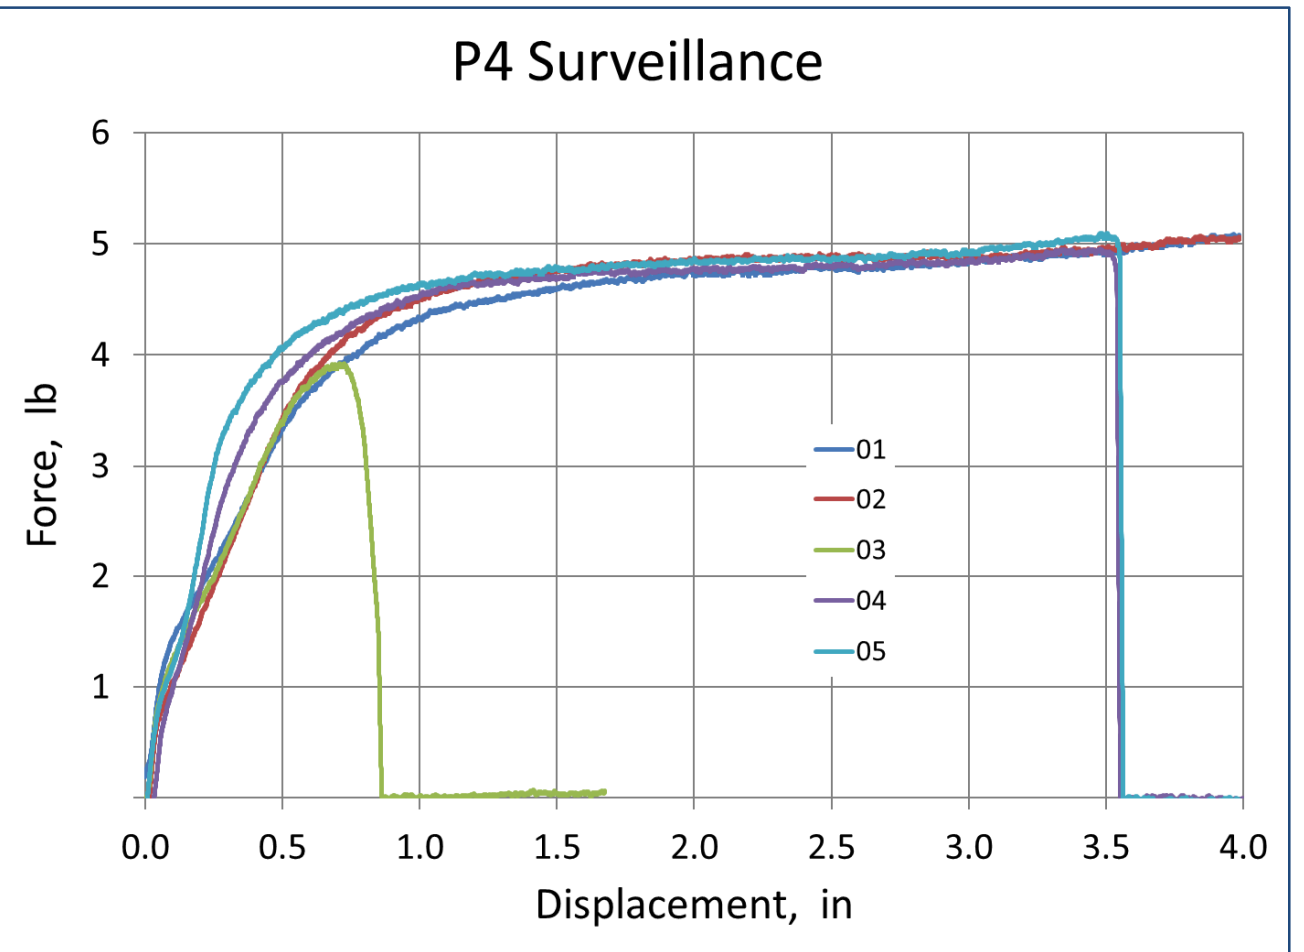
Quasi-Static Uni-Axial Tensile Testing

Tensile testing showed ~35% reduction in strength and a significant reduction in elongation to failure. Substantial variability was observed, particularly in the elongation. This variability may be due to flaws introduced during sample preparation. Additional testing is underway to provide better statistics.

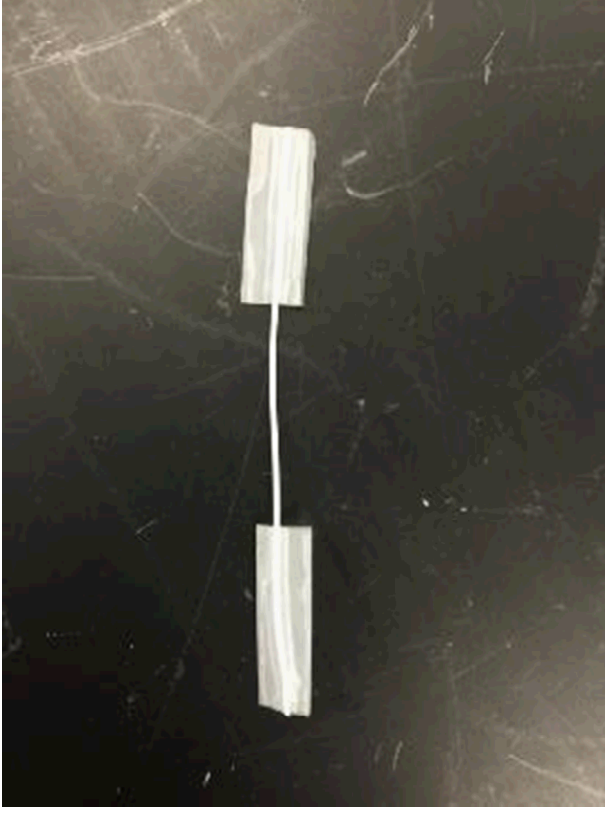
Typical sample before test

- Ends were wrapped with tape for hydraulic grip
