ORNL - TM - 1030

DYNAMIC CORROSION STUDIES FOR THE HIGH FLUX ISOTOPE REACTOR

J.L. English and J.C. Griess

SEPTEMBER 1966

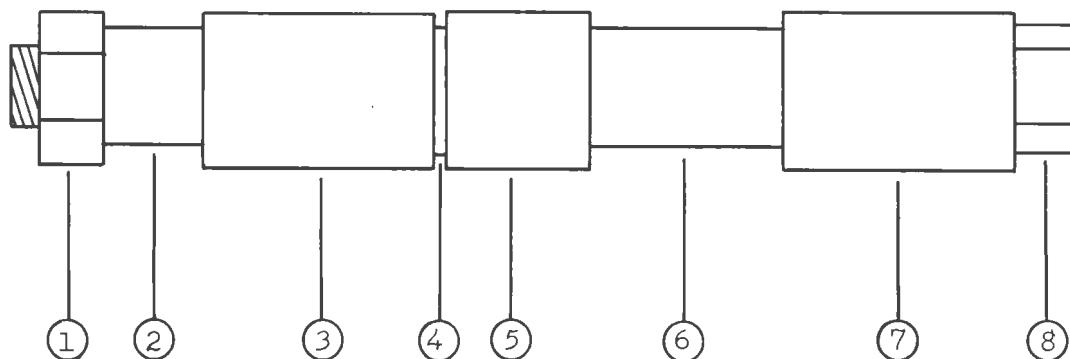
Fig. 14. Schematic Diagram of Galvanic Specimen No. 4.

During the 12,755-hr exposure, seven dismantlings and examinations were made. At no time was there any indication of galling. After the first 1000 hours, an aluminum gasket was inserted between components No. 5 and 6 and between No. 6 and 7 in Fig. 14. These two gaskets received a total exposure of 11,755 hours.

Several examinations later, after a total of 5615 hours, the electropolished aluminum sleeve (No. 5) showed severe flaking and blistering on contact surfaces. Areas from which the coating had peeled were badly pitted; a few pits were nearly 11 mils in depth. The electropolished aluminum nut (No. 2) remained in good condition with no signs of flaking. The 1100 aluminum gaskets showed pits, slightly in excess of 2 mils, on contact surfaces. The beryllium sleeves exhibited scattered pits up to 3 mils deep on all surfaces.

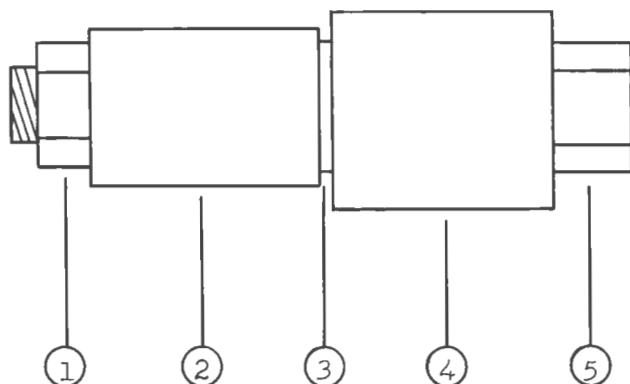
Fig. 15. Schematic Diagram of Galvanic Specimen No. 5.

Galvanic Specimen No. 5 - An assembly consisting of types 304 stain-less steel and hardened 416 stainless steel (Fig. 15) was exposed for 11,775 hours in the pH 5.0 water at 100°C. The 416 stainless steel com-ponents were hardened to 43 Rockwell C by heating at 954°C (1750°F), oil quenching to room temperature, and tempering at 538°C (1000°F) for sev-eral hours.

With one exception, nothing of significance occurred on the com-ponents in the assembly during the entire exposure other than the forma-tion of brown-colored stains on contact surfaces, particularly on the hardened 416 stainless steel members, and the development of several small blisters on the hardened 416 bolt during the final stages of the exposure. The location of the blisters was confined to the threaded portion of the bolt. Defilmed corrosion rates for all components were 0.1 mpy or less. There was no pitting.
