Effects of Charge-Induced Damage on SOI Wafers

Darlene M. Udoni and Mary A. Miller, Sandia National Laboratories, Albuquerque, NM, USA

Problem: Systematic leakage in wafer-level test structures and packaged devices causing significant yield loss

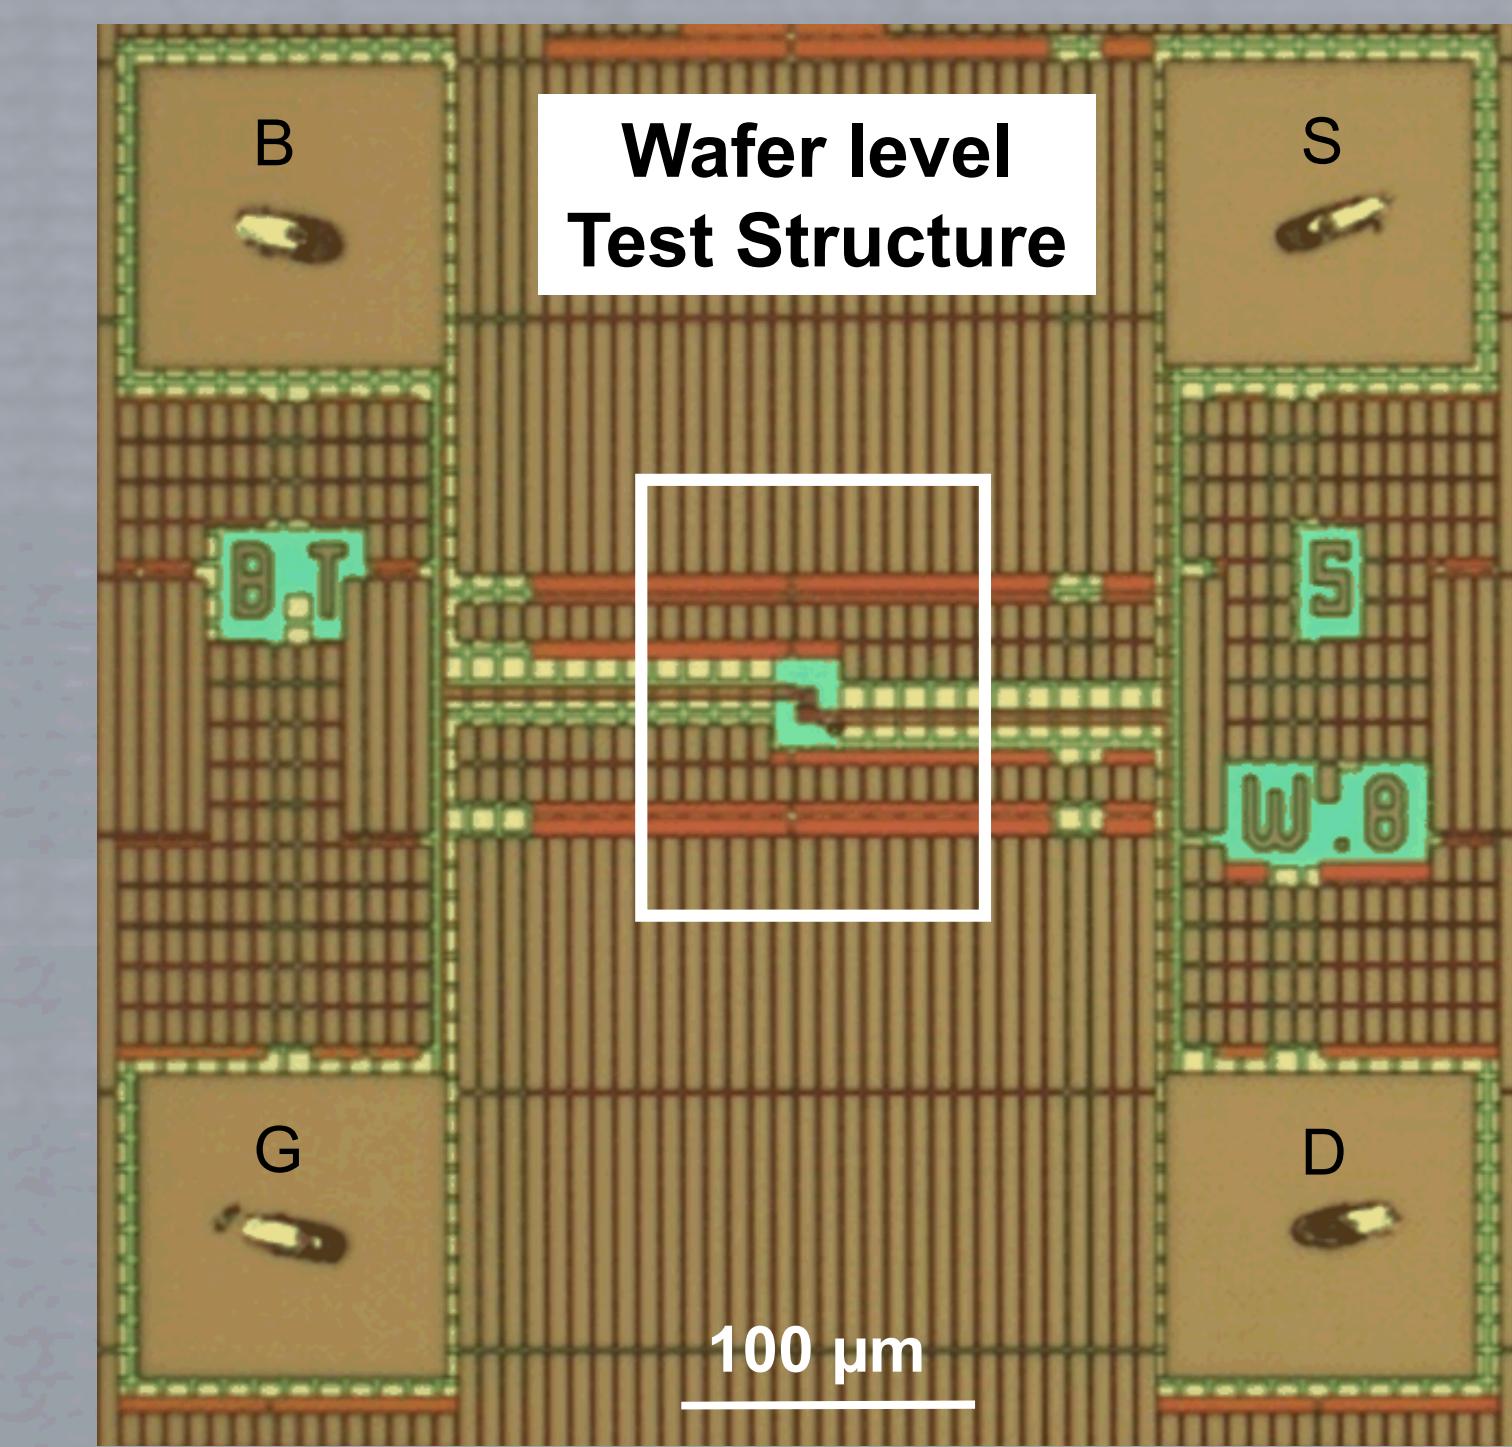
Cracking, metal extrusion on test structure

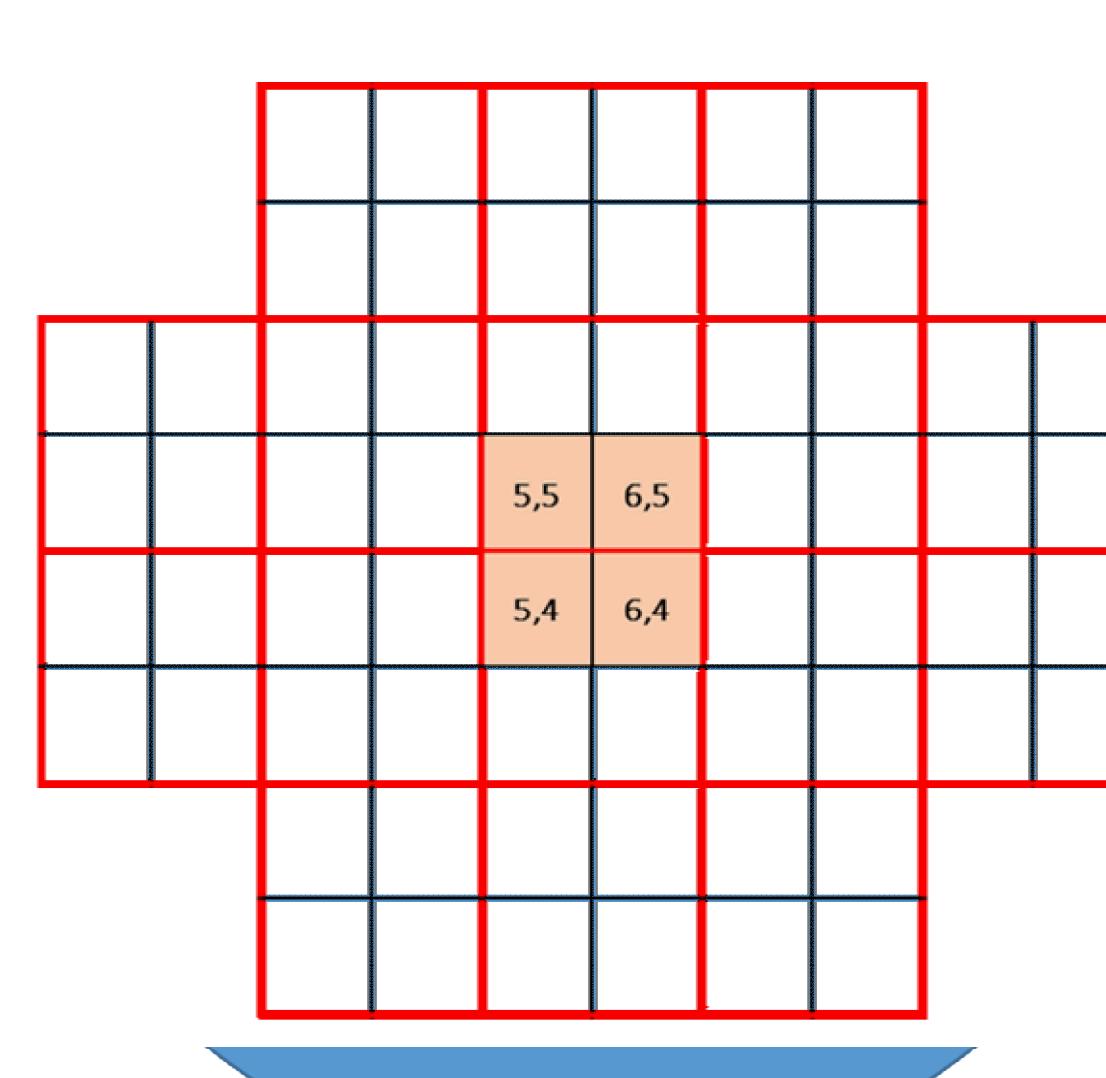
- Wafer center discrete transistors consistently failed $> 1 \text{ mA}$ gate current at 3.3 V (~nA nominal)
- Packaged die from wafer center positions (as shown in schematic) also indicated leakage-type failures that ranged from μA to mA
- Although absolute failing current varied, characteristic shape of IV curve emerged

Wafer schematic of x,y die locations
