**A Section 106 Evaluation of Building CP-1, Area 6, Nevada National Security Site,  
Nye County, Nevada**

**Cultural Resource Technical Report No. 114  
Division of Earth and Ecosystems Sciences  
Desert Research Institute  
Las Vegas, Nevada**

**November 2016**

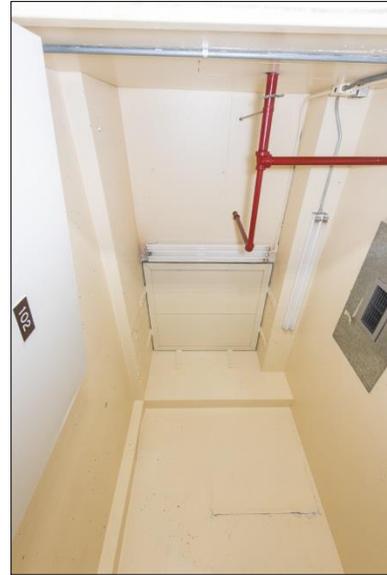
<b>ROOM #:</b> 102/101A	<b>PHASE:</b> A	<b>LEVEL:</b> Basement	<b>AREA:</b> 56 sq. ft.	<b>DATE:</b> 5/3/16
<b>FUNCTION(S):</b> Storage, Circular Stair (removed)

View of ceiling, showing steel-framed patch where circular stair was removed, view south (DSC2833).

ELEMENT	DESCRIPTION	CONDITION
North wall	Drywall	
South wall	Concrete with pilaster in southeast corner. Door labeled 102 but identified as Room 101A on Space Management Plan.	Cracks
East wall	Concrete rectangular CMU wall patch surrounded by cracks which extend to corner of building.	Cracks
West wall	Drywall	
All walls	Pale yellow	
Ceiling	The north half of the ceiling is concrete. South is steel-framed patch where circular stair was removed. Concrete floor beam exposed above west wall.	
Floor	Tan 1 ft. square linoleum tiles with brown plastic 4 in. base	
Doors	Flush steel	
Windows		
Lighting	Surface-mount neon 2 and 3-tube without diffuser	
Built-ins

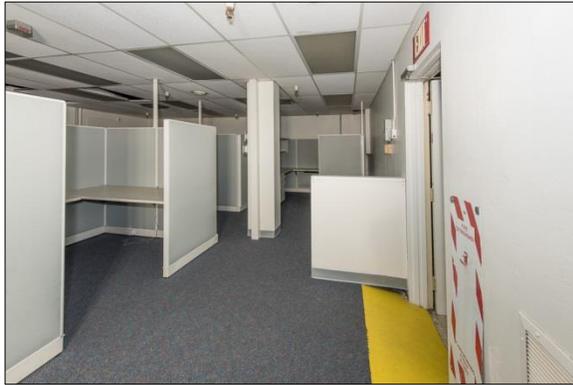
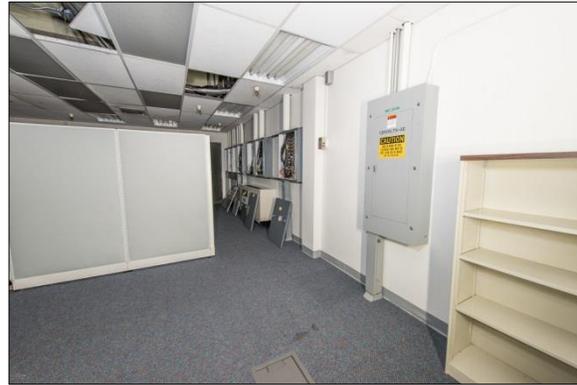
<b>ROOM #:</b> 105	<b>PHASE:</b> 1	<b>LEVEL:</b> Basement	<b>AREA:</b> 769 sq. ft.	<b>DATE:</b> 5/3/16
<b>FUNCTION(S):</b> Laboratory (originally Boiler Room 117)

ELEMENT	DESCRIPTION	CONDITION
North wall		
South wall	Air handler and communication cable/relay boxes. Blocked double door barely visible as cracks. The door is CMU covered with plaster and painted.	
East wall	North end of the wall is plywood, the rest is drywall furred over concrete. A communications rack is attached to plywood.	
West wall	Air handler	
All walls	The walls are 8 in. thick concrete. Most blocked doors are not visible from inside room.	
Ceiling	The ceiling is 2 x 4 ft. suspended panels. Original ceiling is visible through removed panels and is gray painted concrete with remnants of light fixtures and conduit.	
Floor	Raised 6 in. with dark blue carpet and 4 in. gray plastic base. Nonskid ramp. Parapet rail next to ramp is drywall with metal trim.	
Doors	The door is flush steel with steel frame, louver vent, and keypad lock. The door is off white, formerly light green.	
Windows	None	
Lighting	2 x 4 ft. inset with diffusers

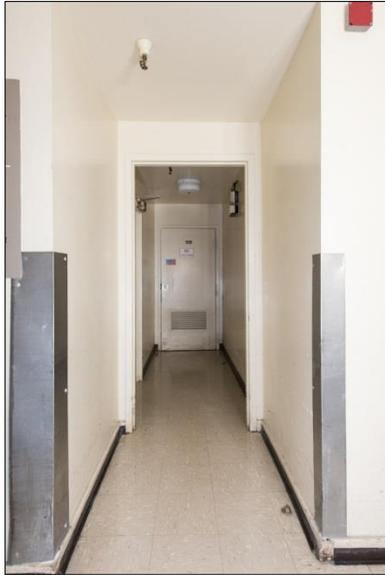
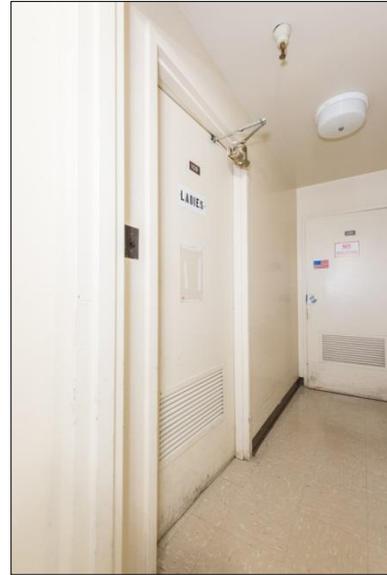
<b>ROOM #:</b> 107	<b>PHASE:</b> 1	<b>LEVEL:</b> Basement	<b>AREA:</b> 46 sq. ft.	<b>DATE:</b> 5/3/16
<b>FUNCTION(S):</b> Circulation

ELEMENT	DESCRIPTION	CONDITION
North wall		
South wall		
East wall	Emergency light	
West wall		
All walls	Off-white drywall	Many cart scrapes
Ceiling	Off-white drywall	
Floor	Tan 1 ft. square linoleum tiles with 4 in. brown plastic base	
Doors	Doors in the circulation have been removed. Steel frame remains in partition.	
Windows		
Lighting	Surface-mount circular incandescent	
Built-ins

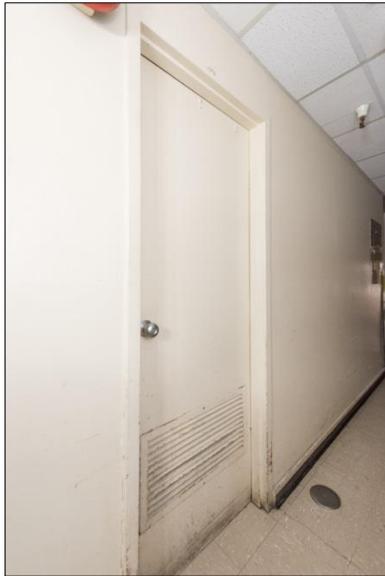
<b>ROOM #:</b> 109A	<b>PHASE:</b> 1	<b>LEVEL:</b> Basement	<b>AREA:</b> 25 sq. ft.	<b>DATE:</b> 5/3/16
<b>FUNCTION(S):</b> Custodian Storage (formerly part of Women’s Dormitory Room 104)

ELEMENT	DESCRIPTION	CONDITION
North wall	Blue melamine wainscot, gray-painted plywood shelves	
South wall		
East wall	The same wainscot is behind porcelain sink with stainless rim.	Severe water/wear damage
West wall		
All walls	Off-white drywall	
Ceiling	Unpainted bottom of concrete floor	
Floor	Tan 1 ft. square linoleum tiles with 4 in. brown plastic base	
Doors	Flush with louver in steel frame	
Windows		
Lighting	Bare bulb	
Built-ins	Water de-ionizer is mounted on east wall above sink.

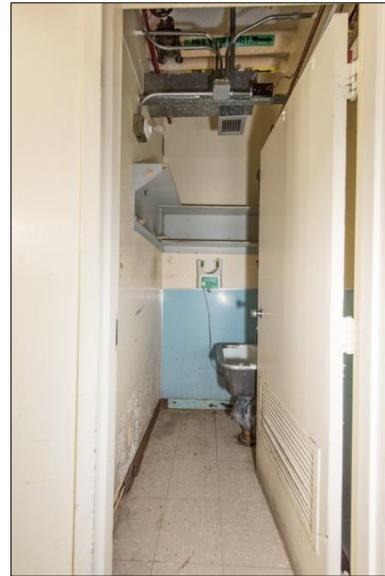
View of Custodian Storage, showing blue melamine wainscot, view north (DSC2627).

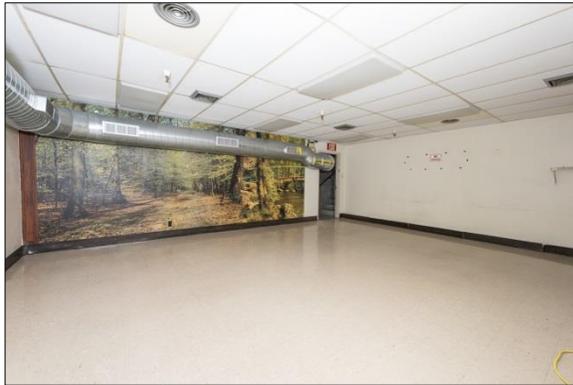
Overview from the southwest corner of the room, showing mural on the north wall, air duct, and emergency exit, view northeast (DSC2873).

ELEMENT	DESCRIPTION	CONDITION
North wall	The wall is concrete and covered with a large woodland mural.	Insects
South wall	Drywall	
East wall	Drywall	
West wall	Concrete with pilaster	
All walls	Gloss off-white	
Ceiling	Suspended 2 x 4 ft. panels	
Floor	The floor is tan 1 ft. square linoleum with 6 in. dark brown base.	
Doors	The 4 ft. wide circulation door is flush with louver and light. The door from the kitchen is flush sliding with top-rail suspension and galvanized base.	
Windows	None	
Lighting	Recessed 2 x 4 ft. lighting with projecting diffusers.	
Built-ins	Stainless steel service bench with water/ice dispenser on the south wall.

MISCELLANEOUS ROOM NOTES
Room is now dominated by an 18 in. diameter air duct with many vents. It originates outside north wall at a temporary air handler (now removed) which was installed after failure of the building’s chiller (in Room 116). The duct enters metal wall of the exit addition (Room 110B), enters through top of the doorway, and follows the north and west walls to the kitchen. Several louver vents are spaced along the duct. Return air flow exited the north door, permanently kept open by the duct, and exited via another vent in the metal wall of the exit stairway.

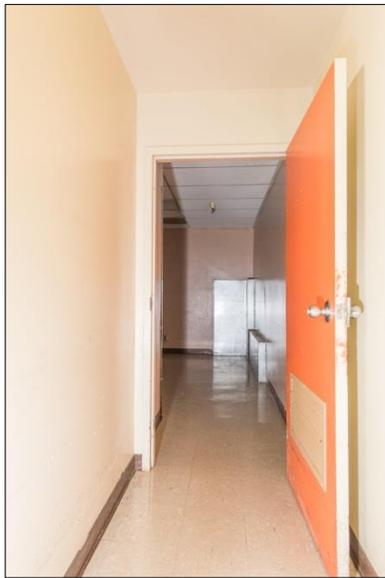
Entry into Storage from 107 Circulation, galvanized boxes are in the northeast corner, view north (DSC2650).

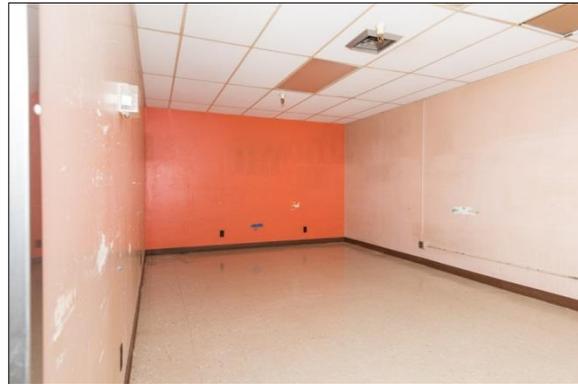
Orange drywall on west wall, view west-northwest (DSC2651)

ELEMENT	DESCRIPTION	CONDITION
North wall	Concrete, pinkish tan	
South wall	Drywall, pinkish tan with stainless corner protector by entry.	Severely damaged
East wall	Drywall, pinkish tan	Damaged
West wall	Drywall, orange	Badly damaged
All walls		
Ceiling	Suspended 2 x 4 ft. panels	
Floor	Tan 1 ft. square linoleum tiles	
Doors	Flush with louver. Off-white outside, orange inside.	
Windows		
Lighting	Recessed 2 x 4 ft. lights with diffusers	
Built-ins	Galvanized boxes without outlets are in northeast corner. These likely block former vents.

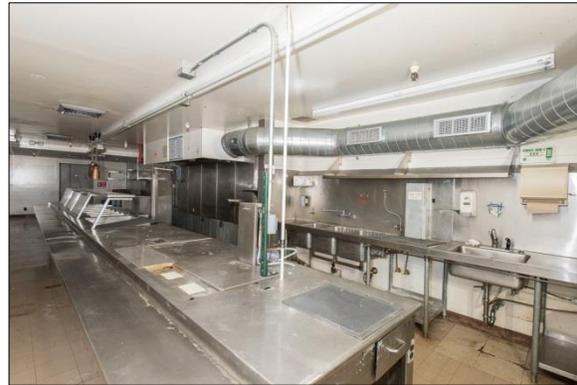
Overview showing grill area, sinks, and service counter, view southwest (DSC2889).

ELEMENT	DESCRIPTION	CONDITION
North wall	Drywall with a mid-height painted wood rounded 2 ½ in. rail, matching door surrounds.	
South wall	Drywall	
East wall	Drywall with the same mid-height painted wood rail as on the north wall, north of the door.	
West wall	Concrete. Full height stainless behind grills, shorter behind sinks and service counter.	
All walls	Gloss off-white	
Ceiling	Drywall ceiling matching walls. The ceiling is dropped 6 in. to base of a beam across the ceiling, marking the north end of former Instrument Shop (Room 120). Ceiling and lighting in Instrument Shop area at the south end of the room is identical to that in Room 110 (Dining Room). Instrument Shop ceiling originally was underside of concrete floor with spray insulation painted white (visible through displaced ceiling panels).	
Floor	Tan 1 ft. square linoleum tiles, many have been replaced.	Heavy damage
Doors	The door on the east wall is flush Dutch.

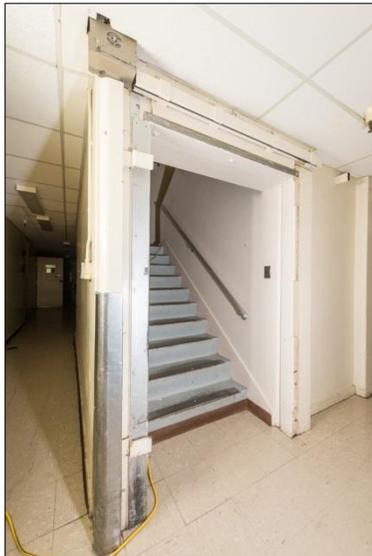
Bottom of the stairs at the entrance to 113 Circulation, showing steel-frame, top rail, and end stops for a blast door, the door has been removed, view southeast (DSC2614).

MISCELLANEOUS ROOM NOTES
<p>The 114A/213 Stairs are a continuous stairwell with a dogleg or half space landing. Therefore, the descriptions of the 114A stairs and the 213 Stairs are the same.</p> <p>Top rail and end stops are in place for a sliding 1 ¾ in. thick steel-framed blast door at the entrance to Circulation 113 at the bottom of the stairs. The steel blast door has been removed.</p> <p>Silver-painted aluminum pipe rails are on concrete parapets.</p>

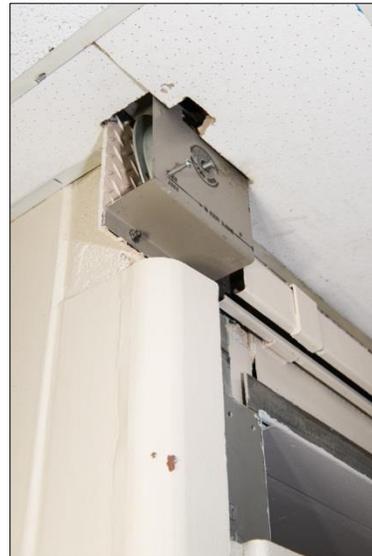
Close-up of end stop for blast door (DSC2615).

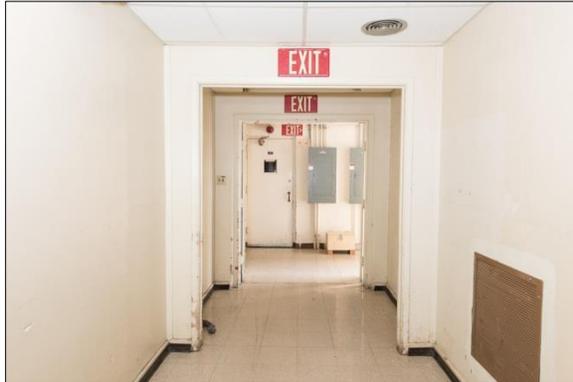
Circulation 115A from 114 Circulation, electrical boxes are visible on the east wall, view east (DSC2813).

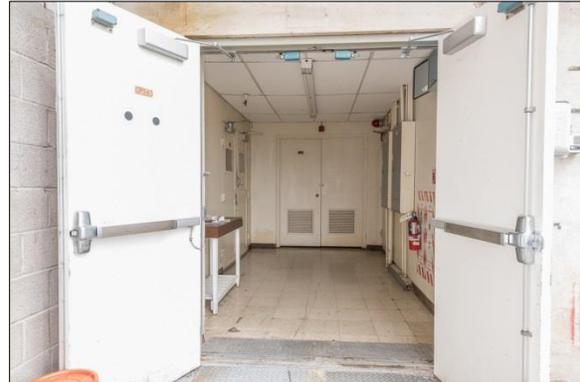
Overview of 115A Circulation from exterior door, steel nonskid plate at door threshold, view north (DSC2842).

ELEMENT	DESCRIPTION	CONDITION
North wall		
South wall		
East wall	Electrical boxes	
West wall		
All walls	Off-white concrete without corner bevels.	
Ceiling	Suspended 2 x 4 ft. panels	
Floor	Tan 1 ft. square linoleum tiles match Circulation 114 except for many replacements. Many broken tiles and water damage near the south entrance. The floor has a 4 in. brown plastic base. Steel nonskid plate at door threshold.	Water damage
Doors	South door is double flush steel "CP1-3" with alarm. The west door to 114 Circulation is double steel panel, each with a single light.	
Windows	None	
Lighting	2-tube surface mounted without diffusers.	
Built-ins

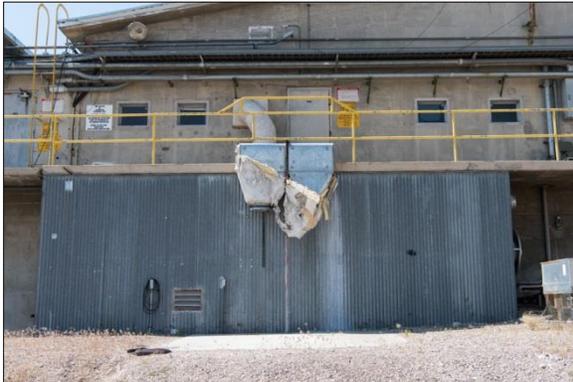
North side of exterior, showing louver vent, view south (DSC3220).

MISCELLANEOUS ROOM NOTES
Door has long been blocked by slopewash. See Drawing 15537 for original design with metal-clad CMU walls, apparently not built. Converted in 1962 to air handling, see Drawing 15519.

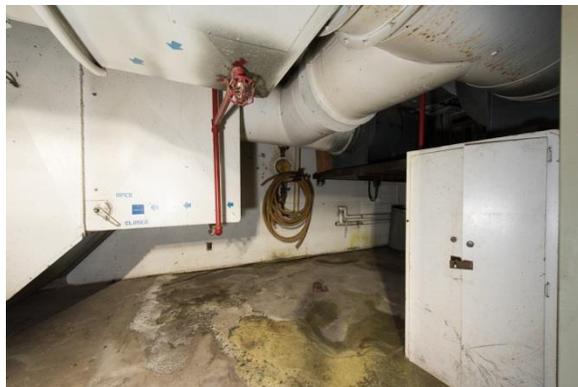
Intake duct and fan assembly from Room 116A duct in the northeast corner, view east (DSC2948).

<b>MISCELLANEOUS ROOM NOTES</b>
<p>A note on the intake duct and fan assembly from Air Intake Room 116A is as follows:</p> <p>BUILDING SHUTDOWN                      BUTTON-UP CONDITIONS – NO OUTSIDE AIR TO BUILDING                      SHUT OFF ALL FRESH AIR DAMPERS. (PUSH BUTTON TO CLOSE DAMPERS)                      ALL FRESH AIR AND EXHAUST FANS WILL AUTOMATICALLY CLOSE</p> <p>This shutdown control has been removed so long ago that present facilities staff has no memory of it.</p>

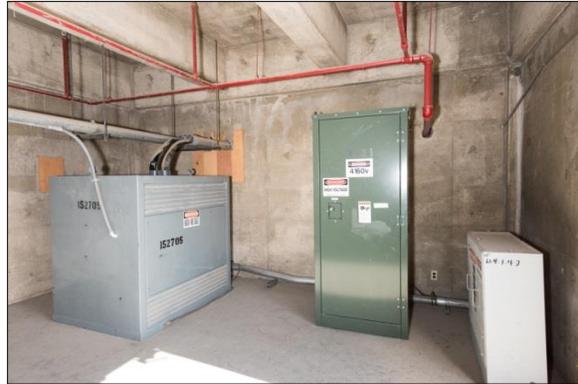
Transformers in the northern portion of Room 118, view northwest (DSC2575).

ELEMENT	DESCRIPTION	CONDITION
North wall		
South wall		
East wall	Steel louver vent, circular exhaust fan near ceiling	Cracks
West wall		
All walls	Concrete, form tie divets plugged, all are unpainted. Many threaded concrete anchors that are no longer used.	
Ceiling	Underside of concrete floor and beams	
Floor	Concrete with floor drain	
Doors	East door is CP1-5. It is steel panel dark gray faded to light gray outside. The flush steel frame is alarmed.	
Windows		
Lighting	Suspended incandescent	
Built-ins	Transformers: Two are G&W model BZ-FS 5200 v. G&W Electric Co., Blue Island, Ill. (last tested 1983). Two transformers are 4160 v. One 300 KVA by Niagra Transformer Corp., Buffalo N.Y. (last tested 1985). One 300 KVA by International Transformer Corp., Pico Rivera, CA (last tested 1971). One unlabeled.

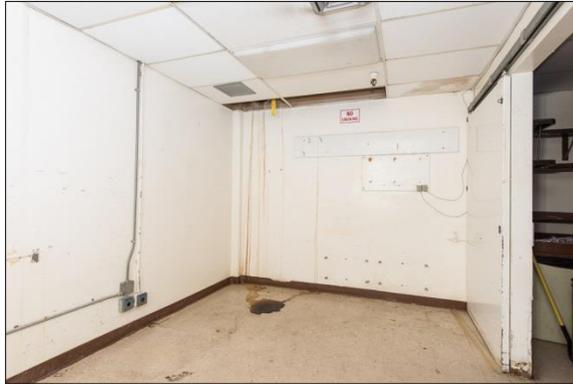
Western section of the room, note damage and leak from suspended ceiling, view southwest (DSC2912).

ELEMENT	DESCRIPTION	CONDITION
North wall	Drywall	
South wall	Concrete	
East wall	Concrete	
West wall	Concrete with two wood panels attached for hanging items. Grease seeping down wall from exhaust vent through outside wall above suspended ceiling.	Grease
All walls	Gloss white	
Ceiling	Same as 110 and 112	
Floor	Tan 1 ft. square linoleum tiles with 4 in. brown plastic base	
Doors	Door from Room 112 is flush steel with surface-mounted slider. Door from Room 121 is flush with louver.	
Windows	None	
Lighting	Same as Room 110 plus one 2-tube surface mounted without diffuser.	
Built-ins

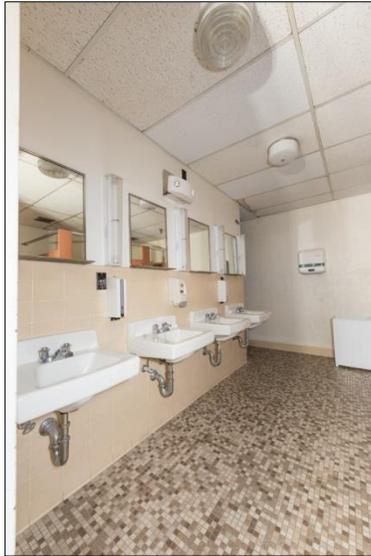
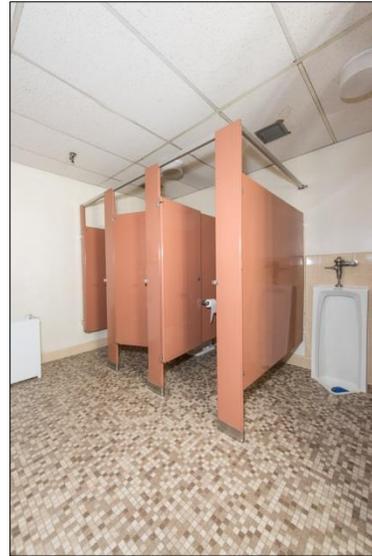
ELEMENT	DESCRIPTION	CONDITION
North wall	Drywall	
South wall	Concrete	
East wall	Drywall	
West wall	Drywall	
All walls	Off-white	
Shower Walls	Metal lath and plaster, full height ceramic tiles	Entry corner broken
Ceiling	Suspended 2 x 4 ft. panels	Water damage
Floor	Ceramic tiles are 1 in. square random brown to off-white, tile base. All wall and base tiles are 4 x 6 in. light tan ceramic.	
Doors	Flush stained, expanded metal vent, stainless kick plate.	
Windows		
Lighting	Surface-mounted circular incandescent; vertical 1-tube with diffuser between mirrors; stainless-framed mirrors with stainless shelves	
Built-ins	Wood bench by shower; porcelain commodes, urinals, and sinks; stainless-framed mirrors with stainless shelves

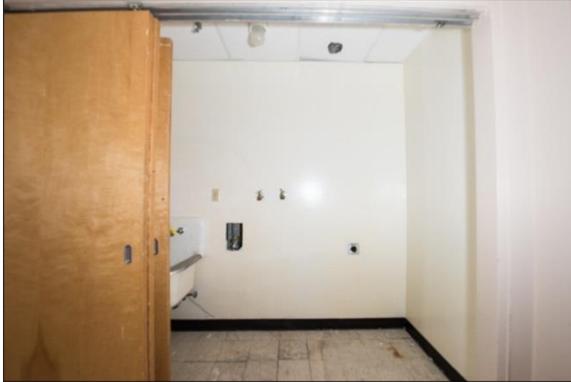
ELEMENT	DESCRIPTION	CONDITION
North wall		
South wall		
East wall		
West wall		
All walls	Off-white drywall	
All Walls		
Ceiling	Suspended 2 x 2 ft. panels	Water damage
Floor	Tan 1 ft. square linoleum tiles with 4 in. black plastic base	
Doors	Flush stained triple slider	
Windows		
Lighting	Surface-mounted incandescent globe	
Built-ins	Porcelain sink with stainless rim, plumbing for washer and dryer

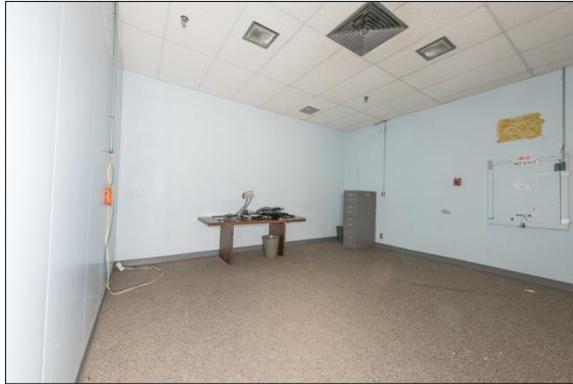
Southern end of Room 135 from entrance, shows emergency exit on west wall, view southwest (DSC2245).

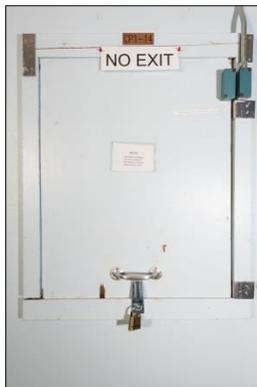
Close-up of emergency exit (DSC2245).

ELEMENT	DESCRIPTION	CONDITION
North wall	Drywall	
South wall	Concrete	
East wall	Drywall with two exposed pillars	
West wall	Concrete plywood inner door leads to escape tunnel CP1-14. As shown on Drawing 49739.	
All walls	Pale blue, originally light green	
Ceiling	Suspended 2 x 4 ft. panels	
Floor	Gray carpet matching Rooms 133 and 135, 4 in. gray plastic base	
Doors	Flush wood-stained with combination lock An alarmed plywood inner door leads to escape tunnel CP1-14. As shown on Drawing 49739, a short horizontal corrugated galvanized tunnel leads to a vertical shaft of the same material with a ladder leading to a concrete cellar with its collar at ground surface.

ELEMENT	DESCRIPTION	CONDITION
Doors (continued)	The concrete cellar is full of sand which in an emergency was to be emptied into a sump at the bottom of the shaft, clearing the way for an exit. The sand was kept clean and dry by means of a lightweight galvanized steel gable roof.	
Windows	None	
Lighting	Recessed 1 ft. square incandescent except the ceiling is dropped lower with recessed 2 x 4 ft. lights with diffusers in the entry area matching the ceiling in Circulation 131.	
Built-ins

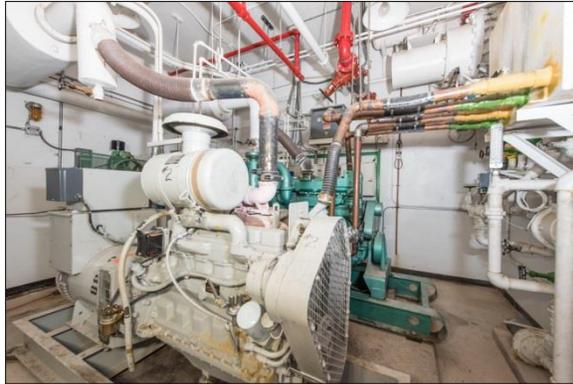
View from the door showing emergency generators (n=2), compressor, blast exhaust, fire suppression, view southwest (DSC2304).

ELEMENT	DESCRIPTION	CONDITION
North wall	Concrete, the base of the wall is eroding from water infiltration from outside.	Water damage
South wall	Concrete	
East wall	Drywall	
West wall	Concrete	
All walls	Off-white	
Ceiling	Pressboard panels attached to underside of floor. The panels are 2 ft. wide.	
Floor	Unpainted concrete with 4 in. black plastic base; raised concrete pedestals for generators; drain in sump	
Doors	Green flush steel with weatherstrip, 4 ft. wide; operable metal louver transom.	
Windows	None	
Lighting	Large suspended incandescent	
Built-ins	Layout shown on Drawing 49730 Equipment includes: -Cummins Model HRF-6-1P Diesel with Onan Generator No. 1 occupies the east side of the room (originally identified as Generator No. 2); -John Deere Diesel with Stamford 110 KW Generator No. 2 occupies the west side of the room; -Engine water coolant pumps, emergency water supply tank, and radiators; -Speedaire 7.5 hp air compressor for powering controls; and -Fuel pumps and fuel oil day tank. Engine exhaust is taken outside through west wall to two external stacks.

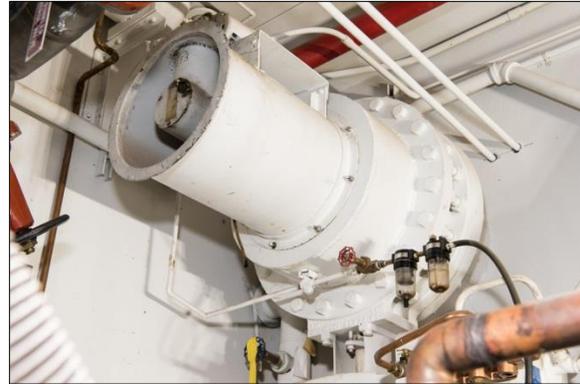
Heavy cast-iron exhaust air outlet in the northwest corner of the room (DSC2318).

Near the ceiling in the northwest corner of the room is the heavy cast-iron exhaust air outlet, which leads to a 24 in. square concrete chimney outside the north wall. A small air compressor operates an emergency blast valve to shut down in case of emergency. The valve also has hand controls.

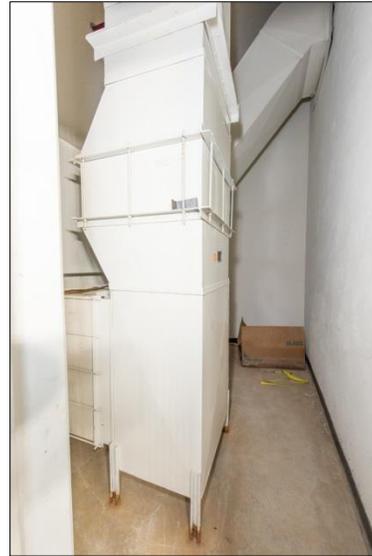
Interior view showing air filter and duct work, view south (DSC2331).

ELEMENT	DESCRIPTION	CONDITION
North wall	Concrete	
South wall	Concrete	
East wall	Drywall with pass-through for pair of ducts	
West wall	Concrete	
All walls	Off-white	
Ceiling	Bottom of concrete floor	
Floor	Unpainted concrete with 4 in. black plastic base Bottom of door casing and the legs of the floor-mounted filter/duct units are rusted from flooding.	Flooding
Doors	Flush steel with weatherstrip	
Windows		
Lighting	Large suspended incandescent	
Built-ins	The pair of fresh air filters and duct work in place are replacements. The carbon filter was last calibrated in 1992 at 99.99% efficiency. Only one of the two ducts has had a carbon filter installed.

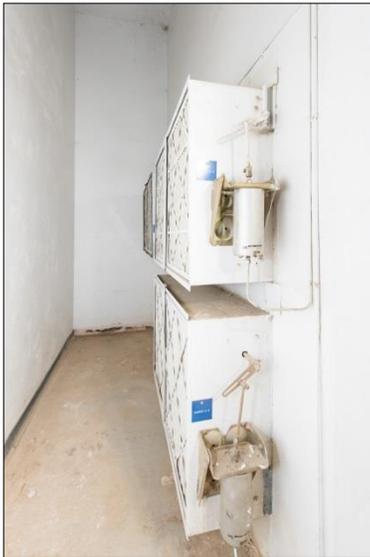
Damper D2 and D3 on the west wall, view south (DSC2332).

ELEMENT	DESCRIPTION	CONDITION
North wall	Concrete	
South wall	Concrete	
East wall	Concrete	
West wall	North half concrete; rest drywall adjacent to Room 137A. Bottom half of drywall badly dissolved by water.	Water damage
All walls	Off-white	
Ceiling	Bottom of concrete floor	
Floor	Unpainted concrete with 4 in. black plastic base. Base has fallen off south and drywall portion of west wall due to flooding.	Flooding
Doors	Flush steel with weather strip repaired with duct tape. The door is off-white inside, green outside and the bottom frame is rusted. Outside fresh air intake is at north end of east wall and is the same design as outlet with blast valve and external concrete intake chimney described in Room 136. The 24 in. blast valve has a dedicated air compressor for emergency operation. Valve is manufactured by Hanna Co., Chicago, Ill.	
Windows		
Lighting	Large suspended incandescent	
Built-ins	Outside fresh air intake at north end of east wall, same design as outlet with blast valve and external concrete

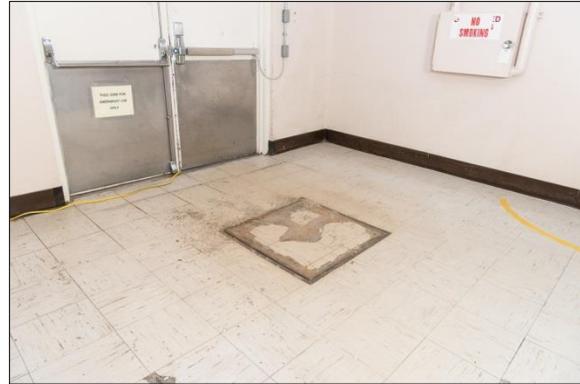
Tile covering drain in Main Entrance Foyer, view southwest (DSC3007).

ELEMENT	DESCRIPTION	CONDITION
North wall		
South wall		
East wall		
West wall		
All walls	Concrete	
Ceiling	Suspended 2 ft. square tiles Decontamination shower head.	Water damage
Floor	Tan 1 ft. square linoleum tile with shower drain. Cracking is concentrated around edges, particularly at junction with original CP1 wall. Baseboard - 6 in. dark brown plastic	Tiles cracked
Doors	Double flush metal with metal surrounds.	
Windows

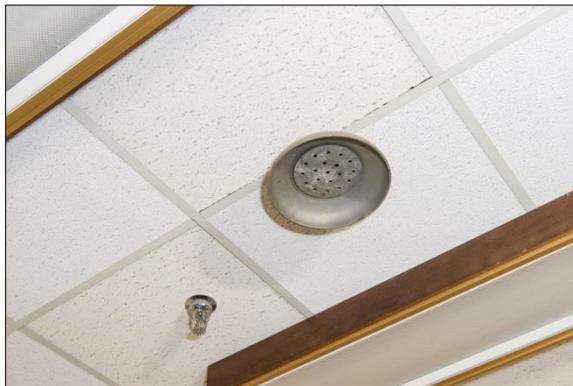
Decontamination shower head (DSC3001).

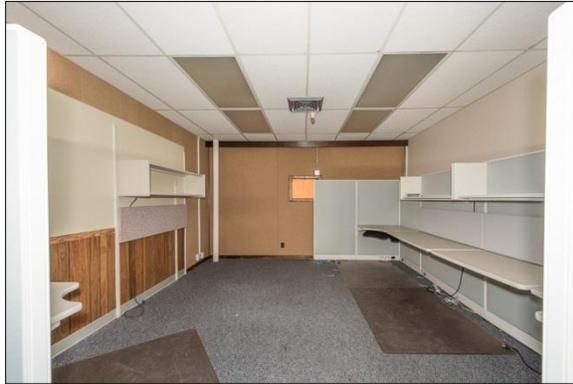
<b>ROOM #:</b> 212	<b>PHASE:</b> 1	<b>LEVEL:</b> First	<b>AREA:</b> 368 sq. ft.	<b>DATE:</b> 4/19/16
<b>FUNCTION(S):</b> Office

Northern end of Office, window (covered with paper) is on north wall, view north (DSC1833).

ELEMENT	DESCRIPTION	CONDITION
North wall	Brown fabric panels Full-length curtain rod and valence at ceiling.	
South wall	Pink/tan drywall (original off-white paint visible in places)	
East wall	Pink/tan drywall	
West wall	Brown fabric panels along top and both sides These panels frame the entrance to Circulation 284. Central portion of wall has plastic off-white panels matching Room 280 above former chair rail (removed to allow installation of cubicle brackets). Below chair rail is a wainscot shorter than that in Room 214 of grooved faux wood plank pattern paneling.	
All walls		
Ceiling	Suspended 2 x 4 ft.	
Floor	Blue carpet, 4 in. gray plastic base	
Doors	No door at entry from Room 214. Opening cased with stained wood and stained ogee molding.	
Windows	Single fixed light viewing port, alarmed, replacement two-layer glass. Moisture is present between inner and outer layers of glass. Window is 18 x 24 in.	Moisture

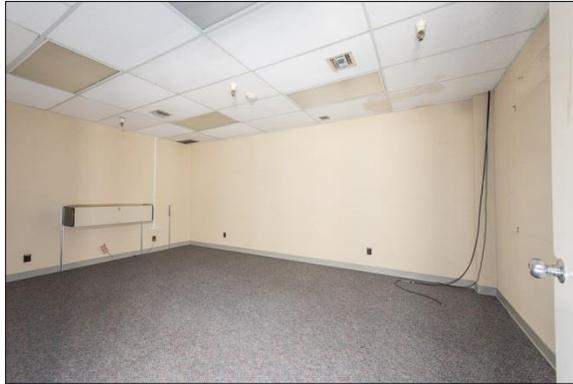
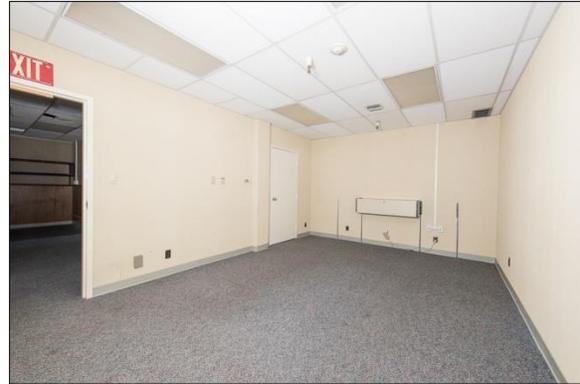
<b>ROOM #:</b> 213	<b>PHASE:</b> 1	<b>LEVEL:</b> First	<b>AREA:</b> 255 sq. ft.	<b>DATE:</b> 4/19/16
<b>FUNCTION(S):</b> Conference

Conference room from the entrance, view northeast (DSC1887).

View from the southeast corner of the room, exit is to 214 Conference Room (DSC1888).

ELEMENT	DESCRIPTION	CONDITION
North wall	Credenza standards	
South wall		
East wall		
West wall	Pillar	
All walls	Adhesive tan fabric "wallpaper." Fabric also covers pillar.	Some peeling
Ceiling	Suspended 2 x 4 ft. and 2 x 2 ft.	
Floor	Blue carpet with 4 in. gray plastic base	
Doors	Off-white flush steel with steel frame	
Windows		
Lighting	Inset 2 x 4 ft. with diffusers	
Built-ins

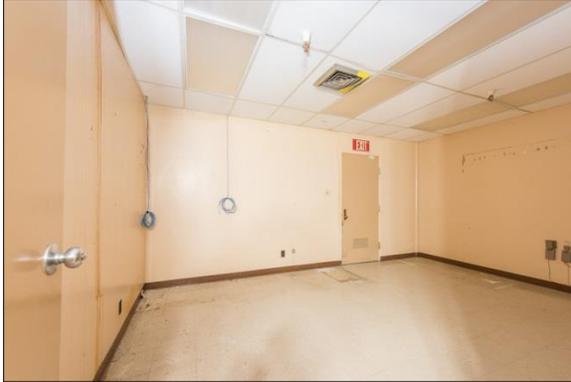
<b>ROOM #:</b> 223	<b>PHASE:</b> 1	<b>LEVEL:</b> First	<b>AREA:</b> 223 sq. ft.	<b>DATE:</b> 9/19/16
<b>FUNCTION(S):</b> Office

Overview from the southeast corner, marked exit is to 205 Circulation, view northwest (DSC1620).

ELEMENT	DESCRIPTION	CONDITION
North wall		
South wall	Staining from ceiling leaks	Much water staining
East wall		
West wall		
All walls	Tan drywall The tan is same color as in Rooms 205 and 254 before these areas were repainted pink/tan.	
Ceiling	Suspended 2 x 4 ft. panels	Heavy water damage
Floor	Tan 1 ft. square linoleum tile; brown 4 in. plastic base	
Doors	Flush with louver vent and wood casing	
Windows		
Lighting	Recessed 2 x 4 ft. with diffusers	
Built-ins

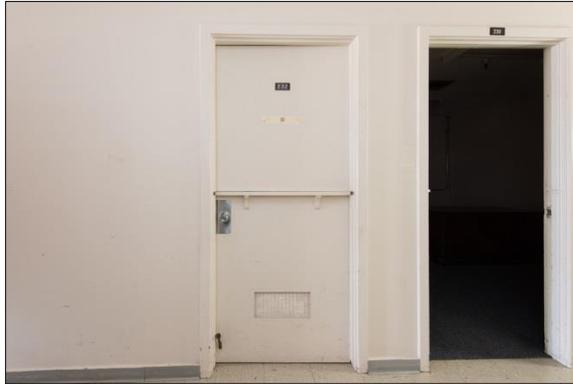
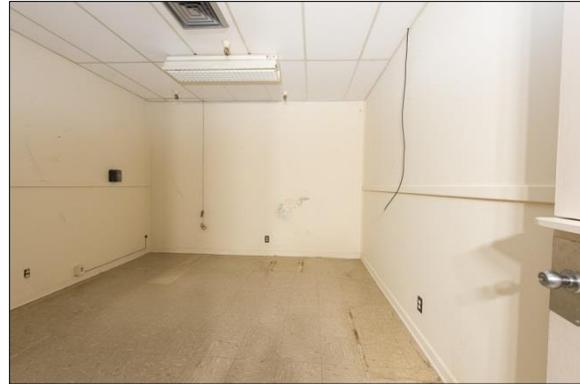
<b>ROOM #:</b> 232	<b>PHASE:</b> 1	<b>LEVEL:</b> First	<b>AREA:</b> 186 sq. ft.	<b>DATE:</b> 4/18/16
<b>FUNCTION(S):</b> Office

Closed door from 205 Circulation, open door is to Room 230, view west (DSC1650). Interior overview, view west (DSC1652).

ELEMENT	DESCRIPTION	CONDITION
North wall	Drywall, 2 ½ in. painted chair rail on north, south, and east walls	
South wall	Drywall	
East wall	Drywall	
West wall	Concrete, plain corner boards; 2 in. hole through wall has conduit removed. I put in temporary paper plug to keep out bats.	Paint flaking off
All walls		
Ceiling	Suspended 2 x 4 in. panels	
Floor	Tan 1 ft. square linoleum tiles, typical wood base and shoe, removal of former partition by unmatched tiles	
Doors	Flush, Dutch with counter and louver vent, removal of former second door in south wall indicated by seam in baseboard	
Windows		
Lighting	Surface mounted 3-tube with diffuser grid	
Built-ins

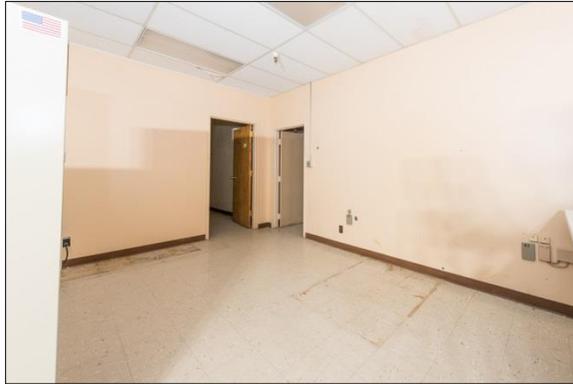
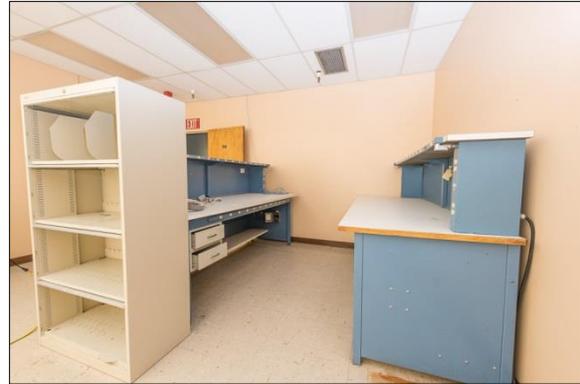
<b>ROOM #:</b> 254	<b>PHASE:</b> 1	<b>LEVEL:</b> First	<b>AREA:</b> 355 sq. ft.	<b>DATE:</b> 4/19/16
<b>FUNCTION(S):</b> Laboratory

ELEMENT	DESCRIPTION	CONDITION
North wall	The concrete pillar not chamfered on this side only. This is an unintentional construction error when assembling the form.	
South wall		
East wall		
West wall		
All walls	Tan drywall	
Ceiling	Suspended 2 x 4 ft. panels	One panel is broken
Floor	Tan 1 ft. square linoleum tiles with 4 in. brown plastic base	
Doors	The west and east doors are flush, and the wood is stained with painted steel frames.	
Windows	None	
Lighting	Recessed 2 x 4 ft. with diffusers	
Built-ins

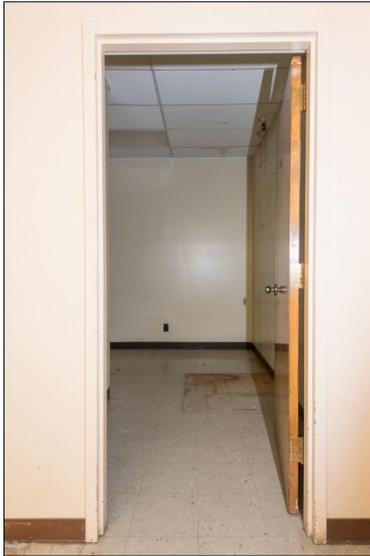
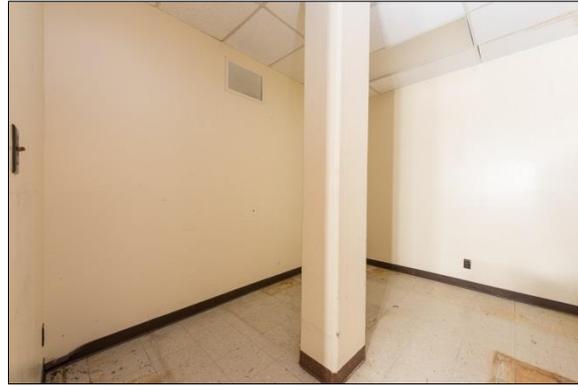
<b>ROOM #:</b> 255	<b>PHASE:</b> 1	<b>LEVEL:</b> First	<b>AREA:</b> 249 sq. ft.	<b>DATE:</b> 5/5/16
<b>FUNCTION(S):</b> Laboratory

ELEMENT	DESCRIPTION	CONDITION
North wall		
South wall		
East wall		
West wall		Water damage from above
All walls	Off-white drywall	
Ceiling	Suspended 2 x 4 ft. panels	Water damage
Floor	Tan 1 ft. square linoleum tiles with 4 in. brown base	Water damage
Doors	Flush; stained wood	
Windows		
Lighting	Inset 2 x 4 ft. with diffusers	
Built-ins

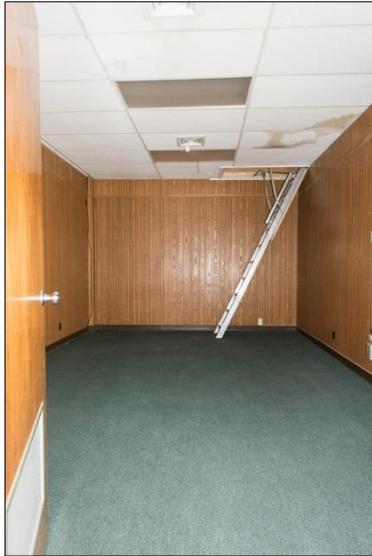
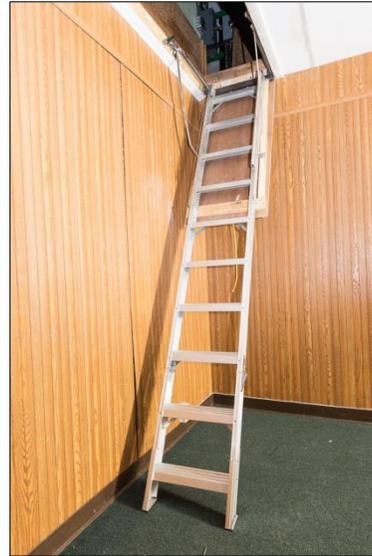
<b>ROOM #:</b> 256	<b>PHASE:</b> 1	<b>LEVEL:</b> First	<b>AREA:</b> 259 sq. ft.	<b>DATE:</b> 4/18/16
<b>FUNCTION(S):</b> Conference Room

ELEMENT	DESCRIPTION	CONDITION
North wall	Concrete (utility shaft), former return air vent covered by paneling	
South wall	Drywall	
East wall	Drywall	
West wall	Drywall	
All walls	Covered with oak veneer pressboard panels	
Ceiling	Suspended 2 x 4 ft. panels, access to attic in northeast corner	Water damage
Floor	Blue carpet with 4 in. brown plastic base	
Doors	Flush, stained wood with off-white steel surround and louver vent	
Windows		
Lighting	Inset with diffusers	
Built-ins

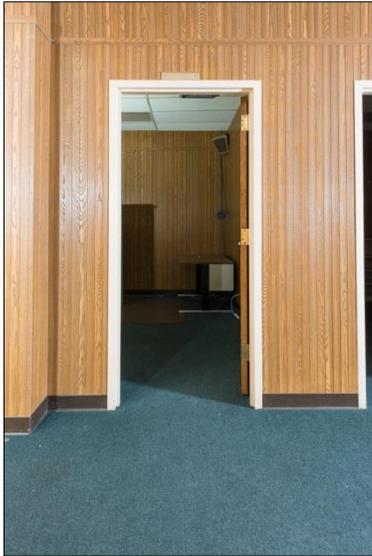
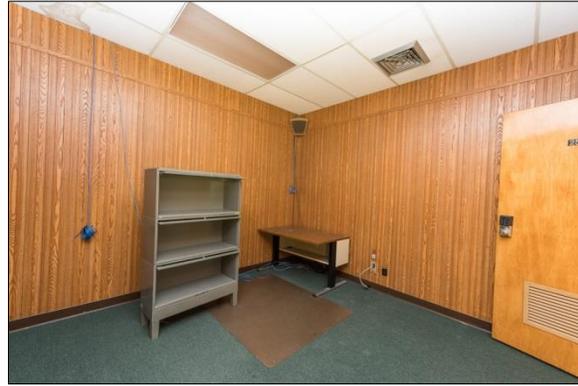
<b>ROOM #:</b> 257	<b>PHASE:</b> 1	<b>LEVEL:</b> First	<b>AREA:</b> 163 sq. ft.	<b>DATE:</b> 4/18/16
<b>FUNCTION(S):</b> Office

ELEMENT	DESCRIPTION	CONDITION
North wall		
South wall		
East wall		
West wall		
All walls	Drywall with oak veneer pressboard panels	
Ceiling	Suspended 2 x 4 ft. panels	Water damage
Floor	Blue carpet with 4 in. brown plastic base	
Doors	Flush, stained wood with off-white steel surround, louver vent, and combination lock	
Windows		
Lighting	Inset with diffusers	
Built-ins
