**United States Department of Energy  
Sandia National Laboratories, California  
Arroyo Seco Improvement Program  
Annual Report for 2019**

Robert C. Holland  
Environmental Management Department  
Sandia National Laboratories, California

January 2020

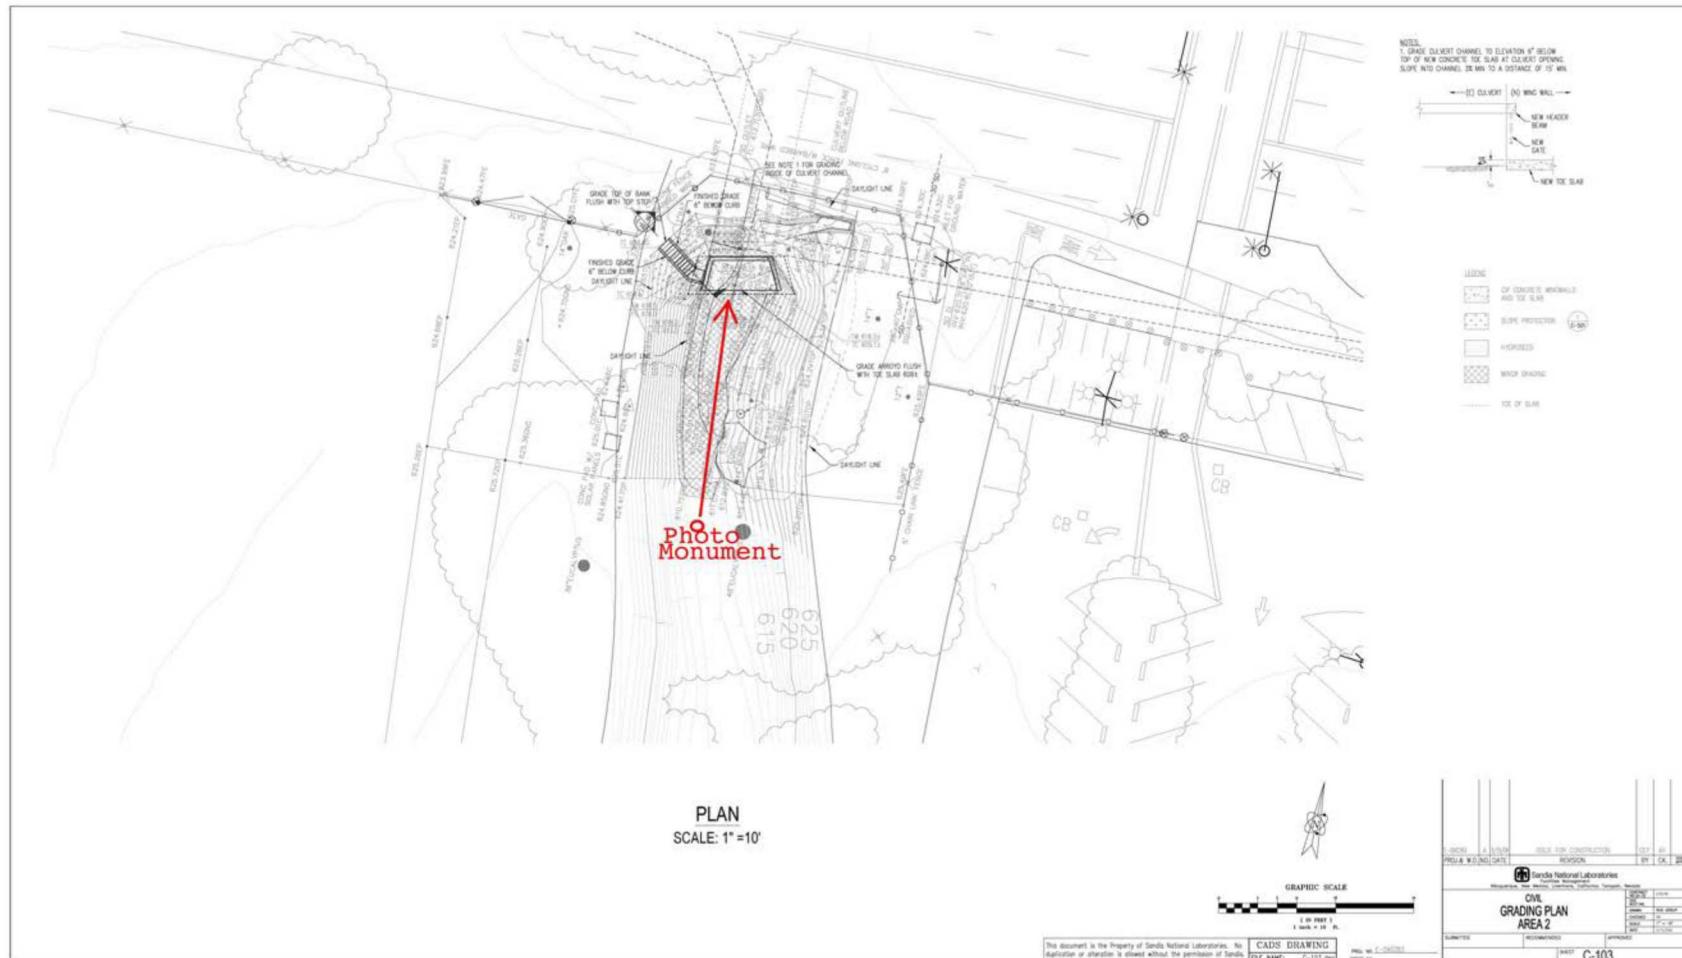
Figure 1. As-built drawing for Project 2

Photos for this location will be taken from the streambed. The photo location is noted on Figure 1. Pre-construction and post-construction photos are shown below.

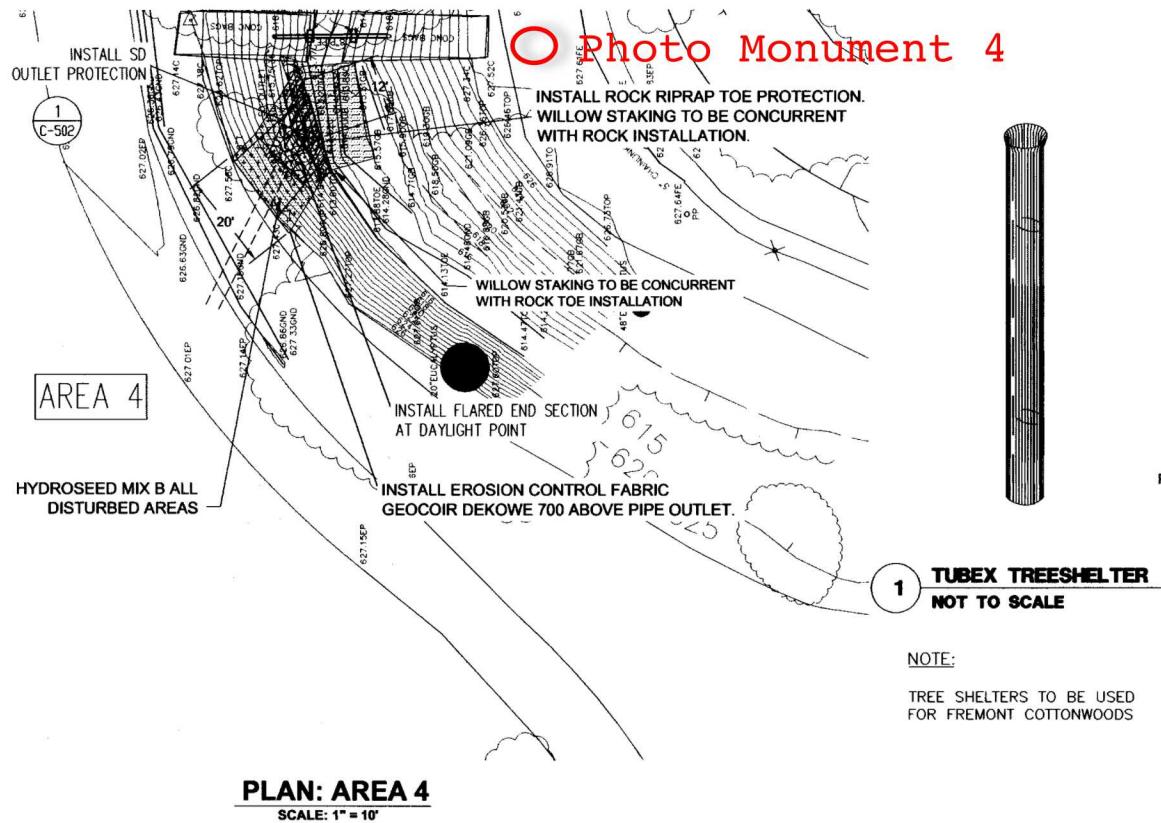
Figure 4. Drawing for Project 4

Site 4 has one photo monument, designated 4. The location of this monument is shown in the as-built drawing, Figure 4. Photographs are shown for this monument before and after construction.

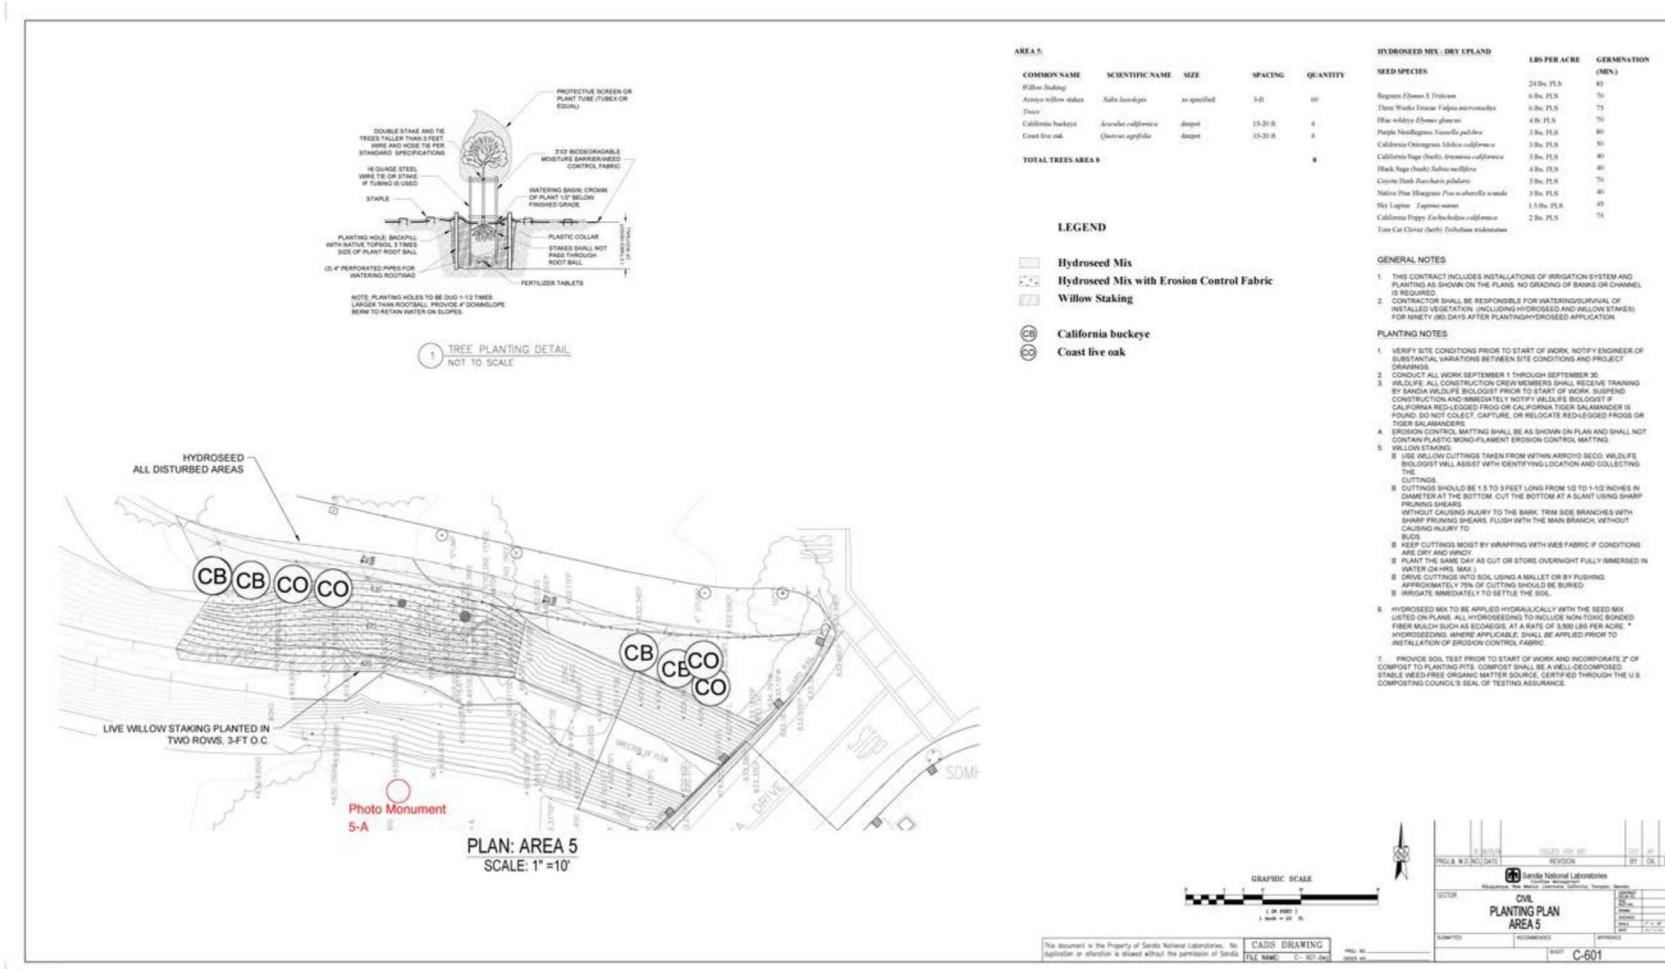
Figure 7. Drawing for Project 5

Project 5 has one photo monument, designated 5-A. The location of this monument is shown on the as-built drawing, figure 7.

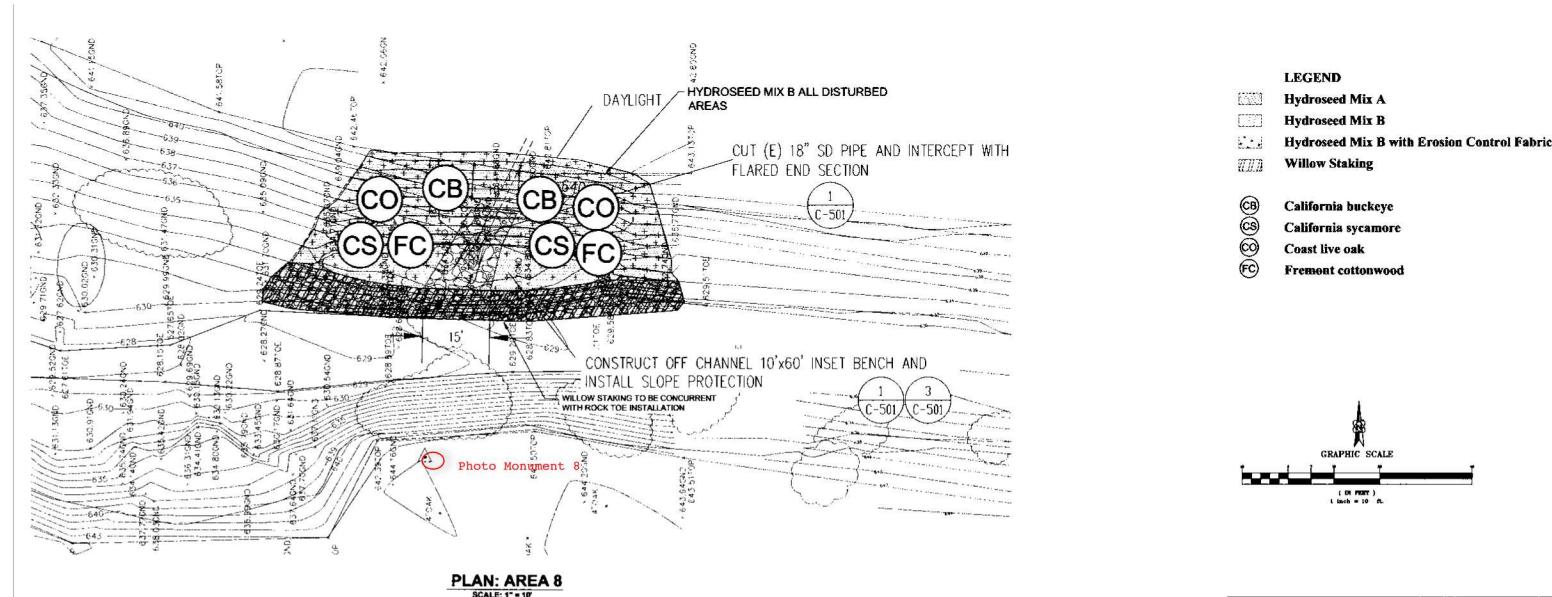
Figure 10. Drawing for project 8

Site 8 involved repairing a storm drain outlet between the C Street Bridge and the Pedestrian Bridge. Grading of the existing slope was done to create a small inset bench. The existing erosion gully was filled with riprap and compacted fill.

Due to heavy rainfall during the winter of 2016-2017, and consequent high flows in the Arroyo Seco, a scour hole formed in the bed of the Arroyo at the junction of Project 8 and Project 9. The scour hole was repaired during the summer of 2019.

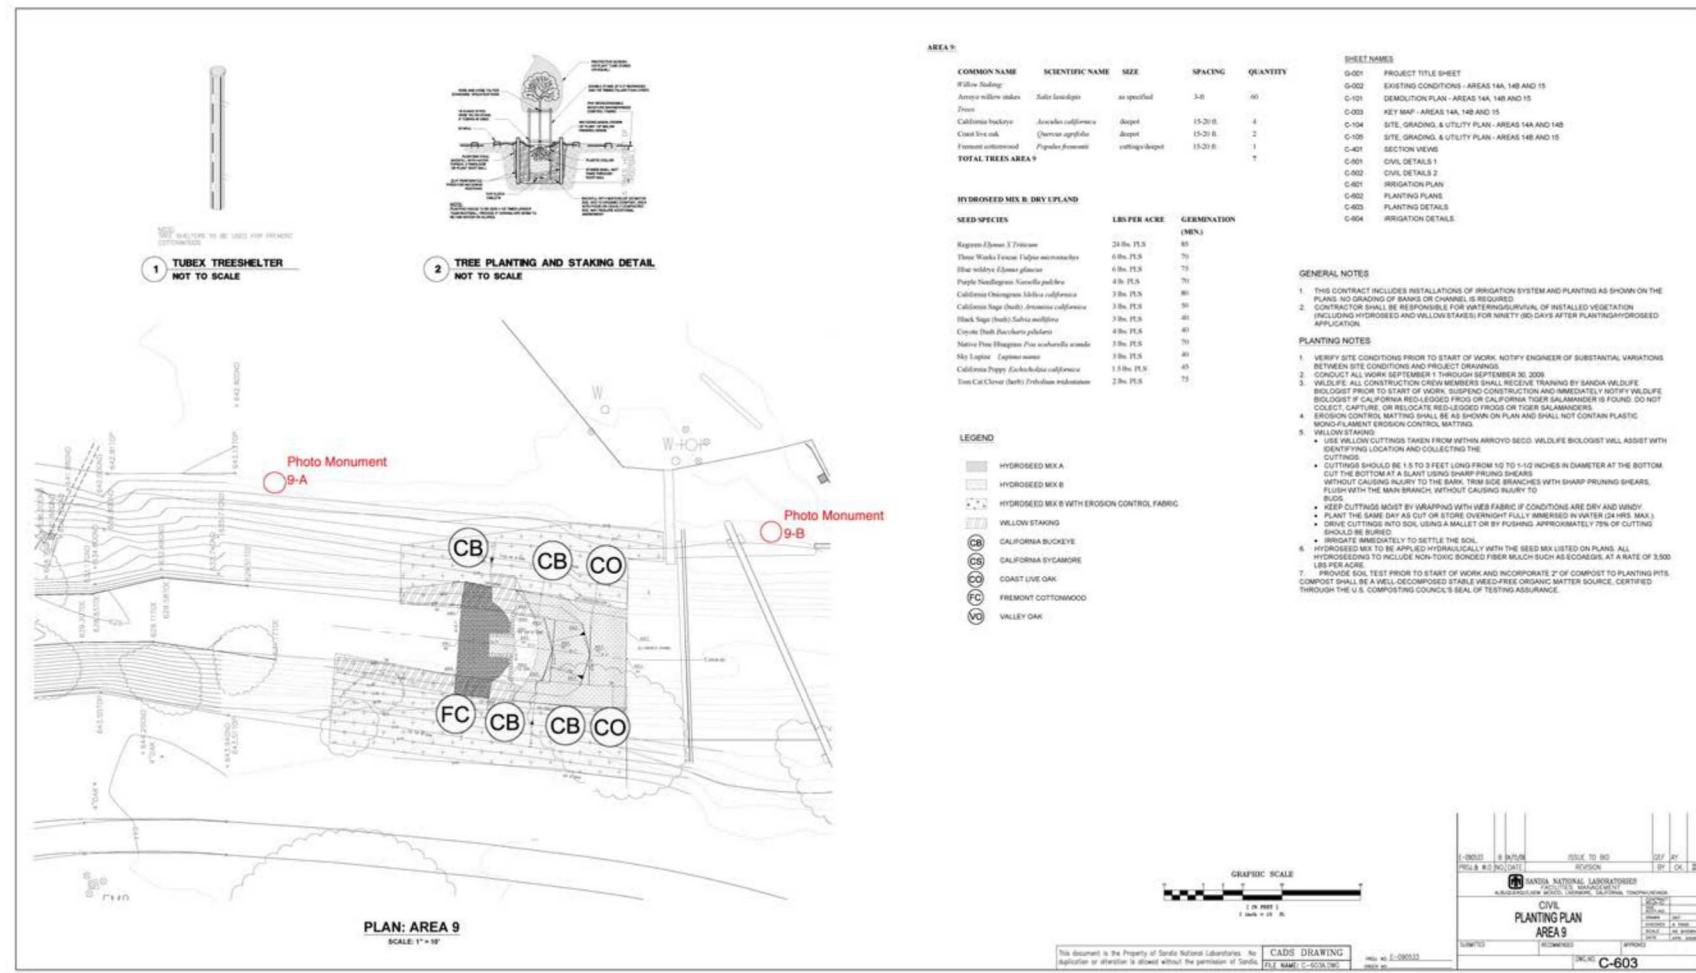
**Figure 13. Drawing for Project 9**

Project 9 involved the correction of erosion at the C Street bridge. This included removal of large blocks of concrete that had been placed earlier for energy dissipation, and the repair of a scour hole downstream of the structure.

Due to heavy rainfall during the winter of 2016-2017, and consequent high flows in the Arroyo Seco, a scour hole formed in the bed of the Arroyo at the junction of Project 8 and Project 9. The scour hole was repaired during the summer of 2019.

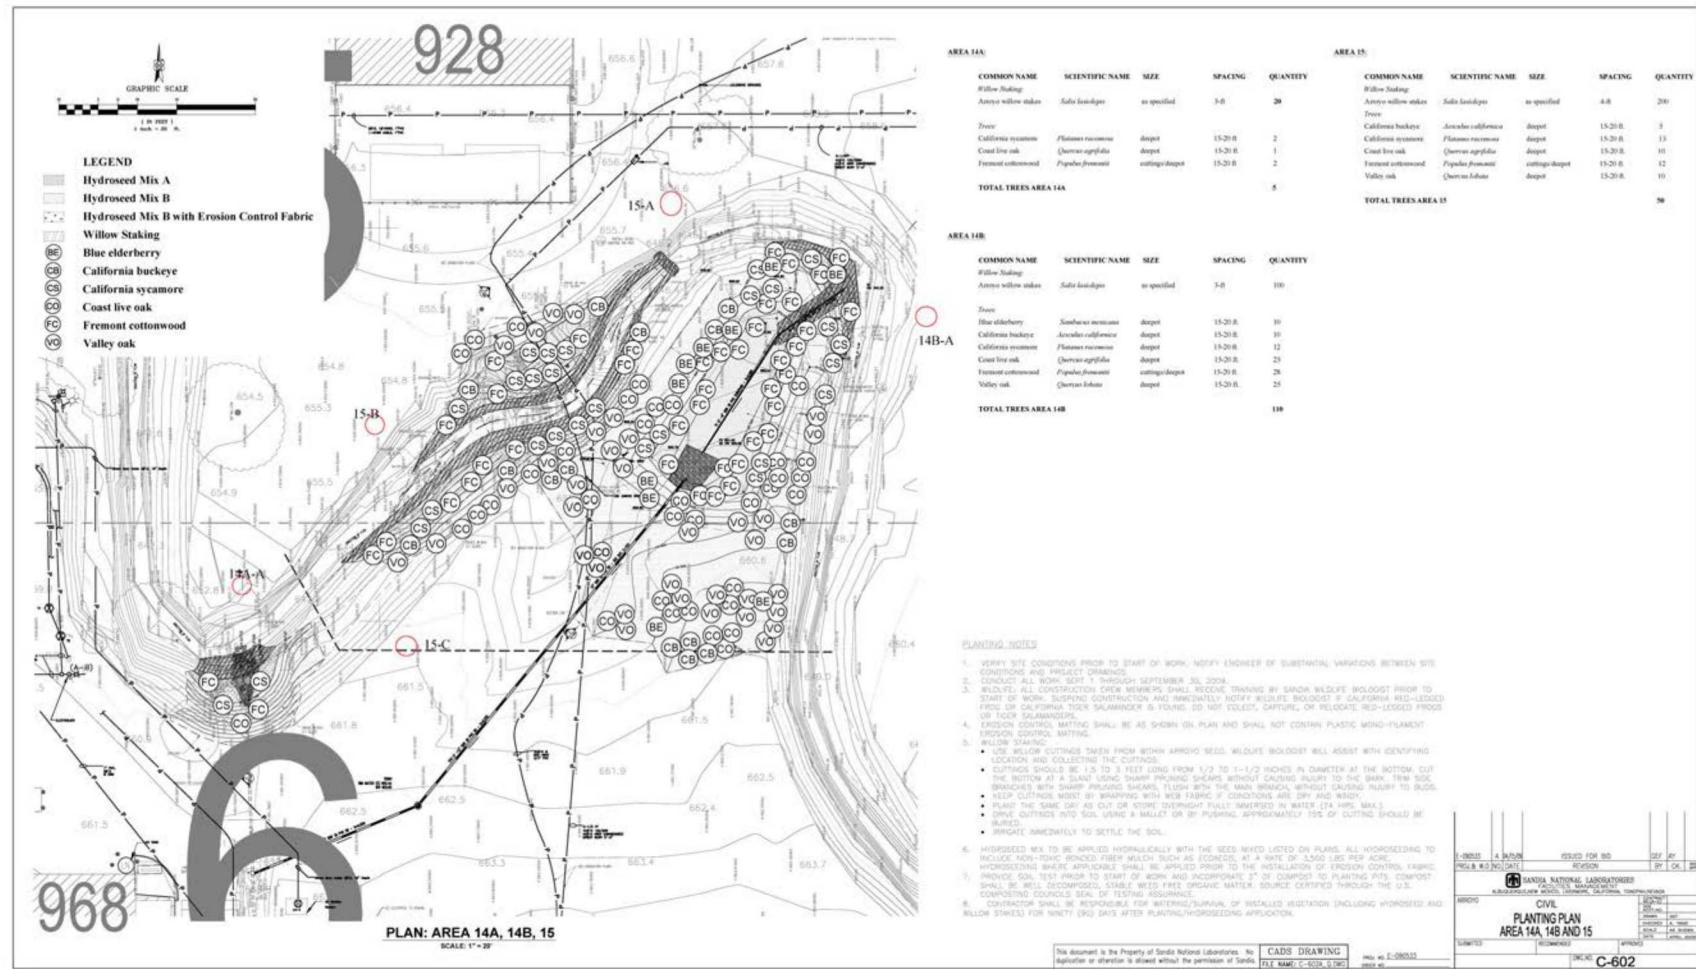
Figure 18. Drawing for Project 14A

Project 14A involved repair of a heavily eroded storm drain outlet downstream of the land bridge. During the creation of the inset floodplain at Project 14B, the storm drain was relocated.

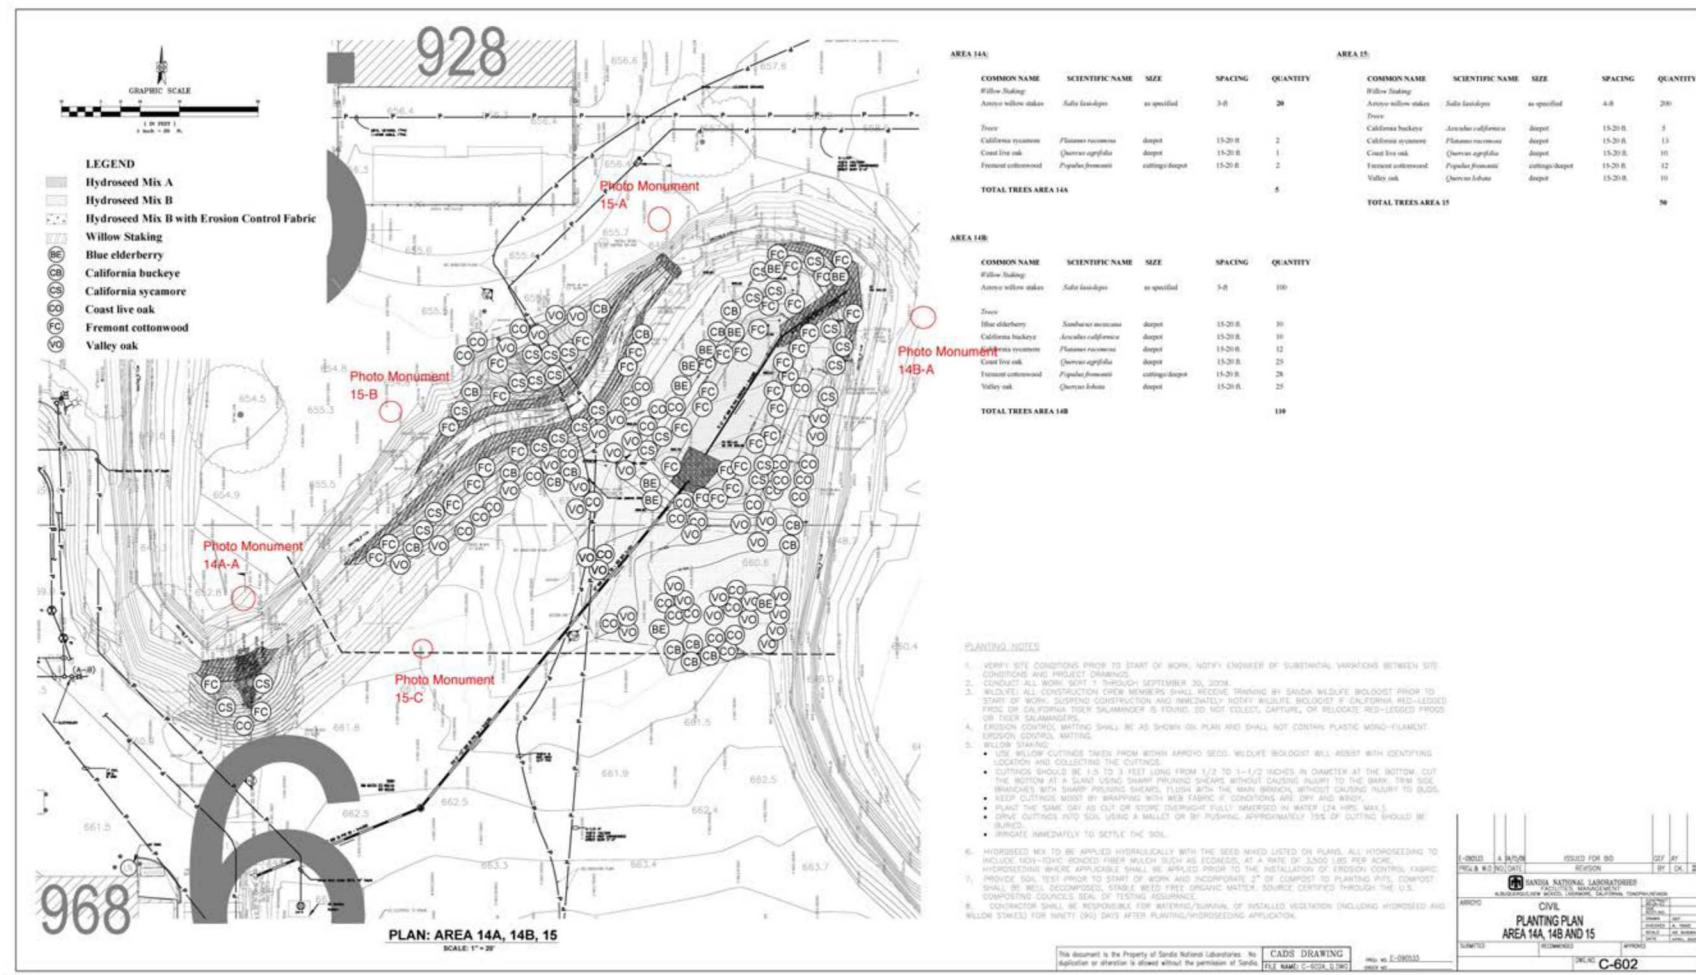
**Figure 23. Drawing for Projects 14B and 15**

Four photo monuments were established for Projects 14B and 15, labeled as photo monuments 14B-A 15-A, 15-B, and 15-C. The location of these monuments is shown on the as-built drawing shown in Figure 48.

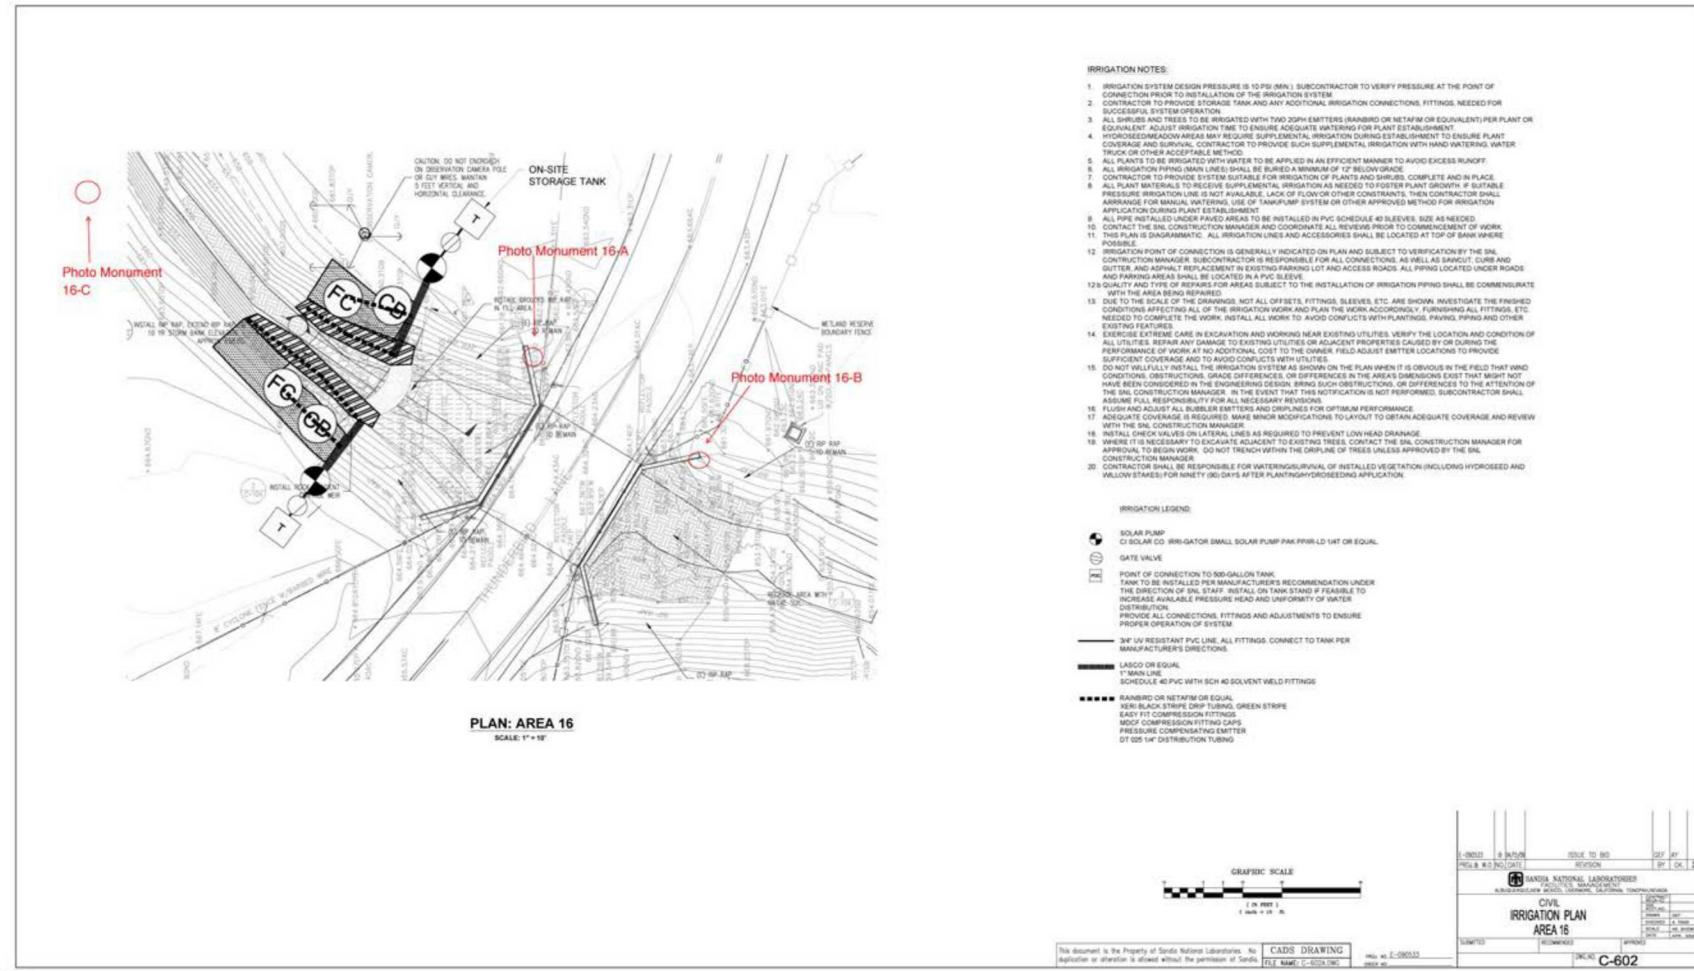
**Figure 32. Drawing for Project 16**

Project 16 involved repair of erosion damage at the Thunderbird Lane Bridge.

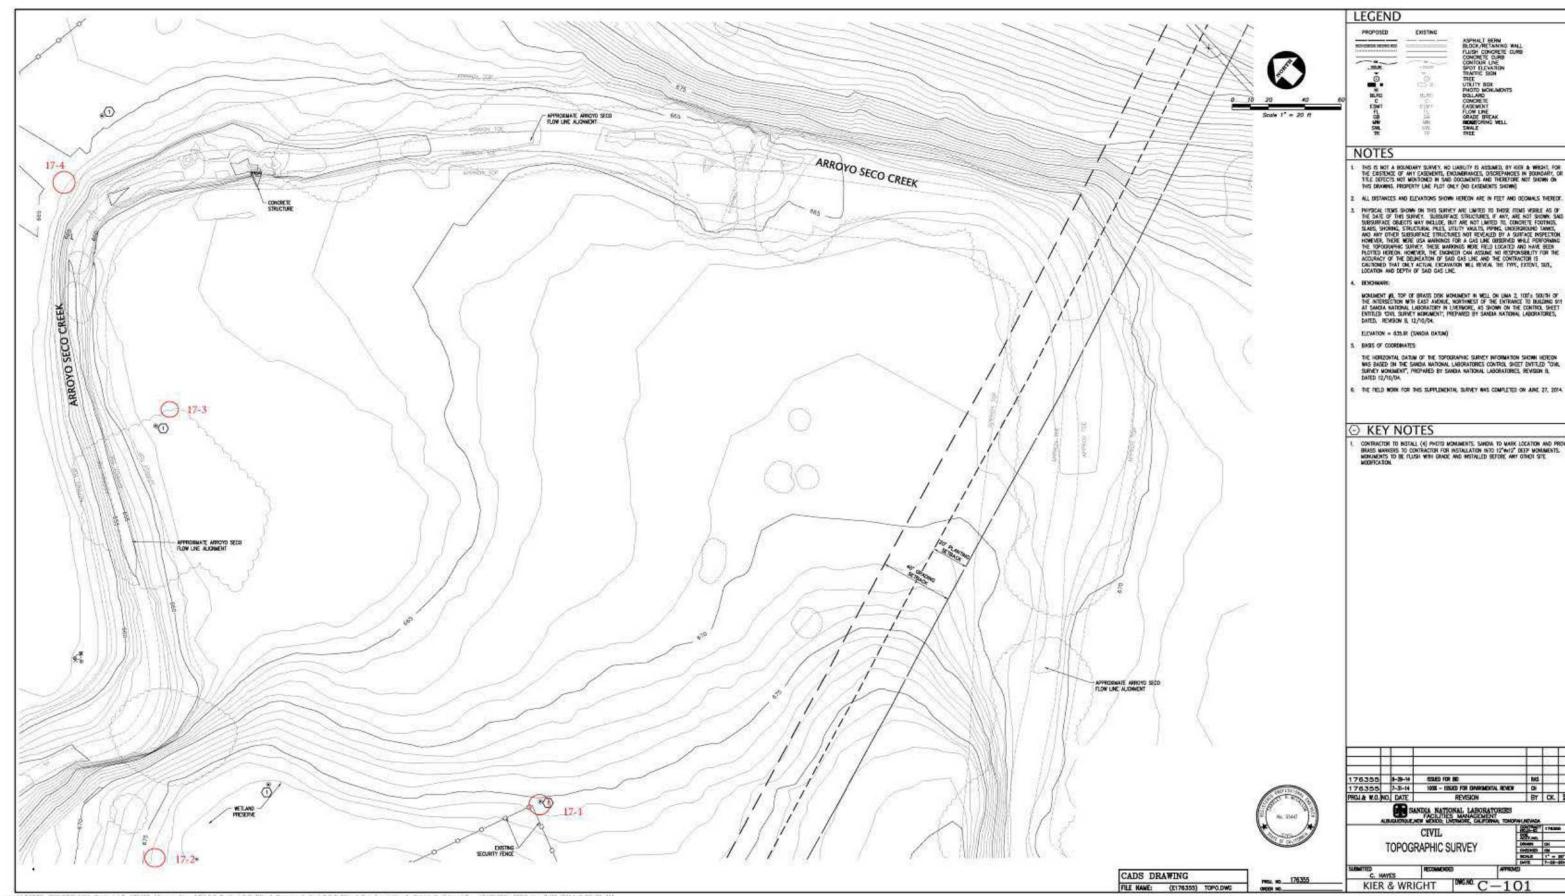
**Figure 41. Photo Monuments for Site 17A and 17B**

Four photo monuments were established for Site 17, labeled as photo monuments 17-1, 17-2, 17-3, and 17-4. The location of these monuments is shown in Figure 68.

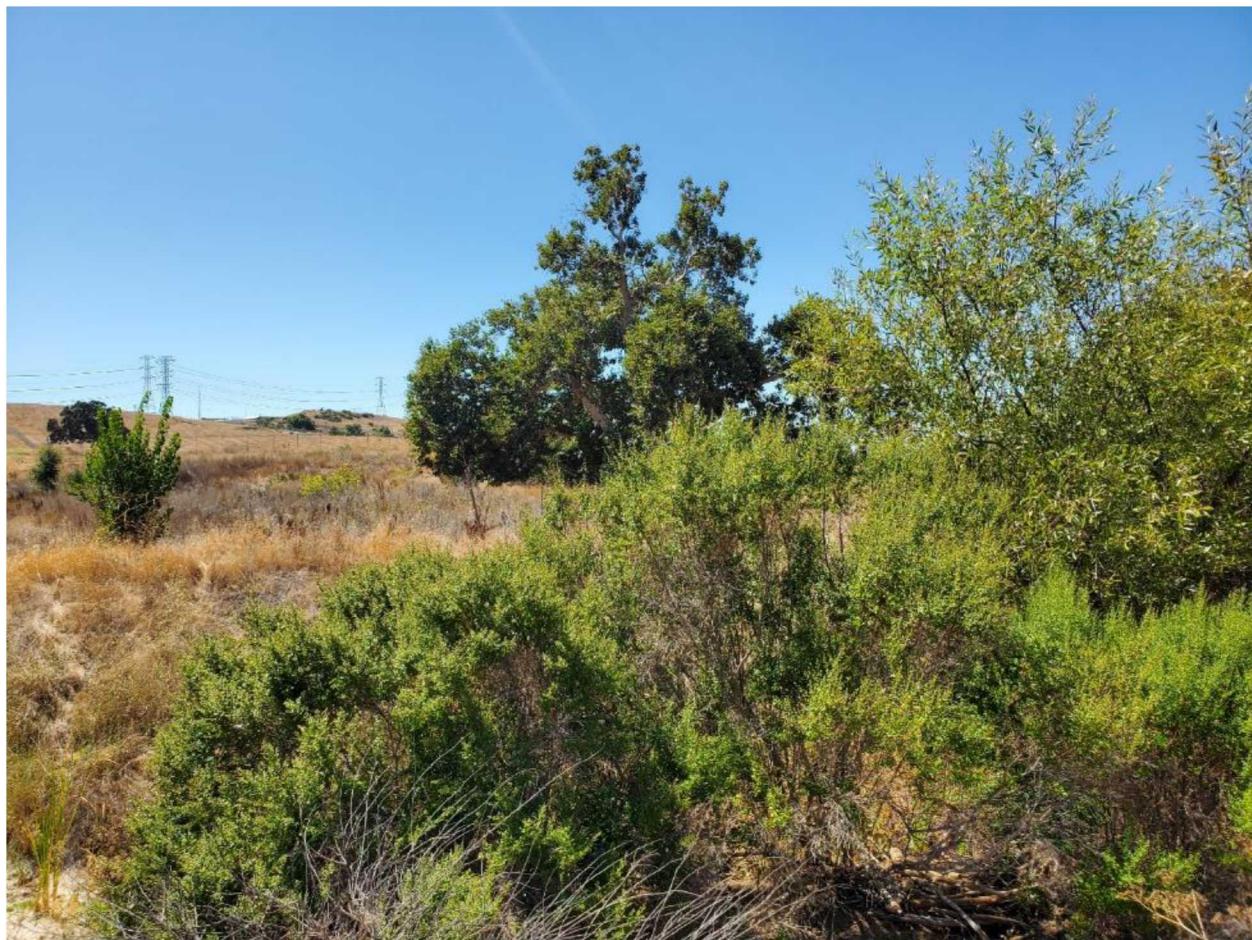
**Figure 55. Photo monument 17-4 looking southwest, post-construction, 2019**
