K/ETO-155  
ORNL/TM-12840

### Investigation of Breached Depleted UF<sub>6</sub> Cylinders at the K-25 Site

INVESTIGATION OF BREACHED DEPLETED UF<sub>6</sub>  
CYLINDERS AT THE K-25 SITE

Date Published: October 1994

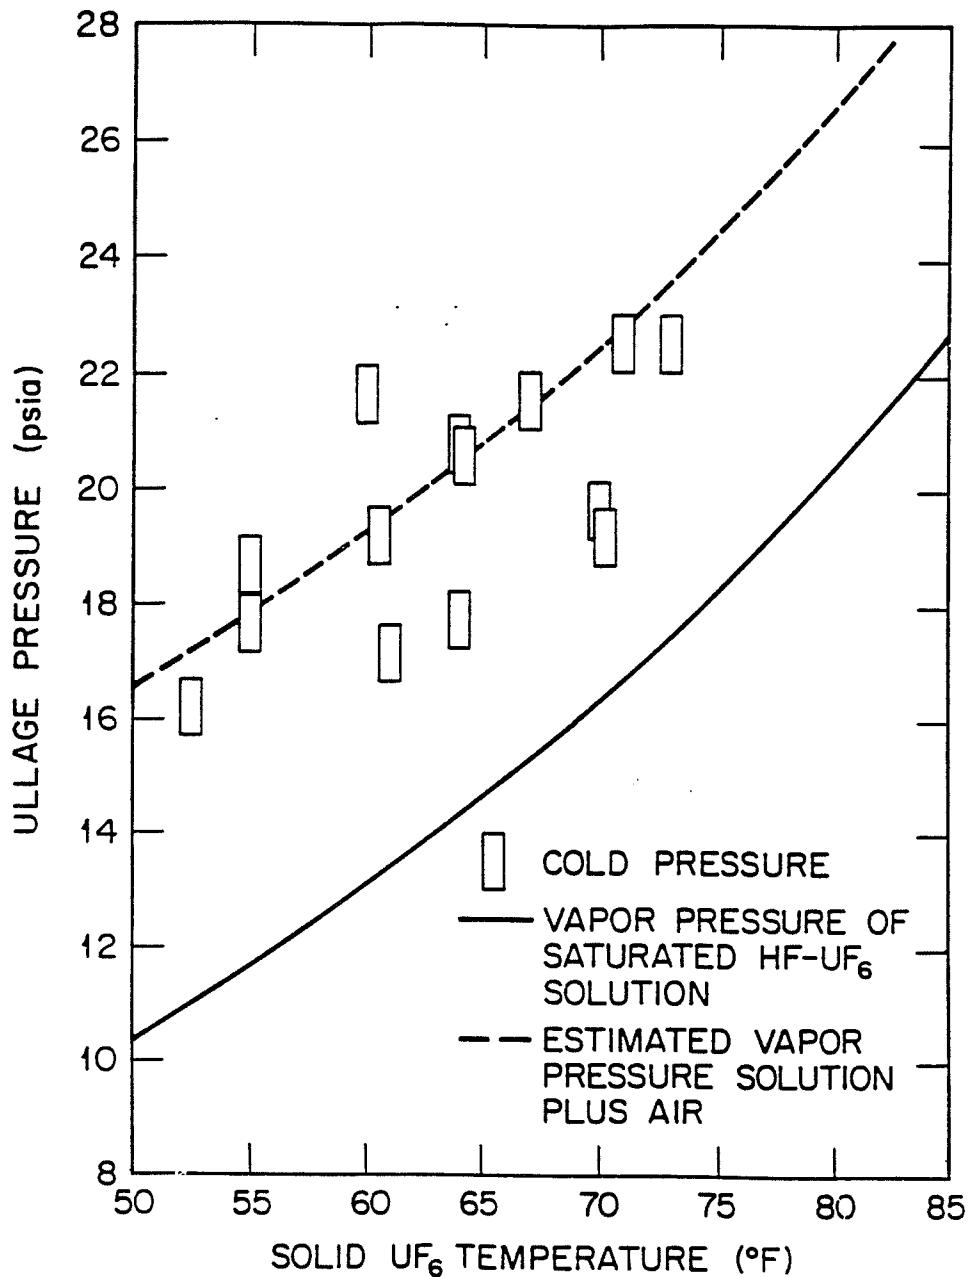
Based on the analytical data on the samples withdrawn from the ullage and the bottom temperature reading at 14:00 h when the samples were taken, the temperature of the  $\text{UF}_6(s)$  is taken to be  $11^\circ\text{F}$  less than the measured bottom temperature at 2 p.m. The "cold pressure" or ullage pressure could be read to  $\pm 0.5$  psia and the TCs to about  $\pm 1^\circ\text{F}$ . Part of the  $11^\circ\text{F}$  discrepancy noted may be due to inadequacy of the thermal isolation and the method of attachment of the TCs. Plotting the "cold pressure" data given in Table C-2 between 03/19/92 and 06/05/92 as a function of the solid  $\text{UF}_6$  temperature obtained by correcting the corresponding bottom temperatures by  $11^\circ\text{F}$  gives the datum rectangles shown in Fig. C-1. The solid curve in Fig. C-1 shows the pressure of a saturated solution of  $\text{UF}_6$  in HF, and the dashed curve shows the same data with an added 6.2 psia of air. The pressures of the HF solutions saturated with  $\text{UF}_6$  were computed from the vapor pressure equations given in K/ETO-37 (ref. 3). Table C-3 lists these equations and the computed pressures for HF solutions saturated with  $\text{UF}_6$ . The data in Fig. C-1 are further confirmation of the existence of an HF solution saturated with  $\text{UF}_6$  in the ullage of Cylinder 101244. Based on the pressure built up in the collection cylinder and the assumption that the vapor samples collected are representative of the composition of the vapor removed from the cylinder ullage, the 139 std ft<sup>3</sup> collection cylinder is expected to contain about 5 lb  $\text{UF}_6$ , 2 lb HF, and 2.6 lb air for a total of 9.6 lb. Very similar results were obtained at PORTS for the cylinder with the large hole where about 8 lb of vapor and gas was removed from the ullage. This suggests the chemical processes occurring in a tails cylinder after a breach are similar at the two sites.

Fig. C-1. Cold pressure of Cylinder 101244 as a function of solid  $\text{UF}_6$  temperature compared to vapor pressure of HF solution saturated with  $\text{UF}_6$ .

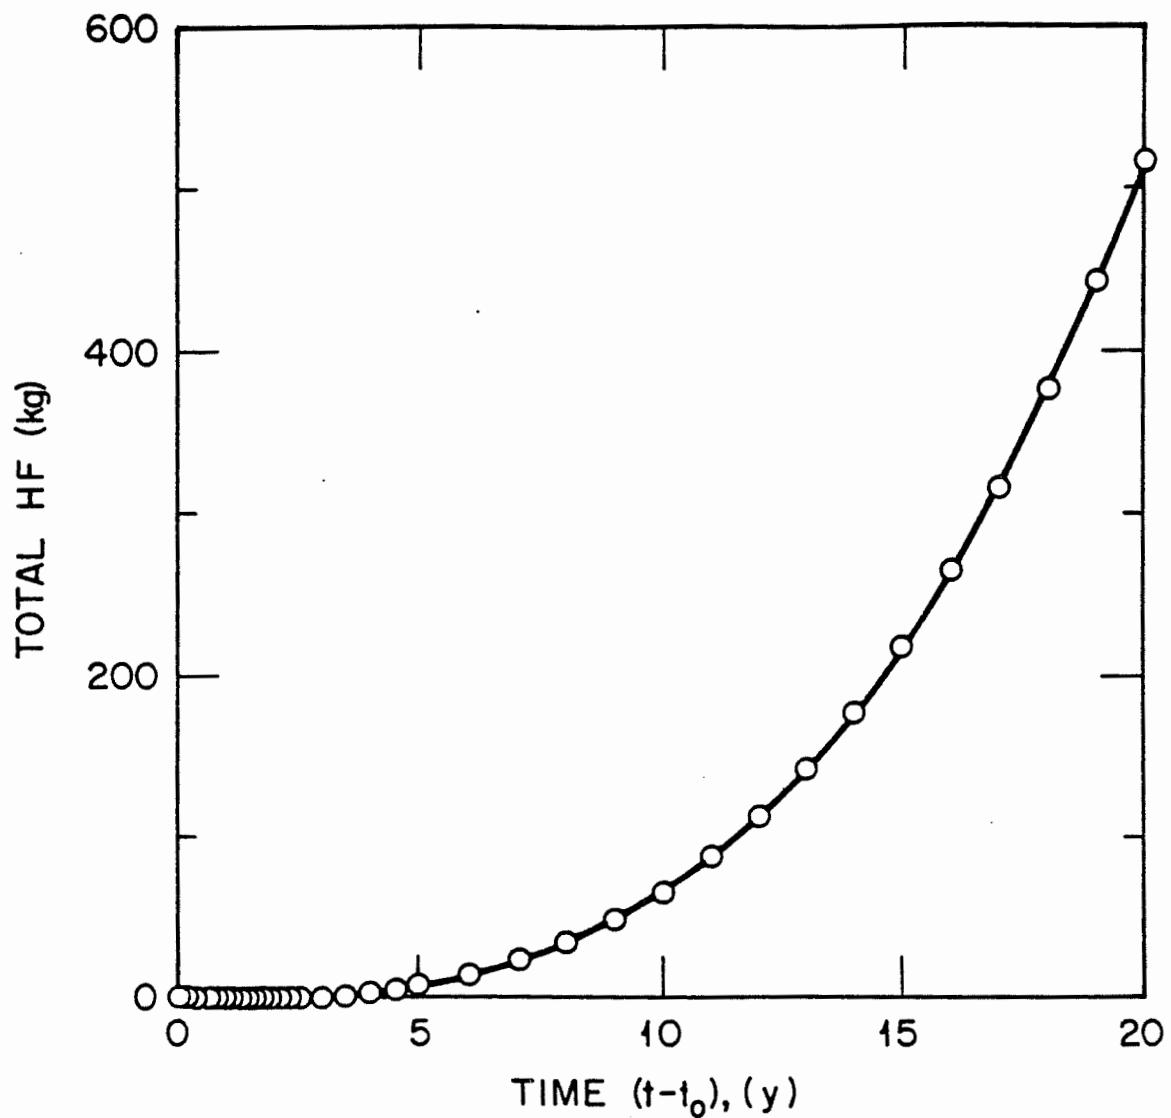
On this basis, Eq. (C-1) above can be used to calculate the total amount of HF released at any time after the actual enlargement of the hole begins. The minimum value of  $t_o$  can be taken as 1 year. This value of  $t_o$  is relevant only for breach growth resulting from through-the-wall impact fractures. For fractures partially penetrating the wall or for penetration by wall corrosion from the outside,  $t_o$  may be many years. Figure C-2 shows the cumulative loss of HF in kilograms HF as a function of  $(t-t_o)$ . The actual value of  $t_o$  must be subtracted from the total exposure time to give the time shown in the plots.

The minimum value of  $t_o$  is the time required for the reactions of  $UF_6$ , water, and iron to begin to increase the hole cross section through the entire depth of the wall. For impact fractures extending part way through the wall, the time for mechanical crack extension and external atmospheric oxidation to complete the penetration must be added to the minimum  $t_o$ . Thereafter, one would expect behavior similar to that in which the impact fracture went totally through the wall. If the wall penetration is due to general corrosion over a wide area, the actual enlargement of the hole, once the wall is penetrated, may proceed much faster than is predicted from the PORTS experience, or the hole may already be several inches in diameter when its existence first becomes obvious. As noted for Cylinder 7953, there is evidence that the reaction products on the ground underneath the cylinder had only recently fallen, and the amount of HF in the ullage of Cylinder 7953 at the K-25 Site was significantly less than in the case of the large hole at PORTS. Thus, while the quantity of HF accumulated in the ullage

Fig. C-2. Expected cumulative loss of HF vs. time for impact breaches.

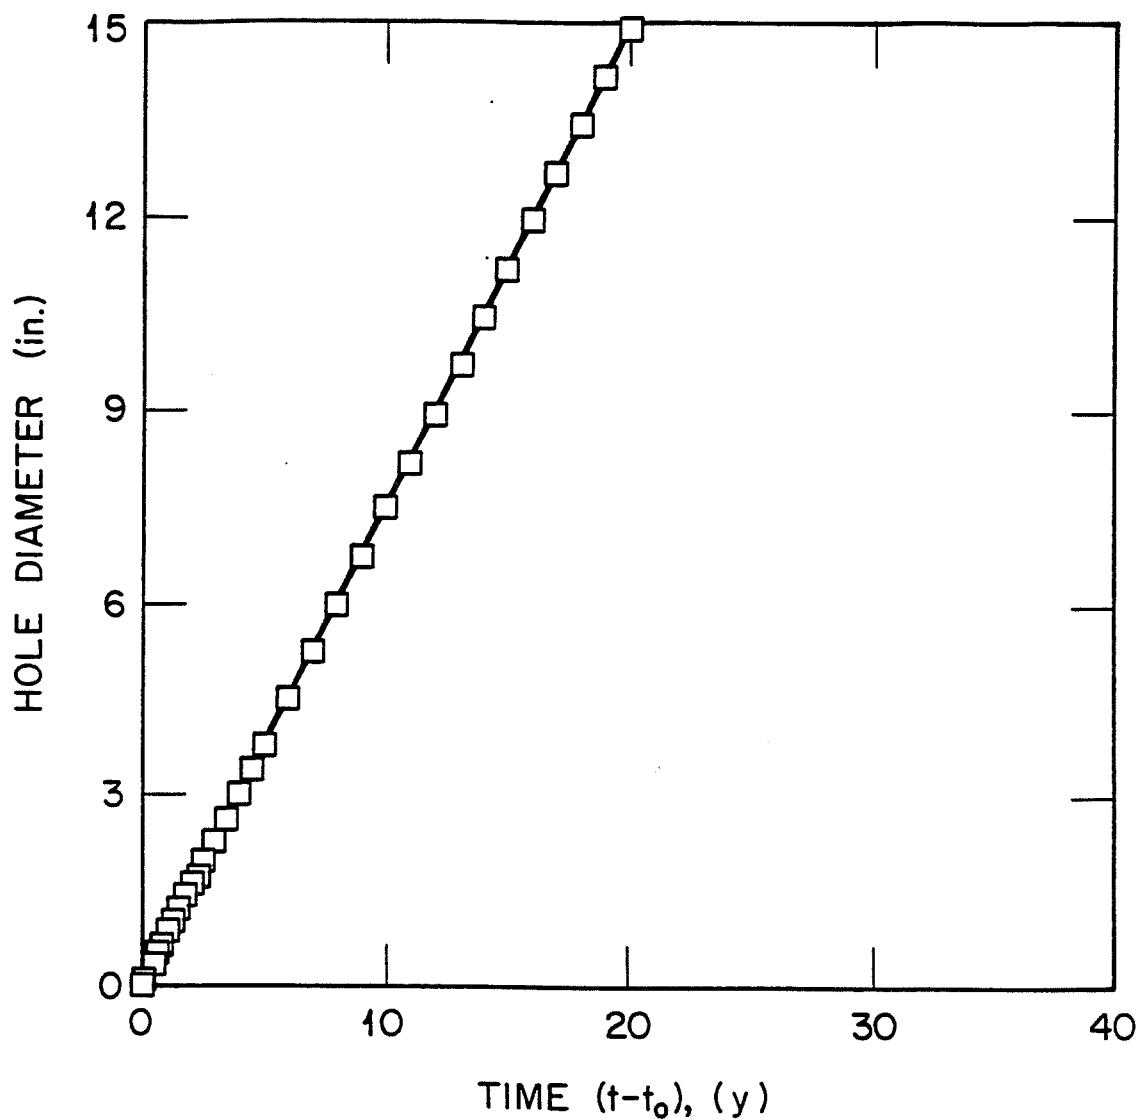
Impact breaching upon stacking may be viewed from the chemical viewpoint as a short circuiting event which eliminates the need for penetration of the wall by external corrosion, and the failure mechanism is that described for the two cylinders at PORTS.<sup>1</sup> By use of the estimates of exposure time after filling with depleted  $UF_6$  made in the main text for the two cylinders with the holes in the bottom (101244 and 7953) and the time since stacking of the other two Cylinders (114951 and 116797), a comparison can be made with the hole size

Fig. C-3. Hole size as a function of time for impact breaches.

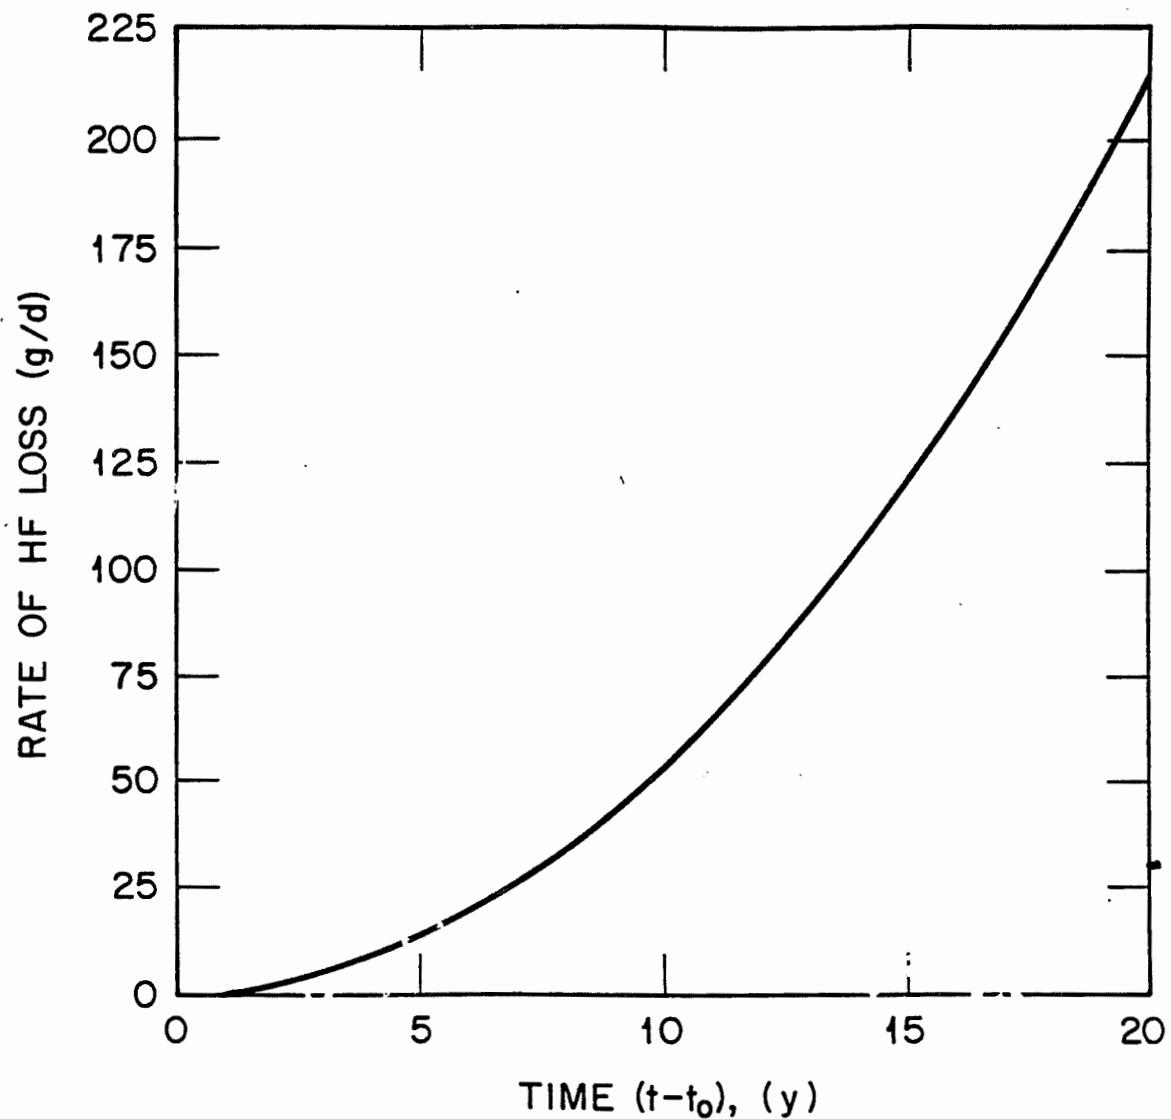
Fig. C-4. Rate of HF loss vs. time for impact breaches.

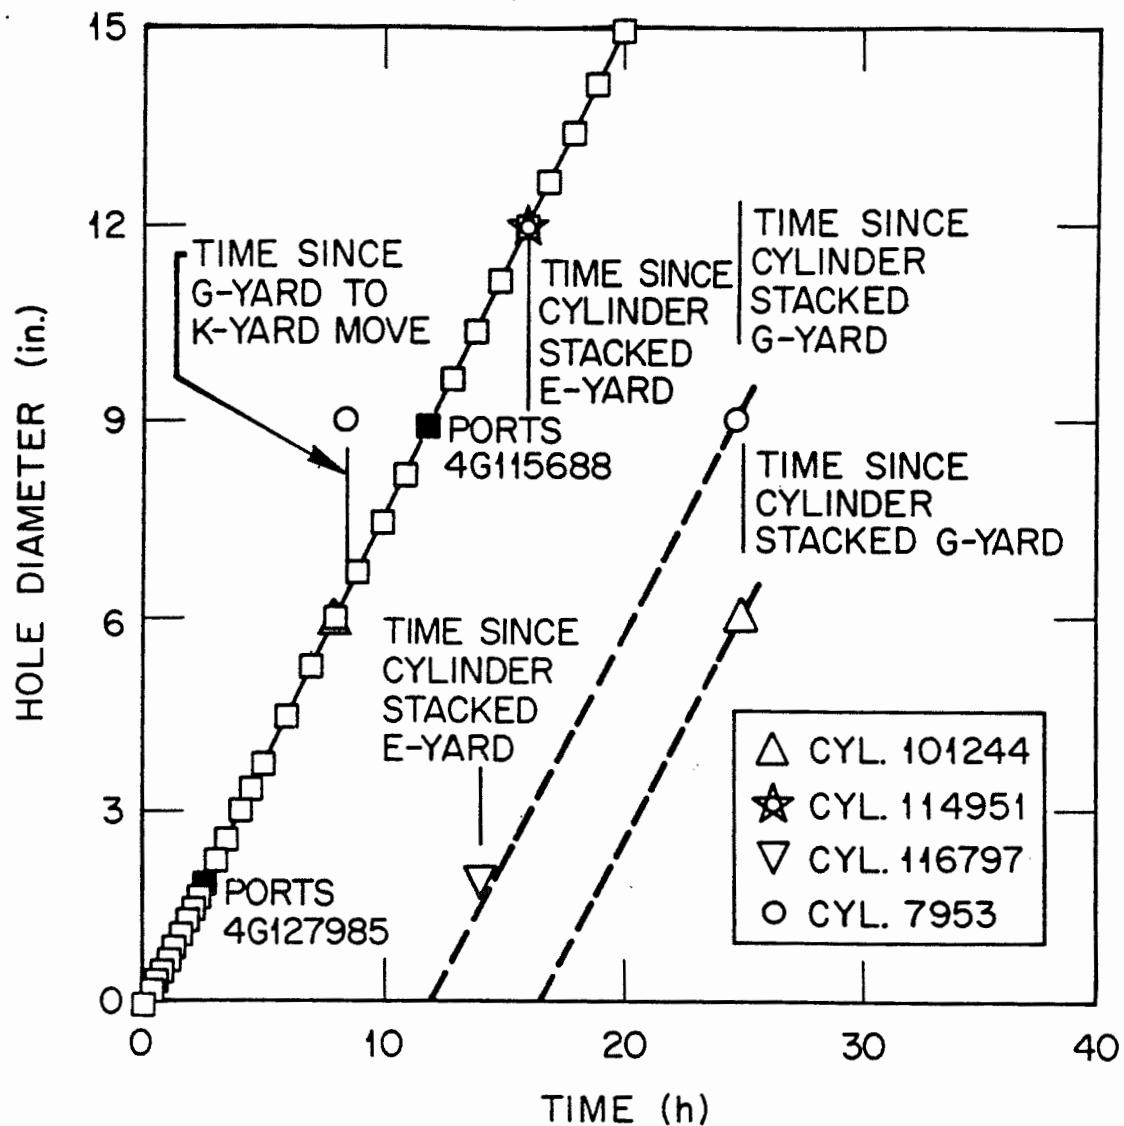
development experience for the two PORTS cylinders. In Fig. C-5, this correlation of the hole size with cylinder storage time, less 1 year to allow the time needed to begin to enlarge impact breaches, is shown for all the breached cylinders including the two at PORTS. The hole sizes of Cylinders 101244 and 7953 are also plotted versus the approximate time since these cylinders were moved from K-1066-G yard to K-1066-K yard. The curve for prediction of hole size as a function of enlargement time after impact breaching, which was developed from the PORTS data, is included for reference. The breach in Cylinder 114951, as noted previously, conforms to the expectations for a through-the-wall impact fracture. The breach in Cylinder 101244 also conforms if the breach resulted from a through-the-wall impact fracture at the time of restacking in K-yard, but other observations indicate that this is not the most probable failure mechanism. The breach in the wall of Cylinder 116797 is smaller than would be predicted for an impact breach at the time of stacking. It is concluded that the fracture either did not initially extend through the wall and additional time was required for crevice corrosion to complete the wall penetration, or that the presence of the lifting lug in the fracture somehow slowed the process. The breach in Cylinder 7953 does not fit the model developed for impact breaching at the time of stacking.

If the assumption is made that enlargement of all breaches after discovery goes at least as fast as with impact breaches, the dashed curves in Fig. C-5, which pass through the hole sizes for the three non-conforming K-25 cylinders with the same slope as the PORTS model,

Fig. C-5. Correlation of hole sizes of K-25 breached cylinders with sizes resulting from mechanically-induced breaches.

intercept zero hole size at about 12, 12, and 16 years for Cylinders 116797, 101244, and 7953, respectively. If these times are interpreted as the minimum time required for penetration of the wall, the respective maximum attack rates of the steel by a differential oxidation corrosion process (see Appendix B) are of the order of >26, 26, and 20 mils/year. The "greater-than" designation is used for Cylinder 116797 because the wall is partially penetrated by the impact fracture.
