Catastrophic Failure of Contaminated Fused Silica Optics at 355 nm

**This paper was prepared for submittal to
2nd Annual International Conference on Solid-State
Lasers for Applications to Inertial Confinement Fusion
Paris, France
October 22-25, 1996**

December 3, 1996

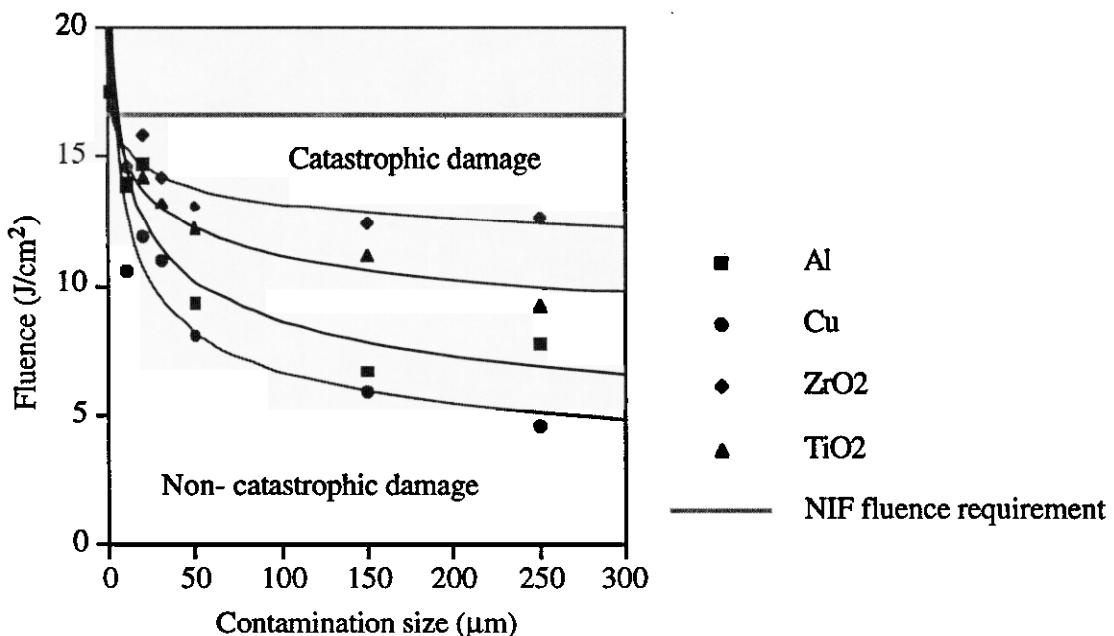
The relationship between fluence and input surface contamination size that induce catastrophic damage is plotted on a damage map in Fig. 7. The results show that for a given size, the contamination material has a strong influence on the fluence level that can induce catastrophic failure. This map represent a useful tool to determine the size at which contamination must be controlled on the laser and which types of materials to avoid. In this case, input surface contamination was found to have the potential for inducing catastrophic failure of the glass at fluences as low as 5 J/cm² for the 250 μ m copper particles. The maps

can explain the reason why lasers such as Nova designed to operate under 4 J/cm^2 did not suffer major damage incidents even in the absence of tight cleanliness requirements. However, they show that contamination problems will have to be addressed very seriously on the NIF and LMJ lasers for which the 355 nm peak design fluence is 14 J/cm^2 .

Fig. 7: Damage stability map at 355 nm showing the dependence of the onset of catastrophic damage on the fluence level and particle size for 1 μm thick sputtered particles of aluminum, copper, titania and zirconia located on the *input surface* of the silica window.

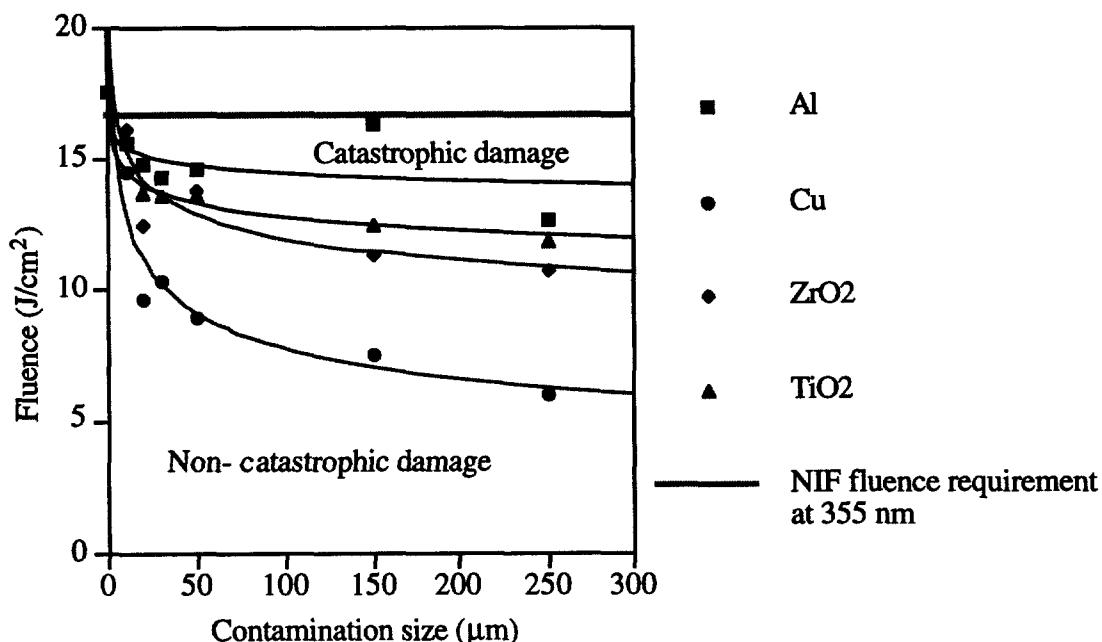
A damage map (analogous to Fig. 7) was also plotted for output surface contaminants. The results are summarized in Fig. 9. The map shows that the effects of output surface contamination is not as severe as those of the input surface. Output surface contamination was found to have the potential for inducing catastrophic failure of the glass at fluences as low as 6 J/cm^2 for the $250 \mu\text{m}$ Cu particles. The tests also showed that failure occurs at different fluence levels for different materials. In particular, copper contaminants had a more negative effect than other types of contaminants. The reasons for these differences between contamination materials are currently being investigated.⁷

Fig. 9: Damage stability map at 355 nm showing the dependence of the onset of catastrophic damage on the fluence level and particle size for $1 \mu\text{m}$ thick sputtered particles of aluminum, copper, titania and zirconia located on the *output surface* of the silica window.
