SAND2019-7871C

# Nanofocus X-ray Computed Tomography and Ultrasonic Inspection of Barely Visible Impact Damage in Carbon Fiber Reinforced Polymers

Elliott Jost—July 17, 2019—QNDE 2019

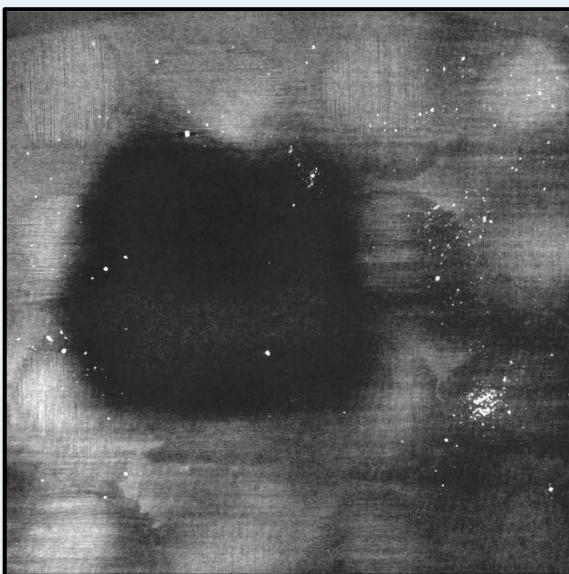
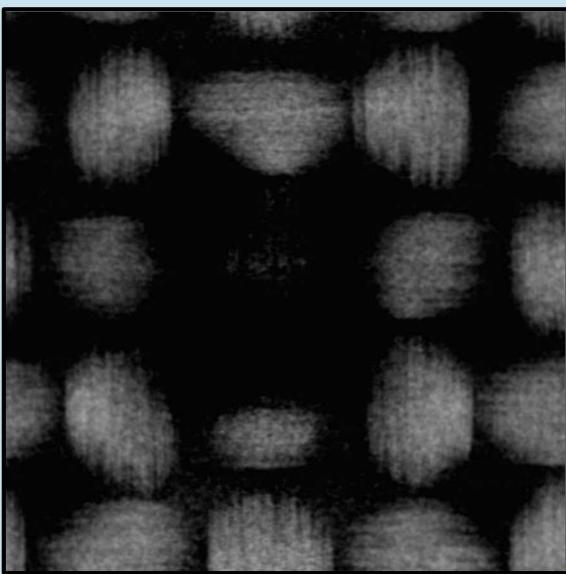
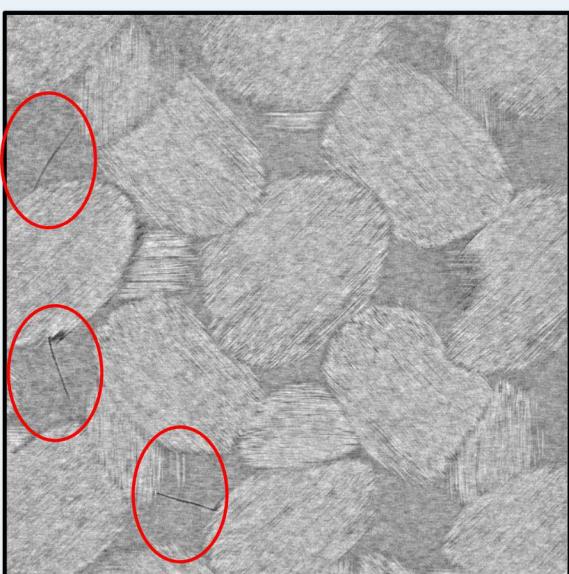
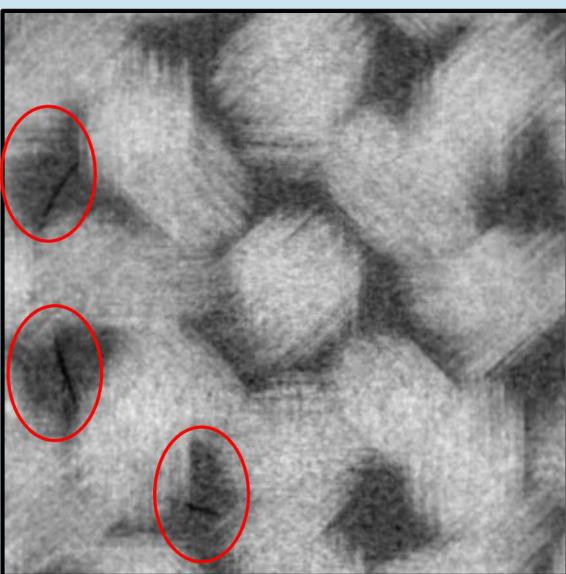
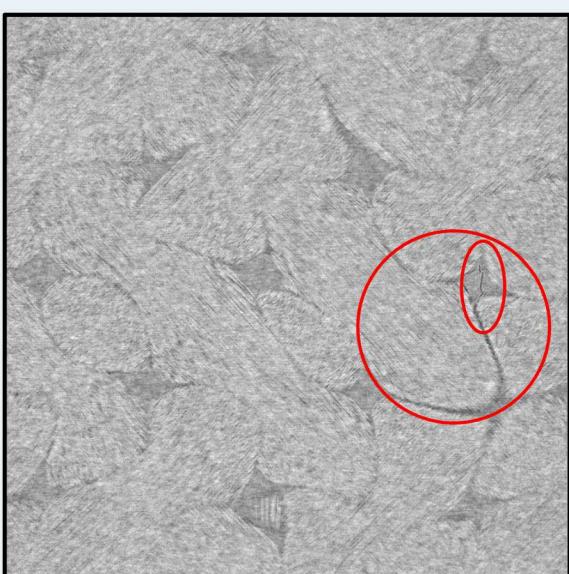
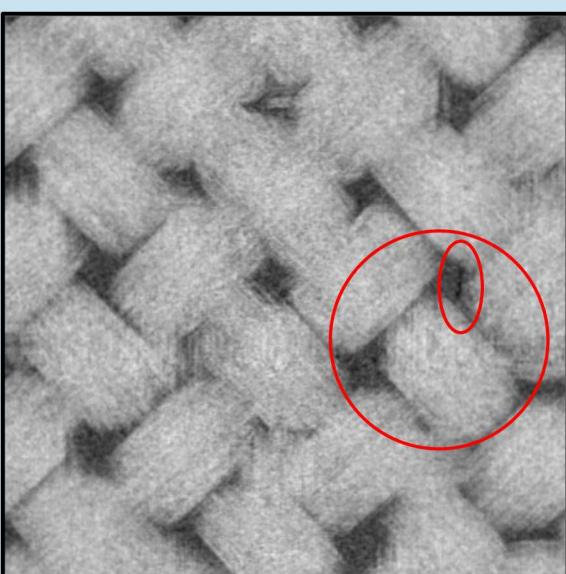
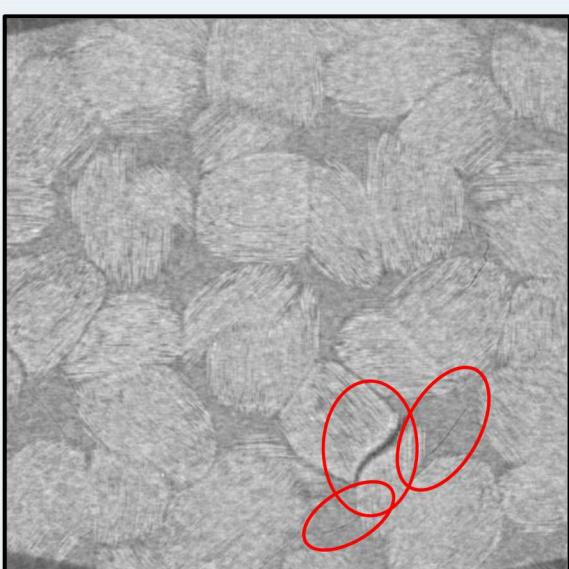
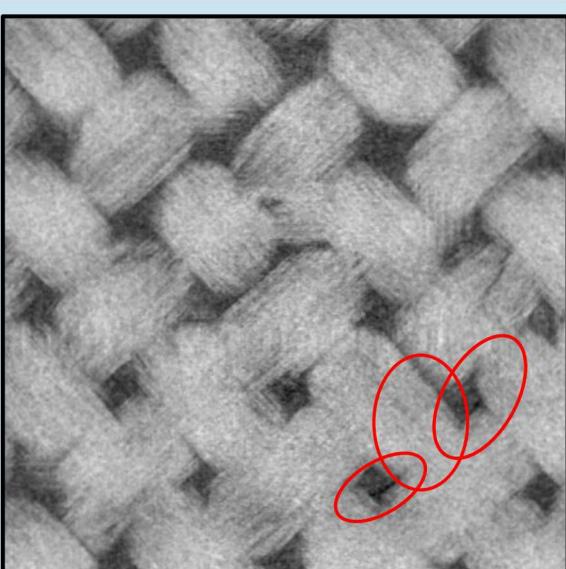
## 7.5J Impact: Nano/Microfocus Comparison

Damage Mode	7.5 J Impact	9.5 J Impact
Shear Cracking	Yes	Yes
Bending Cracking	Yes	Yes
Delamination	Yes	Yes
Fiber Breakage	No	Yes
Penetration	No	No

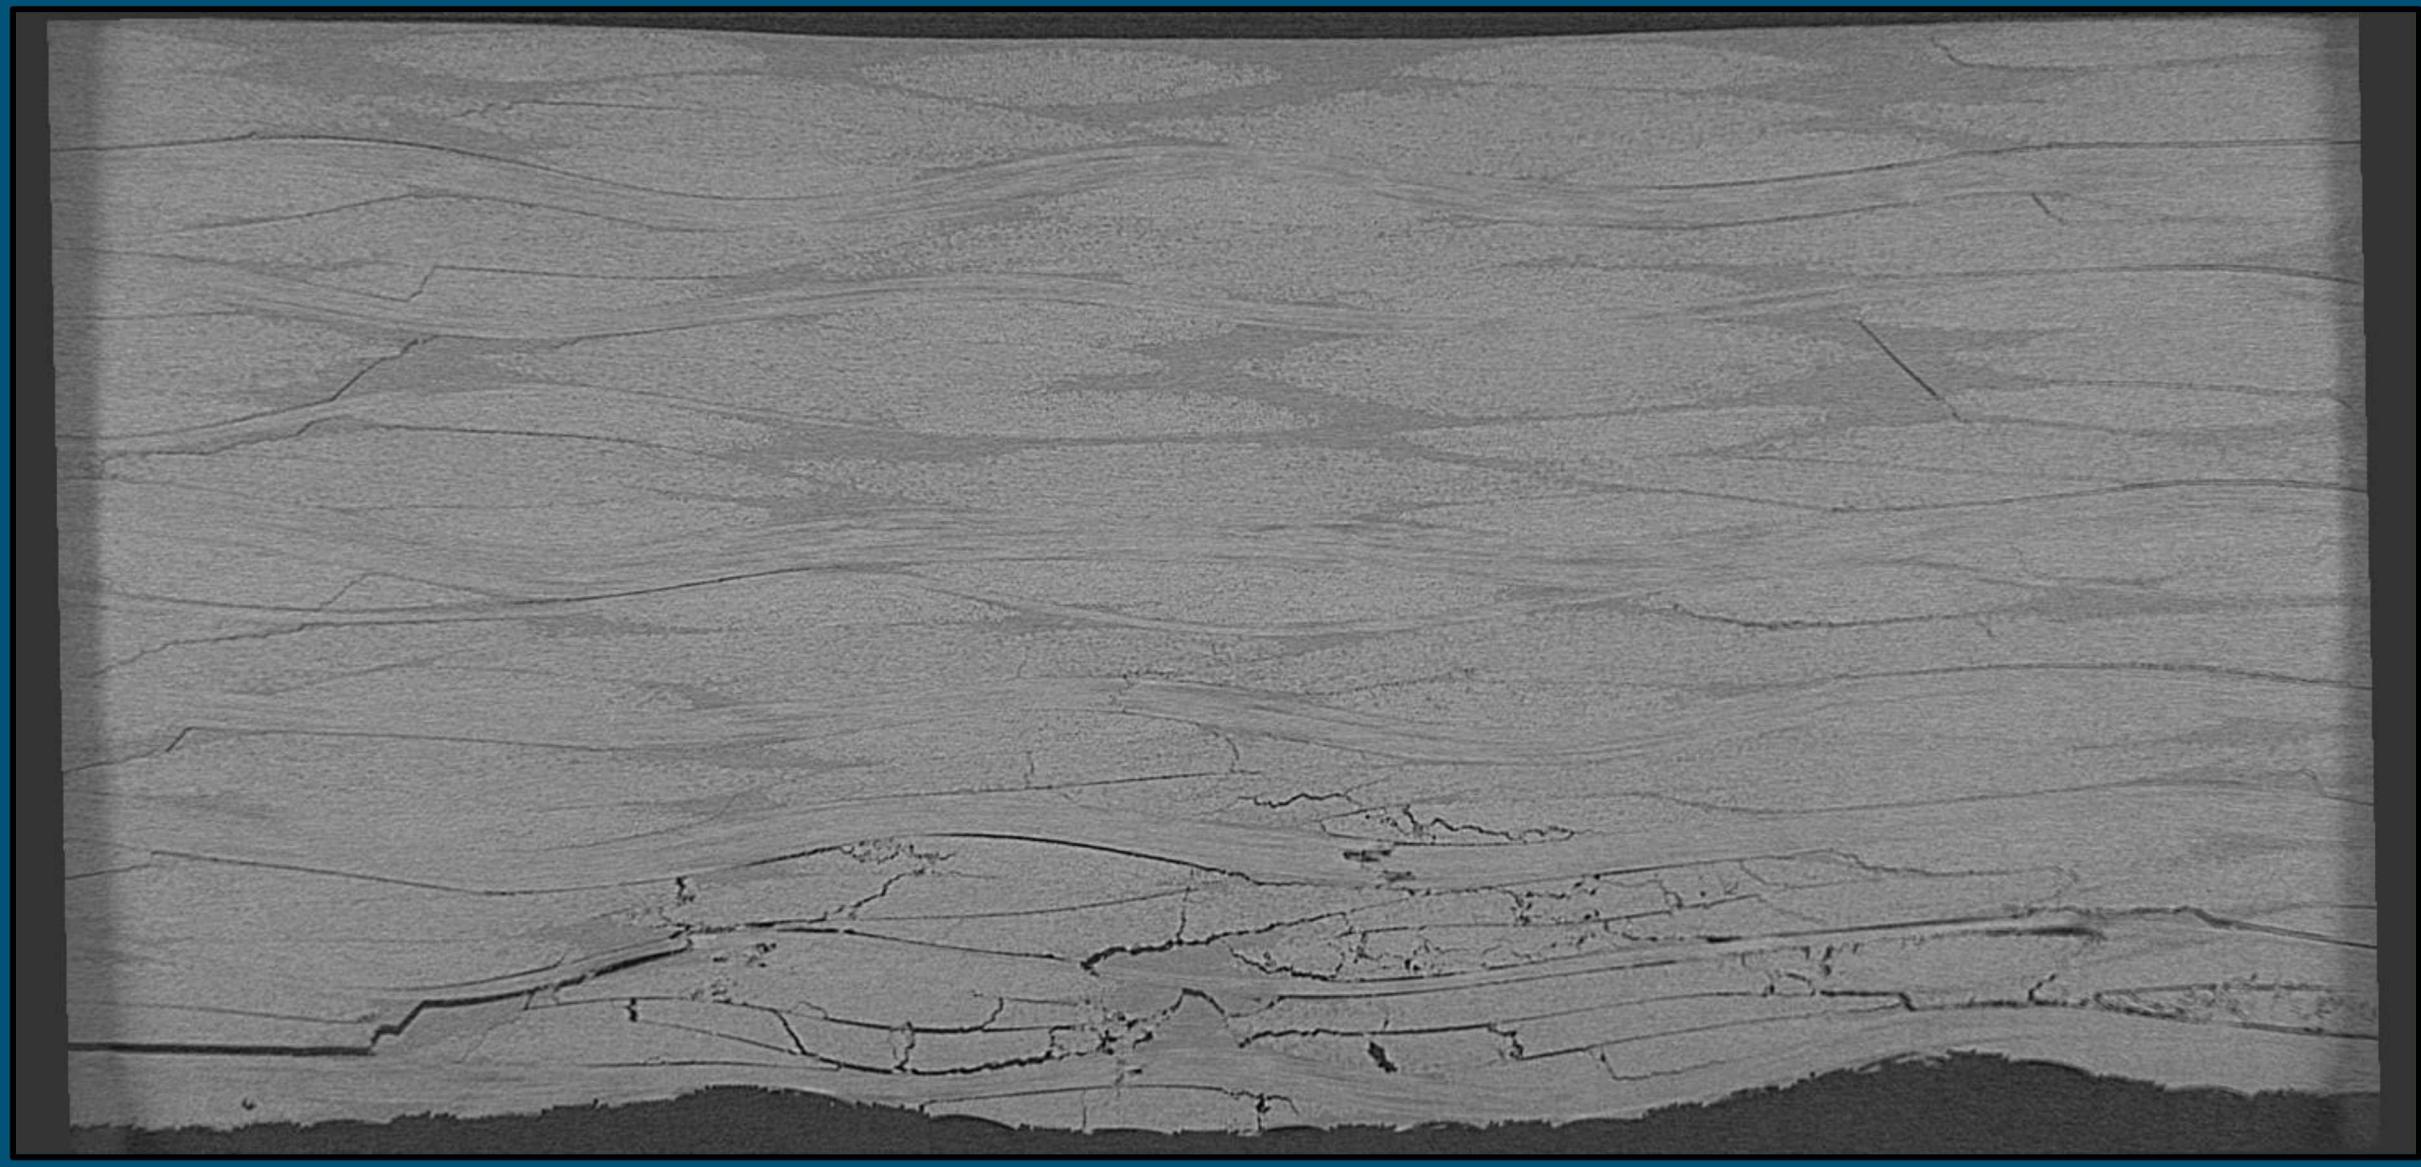
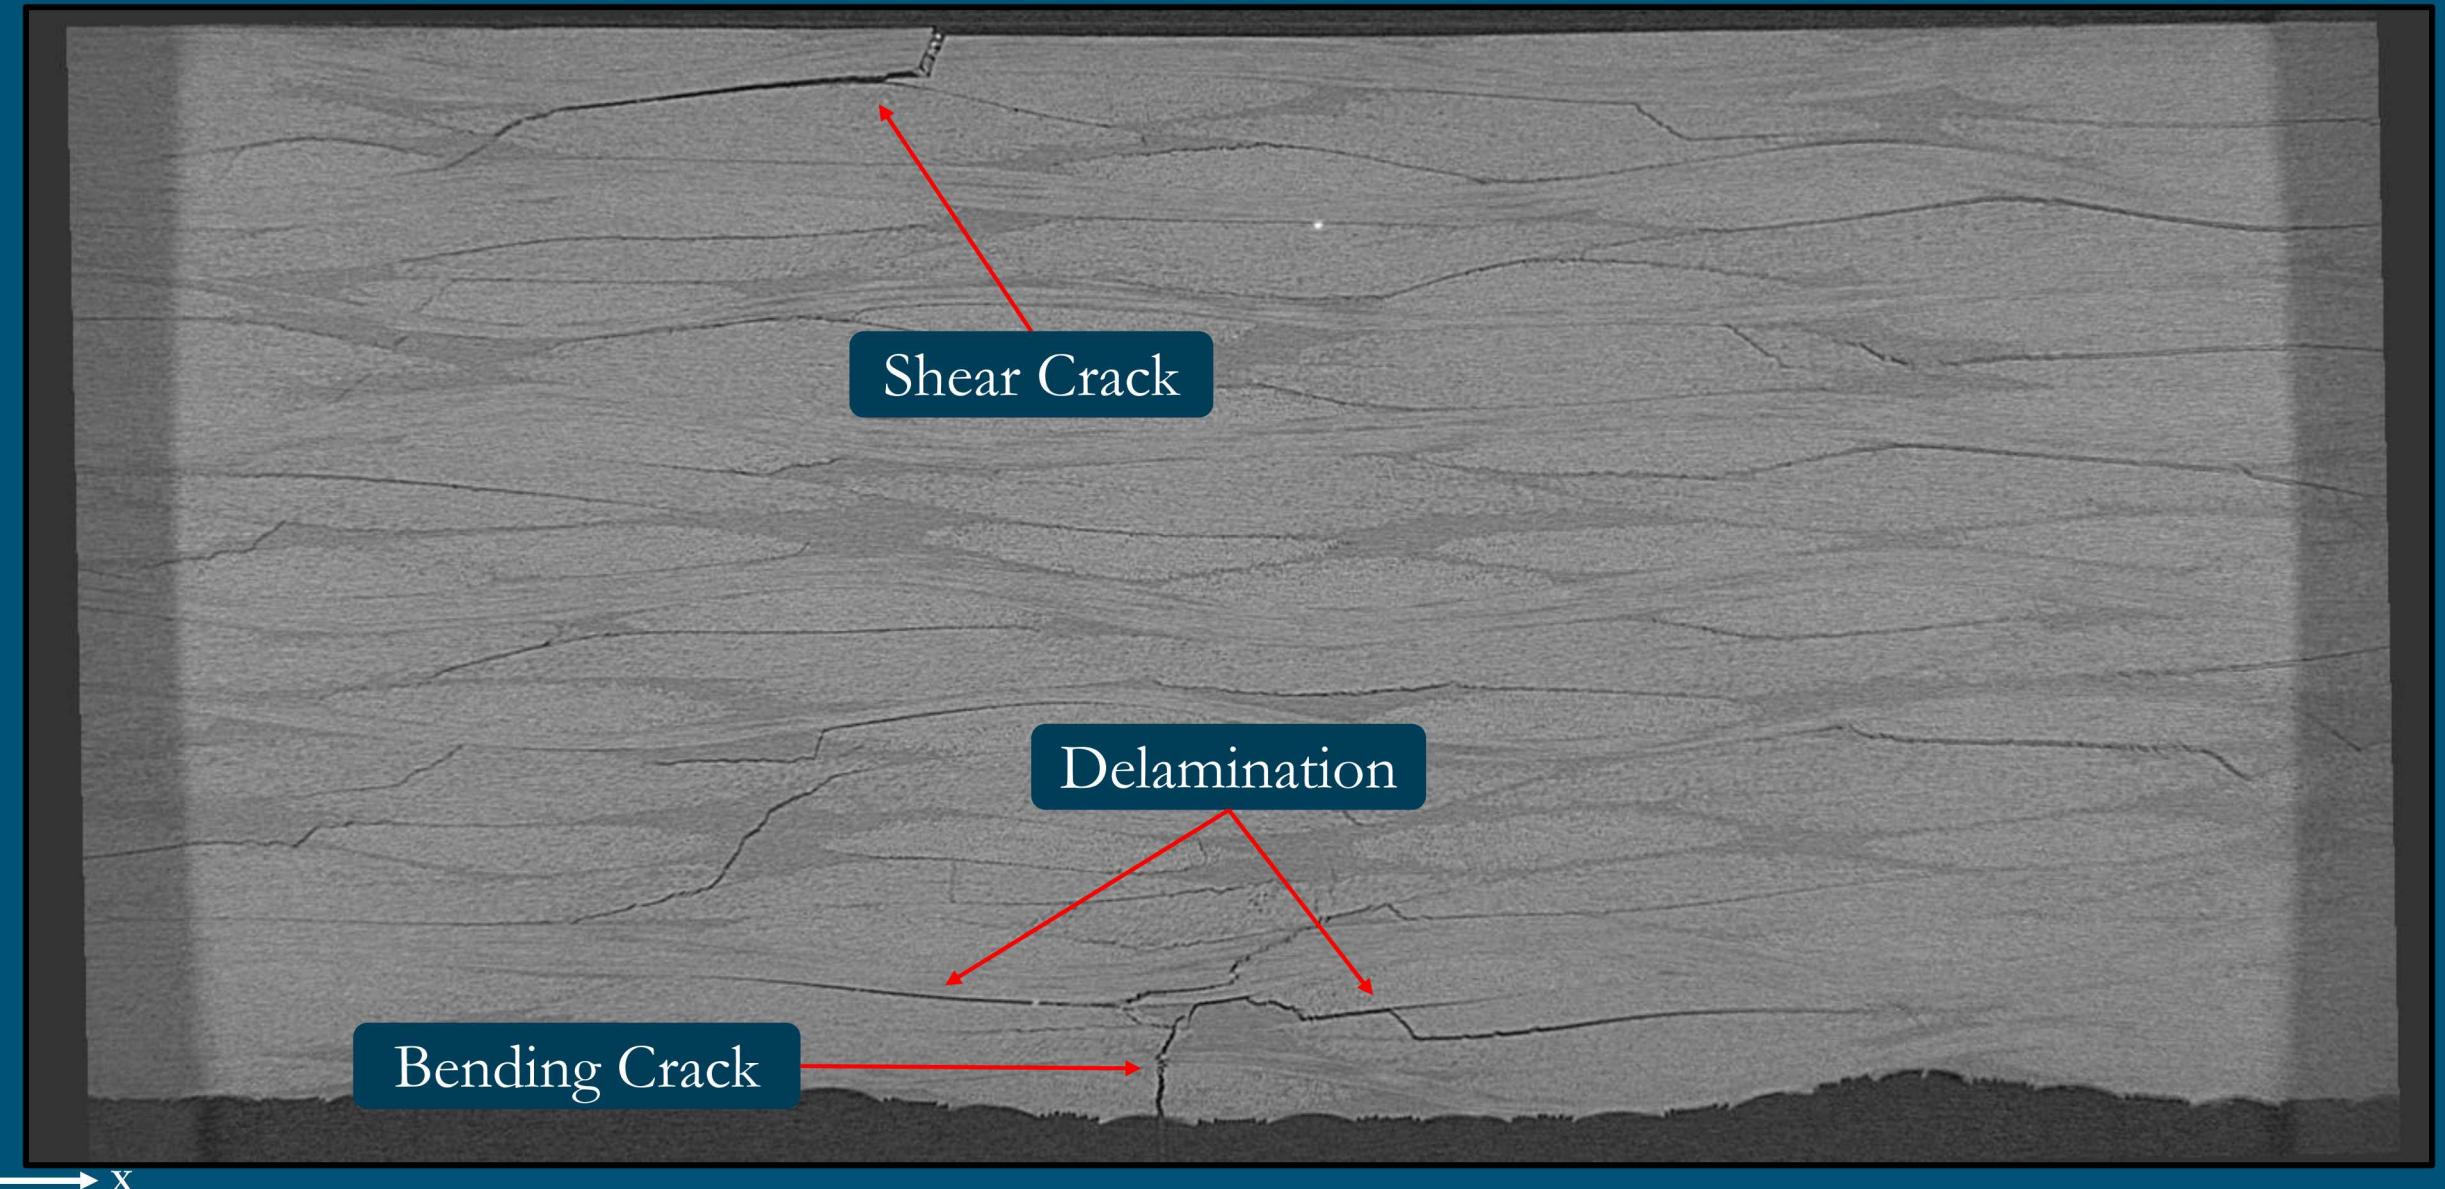
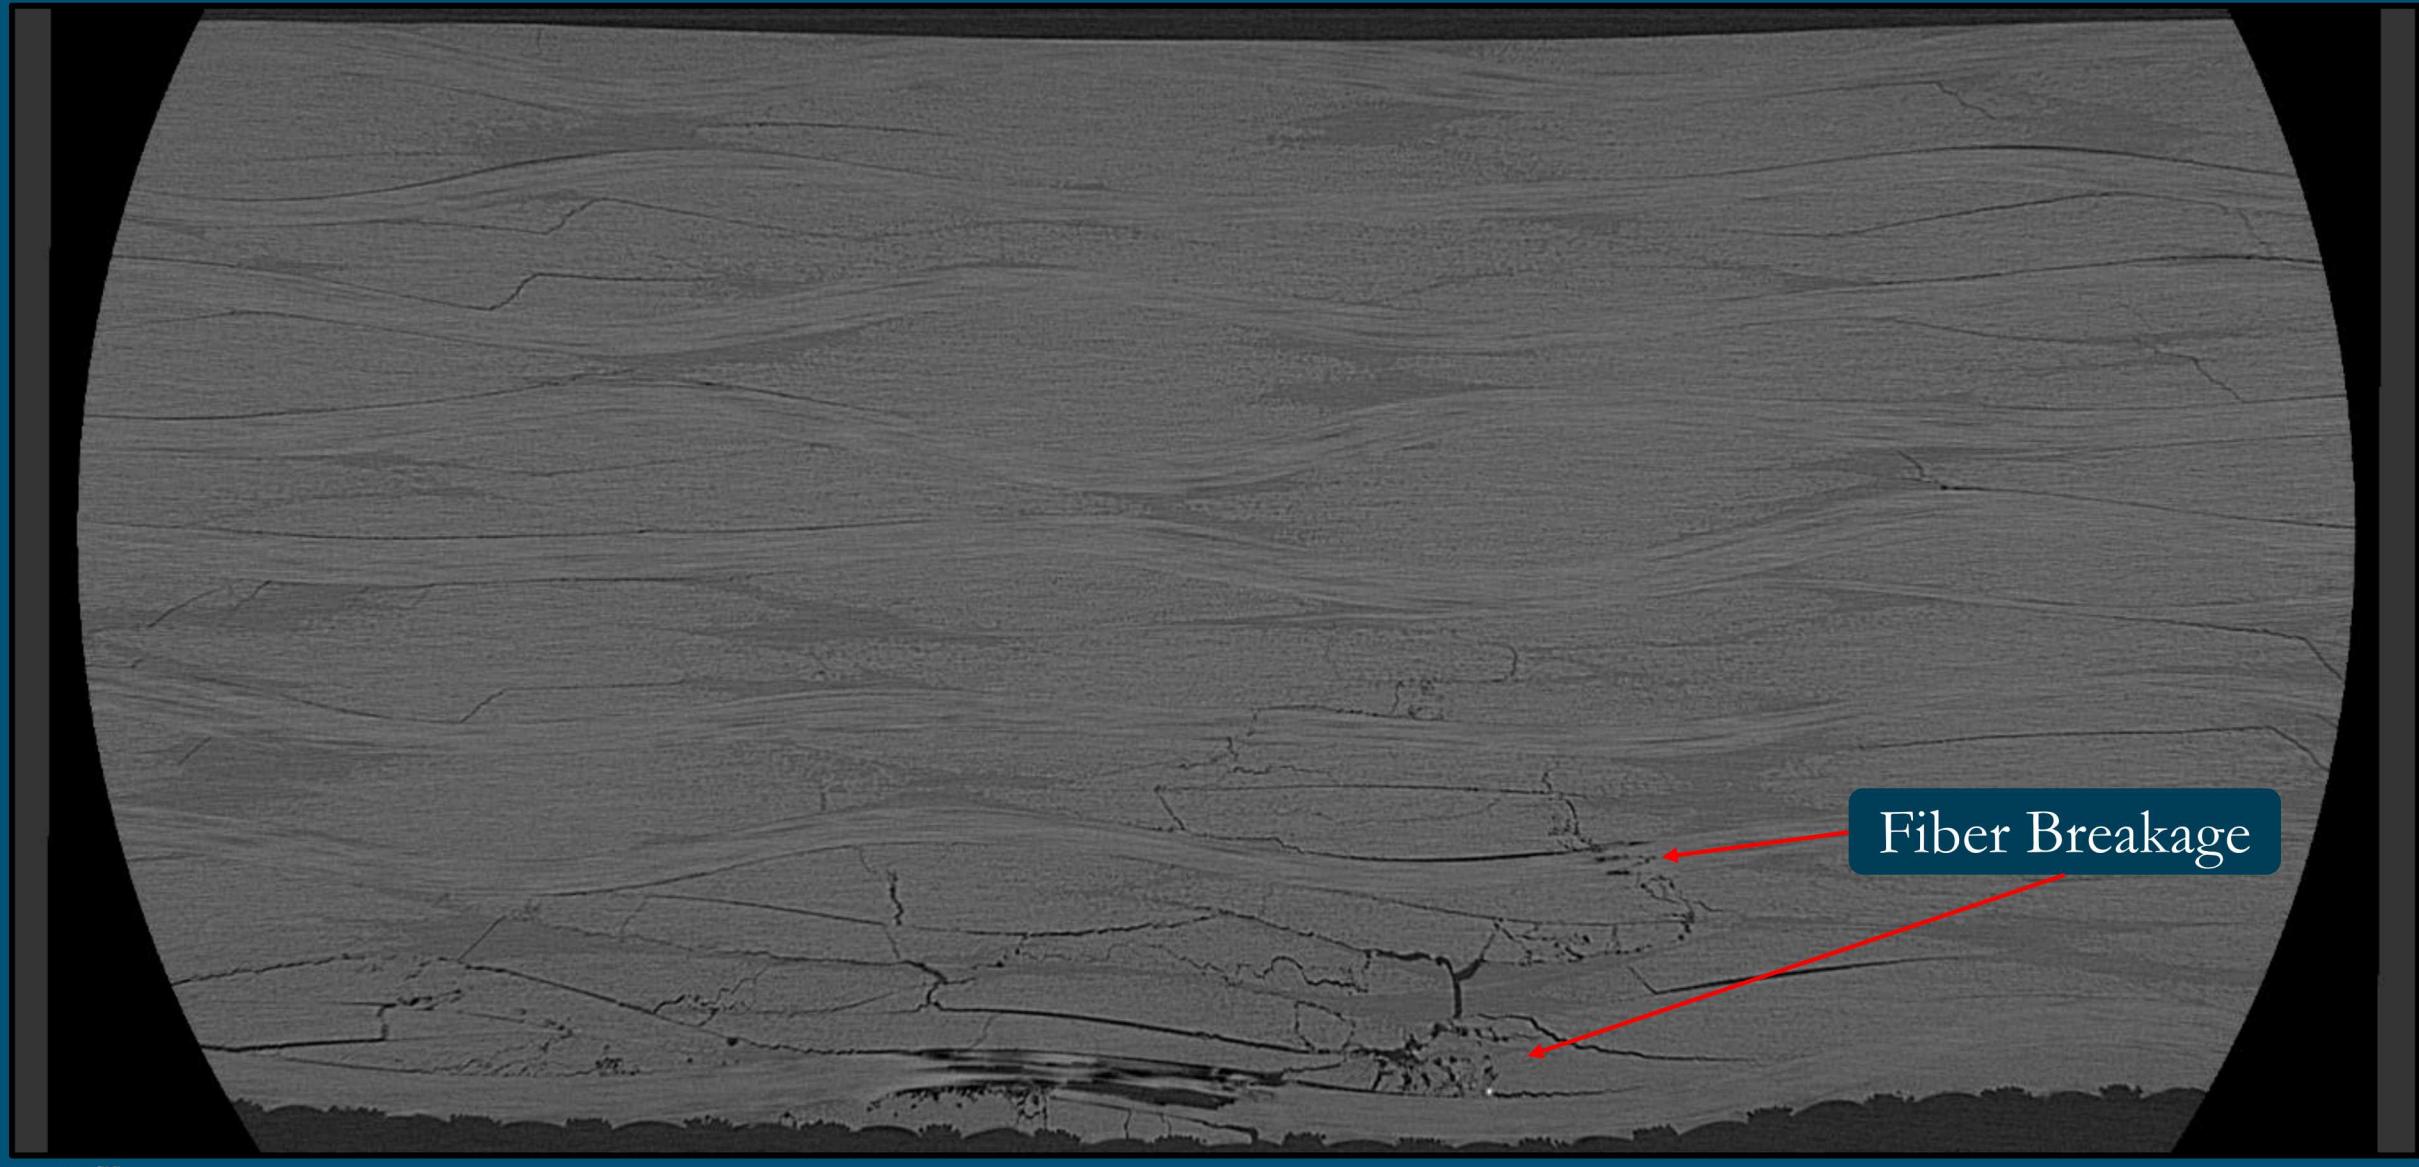
Comparison of indent depth to impact energy provides easy-to-calculate damage metric.

Clear surface cracking observed in 9.5J impact sample
