Characterization of Failure Modes in Deep UV and Deep Green LEDs Utilizing Advanced Semiconductor Localization Techniques

Mary A. Miller, Edward I. Cole Jr.,
and Paiboon Tangyunyong

Outline

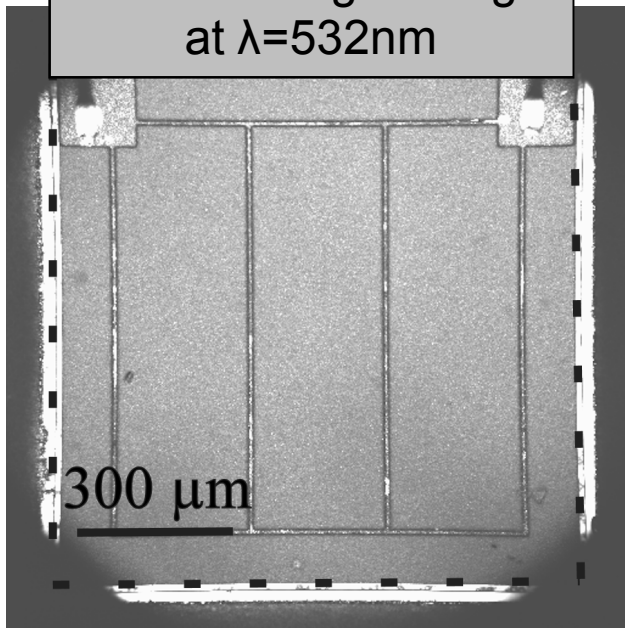
Applied Voltage Map (LIVA
Image) at $\lambda=532\text{nm}$, $4\mu\text{A}$

- ~5-20 bright defect spots observed per device
- Intensity was defect and bias dependent
- No bright defect signal from 1340 or 1064nm lasers → *LIVA signal only, indicates an electron-hole (e-h) pair recombination site*
- Only one matching spot in the LE image

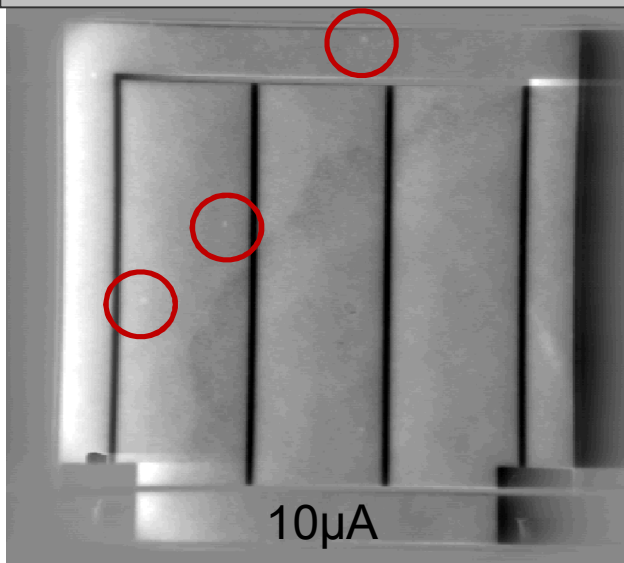
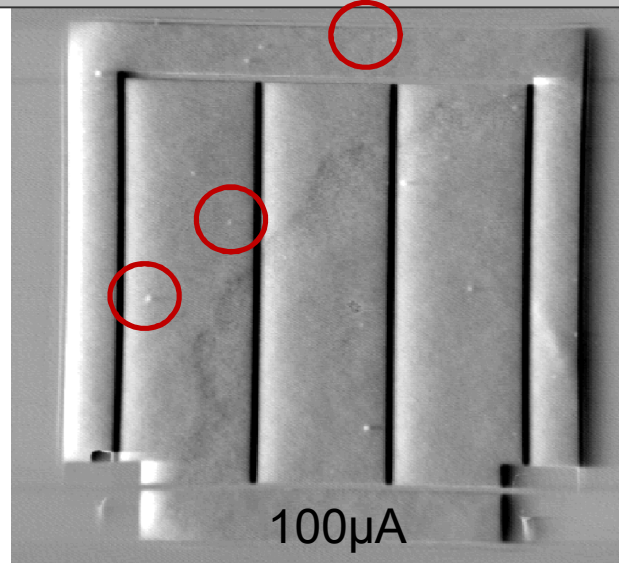
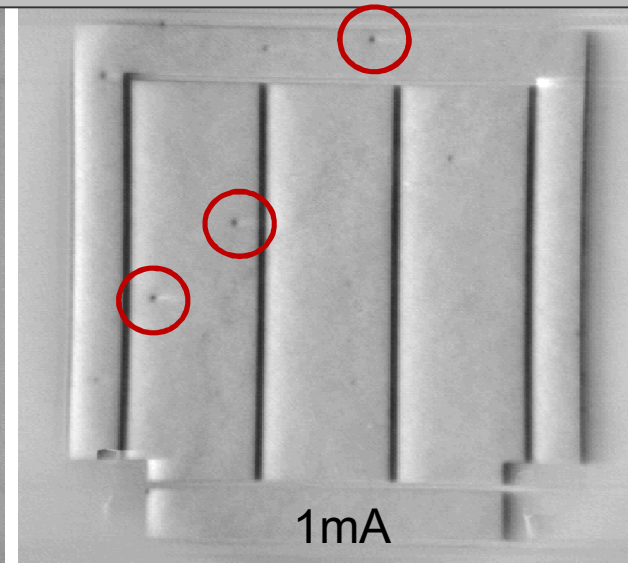
Applied Voltage Maps (LIVA Image) at $\lambda=532\text{nm}$

- The bright defect spots are bias dependent—the most show up near $100\mu\text{A}$
- Some of the defects switch polarity at higher currents

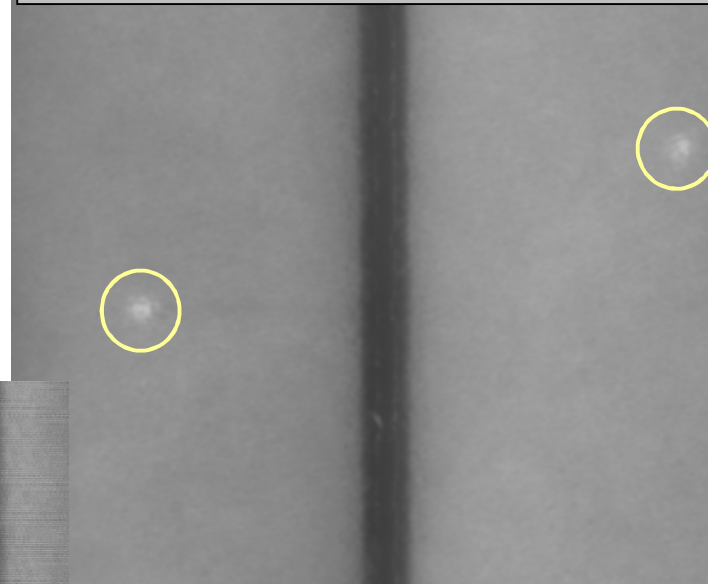
LIVA Image at $\lambda=532\text{nm}$,
4 μA Applied Current

- Defects were not matched to physical features
 - *masked by surface roughness*
 - *within the thickness of the chip*
 - *too small to be optically resolved*

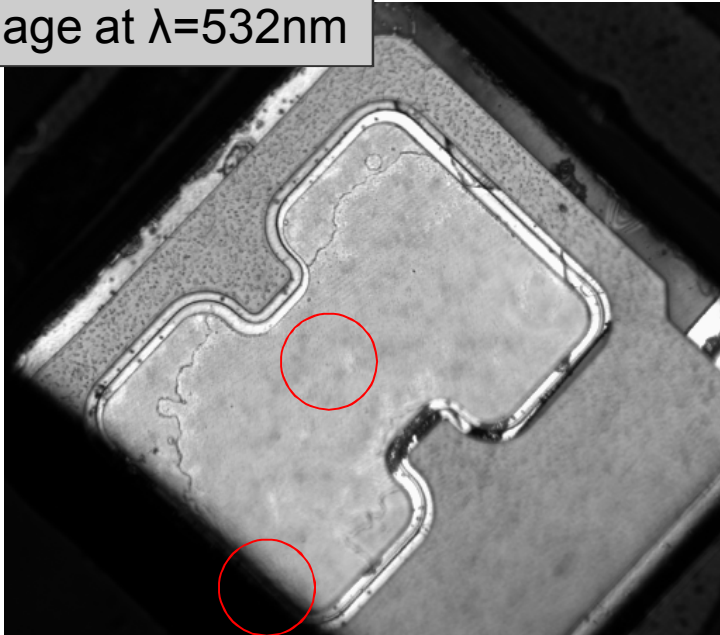
-IVA map at $\lambda=532\text{nm}$, 10μA

- Dark defect signals have a turn on voltage
- Signals always present with the 532nm laser
- Mixed response to 1064nm and 1340nm lasers → mixed TIVA/LIVA signals
- Light emission shows only some of the -IVA sites

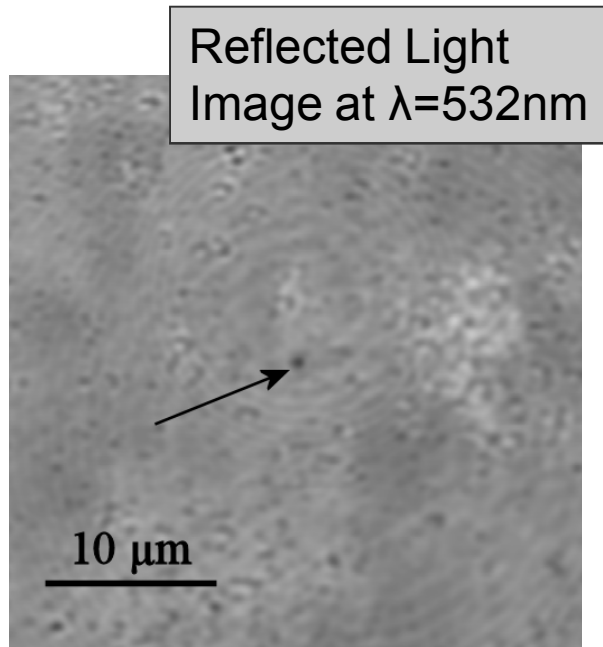
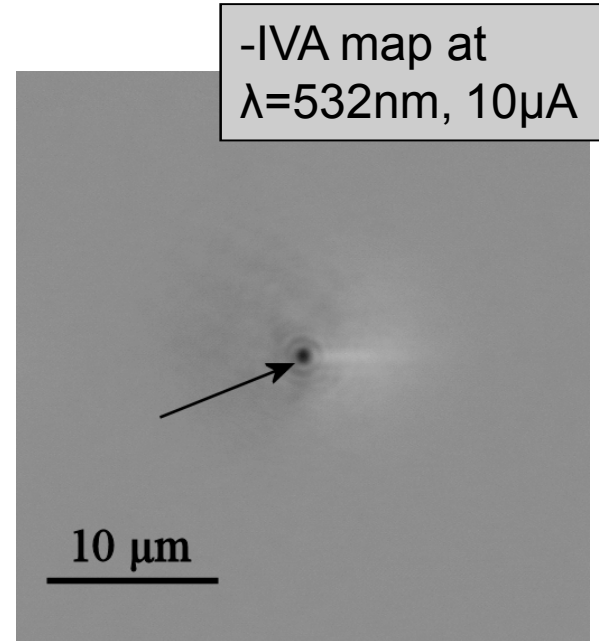
- All spots had physical defects at the origin of the signal
- All of the tested UV LEDs had 0-4 defect spots

TIVA/LIVA FA techniques identified electrically active defects among a large number of optically similar sites

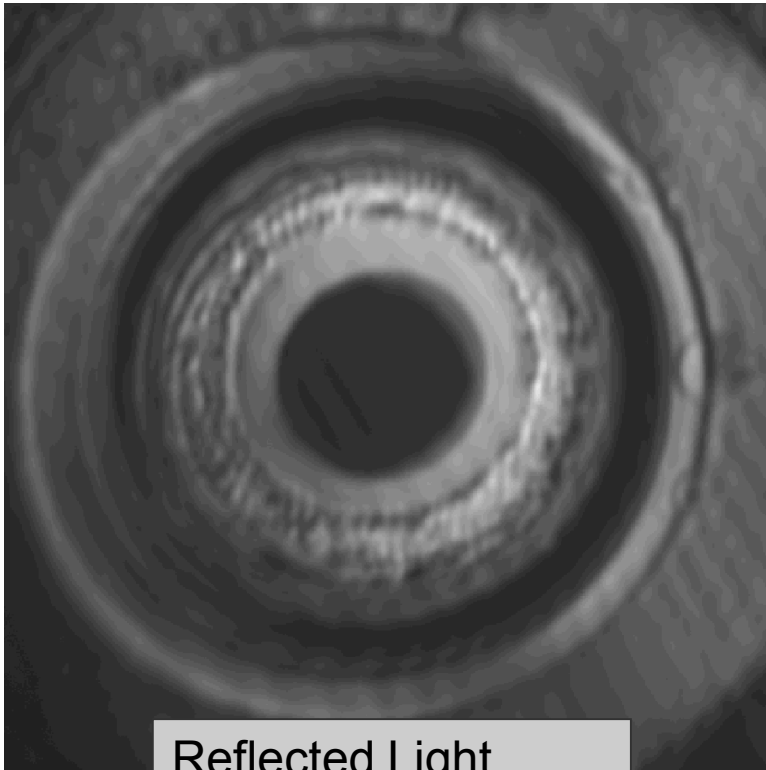
- TIVA/LIVA was successfully applied to VCSEL technology
- Dislocation networks were localized in failed parts
