Failure of a Lithium-filled Target and Some Implications for Fusion Components

Abstract: In preparation for testing a Li-He heat exchanger at Sandia, unexpected rapid failure of the mild steel lithium preheater occurred when Li at ~ 400 °C flowed into the preheater then at ~ 200 °C.

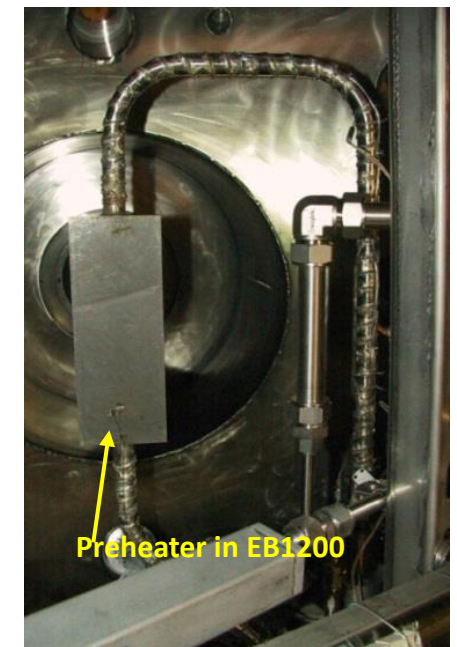
a. experimental arrangement, b-c. neutron radiographs of the body of the preheater from the back (left) and front (right); yellow line shows level of liquid lithium when analyzed; red lines indicate cracks, d. photo, inside of failed unit.
The separation into pieces resulted from sectioning for evaluation.

- Radiography showed numerous cracks.
- SEM examination showed brittle fracture patterns with strong directional features for crack propagation.

The preheater never broke apart but, lubricated by the wetting of the fracture surfaces, streams of lithium spewed from thin cracks in streams that not only reached the vessel wall but also went up the beam line of one of the e-beams. Contact there with a ceramic insulator led to a lithium fire.
