# Monitoring of Unvented Roofs with Fibrous Insulation, Diffusion Vents, and Interior Vapor Control in a Cold Climate

September 2020

*Prepared by:*  
Building Science Corporation  
70 Main Street  
Westford, MA 01886

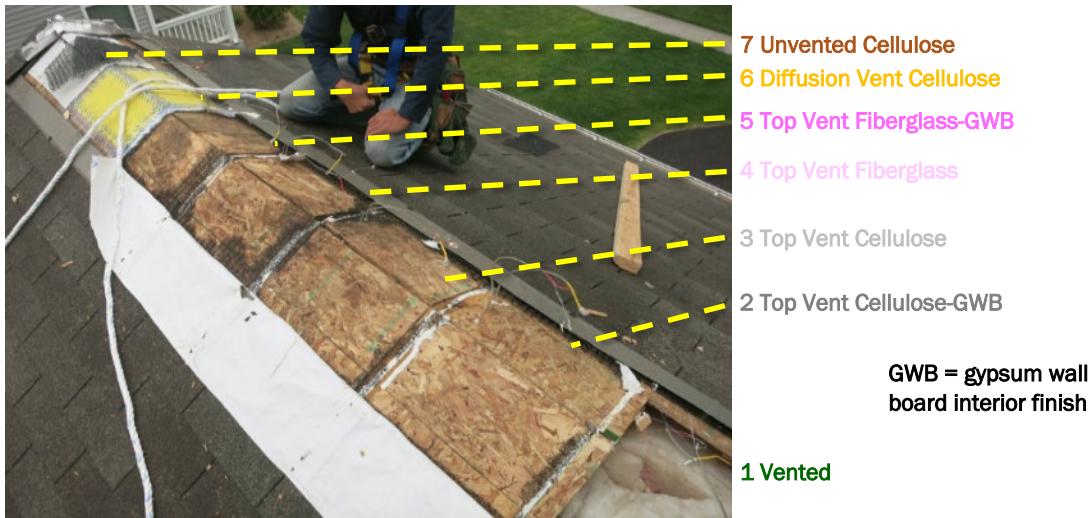
**Figure 1. Disassembly of Chicago unvented roof assemblies at conclusion of experiment**

Previous Building America-funded research monitored unvented roof assemblies in a cold climate (Chicago, climate zone 5A; Ueno and Lstiburek 2015). That work demonstrated that an unvented cellulose roof assembly has high moisture risks when subjected to high interior RHs (Figure 1). That work also demonstrated that a diffusion vent provides limited drying ability—insufficient to avoid failures. The project also showed that dense-pack cellulose had lower moisture risks than commodity fiberglass batt insulation. However, this work did not study the effect of interior vapor control beyond latex paint (Class III vapor retarder, ~10 perms). Lower interior permeance could control moisture entry into the cavity sufficiently to minimize risks.

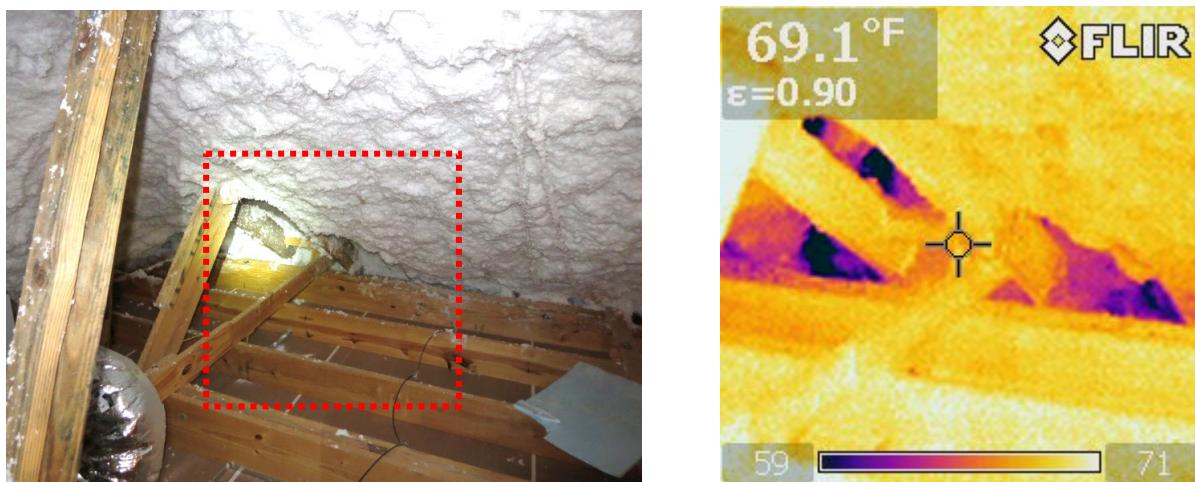
Figure 5. Air leakage at roof-to-wall details at dormer/intersecting roofs

One conclusion from the Houston and Orlando work (Ueno and Lstiburek 2016a, 2016b) is that when switching from spray foam to fibrous (air permeable) insulation, air barrier detailing—especially at roof-wall connections—is critical. Figure 5 shows an infrared image during depressurization air leakage testing with cold exterior conditions; complicated roof-wall interfaces were a common source of air leakage.

Some incremental cost will need to be absorbed by ensuring air barrier performance when implementing unvented roofs with fibrous insulation. However, the design of the proposed cold-climate assemblies includes an interior air/vapor barrier/retarder, which would nominally fulfill this role.

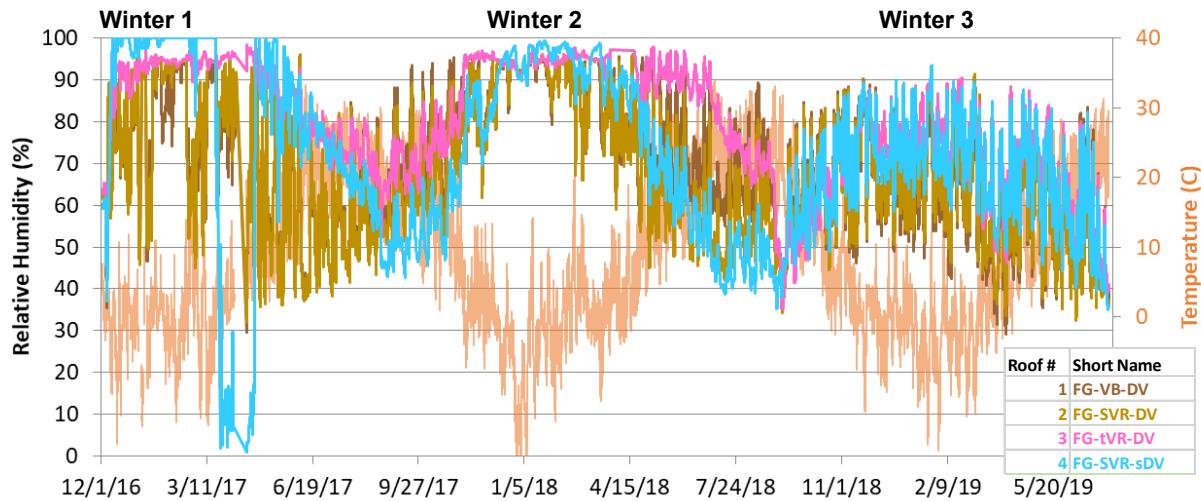
**Figure 42. Fiberglass roofs' (1–4) ridge RH conditions, 24-hour moving average**

In Winter 1, the non-diffusion-vent roofs (Roof 3 and Roof 4) reached 95%+ RH conditions early in the winter, stayed at high RH levels (95%–100%) for most of the winter, and only showed significant drying in April. In contrast, the diffusion vent roofs' (Roof 1 and Roof 2) ridge conditions oscillated between 95% and much lower RHs. This results in lower sustained RH levels than non-diffusion-vent roofs, which is consistent with localized drying at the ridge.

Winter 2 had long extended periods at high humidity at the ridge in all four roofs: levels rose to ~95% in early winter, and remained there into spring. This shows the more challenging effect of 50% interior RH on these assemblies. Note that Roof 1 and Roof 2 are unchanged from Winter 1, but show markedly worse behavior in Winter 2. Lastly, the tight diffusion vent roof (Roof 3) is an outlier, being the slowest to dry in the spring. This indicates that a ~25-perm material is insufficient for a ridge diffusion vent material, at least under these experimental conditions.

In contrast, in Winter 3, ridge RH levels were much lower than in Winter 2, despite identical interior conditions and similar outdoor temperatures. As discussed previously, a likely reason is that repacking the roof bays with insulation resulted in greater densities, elimination of voids, and therefore less convective airflow within the rafter bay. The settling and insulation retrofit are covered in Section 13: Diffusion Vent Retrofit and Insulation Settling (Prior to Winter 2) and Section 15.2: Roof Reassembly.

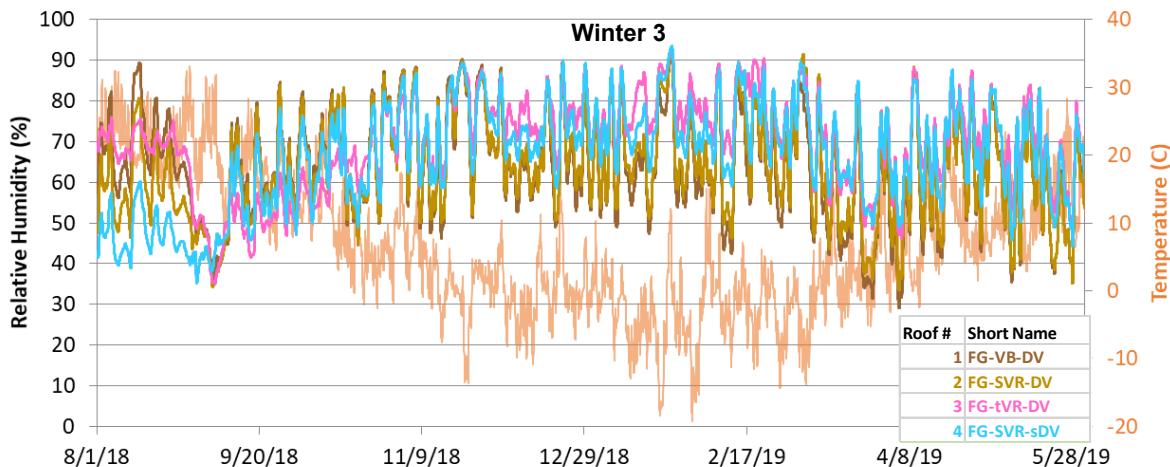
**Figure 43. Fiberglass roofs' (1–4) ridge RH conditions, 24-hour moving average, Winter 3 detail**

A detail of Winter 3 is shown in Figure 43: [Roof 3](#) (tight vapor retarder, full-size diffusion vent) and [Roof 4](#) (small diffusion vent) appear to remain wetter than Roofs 1 and 2. However, performance is relatively close between all four roofs. The addition of air leakage in late February 2019 is not discernable in the ridge data.

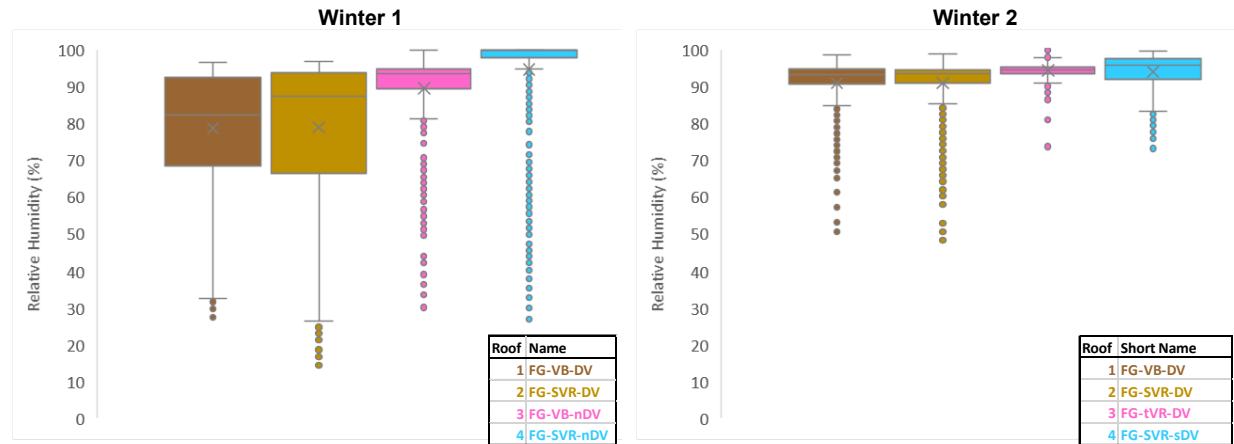
Figure 44. Fiberglass roofs' (1–4) ridge RH box-whisker plots, Winter 1 vs. Winter 2

The ridge RH plots are shown in Figure 44: in Winter 1, they demonstrate the greater drying (range of RHs) for [Roof 1](#) and [Roof 2](#) (full-size diffusion vent) compared to [Roof 3](#) and [Roof 4](#) (no diffusion vent). Note that [Roof 4](#) (no diffusion vent) had sensor anomalies resulting in the range of outlier data points in Winter 1 (see Figure 42). In Winter 2, however, interior humidification pushes all roofs into the 90%–95% RH range. [Roof 3](#) had an RH sensor failure, but it occurred after the December–February window (late March 2018).

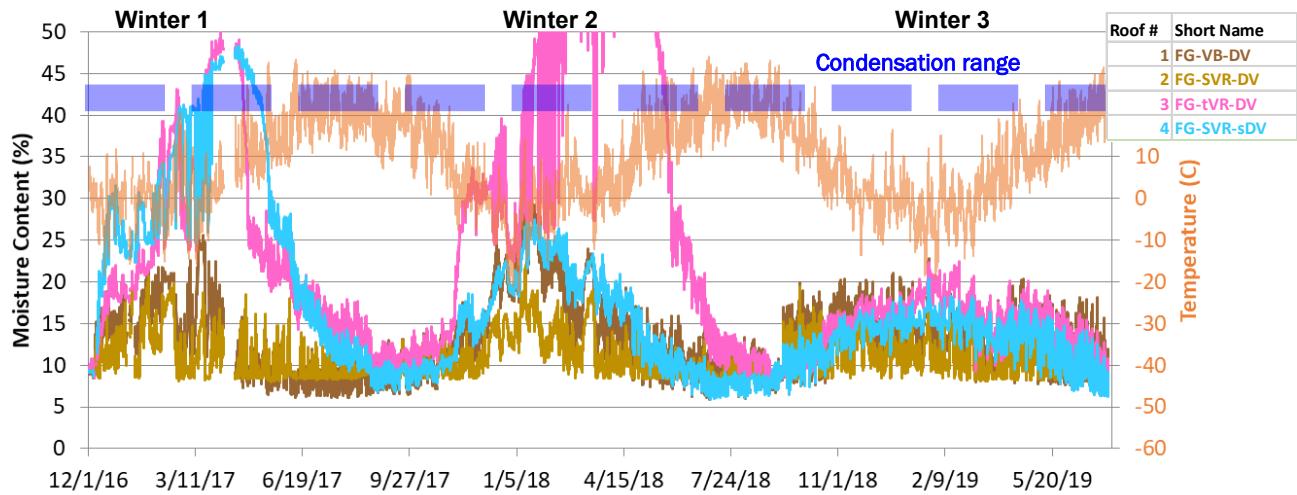
Figure 45. Fiberglass roofs' (1–4) ridge wafer MC measurements

In Winter 1, **Roof 3** and **Roof 4** (no diffusion vent) have MC peaks of 45%–50%, while **Roof 1** and **Roof 2** (diffusion vent) have peaks under 25%. These measurements can be compared with previous calibration of the wafer sensor (Ueno and Straube 2008). In that work, the wafer sensors came to equilibrium with 100% RH conditions (air in closed container over water) at 28%–30% MC. However, immersing the sensors in liquid water increased their MC to the 40%–

45% range (“Condensation range” is the dotted blue/purple line in Figure 45). Therefore, 40%–45% wafer MCs indicate possible liquid water condensation.

The wafer measurements therefore indicate that **Roof 3** and **Roof 4** (no diffusion vent) ridges are at 100% RH conditions for much of the winter, and with possible condensation in February–May 2017. In comparison, **Roof 1** and **Roof 2** (diffusion vent) are below 100% RH, with no condensation.

In Winter 2 ridge RH measurements, **Roof 3** (tight diffusion vent) shows much greater accumulation than **Roof 1**, **Roof 2**, and **Roof 4** (diffusion vent/small diffusion vent). **Roof 3** has peaks over 50% MC, indicating liquid water condensation. This indicates that the ~25-perm diffusion vent material provides insufficient drying. In contrast, the other roofs did not show indications of condensation in this measurement (peak wafer values of 20%–30% MC), but did indicate extended high humidities (95%–100% RH-equivalent).

**Roof 3** (tight diffusion vent) remained at high moisture levels through much of the spring, taking the longest to dry, reflecting its greater wintertime accumulation and poor drying. In comparison, the other roofs had lower peak MCs and dried more rapidly.

All wafer sensors were replaced between Winters 2 and 3. In Winter 3, wafer data showed much lower moisture levels, with rare excursions over 20%—essentially, safe behavior. The contrast between Winters 2 and 3 is notable given identical interior conditions (50% RH) and three unchanged roof assemblies (**Roof 1**, **Roof 2**, and **Roof 4**; diffusion vent/small diffusion vent). This is an indication of the positive effect of repacking the fiberglass insulation at the ridge; further detail is provided in Section 15.2: Roof Reassembly.

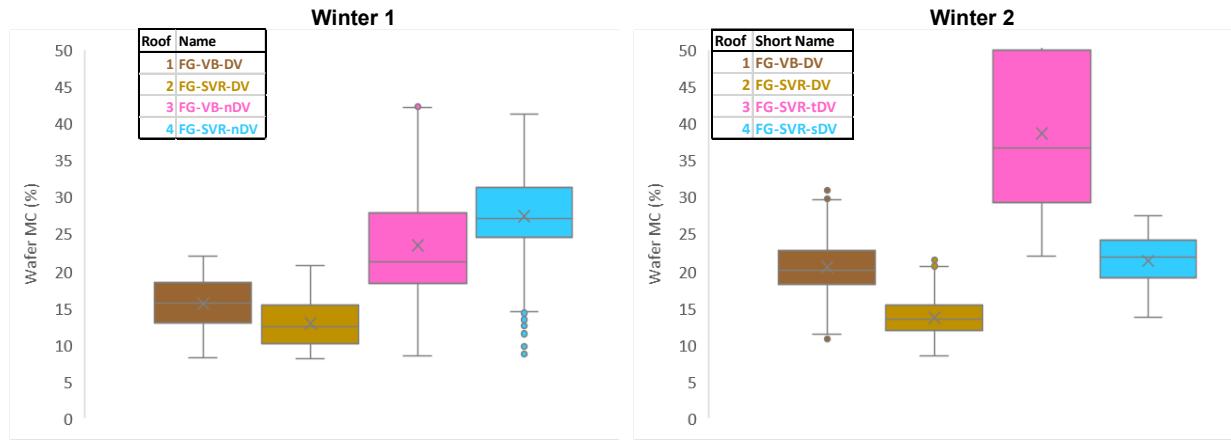
Figure 46. Fiberglass roofs' (1-4) ridge wafer MC box-whisker plots, Winter 1 vs. Winter 2

Box and whisker wafer plots contrasting Winters 1 and 2 are shown in Figure 46. They demonstrate the greater drying of **Roof 1** and **Roof 2** (full-size diffusion vent) in Winter 1, compared to **Roof 3** and **Roof 4** (no diffusion vent). In Winter 2, they show that **Roof 3** (tight diffusion vent) is the high outlier with poor performance.

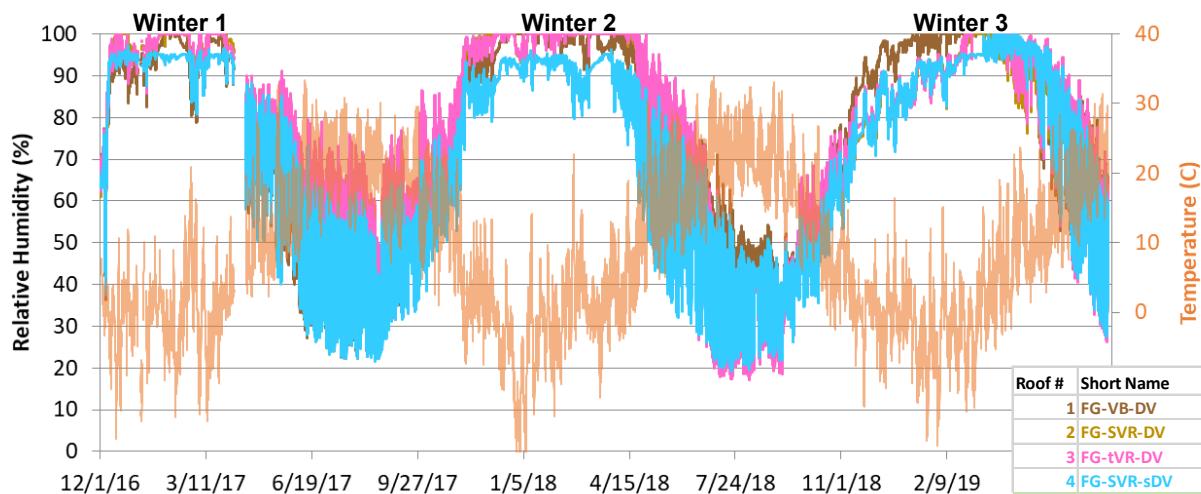
Figure 48. Fiberglass roofs' (1–4) mid-bay RH north conditions

During Winter 1, all four roofs rose uniformly to ~90%–100% RH and remained there for most of the winter. There was a brief dip to the 80%–90% RH range during unseasonably warm February 2017 temperatures. By April 2017 (after missing data), dropping RHs indicated drying of the insulation-sheathing interface. RHs also begin to show a strong diurnal swing pattern; this is due to greater diurnal temperature cycling caused by solar gain to the north-side roof (see Figure 40).

In Winter 2, all roofs also rose to 90%–100% RH for the entire winter, remained at that level into spring, and eventually fell in late April as the temperature gradient shifted inward. [Roof 4](#) (small diffusion vent) consistently shows drier conditions than the remaining roofs; this is ascribed to a sensor anomaly. [Roof 3](#) (tight diffusion vent) has the highest mid-height north RH levels, providing evidence that the ~25-perm diffusion vent inhibits drying for the remainder of the assembly, not just the ridge. In other words, it indicates that the diffusion vent provides more than localized ridge drying, and instead dries the entire rafter bay (given sufficient moisture accumulation).

In Winter 3, north-side interface RH levels took longer to rise to the 95%–100% range than in Winter 2, despite identical interior conditions. This measurement is consistent with the previous theory of higher insulation density reducing airflow and moisture movement.

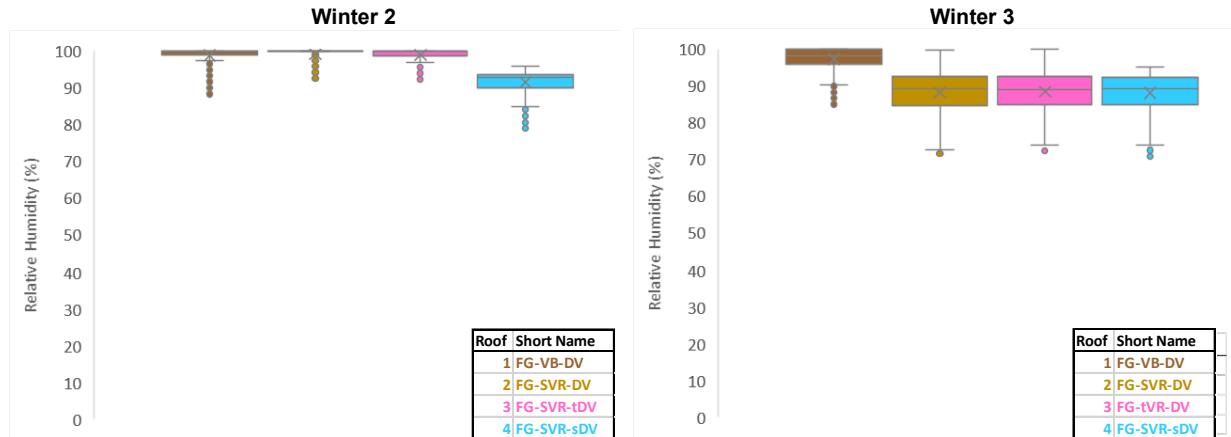
**Figure 50. Fiberglass roofs' (1-4) mid-height north RH box-whisker plots, Winter 2 vs. Winter 3**

Figure 50 (Winter 2 vs. Winter 3) demonstrates that Winter 3 had much drier (lower RH) conditions than Winter 2 (despite identical interior conditions), and the fact that [Roof 1](#) (fixed-perm vapor barrier, diffusion vent) was a wetter outlier in Winter 3.

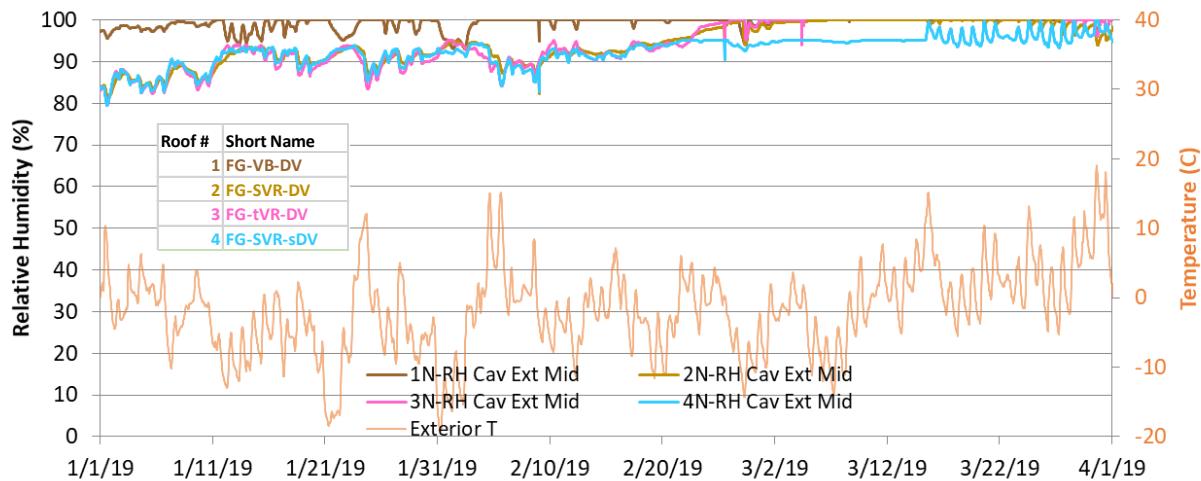
Figure 51. Fiberglass roofs' (1–4) mid-bay RH north conditions, Winter 3 detail

A closer examination of Winter 3 (January–March 2019) conditions is shown in Figure 51: Roof 1 (fixed-perm vapor barrier/DV) is the high outlier. However, almost all roofs converge on 100% RH in late February; this is roughly consistent with the addition of air injection into the north-facing roof and/or the associated slight increase in interior dewpoint. One exception is Roof 4, which remains slightly drier (again, a possible sensor issue).

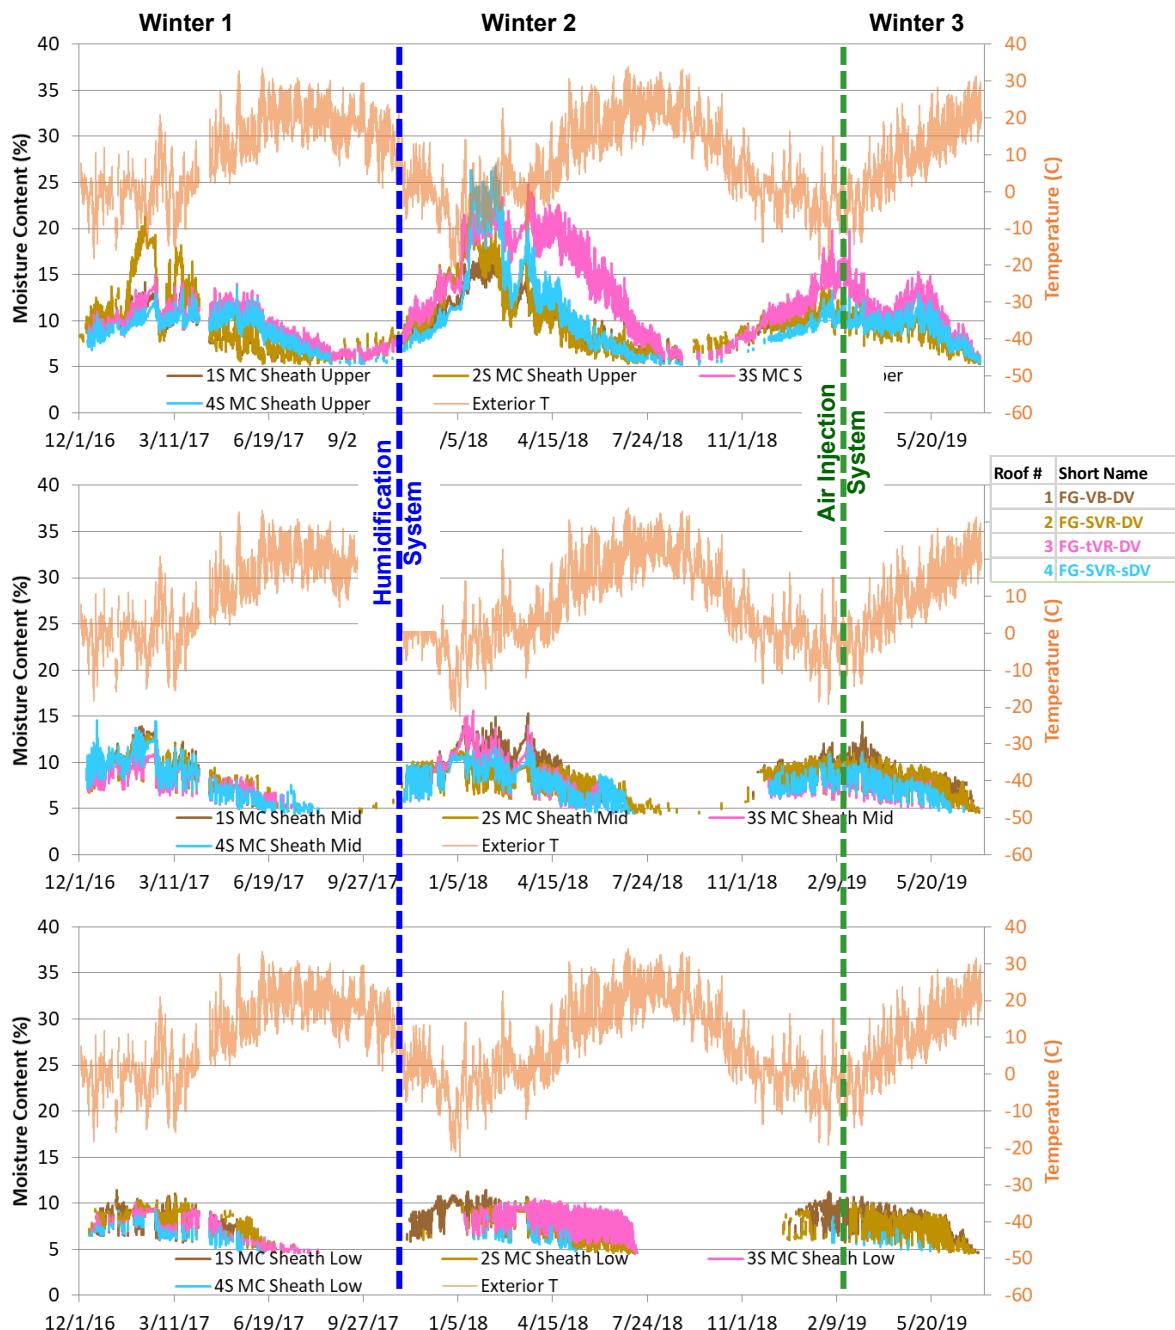
Figure 58. Fiberglass roofs' (1-4) sheathing MC south measurements

The sheathing MCs for the south fiberglass roofs are shown in Figure 58. This showed similar patterns of Winter 2 having higher MCs than Winter 1 (due to humidification). As expected, all south MCs are drier than the corresponding north measurements.

In Winter 2, operation of the humidification system increases MCs, which is particularly noticeable at the mid and lower heights. However, MCs remain within the safe range at those locations.

Winter 3 results are drier than Winter 2 (again consistent with repacking of insulation suppressing convective airflow). The air injection system was not designed to impact the south-facing roofs, so no response was expected.

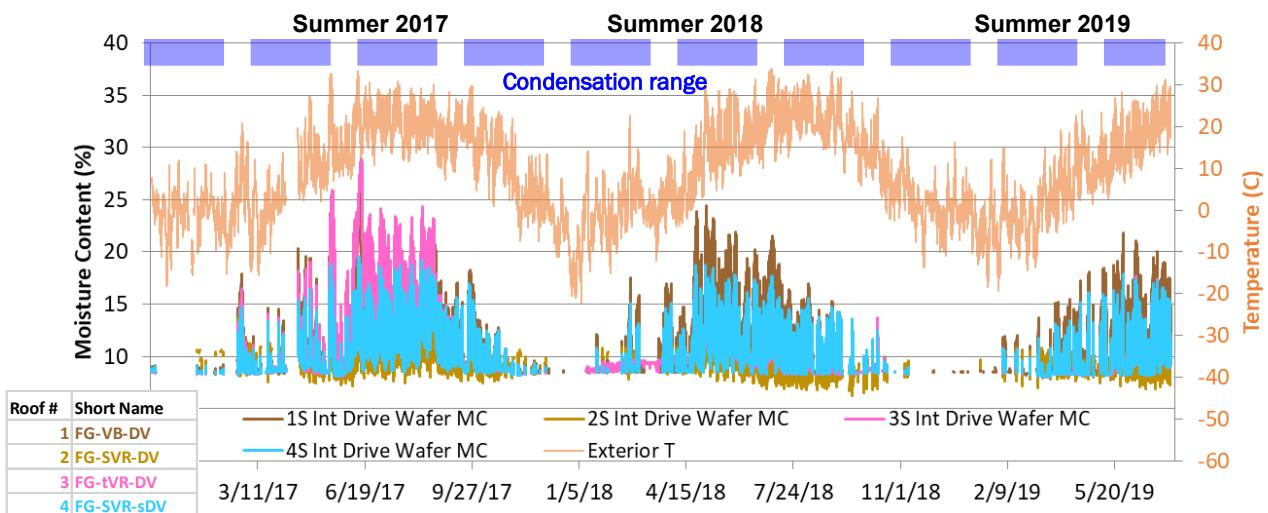
Figure 60. Fiberglass roofs' (1–4) inward drive wafer MC south measurements

The south-side wafer sensor (Figure 60) reflects moisture accumulation; the condensation range is shown by the dotted **BLUE** line.

In 2017, wafer peaks first occurred in February 2017, during unusually warm outdoor conditions. As exterior temperature warmed, moisture spikes occurred more frequently, and in proportion to outdoor temperatures. Moisture spikes remained well below the 40% MC range that indicates condensation. However, summertime spikes were above levels consistent with 100% RH.

The highest moisture spikes occurred in **Roof 1** and **Roof 3**, which both had fixed-perm (1 perm) interior vapor and air barriers. In contrast, **Roof 2** and **Roof 4** (variable-perm vapor retarders) had noticeably lower peaks and accumulation of moisture.

The presence of liquid water condensation was noted during roof disassembly work (vapor retarder replacement) in summer (August) 2017. Specifically, condensation was found on **Roof 3** (fixed-perm vapor retarder in Winter 1) within 3 ft of the ridge; this disassembly work is covered in Section 12.3: Inward Vapor Drive Condensation. The instrumentation at mid-height did not capture this extreme accumulation.

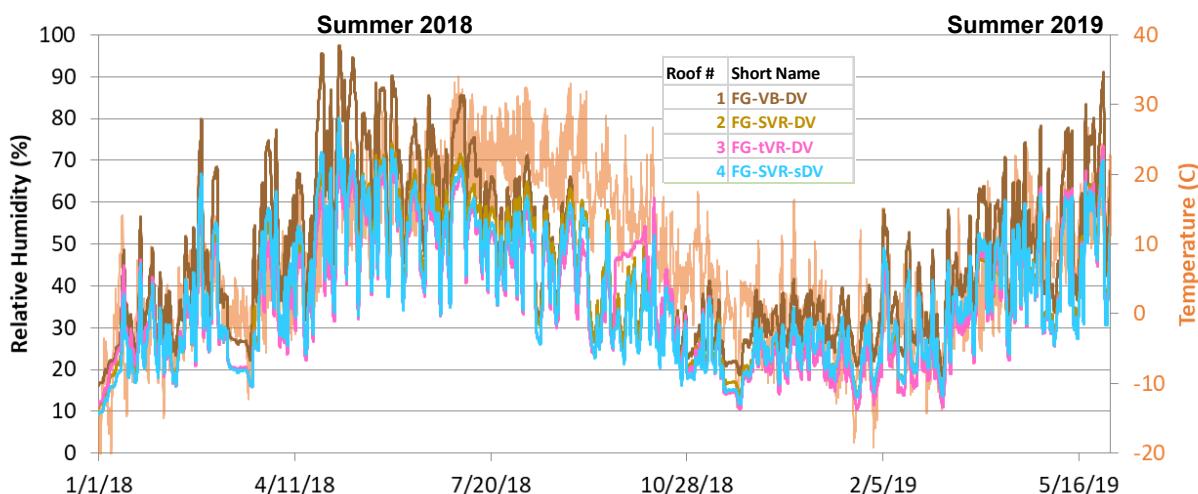
**Figure 61. Fiberglass roofs' inward drive 24-hour average RH, south measurements, 2018–2019**

The south-facing inward drive RH sensors' 24-hour moving average data are plotted in Figure 61, for summer 2018 and summer 2019. Averaging was used to make the data readable. Again, **Roof 1** (fixed-perm vapor barrier) is the consistent high outlier, although moisture levels remain in the safe range (mostly below 90% RH).

One observation when comparing Figure 61 (south RHs) and Figure 62 (north RHs) is that inward drive problems appear to be worse on the north side. This was surprising, given the greater solar gain on the south roof elevation. This is ascribed to greater wintertime moisture accumulation in the north-side assembly, which provides a greater reservoir of moisture.

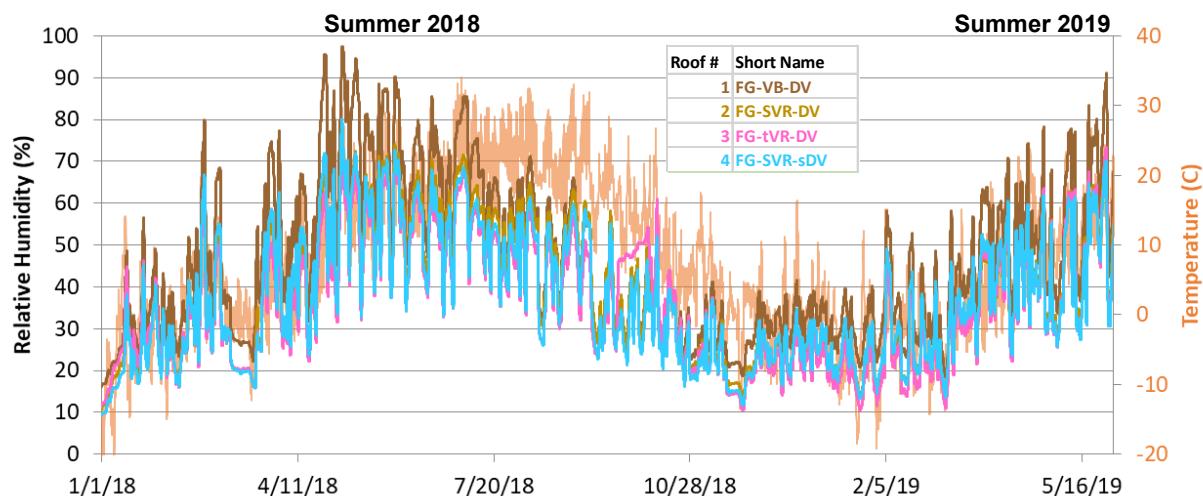
Figure 62. Fiberglass roofs' (1–4) inward drive 24-hour average RH, north measurements 2018–2019

Again, **Roof 1** (fixed-perm vapor barrier) is the high outlier, although other roofs operate in a similar range. Summertime peaks on the north side reach 100% RH.

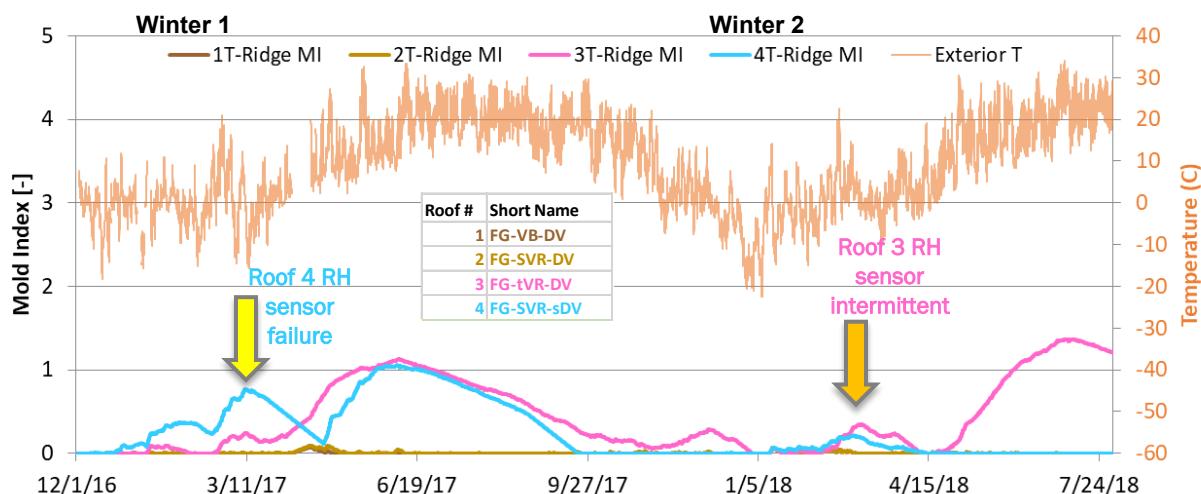
Figure 63. Fiberglass roofs' (1–4) ridge mold index calculations

In Winter 1, **Roof 3** and **Roof 4** (no diffusion vent) had extended winter periods at high RH (95%–100%) and indications of condensation. In contrast, **Roof 1** and **Roof 2** (diffusion vent) had much lower RH levels and no indication of condensation. The calculated mold index shows a rise slightly above 1.0 (microscopic mold growth levels) in **Roof 3** and **Roof 4** in the spring, as outdoor temperatures warmed while RH levels remained high. In contrast, **Roof 1** and **Roof 2** mold index values barely exceeded 0.

The decline seen in **Roof 4** (YELLOW arrow in Figure 63) is an artifact of sensor failure; the ridge RH sensor failed in March 2017, returning unrealistically low measurements and zeroes. **Roof 4** would likely have a higher mold index than **Roof 3** if the sensor returned valid data.

In Winter 2, all roofs had extended periods at 95%–100% RH (Figure 43). **Roof 3** (tight diffusion vent) showed indications of extensive wintertime ridge condensation (Figure 45); other fiberglass roofs remained below the condensation range. **Roof 3**'s RH ridge sensor was intermittent during April 2018, also causing an artificial decline (**GOLD** arrow in Figure 63). However, the calculated mold index remained below 2.0, and well below the failure criterion of 3.0.

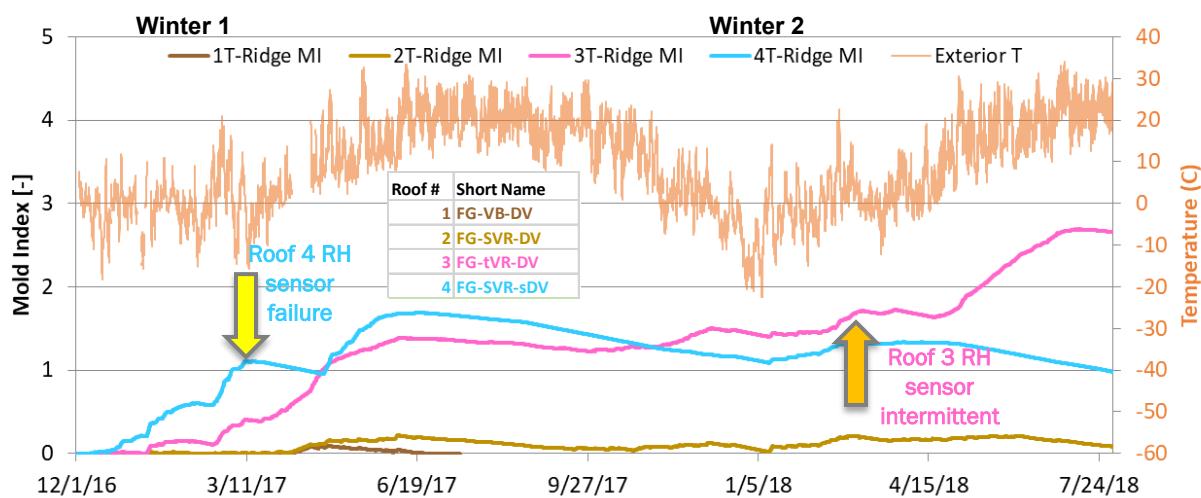
Figure 64. Fiberglass roofs' (1–4) ridge mold index calculations, with decline coefficient 0.25 (versus 1.0 default)

One variable to adjust in the mold index calculation is the decline coefficient. It was changed from 1.0 (default value) to 0.25 (“relatively low decline”), with results for the ridge T/RH sensor shown in Figure 64. For reference, a decline coefficient of 0.1 is “almost no decline.” These results can be compared between Figure 63 (1.0 value) and Figure 64 (0.25 value). The smaller decline coefficient results in higher peak mold indices; however, maximum values remain below 3.0.

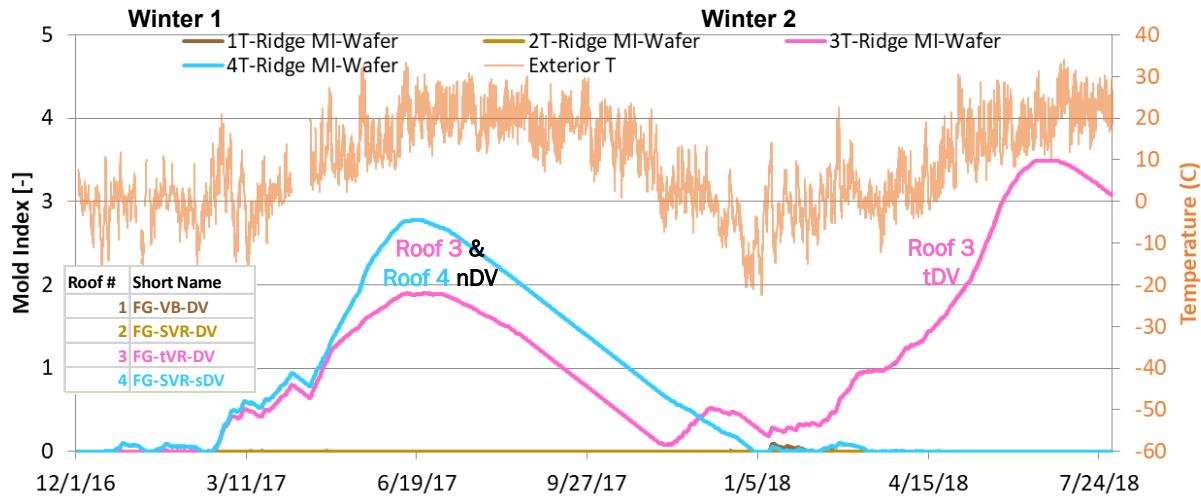
Figure 65. Fiberglass roofs' (1-4) ridge mold index calculations (derived from wafer MCs)

The mold index results are shown in Figure 65 for both Winter 1 and Winter 2. Winter 1 showed higher risks of **Roof 3** and **Roof 4** (no diffusion vent) but below the risk threshold of 3.0.

Winter 2 shows **Roof 3** (tight diffusion vent) with a mold index rising over 3.0 in late spring/early summer, which is consistent with the sustained high moisture levels measured at the ridge.

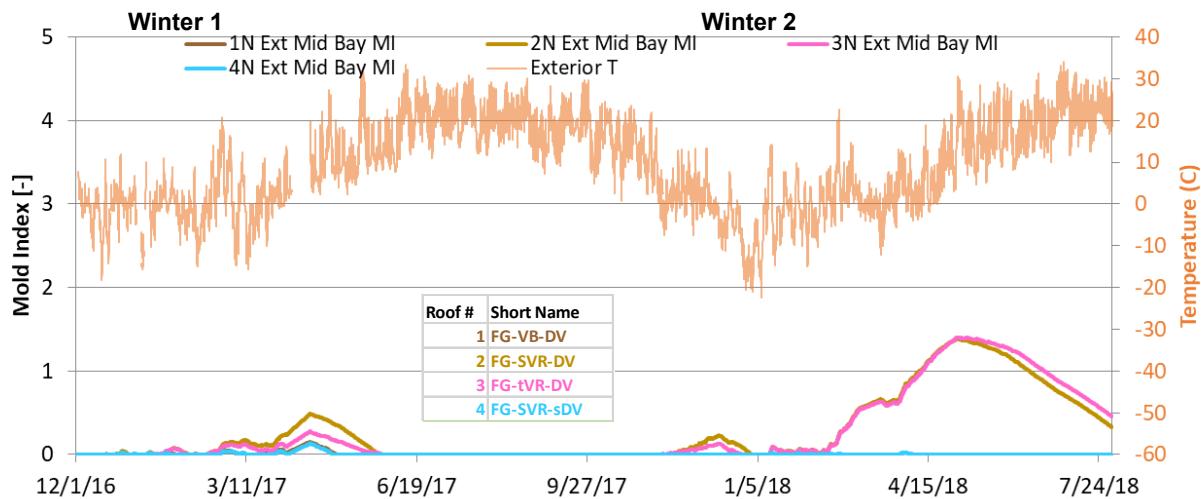
Figure 66. Fiberglass roofs' (1-4) north sheathing-insulation interface mold index calculations

Another high-risk location was the north-side sheathing-insulation interface. In Winter 2, this interface had extended periods at 95%–100% RH in all four roofs (Figure 48) and sheathing MCs over 25% in some roofs (Figure 57). The mold index calculation results are shown in Figure 66: peak values were well below 2.0 for Winter 2, indicating low risk. **Roof 4** (small diffusion vent) had lower interface RHs, which was ascribed to a sensor anomaly, rather than an actual performance difference; the mold index for this roof remains near zero for the winter. Given these low risks, mold indices were not calculated for the drier south sheathing-insulation interface.

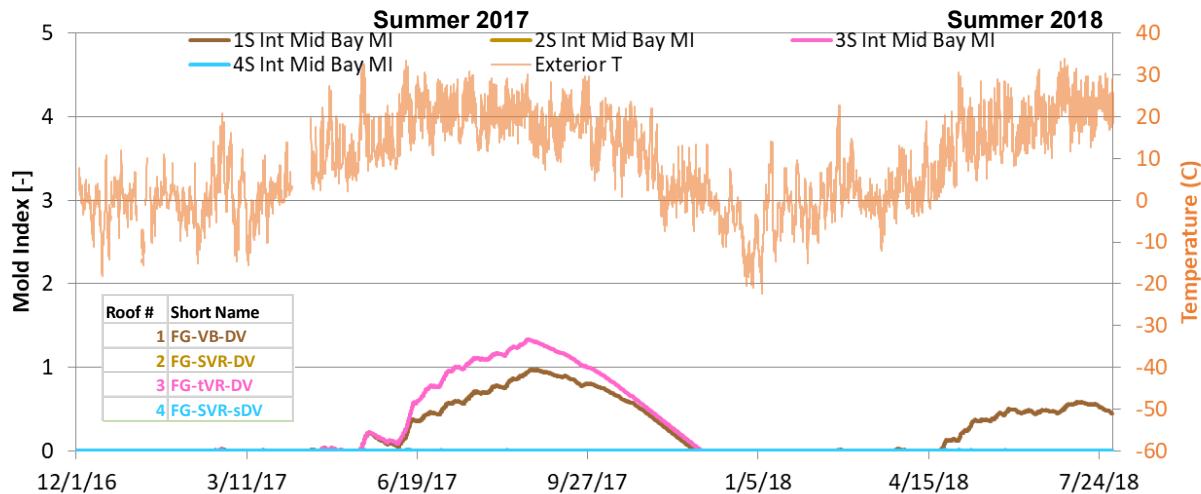
Figure 67. Fiberglass roofs' (1-4) south inward drive mold index calculations

A final area at risk was the insulation-vapor retarder interface, given the measurements of inward vapor drive and accumulation in fixed-perm vapor retarder roofs. The variable-perm vapor retarders showed lower RH peaks, indicating that the membrane allowed drying to the interior when loaded with moisture. The results are shown for the south side (Figure 67) and the north side (Figure 68).

In summer 2017, consistent with RH and wafer measurements, **Roof 1** and **Roof 3** (fixed-perm vapor retarder) showed higher risk than **Roof 2** and **Roof 4** (variable-perm vapor retarder). Mold indices for the fixed-perm vapor retarder roofs rose slightly above 1, which is below the failure threshold, but greater than the ridge mold index maximum. In addition, the north side had higher maxima than the south side, which was ascribed to greater stored moisture from the winter in the north-facing roof.

In summer 2018, **Roof 1** (fixed-perm vapor barrier) was the higher outlier on both the north and south sides, consistent with a lack of inward drying, compared to SVRs used in **Roof 2**, **Roof 3**, and **Roof 4**. Note that summer 2018 follows Winter 2 (humidified condition) with substantial moisture accumulation in the rafter bays. However, mold index remained below 3.0 on both orientations. The north-side roofs showed higher mold indices than the south side, again consistent with inward drive of stored wintertime moisture.

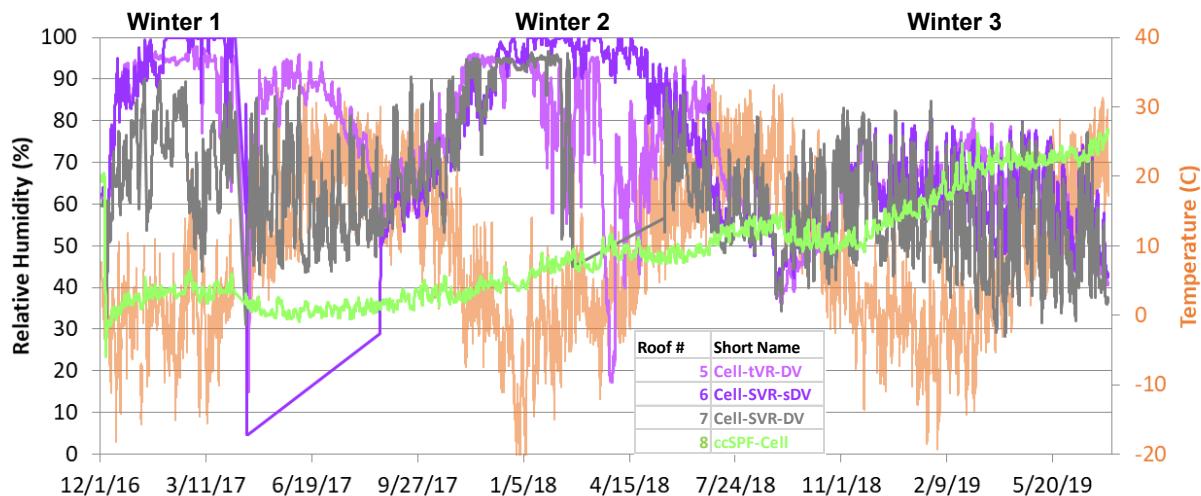
Figure 70. Cellulose roofs' (5–8) ridge RH conditions, 24-hour moving average

In Winter 1, [Roof 5](#) and [Roof 6](#), (no diffusion vent) have similar behavior to the equivalent fiberglass roofs: RH levels rise to 95%–100% RH and remain there over the course of the winter. However, [Roof 7](#) (SVR and diffusion vent) has markedly drier behavior, with only brief excursions over 90% RH through the winter.

During spring drying, [Roof 5](#) (no diffusion vent) remained wetter than [Roof 7](#) (diffusion vent). The ridge RH sensor in [Roof 6](#) failed in April 2016, so spring drying data are not available; however, this sensor started to return data in fall 2017.

Lastly, [Roof 8](#) (ccSPF and cellulose) had consistently low RHs at the ridge, remaining in the 35%–45% range. This is consistent with the air- and vapor-impermeable ccSPF protecting the sheathing from interior moisture; the code-compliant roof has the driest conditions. These moisture levels continued through the spring dry-down.

In Winter 2, all ridge RHs were higher than Winter 1 due to interior humidification. For instance, [Roof 7](#) (full-sized diffusion vent) can be compared between Winters 1 and 2, as it is unchanged between those two periods. In Winter 1 (moderate interior RH), ridge RH seldom peaked above 90%, but in Winter 2 (humidification to 50% RH), RHs rose to ~95% and remained there until sensor failure. [Roof 5](#) also showed drops in RH consistent with sensor issues rather than actual drying.

In contrast, [Roof 8](#) (hybrid ccSPF-cellulose) only shows a slight rise from 40%–50% RH over the course of the winter, which is well below risk thresholds. The cellulose ridge RH sensors were replaced between Winter 2 and Winter 3, except [Roof 8](#) (hybrid).

[Roof 8](#) (ccSPF-cellulose) shows a slow increase in RH over the three years. This trend does not match expected behavior or typical observed field conditions for this type of assembly. Ridge conditions at this roof were examined more closely with handheld instruments, as covered in Section 8.5: Ridge Sensors and Long-Term Moisture Accumulation. These measurements indicate that the upward trend is likely sensor drift.

The §R806.5 code-compliant hybrid ccSPF-cellulose roof (Roof 8) showed a concerning trend at one sensor over the three-year experiment: the ridge RH sensor showed a constantly increasing accumulation of moisture (Figure 70). It was unclear if this was due to sensor drift or an

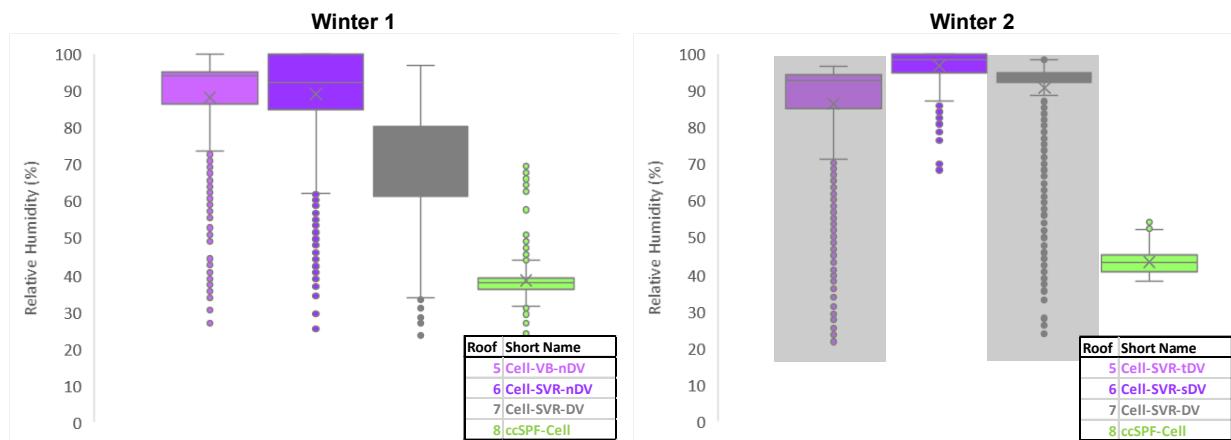
Figure 71. Cellulose roofs' (5–8) ridge RH box-whisker plots, Winter 1 vs. Winter 2

Box and whisker plots for the cellulose roof ridges in Winters 1 and 2 are shown in Figure 71. Winter 1 shows the superior performance of [Roof 7](#) (diffusion vent) and [Roof 8](#) (hybrid ccSPF-cellulose). But in Winter 2, interior humidification pushes all cellulose roofs into the 85%–95% RH range, including the best-performing [Roof 7](#). The Winter 2 plot should be interpreted with caution: the RH sensor in [Roof 5](#) and [Roof 7](#) showed erratic data for much of the winter, as denoted by the gray shaded bars.

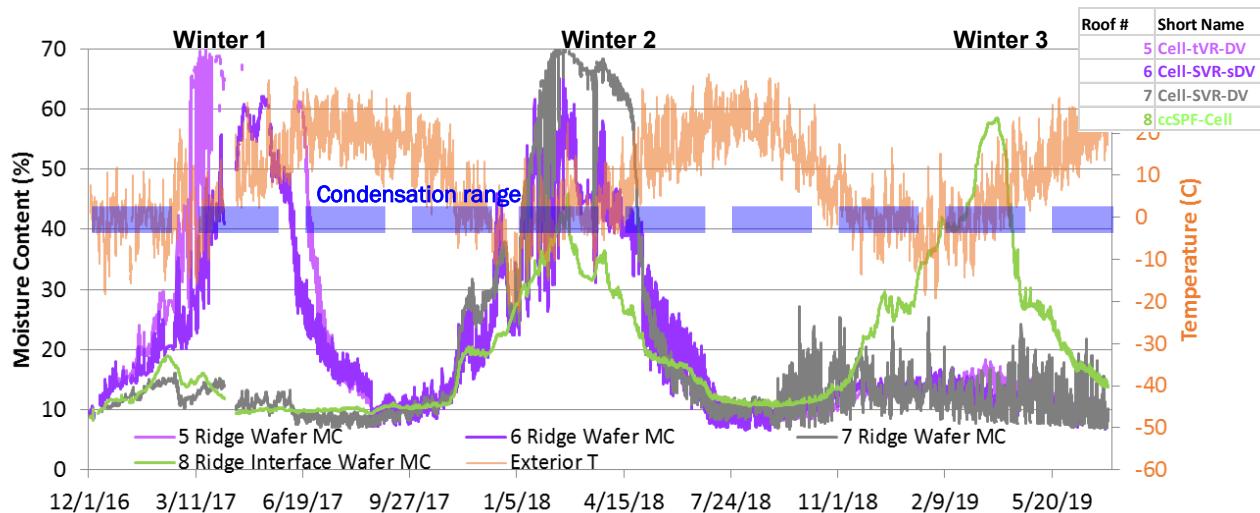
Figure 72. Cellulose roofs' (5–8) ridge wafer MC measurements

The ridge wafer results are shown in Figure 72, with the condensation range for these sensors shown in **BLUE**.

In Winter 1, wafer MC rose sharply in [Roof 5](#) and [Roof 6](#) (no diffusion vent). The MC measurements are well outside the realistic range, with maxima of 60%–70% MC. This is ascribed to migration of borate salts from the cellulose insulation into the wafer, which lowers electrical resistance, resulting in these false high readings. Migration of borate salts occurs at high moisture levels (in the presence of liquid water due to capillary salt transport); this is consistent with wafer measurements rising above 40%–45% MC (condensation range). These moisture levels remain high well into spring; this matches the [Roof 5](#) ridge RH measurements, but the absolute wafer MCs are suspect.

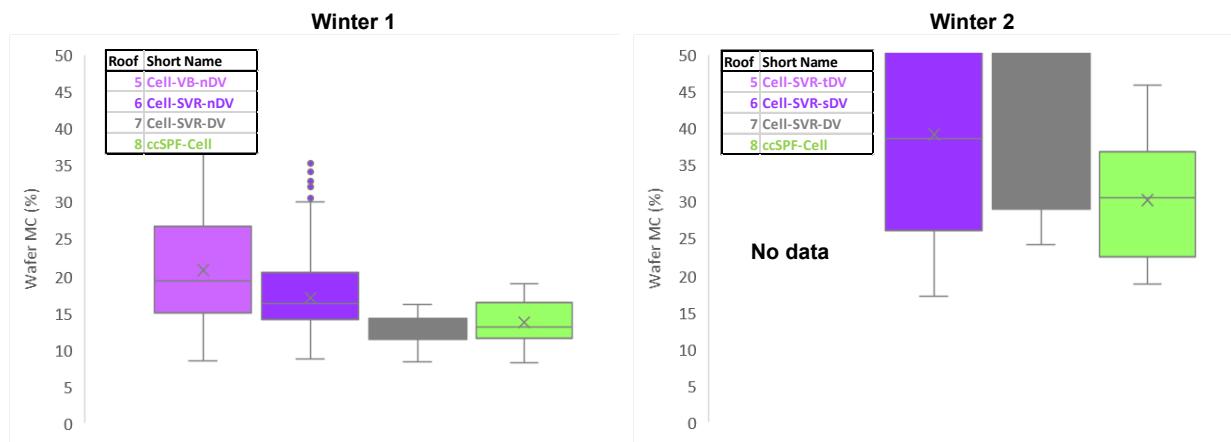
Figure 73. Cellulose roofs' (5–8) ridge wafer MC box-whisker plots, Winter 1 vs. Winter 2

The ridge wafer sensor plots are shown in Figure 73. They demonstrate the greater drying of Roof 7 (full-size diffusion vent) and safe behavior of **Roof 8** (ccSPF-cellulose hybrid) in Winter 1.

In Winter 2, **Roof 5** (tight diffusion vent, SVR) had no sensor and is not plotted. **Roof 6** and Roof 7 had very high wafer MCs, ascribed to borate contamination.

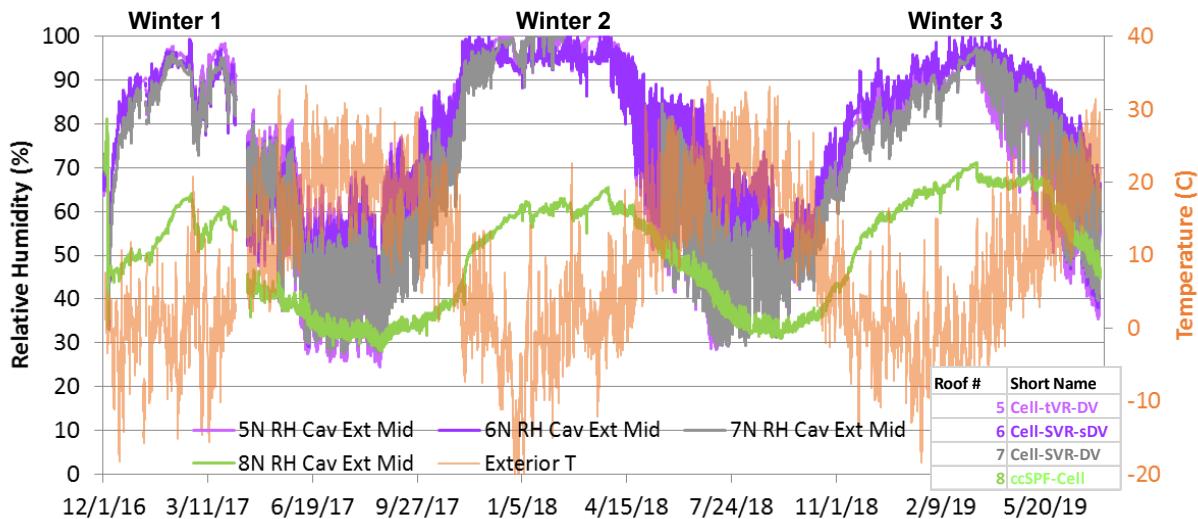
Figure 75. Cellulose roofs' (5–8) mid-bay RH north conditions

In Winter 1, the north-facing cellulose roof RHs (Figure 75) follows patterns similar to the fiberglass roofs, with RHs rising over the course of the winter to 90%–100% RH. However, the winter rise is more gradual in the cellulose roofs (compared to fiberglass), due to the moisture storage of the cellulose insulation. Consistent 90%+ RH levels only occur by mid-January in the cellulose roofs, compared to early December in the fiberglass roofs. In addition, the north-facing cellulose roofs do not reach 100% RH, unlike the fiberglass roofs.

Winter 3 north sheathing RHs (Figure 75) are much lower than Winter 2, with a much briefer period in the 95%–100% range. This is consistent with repacking of insulation improving hygrothermal performance. Roof 6 (small diffusion vent) is the high outlier, consistent with reduced drying through a smaller diffusion vent. Roof 8 (ccSPF-cellulose) is consistently much drier than the experimental cellulose roofs, well in the safe range.

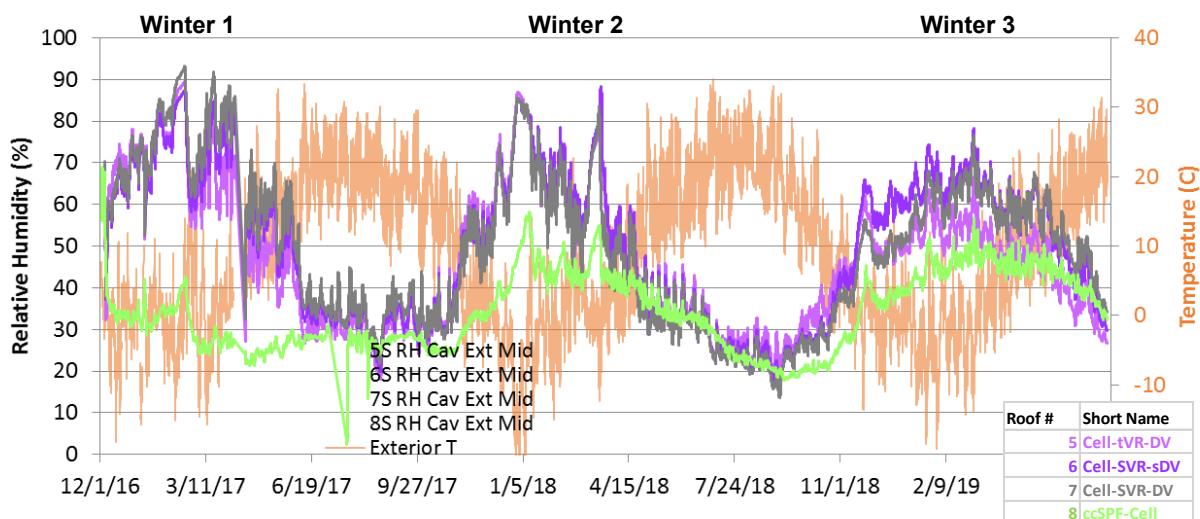
Figure 76. Cellulose roofs' (5–8) mid-bay RH south conditions, 24-hour moving average

The 24-hour moving average of south sheathing interface RH data (Figure 76) show expected trends, including drier conditions than the north side, Winter 2 (humidification) being wetter than Winter 1, and drier conditions in Winter 3 compared to Winter 2. Sheathing-insulation interface RHs remain below risk levels.
