# Monitoring of Unvented Roofs with Fibrous Insulation, Diffusion Vents, and Interior Vapor Control in a Cold Climate

September 2020

*Prepared by:*  
Building Science Corporation  
70 Main Street  
Westford, MA 01886

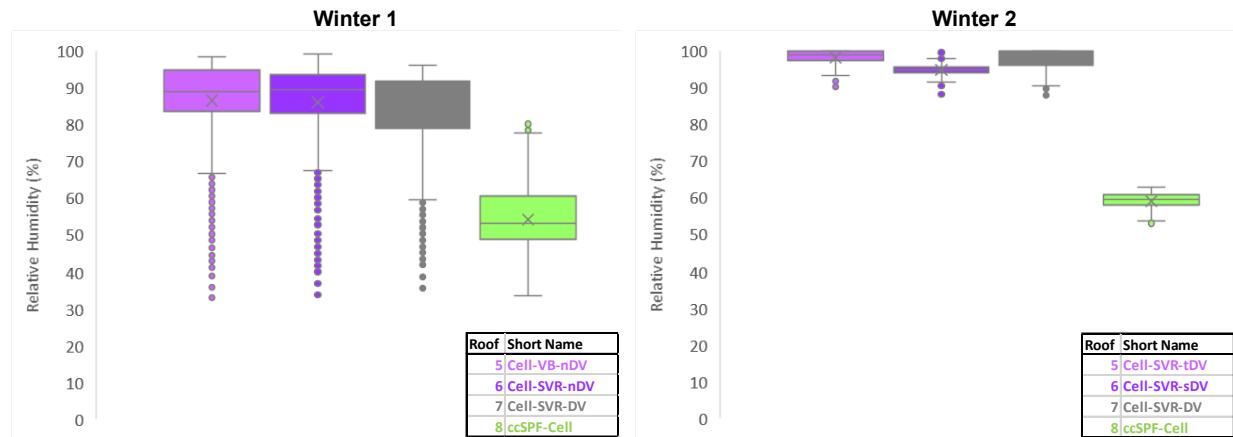
Figure 77. Cellulose roofs' (5–8) mid-height north RH box-whisker plots, Winter 1 vs. Winter 2

The Winter 1 vs. Winter 2 plots (Figure 77) show the severity of Winter 2's humidified load, pushing interface RHs near 100% for much of the winter, with no low-RH outliers as seen in Winter 1. There is no clear differentiation between the experimental cellulose roofs, although Roof 7 (full-size diffusion vent) is the driest in Winter 1, consistent with its greater outward drying. Roof 8 (hybrid ccSPF-cellulose) runs at much lower (drier) RHs throughout both winters.

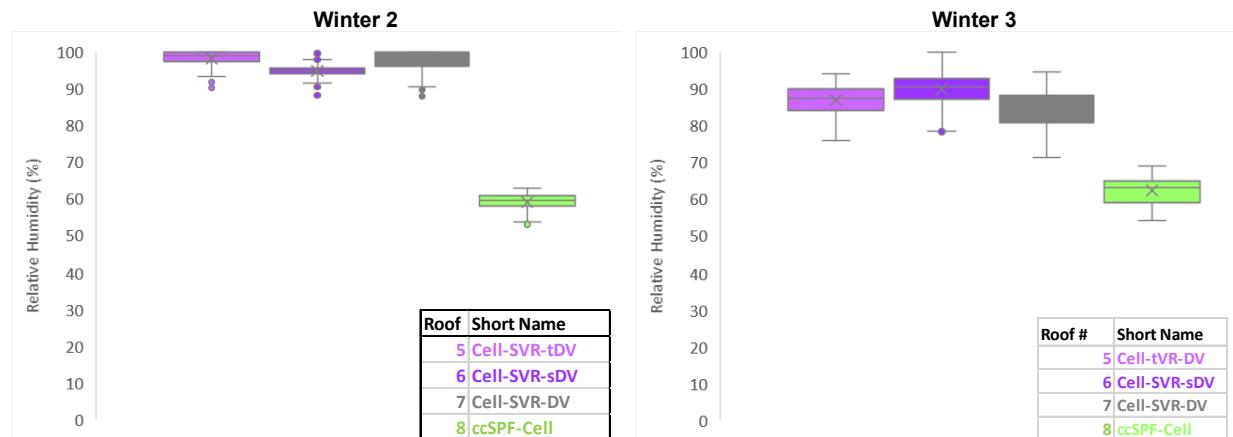
Figure 78. Cellulose roofs' (5–8) mid-height north RH box-whisker plots, Winter 2 vs. Winter 3

The Winter 2 vs. Winter 3 plots (Figure 78) show drier conditions in Winter 3 compared to Winter 2, and the fact that Roof 6 (small diffusion vent) appears to be the higher outlier relative to Roof 5 and Roof 7 (full-size diffusion vents). This suggests that the diffusion vent might provide more than localized drying at the ridge. However, this difference is close to RH sensor accuracy limits ( $\pm 3.5\%$  RH).

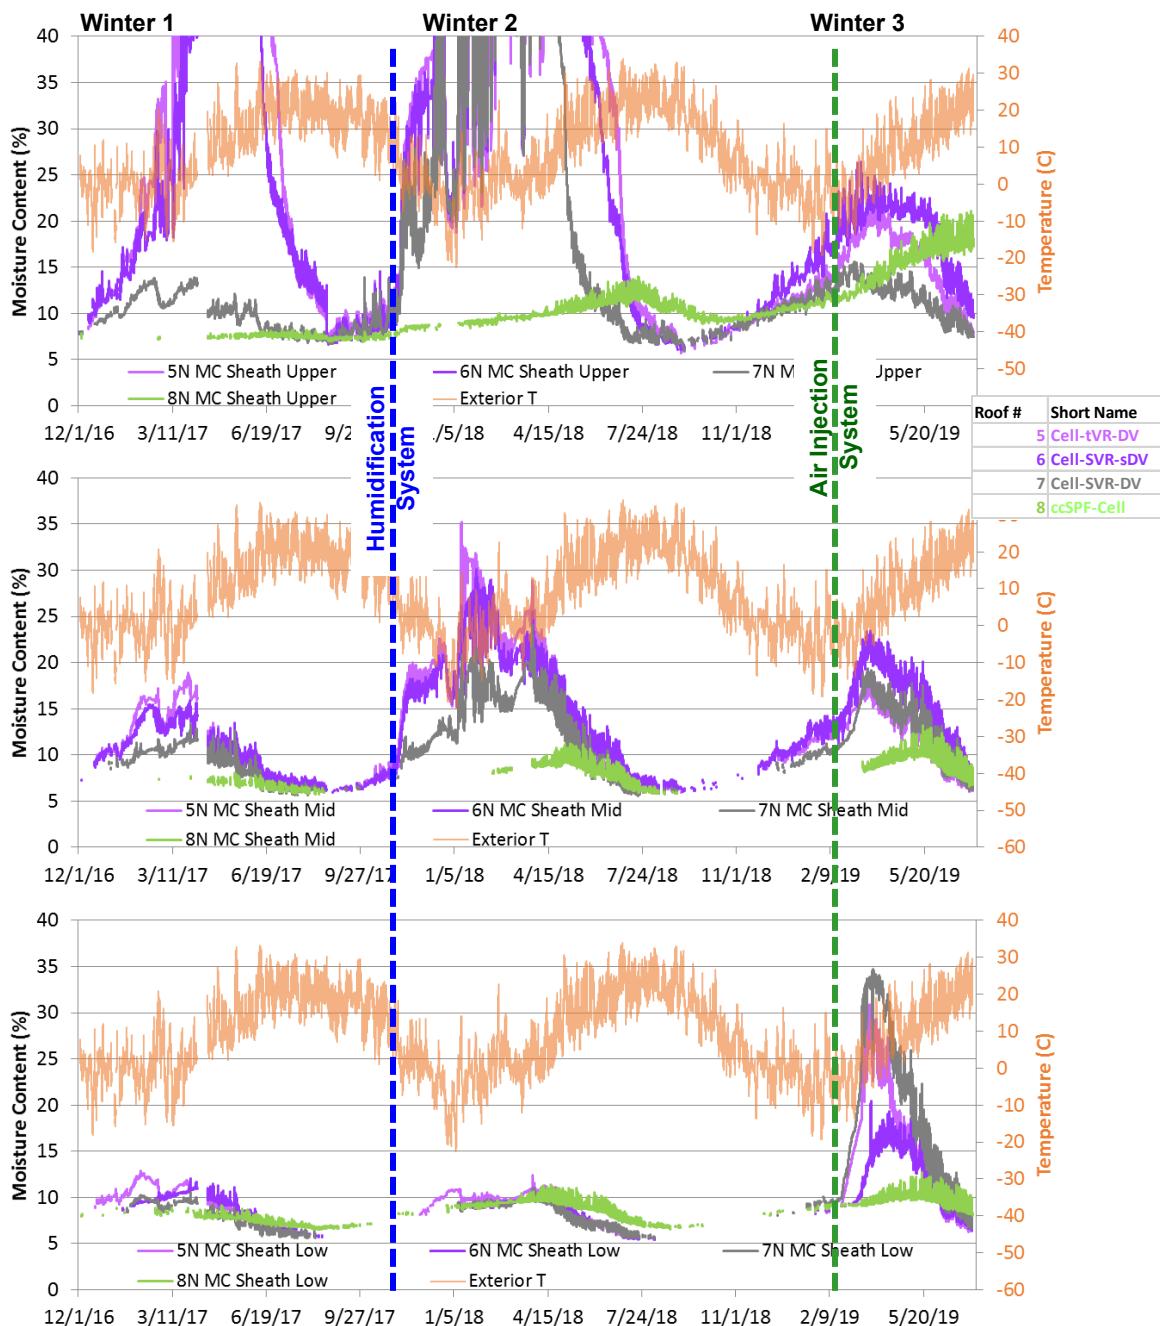
**Roof 8** (ccSPF/cellulose) shows a cycling rise in MC at the upper sheathing location, which appears to peak in late spring/early summer; this seasonal response is different than the cellulose roofs, and could indicate slow moisture accumulation in the assembly. However, peak MCs are within the safe range. These trends are further examined below.

Figure 80. Cellulose roofs' (5-8) sheathing MC north measurements

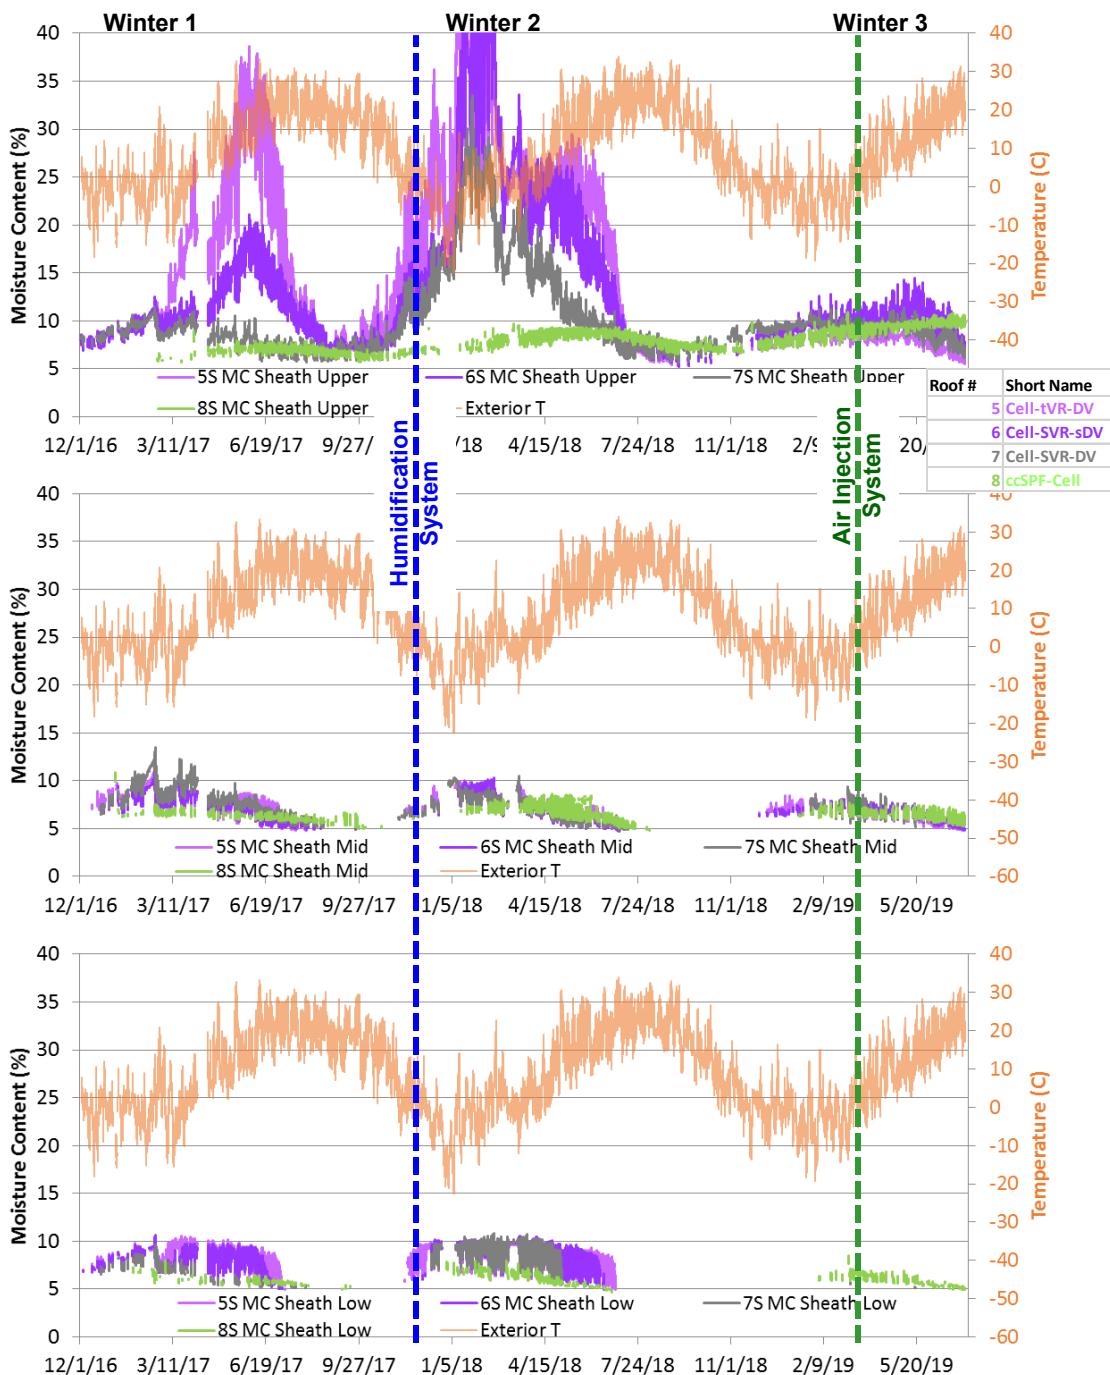
The south-side roof sheathing MCs are plotted in Figure 81. Again, south-side measurements are much drier than the north side, and the expected spatial pattern (wettest at upper location) is observed.

Figure 81. Cellulose roofs' (5–8) sheathing MC south measurements

On the south side, in Winter 1, the same pattern was seen of **Roof 5** and **Roof 6** (no diffusion vent) showing greater moisture accumulation near the ridge than **Roof 7** (diffusion vent). However, unlike the north side, this rise began during warmer spring conditions (March–April 2017). MCs rose to 20% (**Roof 6**) and over 35% (**Roof 5**); again, these results are suspect due to condensation and possible migration of borate salts into the sheathing. **Roof 8** (ccSPF-cellulose)

both had safe conditions at the south upper location (under 10% MC). The middle wood south-side MCs all remained below 15%, and the lower MCs below 10%.

In Winter 2, the south side shows similar issues of much higher MCs than Winter 1 due to interior humidification. **Roof 7** (full-sized diffusion vent) appears drier than **Roof 5** (tight diffusion vent) and **Roof 6** (small diffusion vent) at the upper location, consistent with greater wintertime drying. **Roof 5** and **Roof 6** show peak MCs over 40%, which is likely a combination of high moisture levels and borate migration. As expected, **Roof 8** (hybrid ccSPF-cellulose) shows low sheathing MCs throughout, including the humidified Winter 2.

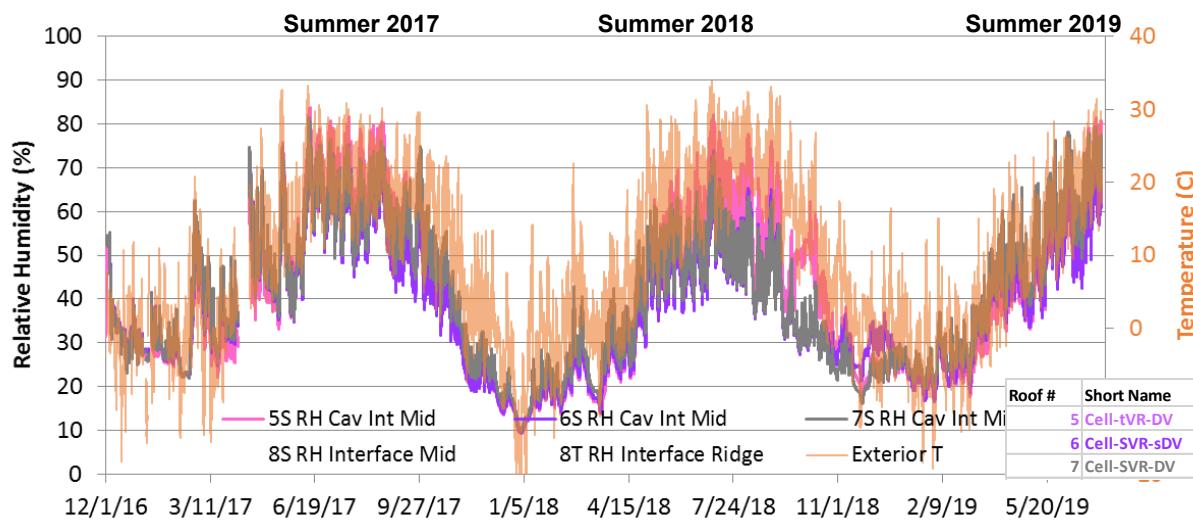
The cellulose roof south-facing inward drive RH measurements (Figure 83) rose and fell in a pattern matching outdoor temperatures, which would dominate the vapor drive direction in this closed cavity.

Figure 83. Cellulose roofs' (5–8) inward drive RH south measurements

In all three summers, peak RHs rarely exceeded 80%, compared to extended 100% RH peaks seen in the fiberglass roofs. This demonstrates safer behavior in the cellulose roofs due to moisture storage.

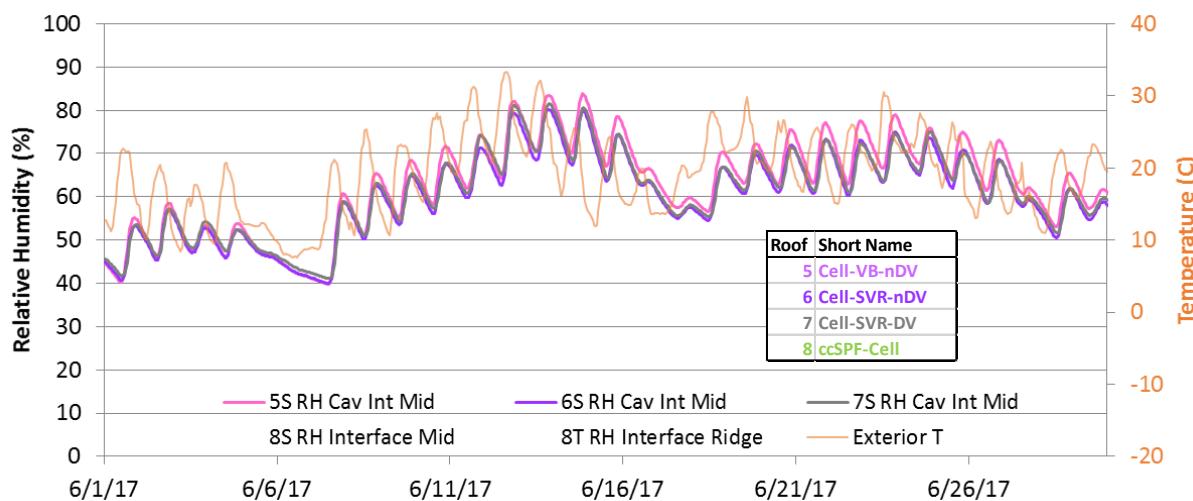
A detail of June 2017 conditions (Figure 84) was used to try to differentiate roof behaviors. **Roof 5** (fixed-perm vapor retarder) had slightly higher peaks than **Roof 6** and **Roof 7** (variable-perm vapor retarders), but the difference was very small. This contrasts with the fiberglass roofs, where interior vapor retarder permeance created a large difference in behavior. The lack of difference between these two vapor control materials (**Roof 5**, **Roof 6**, and **Roof 7**) is ascribed to the fact that very high RHs did not occur at the interface, which would “activate” the open vapor permeance of the variable-perm vapor retarder.

Figure 84. Cellulose roofs' (5–8) inward drive RH south measurements, June 2017 detail

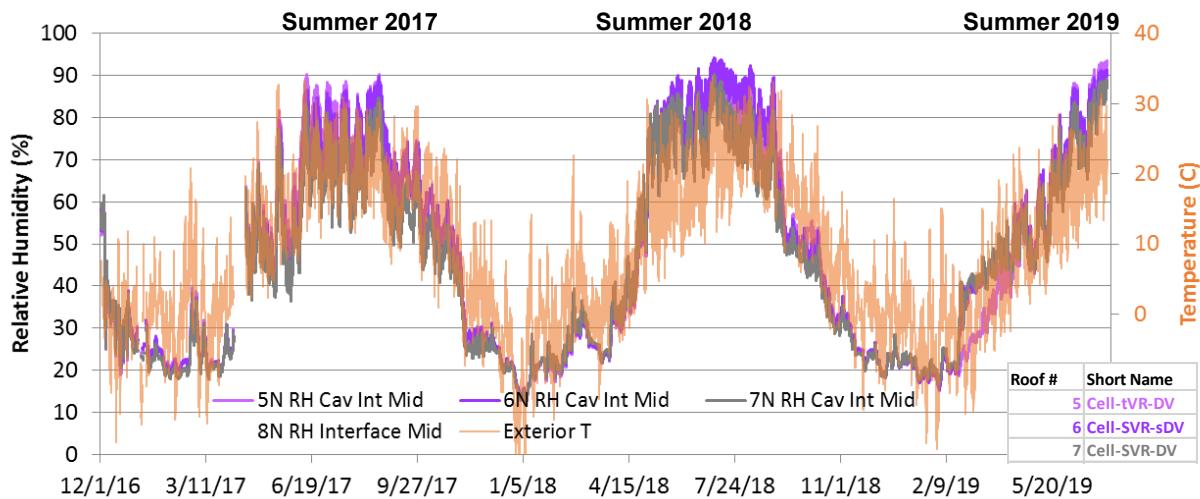
The north-facing inward drive RH sensor results are shown in Figure 85, with behavior similar to the south-facing roof. RH peaks were slightly over 90% on the north side (vs. 80% on the south

side); this is likely due to greater stored moisture in the assembly from the winter. These north RH peaks were also lower than those observed in the fiberglass roofs, due to greater moisture storage of cellulose insulation, compared to fiberglass or mineral fiber.

Figure 85. Cellulose roofs' (5–8) inward drive RH north measurements

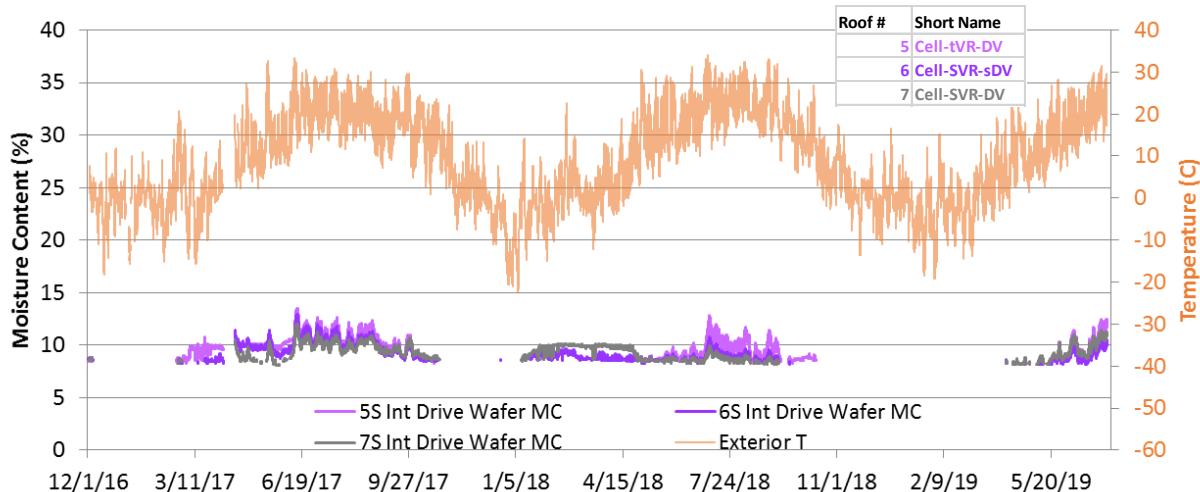
The inward drive south-side cellulose wafer sensors (Figure 86) showed a small rise during summer conditions, but MCs remained well below 15%. In contrast, the equivalent fiberglass wafers had peaks in the 20%–25% range, again demonstrating hygric storage of cellulose.

Figure 86. Cellulose roofs' (5–8) inward drive wafer MC south measurements

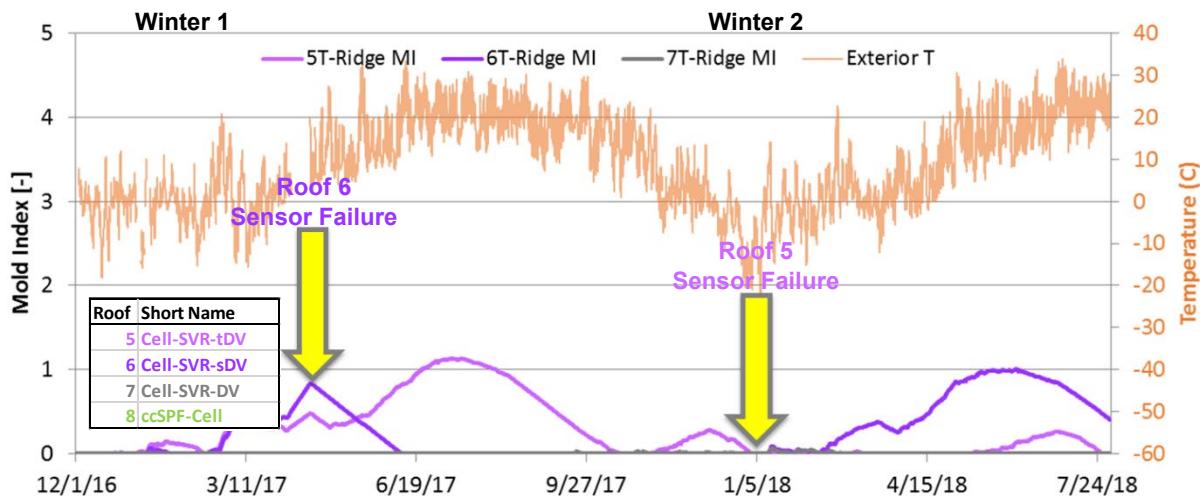
In Winter 1, **Roof 5** and **Roof 6** reached 95%–100% RH early in the winter, while **Roof 7** remained drier (Figure 70). In Winter 2, all three cellulose roof ridges rose to 95%–100% RH

early in the winter, and remained there until RH sensors failed. Sensor failures included [Roof 6](#) in Winter 1 (mid-April 2017) and [Roof 5](#) in Winter 2 (January 2018), as noted by yellow arrows. As a result, these mold index results are suspect; based on the raw data, all mold indices remain below 2.0. Unfortunately, the wafer sensors cannot be used as surrogates for RH, due to the borate salt migration issues.

**Figure 87. Cellulose roofs' (5–8) ridge mold index calculation results**

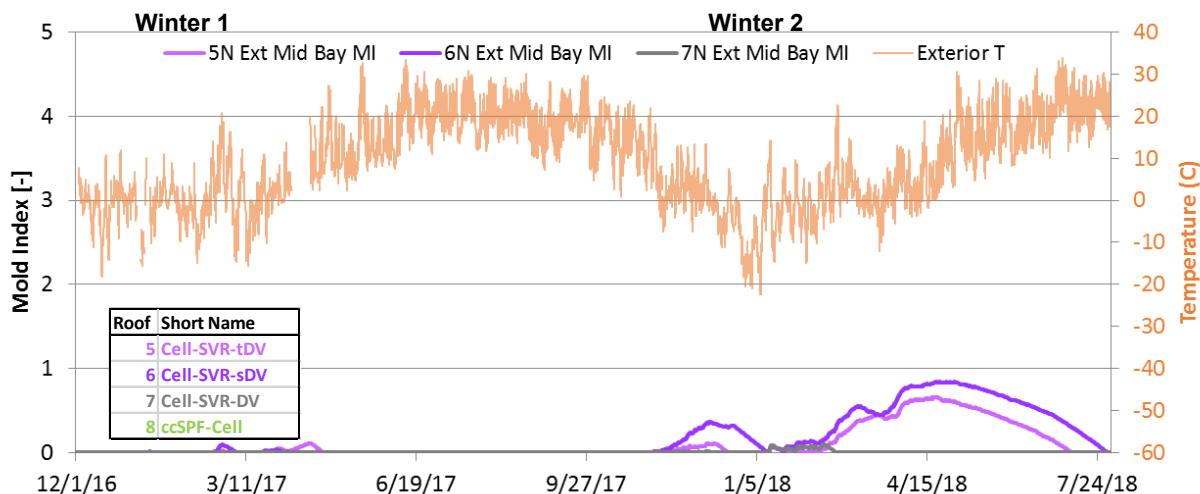
The north mid-bay insulation-sheathing interface mold index results are plotted in Figure 88. RHs were higher in Winter 2 compared to Winter 1, with 90%–100% RH conditions for most of the winter. This results in higher mold index values for [Roof 5](#) and [Roof 6](#); however, mold index values did not exceed 1.0. The south orientation had even lower RH levels, so mold index values were not plotted.

**Figure 88. Cellulose roofs' (5–8) north mid-bay interface mold index calculation results**

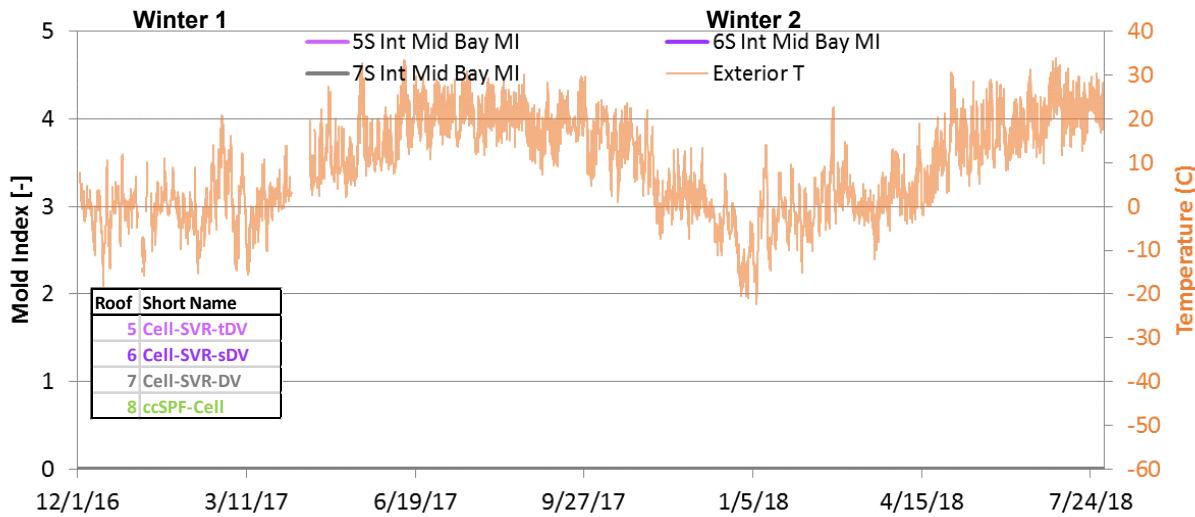
The south-side inward drive insulation-vapor retarder interface mold index results are shown in Figure 89; previous measurements demonstrated lower risks in the cellulose roofs than the fiberglass roofs. This is consistent with near-zero mold index values (peak value 0.004).

**Figure 89. Cellulose roofs' (5–8) south mid-bay inward drive mold index calculation results**

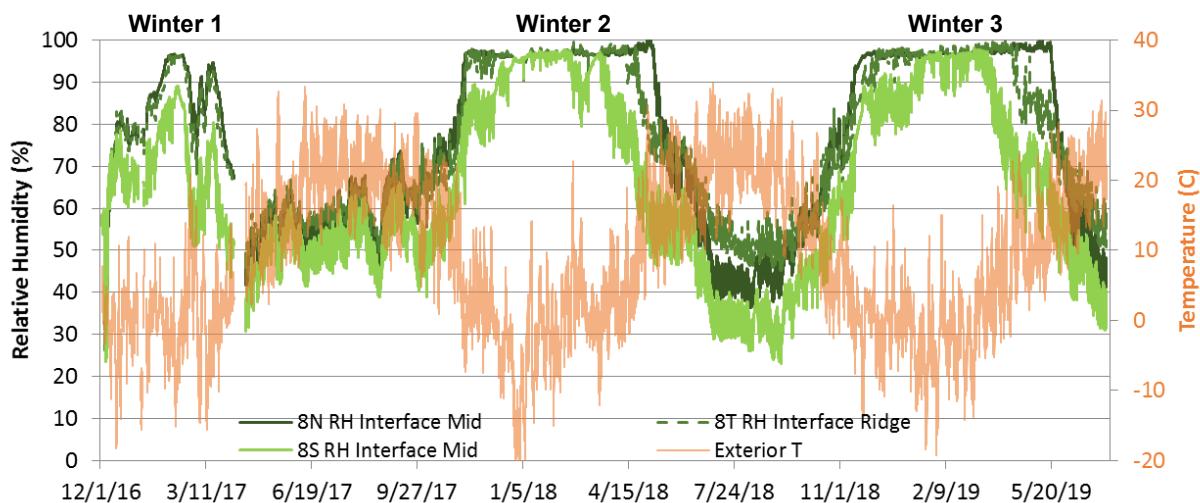
The interface RH measurements for the north, south, and ridge are shown in Figure 91. In Winter 1, the north side and ridge have the highest RHs (with short peaks ~95% RH), and the south side has lower peaks. This matches previous measurements of moisture stratification and cooler temperatures on the north-side roof assembly. The RH levels track roughly inversely to the exterior temperature, as exterior temperature will affect interface temperature (assuming a constant interior temperature).

Figure 91. Hybrid ccSPF-cellulose interface RH measurements, with exterior T

However, Winters 2 and 3 (humidified 50% RH interior) resulted in higher moisture risks at the interface; RH levels rose to 95%–100% for most of the winter. RHs were highest at the ridge/peak and on the north side.

For reference, visual inspection from the interior after Winter 2 did not reveal any moisture issues from the interior (dripping or staining). Disassembly of a guard bay after Winter 2 revealed no caking or visible moisture issues at the interface (see Section 8.6: Interface Surface Examination). Interface RH levels fell rapidly (to 30%–60%) each spring as exterior temperatures warmed.

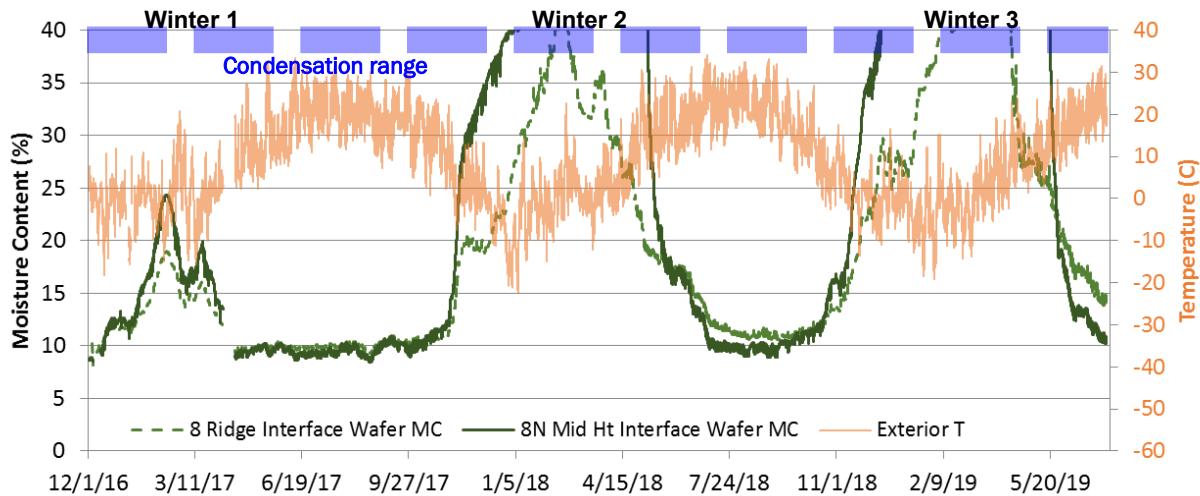
The wafer sensors at the interface (Figure 92) run roughly parallel to the RH measurements. Winter 1's maximum MCs are under 25%—far below the 100% RH or condensation range. However, in Winters 2 and 3, wafers rose over 40% MC, into the condensation risk range (BLUE). Liquid water condensation and borate contamination of the wafers likely plays a part in these high MCs.

Figure 92. Hybrid ccSPF-cellulose interface wafer measurements, with exterior T

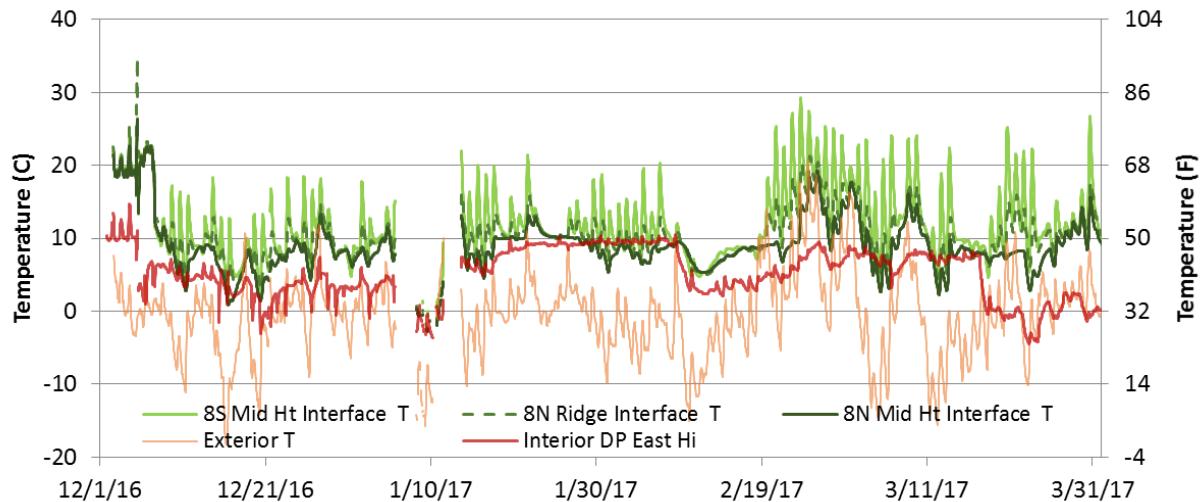
In Winter 1 (Figure 93), interior dewpoint (**RED**) mostly remained below interface temperatures (**GREEN**). When the interior dewpoint overlapped with interface temperature (late January 2017), there was a noticeable rise in RH and wafer MC (Figure 91 and Figure 92).

Figure 93. Hybrid ccSPF-cellulose interface Winter 1 temperature, with interior dewpoint

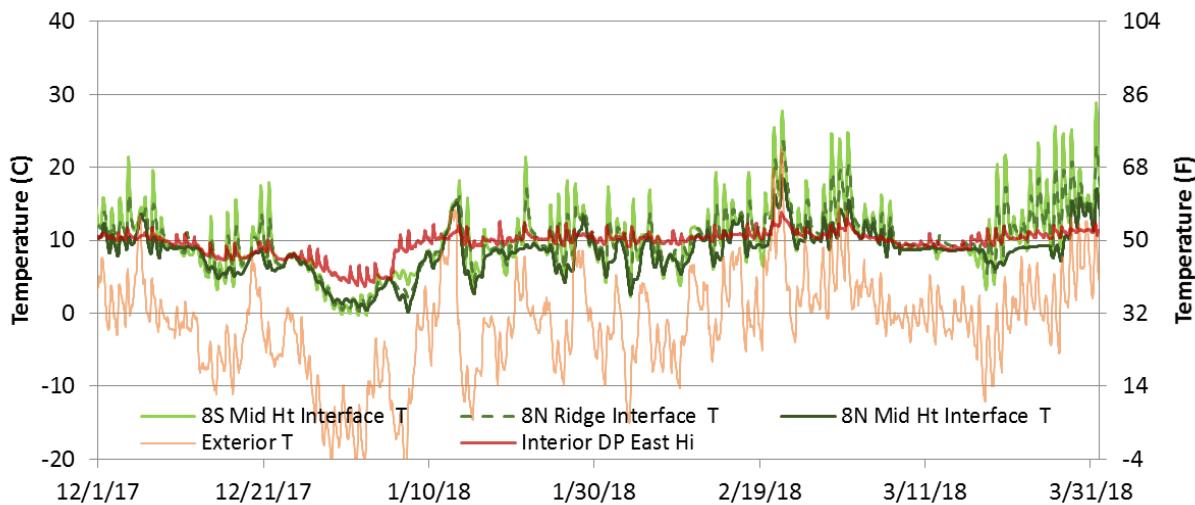
In contrast, in Winter 2 (Figure 94), interior dewpoint (RED) was higher than the interface temperatures (GREEN) for much of the winter, resulting in the measurements of high RH and possible condensation.

Figure 94. Hybrid ccSPF-cellulose interface Winter 2 temperature, with interior dewpoint

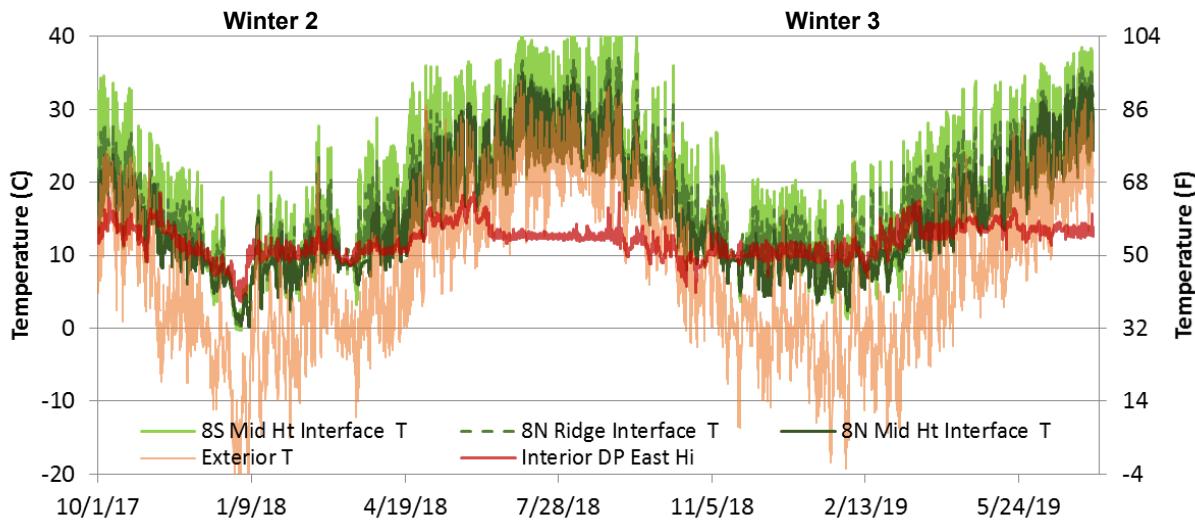
The interface conditions during Winter 2 and Winter 3 are shown for reference in Figure 95. With 50% RH interior conditions, the interior dewpoint was often greater than the interface temperature.

Figure 95. Hybrid ccSPF-cellulose interface Winter 2 and 3 temperatures, with interior dewpoint

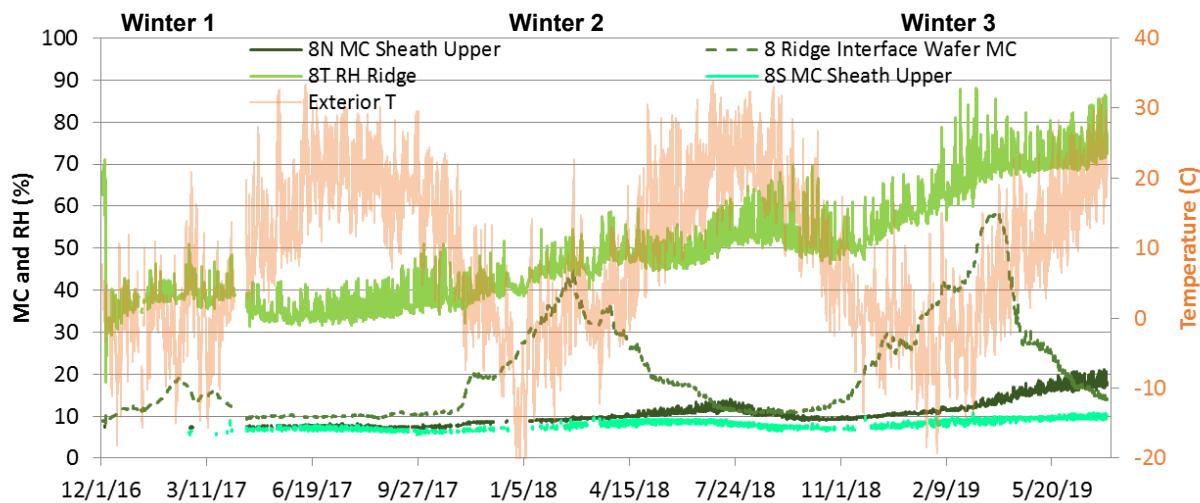
The ridge RH and upper sheathing MC (north and south) are plotted together in Figure 97; these reflect moisture conditions at the ccSPF-to-sheathing interface near the roof ridge. Ridge wafer MC (cellulose-to-ccSPF conditions) is also plotted; outdoor temperature is also plotted for reference.

Figure 97. Hybrid ccSPF-cellulose interface RH measurements, with exterior T

The continuous increase in RH (from 30% to 80%) would result in MCs rising from roughly 6% to 16%, assuming a typical sorption isotherm; this is roughly comparable to the north sheathing upper MC patterns. However, sheathing MCs indicate generally dry conditions and low risk. Wafer and sheathing MCs are not directly comparable; the wafer has a small form factor and is not subject to the same temperature gradients as roof sheathing, and is a different wood species than those composing OSB.

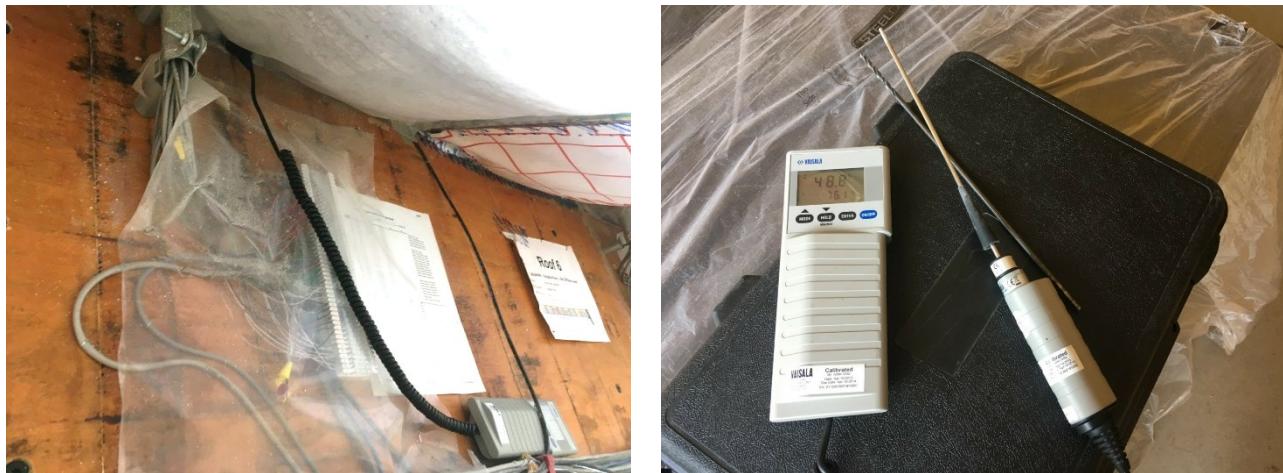
Figure 98. Measurement of T/RH at ridge using Vaisala probe

The Vaisala measurements showed temperatures consistent with instrumentation results, but RHs roughly 10% lower than logger data. This is consistent with the ridge RH sensor drifting upward over time. The roof ridge hits temperatures over 120°F/50°C during summertime conditions, which is a likely cause of long-term damage to sensors, especially capacitive polymer RH sensors.

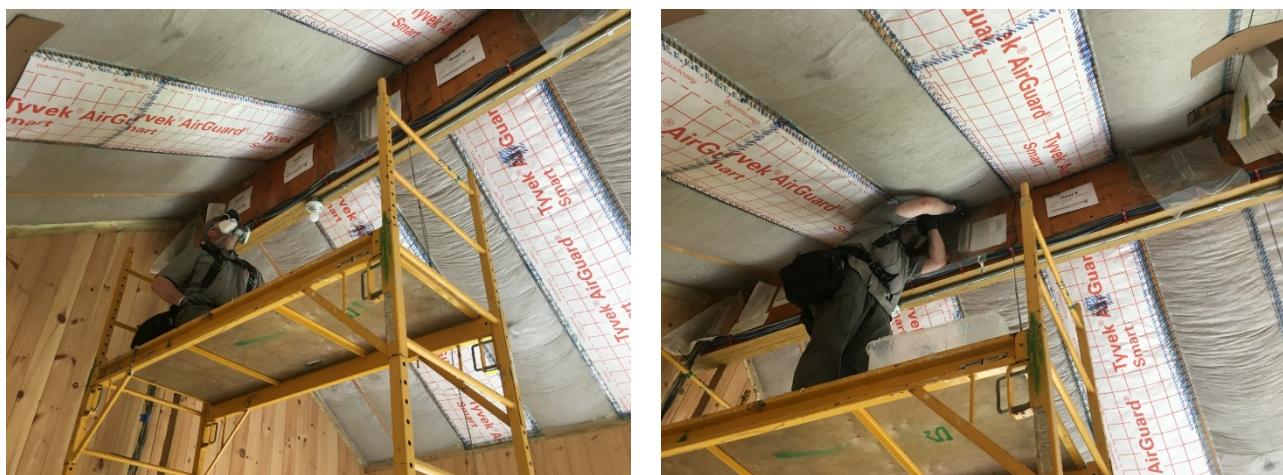
Given the high ccSPF-cellulose interface moisture levels, conditions were visually examined at the conclusion of the experiment. The guard bay between Roofs 6 and 7 was opened and the cellulose at the ridge removed (Figure 99).

Figure 99. Cellulose insulation removal at guard bay between Roofs 6 and 7

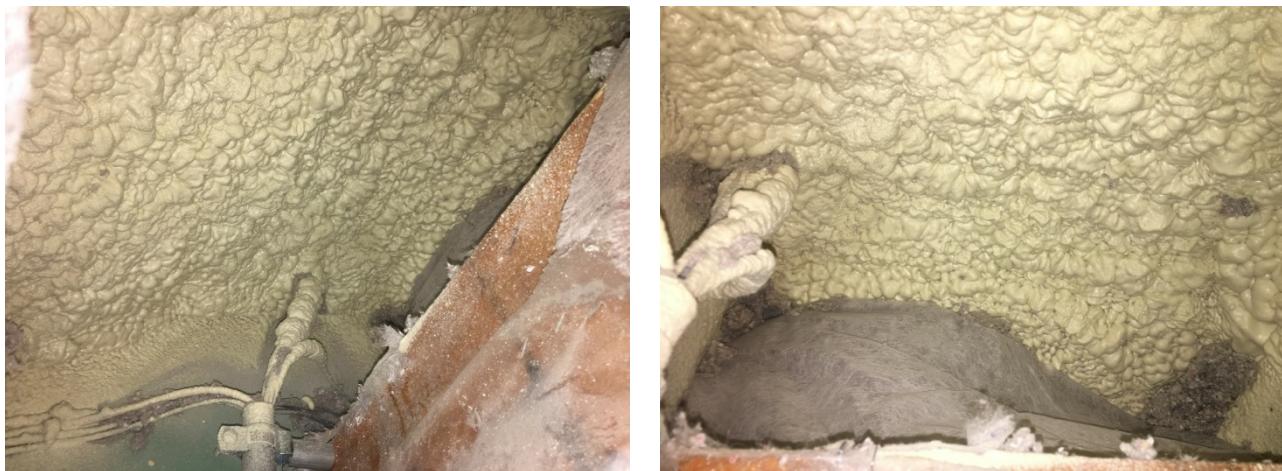
The cellulose was not “caked” or “packy” at the ccSPF-to-cellulose interface, as would be expected after liquid water wetting. The cellulose fell away freely when removed from the netting, leaving the ccSPF exposed. There was no visual indication of mold damage or staining on the ccSPF surface. Overall, this indicates that whatever wetting occurred safely dried without creating moisture issues. No insulation voids were noted between the ccSPF and cellulose in this disassembly.

Figure 100. ccSPF surface conditions after removal of cellulose insulation

However, direct observation of the interface (Figure 99 and Figure 100) showed no indication of mold growth. Note that in cellulose insulation assemblies, the combination of hygric storage and borate preservatives have been noted to reduce incidence of mold; the safety of this interface with other insulation materials is unknown.

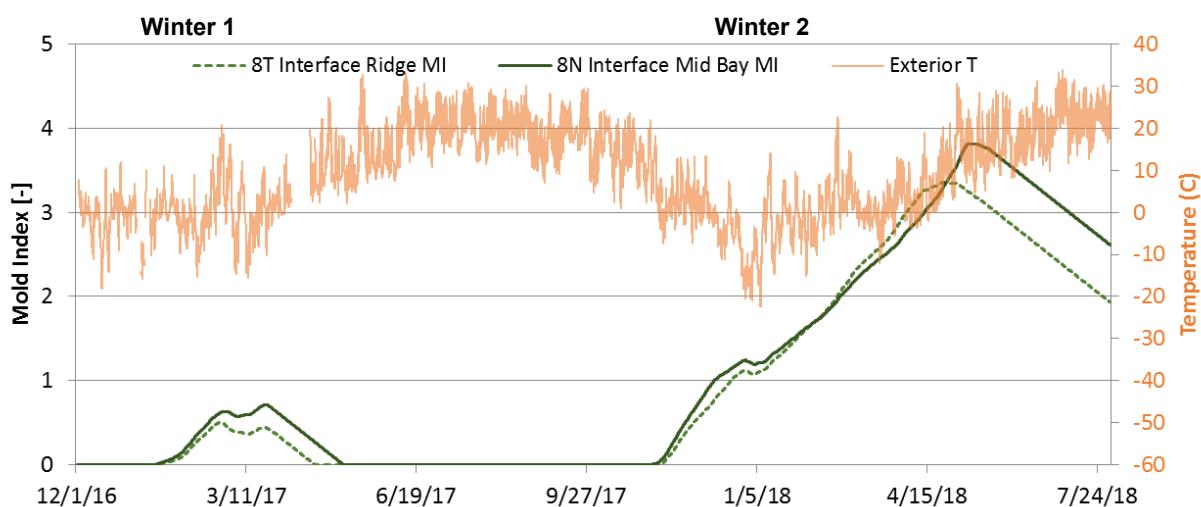
Mold index values were calculated for the ccSPF-cellulose interface (Figure 101); one potential risk is that warmer wintertime temperatures at this interface would be more amenable to mold growth. In Winter 1, the mold index at the north and ridge conditions remains low (well below 0.5). However, Winter 2 and the following spring showed mold index values over 3.0, in the risk range.

Figure 101. Hybrid ccSPF-cellulose interface mold index, with exterior T

The hybrid ccSPF-cellulose roofs showed elevated moisture levels in Winter 2 (Figure 91), with mold index predictions of noticeable growth (over 3.0, Figure 101). Therefore, disassembly exposing this interface was prioritized. However, the guard bays have identical construction to the hybrid Roof 8. In addition, one of the guard bays appeared to be the source of the ant infestation in Roof 3 (Figure 155).

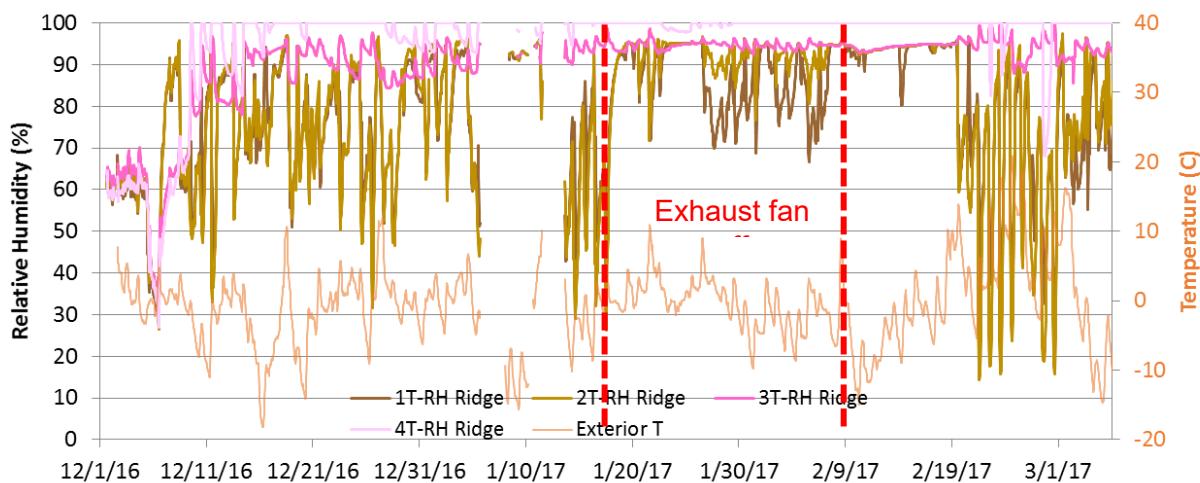
**Figure 112. Fiberglass roof ridge RH measurements, showing exhaust fan on/off**

RH at the roof ridge is plotted in Figure 112, and the period with the exhaust fan turned off is noted in red. During this fan-off period, the RH levels in Roofs 1 and 2 (diffusion vent/fiberglass) rise markedly and remain high. The likely explanation is that during exhaust fan-on periods, induced infiltration (small amounts of inward air leakage around or through the diffusion vent) protects the ridge from interior moisture. Turning off the fan removes this effect, as shown by the sharp rise in ridge RH. After the exhaust fan is turned off, RHs remain high for several weeks (possibly storage of accumulated moisture), but then drop.

After these findings were confirmed, the exhaust fan was turned off in early March (Figure 113), and noted in the data collection.

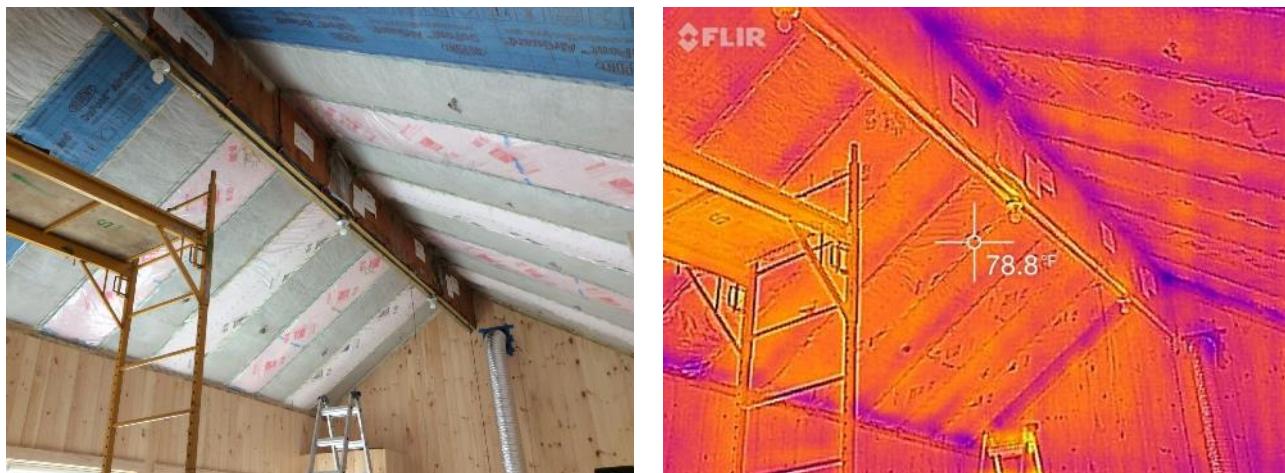
Figure 114. Visual and infrared image of interior of roof, no depressurization

Key findings include some thermal bridging at the ridge, rafters, and gable end/rake walls (Figure 114), as well as thermal bridging at the slab perimeter (Figure 115).

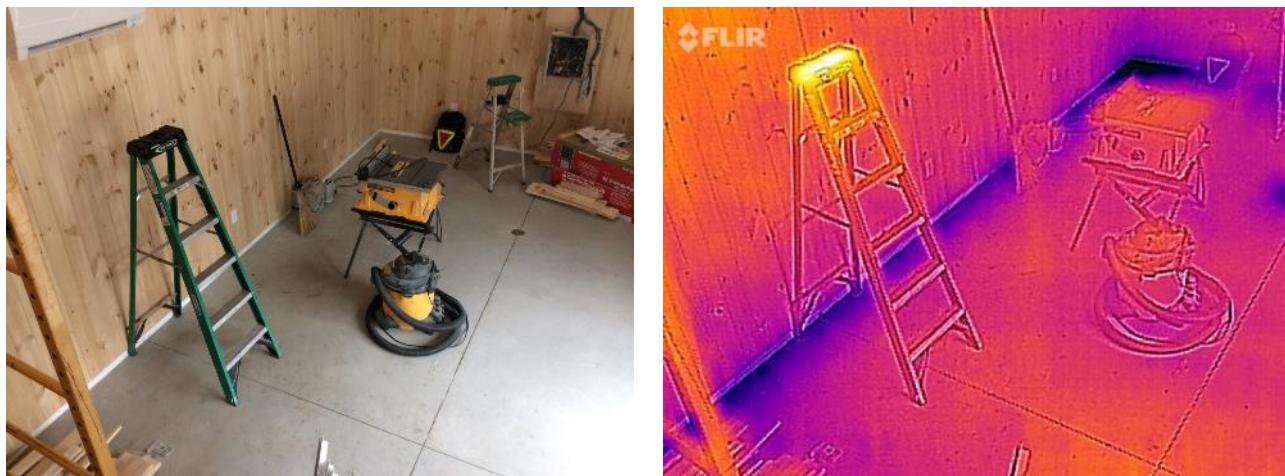
Figure 115. Visual and infrared image of floor-to-slab joint, no depressurization

The slab edge is insulated (with 4-in. semi-rigid mineral fiber); however, the wall is an even higher R-value (4-in. mineral fiber and 5-in. ccSPF), potentially causing this thermal anomaly. There are no noticeable thermal anomalies between roof bays (interior surface temperatures); concerns of uneven heat distribution from the wall-mounted minisplit head appear to be unfounded.

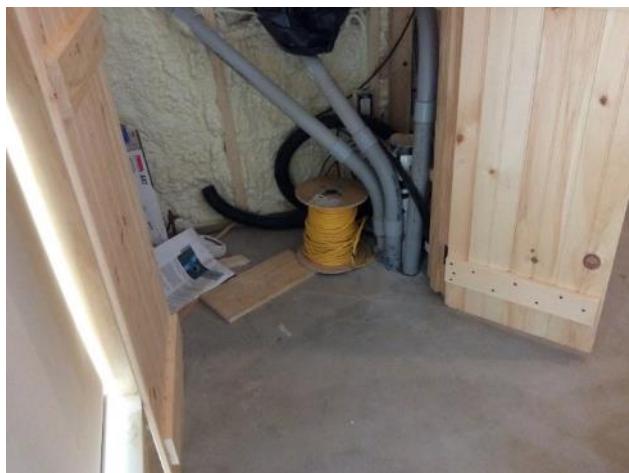
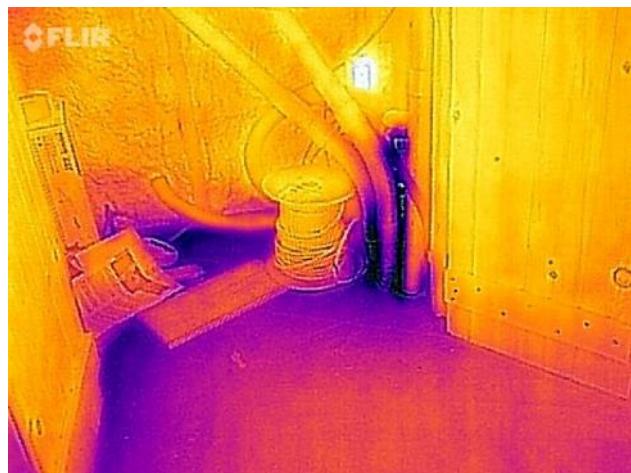
**Figure 116. Visual and infrared image of conduit penetration at slab, depressurization test**

The most significant air leakage was associated with electrical conduit penetrations through the slab (Figure 116); leakage occurred both through the conduit and at the opening between conduits. Exterior-to-interior airflow was confirmed with air velocity and temperature measurements via a Fieldpiece STA2 In Duct Hot-wire Anemometer (Figure 118, left), at 650 ft per minute/FPM and 58°F.

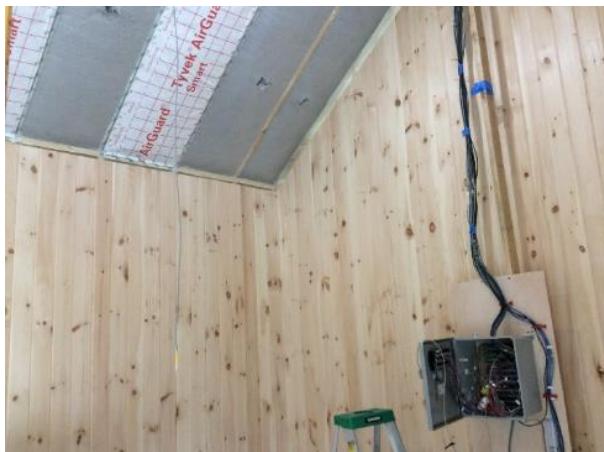
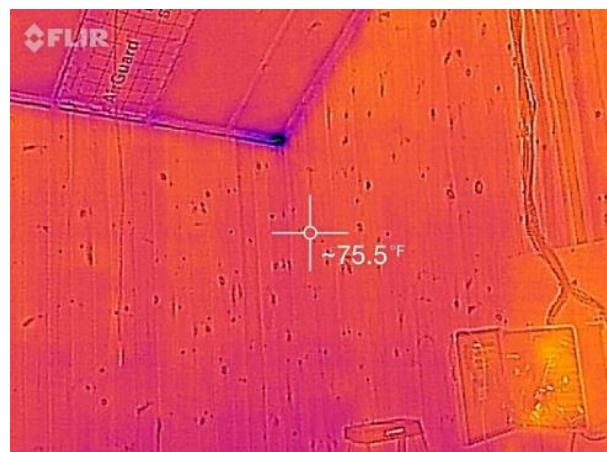
**Figure 117. Visual and infrared image of roof corner, depressurization test**

Another set of thermal anomalies was seen at the roof corners at the three-way intersection between the walls and roof (Figure 117). They were also examined with the anemometer (Figure 118); some corners showed airflow (99 FPM/66°F), but others had no measurable airflow despite the thermal anomaly.

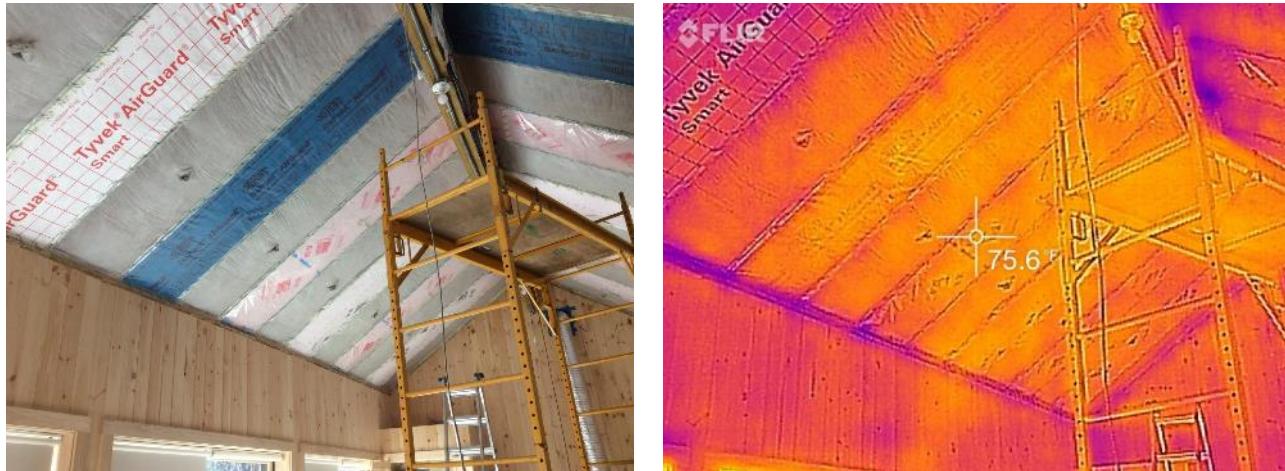
Figure 119. Visual and infrared image of overall roof, depressurization test

An infrared overview of the roof under depressurization testing is shown in Figure 119; no clear difference between the unpressurized and depressurized test was evident. Although there might be air leakage hidden behind the fibrous insulation, if rates are low, they would be difficult to detect from the interior.
