# Monitoring of Unvented Roofs with Fibrous Insulation, Diffusion Vents, and Interior Vapor Control in a Cold Climate

September 2020

*Prepared by:*  
Building Science Corporation  
70 Main Street  
Westford, MA 01886

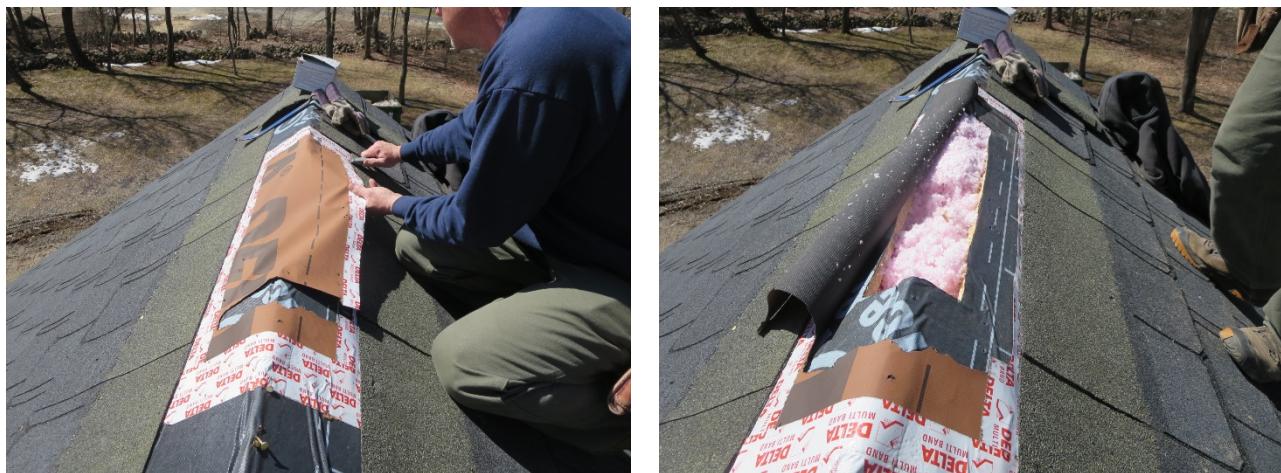
**Figure 121. Cutting open existing diffusion vent ridge membrane, after vent removal**

The ridge vent was removed and the diffusion vent material was opened to expose cavity conditions (Figure 121). The only notable anomaly was that the diffusion vent material was cut much larger than the sheathing opening. No empty nail holes penetrated the diffusion vent.

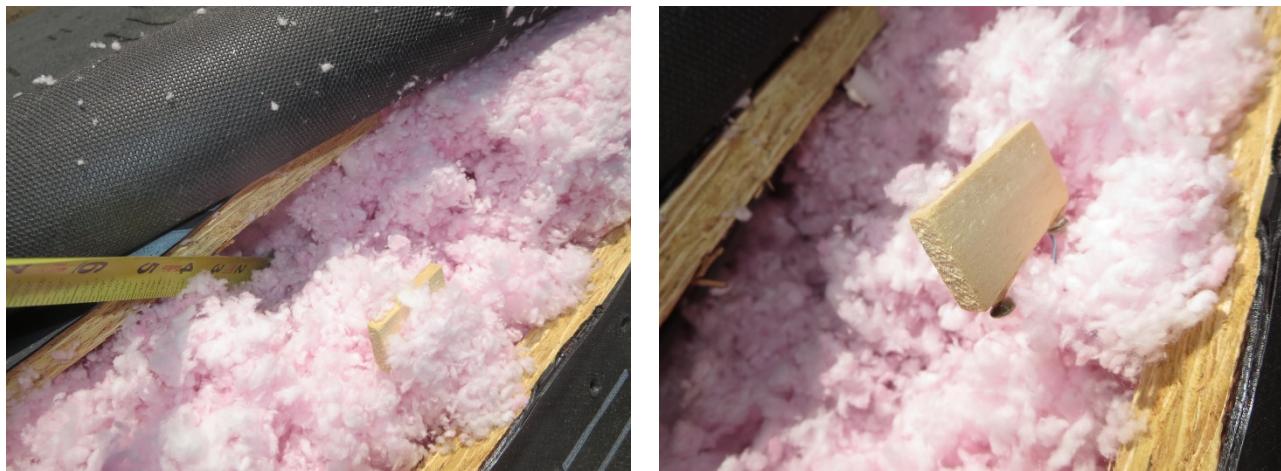
Conditions inside the cavity revealed incomplete fill of fiberglass insulation at the ridge (Figure 122, left). The ridge wafer was examined for any sign of moisture damage or mold spotting (Figure 122, right); none was seen. In the monitored data, Roof 1 has the driest ridge conditions out of the four fiberglass roof assemblies (1–4).

**Figure 122. Void at Roof 1 ridge insulation (left) and ridge wafer condition (right)**

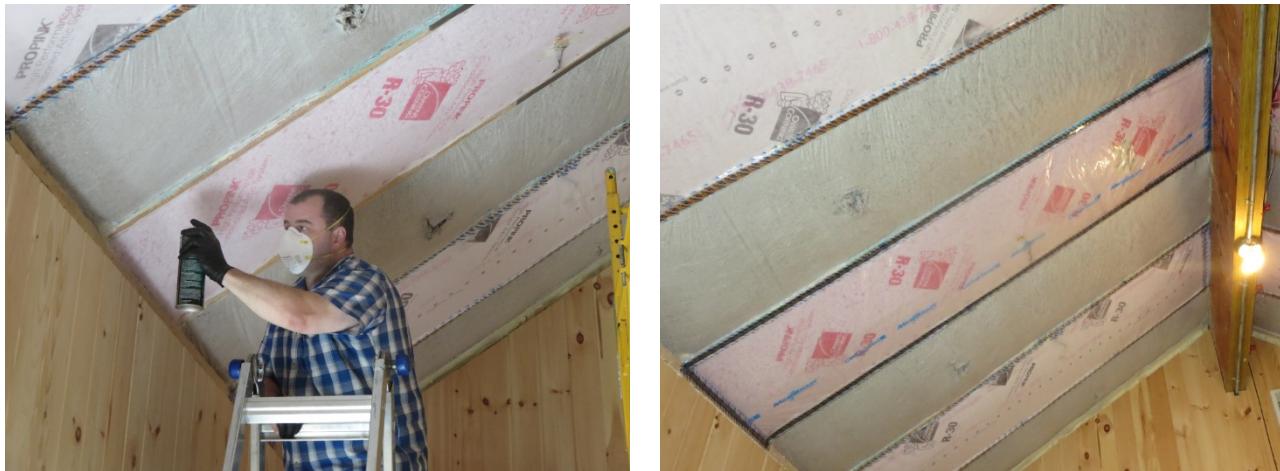
**Figure 128. Reinstallation of Roof 2 vapor retarder: spray adhesive (left) and taped edges (right)**

Measurements of ridge conditions during Winter 1 indicated that Roof 2 had signs of disproportionate leakage of interior air near the ridge. Inspection of current conditions at Roof 2 showed a loss of adhesion of the housewrap tape and the double-sided tape near the ridge, thus connecting the bay to interior conditions (Figure 127). In addition, several roofs were retrofitted with alternate interior vapor retarders. Instead of repairing this installation, the existing vapor retarder was removed and a new interior membrane was installed.

A multistep process was used to improve the air seal (Figure 128), including (a) removal of all old tapes and seals, (b) using contact spray adhesive (3M 90) on the face of the wood rafter, (c) using double-sided tape on the rafter to form a primary seal (Saint-Gobain Norbond foam tape), (d) using high-performance housewrap tape on the rafter as a secondary seal (Dow Weathermate Construction Tape), and (e) using a roller and/or squeegee to improve the adhesive bond.

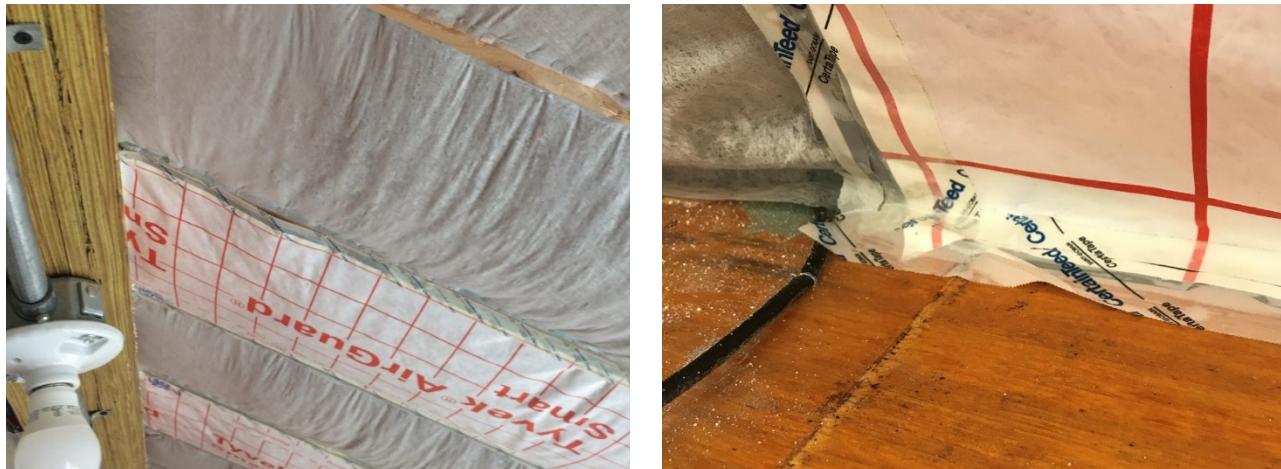
Some of the other roofs showed minor tape adhesion issues (Figure 131). This was addressed by retrofitting the tape seals in place, by cutting away the failed housewrap tape (leaving the double-

Figure 131. Tape adhesion loss at Roof 6 along rafter and at ridge

sided tape in place), applying high-performance construction tape, and rollering to improve adhesion (Figure 132). This was done at all bays that had the older housewrap tape.

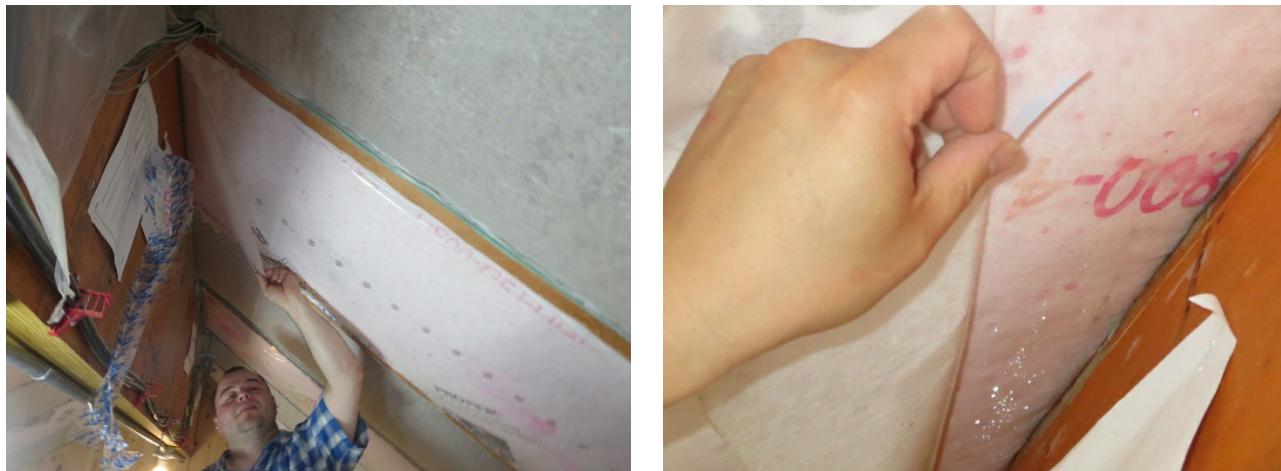
The interior fixed-perm vapor retarders on Roofs 3 and 5 were removed from the ridge beam downward (Figure 133, left); this revealed the accumulation of liquid water condensation at the vapor retarder-insulation netting interface, as demonstrated by visible droplets and water indicator paper (Figure 133, right). Further demonstrations of this wetting are shown in Figure

The pattern of wetness was worst at the ridge and decreased down the slope of the roof. The most noticeable patterns of wetness extended roughly 3 ft from the ridge. Wetness appeared to be roughly similar on north and south slopes.

Figure 133. Roof 3 vapor retarder removal (left), condensation accumulation (right)

This condensation might not fully reflect normal operating conditions: due to a controls issues, the interior temperature was set at roughly 60°F for a period before these observations. However, even if the interior temperature is non-representative, the spatial accumulation patterns are useful information.

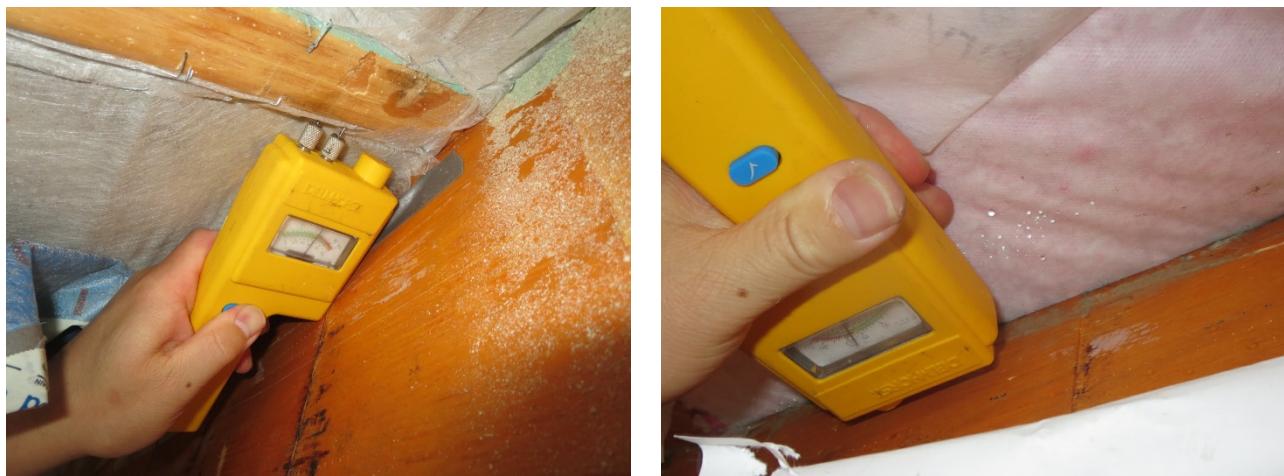
Wood MCs were measured at the framing with a handheld Delmhorst BD-10 meter (Figure 136). Consistent patterns were not seen, but MCs ranged from roughly 15% to 25%, with the highest MCs at the edges of the rafters near the ridge (per Figure 136, left).

Figure 136. Wood MC measurements at framing

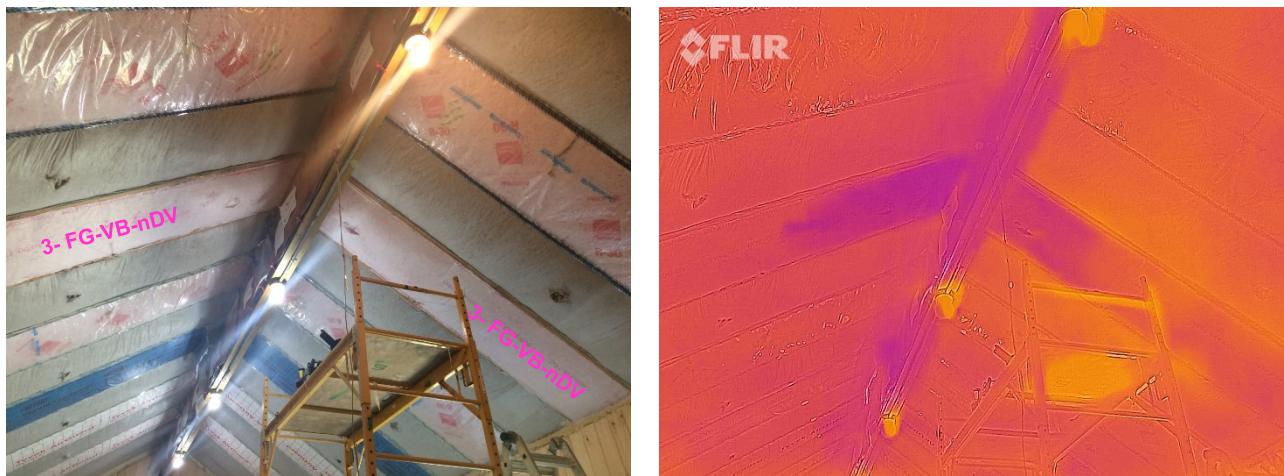
Roof conditions were also examined with an infrared camera (FLIR ONE Pro, -20°C to 400°C/ -4°F to 752°F, accuracy  $\pm 3^\circ\text{C}/5.4^\circ\text{F}$  or  $\pm 5\%$ , typical). With the interior vapor retarders removed, a pattern of cooler temperatures was observed at the ridge (Figure 114 and Figure 138), matching the wetted areas. This is ascribed to evaporative cooling of water from the exposed surfaces to the interior.

Figure 137. Visual and infrared image of Roof 3 (fiberglass) after fixed-perm vapor retarder removal

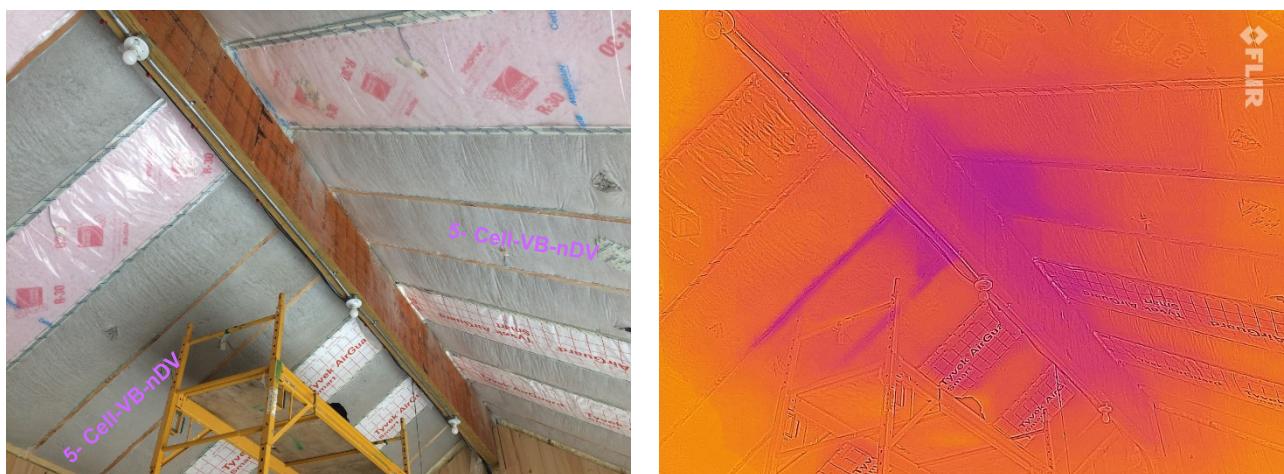
At Roof 5 (cellulose, Figure 138), the rafter framing was also cooler than adjacent bays, suggesting moisture accumulation at the wood. In addition, cooler surfaces were seen at the ridges of Roofs 6 and 7, suggesting possible ridge moisture accumulation in these variable-perm roof bays.

Figure 138. Visual and infrared image of Roof 5 (cellulose) after fixed-perm vapor retarder removal

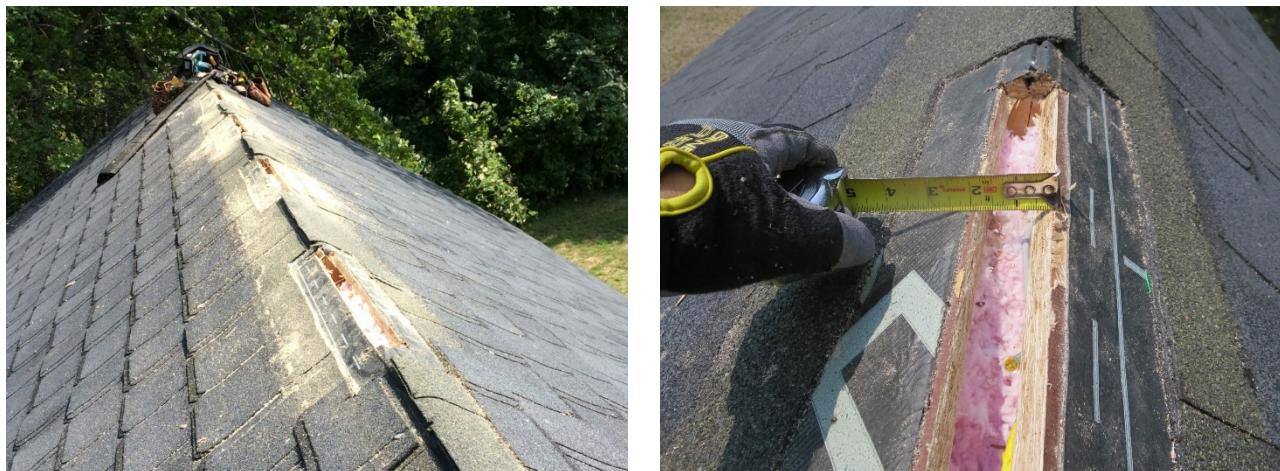
Figure 140. Retrofit of 2-in. wide diffusion vents at Roofs 4, 5, 6, and 7

The non-diffusion-vent roofs (Roofs 3, 4, 5, and 6) were retrofitted with 2-in. wide diffusion vents (as detailed in Table 3) in late August 2017. The self-adhered membrane and sheathing were cut back to create a roughly 2-in. wide opening (Figure 140). The openings are roughly 22 in. wide (full width of the rafter bay).

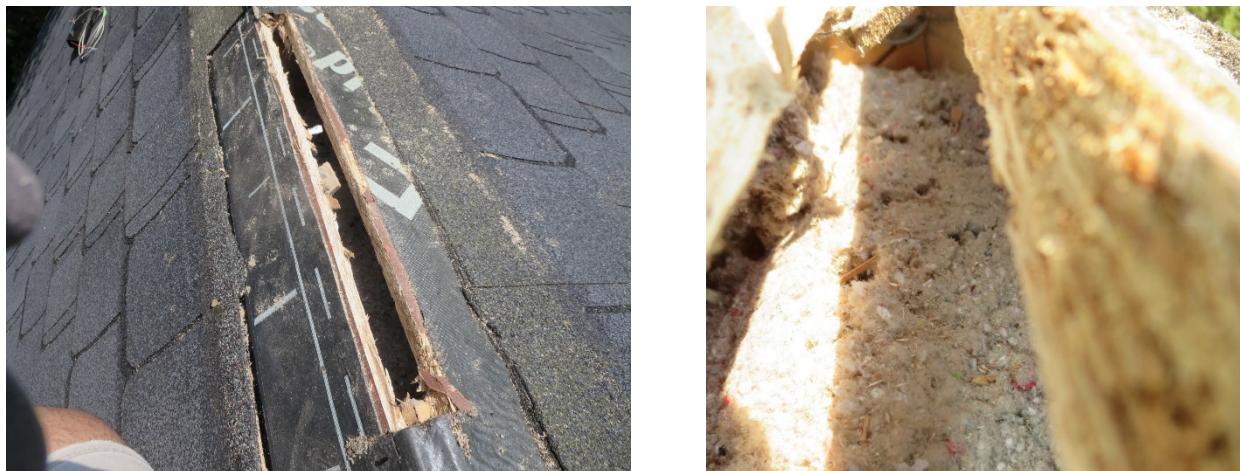
Insulation settling was also seen at the cellulose roofs (Figure 143). This settling at the ridge was in the range of 4 to 8 in., typically (Figure 144).

Figure 143. Settling of cellulose insulation at ridge, Roof 5

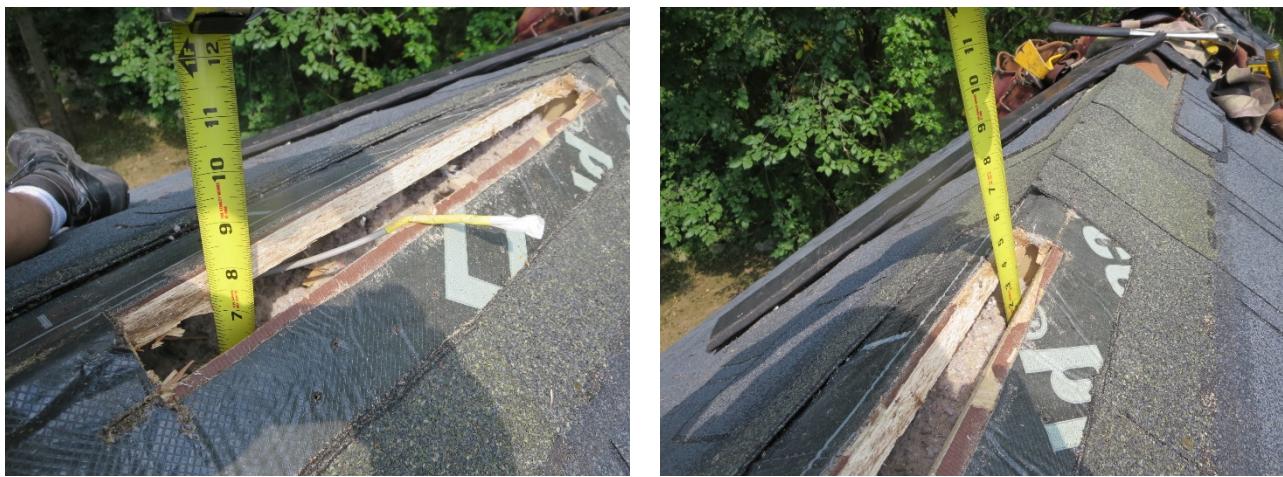
**Figure 144. Settling of cellulose insulation at ridge, Roof 6**

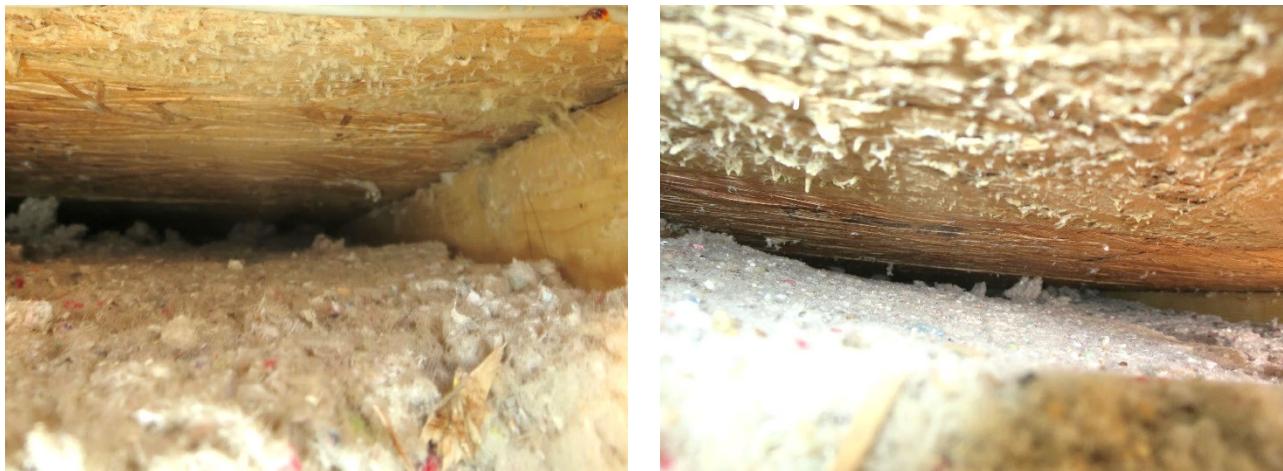
However, a surprising finding was that there was significant settling on the north-facing slope in both Roofs 5 and 6, varying from minimal to roughly 1 in. (Figure 145, showing view down slope).

**Figure 145. Settling of cellulose insulation on north-facing slope, Roof 5**

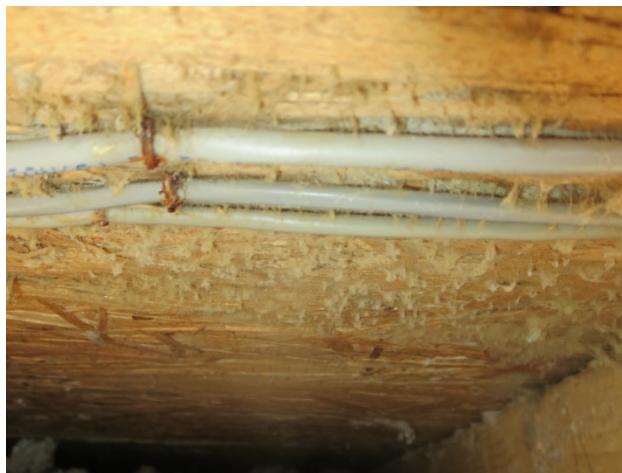
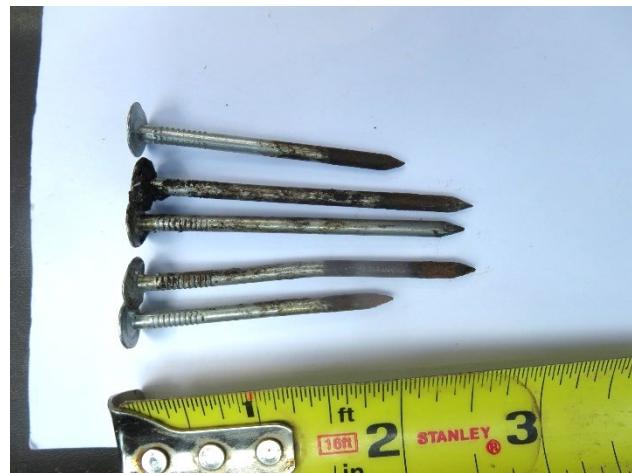
- The disassembled non-diffusion-vent roofs did not show visible mold growth or damage to the sheathing from openings at the ridge exterior. However, signs of moisture issues included corrosion of metal hardware exposed to the rafter cavity, including roofing nails and instrumentation staples. This disassembly work is covered in Section 13: Diffusion Vent Retrofit and Insulation Settling (Prior to Winter 2) and Figure 147.

In addition, this roof disassembly allowed for examination of the assembly for signs of moisture issues. The sheathing removed to create the ridge diffusion vent was intact and did not show macroscopic signs of mold growth, delamination, or other damage. However, metal fasteners exposed to roof bay conditions shows signs of corrosion, including staples used for instrumentation wiring (Figure 147, left), and roofing nails, where they penetrated the sheathing (Figure 147, right). Note that the longer nails were used at the ridge cap, with less of the shank penetrating the sheathing.

Figure 147. Corrosion of wire staples (left) and corrosion of roofing nails (right)

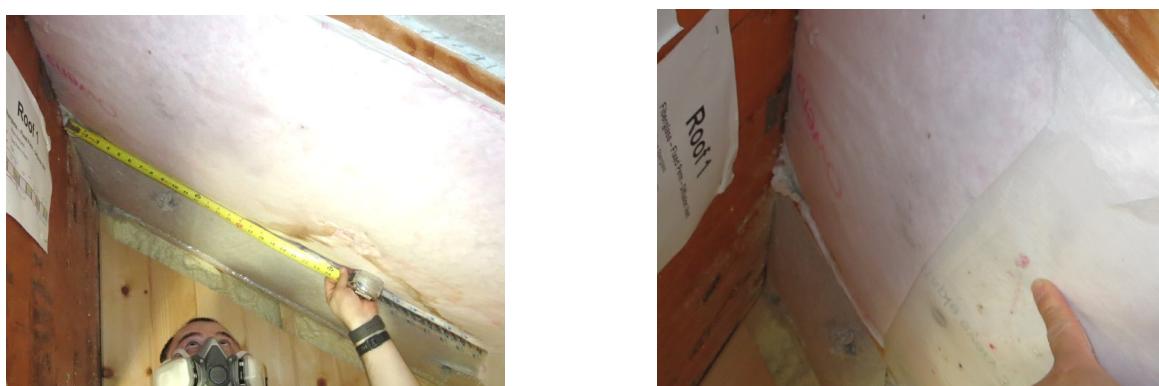
Roof 1 (Winter 1 and 2-full-size diffusion vent; fixed-perm interior vapor barrier) disassembly showed noticeable water staining on the vapor retarder and netting, on the north side (Figure 150, left).

Figure 150. Roof 1 water staining on netting (left) and pink spotting on fixed-perm vapor barrier (right)

In addition, dried pink spotting was found on the exterior side of the interior vapor barrier (Figure 150, right), consistent with summertime inward drive condensation on the fixed-perm vapor retarder at the ridge (like Roof 3, Figure 133 and Figure 134).

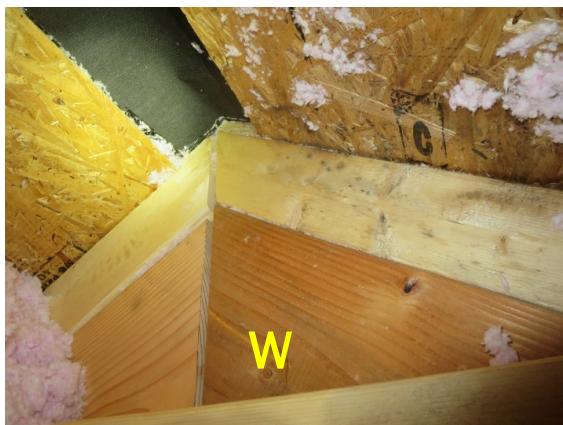
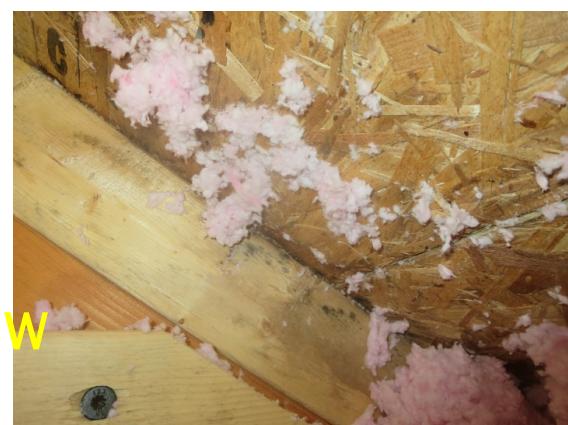
Further disassembly revealed minor mold spotting on the framing. The rafters are framed with a “stacked” 2x12 and 2x4 assembly to achieve a ~14.75-in. cavity depth. The visible mold occurred in the north bay, on the west-side rafter, on the 2x4 (lighter colored wood, Figure 151, left). There was minor staining on the roof sheathing near the west-side rafter (Figure 151, left, and Figure 152, left). In comparison, the east-side rafter was mostly clean, but with some minor mold spotting on the 2x4 (Figure 152, right). Some minor spotting was also seen on the horizontal collar tie (similar light-colored lumber to “stacked” 2x4).

The west-side rafter showed a noticeable bulk water stain on the 2x4, originating at the sheathing joint (Figure 151, right). The most likely explanation based on the visible patterns was condensation and rundown from the roof ridge along the sheathing; at the sheathing joint, surface tension resulted in a “drip,” causing the visible staining on the interior vapor control shown in Figure 150 (left).

Figure 151. Roof 1 mold spotting on sheathing/framing (left) and bulk water stain on 2x4 (right)

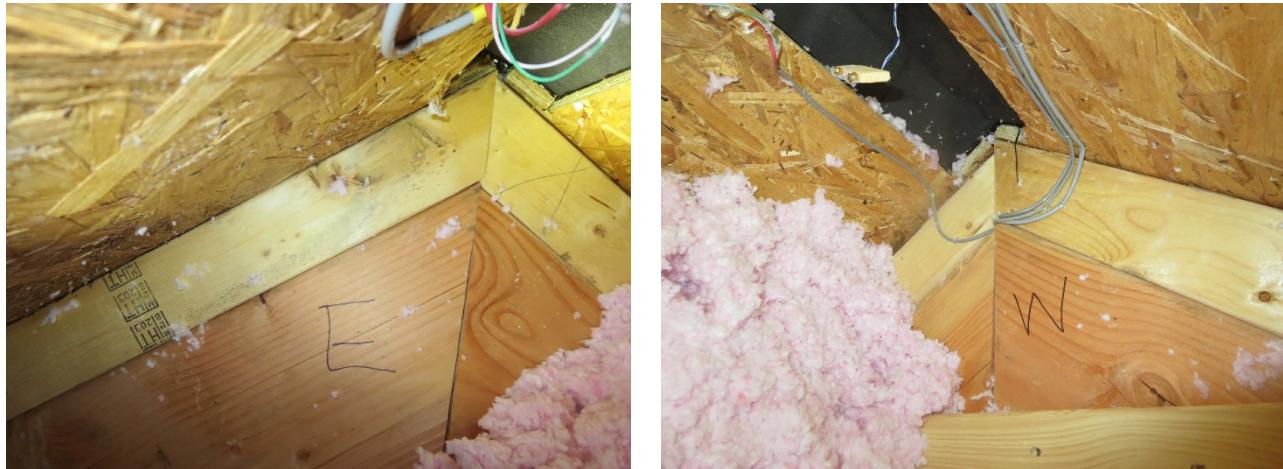
Roof 2 (Winter 1 and 2 full-size diffusion vent; variable-perm interior SVR) showed minor mold spotting on the east-side rafter (Figure 153, left) and no visible issues on the west side (Figure 153, right). This roof generally showed the least moisture accumulation, given the large ridge diffusion vent and variable-perm interior vapor control.

Figure 153. Roof 2 minor mold spotting on east rafter (left) clean conditions on west rafter (right)

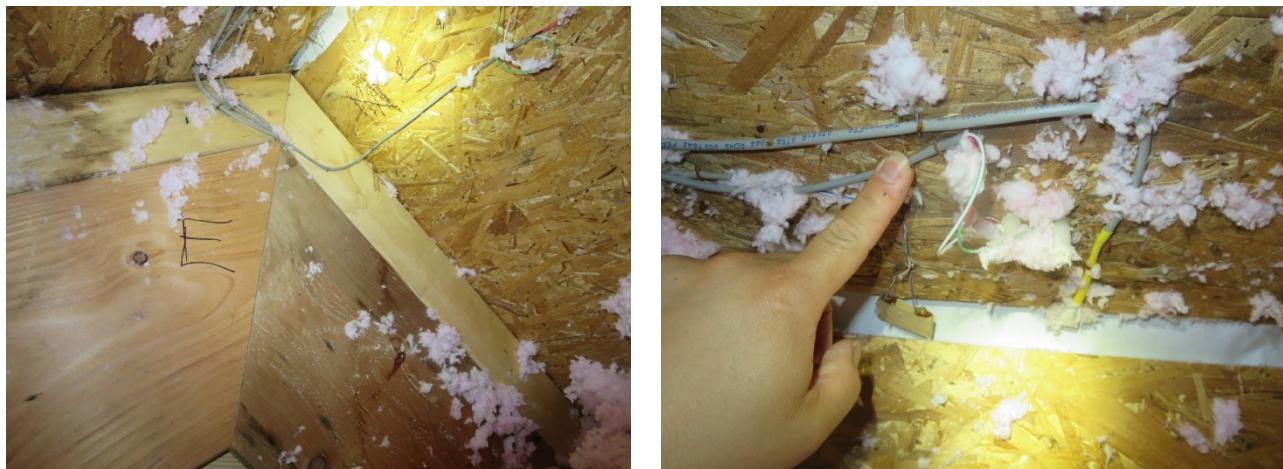
Roof 3 (Winter 1 no diffusion vent, fixed-perm vapor barrier; Winter 2 tight diffusion vent, SVR) showed some of the worst moisture accumulation in monitoring, specifically during Winter 2. Roof 3 had extensive stains matching bulk water drainage near the ridge on the east rafter (Figure 154, left), and some visible spotting. This stain is consistent with ridge condensation that drained down from the sheathing.

At the sheathing, there was noticeable discoloration, raising of the wood grain/wafers or slight delamination, and extensive corrosion of the instrumentation staples (Figure 154, right).

Figure 154. Roof 3 mold and staining on east rafter (left); sheathing damage and rusted staples (right)

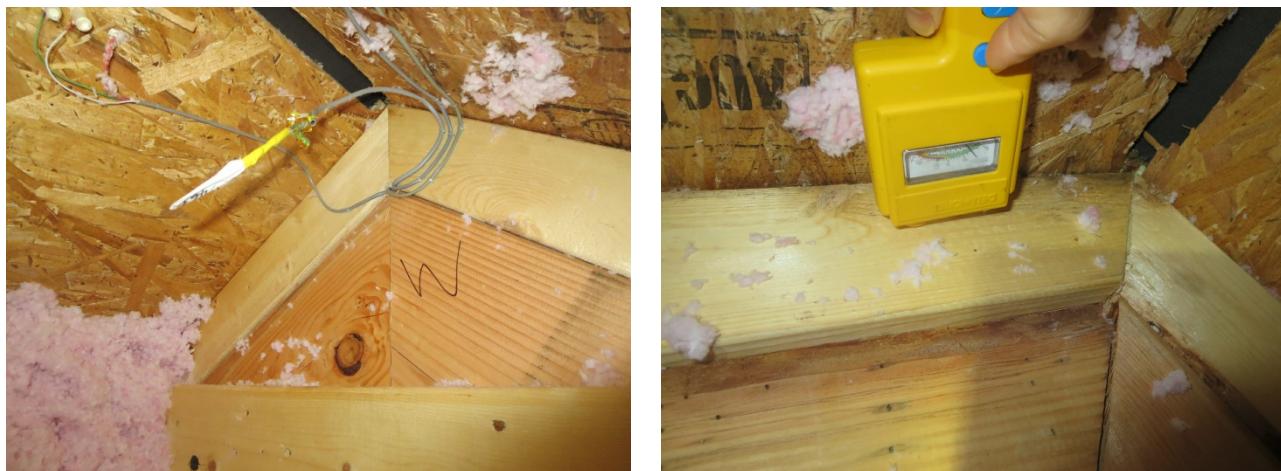
The west rafter appeared to be mostly intact and unstained (Figure 157, left).

In addition to visual inspections, wood MC measurements were taken at all stained areas, using a handheld Delmhorst BD-10 meter (Figure 157, right); all conditions were dry, as would be expected for summertime measurements.

**Figure 157. Roof 4 mostly clean conditions on west rafter (left) wood MC measurements (right)**

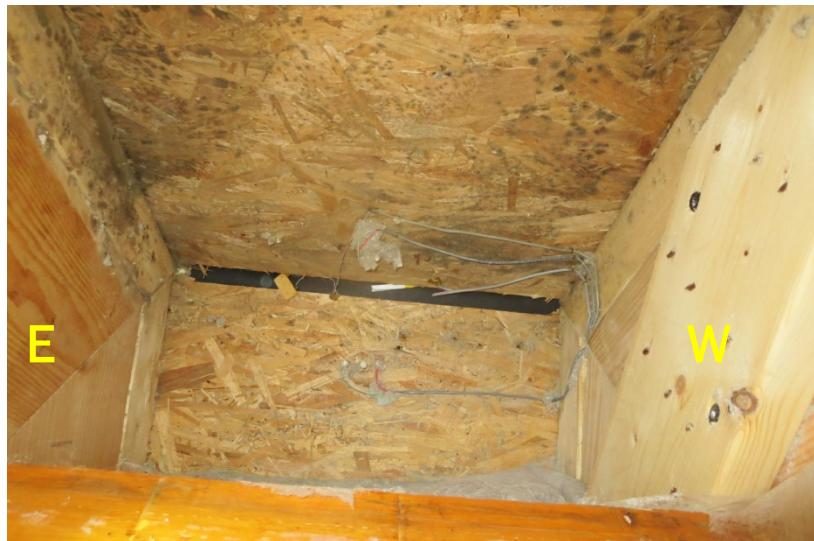
Roof 6 (Winter 1 no diffusion vent, SVR; Winter 2 small diffusion vent, SVR) also showed extensive staining to the framing (east-side rafter) and north roof bay sheathing, per Figure 162. The sheathing showed discoloration, grain raise, mold spotting, and extensively corroded fasteners.

**Figure 162. Roof 6 peak overview; extensive mold on east rafter and north sheathing**

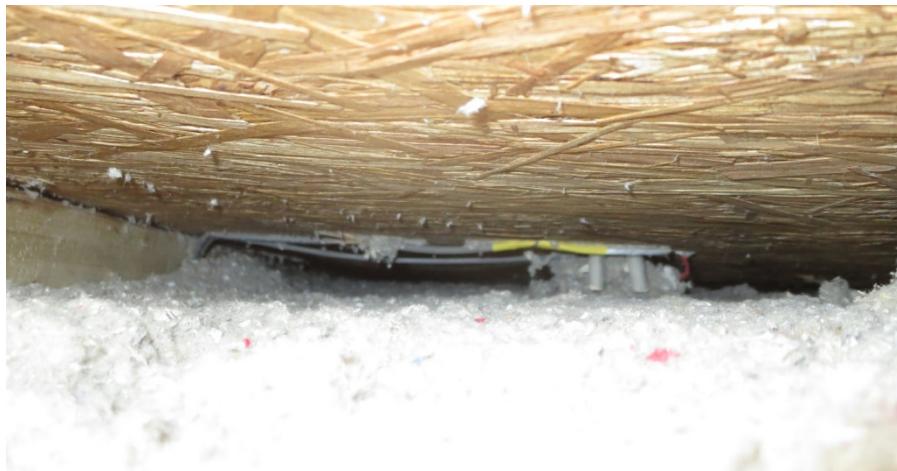
Roof 6 showed the same cellulose settling seen on Roof 5; a shot down the north rafter bay (Figure 164) shows cellulose stuck between the sheathing instruments. This indicates that settling occurred after insulation installation.

**Figure 164. Roof 6 cellulose settling and gap at north rafter bay; note cellulose stuck in instruments**

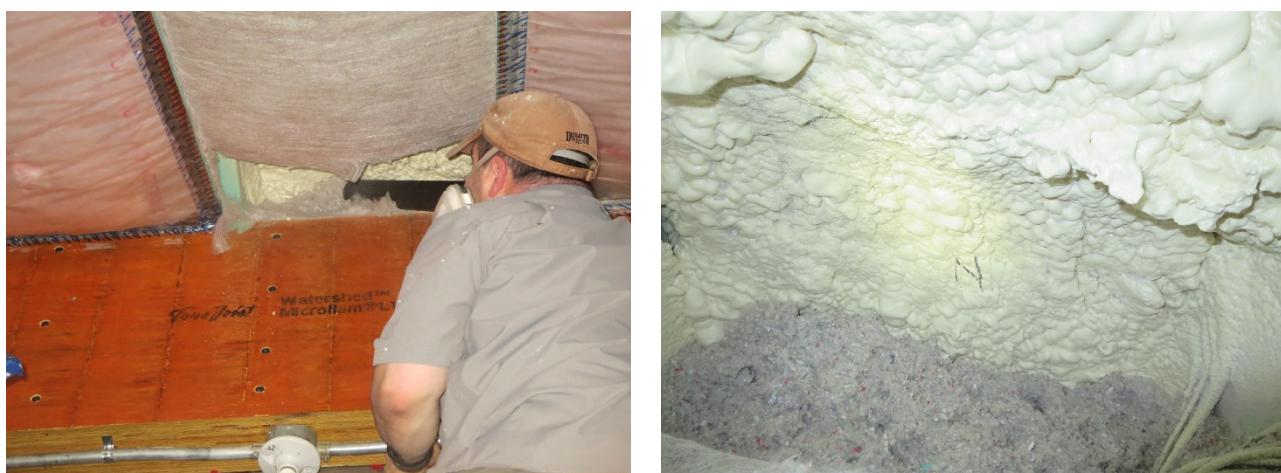
Therefore, the guard bay between Roofs 3 and 4 was disassembled, exposing the interface (Figure 167, left). No evidence was found of significant wetting, which would include “packy” or caked cellulose insulation, visible staining, or odors.

Figure 167. Disassembly of guard bay (hybrid ccSPF-cellulose) ridge and examination

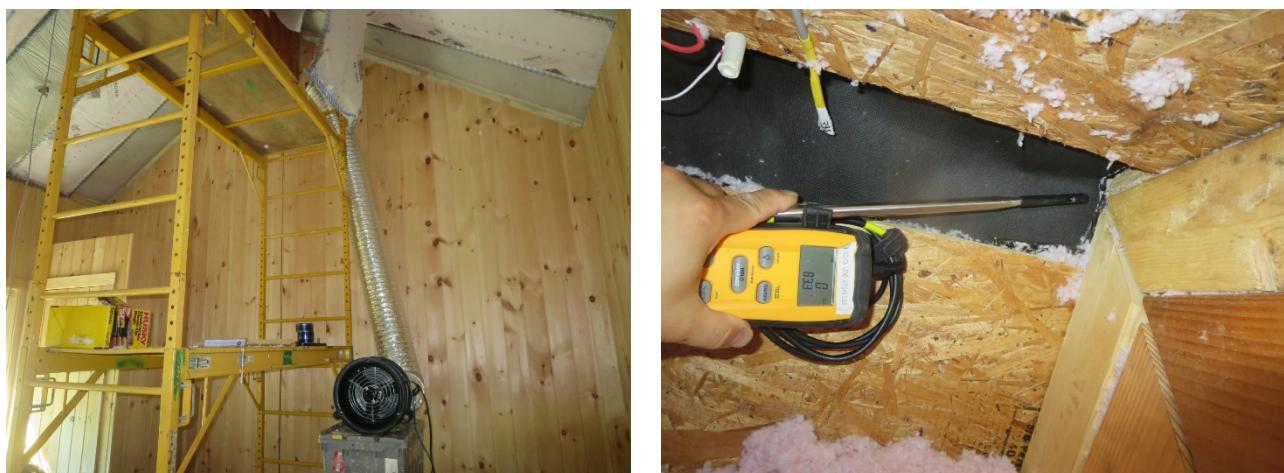
Therefore, the test hut was depressurized to  $-75 \text{ Pa}$  (Figure 168, left), and airflow at the diffusion vent was measured with a Fieldpiece STA2 In Duct Hot-wire Anemometer (Figure 168, right). No airflow was measured. However, later calculations demonstrate that an airflow of  $0.69 \text{ l/(s}\cdot\text{m}^2\text{)} @ 75 \text{ Pa}$  is equal to a velocity of  $0.13 \text{ ft per minute/FPM}$ , which is far below the equipment's measurement range of  $40 \text{ FPM}$ . However, this testing showed no "bypass" air leakage, due to imperfect tape sealing of the diffusion vent.

Figure 168. Test hut depressurization (left) and airflow measurement at diffusion vent (right)

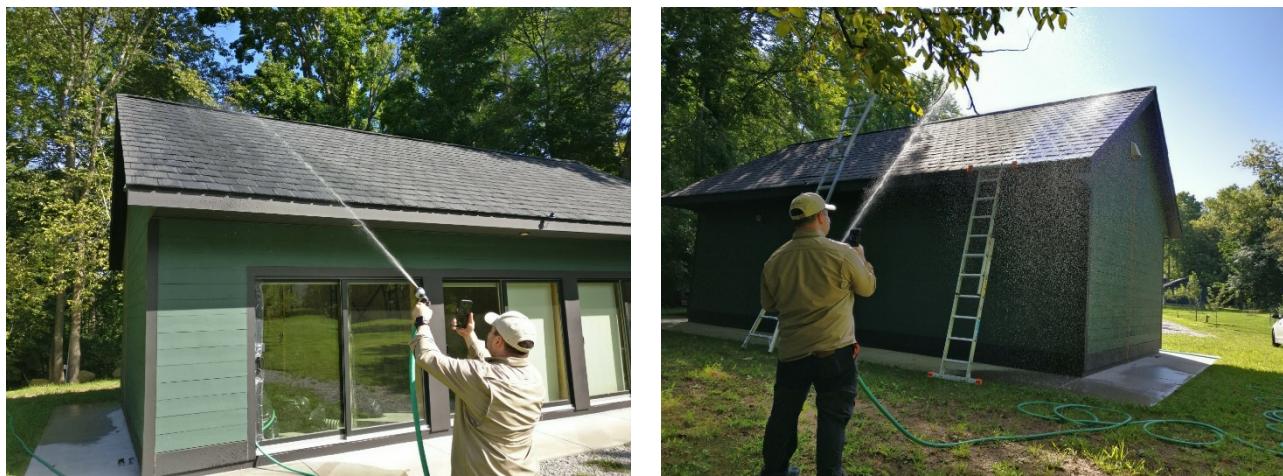
**Figure 169. Hose spray testing of roof ridges with interior observation**

Another possible issue was that the visible bulk water staining was due to precipitation leakage rather than condensation rundown. Therefore, the test hut was depressurized to  $-75 \text{ Pa}$ , and water was sprayed, aiming at the ridge detail (Figure 169), to simulate the effect of wind-driven rain.

This test was conducted for 10 minutes of water spraying from each side, with no detectable water leakage visible from the interior. Infrared observation during this testing distinctly showed cooling of the diffusion vent and ridge from water spraying, but no water penetration.

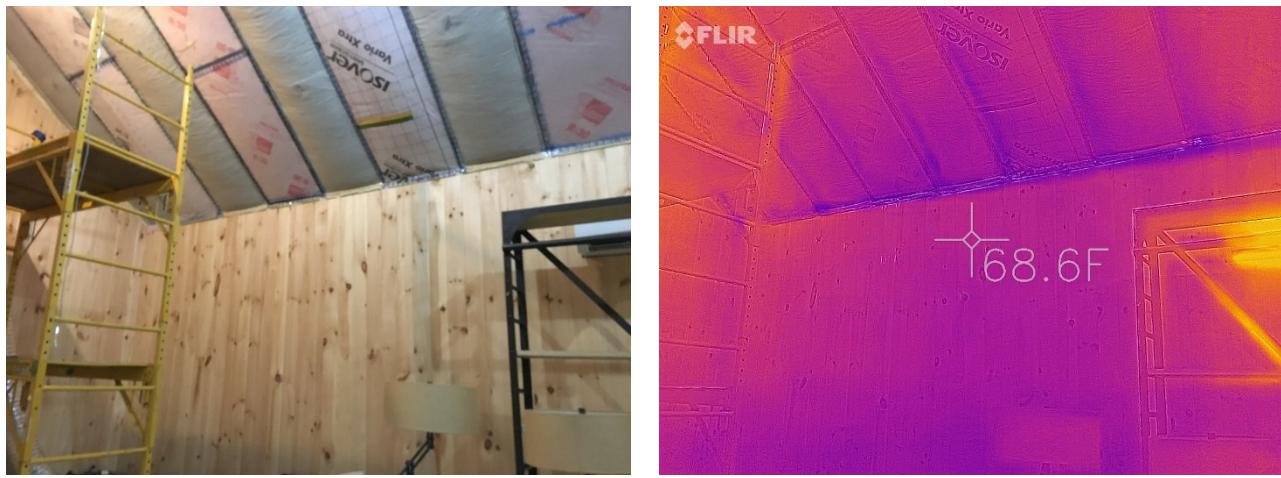
Figure 173. Visual and infrared image of interior of roof, depressurization testing

A baseline infrared observation of the building was done prior to depressurization to identify existing thermal bridges or other anomalies and to avoid ascribing them to depressurization air leakage. Findings included thermal bridging at the roof framing (Figure 173), thermal stratification of the interior (consistent with interior temperature measurements), and thermal bridging at the slab perimeter (per previous observations).

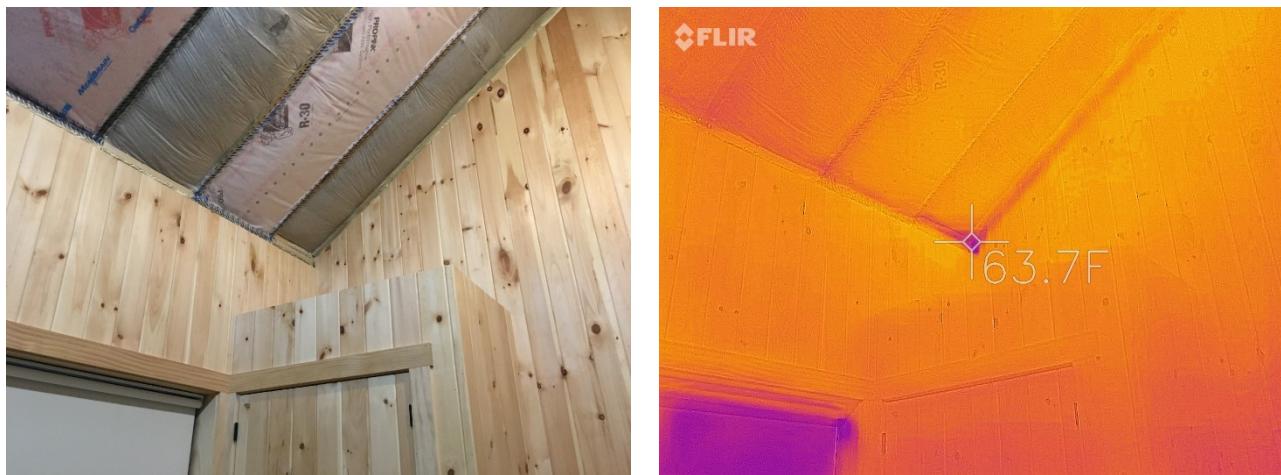
Figure 174. Visual and infrared image of interior of roof, depressurization testing

Then, infrared observation was combined with depressurization to search for air leakage. Figure 174 shows a point air leak at the corner of the building (triple point connection of walls to roof). However, this air leak is in a guard bay, not a test bay, so it does not affect the research. Similarly, a point air leak was found at an upper corner of a sliding glass door (Figure 175, Figure 116); again, this does not affect the test roofs.

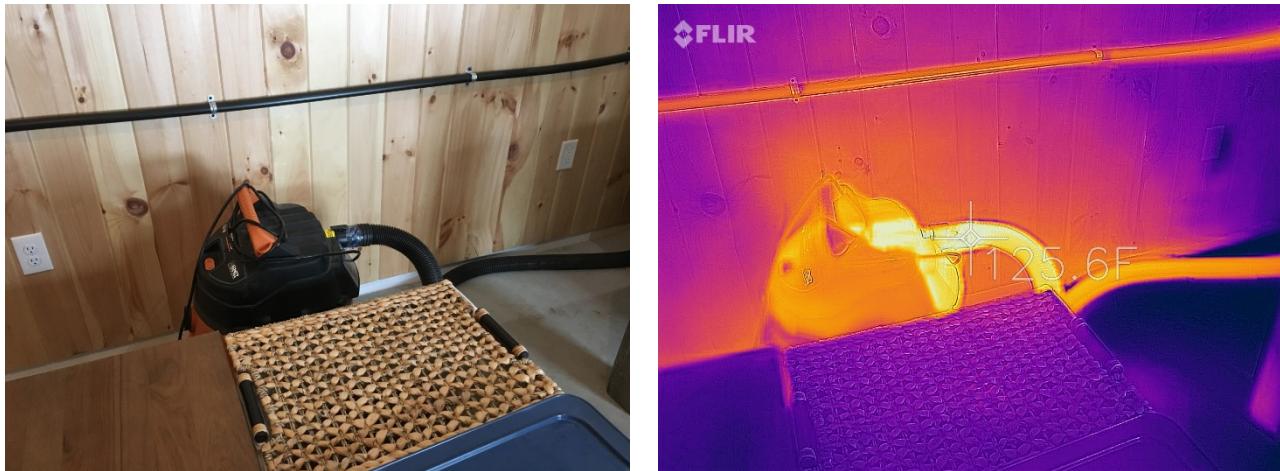
Figure 191. Visual and infrared image of shop vacuum; heat generation visible

The air injection system and roof bays were inspected with an infrared camera while in operation. The shop vacuum was noticeably hot in operation (maximum temperature 113°F, Figure 173); this is consistent with the unit operating with constricted flow and in continuous operation. This was concerning, as injecting high-temperature air into the rafter bays is not representative of in-service air leakage in the field.

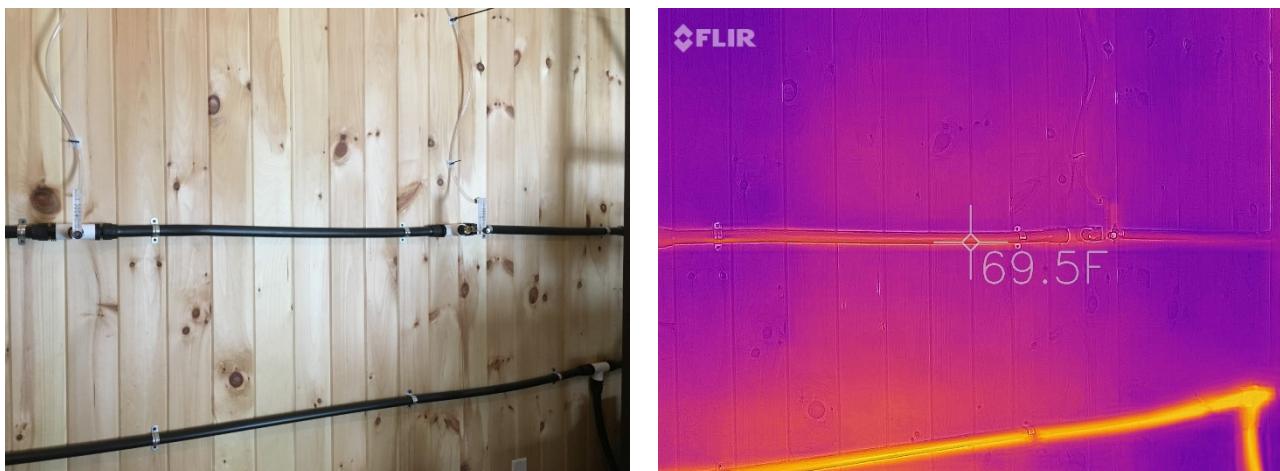
Figure 192. Visual and infrared image of manifold and tubing; PVC tubing at ambient temperature

However, examining the upper manifold tube and the small-diameter PVC tubing (Figure 192), the air had cooled to ambient test hut conditions. This is consistent with the small airflow (0.5 CFM per rafter bay) and exposed surface area of the tubing.

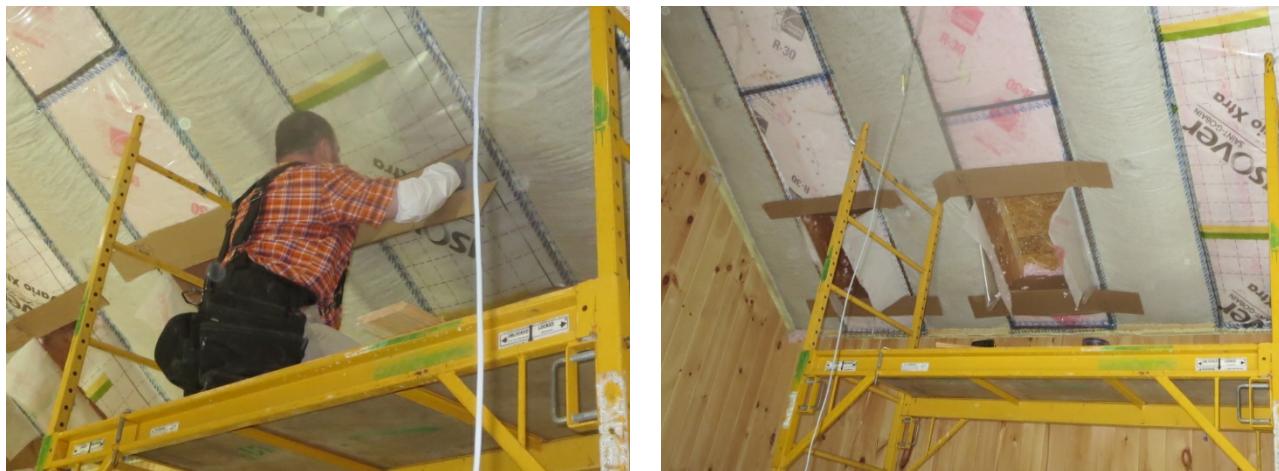
Figure 193. Installation of cardboard baffles for north roof sheathing examination

Given the high sheathing MCs measured at the north lower roofs after running the air injection system (Figure 57 and Figure 81), the assembly was visually inspected to examine indications of moisture damage and/or mold. The interior vapor control and netting were opened directly above the air injection port, low on the north roof, 1 or 2 ft up. Cardboard baffles were inserted to hold back the insulation, fastened in place, and the insulation removed, per Figure 193 and Figure 194.

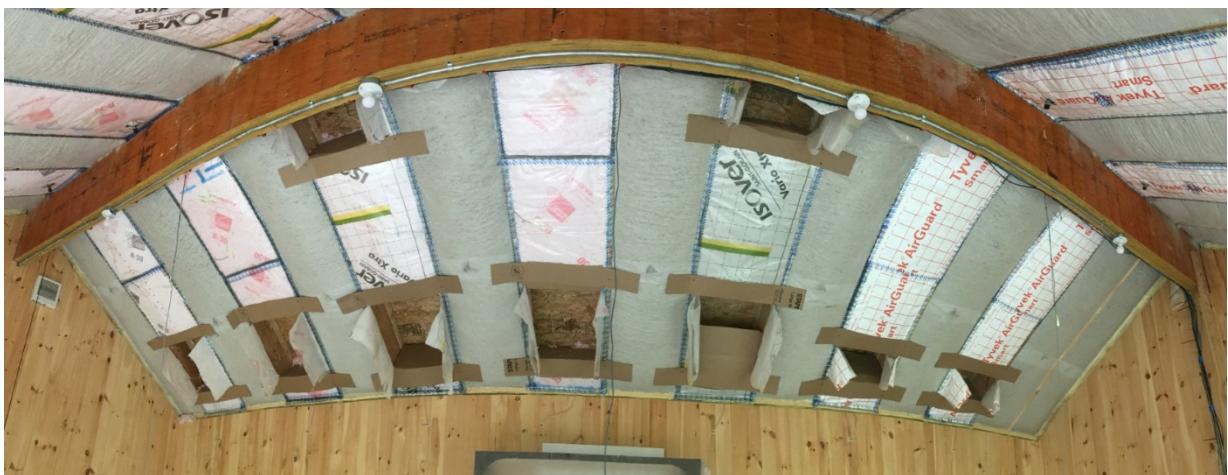
Figure 194. Overview of north-side roof openings

Given the lack of visual indications of problems, Roofs 6 and 7 were only opened for a 1-ft distance along the roof, rather than 2 ft (Figure 194).

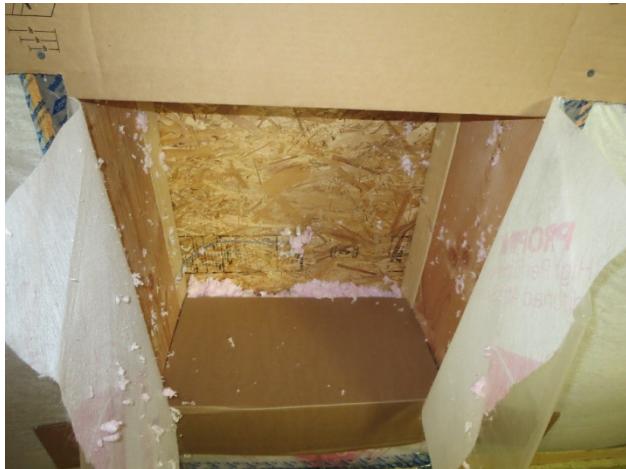
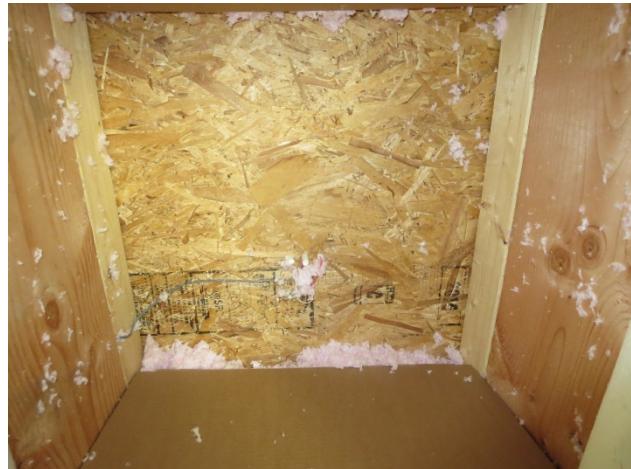
Figure 195. Opening at north-side roof sheathing and OSB conditions (Roof 2 fiberglass)

Roof sheathing conditions were then visually examined. No roof showed signs of sheathing moisture distress, such as mold or staining (Figure 195 and Figure 196). At most, there was arguably some raised grain at the OSB surface. While removing the insulation, no “packy” or adhered conditions (indicating previous wetting) were observed.

A possible contribution to the intact OSB conditions is the fact that the roof OSB was Huber ZIP sheathing. Their OSB formulation uses a significant fraction of MDI (methyl diisocyanate/polymeric diphenylmethane diisocyanate) resin adhesive, which is known to improve moisture resistance and reduce water uptake. This adhesive has been documented to improve performance in accelerated exposure tests (Marra 1992), and is anecdotally reported to improve mold resistance compared to commodity OSB (Davidovic 2019). This is consistent with previous studies of double-stud walls in Massachusetts (Ueno 2015). That work found that
