subject: Safety Review Board review of explosive pressing initiation event

On June 30, 2020, a 0.87 gram PETN charge being pressed in the Rapid Prototyping Facility (RPF), room 1313 of the Explosive Components Facility (ECF; building 905), unexpectedly initiated, resulting in destruction of the pressing fixture but no injuries or facility damage^{1,2}. In response to a request from Leanna Minier, manager of organization 2554 at the time, the Explosives Technologies Group (ETG) Safety Review Board (SRB) met on Aug. 13, 2020 and Oct. 1, 2020 to review information collected following the incident, consider likely direct causes, and form recommendations.

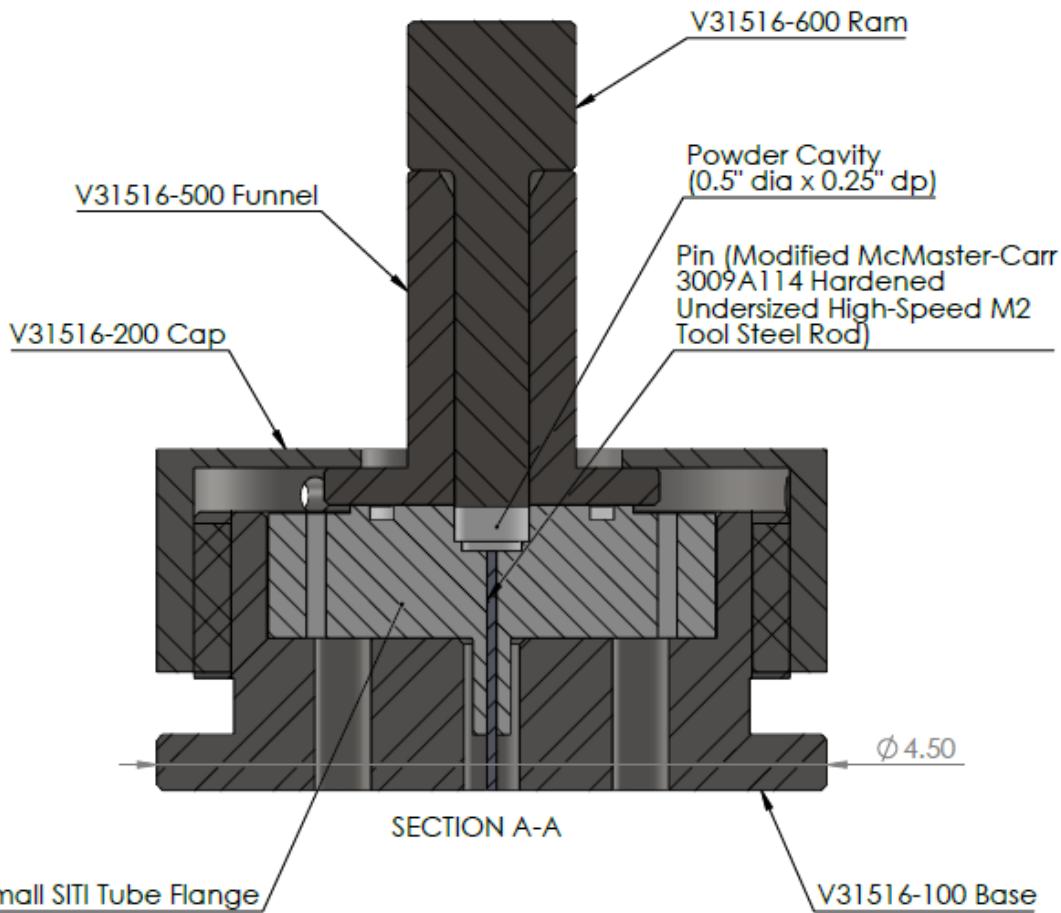
The pressing process begins with loose assembly of all the parts shown in Figure 1. In this configuration, the Ram extends 0.010" into the powder cavity and aligns the SITI Flange, Funnel, and Ram. At this point, the Cap, which is threaded onto the Base, is tightened, clamping the Funnel, Flange, Base, and Cap together. The Ram is withdrawn from the Funnel and powder is loaded into the Flange and Funnel. The Ram is then inserted back into the Funnel and a 0.010" thick shim is placed between the Ram and Funnel so that the resulting pressed powder bed is flush with the top of the Flange (other shim thicknesses are used to achieve desired pressed bed height). The fixture is placed under the ram of a press, in this case a Schmidt pneumatic press with 10,000 lbf capacity, and the operator actuates the press by pushing two buttons outside a shield. This shield is rated for 2.5 g TNT equivalent.

Figure 1. Cross-sectional illustration of a small SITI Tube Flange in a V31516 Loading Fixture.
