**Contamination Source Review for Building E5032,  
Edgewood Area, Aberdeen Proving Ground, Maryland**

## **Contamination Source Review for Building E5032, Edgewood Area, Aberdeen Proving Ground, Maryland**

*Contamination Source Review  
Edgewood Area, Aberdeen Proving  
Ground, Maryland —  
Building E5032*

September 1995

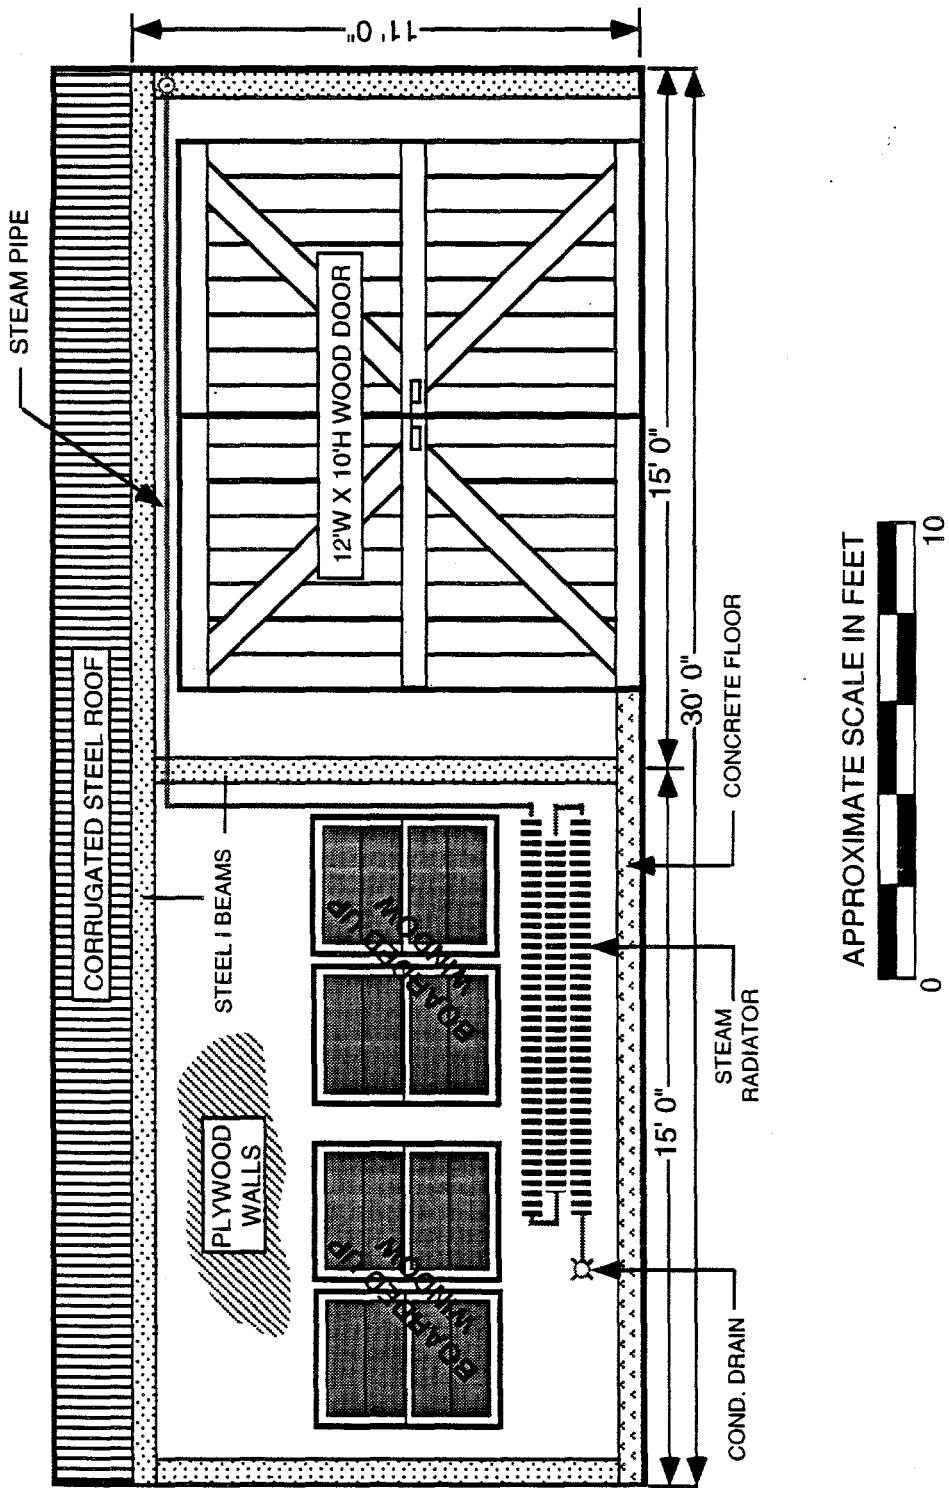
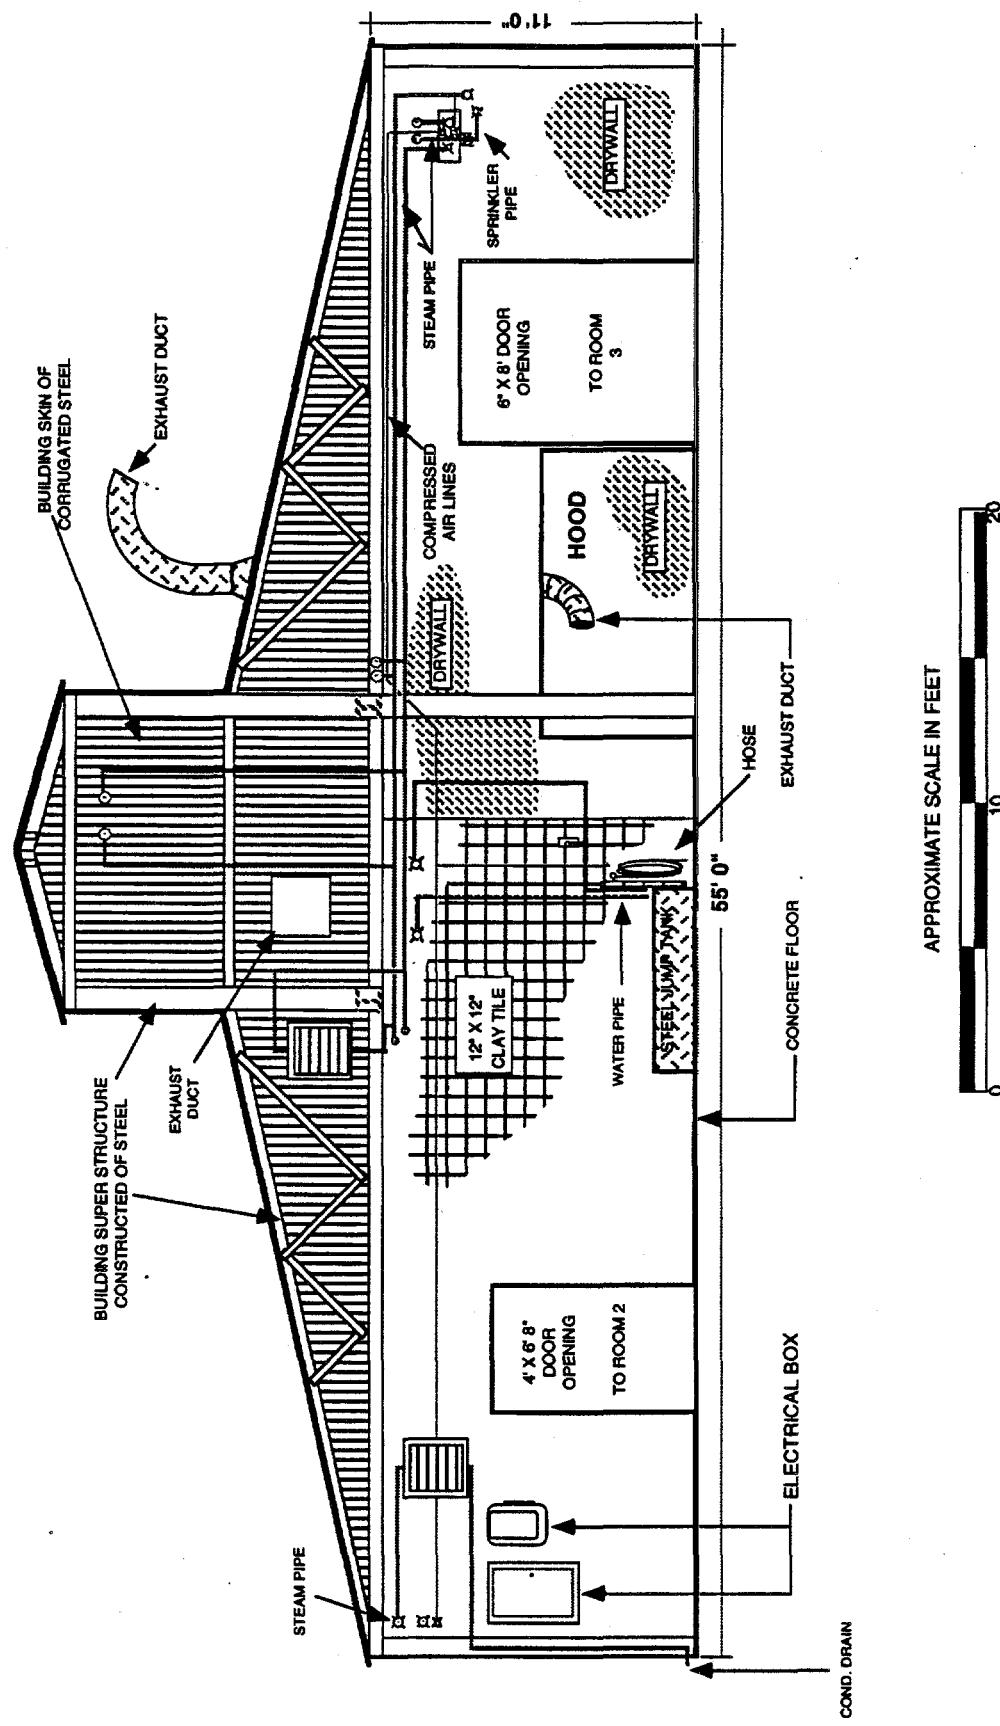
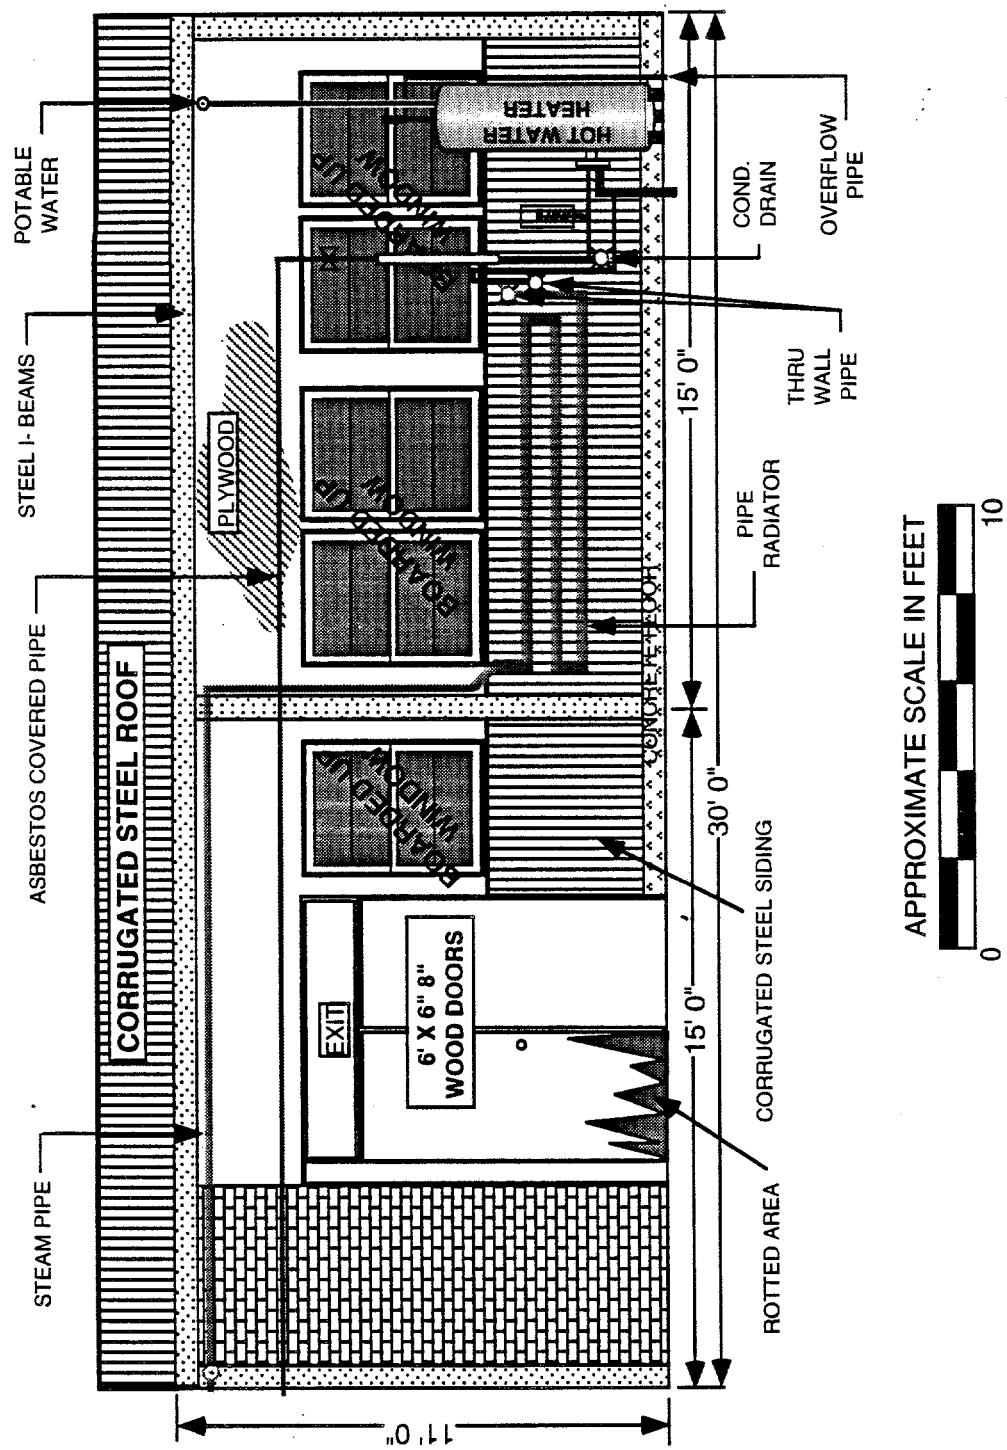
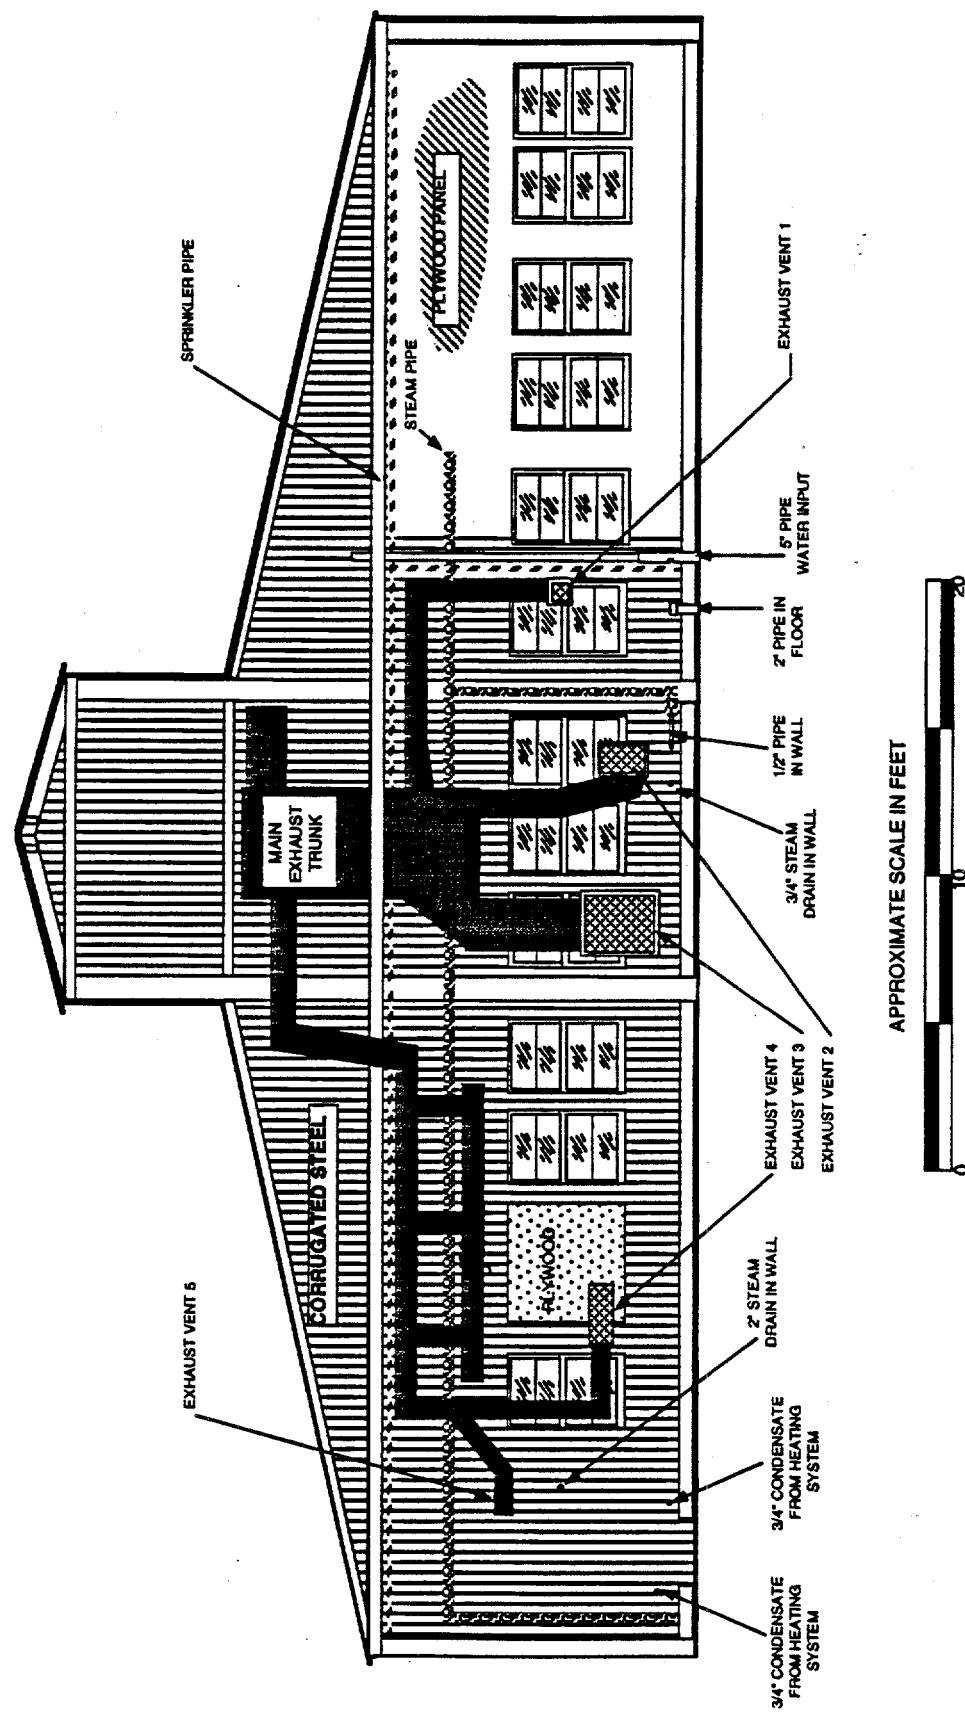
2 ft high, is labeled as a "jump tank" on a wall sign above it. Exhaust pipes are connected to the exhaust system in the room. A pipe covered by suspect asbestos-containing insulation is connected to a hot water heater on the south wall of the building. Numerous other pipes are also present. See Figures 10 through 13 for the locations of these pipes.

The windows on the exterior walls are boarded over with plywood. The only doors accessible from the outside are on the north and south walls. The door on the south wall is boarded shut. See Figures 10 through 13 for wall materials, window locations, and door locations.

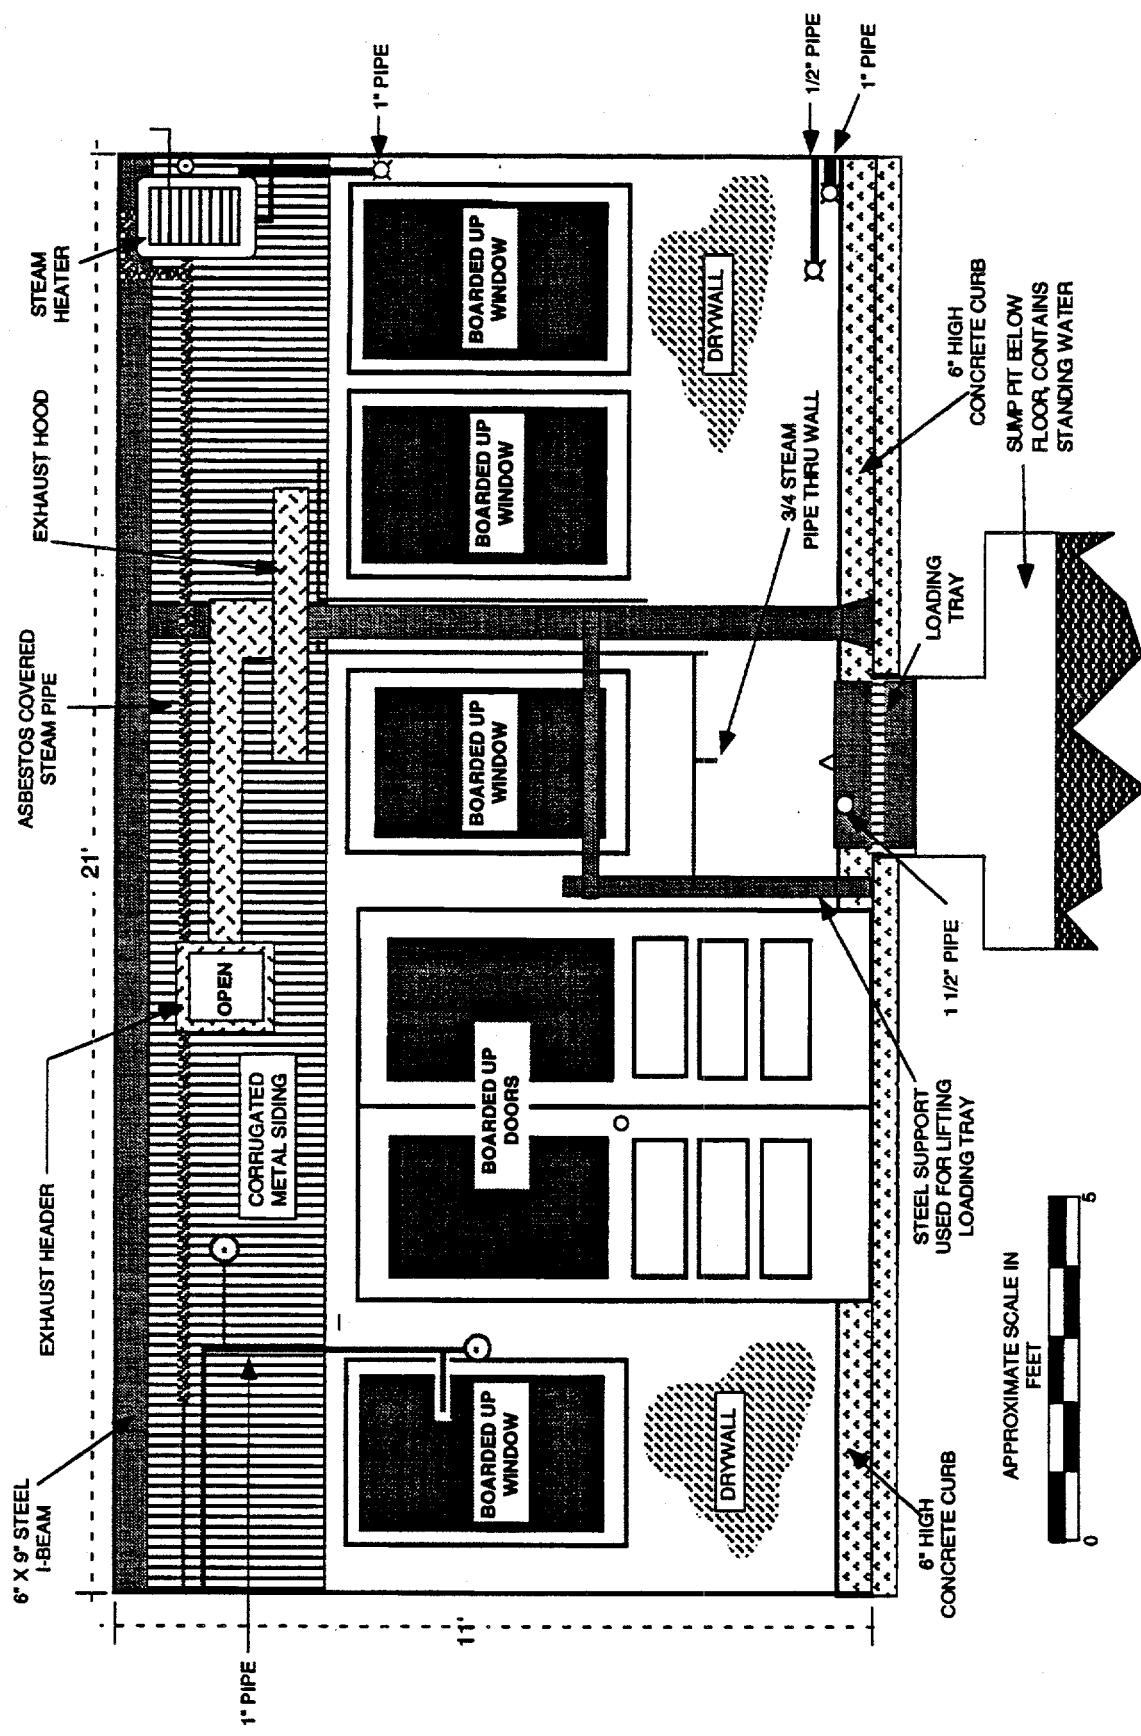
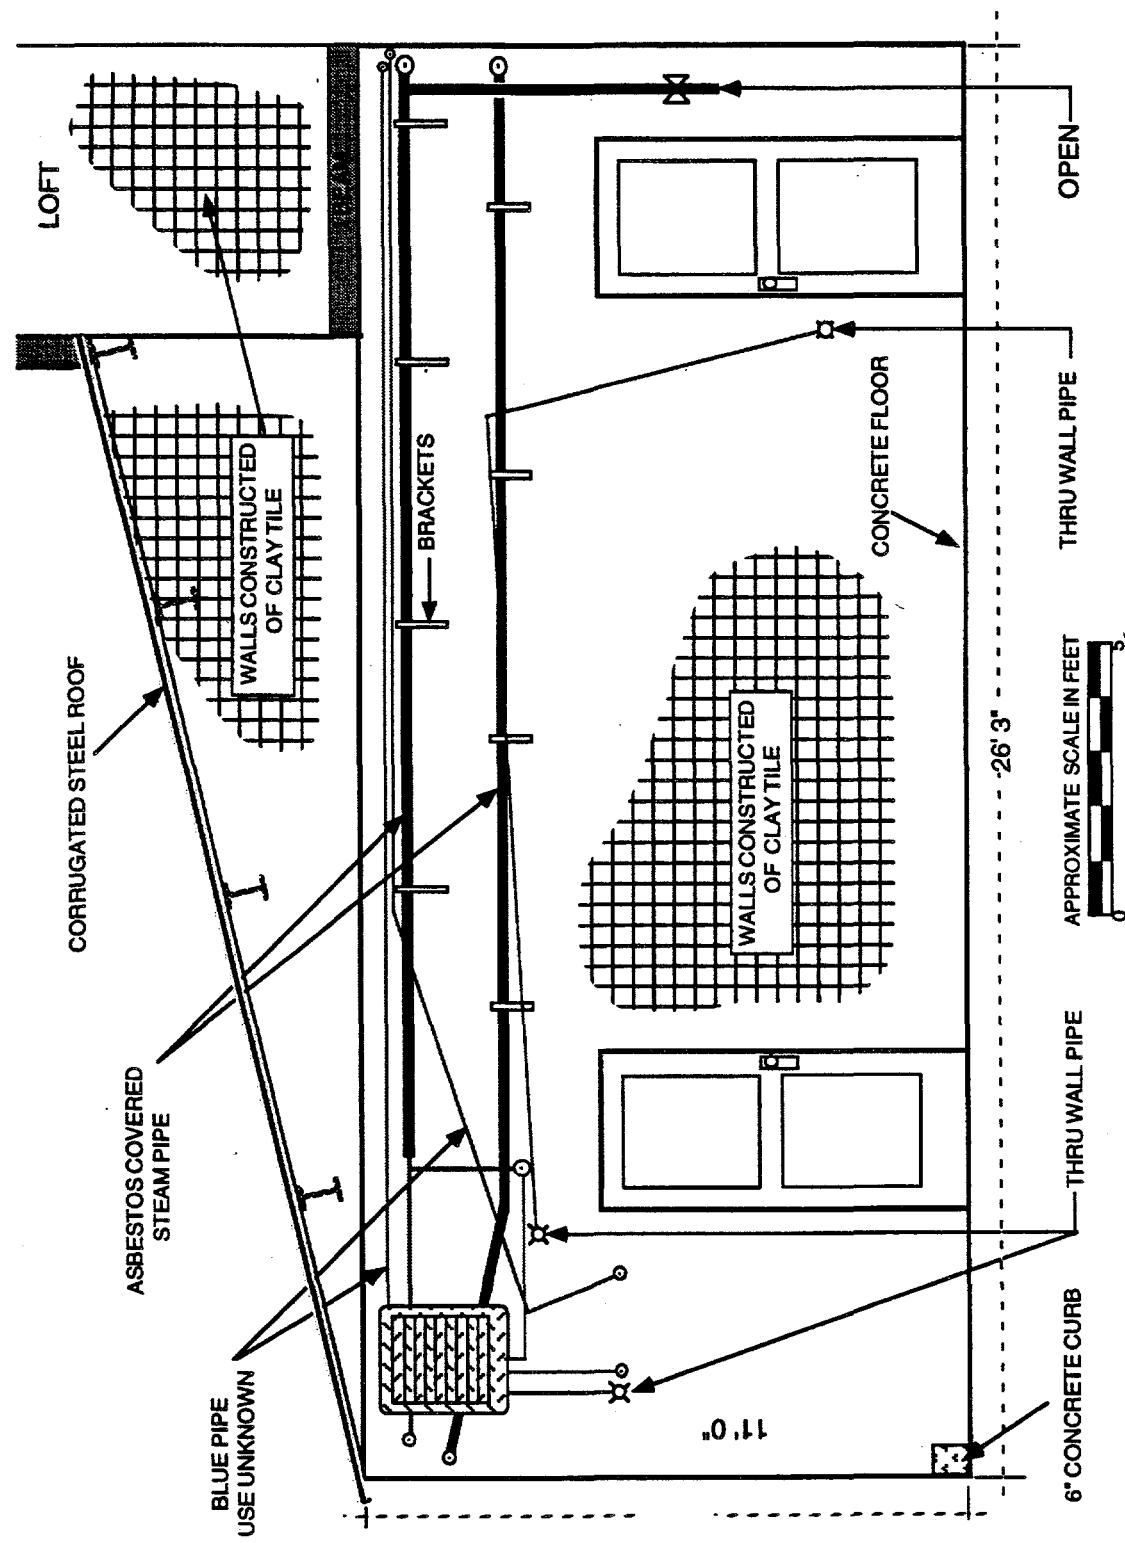
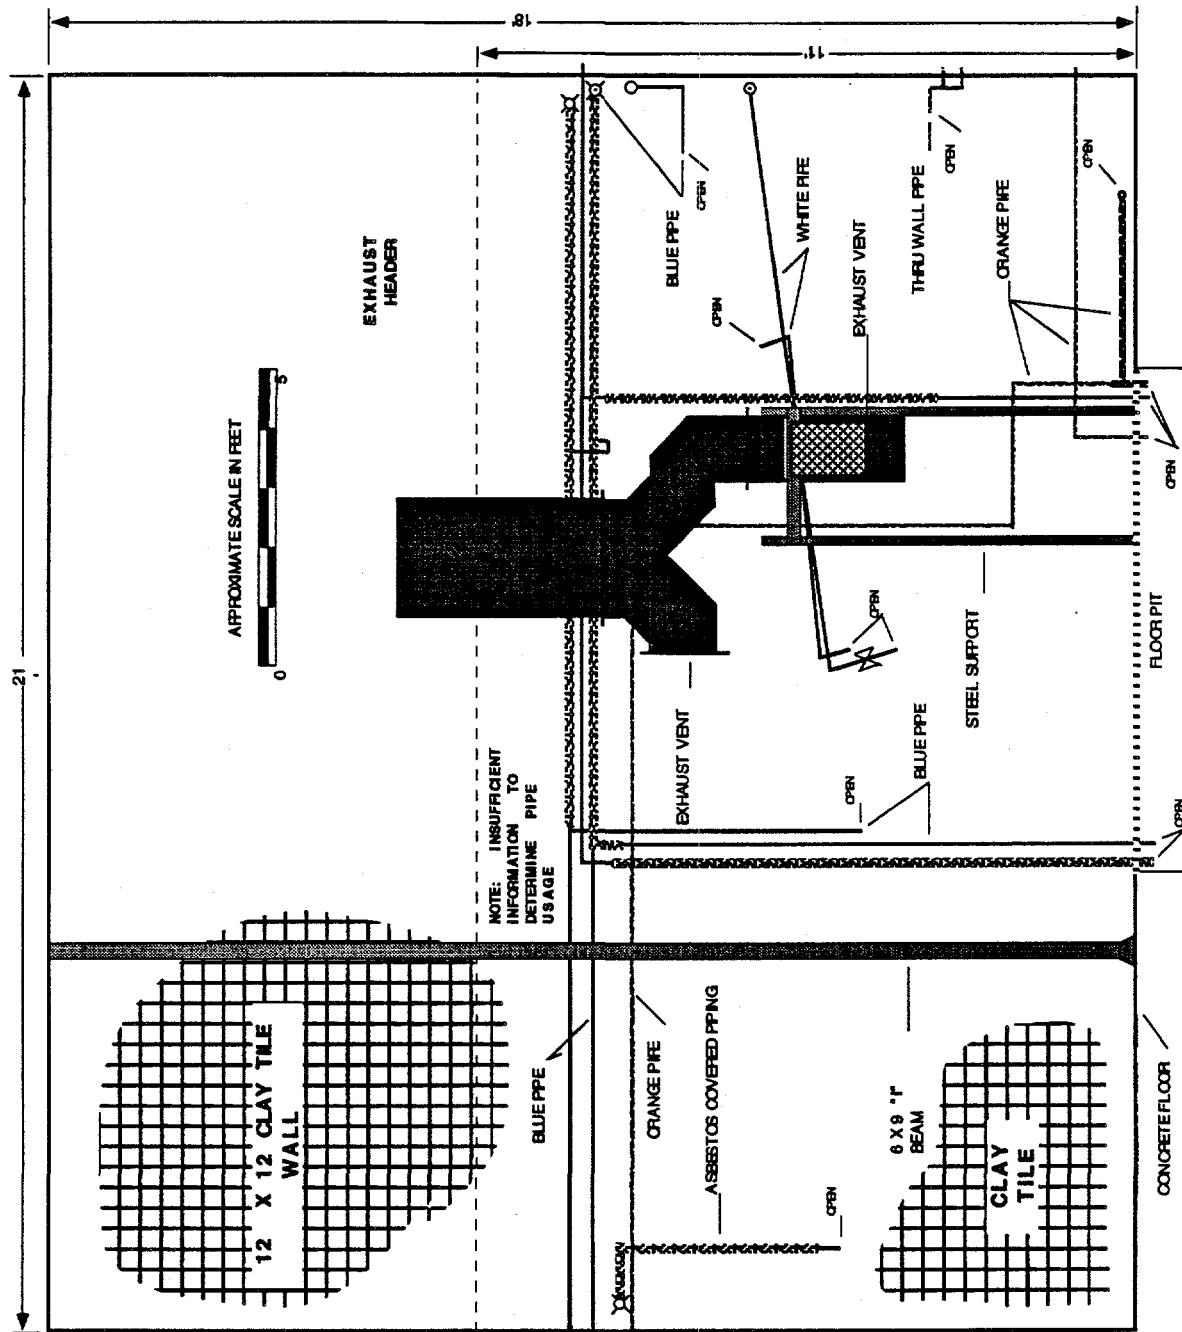
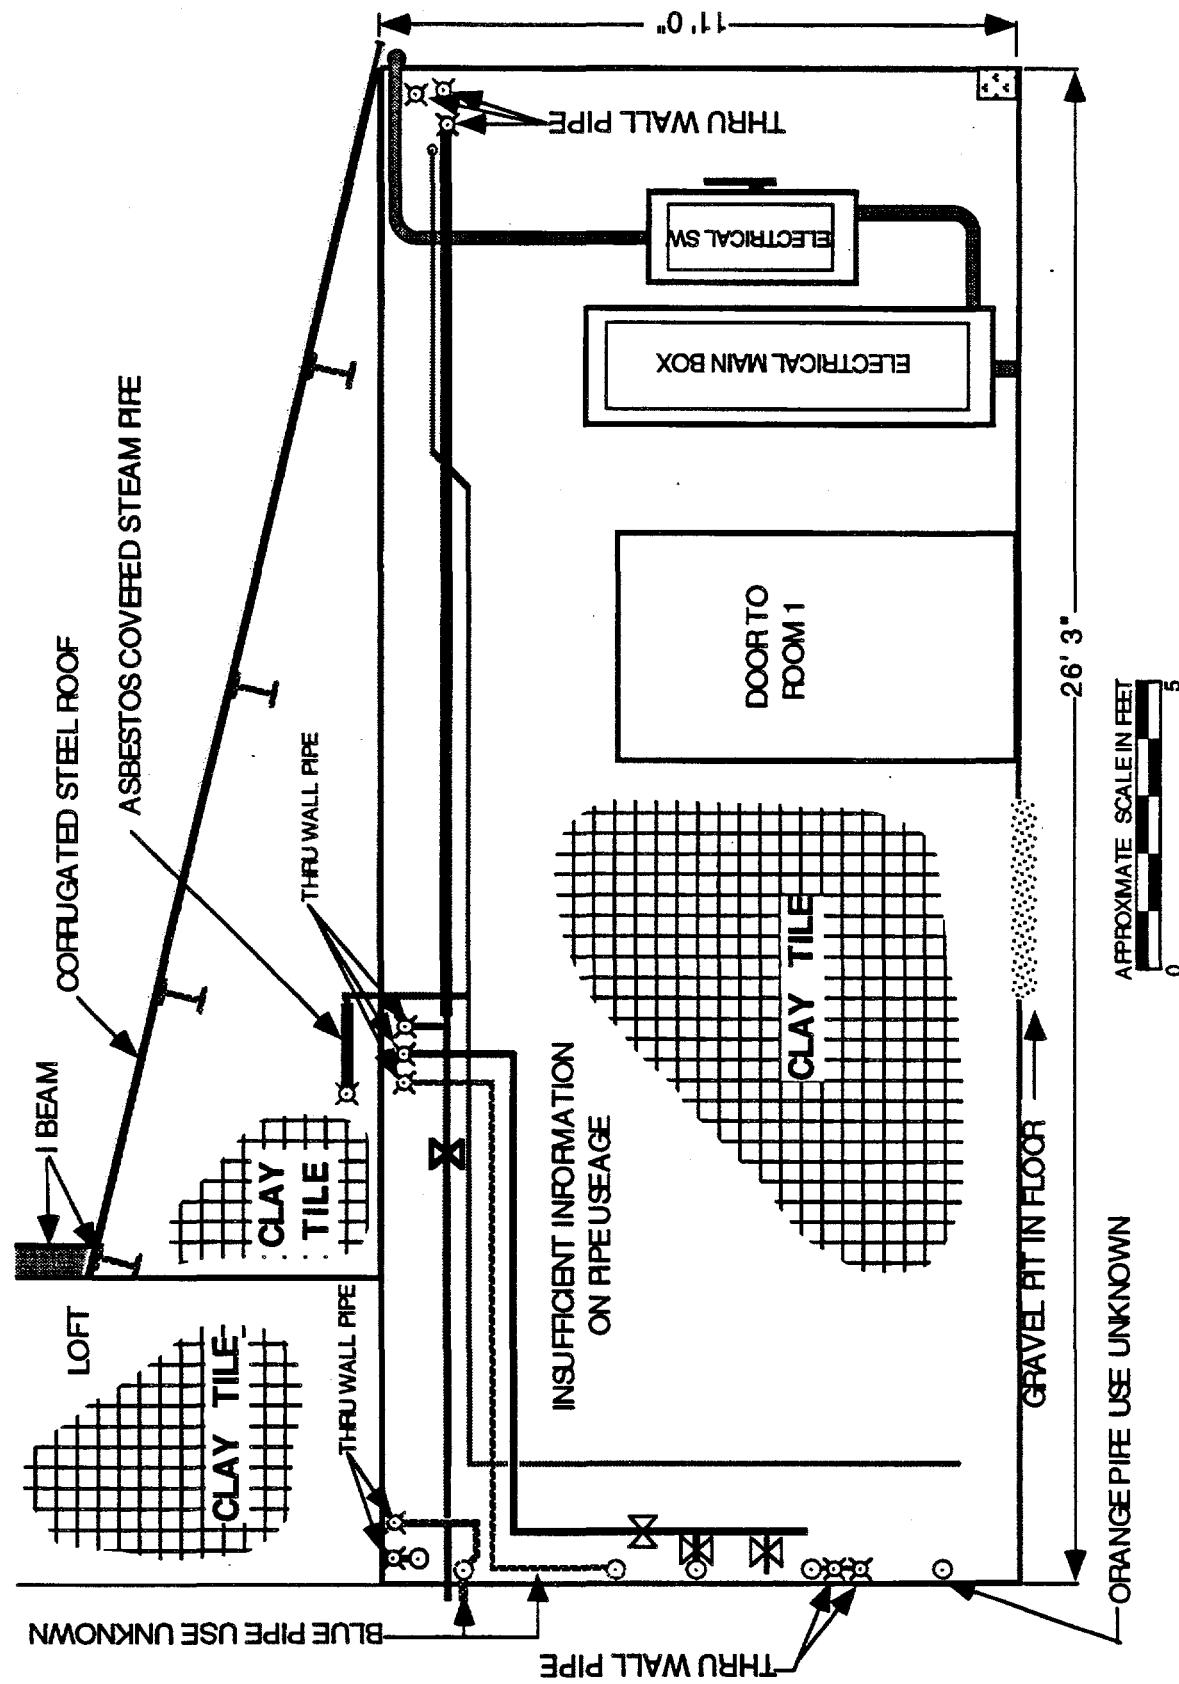
Numerous pipes run along each of the four walls. These pipes are covered by suspect asbestos-containing insulation. Pipes are also present in the collection trench. Figures 16 through 19 show the locations of the pipes.

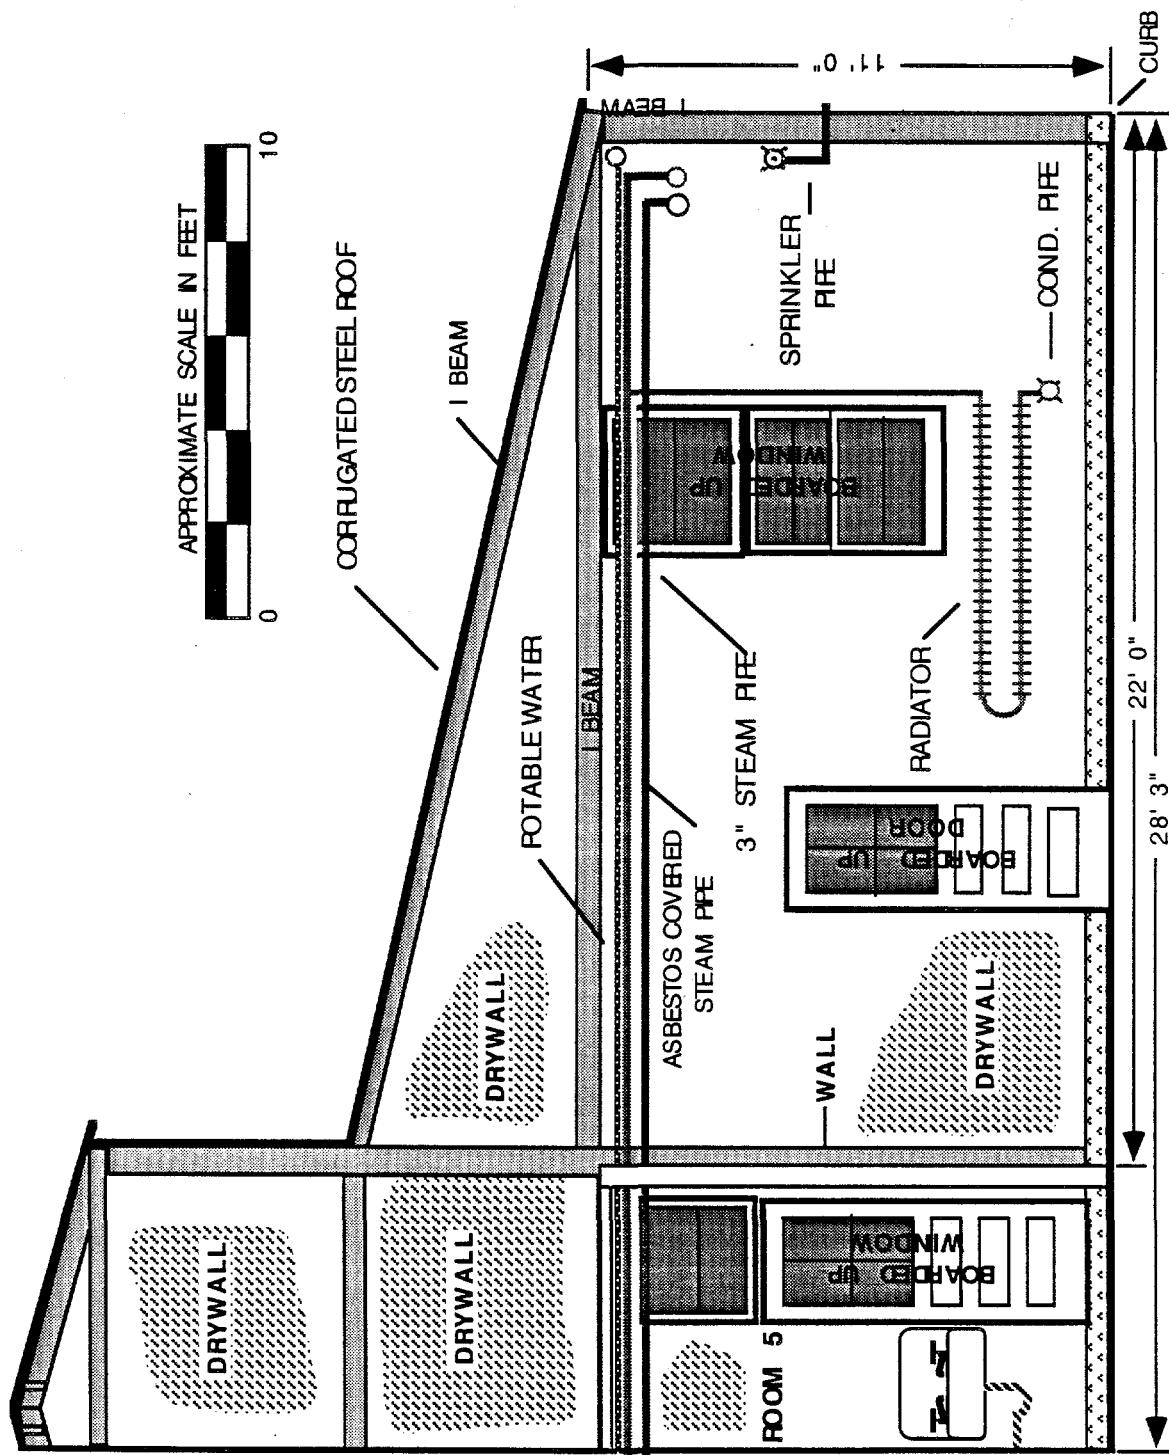
FIGURE 27 Rooms 4 and 5 — East View

The exterior walls are constructed of brick and corrugated metal sheeting. The interior walls are constructed of drywall, clay tile brick, wood, and 12-in. by 12-in. clay tile. A 10-ft-high wire fence separates rooms 3 and 4 (Figure 27).

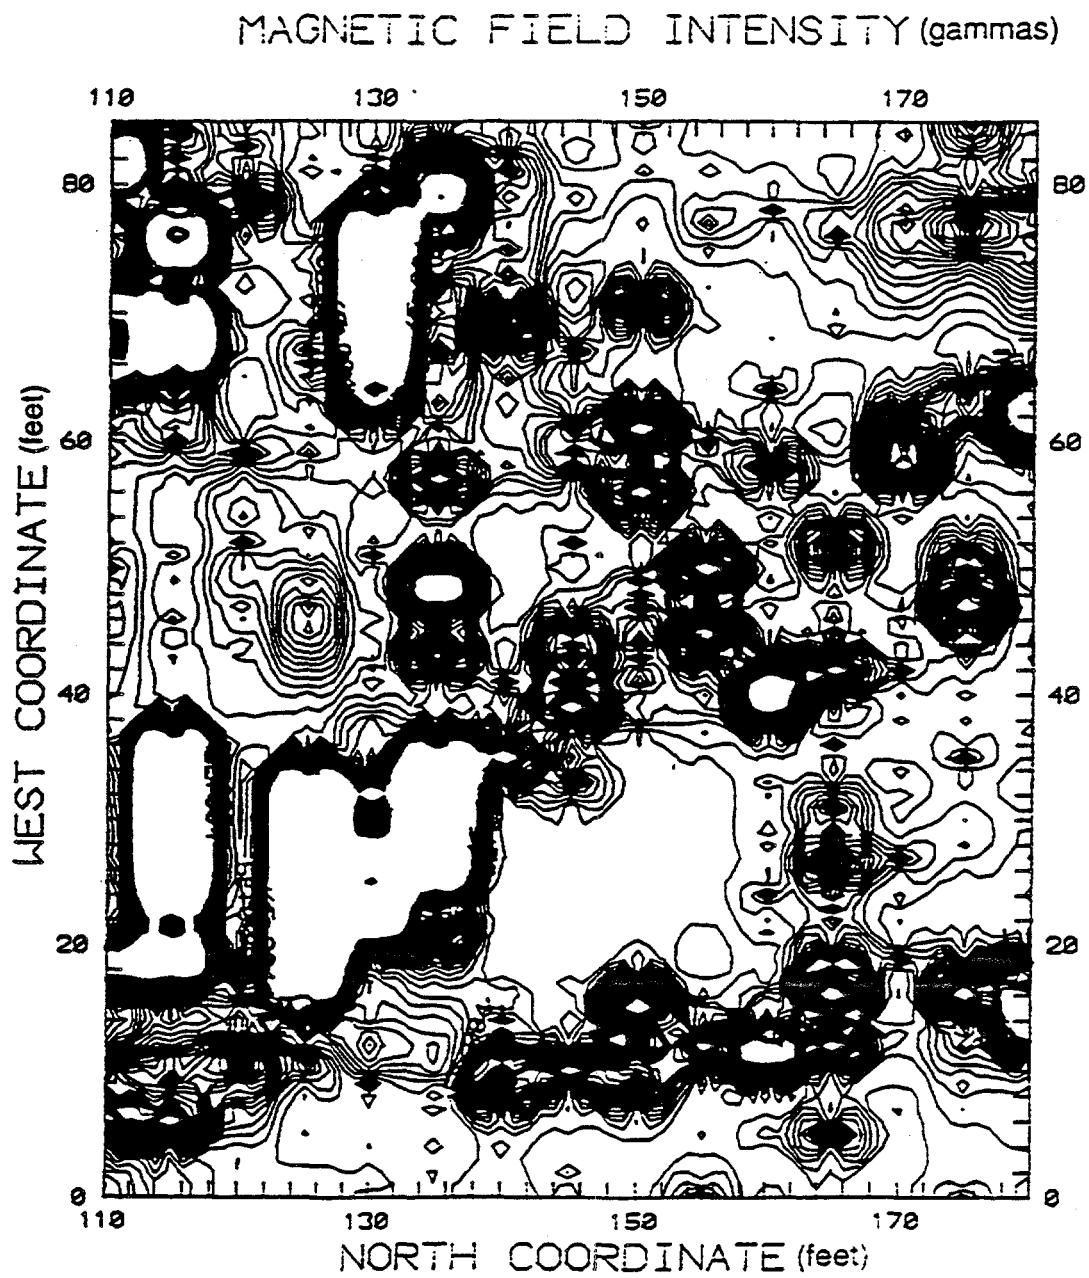
FIGURE 3 Magnetic Map of the Flat Area North of the Building

Strong magnetic anomalies, observed over much of the region north of the building, are attributed to iron pipes, buried tanks, remnants of a former railroad line, and other metallic debris (Figure 3). One strong anomaly approximately 130 ft north of the building appears to be caused by a large iron tank or vault (located at coordinates 220N,65W). GPR data indicate a strong reflector at the location (Figures 4 and 5). Other magnetic anomalies centered at coordinates 130N,70W; 135N,30W; 128N,30W; and 115N,30W also appear to be caused by buried tanks. However, a concrete slab with steel reinforcement around the anomalies makes positive identification difficult.
