Assessment of Isolator Units Following Shock Testing

P. Vianco, S. Dickens, and C. Jaramillo

Sandia National Laboratories

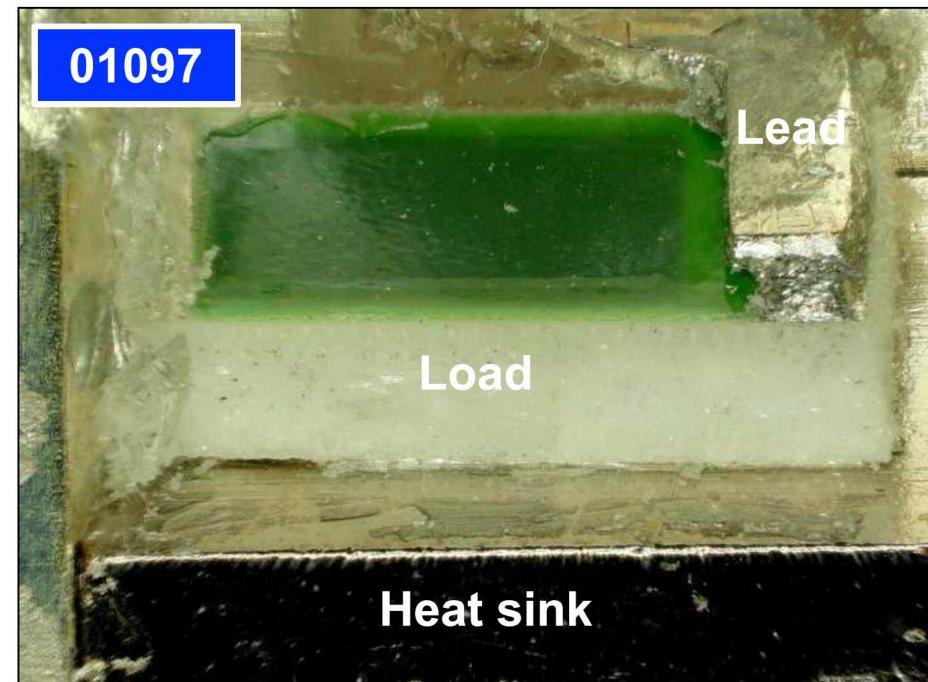
- ◆ The high-magnification photograph shows a crack (magenta arrows) in the solder fillet, which pinpointed the potential anomaly that was responsible for the electrical failure.

The vendor's technique for removing the RTV was particularly harsh, leaving many artifacts on critical areas of the solder joint.

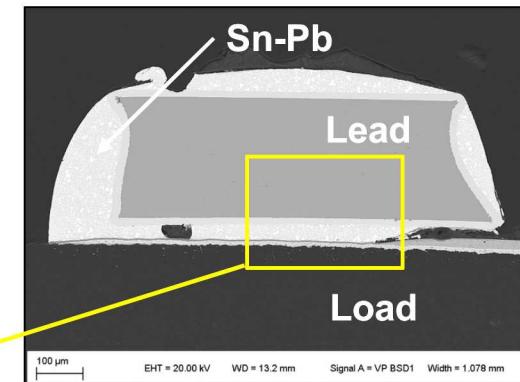
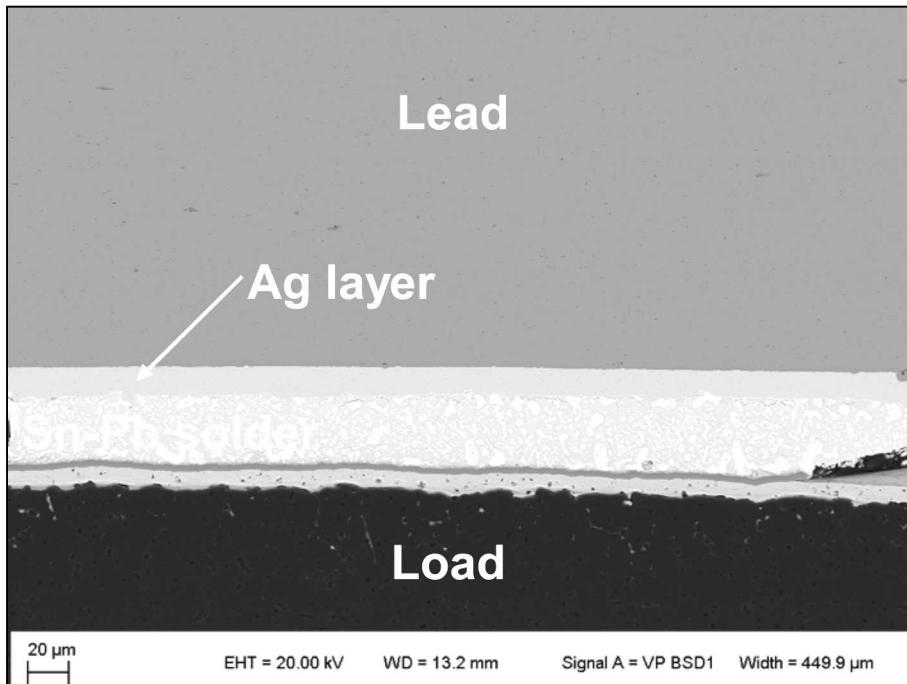
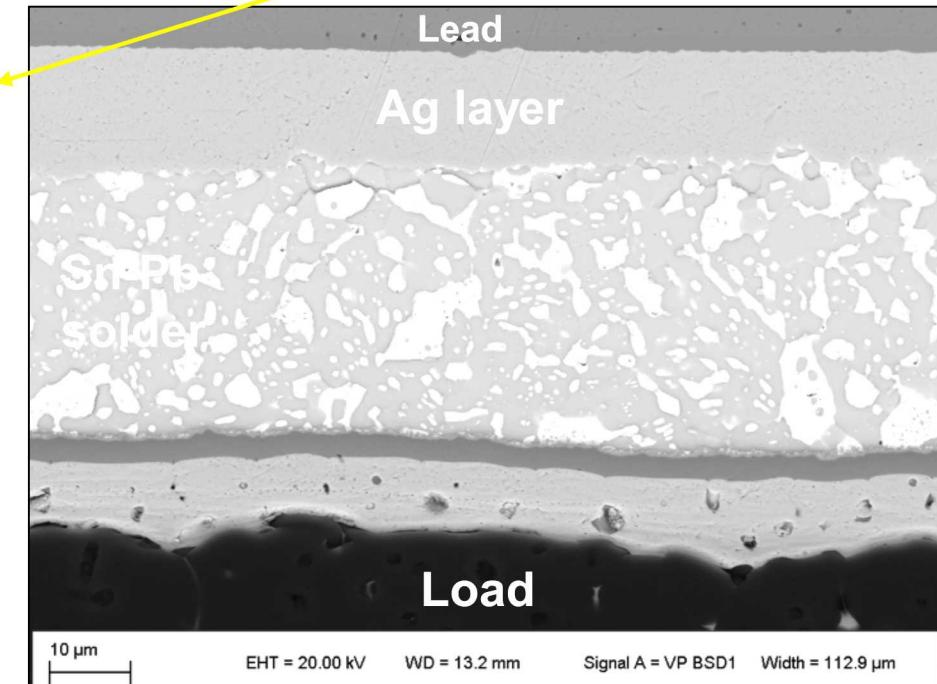
Analysis: S/N 01080 and S/N 00913, *Baseline Units*

- ◆ The microstructures were documented for these two “baseline” units. The focus was placed on the S/N 01080 unit.

- ◆ A significant extent of filler metal was missing from the the heat sink-to-frame (housing) solder joint.

- ◆ The second baseline unit, S/N00913, showed the same defect.

The recommendation is to accept this lot of isolators, based upon the findings of this failure analysis.
