Characterization of Composite Wind Turbine Blades

Wind Turbine Background

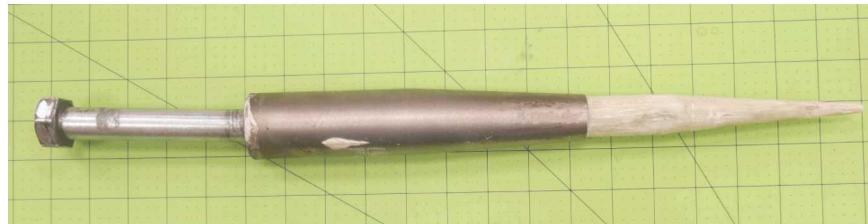
SS Root Carrot with
Fiberglass Insert

- The turbine used a bonded 30 carrot system to attach each blade to the slewing ring of the hub
 - 5 stainless steel (SS)/fiberglass carrots are bonded into curved wedge shaped fiberglass root inserts using a structural adhesive.
 - 6 root inserts in total are made for each blade.
 - These prebonded root inserts are co-molded into the fiberglass box beam that is made up of the Low Pressure Plate, High Pressure Plate, and Leading and Trailing Edge Webs.
 - The High Pressure and Low Pressure skins are molded separately and bonded to the box beam.

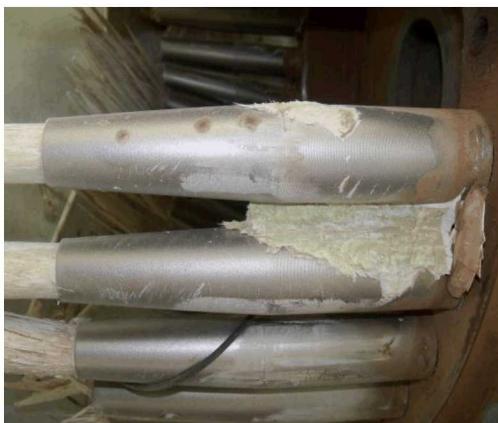
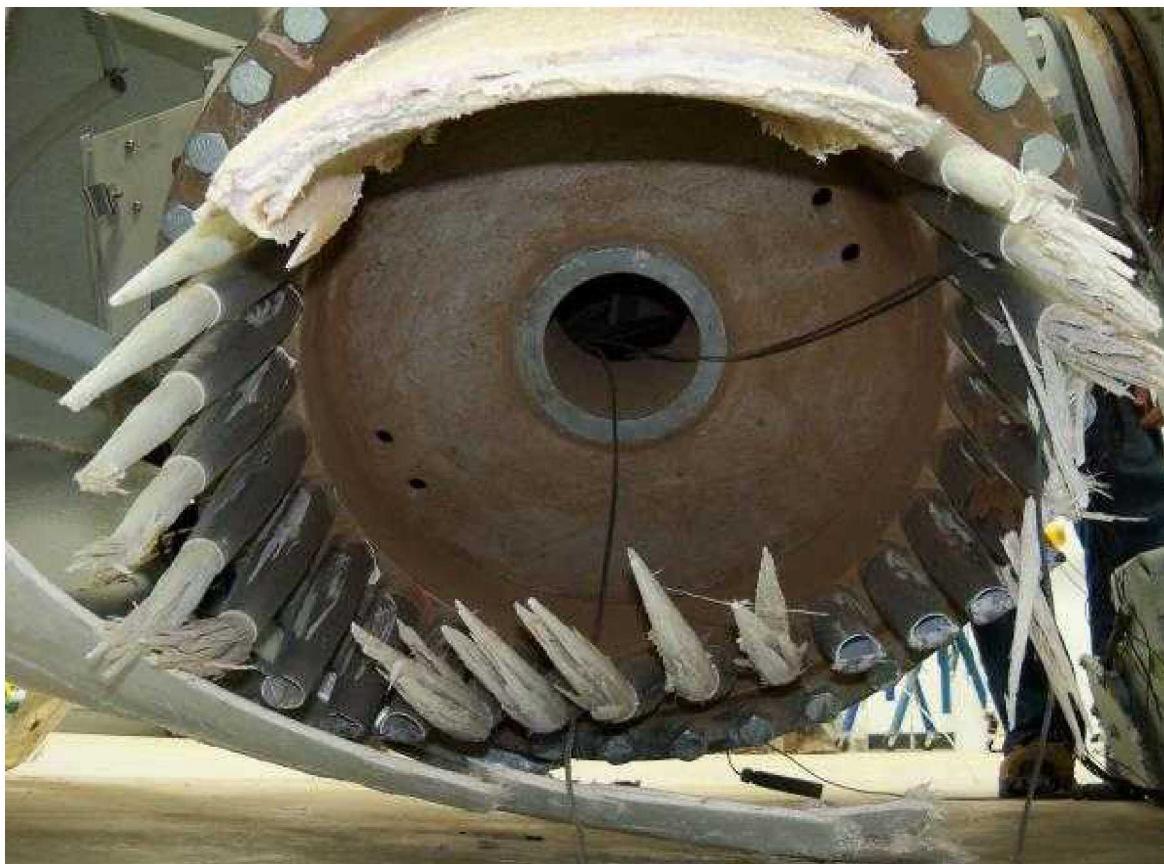
Blade 4 Investigation: adhesive failure?

- The photo clearly shows all but 5 carrots of Blade 4 are exposed after the failure. This raised questions of a possible premature adhesive failure between the SS carrots and the fiberglass root inserts.

- Only the Trailing Edge Web root insert remains attached (seen at top of picture).
- Examination of the remaining 24 SS carrots shows little remaining adhesive.
- Some carrots show signs of surface contamination near the base of the carrot.
- Investigation focused initially on the remains of Blade 4 and the Trailing Edge Web Insert.

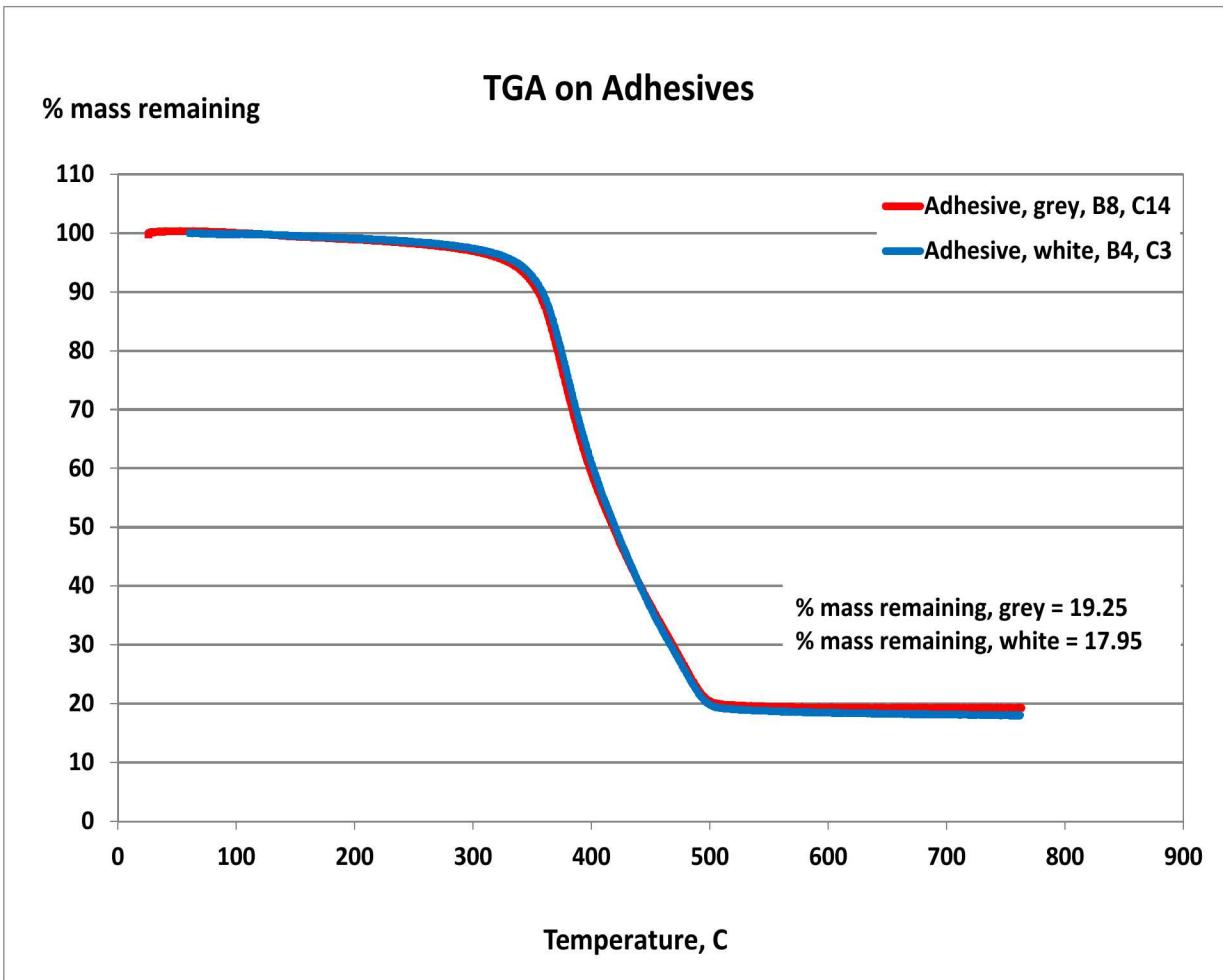
Thermogravimetric Analysis (TGA) of white and grey adhesives

- The similarity in the final weight percent values (19% for grey adhesive, 18% for white adhesive) is indicative of similar non-volatile/non-thermally-degradable material content.

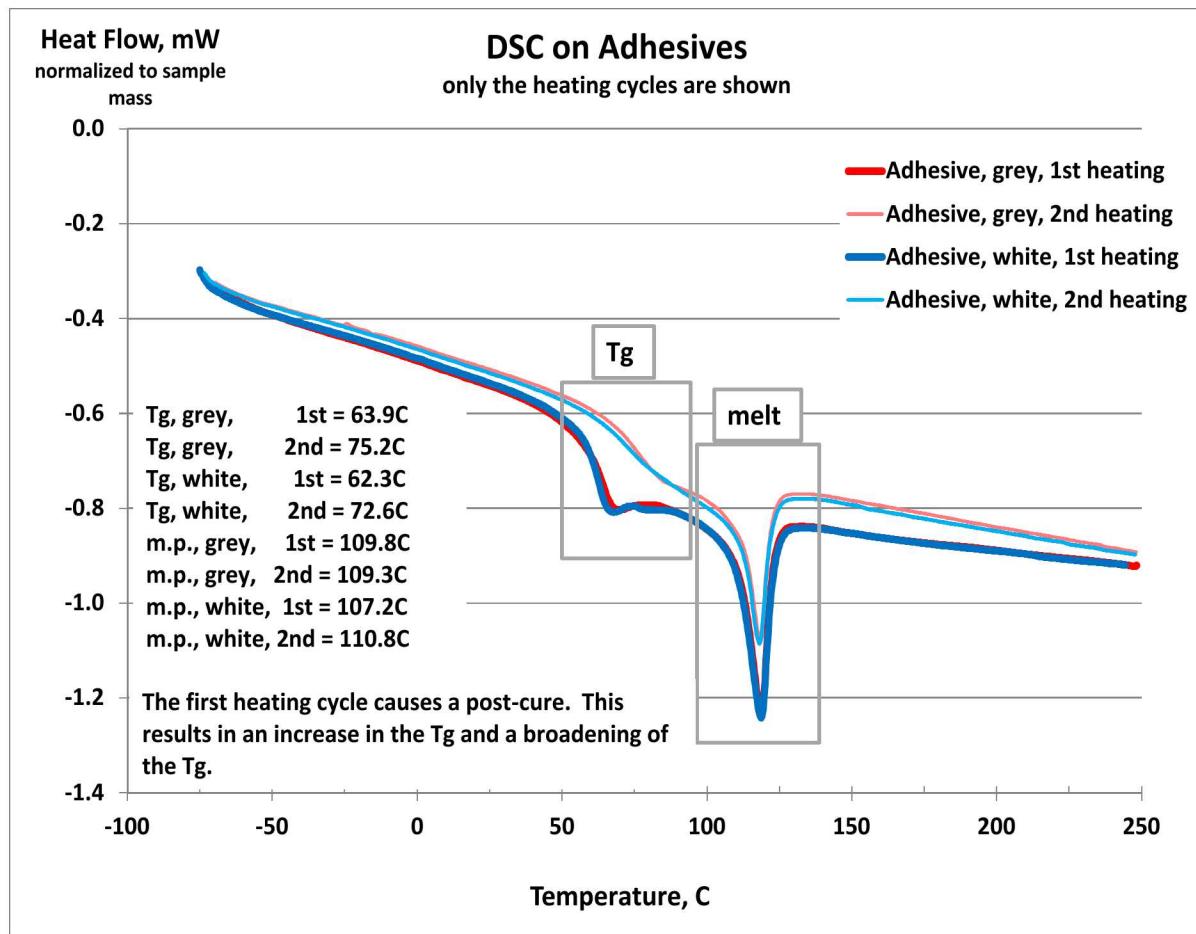
Differential Scanning Calorimetry (DSC) of white and grey adhesives

- Strong overlap between the DSC curves for the white and grey adhesives, including the similarity in the measured T_g values of 65 C and measured melt temperatures of approximately 120 C, indicate that the white and grey adhesives have very similar thermal properties.

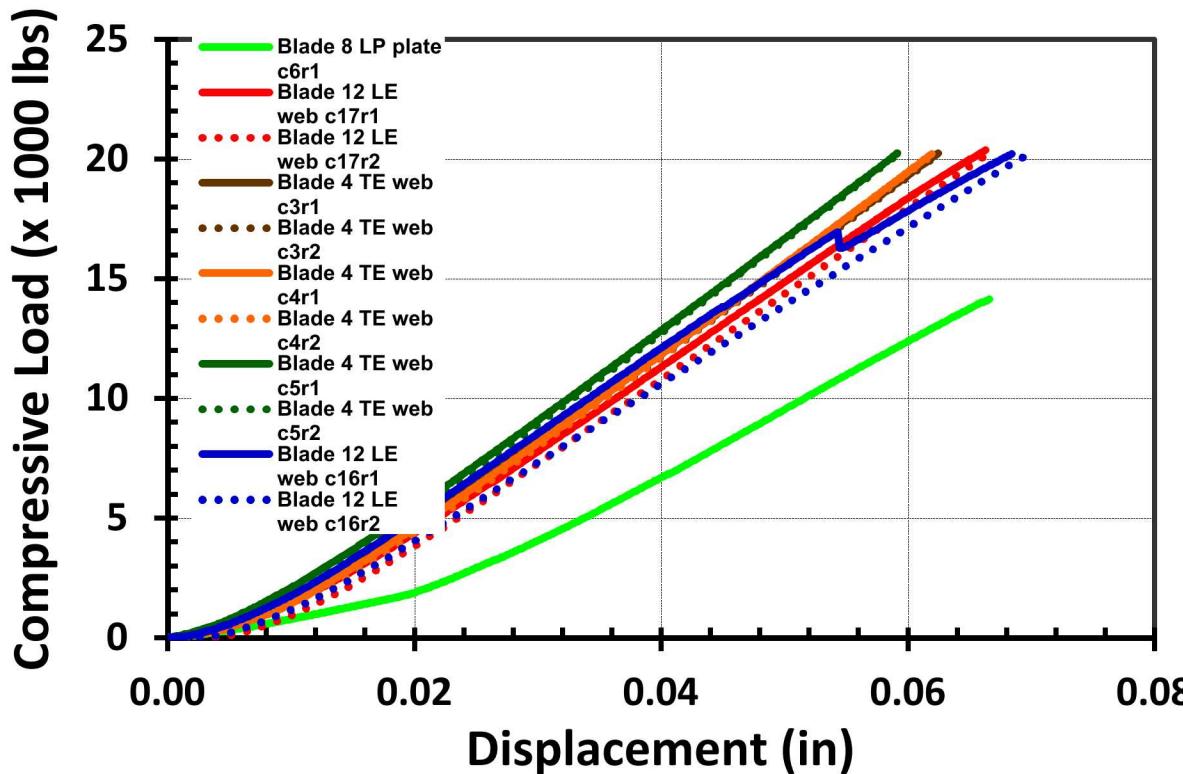
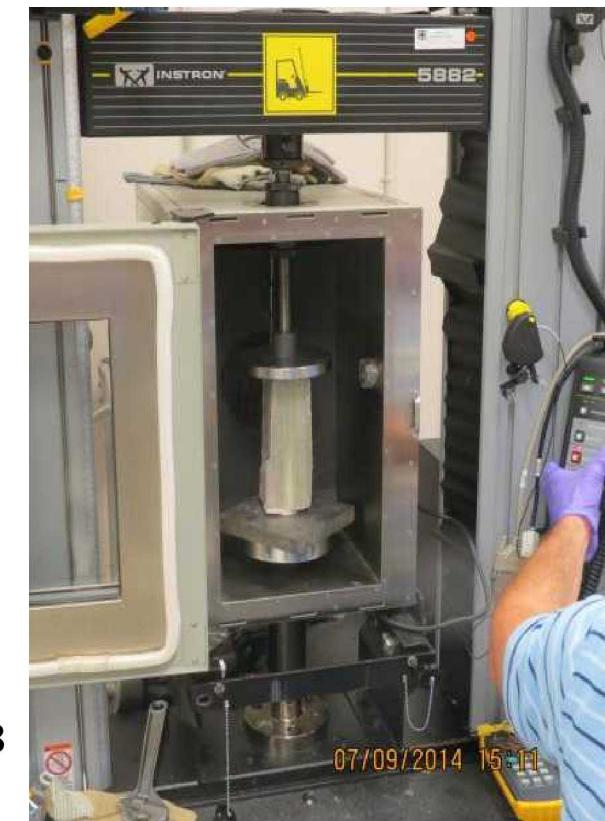
Compression Tests of Wind Turbine Blade Carrots

- All samples were loaded twice to 20,000 lbs (maximum output for our Instron load frame).
- A steel ring was used to isolate the SS root from the fiberglass and place the adhesive in shear mode.
- A lack of samples makes quantitative analysis difficult. However:
 - Results show that the low pressure side of Blade 8 (position 6, root number 1) failed during the first ramp to 20,000 lbs (neon green curve).
 - In total, 40 of 42 carrots tested passed this test!

- 28 passed the compressive load of 20,000 lbs administered twice.
 - 1 failed this test (Carrot 16, an interface carrot). The other 7 interface carrots all passed.

- For Blade 4 (which was badly damaged) and Blade 8:
 - 12 of the 13 carrots that were tested passed the compressive load of 20,000 lbs administered twice.
