**SANDIA REPORT**

SAND2021-11327

# HEAF Cable Fragility Testing at the Solar Furnace at the NSTTF

Austin M. Glover, Chris LaFleur, Jeff Engerer

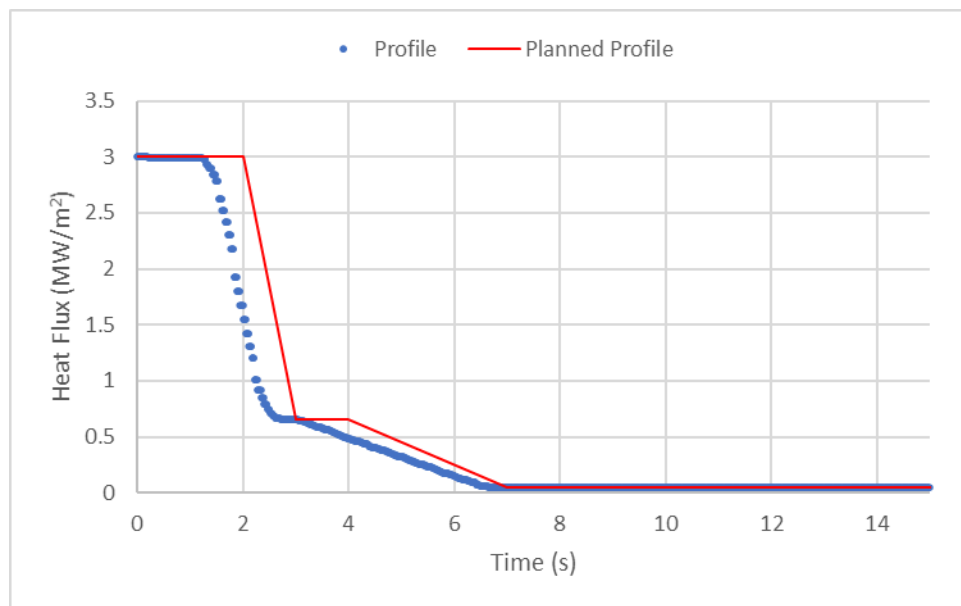
**Figure 3-1: Test 1-02 Heat Flux Profile**

Figure 3-1 and Figure 3-2 show the heat flux profile and total energy for which the cable target was exposed. As shown, the heat flux profile remained at the primary heat flux for a lesser duration when compared to the planned profile. The cable target was exposed to a total of approximately 14 MJ/m<sup>2</sup>.

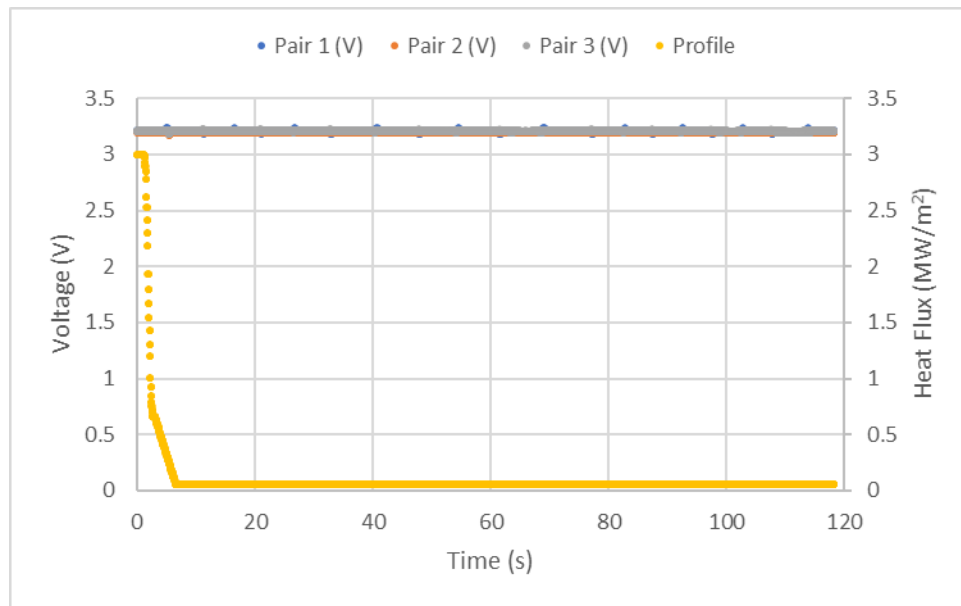
**Figure 3-3: Test 1-02 Electrical Monitoring**

Figure 3-3 shows the electrical results from the test. Three pairs were monitored in the 7C cable for short circuit failure. As shown, electrical failure was not observed.

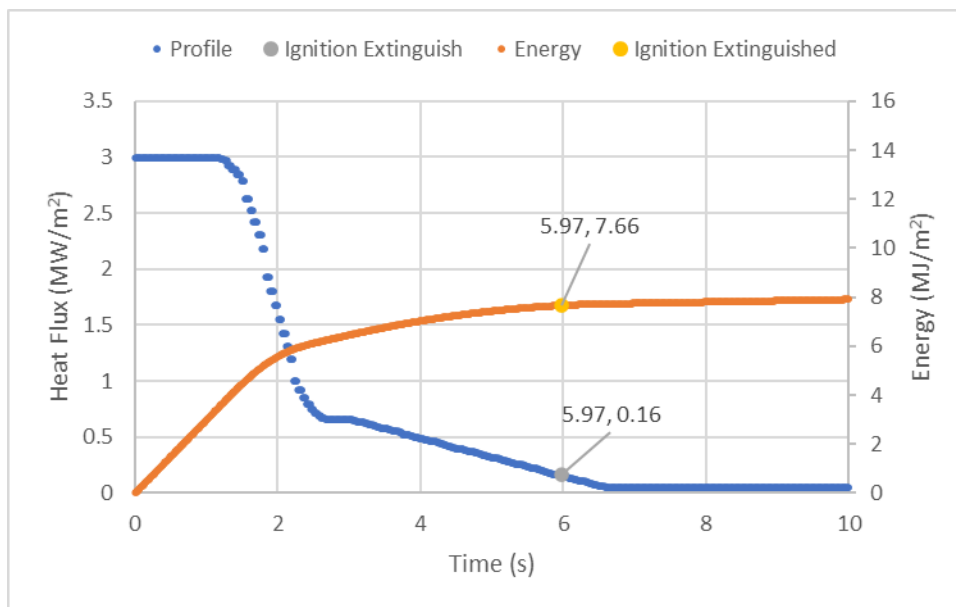
Figure 3-5: Test 1-02 Sustained Ignition as a Function of Heat Flux and Time

The video was reviewed to determine the time at which pyrolysis, ignition, and extinguishment occurred during this test. Ignition and pyrolysis happened essentially immediately, prior to the shutters being fully open. The shutters were fully open at 0.5 seconds. This delay is reflected in all figures in this section and the total energy calculation. The ignition extinguished at 5.97 seconds after the shutter was fully open. Figure 3-5 shows the time at which the ignition extinguished as a function of total energy and heat flux.

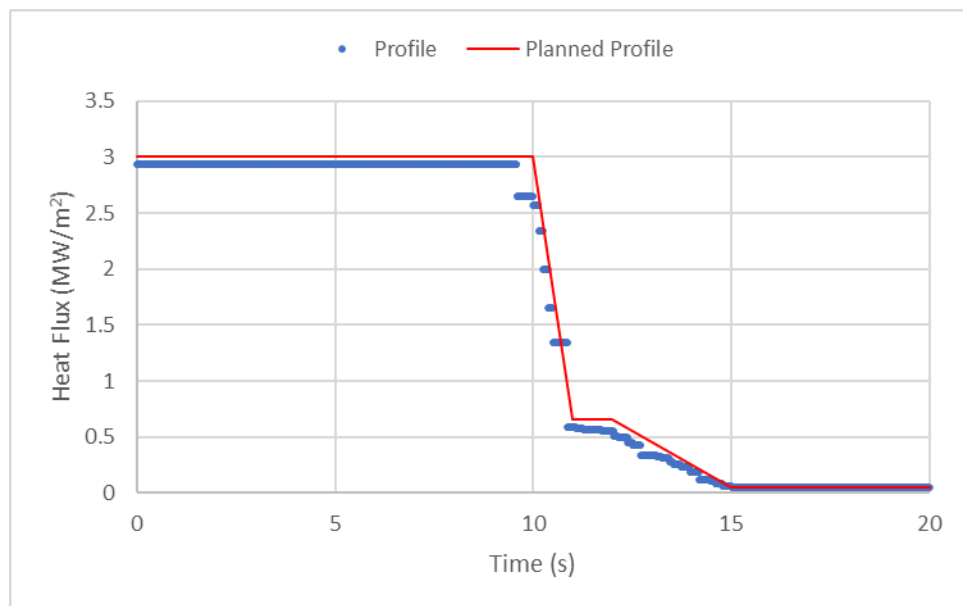
**Figure 3-6: Test 1-03 Heat Flux Profile**

Figure 3-6 and Figure 3-7 show the heat flux profile and total energy for which the cable target was exposed. As shown, the primary flux magnitude is slightly less than the planned 3 MW/m<sup>2</sup>. Also, the profile data from the data acquisition system (DAQ) at the solar furnace is a little choppy. The cable target was exposed to a total of approximately 37 MJ/m<sup>2</sup>.

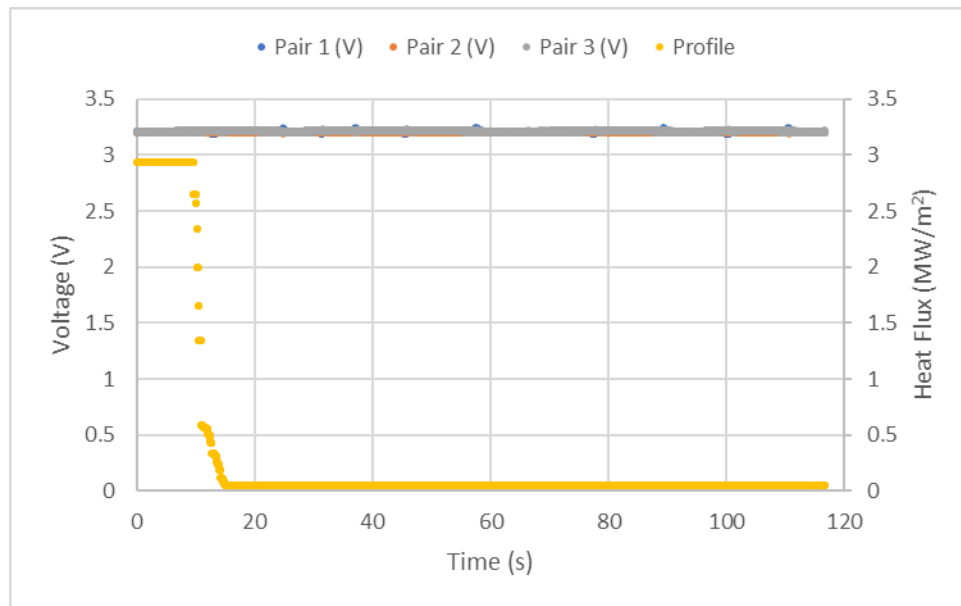
**Figure 3-8: Test 1-03 Electrical Monitoring**

Figure 3-8 shows the electrical results from the test. Three pairs were monitored in the 7C cable for short circuit failure. As shown, electrical failure was not observed.

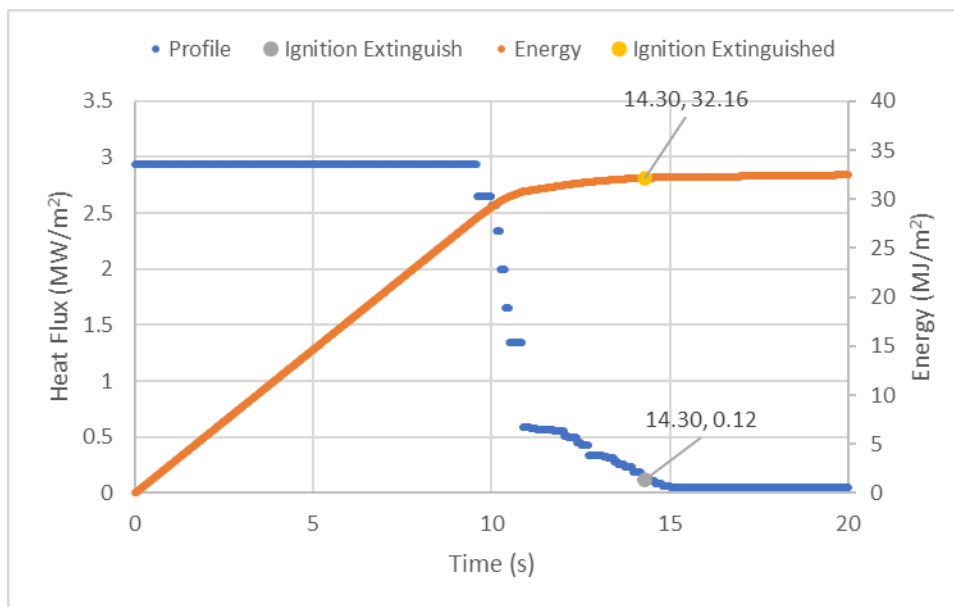
Figure 3-11: Test 1-03 Sustained Ignition as a Function of Heat Flux and Time

The video was reviewed to determine the time at which pyrolysis, ignition, and extinguishment occurred during this test. Ignition and pyrolysis happened essentially immediately, prior to the shutters being fully open. The shutters were fully open at 0.37 seconds. This delay is reflected in all figures in this section and the total energy calculation. The ignition extinguished at 14.30 seconds after the shutter was fully open. Figure 3-11 shows the time at which the ignition extinguished as a function of total energy and heat flux.

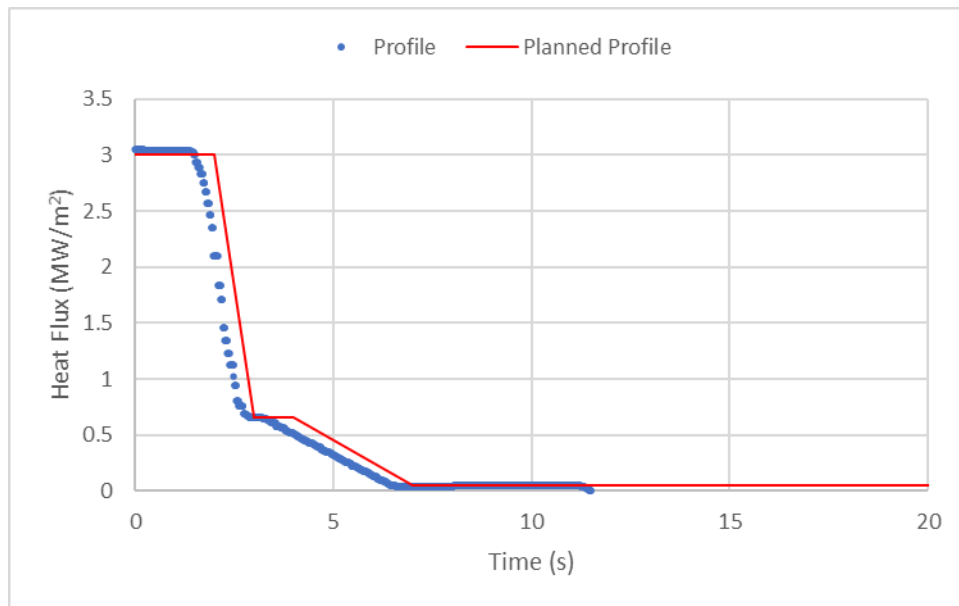
**Figure 3-12: Test 1-05 Heat Flux Profile**

Figure 3-12 and Figure 3-13 show the heat flux profile and total energy for which the cable target was exposed. As shown, the profile is fairly accurate. However, due to operator error, the secondary flux applied to the cable was stopped for approximately 20 seconds, and then restarted. The cable target was exposed to a total of approximately 14 MJ/m<sup>2</sup>.

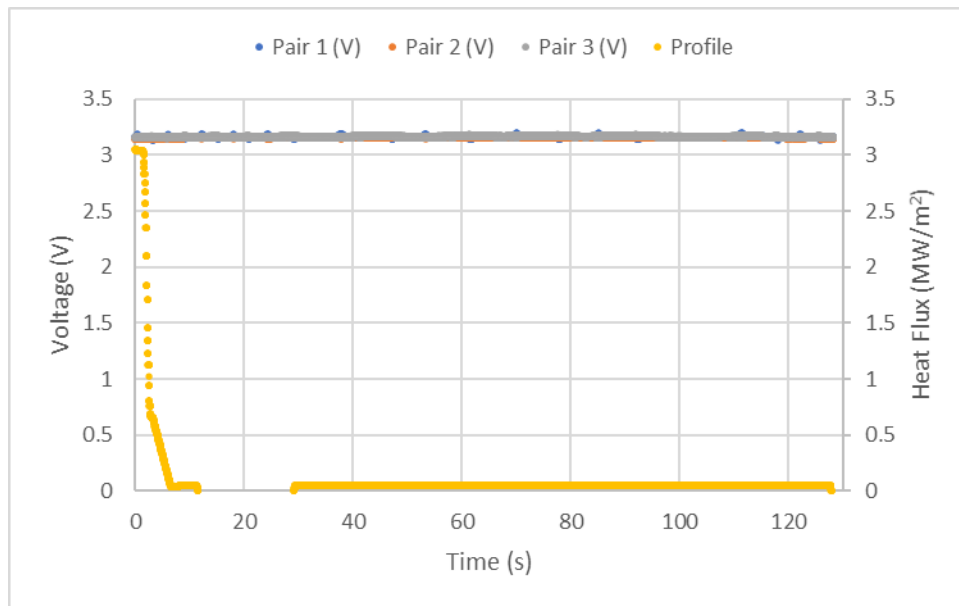
Figure 3-14: Test 1-05 Electrical Monitoring

Figure 3-14 shows the electrical results from the test. Three pairs were monitored in the 7C cable for short circuit failure. As shown, electrical failure was not observed.

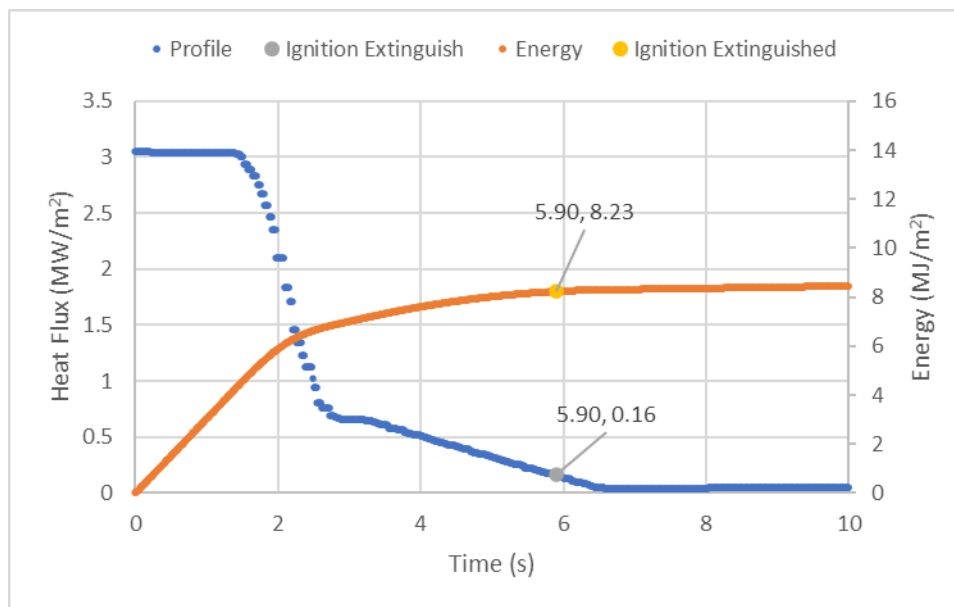
Figure 3-16: Test 1-05 Sustained Ignition as a Function of Heat Flux and Time

The video was reviewed to determine the time at which pyrolysis, ignition, and extinguishment occurred during this test. Ignition and pyrolysis happened essentially immediately, prior to the shutters being fully open. The shutters were fully open at 0.4 seconds. This delay is reflected in all figures in this section and the total energy calculation. The ignition extinguished at 5.90 seconds after the shutter was fully open. Figure 3-16 shows the time at which the ignition extinguished as a function of total energy and heat flux.

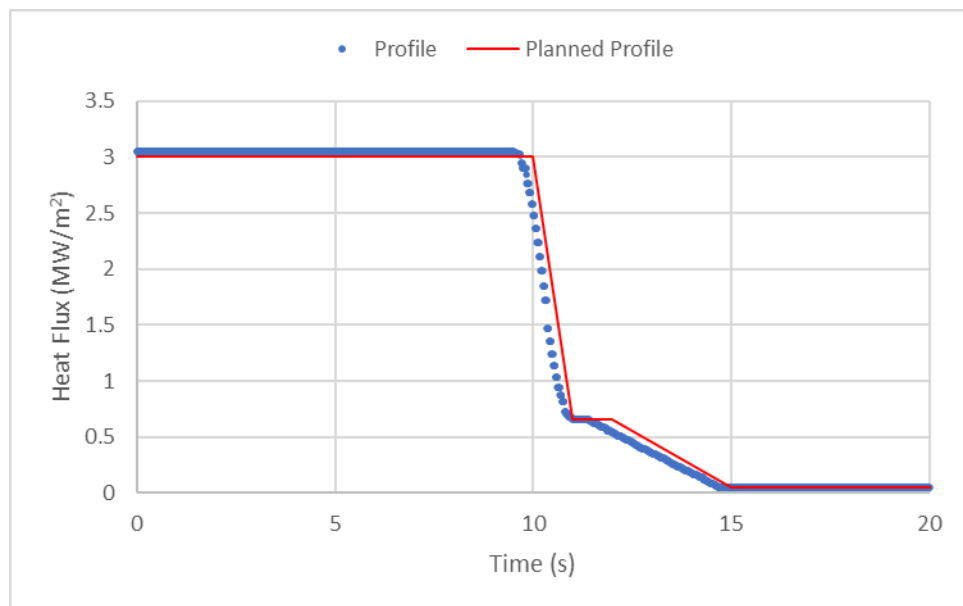
**Figure 3-17: Test 1-06 Heat Flux Profile**

Figure 3-17 and Figure 3-18 show the heat flux profile and total energy for which the cable target was exposed. As shown, the actual profile is fairly accurate compared to the planned profile. The cable target was exposed to a total of approximately 40 MJ/m<sup>2</sup>.

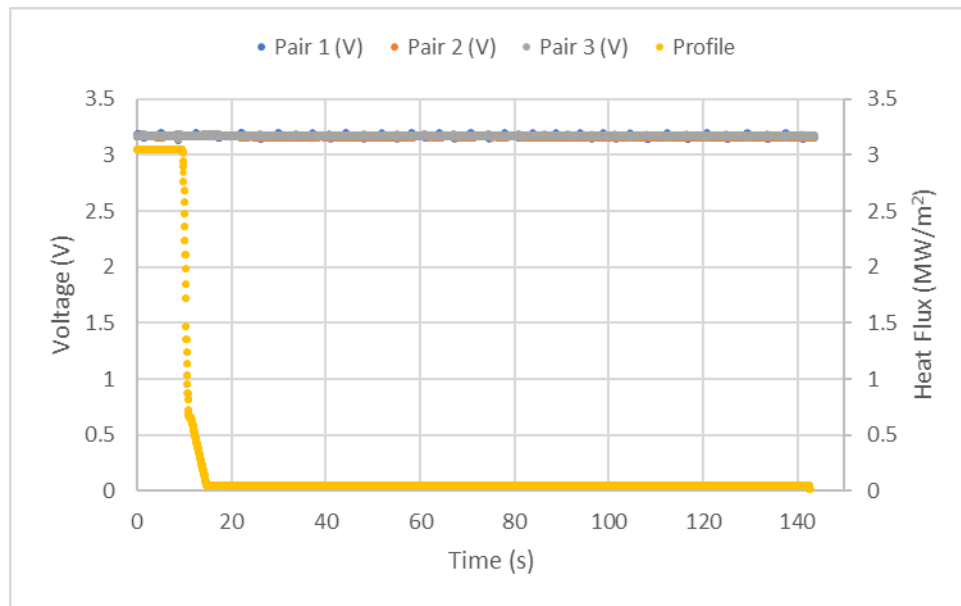
**Figure 3-19: Test 1-06 Electrical Monitoring**

Figure 3-19 shows the electrical results from the test. Three pairs were monitored in the 7C cable for short circuit failure. As shown, electrical failure was not observed.

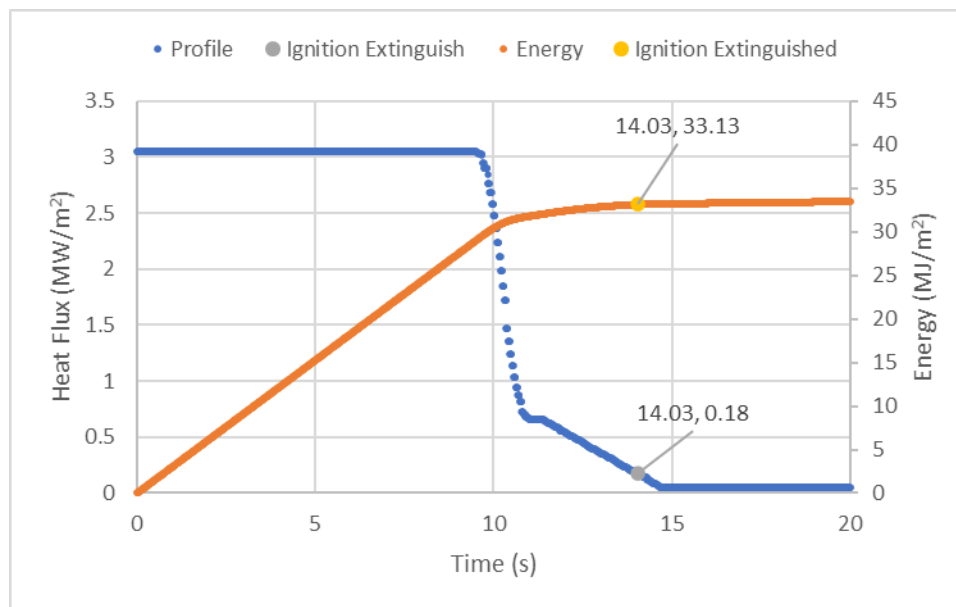
Figure 3-21: Test 1-06 Sustained Ignition as a Function of Heat Flux and Time

The video was reviewed to determine the time at which pyrolysis, ignition, and extinguishment occurred during this test. Ignition and pyrolysis happened essentially immediately, prior to the shutters being fully open. The shutters were fully open at 0.37 seconds. This delay is reflected in all figures in this section and the total energy calculation. The ignition extinguished at 14.03 seconds after the shutter was fully open. Figure 3-21 shows the time at which the ignition extinguished as a function of total energy and heat flux.

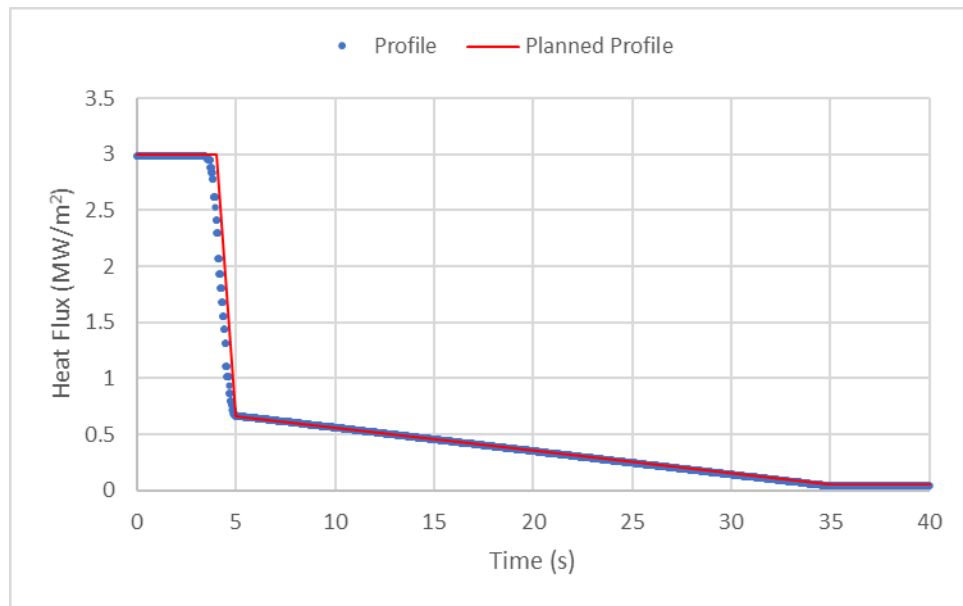
**Figure 3-22: Test 1-07 Heat Flux Profile**

Figure 3-22 and Figure 3-23 show the heat flux profile and total energy for which the cable target was exposed. As shown, a long ramp was used for this test to get better resolution to the heat flux at which ignition extinguished. The cable target was exposed to a total of approximately 24 MJ/m<sup>2</sup>.

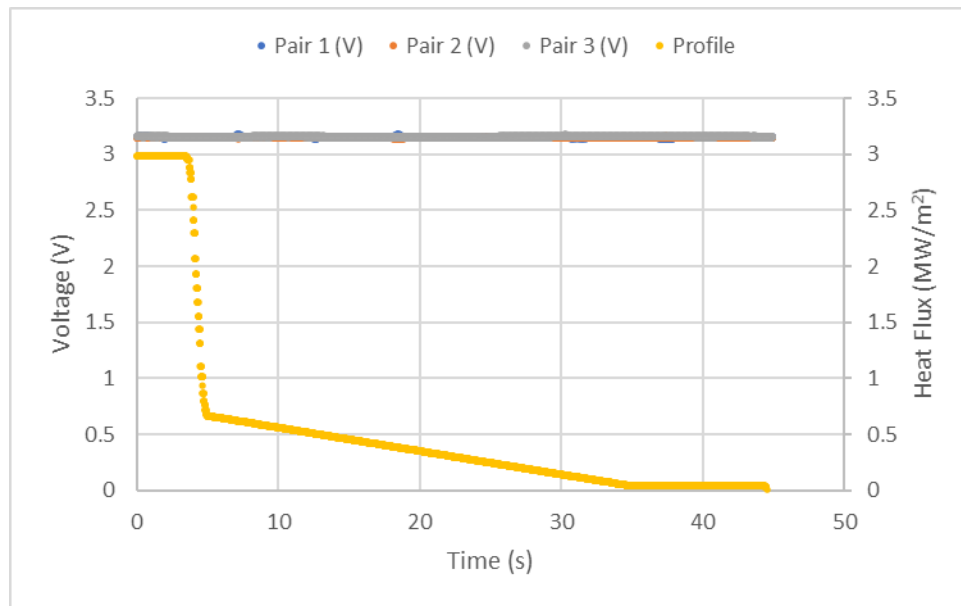
Figure 3-24: Test 1-07 Electrical Monitoring

Figure 3-24 shows the electrical results from the test. Three pairs were monitored in the 7C cable for short circuit failure. As shown, electrical failure was not observed.

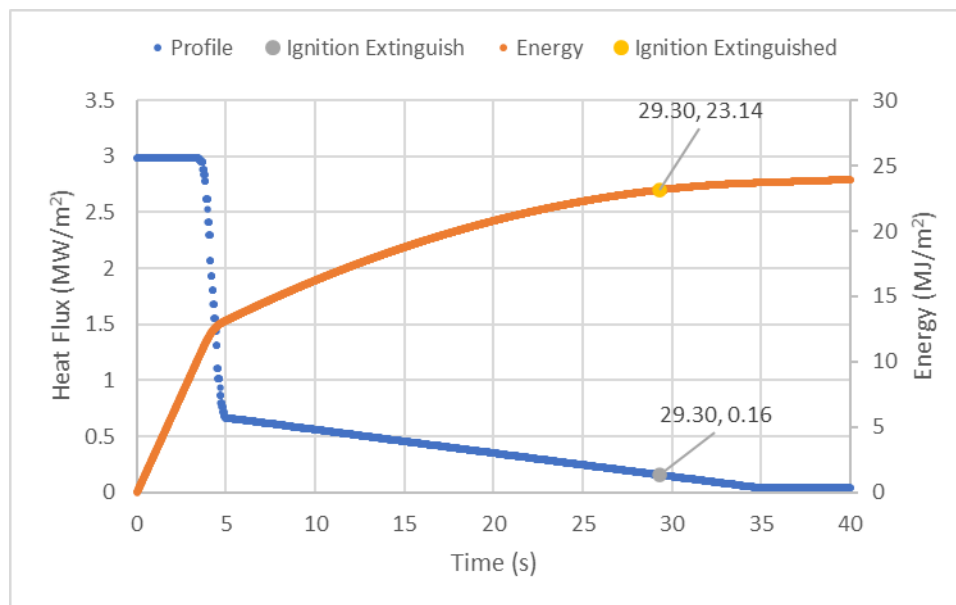
Figure 3-27: Test 1-07 Sustained Ignition as a Function of Heat Flux and Time

The video was reviewed to determine the time at which pyrolysis, ignition, and extinguishment occurred during this test. Ignition and pyrolysis happened essentially immediately, prior to the shutters being fully open. The shutters were fully open at 0.33 seconds. This delay is reflected in all figures in this section and the total energy calculation. The ignition extinguished at 29.30 seconds after the shutter was fully open. Figure 3-27 shows the time at which the ignition extinguished as a function of total energy and heat flux.

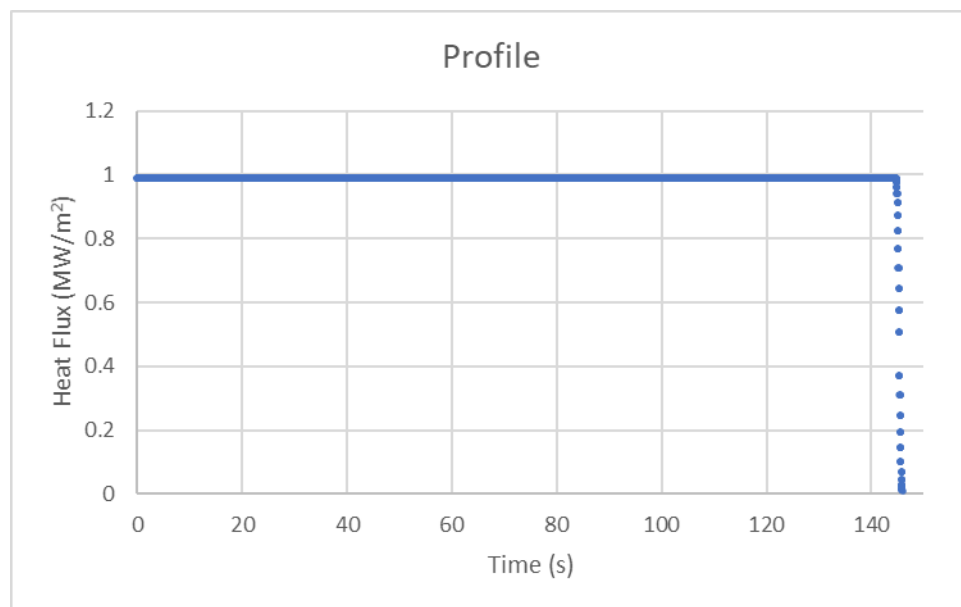
**Figure 3-28: Test 1-08 Heat Flux Profile**

Figure 3-28 and Figure 3-29 show the heat flux profile and total energy for which the cable target was exposed. As shown, a constant heat flux of 1 MW/m<sup>2</sup> was applied for a longer duration to evaluate electrical failure of the cable. The cable target was exposed to a total of approximately 144 MJ/m<sup>2</sup>.

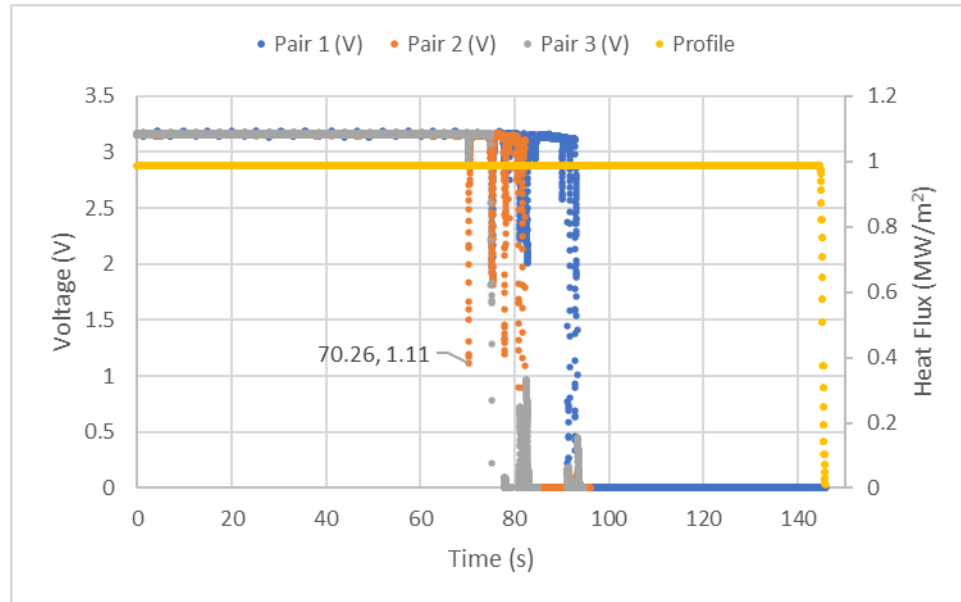
Figure 3-30: Test 1-08 Electrical Monitoring

Figure 3-30 shows the electrical results from the test. Three pairs were monitored in the 7C cable for short circuit failure. As shown, electrical failure was observed for each pair, the first of which occurred at 72 seconds into the test. The total energy at 72 seconds was approximately 69 MJ/m<sup>2</sup>.

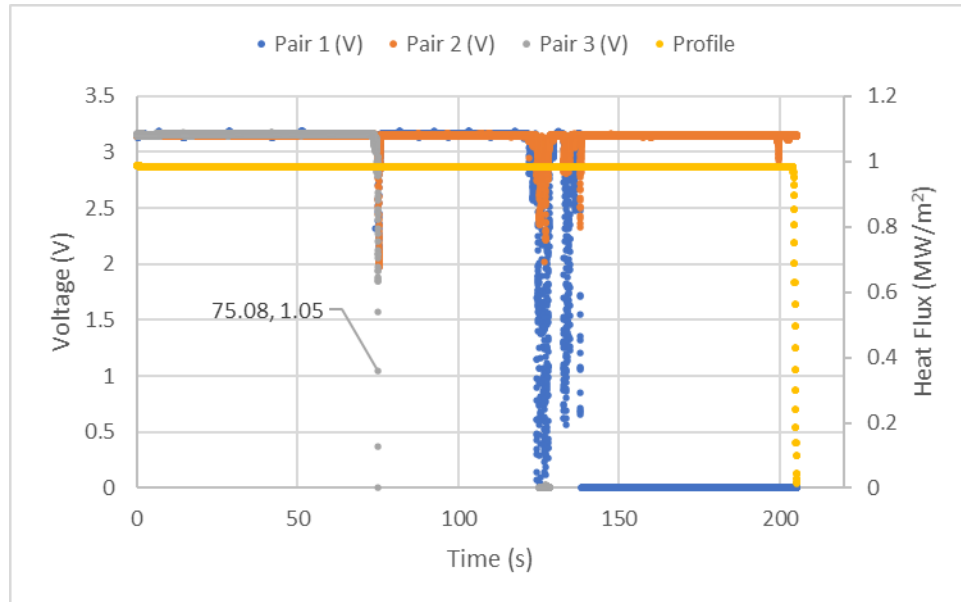
Figure 3-40: Test 1-10 Electrical Monitoring

Figure 3-40 shows the electrical results from the test. Three pairs were monitored in the 7C cable for short circuit failure. As shown, electrical failure was observed for each pair, the first of which occurred at 75 seconds into the test. The total energy at 75 seconds was approximately 74 MJ/m<sup>2</sup>.

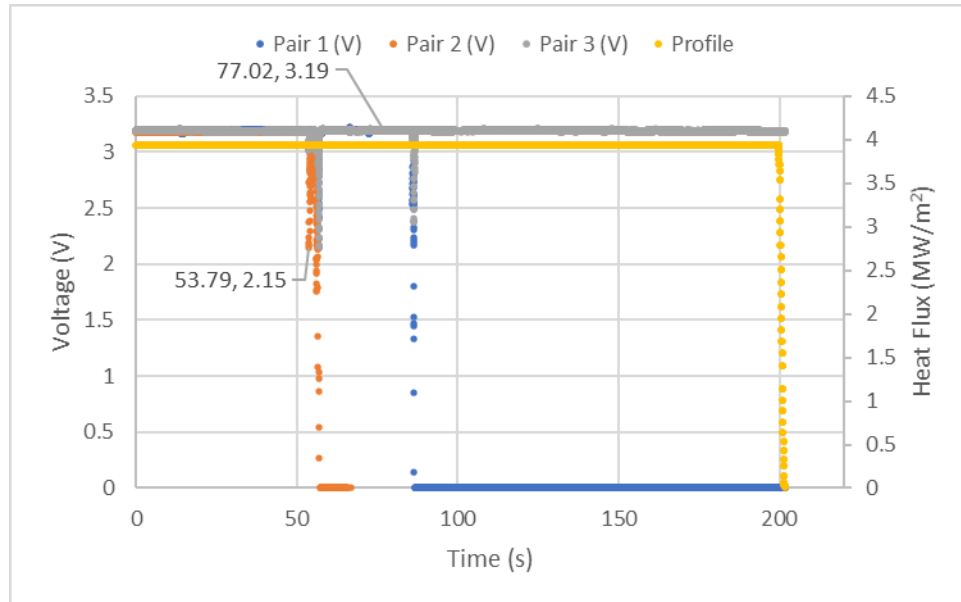
Figure 3-49: Test 1-12 Electrical Monitoring

Figure 3-49 shows the electrical results from the test. Three pairs were monitored in the 7C cable for short circuit failure. As shown, electrical failure was observed for each pair, the first of which occurred at 54 seconds into the test. The total energy at 54 seconds was approximately 212 MJ/m<sup>2</sup>.

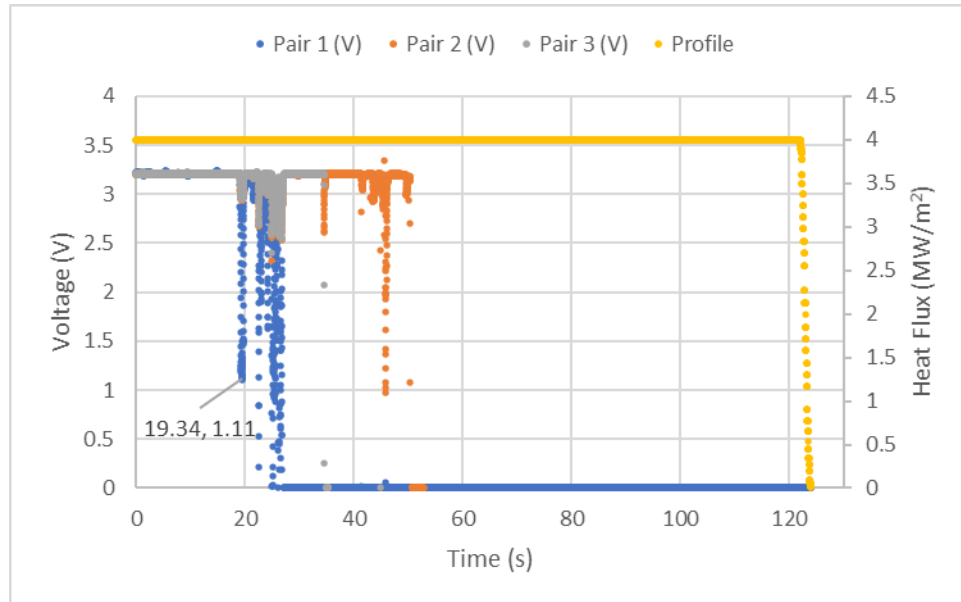
Figure 3-57: Test 1-14 Electrical Monitoring

Figure 3-57 shows the electrical results from the test. Three pairs were monitored in the 7C cable for short circuit failure. As shown, electrical failure was observed for each pair, the first of which occurred at 20 seconds into the test. The total energy at 20 seconds was approximately 77 MJ/m<sup>2</sup>.

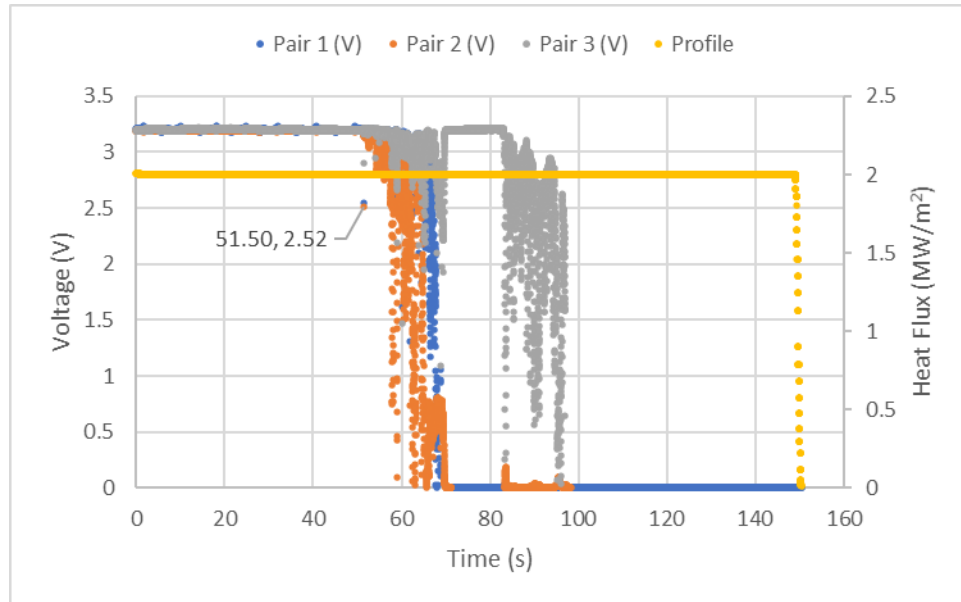
Figure 3-65: Test 1-16 Electrical Monitoring

Figure 3-65 shows the electrical results from the test. Three pairs were monitored in the 7C cable for short circuit failure. As shown, electrical failure was observed for each pair, the first of which occurred at 52 seconds into the test. The total energy at 52 seconds was approximately 103 MJ/m<sup>2</sup>.

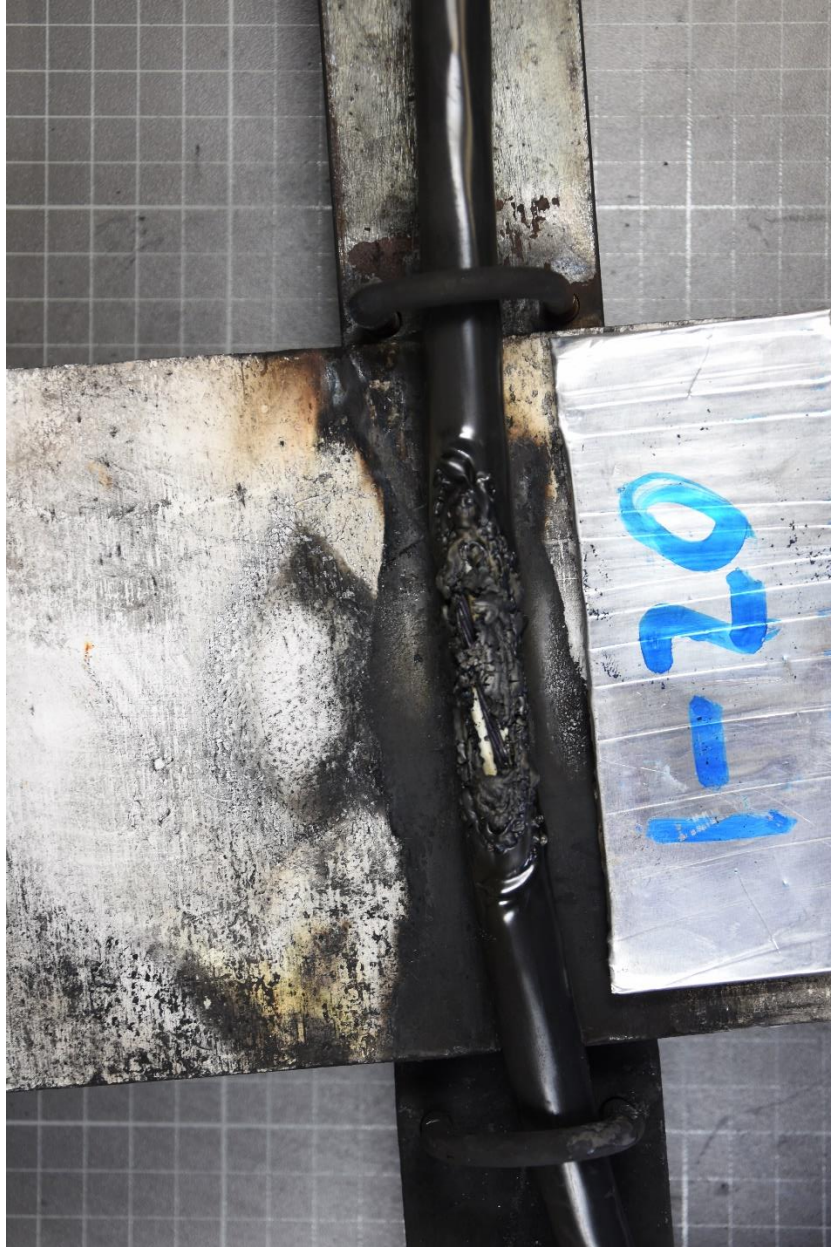
**Figure 3-76: Test 1-18 Post-test Photo (2)**

Figure 3-75, Figure 3-76, and Figure 3-77 show the target cable after the exposure profile. As shown, the insulated wires under the jacket were exposed during this test. Note that the photos for this test were mislabeled as Test 1-20.

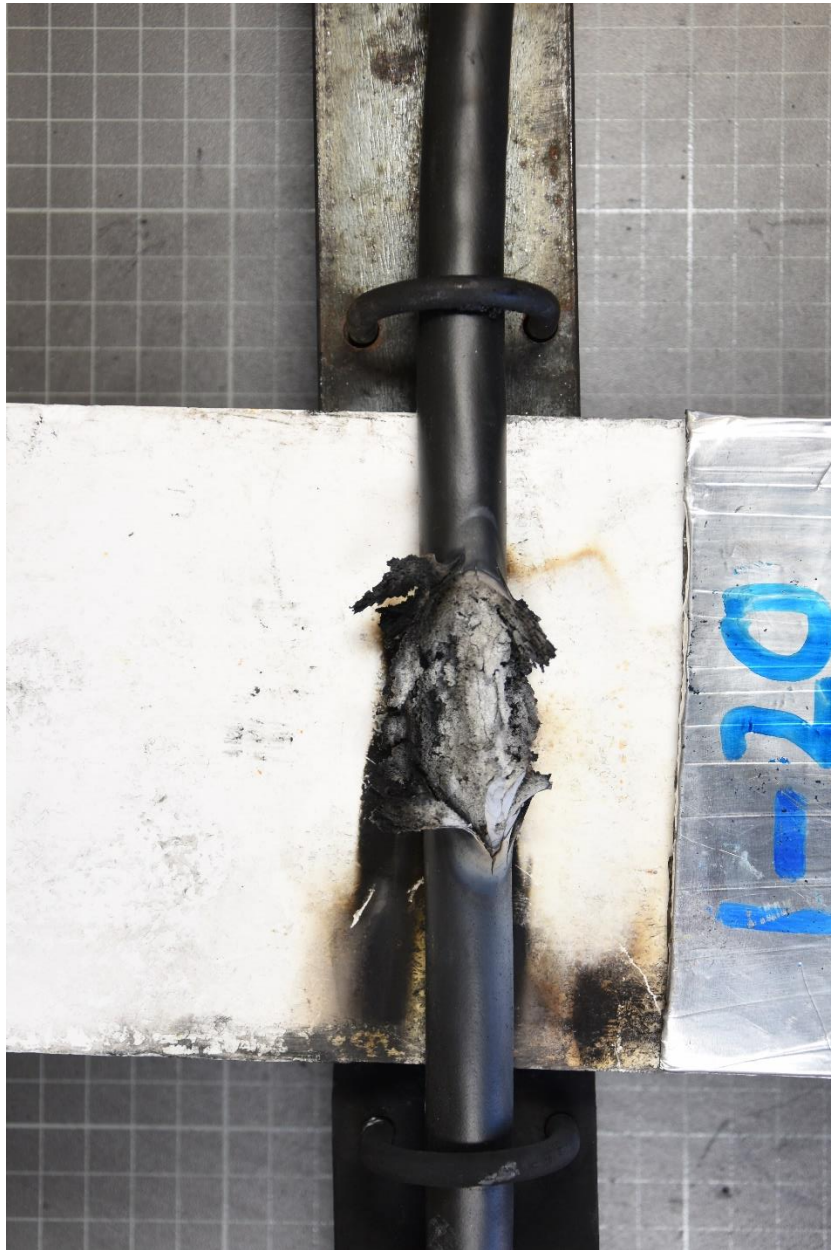
Figure 3-86: Test 1-20 Post-test Photo (1)

Figure 3-86 and Figure 3-87 show the target cable after the exposure profile. As shown, the insulated wires under the jacket were exposed during this test.

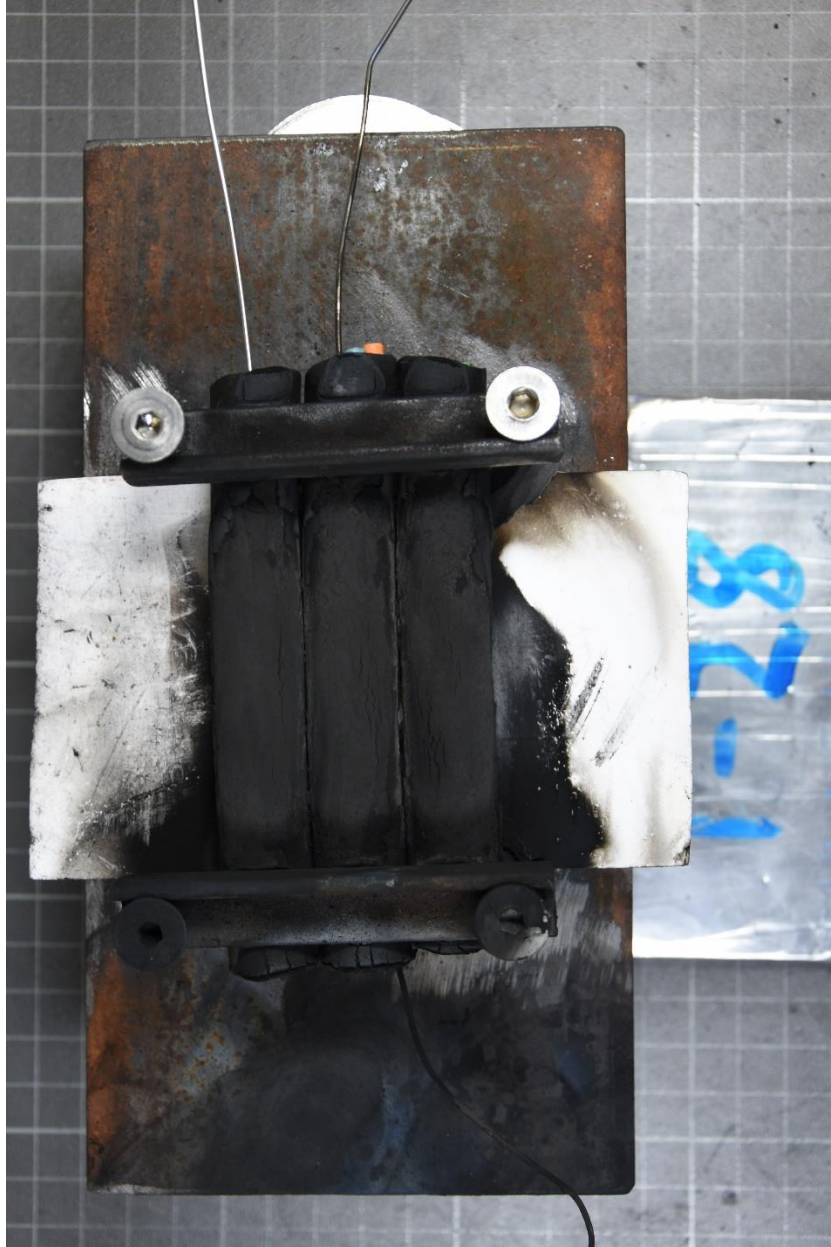
**Figure 3-133: Test 1-28 Post-test Photo (2)**

Figure 3-132 and Figure 3-133 show the target cable after the exposure profile. As shown, surface damage to the jacket is present. However, the insulated wires were not exposed during this test. Note, that there are cracks forming (as shown in Figure 3-133), that indicate that insulation exposure is imminent.

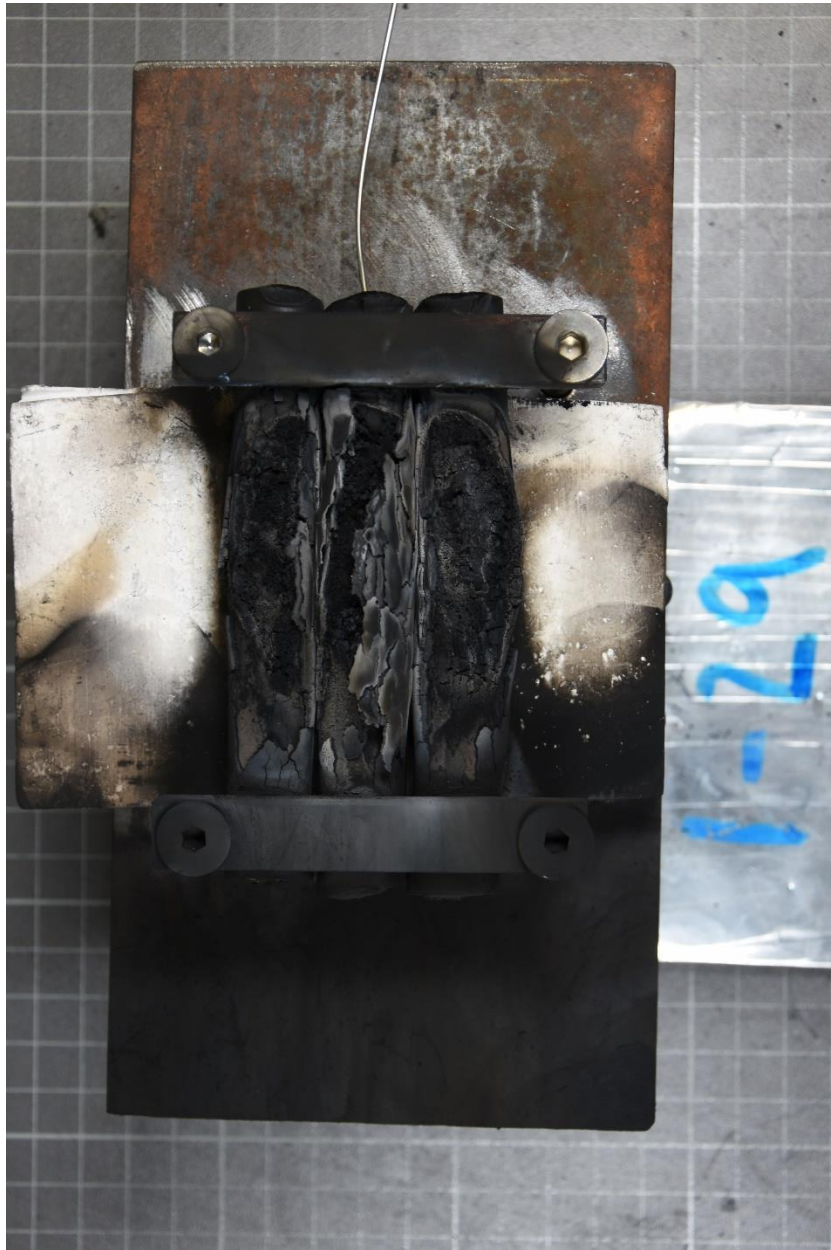
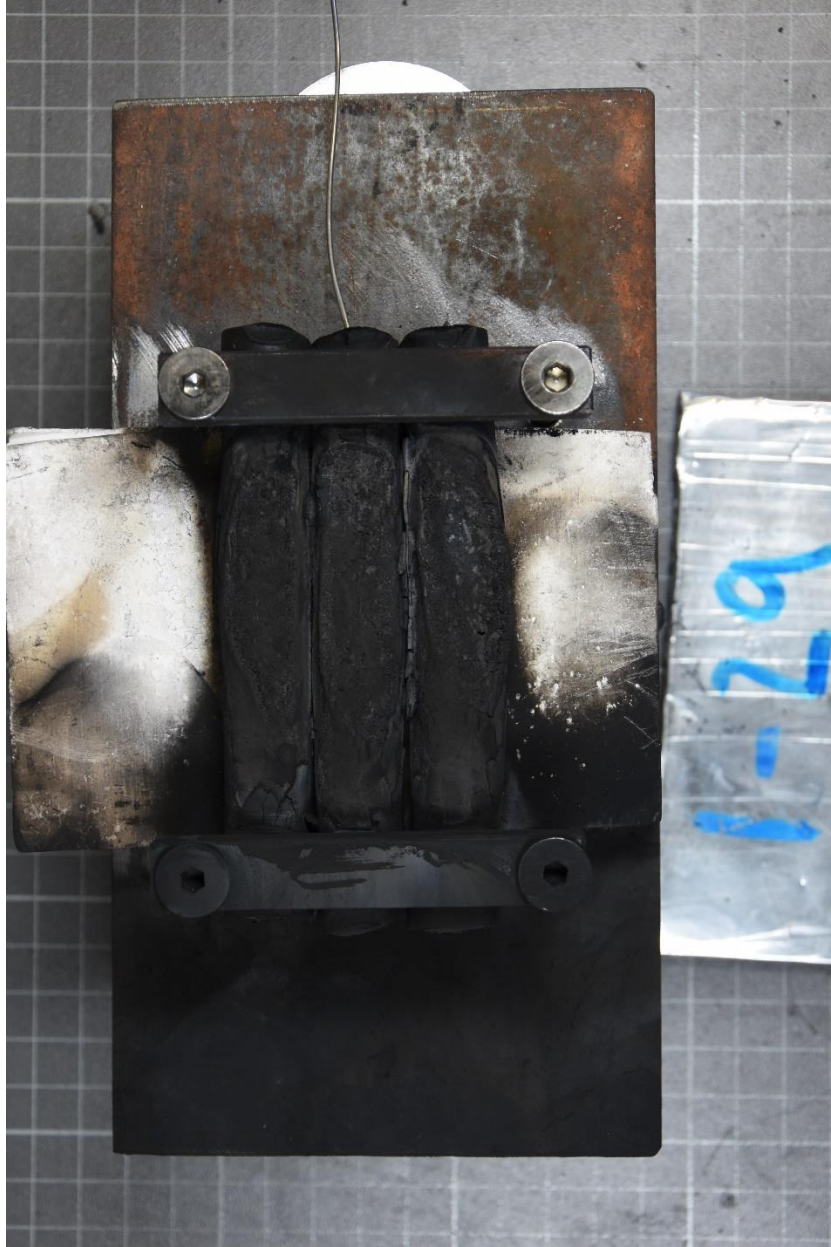
Figure 3-138 and Figure 3-139 show the target cable after the exposure profile. As shown, surface damage to the jacket is present. However, the insulated wires were not exposed during this test.

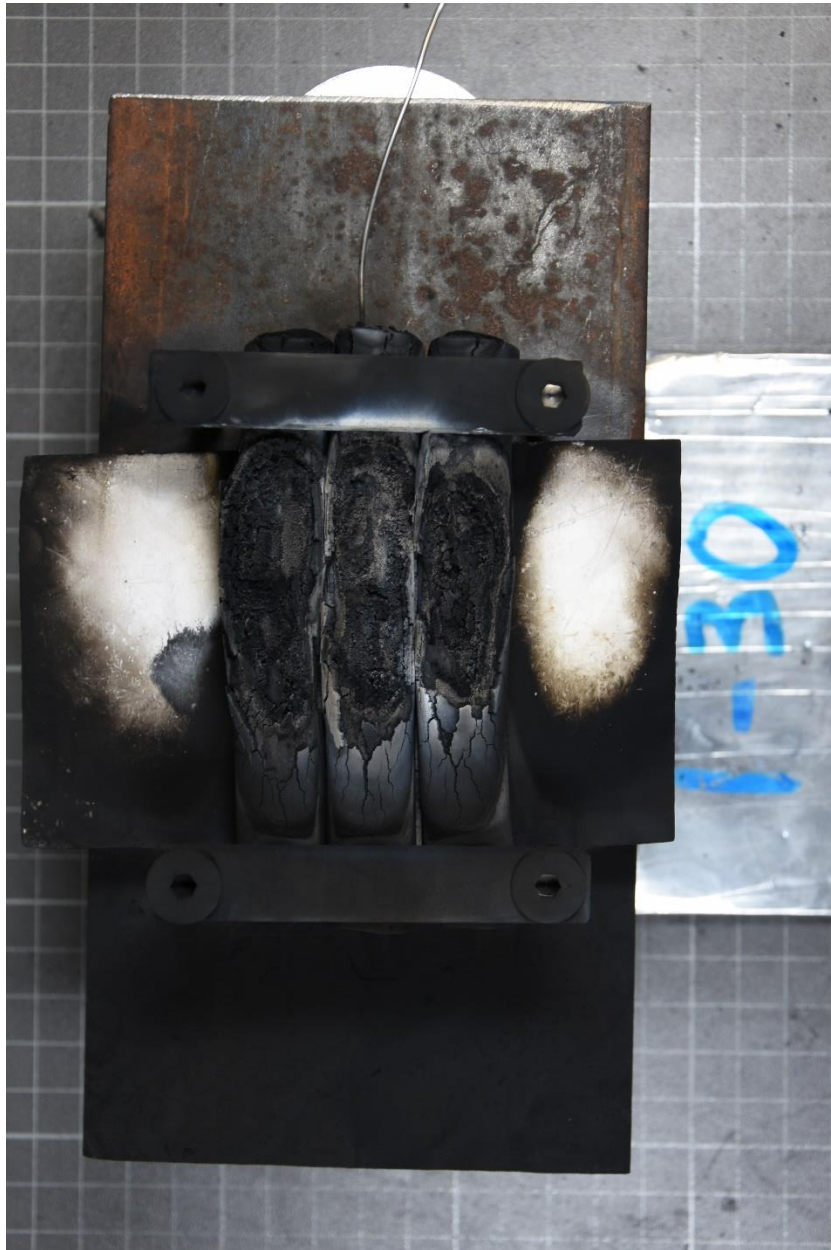
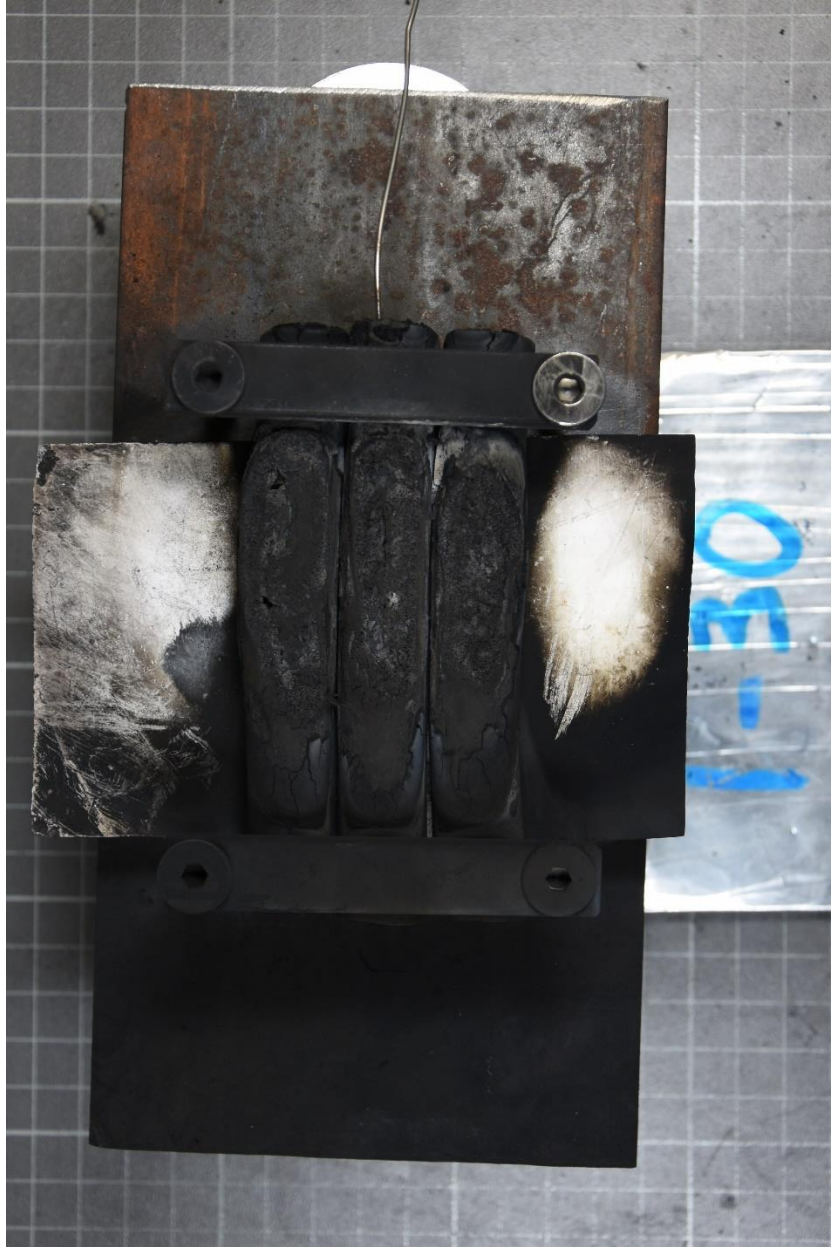
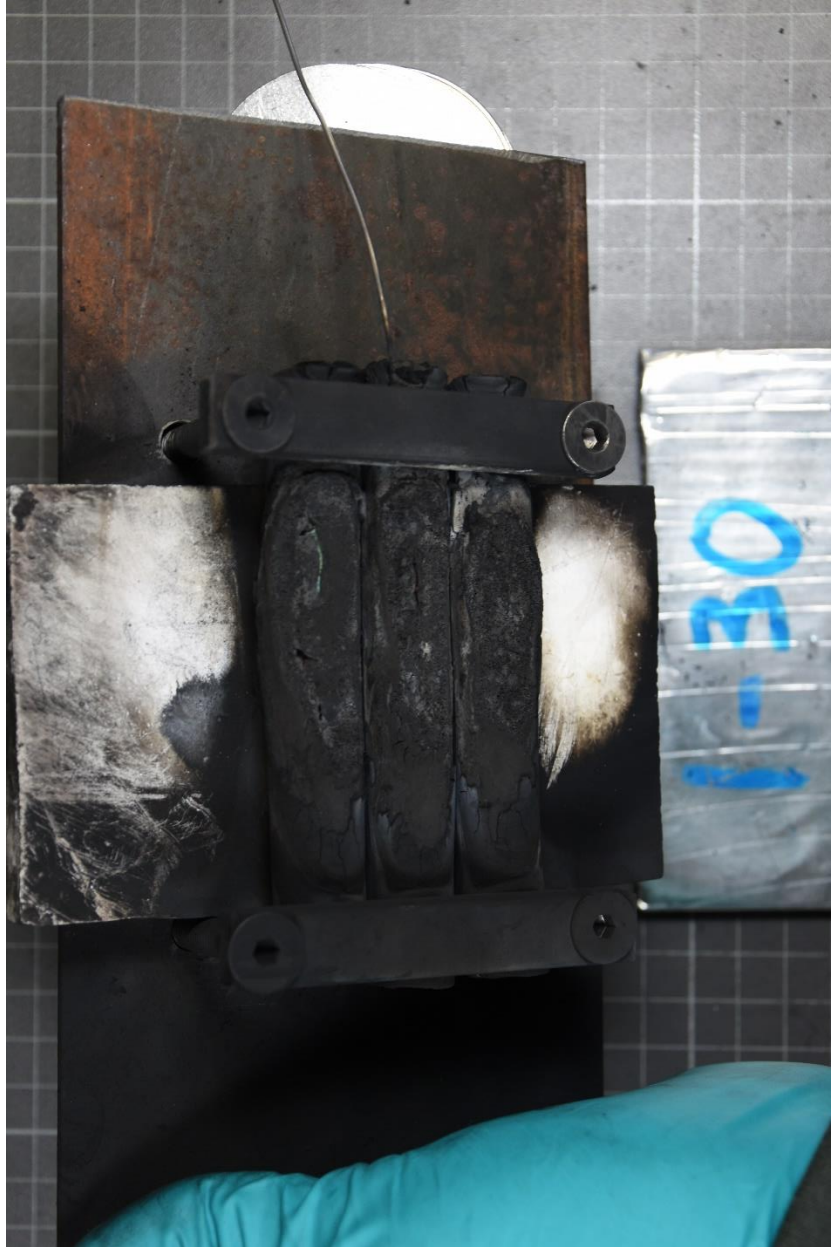
Figure 3-144, Figure 3-145, and Figure 3-146 show the target cable after the exposure profile. As shown, the insulated wires under the jacket were exposed during this test.
