**SANDIA REPORT**

SAND2021-11327

# HEAF Cable Fragility Testing at the Solar Furnace at the NSTTF

Austin M. Glover, Chris LaFleur, Jeff Engerer

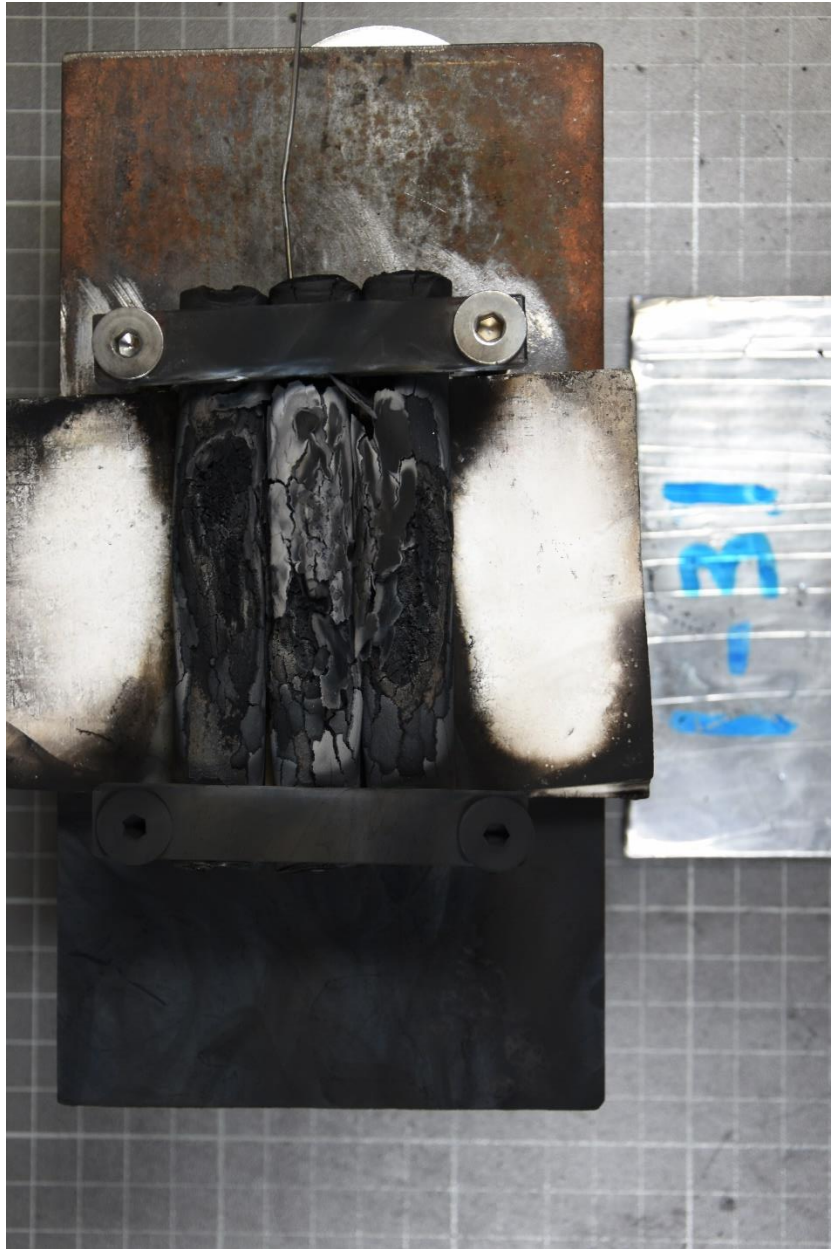
**Figure 3-151: Test 1-31 Post-test Photo (1)**

Figure 3-151 and Figure 3-152 show the target cable after the exposure profile. As shown, surface damage to the jacket is present. However, the insulated wires were not exposed during this test. Note, that pinholes are formed in the center cable (as shown in Figure 3-152), which indicates that insulation exposure is imminent.

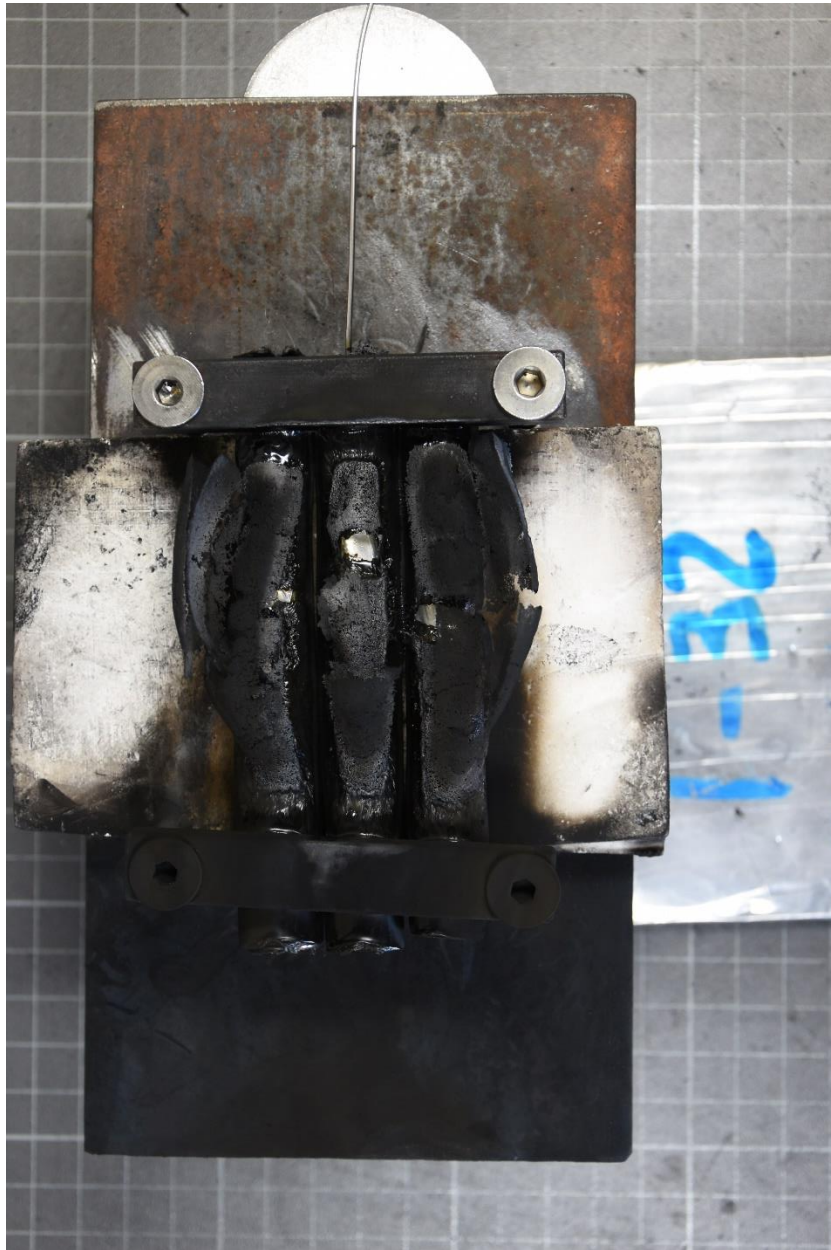
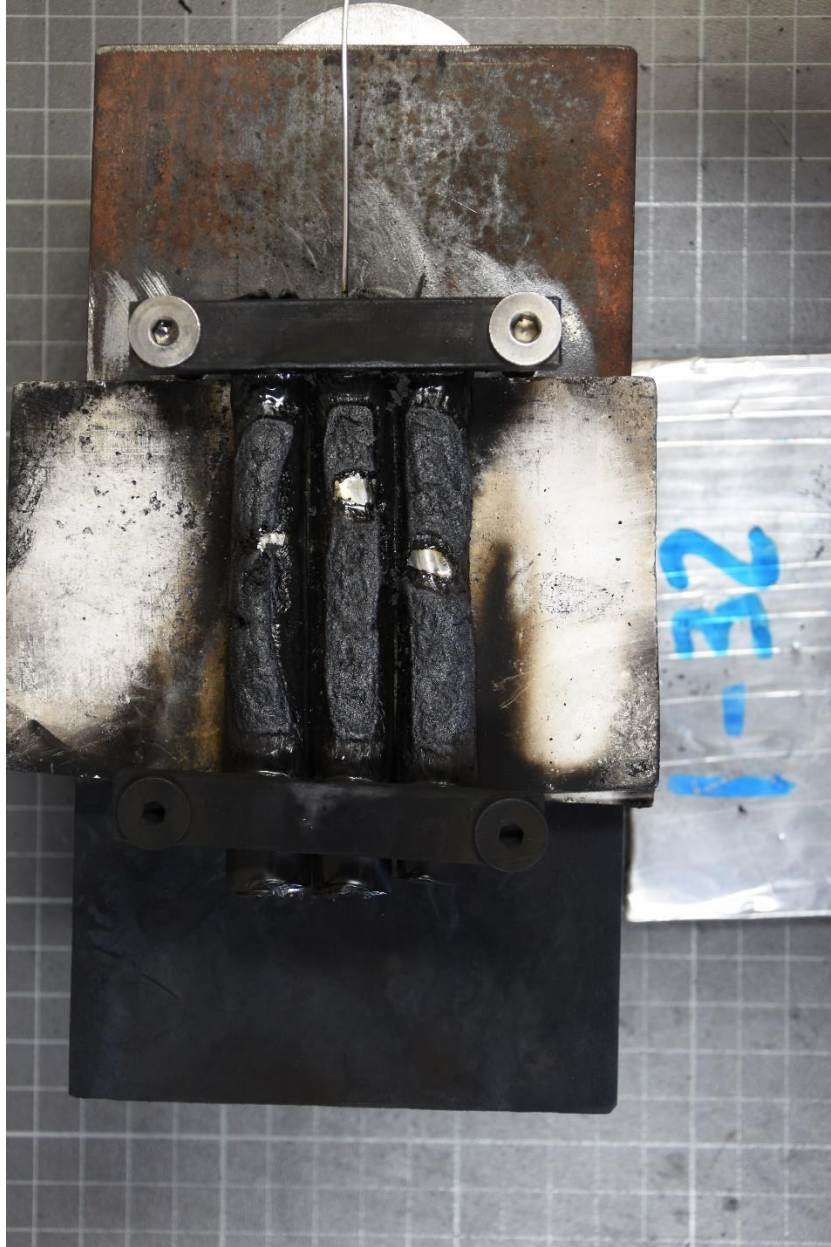
Figure 3-156 and Figure 3-157 show the target cable after the exposure profile. As shown, the sub-jacket metallic shielding was exposed during this test.

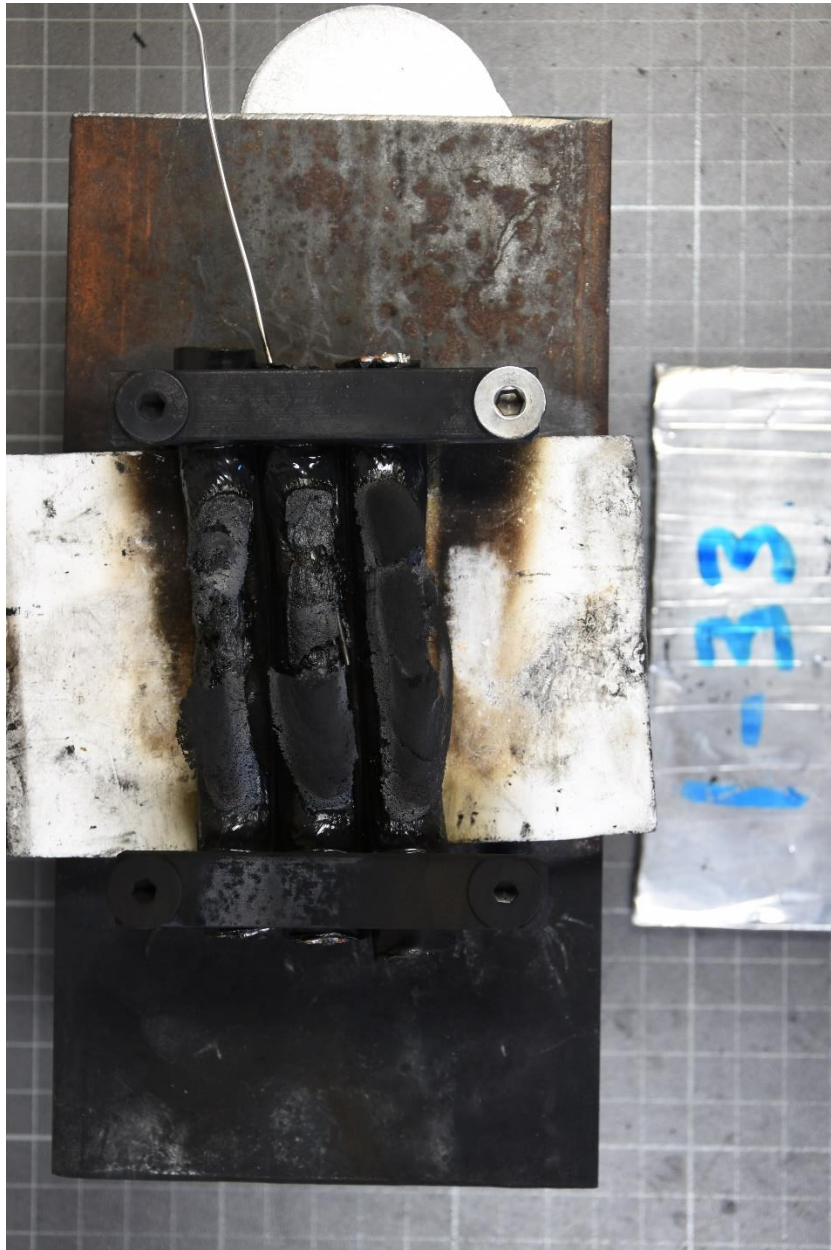
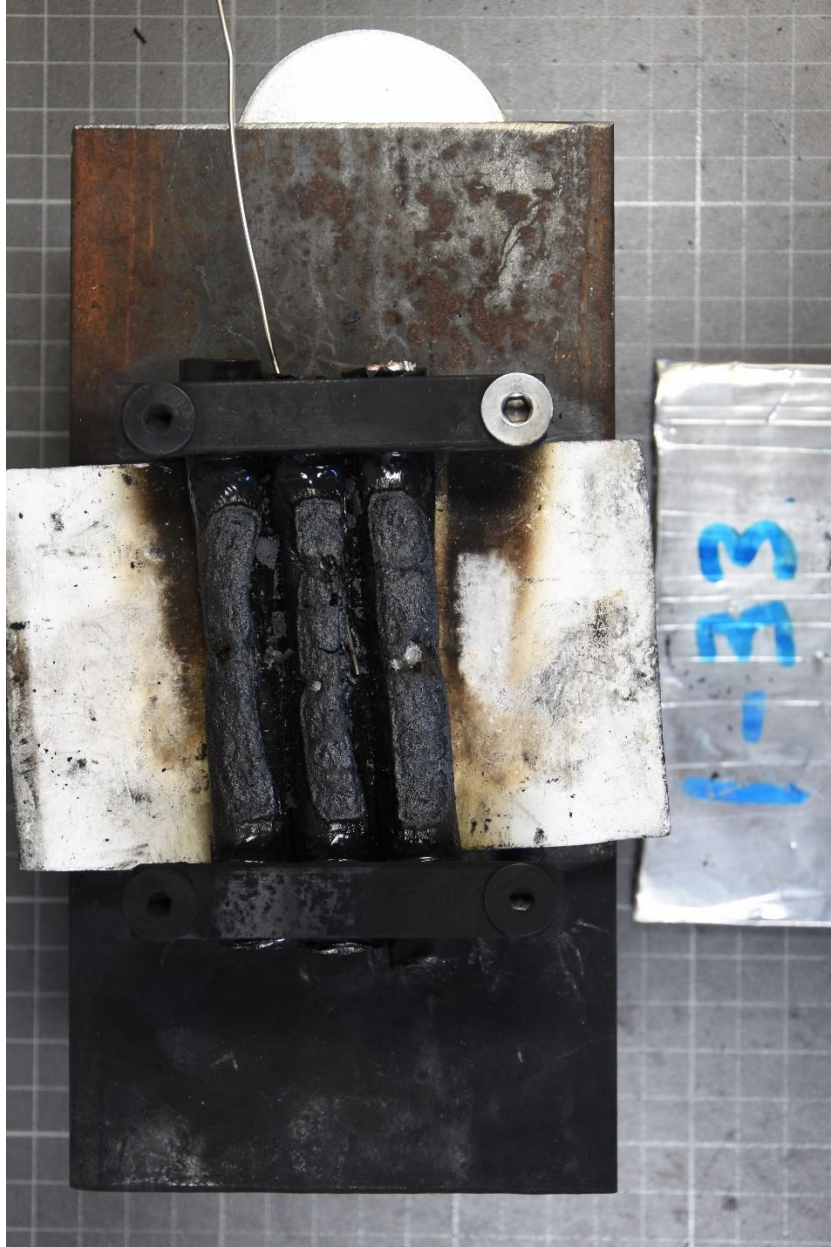
Figure 3-162 and Figure 3-163 show the target cable after the exposure profile. As shown, the sub-jacket metallic shielding was exposed during this test.

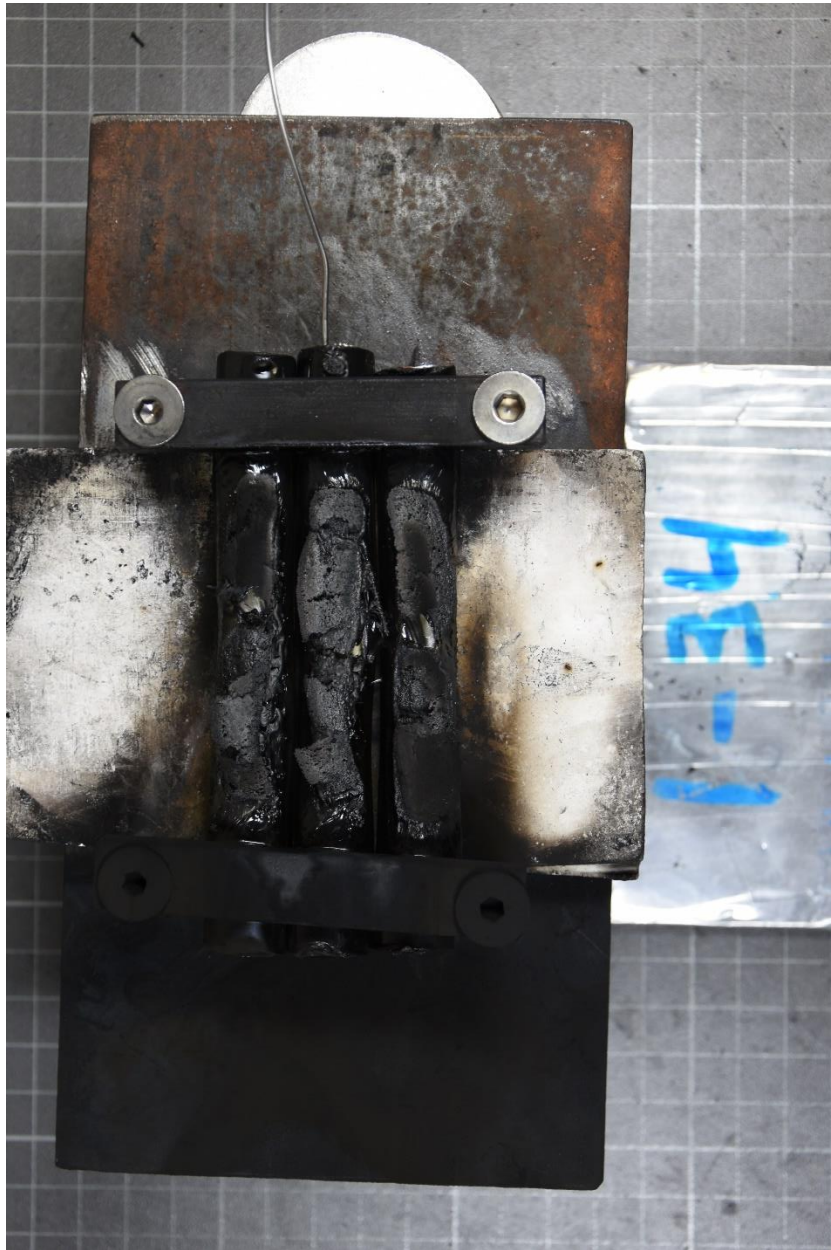
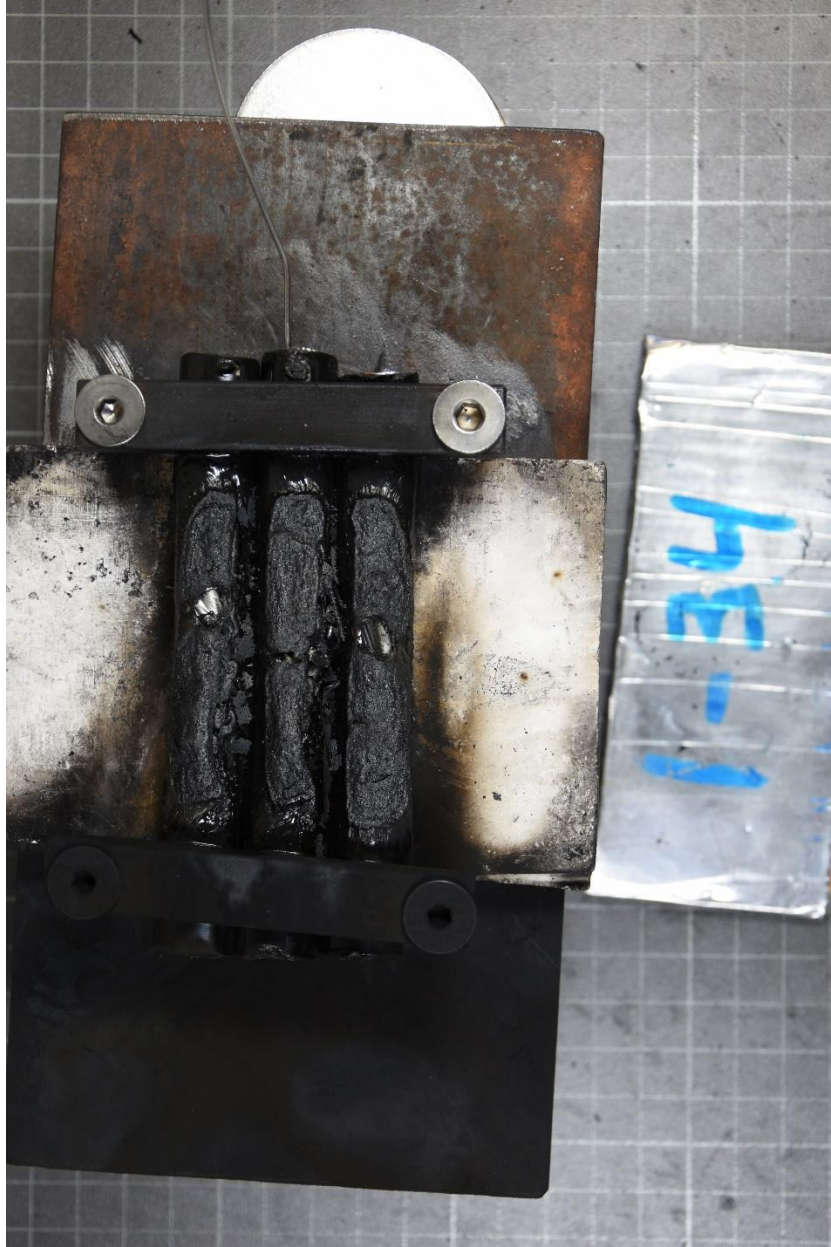
Figure 3-168 and Figure 3-169 show the target cable after the exposure profile. As shown, the sub-jacket metallic shielding was exposed during this test.

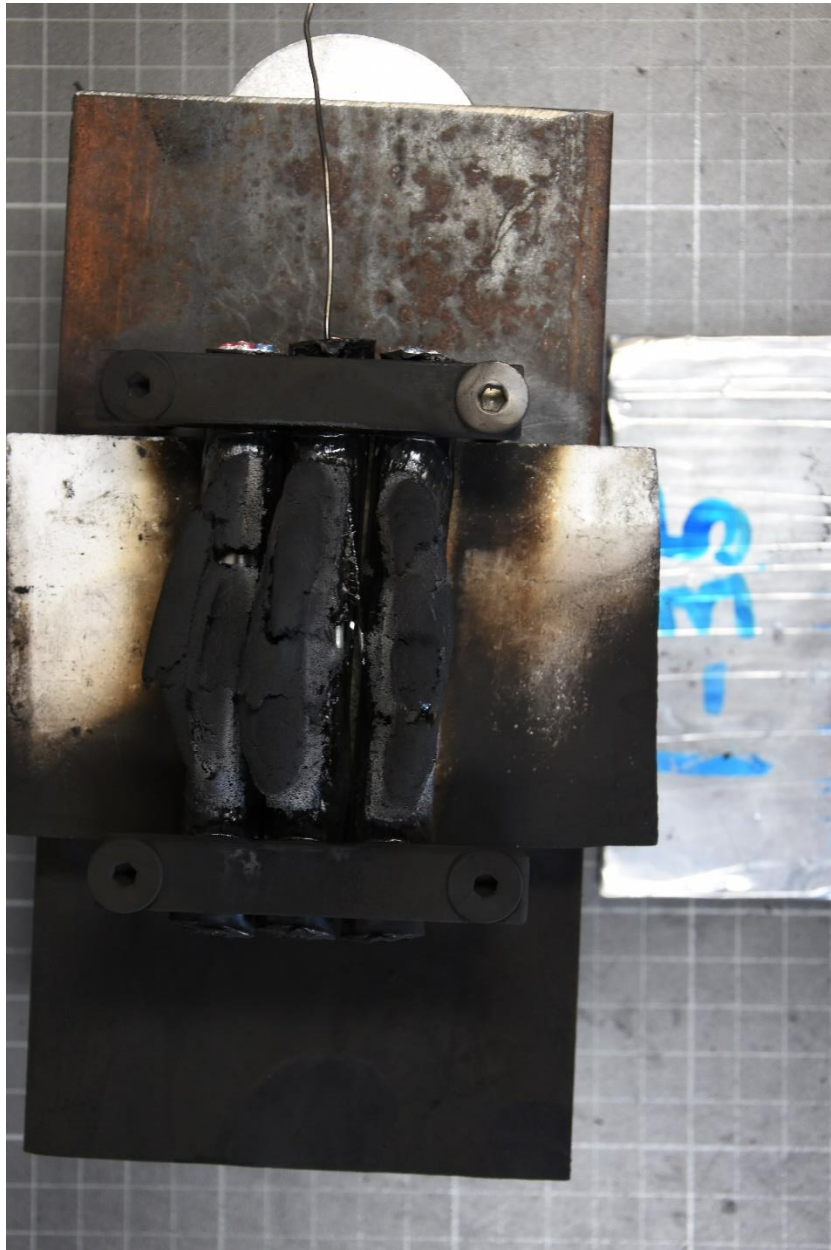
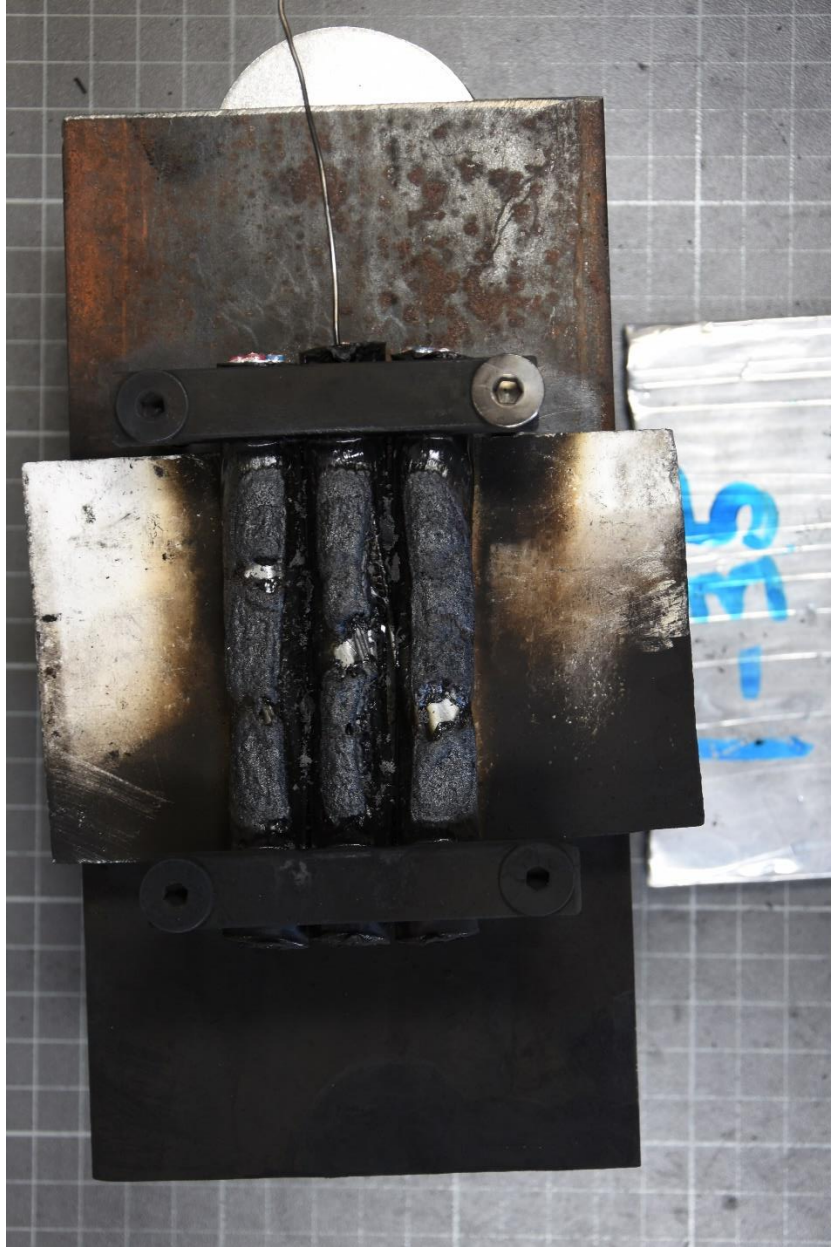
Figure 3-174 and Figure 3-175 show the target cable after the exposure profile. As shown, the sub-jacket metallic shielding was exposed during this test.

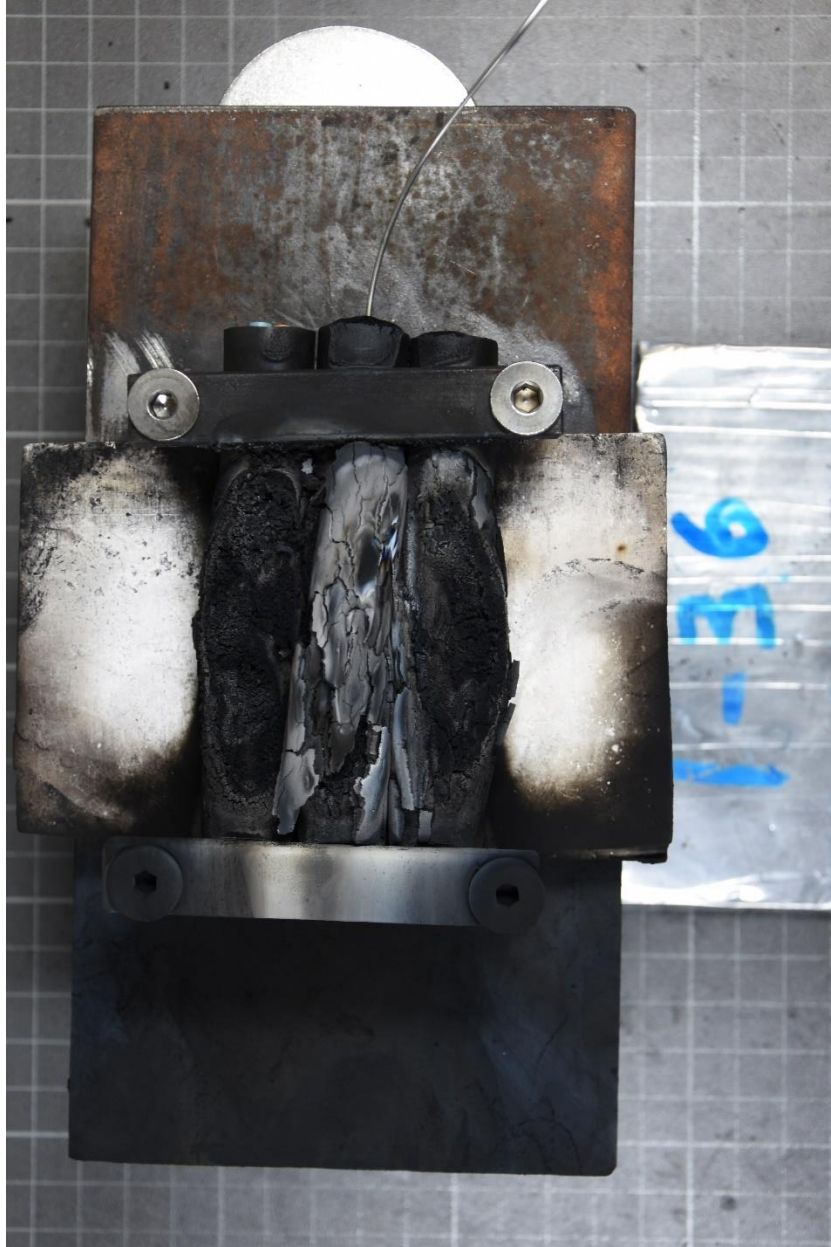
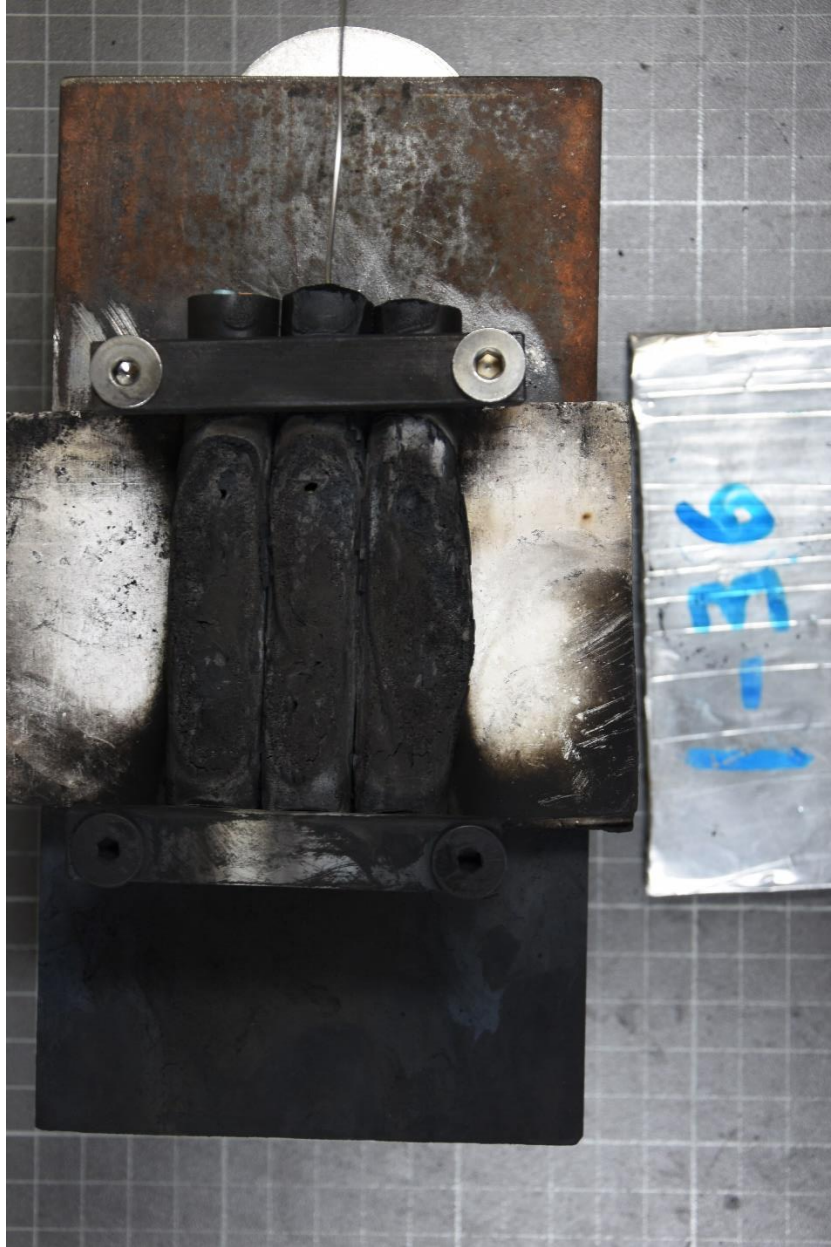
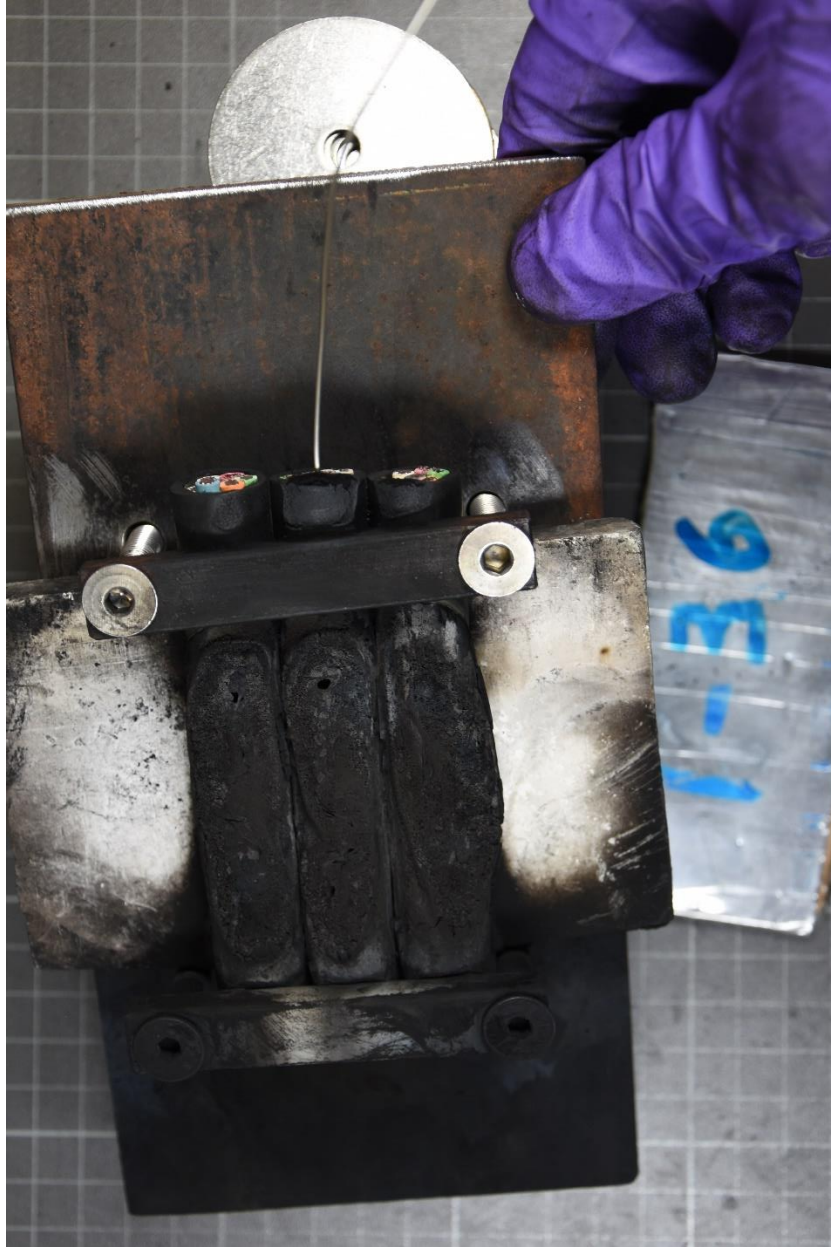
Figure 3-180, Figure 3-181, and Figure 3-182 show the target cable after the exposure profile. As shown, deep pinholes formed in the center and left cable targets. Although not visible in these photos, the insulated wires could be seen through the pinhole in the center cable.

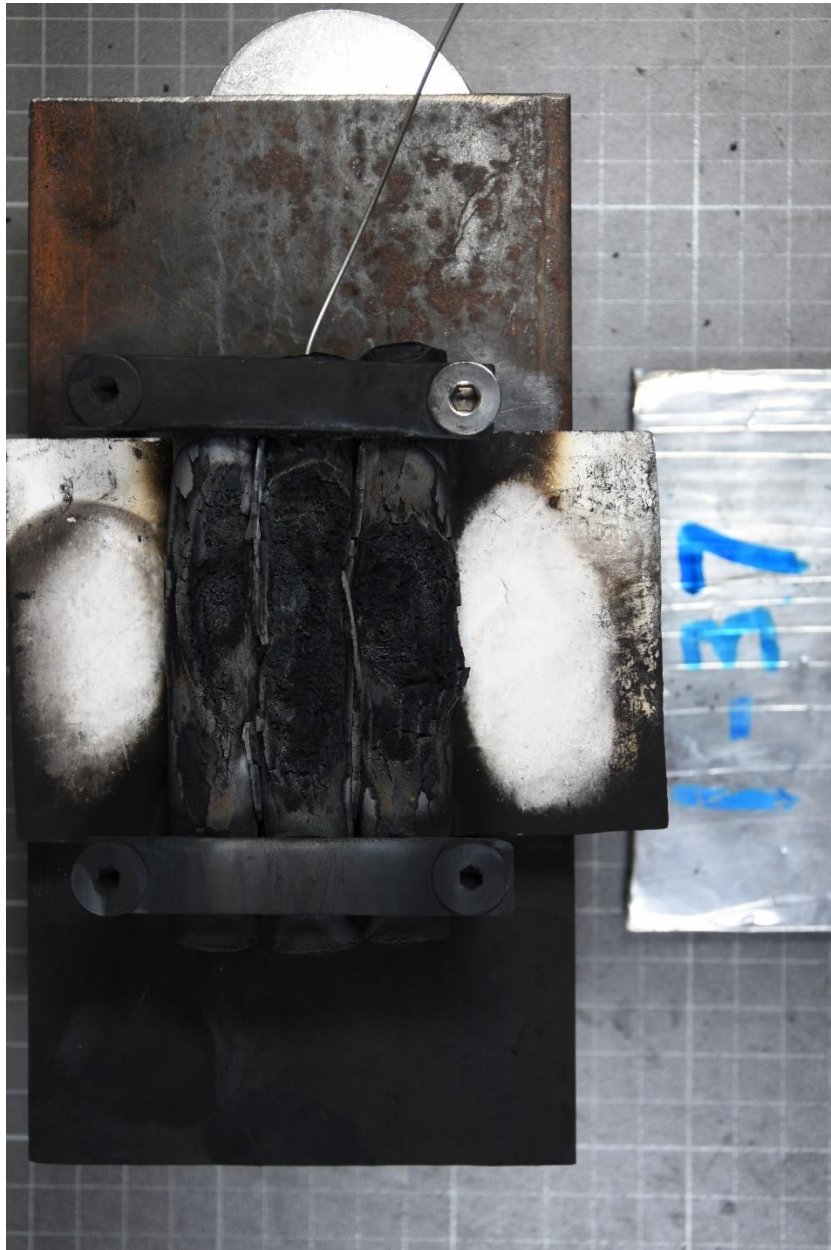
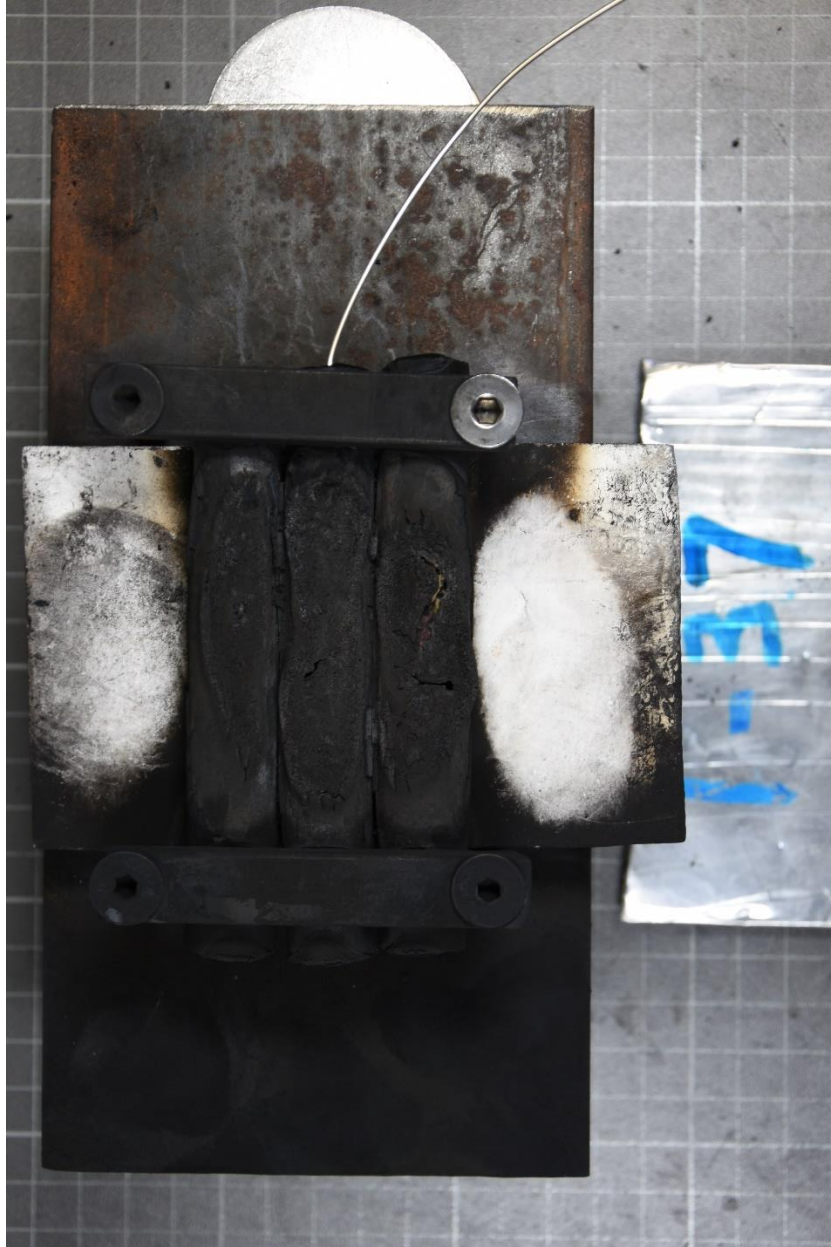
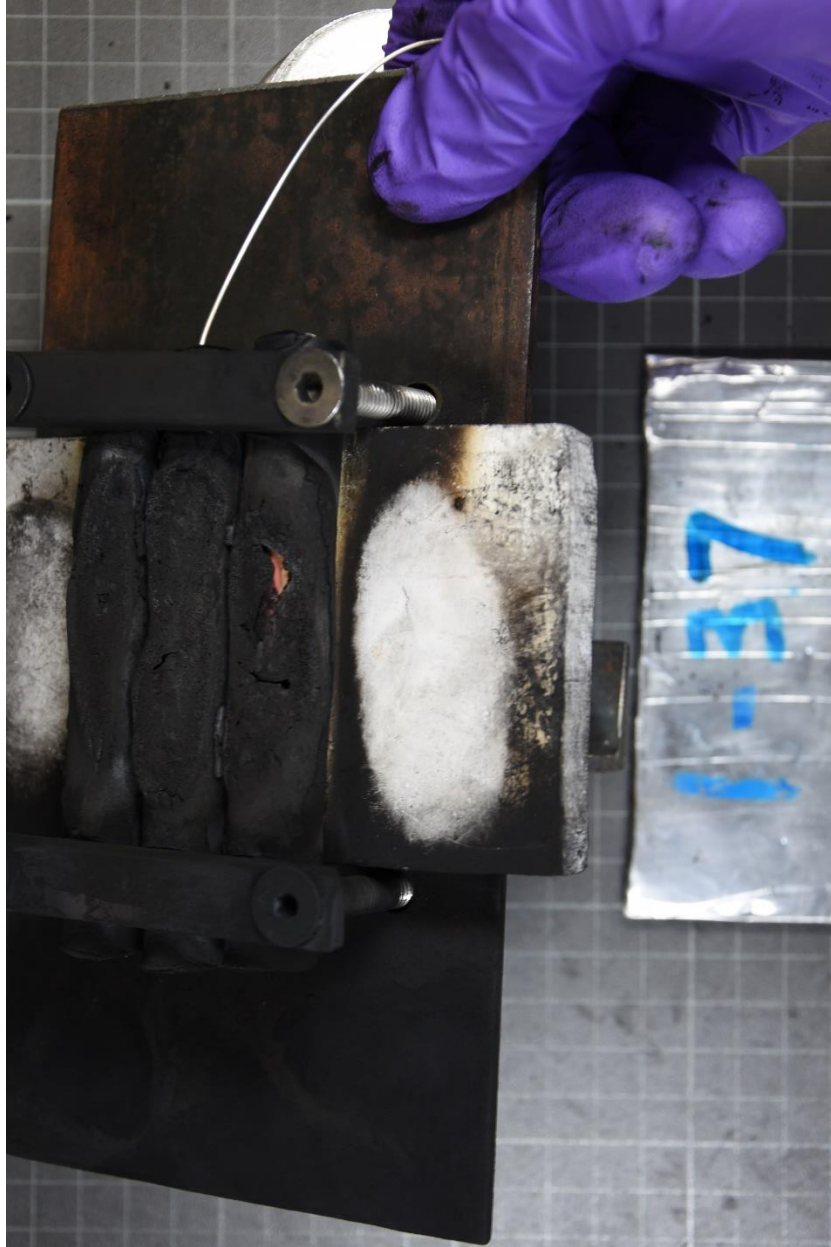
Figure 3-187, Figure 3-188, and Figure 3-189 show the target cable after the exposure profile. As shown, the insulated wires under the jacket were exposed during this test.

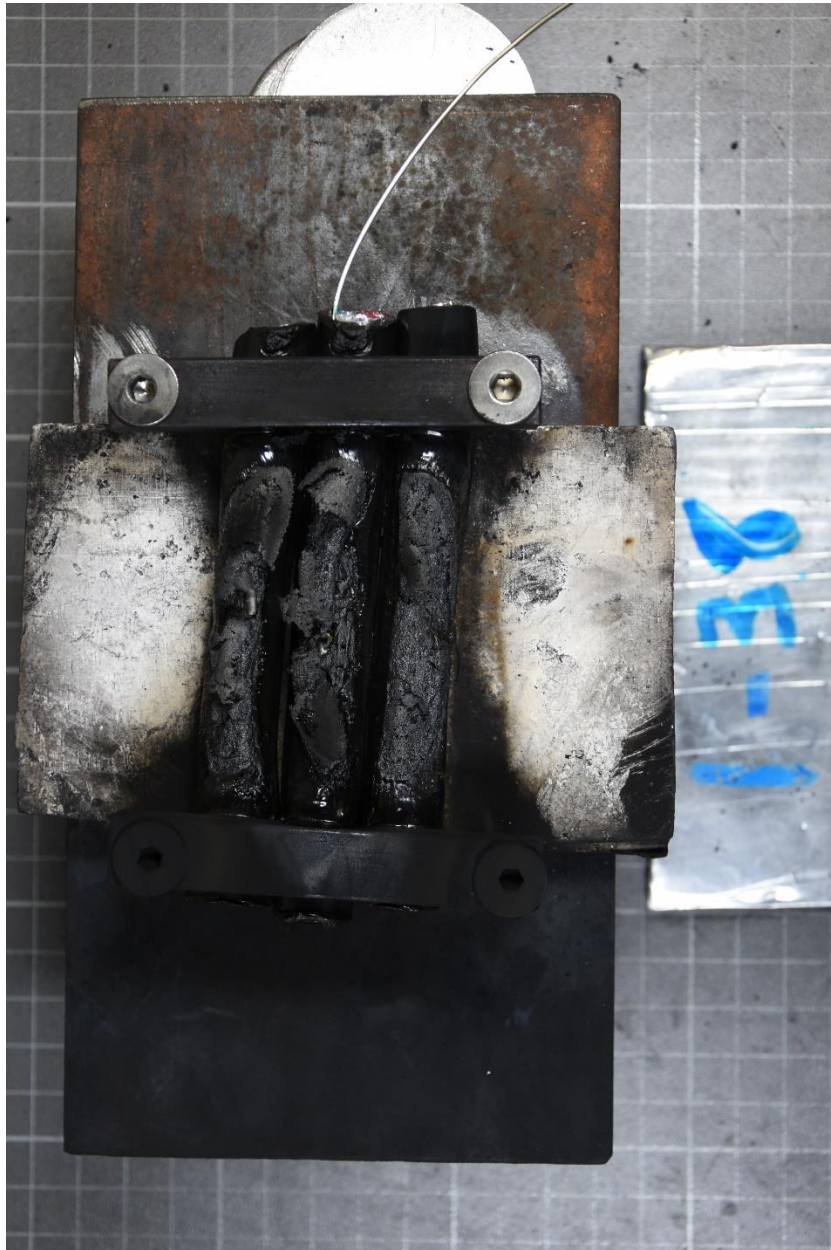
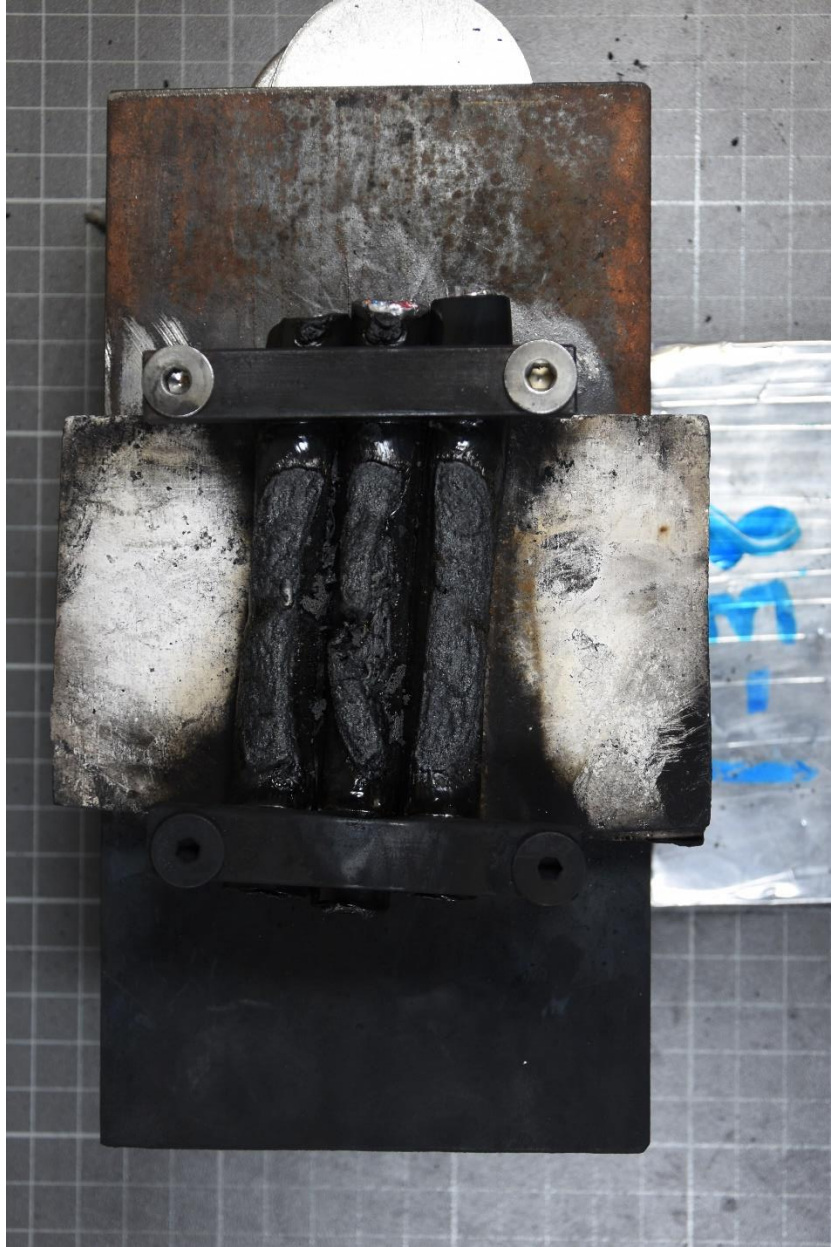
Figure 3-194 and Figure 3-195 show the target cable after the exposure profile. As shown, the sub-jacket metallic shielding was exposed during this test.
