**Title:** Historic Buildings Report: Five-Year Preservation Planning for Manhattan Project National Historical Park Sites

# **Historic Buildings Report: Five-Year Preservation Planning for Manhattan Project National Historical Park Sites**

**Fiscal Years 2022 - 2026**

Historic Building Report No. 394  
Survey No. 1257

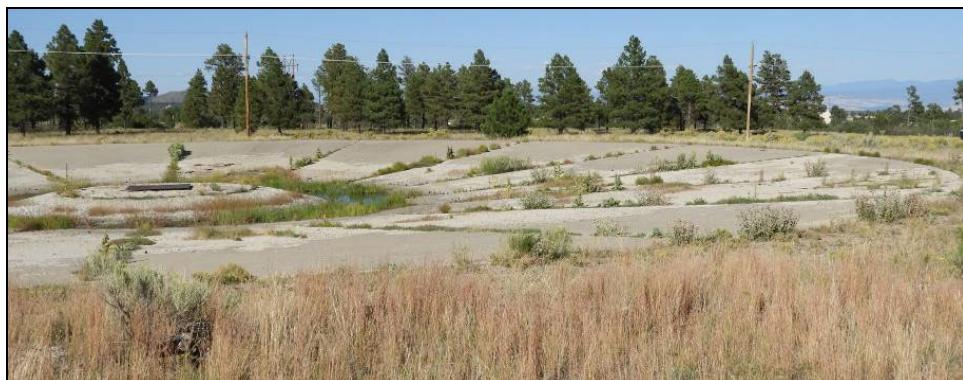
A large effort took place in the summer of 2020 to remove accumulated duff and vegetative debris off the surface of the concrete. Additionally, live vegetation was removed from the deteriorated expansion joints. While the surface of the Concrete Bowl shows a marked difference of vegetative debris on the surface compared to prior the 2020 project, accumulation will continue to occur due to nearby conifer trees dropping material directly on the surface of the Concrete Bowl and wind blowing debris from nearby trees on to the Concrete Bowl. Dirt and water trapped in the deteriorated expansion joints continues and will continue to promote vegetation growth in these areas.

*Figure 2. The majority of the vegetation growth occurs in the expansion joints seen here as green lines radiating out from the center.*

Routine maintenance of the removal of vegetative debris and live plants should be a priority to maintain the structural stability of the Concrete Bowl. Removal should take place on a yearly basis, however, a scheduled work schedule of every six months is considered optimal. Frequent removal of live vegetation from the expansion joints will help prevent live plants from seeding and help inhibit larger plant growth.

In addition to the routine maintenance discussed above, a full replacement of the expansion joints should occur. Newly installed expansion joint material will increase success in keeping live plants from growing in the structure while decreasing the time and labor needed for routine maintenance.

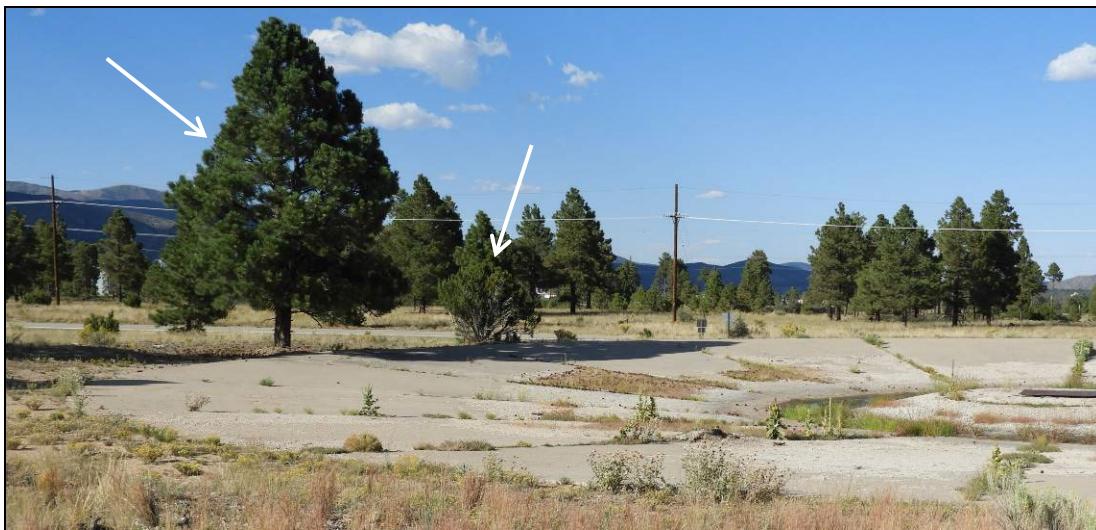
Two trees are growing adjacent to the edge of the concrete on the northwest side. One tree is a medium to large Ponderosa pine and the other is a mature juniper. The root systems of both trees are pushing up on the adjacent concrete slabs promoting severe cracking and structural destabilization. Due to the close proximity of the both trees, duff and conifer litter is deposited at a far greater rate than that of trees farther from the structure. These deposits promote moisture retention in the underlying concrete resulting in weaker concrete and accelerated deterioration.

*Figure 3. The two trees create uplift on the nearby concrete slab and deposit duff on top of the Concrete Bowl.*

Remove both trees with a chainsaw. Any digging is discouraged due to the close proximity of the trees to the concrete. Remaining stumps should be left as close to the ground as possible and treated to help accelerate decay of the visible stump and subsurface root system. All removal debris including trunks, branches, and needles should be completely removed from the site.

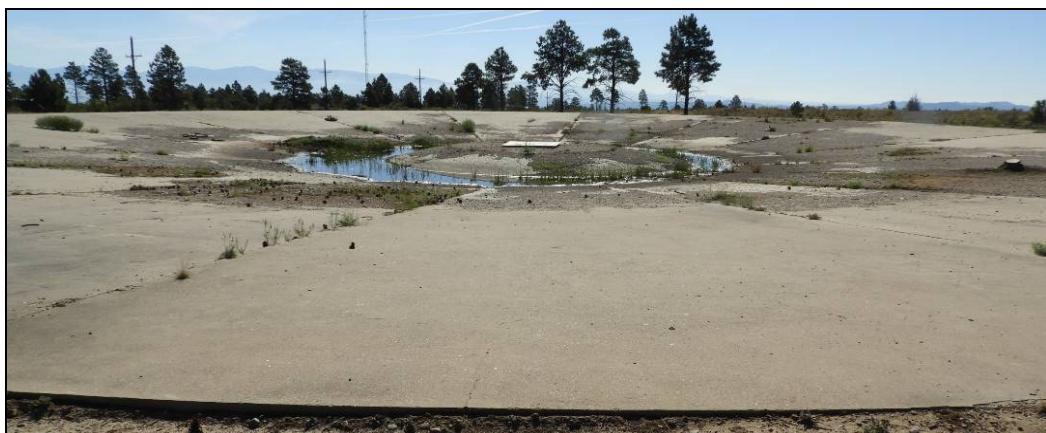
*Figure 5. Standing water can be seen collected at the center of the bowl which sits for months at a time.*

A solution to this problem will not be easy or cheap. In order to better preserve the structure, the water must be removed at regular intervals to ensure a non-permanent presence of water. It may be possible to reinstate the original drain and possibly expand the basin reservoir underneath. Nevertheless, additional research will be required to ensure the Concrete Bowl's historical significance is not impacted if this action is considered further. Removing this water source will undoubtedly have a detrimental effect on wildlife. Accordingly, discussions have explored the possibility of creating an artificial watering hole nearby, out of view from the site. A high chain-link fence may offer a temporary solution, but is problematic due to the wildlife concern and the overall visual impact to the Concrete Bowl.

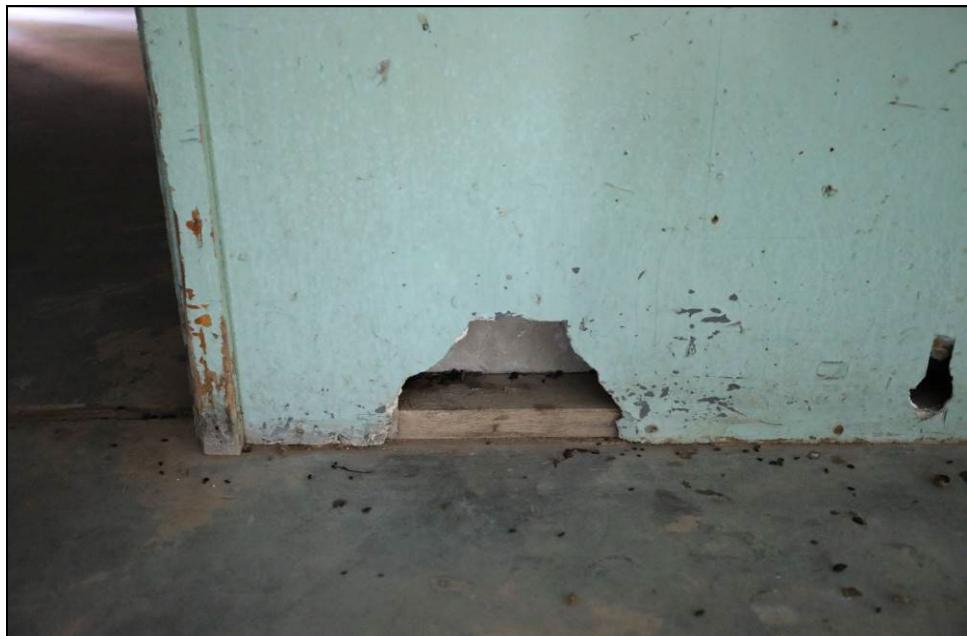
There are many areas inside the building where holes in the interior siding allow pests entry into the inner framework of walls or to an adjacent room. Rodents that are allowed entrance to the interior of walls or to rarely accessed rooms are given greater opportunity to reproduce and build habitat suitable for increasing numbers of offspring and more rodents from the outside. A survey of the building's interior noted numerous opportunities for this type of access and evidence from droppings and nests.

Figure 8. Example of a type of hole frequently found throughout the interior of the building.

Although a perfect seal of the building is not likely due to the nature of historic buildings, pest intrusion will dramatically decrease if a serious attempt is made to close off access points into the building from the outside, and to seal voids found in the interior walls. A continuous cleaning regime is also recommended to prevent inviting more rodents from the outside of the building to the inside. The smell and awareness of rodent habitation through fresh rodent droppings and nesting, lures in more rodents to a safe, habitable space.

Preventing access will involve continuing to remove nesting and excrement debris from the floor and other horizontal surfaces, properly sealing window and door openings (to be followed up with specific recommendations in a later section), replacement of missing vent covers, repairing louvers, installing screen to penetration pipes. There are many instances on the interior of the building where drywall will need repair or replacement.

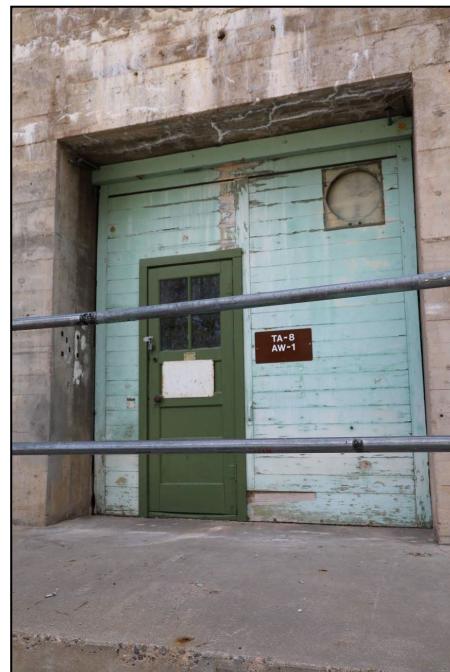
*Figure 17. Overview of the exterior of the bay door.*

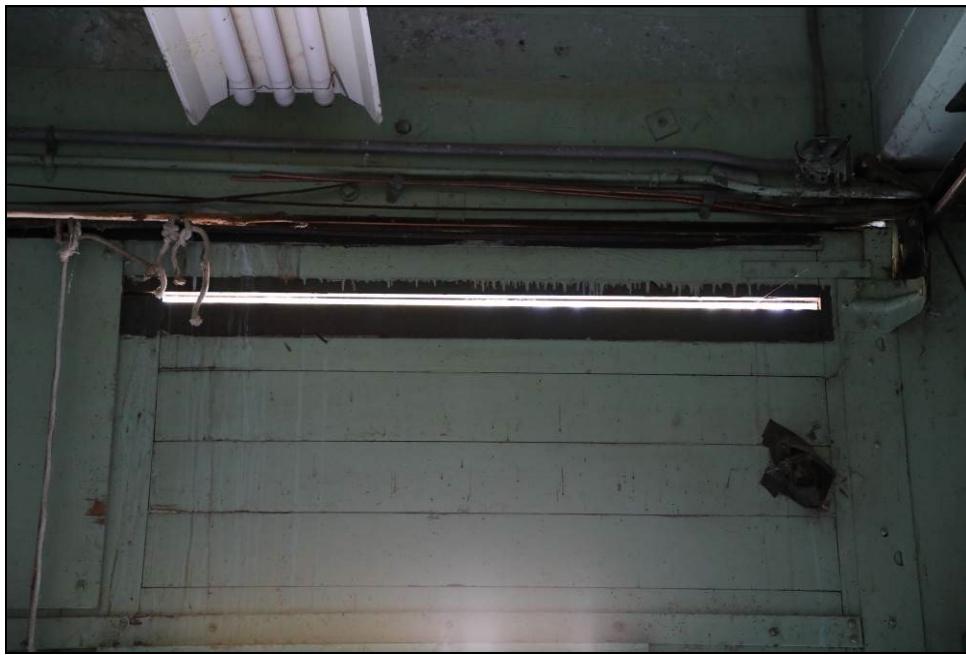
The repairs required for the front bay door involve closing off pest access from the outside to the inside of the building. There is a substantial separation at the top of the bay door that contributes to this access. Paint marks indicate that this opening was covered at one time (Figure 18), but the covering has since been removed. A metal plate that extends vertically to cover the space between the wall and the bay door on the east edge is bent toward the base of the door opening (Figure 19). Utility holes are present in the upper left from the interior of the bay door (Figures 20 and 21). Below the utility conduit holes is a plywood-patched vent hole (Figure 22). Although the seal of the hole is sufficient, further deterioration of the plywood covering may change this in the future and the current aesthetics suffer because of the sloppy nature of this repair.

Figure 18. Daylight can be seen through the separation above the bay door.

For the separation at the top of the bay door, a temporary wood cover that matches the dimensions of the removed board evident by the paint lines can be used for the short-term. A better long-term solution, however, is one that places an inset wood strip to fill the gap between the top board and the frame. The long, metal plate at the bottom of the bay door should be bent back in order to sufficiently cover the area between the door and the wall.

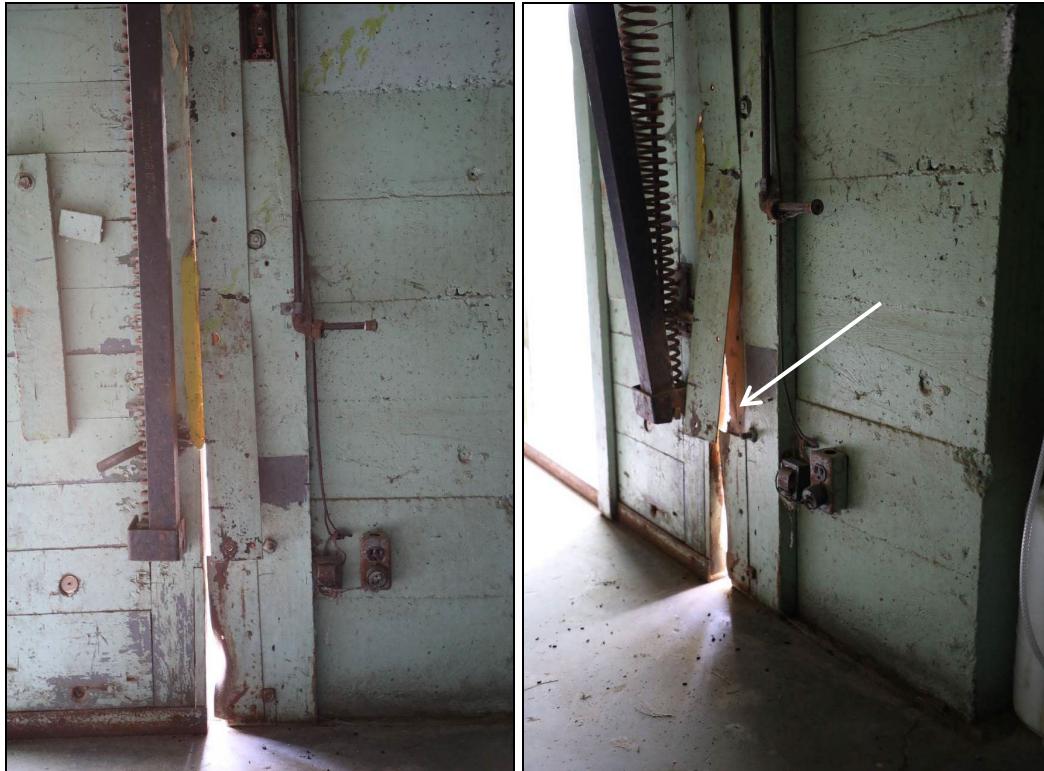
Figure 19. Front and side views of the bent metal plate and basal void at the bottom of the bay door.

Weather stripping or wood trim may need to be used to help further close in the gap. The utility holes in the upper corner should be filled with a wood plug that will be less noticeable when properly installed and painted over. Conduit can be cut prior to plugging the hole. The plywood covering the large vent hole should be removed. A wooden plug should be made that can be inset into the circular ductwork hole. The plug should be constructed from boards that match the width of the surrounding boards and inserted into the existing hole with no voids around the edges present.

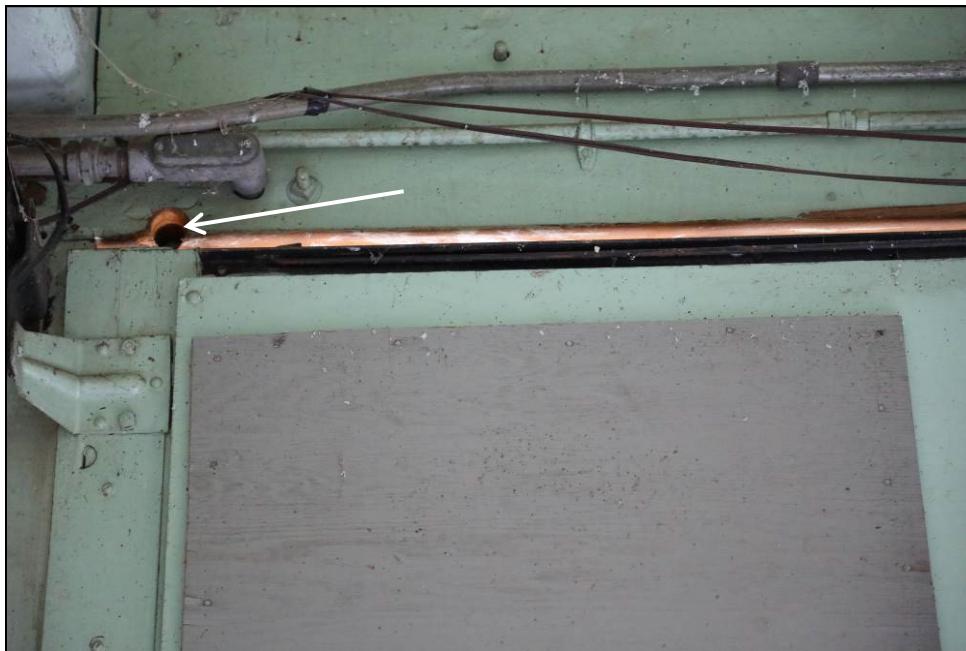
Figure 20. Utility hole in the upper left-hand corner above the bay door.

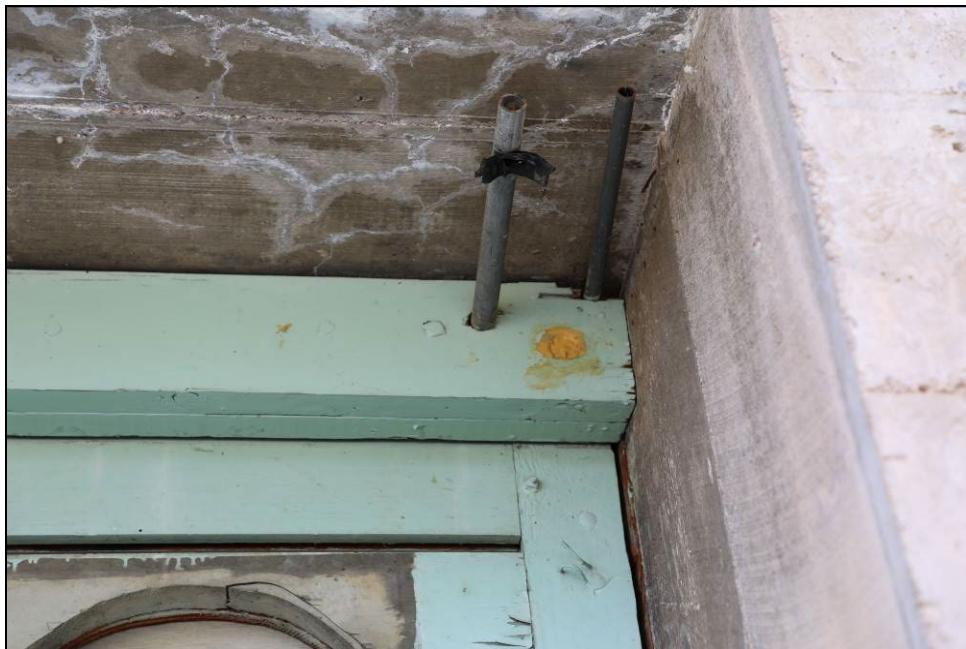
Figure 21. Exterior view of the utility line holes.

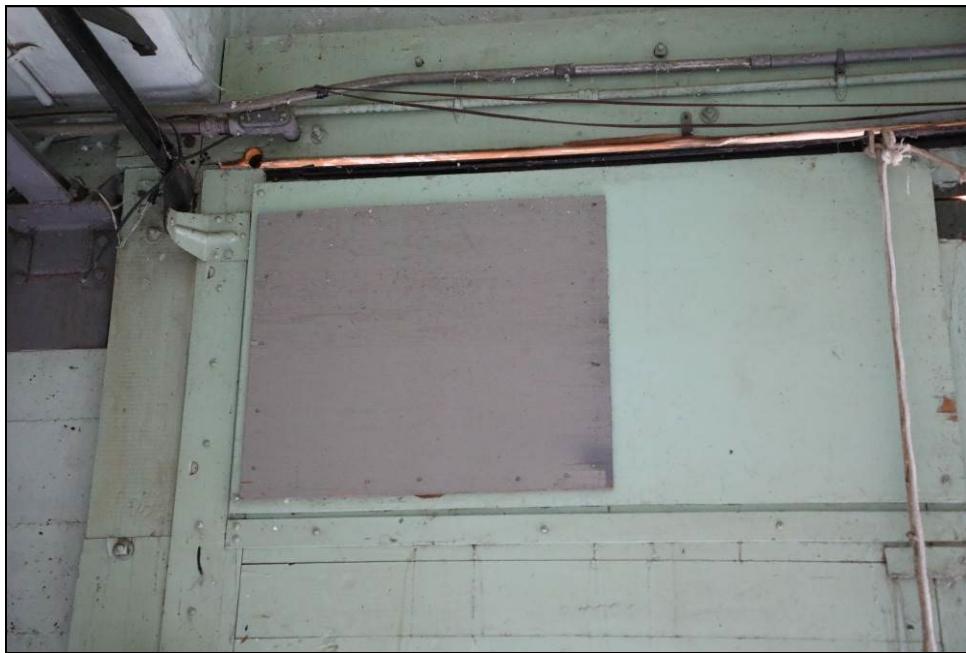
Figure 22. Interior view of the plywood piece covering the round ducting hole.

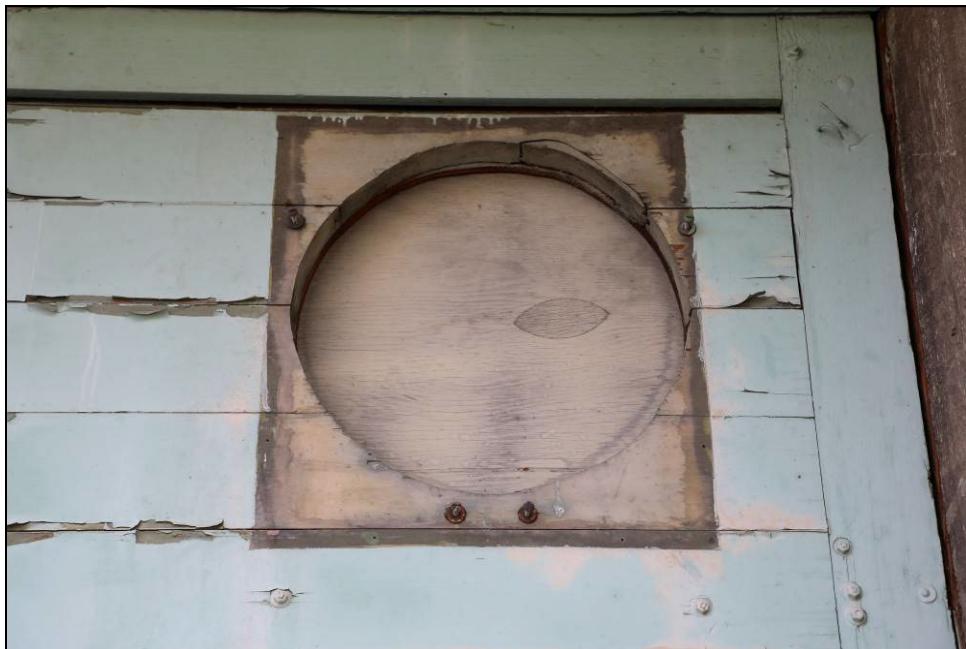
Figure 23. Exterior view of the duct hole and plywood cover.

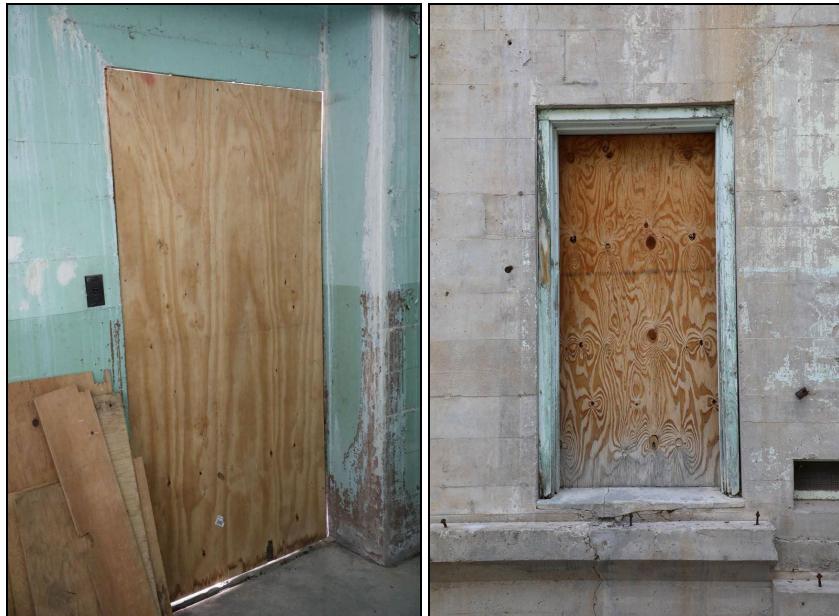
The walk-in door opening west of the bay door on the north elevation is covered with a plywood sheet. Daylight can be seen along the edges from the interior of the building indicating that pests have an entry point into the building (Figure 24). The original door is in pieces and awaiting repair and reinstallation.

*Figure 24. Interior and exterior views of the door cover.*

The door should be repaired to the exact specifications as noted in the original drawings. The frame will also need repaired in the process to help with fit and operability of the door (Figure X). Original hardware should be used if suitable operability can be achieved.

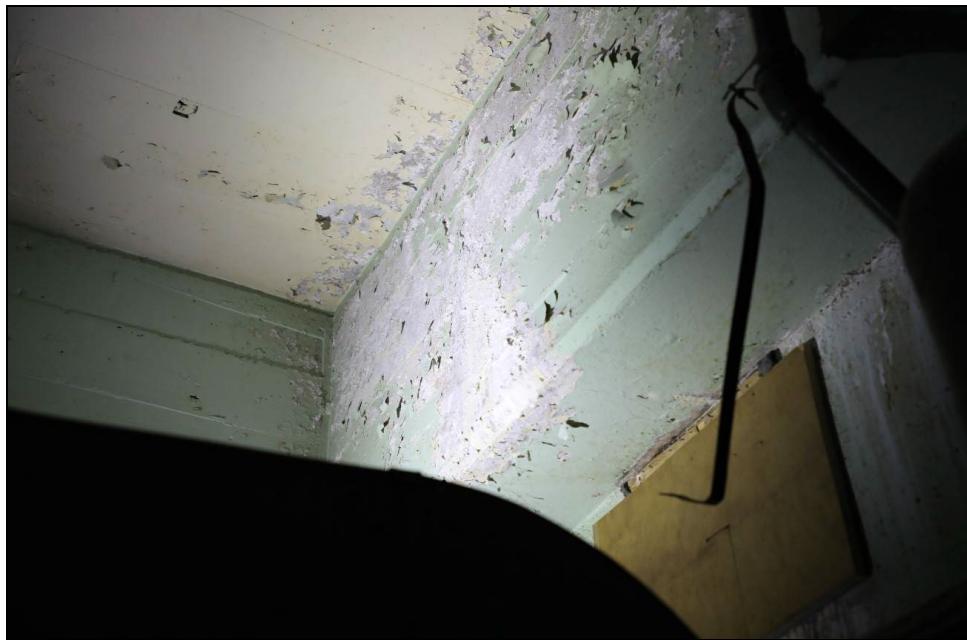
The interior paint exhibits severe deterioration from general wear and tear, past roof leaks, and interior efflorescence. Paint is flaking, worn, and stained.

Figure 27. Peeling paint on and near the concrete ceiling.

The interior of the building should be repainted with the same colors that are currently present on the wall surface. Failing paint should be removed to provide a stable surface for the new coating, however, paint that is structurally sound should remain in-place to provide historical evidence for future paint analyses. A primer is recommended to help with adhesion and durability. Non-period significant conduit may also be removed in preparation for this job. Subject matter experts with the Historic Buildings Program should be consulted prior to any removal of conduit in order to ensure period significant conduit is not removed.

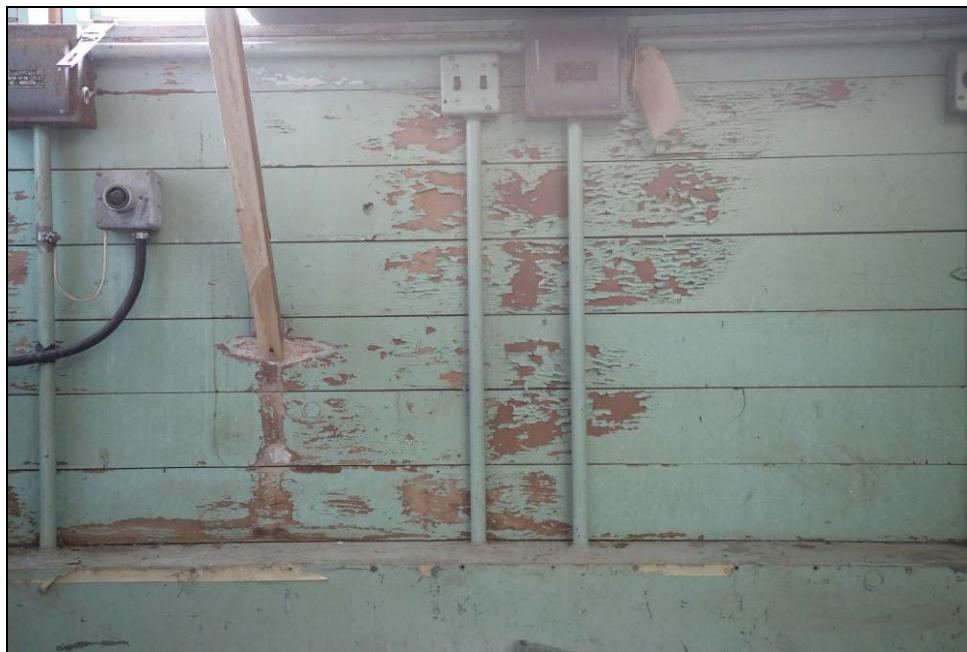
Figure 28. Peeling paint on an interior wood surface.

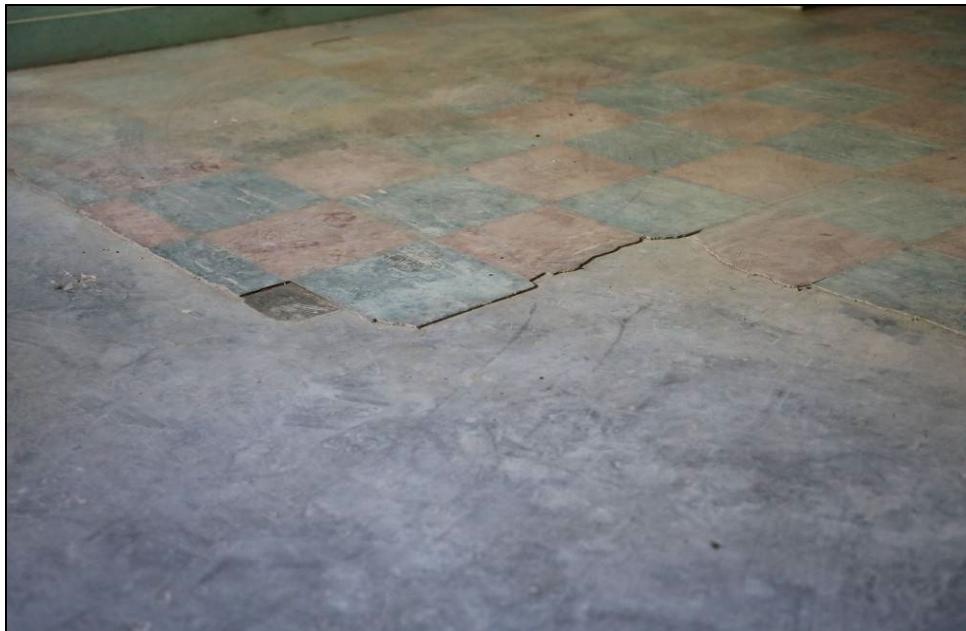
8" x 8" asbestos floor tiles near the west end of the building are chipping and releasing asbestos into the environment. Only the outer edge of the tile work is damaged and chipping.

Linear Feet of Damaged Tiles = Approx. 20'

*Figure 30. The 8" x 8" asbestos tiles are cracking and breaking apart at the edges.*

At this time only the damaged tiles should be removed. Intact tiles do not currently cause an immediate health/safety risk and time can be taken to determine the best course of action. A more intensive plan should be conceived later to remove all the tiles in the building or to encapsulate them as a preservation technique that also mitigates the likelihood of asbestos release from damaged tiles.

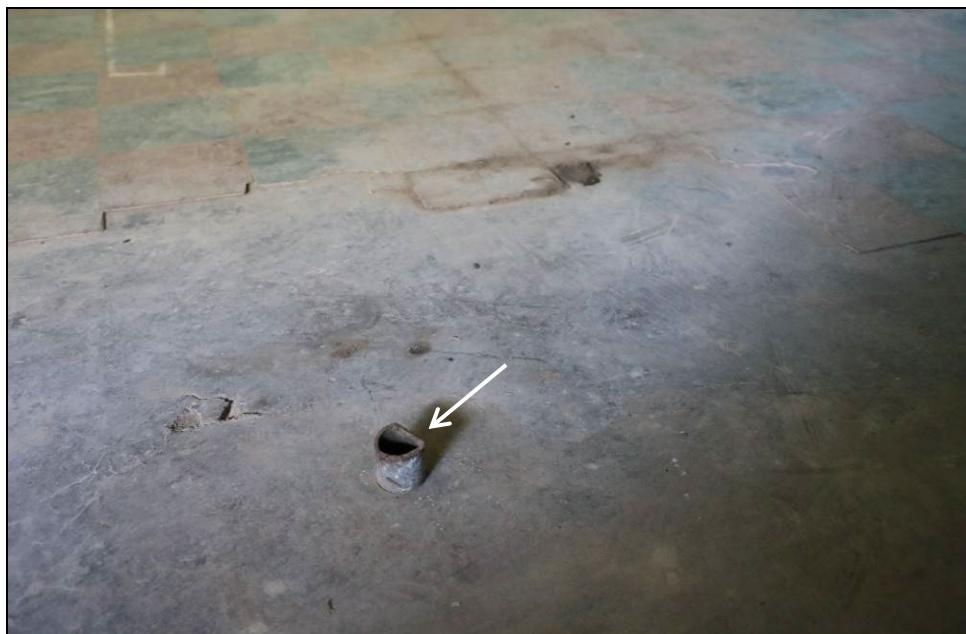
A short length of conduit sticks up from the floor near the damaged asbestos tiles. This presents a substantial tripping hazard due to its location in the middle of floor. A traffic cone is usually placed on top to direct people around the hazard.

*Figure 31. An old utility conduit rises up out of the floor and presents a substantial tripping hazard.*

The conduit should be cut flush with the floor. Additionally, concrete plug/infill (also flush) should be put in the cavity.

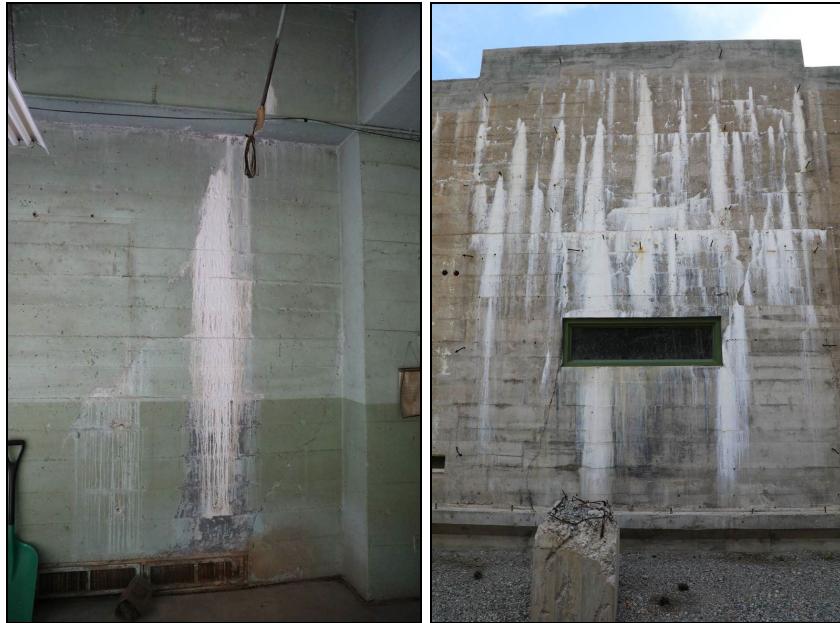
Efflorescence is prevalent throughout the interior and exterior of the building. This is a complicated process that essentially produces damaging crack patterns and fundamental structural instability over a long period of time. The white staining and buildup is indicative of major problems occurring inside the wall.

*Figure 32. Examples of efflorescence on an interior wall and an exterior wall.*

The efflorescence, the staining and buildup of materials leaching from the interior of the concrete walls, can be removed via mechanical processes, however, the root problem will still exist. Removal will really only improve the aesthetics of the buildings for a short time, and end up doing very little to help structural stability and overall preservation. Extensive research, examination, materials testing is required to effectively treat this impact.

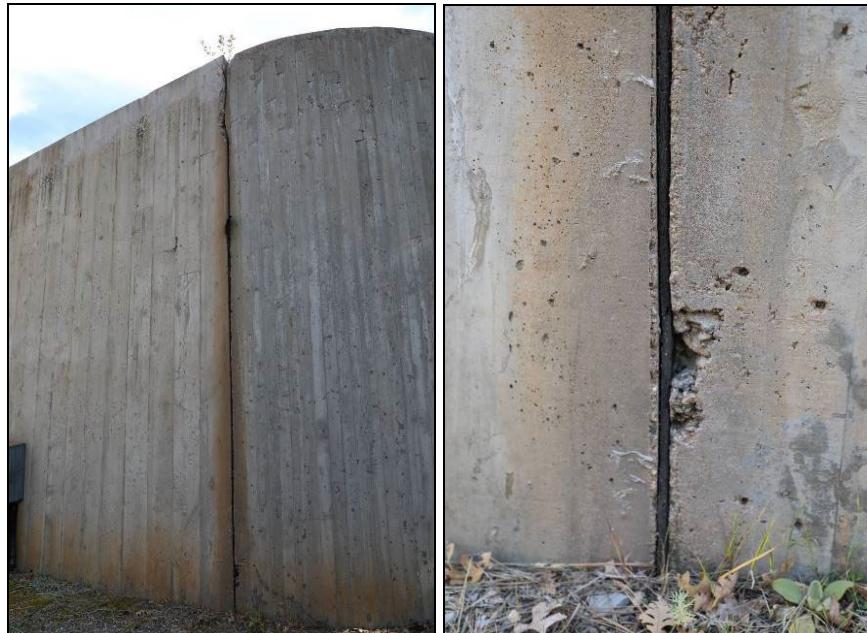
The vertical expansion joints have outlived their performance life. Some areas have deteriorated completely, while others are only partially deteriorated. The failing expansion joints allow moisture access deeper into the concrete walls and help to accelerate deterioration and efflorescence.

Figure 33. An overview shot of a typical vertical expansion joint to show height followed by a close up to show material color.

As much material as possible should be pulled out of the current expansion joints and replaced with a modern replacement. The modern replacement can be of a different material (approved by Historic Buildings SMEs) than the original, but should be consistent in color to preserve the aesthetic character of the building.

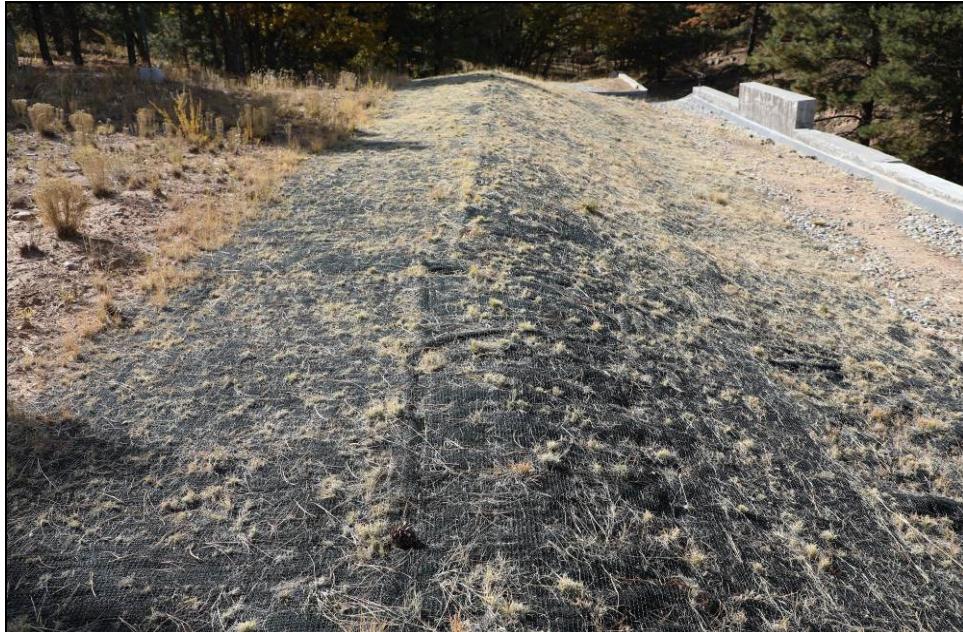
Figure 35. View of installed matting and degree of vegetation growth since 2012.

Reseeding should be attempted prior to the wet season. Increasing native grasses will show potential sheet washing from above and better regulate the amount of water managed by the French drain system during heavier rain events.

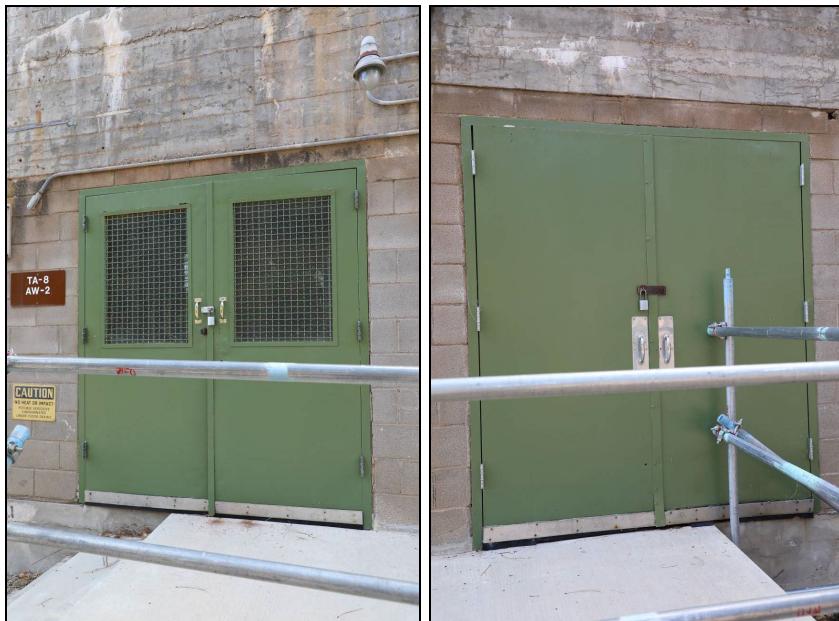
Two sets of doors on the north exterior of the building do not provide an adequate seal or aesthetic quality for the building. Rust is present near the bases and fit is inadequate for a proper closure. The doors are a modern substitution in a non-original concrete-block wall. The original doors were wooden, set into a framed-out blast wall.

Figure 37. Both sets of double doors as viewed from the exterior of the building.

The more immediate need is for a replacement of the inoperable doors; however, replacement of the doors offers a strategic opportunity to bring back the lost historic character that dates to the period of significance. Replacement doors should be made of wood and resemble in character the original doors but fit the current openings if the concrete-block construction is not removed. If the concrete-block construction is removed, then the doors should be reconstructed to the exact specifications as presented in the original drawings.

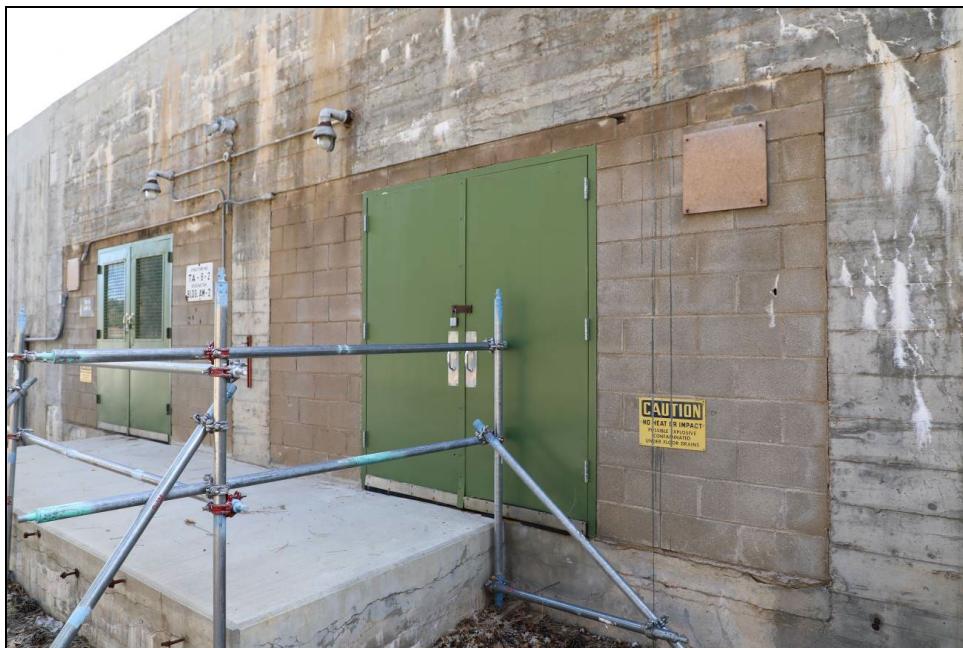
Figure 38. The non-original concrete block can be seen here around the green double doors.

A reconstruction of the original blast walls would require a near exact rebuilding as defined by the original construction drawings. Location of doors within the blast walls would change from the present configuration. The original configuration had both sets of doors nearly adjacent to the dividing center wall. Reconfiguring the doors back to the original design will provide a much logical and safe use of the landing out in front of the doors (Figure 38); eliminating the half-over situation currently utilized when entering and exiting both rooms.

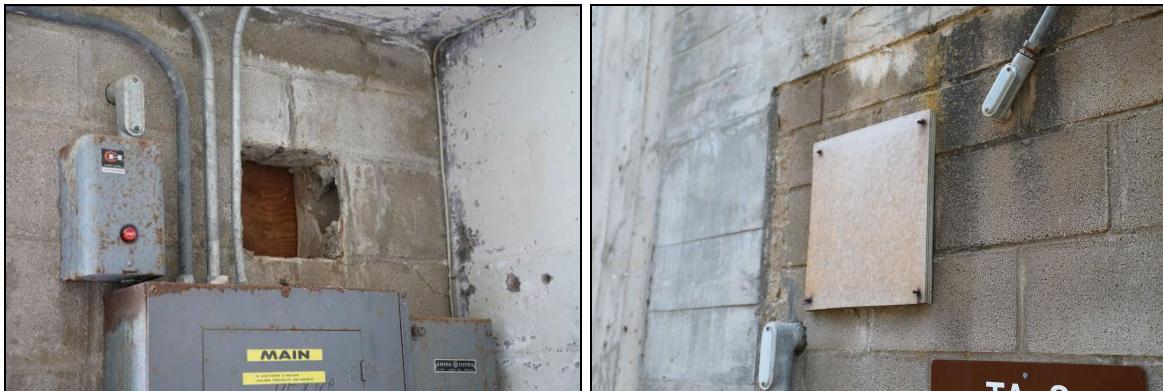
Figure 39. Interior and exterior shots of the eastern vent hole.

If the concrete-block wall remains in place for an extended length of time, the plywood covers should be removed and replaced with a similar-looking concrete block cut to fit. The block would be mortared in place and fitted in such a way that does not draw the eye.

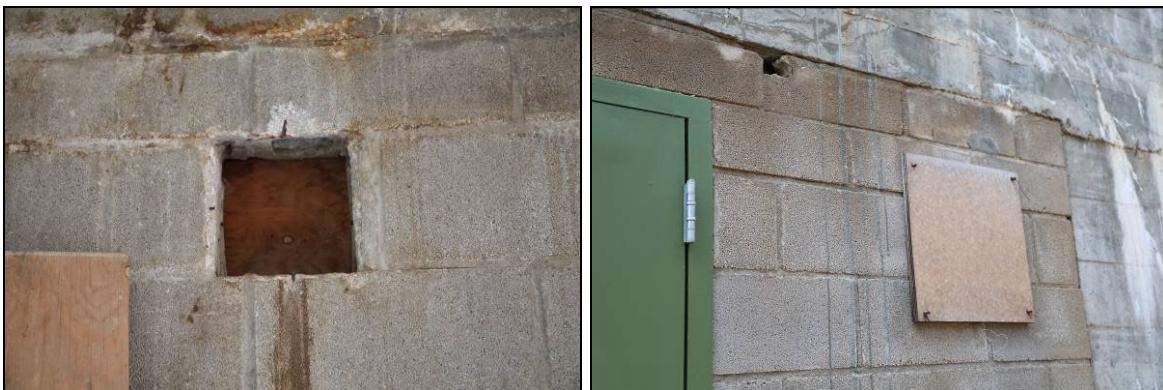
Figure 40. Interior and exterior shots of the western vent hole.

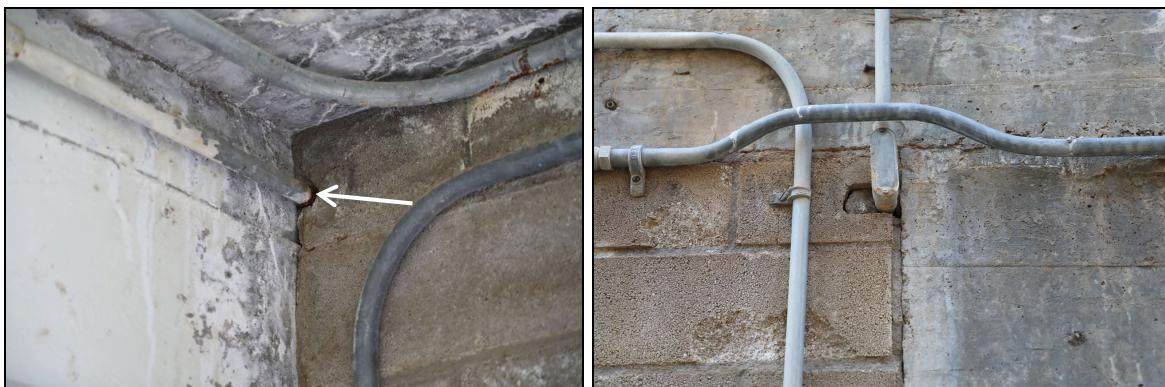
*Figure 41. Example of utility conduit from the interior and exterior of the building.*

If the concrete-block wall remains in place for an extended length of time, the holes should be filled with a concrete mix stained to blend with the surrounding concrete block. Holes with conduit can either be filled in around the edges with the same mix used to fill in the holes without conduit.

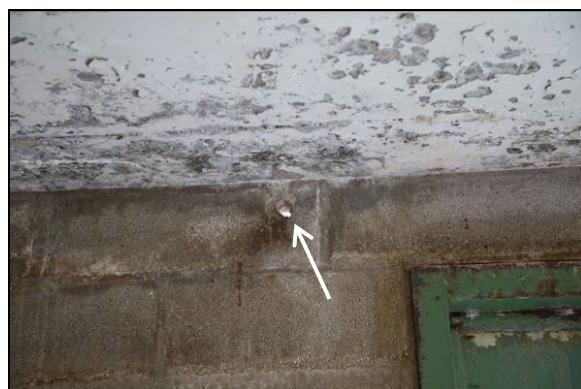
*Figure 42. Example of a utility hole with the conduit removed.*

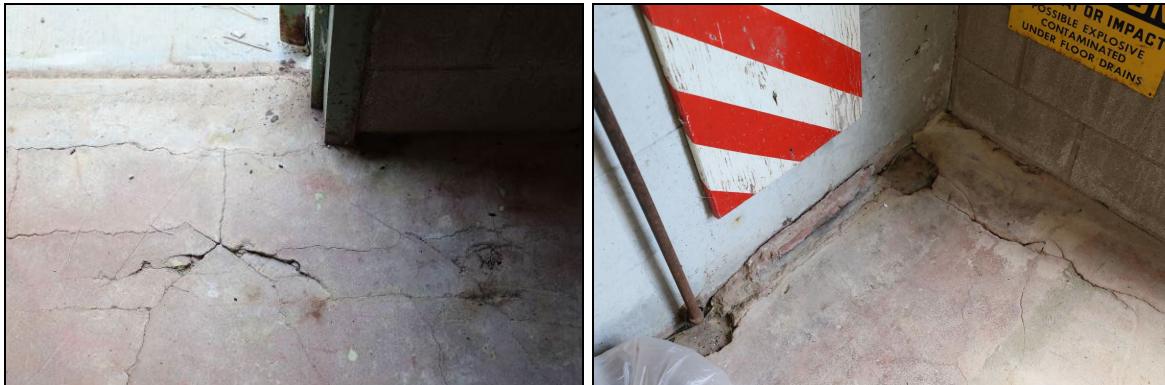
The Hubbelite flooring is experiencing significant cracking and failure; especially around the edges. This cracking will continue to worsen to a point where preservation of the original fabric will not be possible.

*Figure 44. Examples of cracking Hubbelite.*

The deterioration of the Hubbelite flooring will require and in-depth examination of the material and potential preservation strategies to retain the floor. Work to the Hubbelite should only be completed following expanded research and the development of a structured and a carefully thought-out work plan.

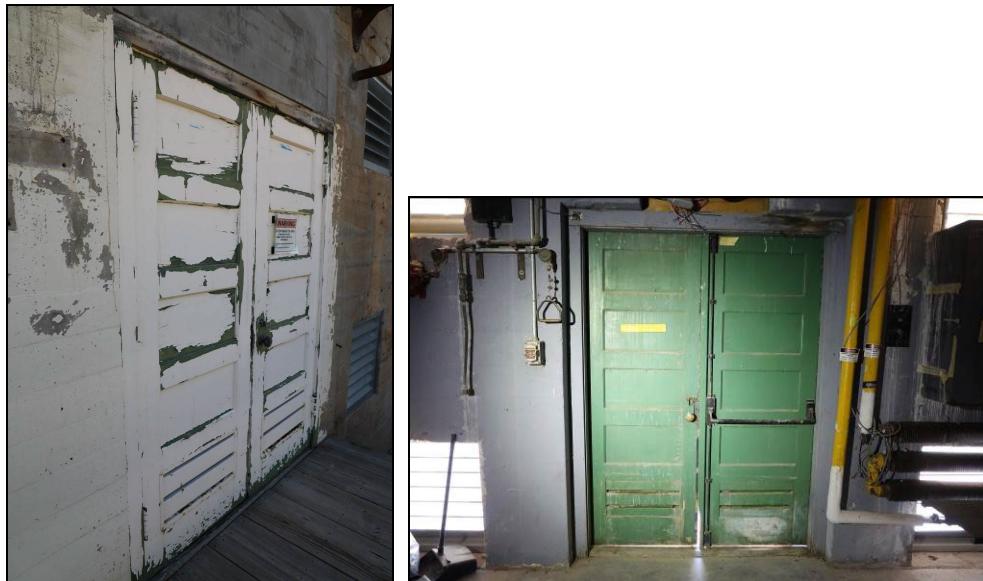
The doors are operable to an extent. They open and close, however, they do not allow for a suitable seal around the edges. The wood is a little soft in some areas and paint is flaking on both the interior and exterior surfaces. Of particular note is the severe deterioration around the door knob and associated hardware. The panic bar on the interior of the door is inoperable. The threshold is in poor condition.

*Figure 46. Exterior and interior photographs of the entrance doors.*

The interior and exterior of both doors should be repainted to the historic color as specified by Historic Buildings staff. Hardware should be inspected, cleaned, and return to a functional condition. Deterioration of wood around the knob and associated hardware should be repaired via a Dutchmen repair. All hardware should be retained unless determined to be not repairable by subject matter experts. The should be retained if possible; however, preliminary examination suggests a replacement may be necessary.

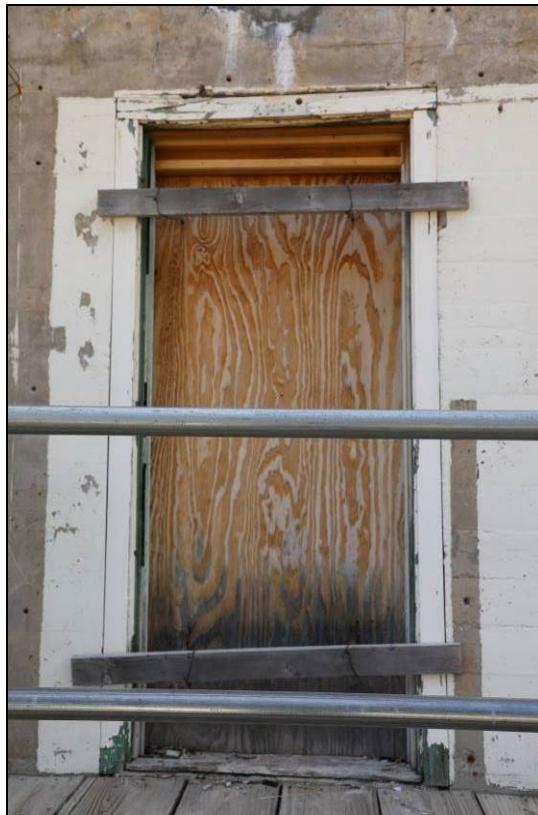
The door is completely missing and the opening is currently covered on the interior by single piece of plywood. Closure of the opening and a seal of the plywood with the frame is achieved with two boards and tensioning wires. This closure represents a temporary solution that is past its designated life cycle.

Figure 47. Exterior photograph of the door opening needing a reconstructed door.

A new door should replicate the door as presented in the original drawings. Slight changes can be made in order to ensure a proper fit and ease of operations. Paint should match that of the nearby double doors. The frame and threshold will require some work to ensure a proper fit. Existing wood used to construct the frame should be reused whenever possible; however, a good fit is more important to the preservation of the building. Irreparable wooden elements may be replaced as necessary to ensure a good fit.

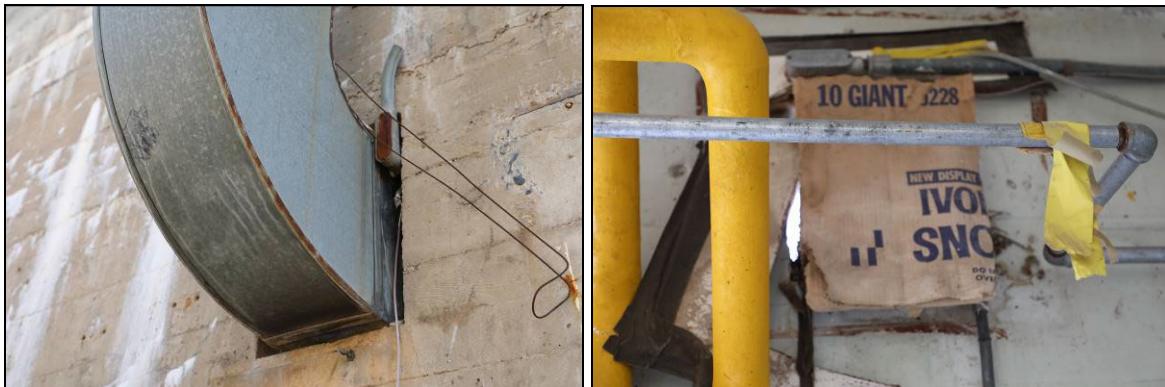
Figure 48. View of the exterior and interior vent penetration.

The interior of the hole should be framed-out and concrete parging that matches the surrounding fabric installed. An effort to match any surrounding board-forming should be made to present a consistent look to the repair.

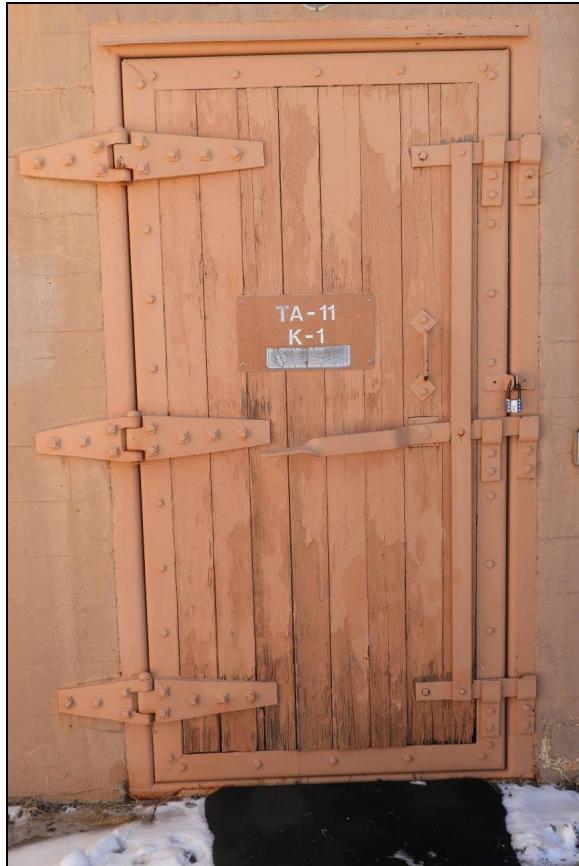
The bottom of the door shows significant signs of rot. The rot has migrated up to the hardware and may eventually affect the operability the bottom hinge and latch. Voids are starting form at the bottom edges of the outer boards which allows moisture access to the interior of the door. If left unchecked, the structural stability of the door will be severely compromised.

Figure 53. Photograph shows wood deterioration at the base of the door.

The bottom portion the boards will need removed and replaced. A less intrusive repair may present itself with further planning, however, Dutchman repairs should be made to each board to provide an appropriate seal between the metal and the wood. This type of repair will help prevent moisture from reaching the interior of the door and provide better protection for the entire door.

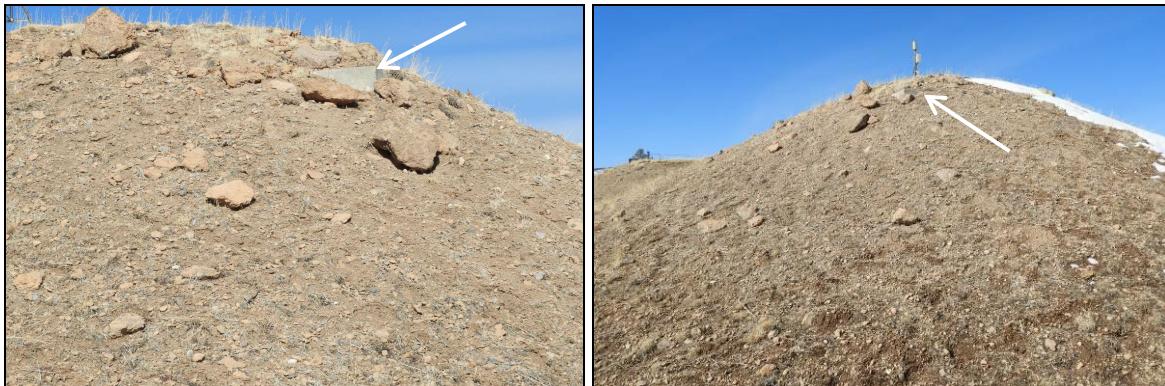
Two corners (northeast and southeast top corners) of the building are exposed due to erosion. This presents an open-air environment that can accelerate concrete deterioration of the exposed portions. Rain and snow fall currently have a direct impact to these exposed corners and will promote deterioration faster than if these surfaces were covered with earth.

Figure 55. Arrows point to the exposed concrete roof corners on the southeast and northeast corners.

Fill material similar in color and consistency should be brought in to sufficiently cover both areas. On-site material from the berm should not be used and cover only as much as necessary to retain the general shape of the berm. Seeding of native grasses should be promoted to help with soil retention. Larger plants are discouraged due to the impact that more extensive root systems can have on the underlying concrete structure. While the removal of larger vegetation is encouraged, grasses should be allowed time to seed and regenerate on the berm. Less aggressive vegetation management (i.e., longer intervals between weed eating and grass cutting activities) is encouraged. Larger growth plants and shrubs should be individually removed on an at-least yearly basis.
