**Title:** Historic Buildings Report: Five-Year Preservation Planning for Manhattan Project National Historical Park Sites

# **Historic Buildings Report: Five-Year Preservation Planning for Manhattan Project National Historical Park Sites**

**Fiscal Years 2022 - 2026**

Historic Building Report No. 394  
Survey No. 1257

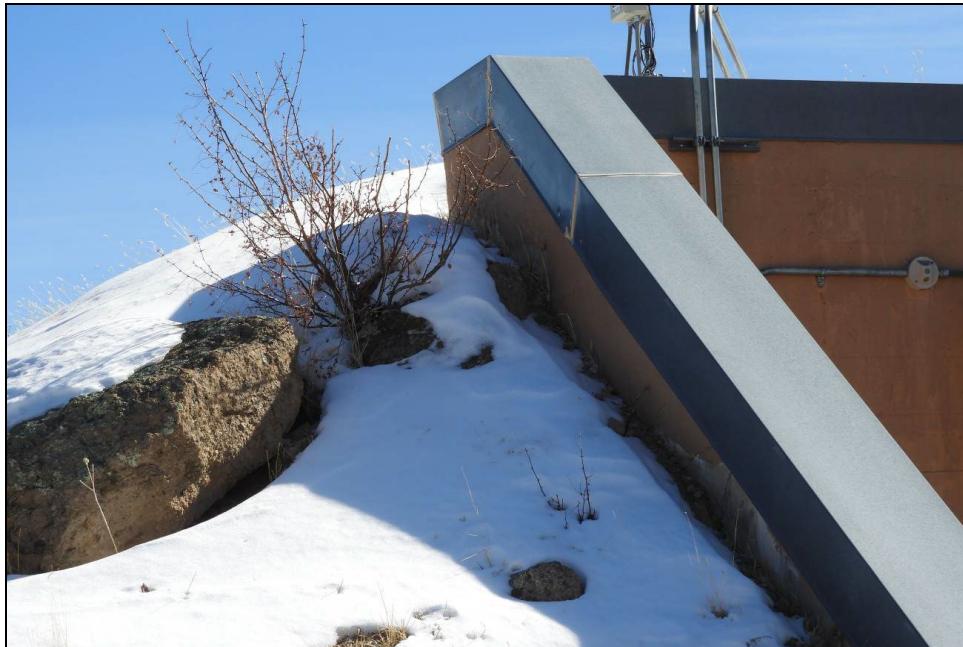
A small to medium shrub is growing adjacent to the top of the north wing wall. The root system of the plant, while helping to slow soil erosion in this particular spot, will eventually cause subsurface damage to the adjacent concrete wall.

*Figure 56. The scrub can be seen here soaking up the sun and moisture from gradual snowmelt.*

The plant should be cut as close to the ground as possible. The root system will eventually decompose. Digging up the plant is not recommended and the plant should be discarded off-site.

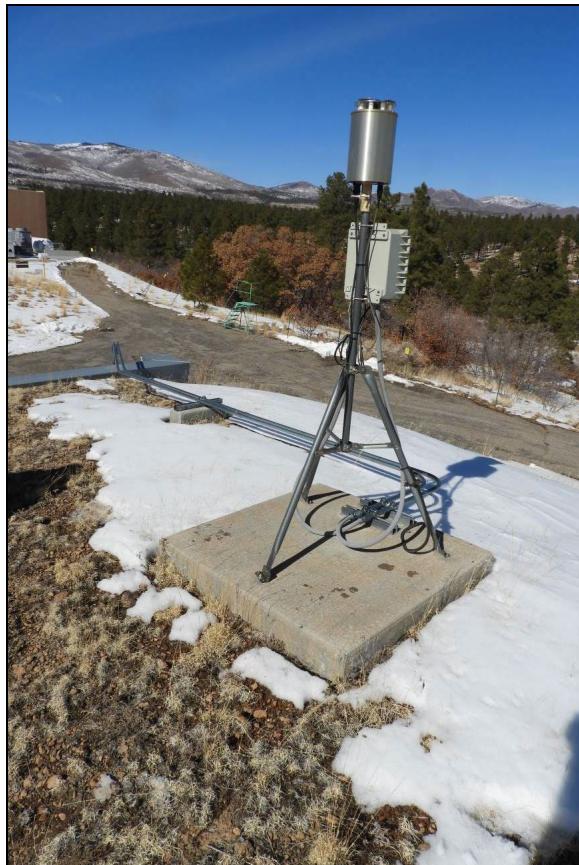
Figure 57. The monitoring device may be operational, but may not be. Either way relocation of the device will benefit the overall preservation of the structure.

Relocation of the monitoring equipment is preferred. Utility conduit should also be removed with care taken with the removal of any anchoring points in to the concrete of the building.

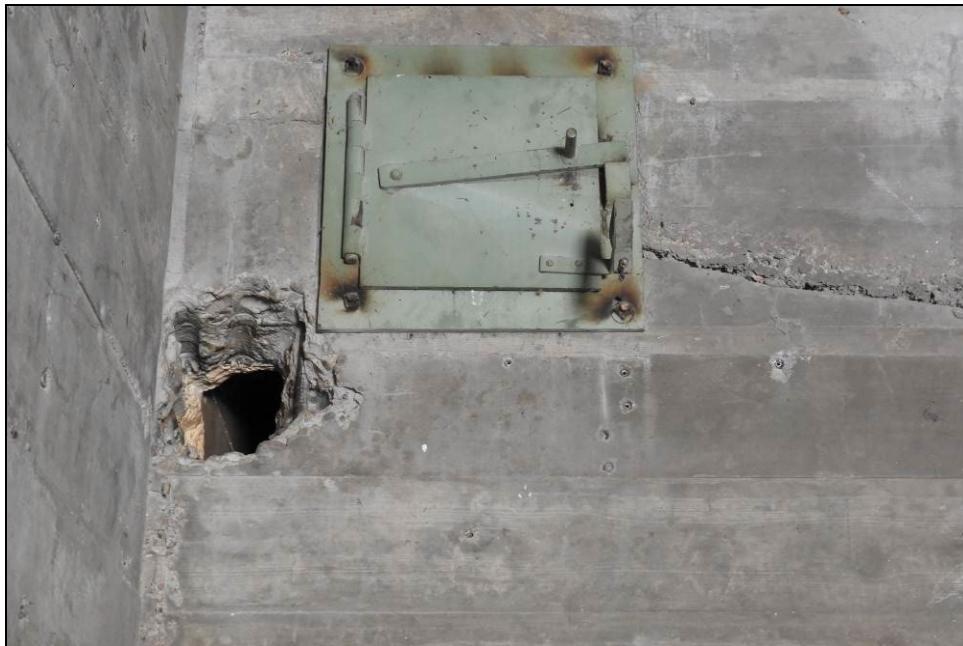
*Figure 60. Utility hole with conduit no longer occupying it.*

Temporary measures should include the use of steel copper packed tightly into all existing utility holes. Long-term mitigation will include the selection of a proper concrete mix and a meticulous in-fill repair that does not draw attention to the patch.

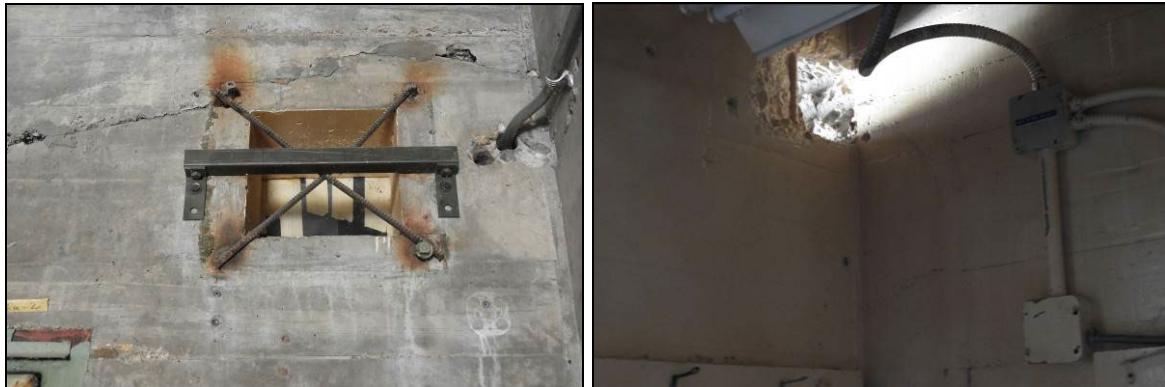
The metal access door (similar to the one pictured in Figure 60) has been removed. This opening allows rodents access to the interior of the original room and is unsightly. Rebar was welded diagonally to the anchor bolts and piece of square tubing was installed as possibly some sort of brace.

*Figure 61. Exterior and interior photographs of the access port with missing door.*

A metal access door similar to the one pictured in Figure 60 should be reconstructed and installed. An effort should be made to reuse the same anchor bolts and anchor bolt locations. Rebar should be removed along with the square-tubed bracing that currently spans the existing hole.

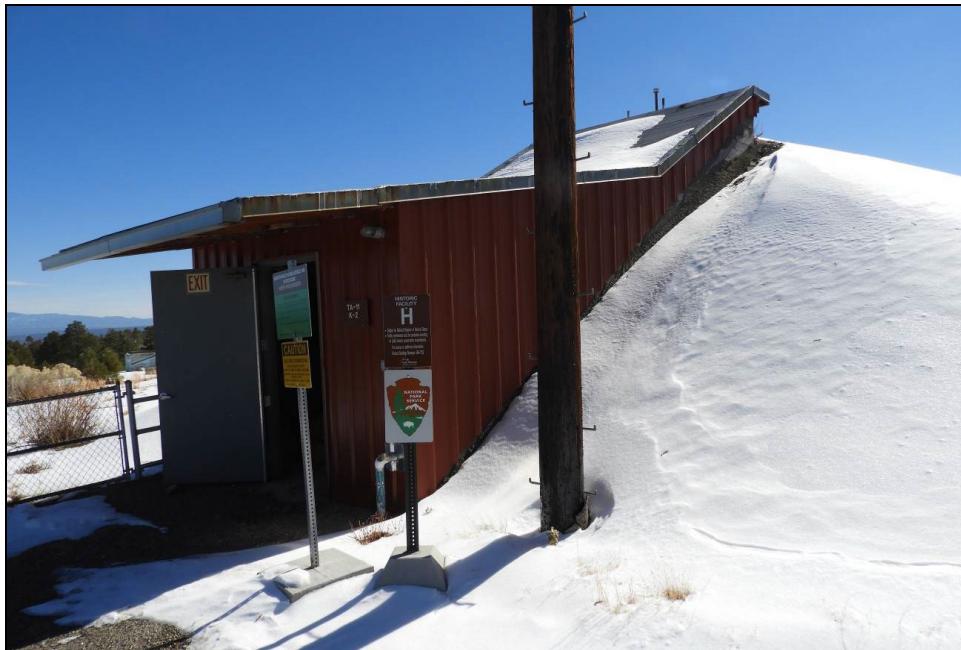
Figure 62. Overview of the addition.

The eventual removal of the addition should only take place after careful consideration and consultation. The addition dates to 1947; one year after the Manhattan Project ended, but offers a great deal of preservation to original fabric. Returning historic significance and architectural integrity is the prime reason for removing the historic addition. If removal is ultimately settled on, then care should be taken to not damage the original building and a satisfactory preservation maintenance plan should be agreed upon and implemented. The protection that is currently provided by the addition will need to be sustained through appropriate and timely preservation treatments.

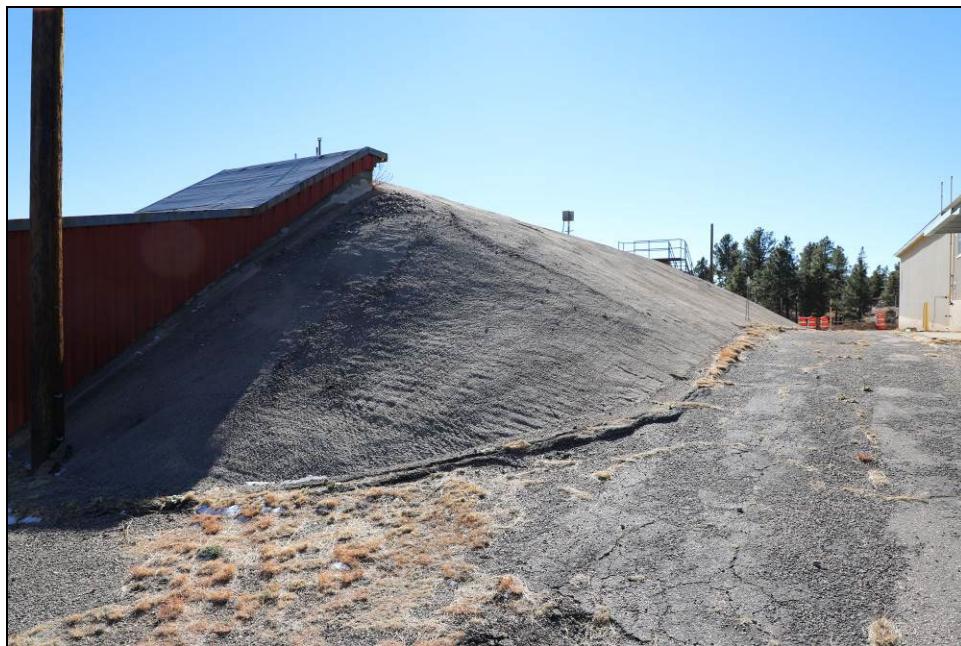
Figure 63. The berm extends along the back of 11-0002 to 11-0003 which can be near the back.

The berm should be completely removed with the exception of east and west elevations that were originally covered. A temporary measure could consist of at least removing the Shotcrete-like product currently trapping moisture in the underlying soils. As with the removal of the addition, a suitable preservation maintenance plan should be developed and agreed upon prior to full removal. The preservation maintenance plan should not only include appropriate treatments to inhibit further oxidation of the newly-exposed iron, but also strategies for avoiding erosion on remaining berm slopes.

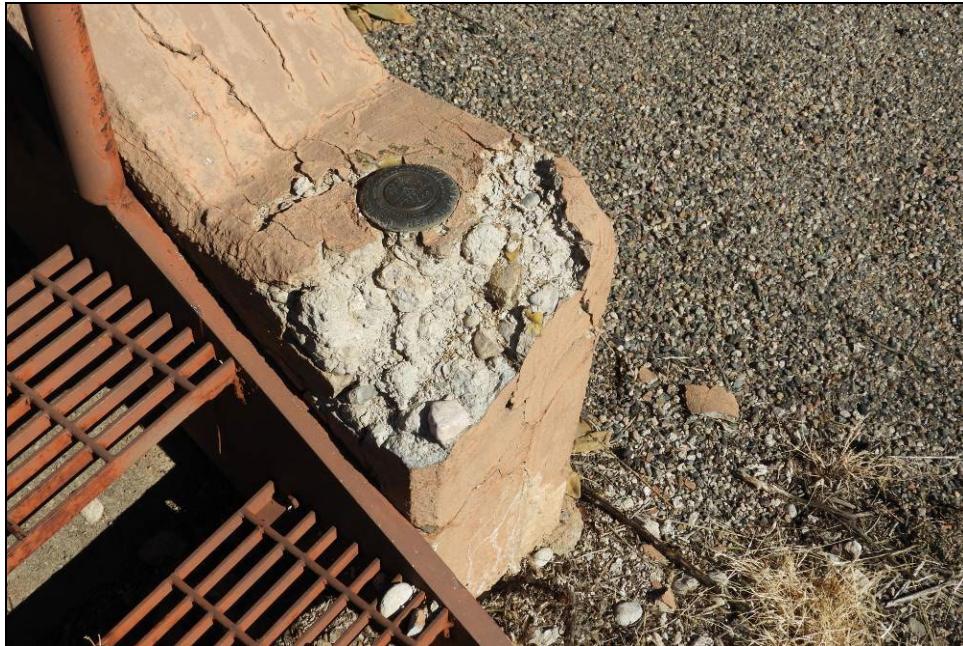
Severe deterioration is occurring near the bottom of the west wing wall. A highly likely scenario is that this area of the concrete became extremely weakened when the benchmark was put in.

*Figure 65. Major concrete deterioration is occurring near the benchmark on the west wing wall.*

The interior of the hole should be framed-out and concrete parging that matches the surrounding fabric installed. An effort to match

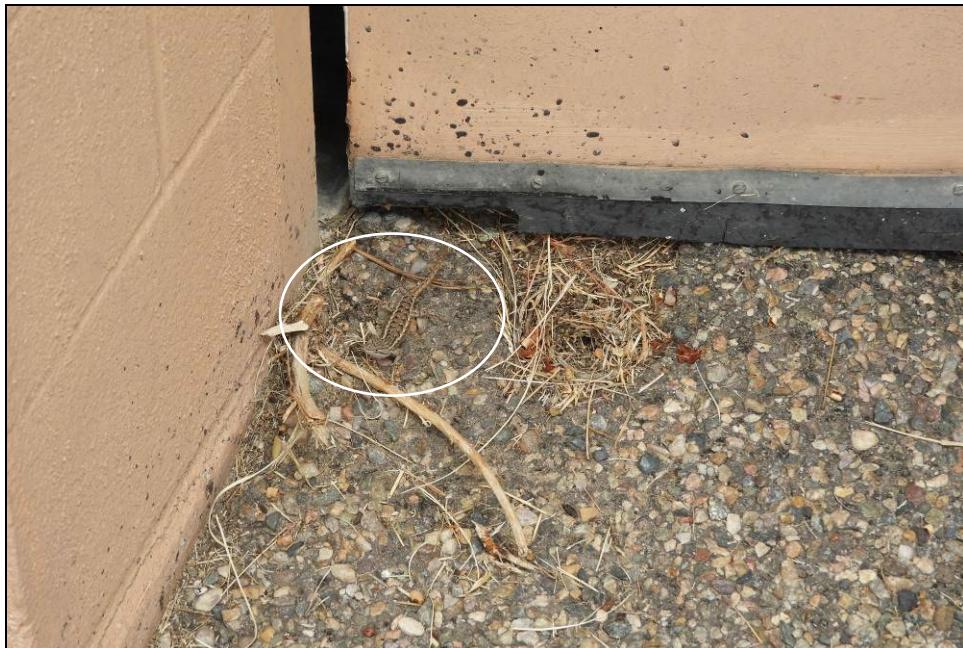
*Figure 72. The rubber underside of the door sweep exhibits serious deterioration and allows passage of pests from the exterior to the interior.*

Full replacement of the sweep is required. A typical door sweep may suffice, however, rodents typically chew on the rubber and gain entry to the building's interior. If a stronger metal sweep can be obtained, then this problem will not have to be addressed for a longer period of time.

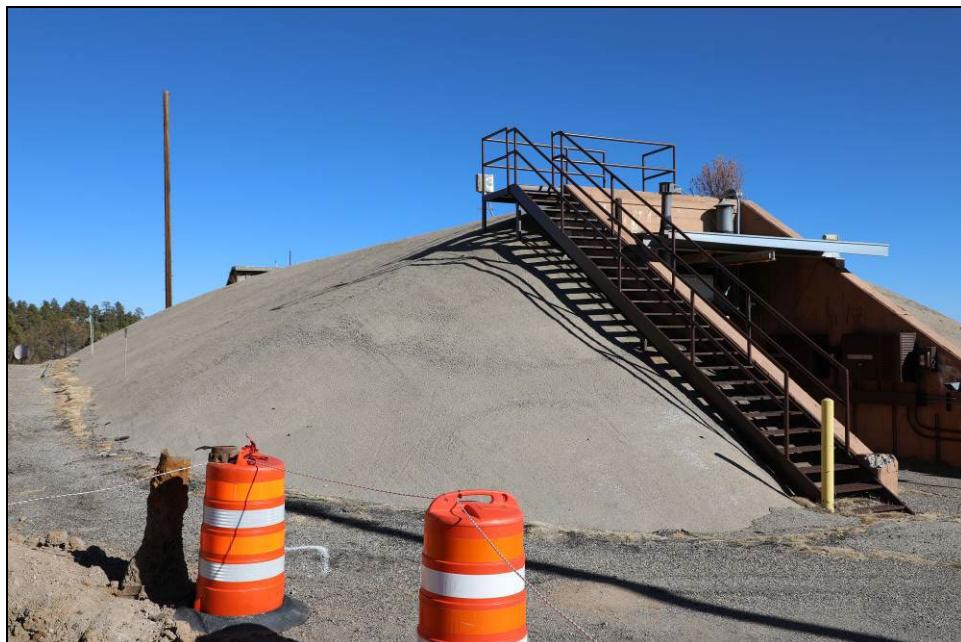
Figure 74. The parging over the earthen berm extends from the sides and back of 11-0003 to the back and sides of 11-0002.

The berm should be completely removed with the exception of east and west elevations that were originally covered. A temporary measure could consist of at least removing the Shotcrete-like product currently trapping moisture in the underlying soils. As with the removal of the addition, a suitable preservation maintenance plan should be developed and agreed upon prior to full removal. The preservation maintenance plan should not only include appropriate treatments to inhibit further oxidation of the newly-exposed iron, but also strategies for avoiding erosion on remaining berm slopes.

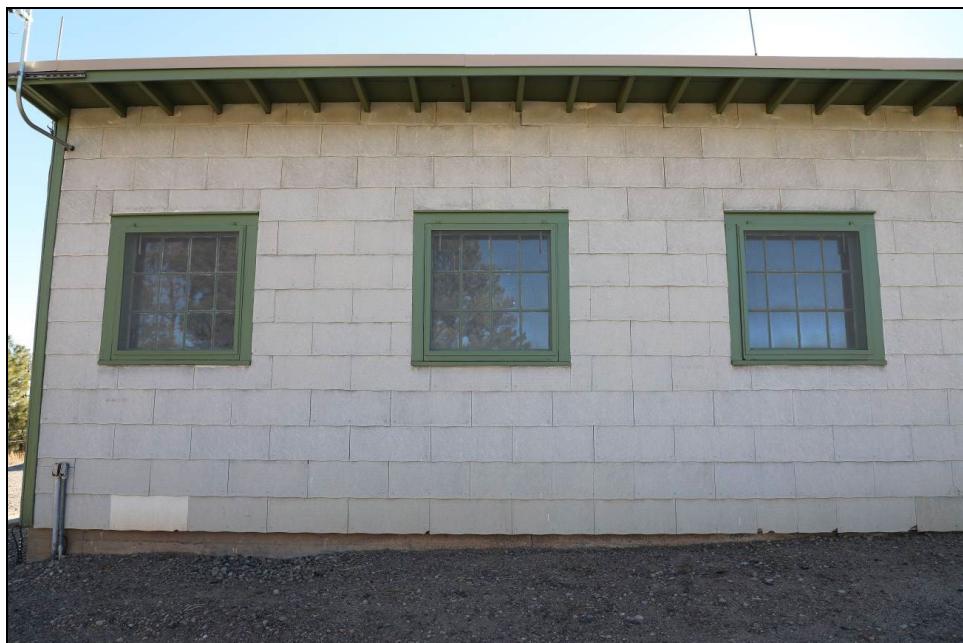
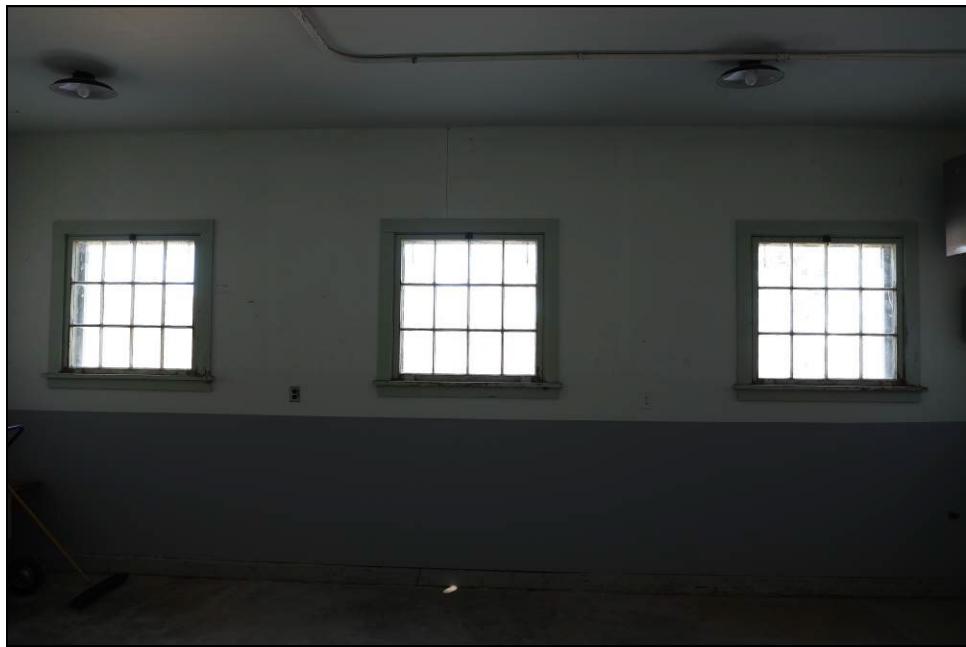
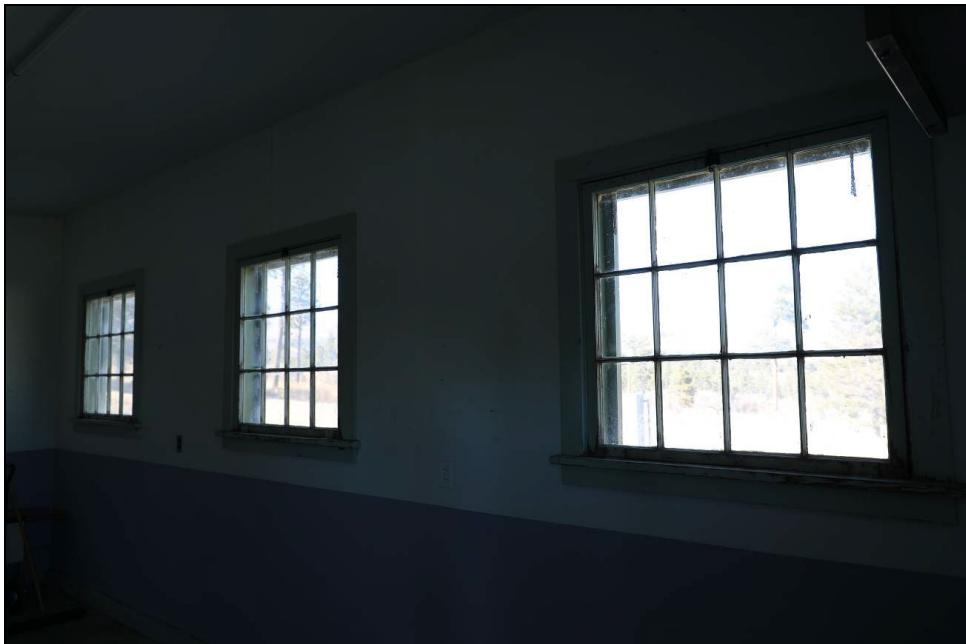
The widow sashes and frames on the north elevation of the building are in fair condition. Minor work is required to maintain operability and stabilization of the wooden elements. The exterior has been repainted recently and requires very little work. The interior of the window openings require a bit more work that includes repainting and wood stabilization.

*Figure 77. The three window openings from the exterior of the north elevation.*

Figure 78. Interior view of the three window openings.

Figure 79. Interior view of the three window openings from an angle.

Focus should be placed on the interior of the window openings. Wood consolidant may be needed in small amounts on the bottom portion of the stiles and the interior sills. Repainting should be undertaken to extend the life of the window openings. The exterior of the window openings are in good condition but should be repainted toward the end of upcoming five-year period.

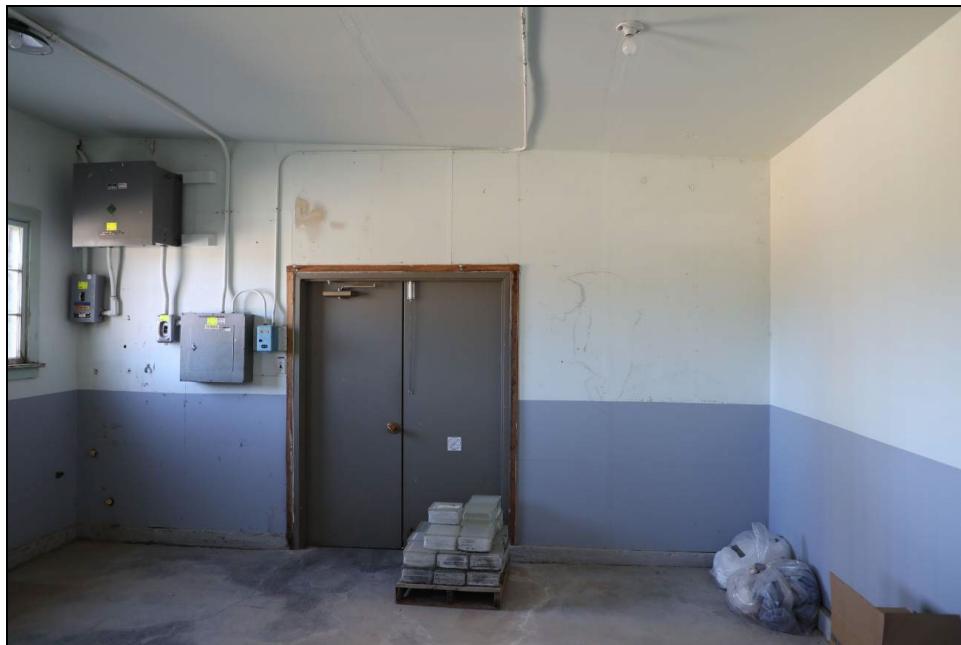
*Figure 80. A view of the east interior where scuffing is more prominent.*

Repaint the walls with the same color that is present. If time and funds permit, consult with historic building subject matter experts to perform a paint analysis. A paint analysis will help determine the original color of the interior and help with selecting a color that is offers greater historical accuracy.

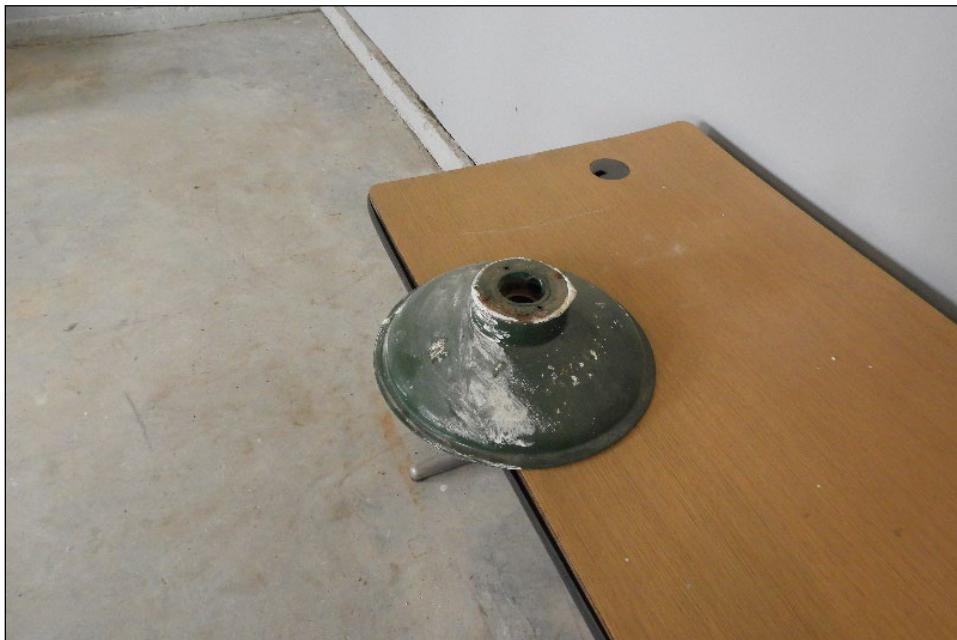
Two light fixtures are missing. One is currently sitting on a table inside the building.

*Figure 81. Historic lamp shade on table-top awaits installation.*

Rehang the fixture on the table. Consult with Historic Buildings staff to obtain another similar fixture for the second installation.

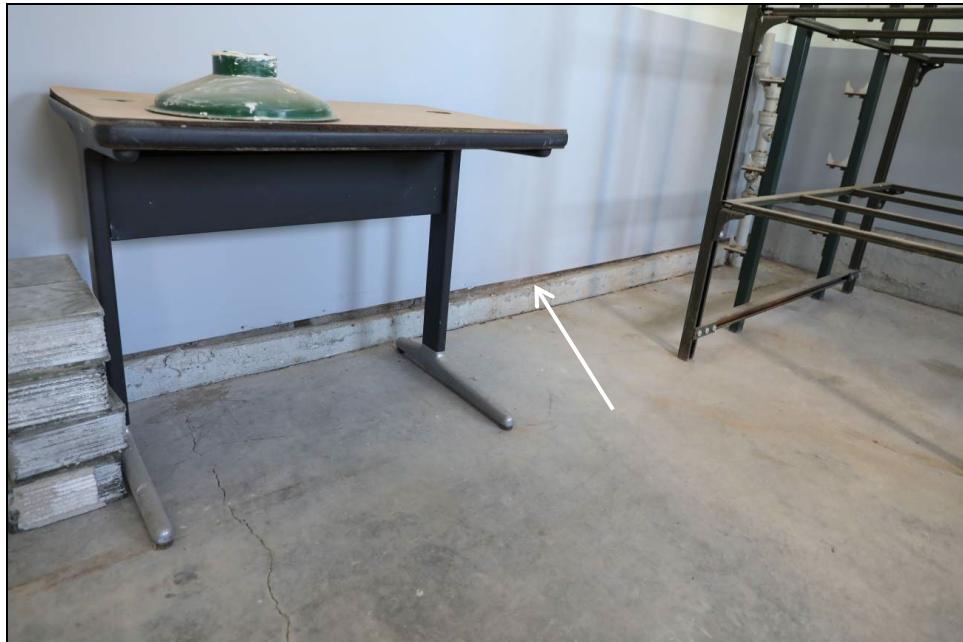
Figure 82. A long-running void can be seen just above the concrete base and the interior siding.

The voids along the base of the interior walls should be sealed with either copper wool as a temporary measure or thin lengths of trim slats for a more long-term solution. The addition of trim slats should be as thin as possible and painted the same color as the bottom portion of the walls.

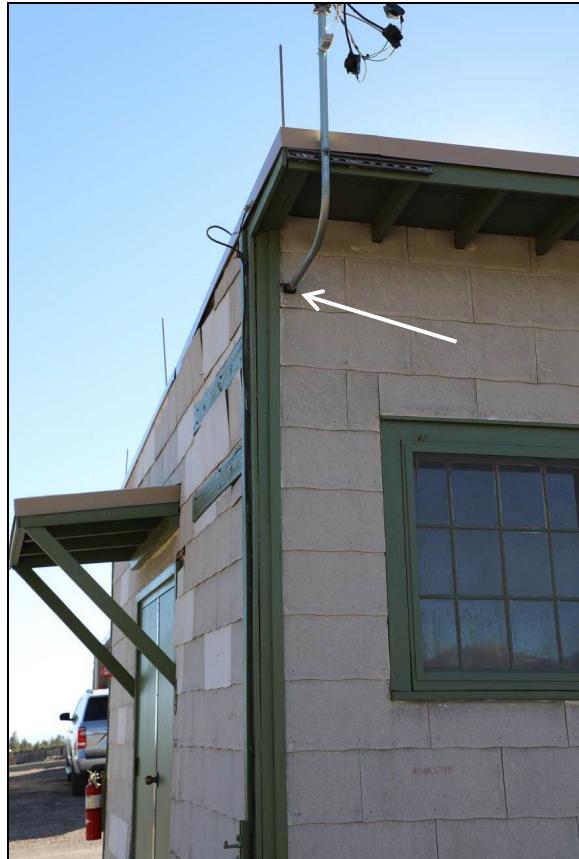
Figure 83. Conduit and related hole can be seen exiting the building in the upper corner of the north elevation.

The hole should be temporarily filled with copper wool packed tightly. A more long-term mitigation should occur when the shingles are removed and the diameter of the hole can be made smaller to more closely fit the diameter of the conduit. If the utility lines running through the conduit are deemed unnecessary, then the conduit should be removed and the hole completely filled.

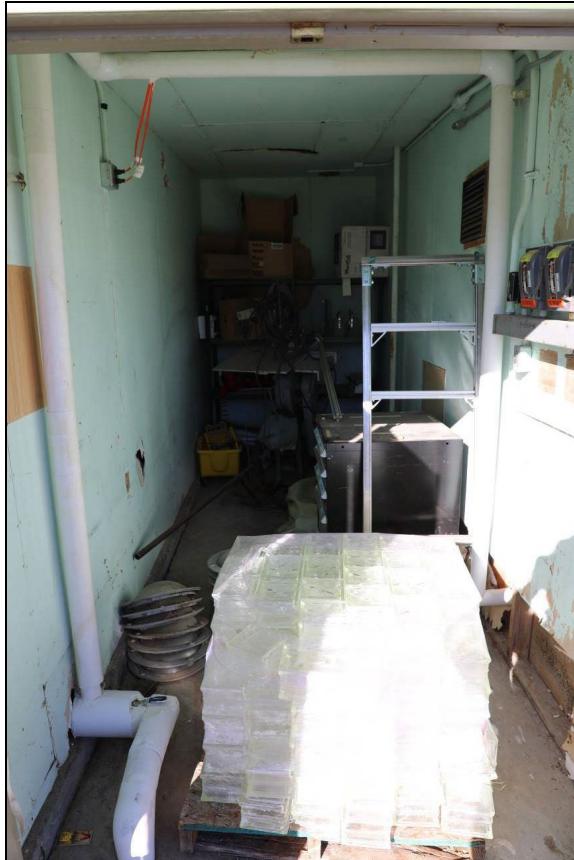
*Figure 84. The newly insulated plumbing can be seen in white in the foreground of the photograph. Still-to-be-repaired water damage can be in the bottom right hand corner.*

While the mitigation described above may sufficient to avoid burst pipes in the future, the installation of a ceiling mounted heater would provide better insurance when temperatures drop well below freezing.

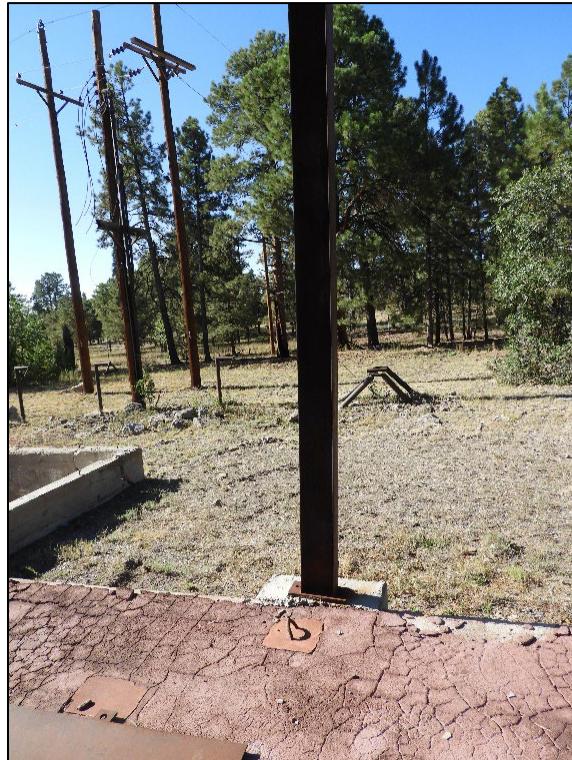
The support beam on the south end of the remaining pad does not sufficiently make contact with the poured concrete base surface. A concrete base represents a modern pour to help make contact, but the iron beam is still loose depending upon weather conditions. The welds of the standing iron supports are currently holding, but are suspect, as is the stability of conduit hanging from the supports.

*Figure 87. The beam does not make sufficient contact with the concrete base underneath it.*

The support beam on the south end should be reattached to the base by either boring into the modern concrete pedestal and bolting the beam to it, or by removing the modern concrete pedestal entirely and repouring a higher pedestal to make contact with the base of the beam. The welds of the remaining beams should be inspected by a qualified professional, and conduit should be further evaluated and tied down for safety.

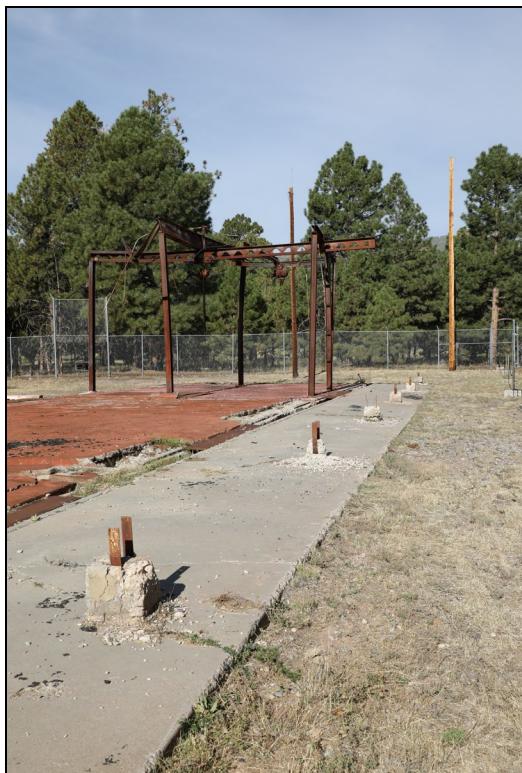
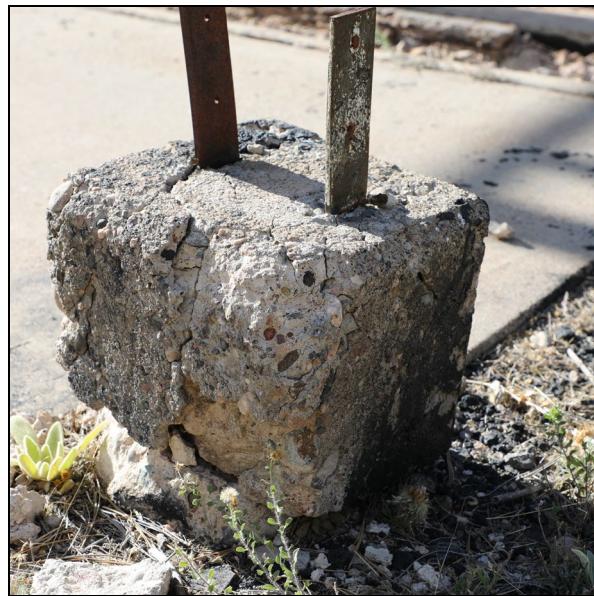
The concrete bases along the north side of the building are severely deteriorated. These bases show the location of the original posts that held up the north elevation overhang. They represent important markers for visualizing the form of the building prior to it burning down.

*Figure 88. The line of concrete bases used to support bracing that held up an overhang.*

Figure 89. Close-up photograph of one of the support blocks.

Reconstruction or replacement is not recommended, but slowing further deterioration should be the main focus. An approved stabilizer solution will be needed to preserve the blocks in place.

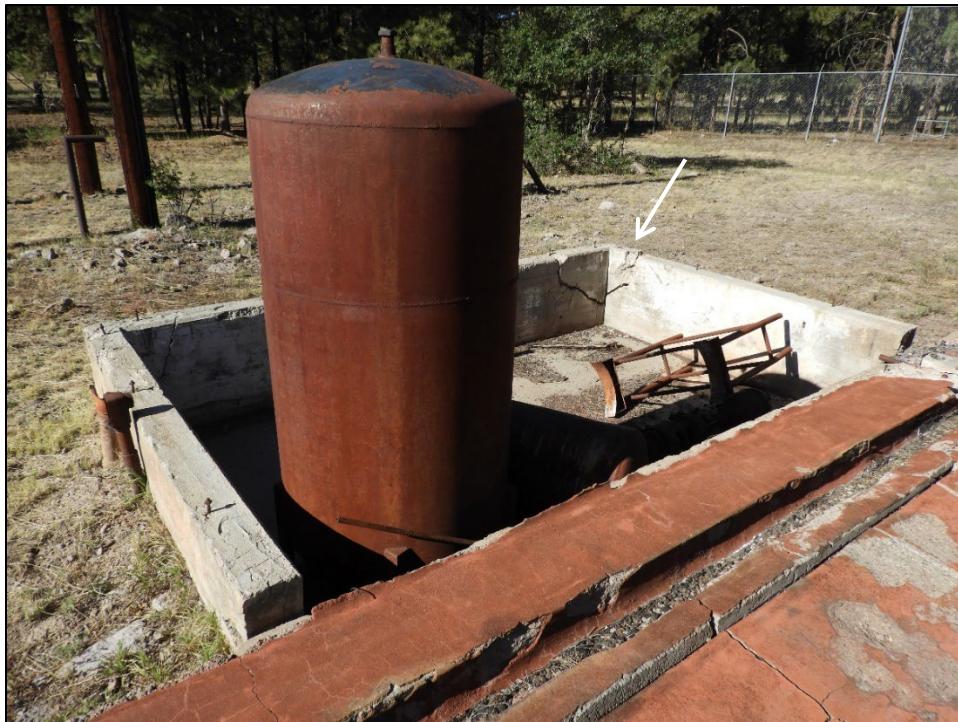
The southwest and northeast corners exhibit the most deterioration. Complete separation has occurred in some areas and if left unaddressed, will help to accelerate deterioration by letting in moisture to the interior of the wall.

Figure 94. The corner separation is easily seen here in the southeast corner of the room.

The large cracks will need to be repaired. Extensive research into the proper repair material, however, will need to be undertaken prior to any on-the-ground repair work.

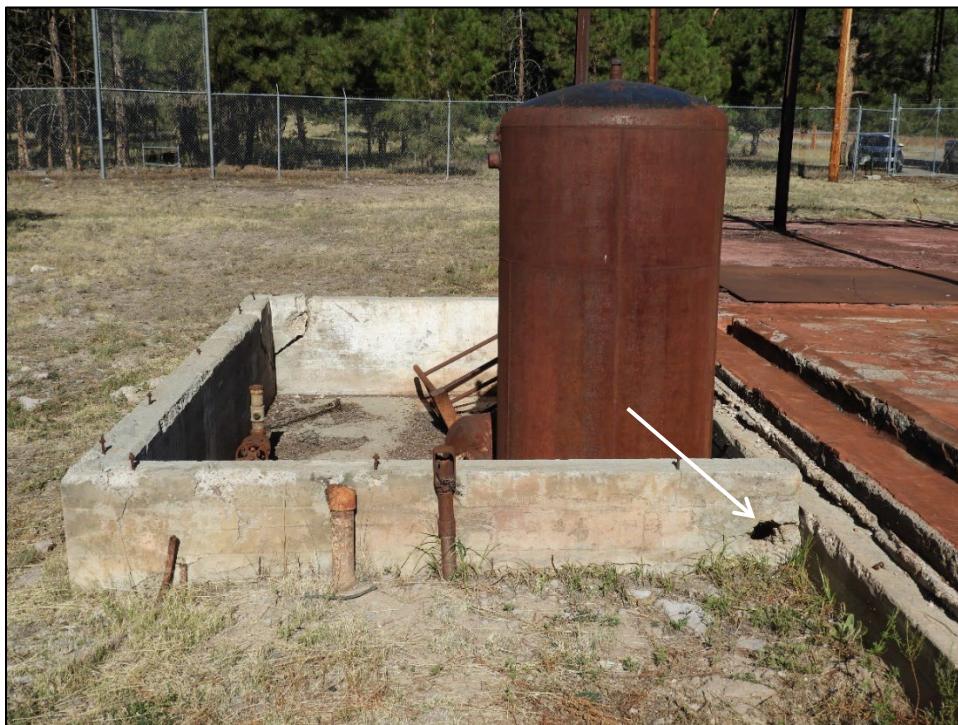
Figure 95. A large utility hole was chipped out of the northeast corner of the room.

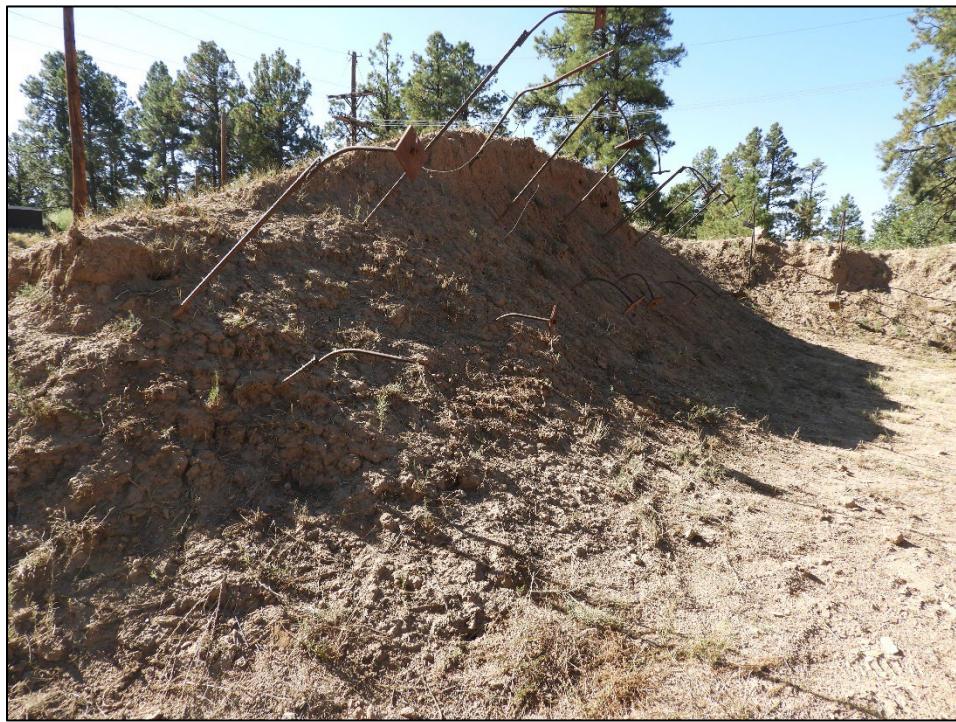
Moderate erosion is occurring due to the degree of the slopes and the lack of vegetation on some areas of the slopes. The north and west facing slopes are particularly worrisome. These two slopes represent the grades that were up against the building and now that the building is gone, lack the proper resistance and incline to prevent further erosion. The south and east facing slopes present a more manageable incline; however, vegetation growth is not sufficient to prevent moderate erosion from occurring during rain events and snow melt that allow for an uncontrolled runoff of moisture.

Figure 100. Profile shot of the east interior of the berm shows the extent of slope and lack of erosion controlling vegetation.

The first choice for the least impact preservation work would be reseed with native grasses. Larger plants are not recommended due to root intrusion and aesthetic characteristics. Seeding would need to be attempted at least three times for proper coverage and growth rate. If seeding fails to take hold, additional options to consider are the use of matting material to help hold soils in place or some other mechanical solution such as reinforcing the sub-grade to some extent. Preliminary ideas include stabilizing bars inserted perpendicular into the slope. However, any mechanical solution should only be undertaken in the event that reseeding fails to produce satisfactory results, and after additional planning and discussions.

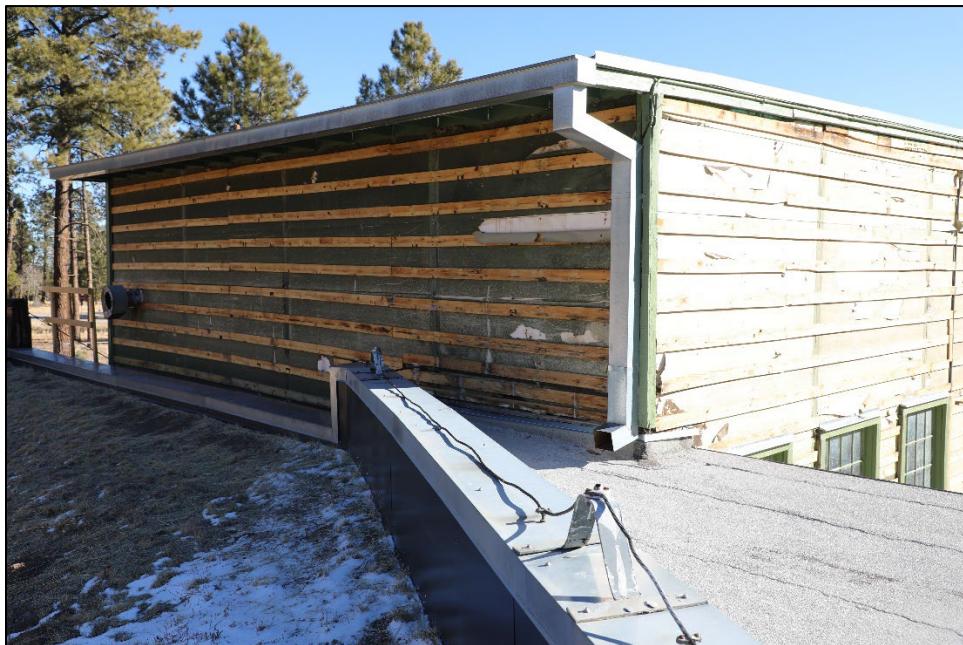
The roof currently drains to the roof of 16-0517. This approach increases the possibility of roof leaks in 16-0517 due to an amplified moisture management load during rainfall events and periods of snowmelt.

Figure 102. Photo shows the current drainage system from 16-0516 on to the roof of 16-0517.

To decrease the opportunity for roof leaks, the most direct drainage route is recommended. A new gutter system designed to transport rainfall and snowmelt to the northwest corner of 16-0516 should be developed and installed. Although this recommendation does not follow the historic drainage pattern, the overall preservation of 16-0516 and 16-0517 will ultimately benefit from this action. This gutter work may be best suited to coincide with an addition of a new roof system for both 16-0516 and 16-0517. The roof on this building will need replaced at the same time as the roof on 16-0517, which is a recommendation that follows in this report.

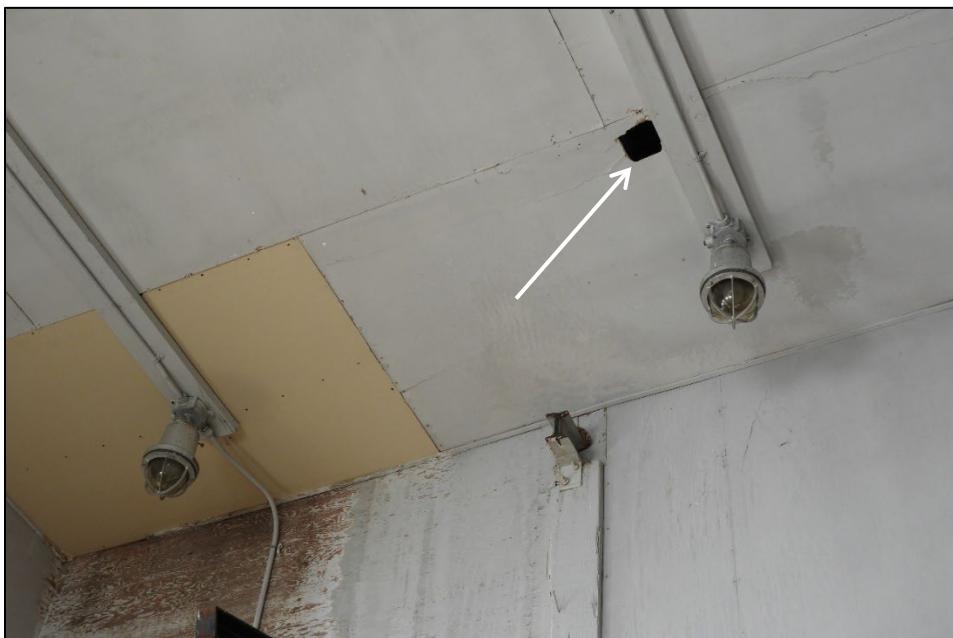
Figure 103. The 5" x 5" hole in the ceiling requires a patch - a difficult task, but achievable.

A patch can be engineered that covers the hole, yet remains flush with the ceiling. A square piece that extends over to the ceiling joist should be removed and the existing hole squared off at the other end. A replacement piece cut to the exact measurements can be tacked to the joist on the one side and on the other side, a wood strip placed above the hole can be tacked down as an anchor point for the other end of the repair. A fresh coat of paint should sufficiently hide the repair.

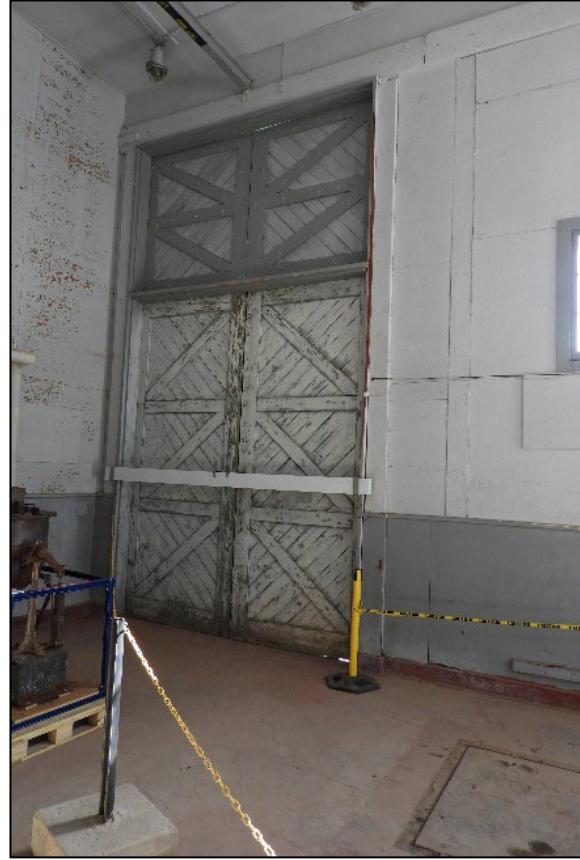
Paint is failing and flaking off the interior of the doors. This flaking promotes an environmental exposure of lead.

Figure 104. Interior view of the large bay doors for 16-0516.

Failing paint should be chemically removed. A chemical paint stripper will help prevent further release of lead into the environment and contain toxins for easy cleanup. The historic paint scheme as determined by subject matter experts should be used to repaint the interior of the doors.

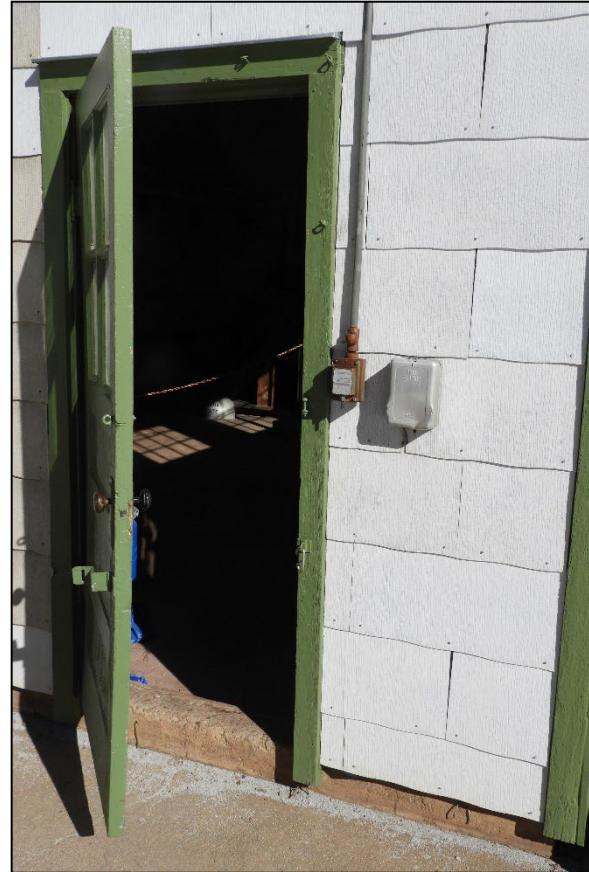
The door bows outward at the top and bottom. This condition allows elements of deterioration easier access to the interior of the building. The less-than-ideal closure permits moisture in the form of snowmelt and windblown rain to enter the building through both the top and bottom. Rodents and other pests also have a simpler avenue for entering the building due to the spaces created by the warped door.

In addition to creating easier access of various elements of deterioration, the present shape of the door puts undo stress on the frame and operational hardware. The act of opening and closing the door places strain on the frame and increases the likelihood of catastrophic failure of the wooden components and fastening elements of the hinge.

Figure 105. Warp in door can be seen in this photograph.

The door should be removed and repaired. If properly executed, the warp of the door can be removed using a large steaming system that will gradually return the door to its required vertical plane. This process requires that the door be repainted and possibly reglazed.

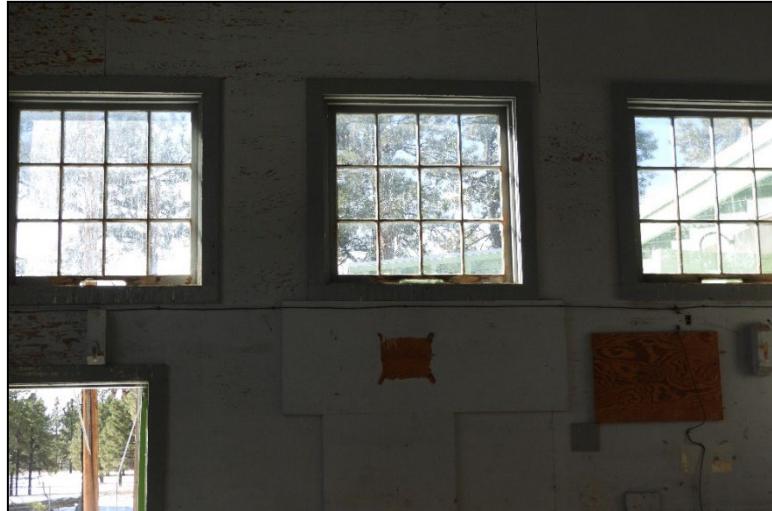
*Figure 106. Interior view of the three window sashes with constructed holes on the bottom rail.*

Being that the function is yet uncertain, efforts should be taken to preserve the integrity of the window sashes by treating the condition in a way that is easily reversible. Therefore, the holes should be filled with material easily removed without damaging the original wood fabric.

Wooden inserts cut precisely to the same dimensions of the holes may be constructed and inserted into the holes without the use of adhesives. Temporary, short-term mitigations may also include the use of darkened copper wool. Copper should be used instead of steel due to the oxidizing nature that steel would have on the surrounding wood fabric. Screen mesh is not recommended due to the transfer of outside temperature extremes to the interior. If the visual nature of the holes become important to preserving the character of the windows and the building itself, then the attachment of Plexiglas with small diameter fasteners may be an acceptable solution to completely filling in holes.

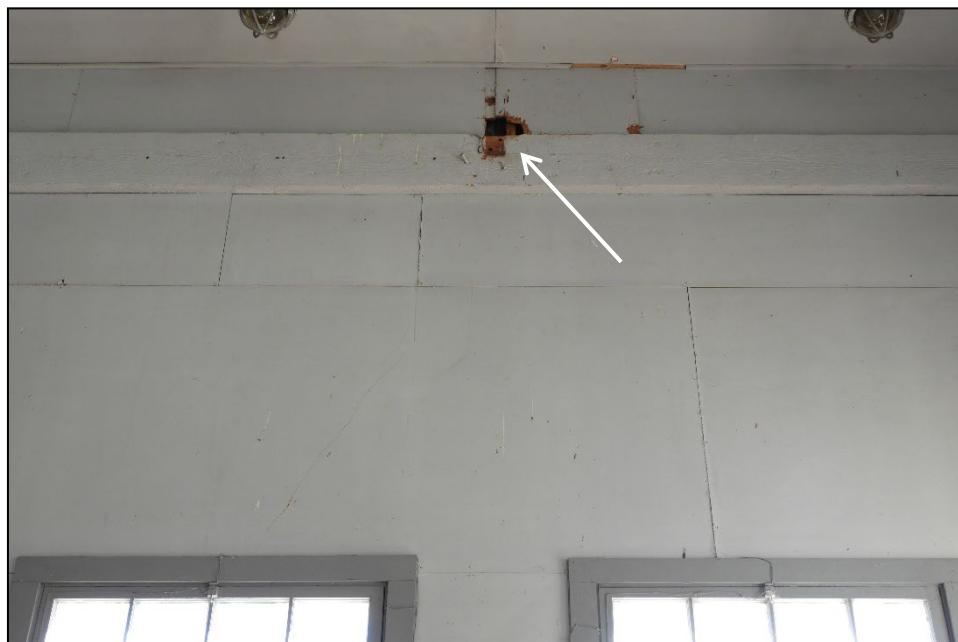
A small, but significant hole located on the east elevation near the top of the southeast corner allows access to pests. Pests such as rodents gain entry into the wall and are able to nest with little to no disturbance. Furthermore, the support beam that runs underneath the hole allows a generous pathway for rodents to access the hole, and, subsequently, the interior of the wall. This area also requires the replacement of missing trim at the junction of the ceiling and wall.

Figure 108. The small hole allows access to the interior of the walls.

A Dutchman repair would be sufficient to close off this access point while preserving the character of the interior of the building. To help ease the application of a Dutchman repair, the smallest amount of original wood fabric necessary to square up the hole may be removed. The repair piece may be tacked into the visible support framing using small finishing nails. Small amounts of wood glue may also be applied around the edges of the repair to assist with the permanence of the repair.

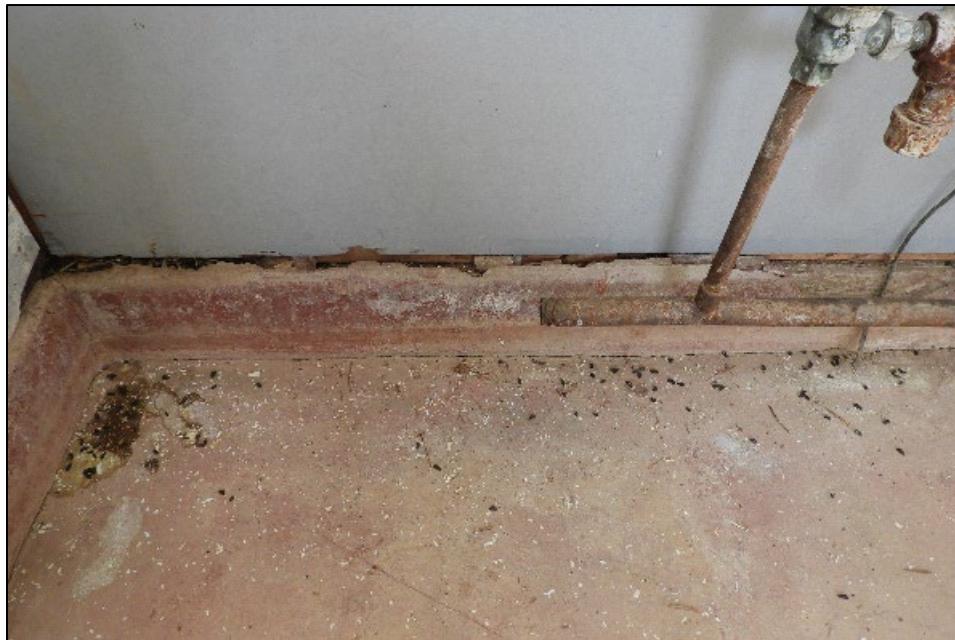
Voids present between the interior concrete base and the plywood siding currently allows rodents and other pests access to the interior of the building. Rodent droppings are prevalent throughout the interior of the building, but are most prolific near these access points. Pest control specialist with LANL require periodic visits to clean up the mess. Droppings present a health and safety hazard for workers and visitors to the V-Site. Closing off voids that allow access to the interior of the building will provide significant help in reducing disease carrying rodent feces.

Figure 109. Photo shows cracking of the baseboard that allows rodent access to the interior of the wall.

Mitigation in the short term would consist of copper wool packed into the voids. In the long term, the fix would involve reinforcing the wall substrate behind the backing.

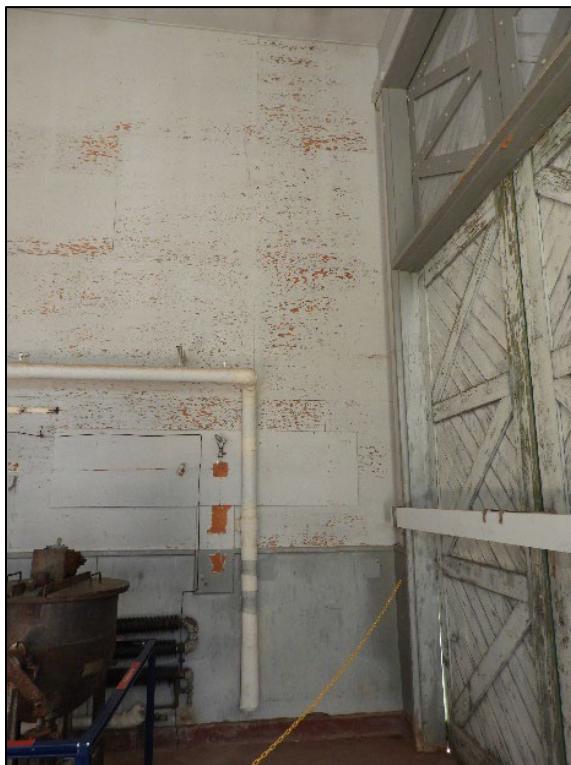
Paint is failing through the entire interior of the building. Failing paint flakes are currently allowing possible lead-based paint to enter the environment. This release into the environment is a health safety issue for staff and visitors to the building.

Figure 110. The underlay of the plywood sheathing is becoming exposed as the paint flakes away from the surface.

The interior walls may not have been painted during the building's period of significance. More research is needed, but if so, the complete removal of paint would bring back the interior plywood look while mitigating the risk of lead exposure to individuals within the building.
