**Title:** Historic Buildings Report: Five-Year Preservation Planning for Manhattan Project National Historical Park Sites

# **Historic Buildings Report: Five-Year Preservation Planning for Manhattan Project National Historical Park Sites**

**Fiscal Years 2022 - 2026**

Historic Building Report No. 394  
Survey No. 1257

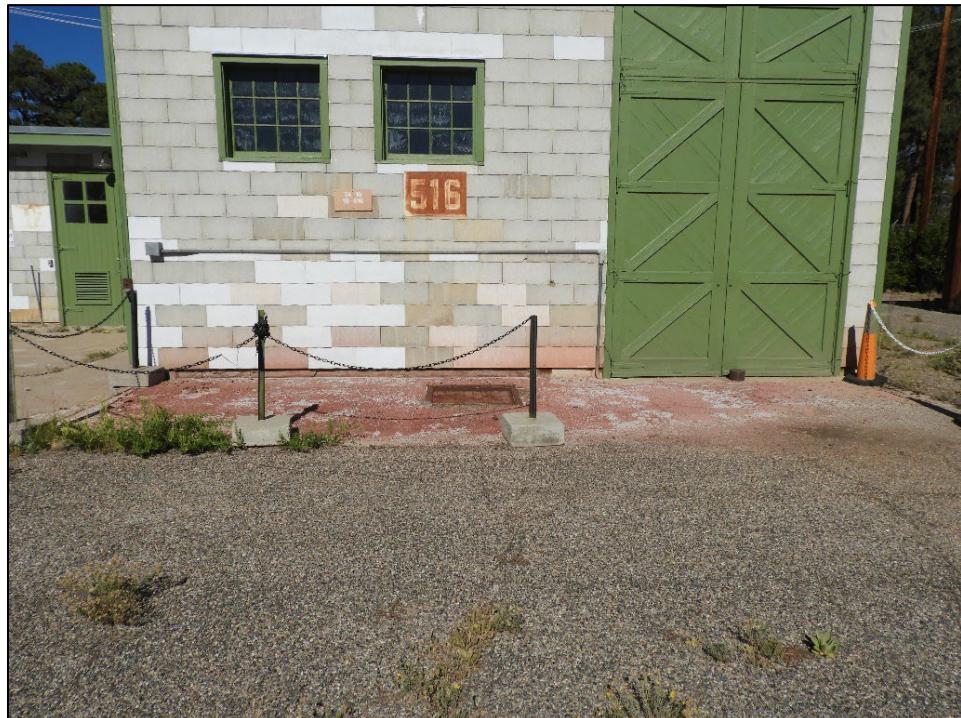
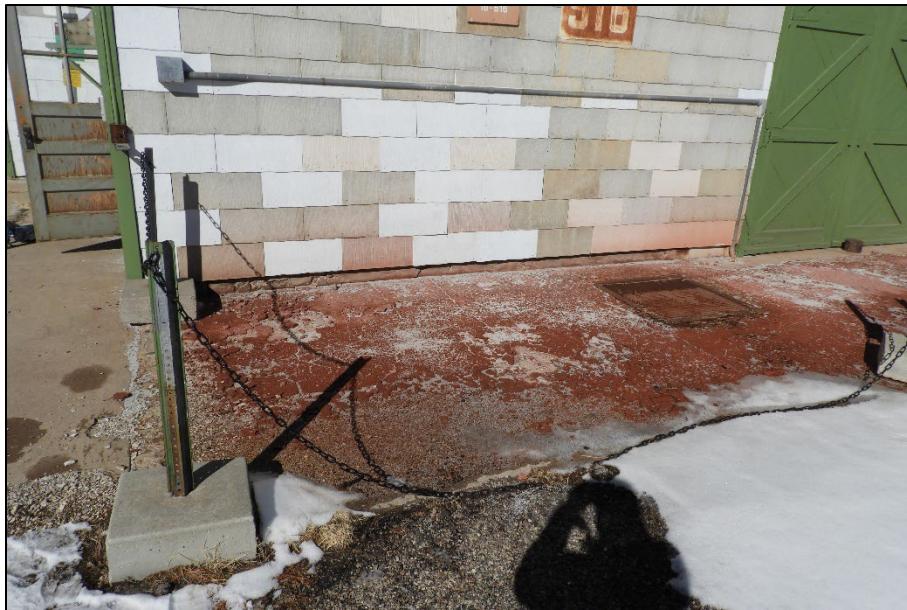
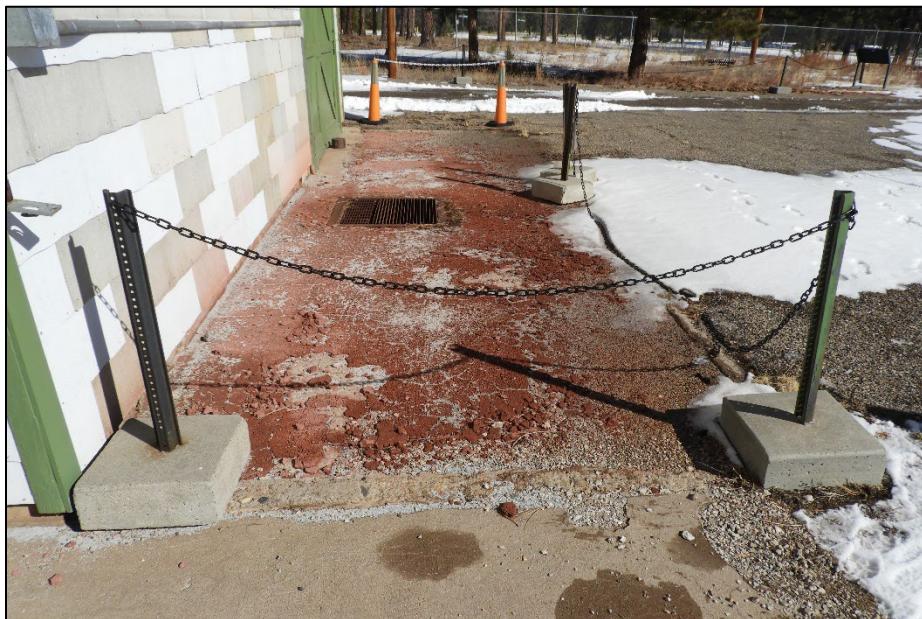
The Hubbelite top coating is deteriorating adjacent to the east elevation of the building.

Figure 112. The Hubbelite separation is considerable and likely irreversible.

Deterioration of the Hubbelite is so great that removal and replacement is likely in order. Hubbelite contains asbestos and care must be taken in the removal process. Research will need to be done to find a suitable replacement that closely matches the color and texture of the original Hubbelite.

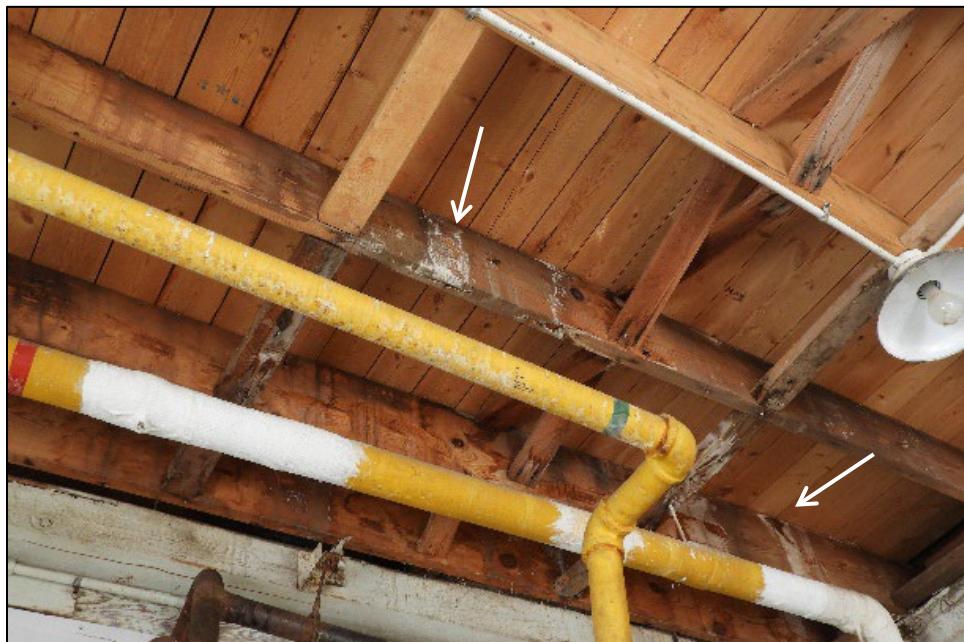
Small leaks are evident on the ceiling of the south portion of the building. Staining has already occurred to portions of the ceiling joists.

*Figure 115. Evidence of recent leaks are evident on the ceiling joists and roof decking.*

A new roof system is required to better address the overall protection of the building. A PVC membrane roof system is recommended. Additionally, it is recommended to proceed with a roof system replacement for the adjacent building (16-0516) at the same time.

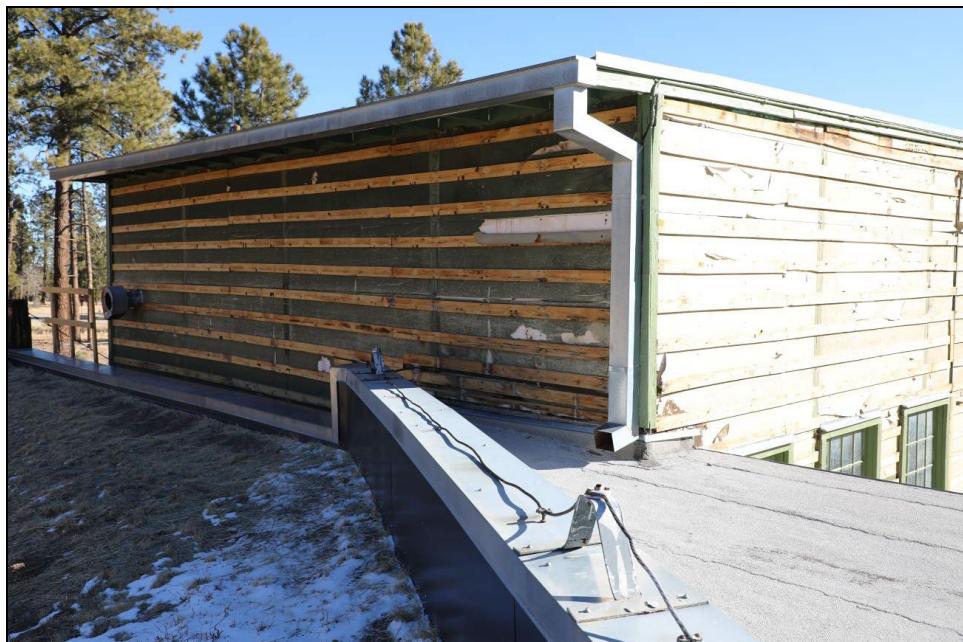
The roof of 16-0516 currently drains to the roof of 16-0517. This approach increases the possibility of roof leaks in 16-0517 due to an amplified moisture management load during rainfall events and periods of snowmelt.

Figure 116. Photograph shows the current gutter and drainage system from the roof of 16-0516 to the roof of 16-0517.

To decrease the opportunity for roof leaks, the most direct drainage route is recommended. A new gutter system designed to transport rainfall and snowmelt to the northwest corner of the 16-0516 should be developed and installed. Although this recommendation does not follow the historic drainage pattern, the overall preservation of 16-0516 and 16-0517 will ultimately benefit from this action.

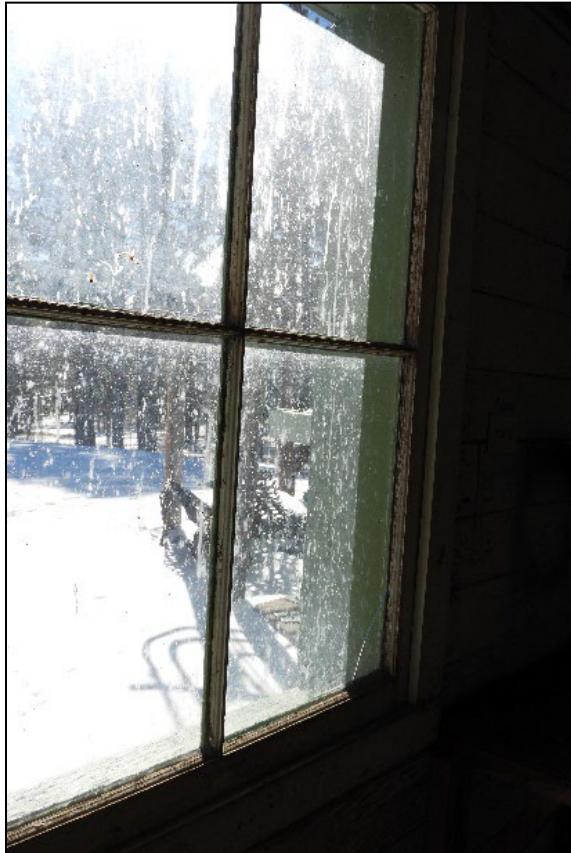
A window pane on the window on the east elevation of the building exhibits a large crack.

*Figure 117. Arrow points to the crack in the window pane.*

The window should be removed and then the pane removed and replaced. Reglazing should also occur.

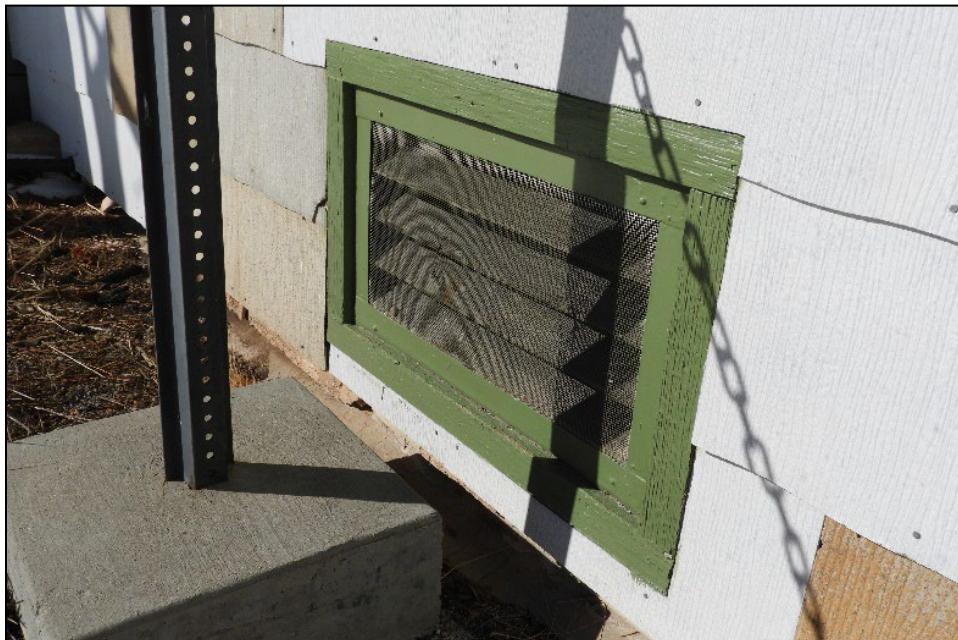
The screen on the vent exhibits rips, loosening, and protrusions from the aging and slackening of the screen. At their current measurements, tears in the screen are large enough to allow small rodents access to the interior of the building. As the tears get larger, pest infestation will increase.

*Figure 118. Screen over the louvered vent has aged and needs replaced.*

The screen should be removed and replaced in kind. Temporary screen patch may be a good temporary repair, however, full replacement of the protruding screen is needed to prevent further damage.

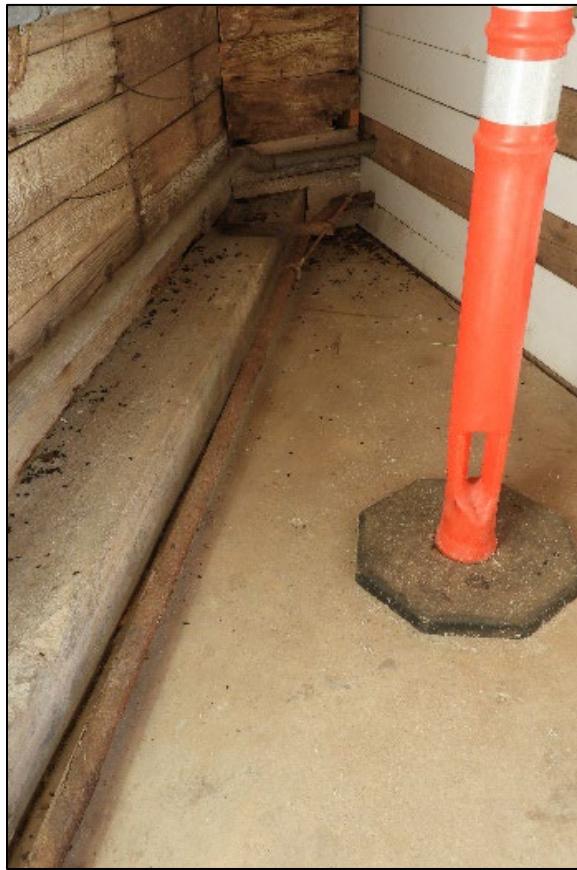
Figure 120. Rodent droppings are prevalent on the floor of 16-0517.

Perform wood repairs for larger voids and seal smaller voids with copper wool.

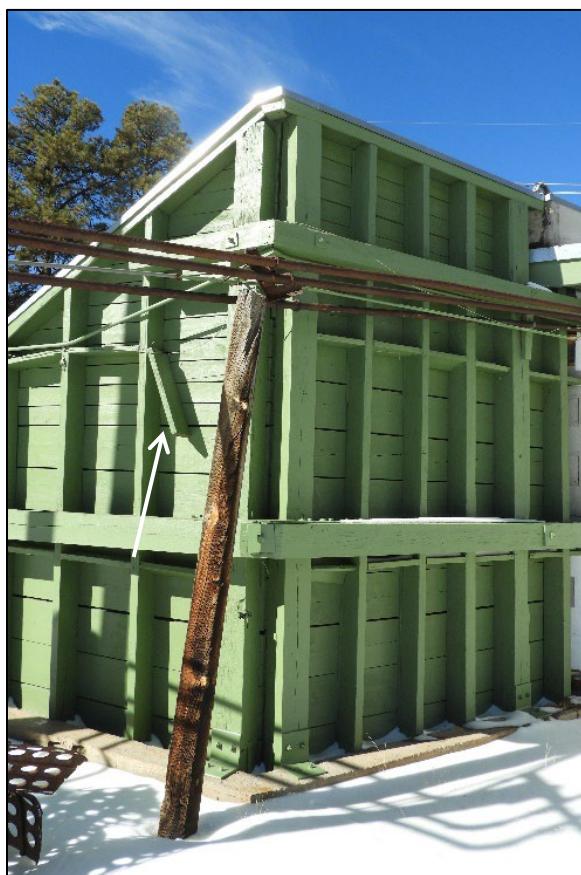
The bracing has completely detached in some areas or is loose and about to detach from the main structure.

*Figure 123. Arrow points to a detached piece.*

Reattach the existing bracing and replace any missing pieces.

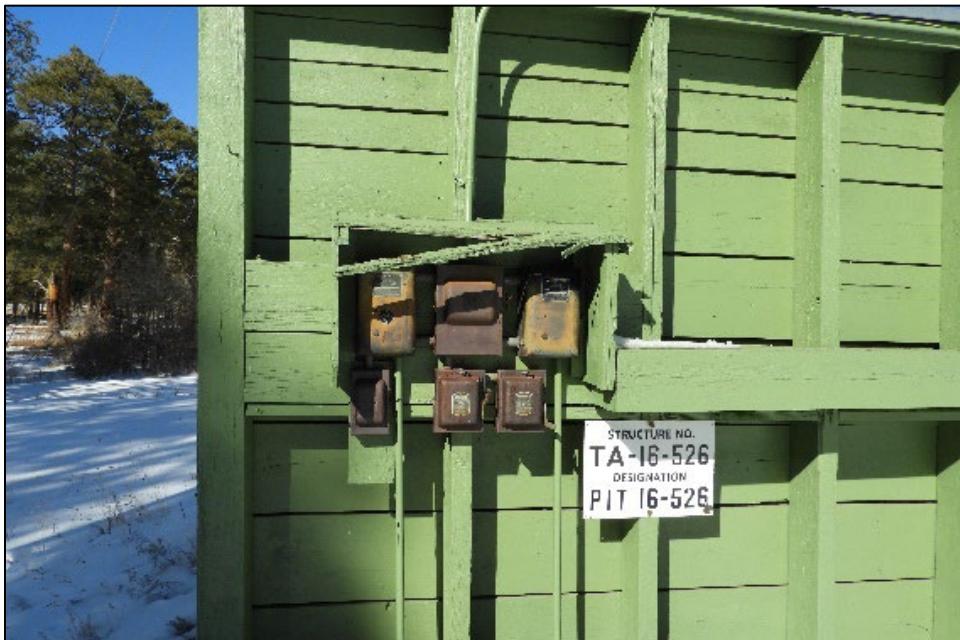
Figure 124. The top of the cover box is in need of repair.

Replace the top cover in-kind.

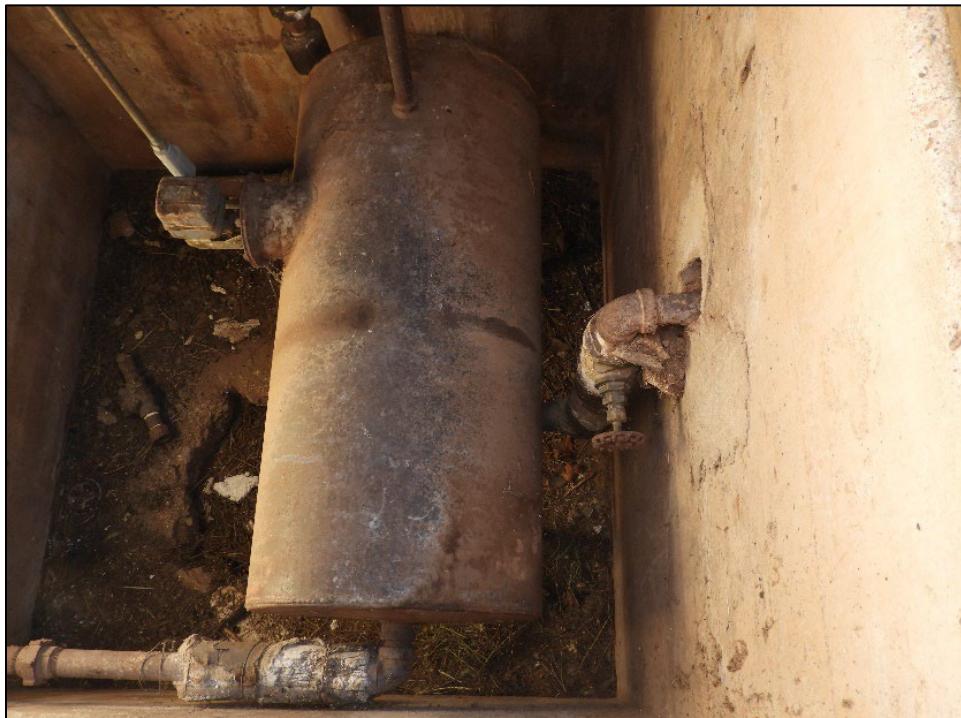
*Figure 125. Photograph of the interior floor of the pit structure.*

Remove rodent debris from the interior of the structure. Specialized training required in confined space and respirator safety.

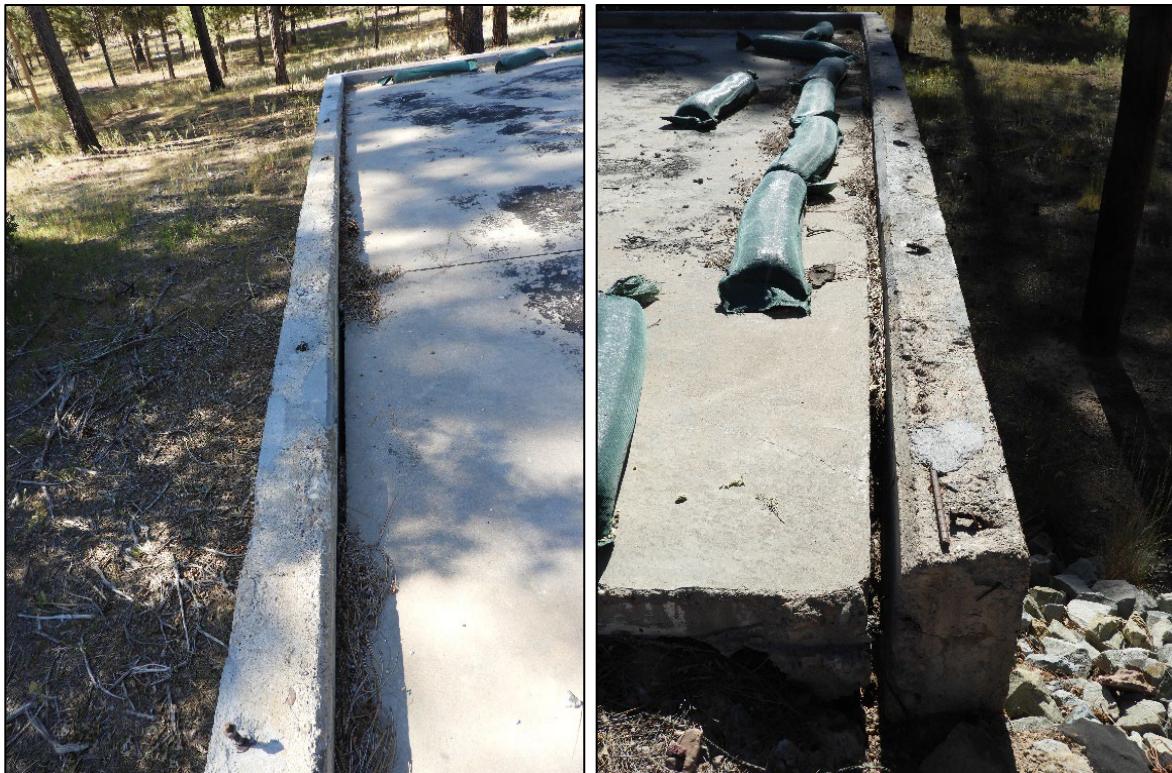
The walls have pulled away from the slab due to moisture infiltration and the pressure of forces under the slab. The slab has not only separated from the stem wall, but has also slumped a few inches lower due to the absence of material underneath that has washed out and settled over time. Currently separation from the stem wall is only a few inches.

Figure 128. The separation extends most of the length of the wall.

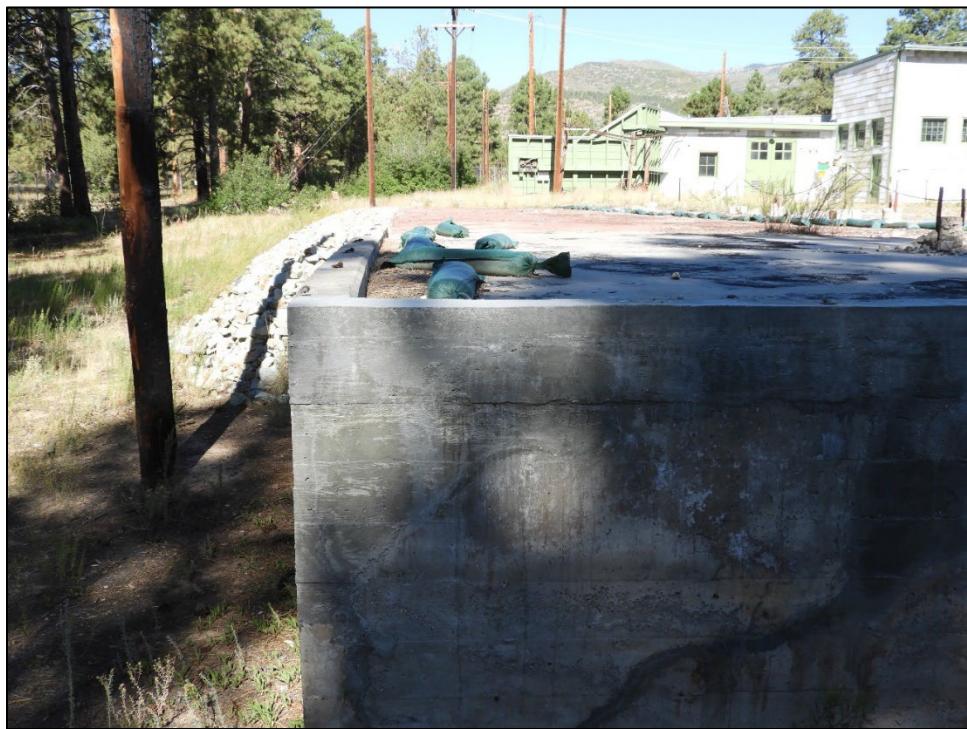
Figure 129. Photo shows the bulging stem wall along the south perimeter.

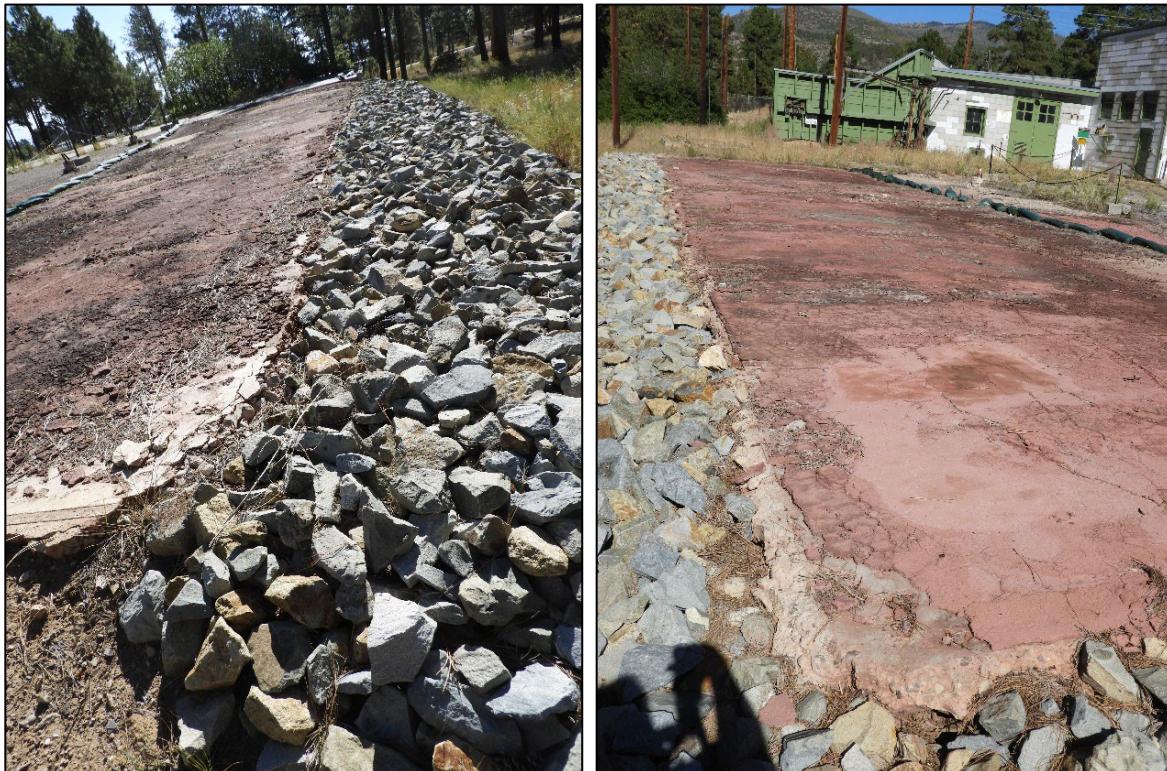
Figure 131. Photos show the introduced rock berm that prevented increased undercutting of the slab.

Eventually remove stones from the makeshift berm once a suitable plan to prevent undercutting while retaining some of the historic character is developed.

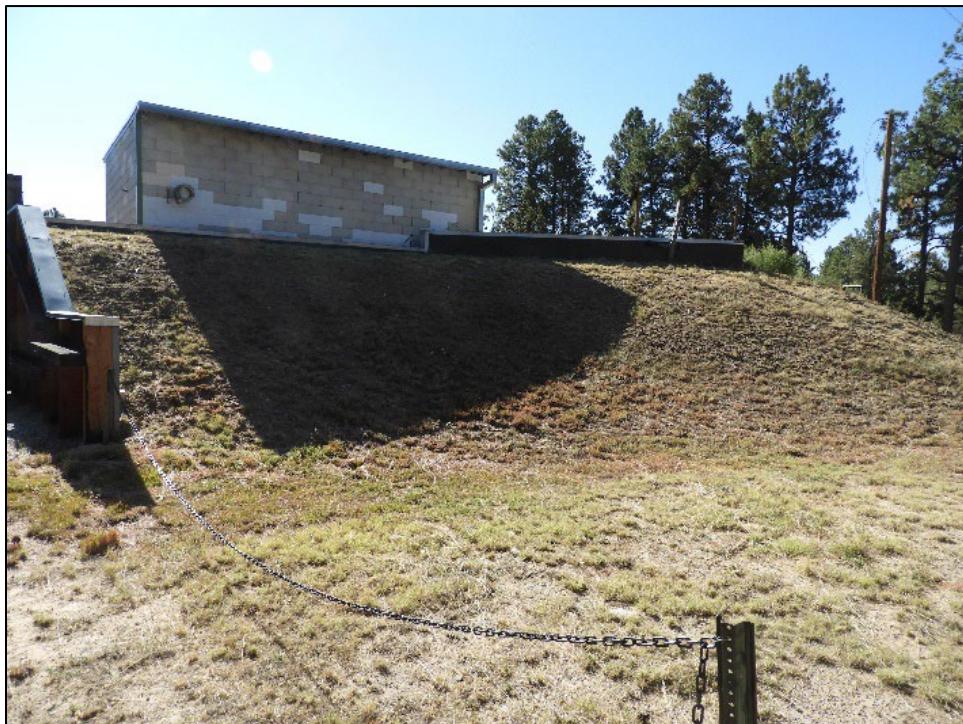
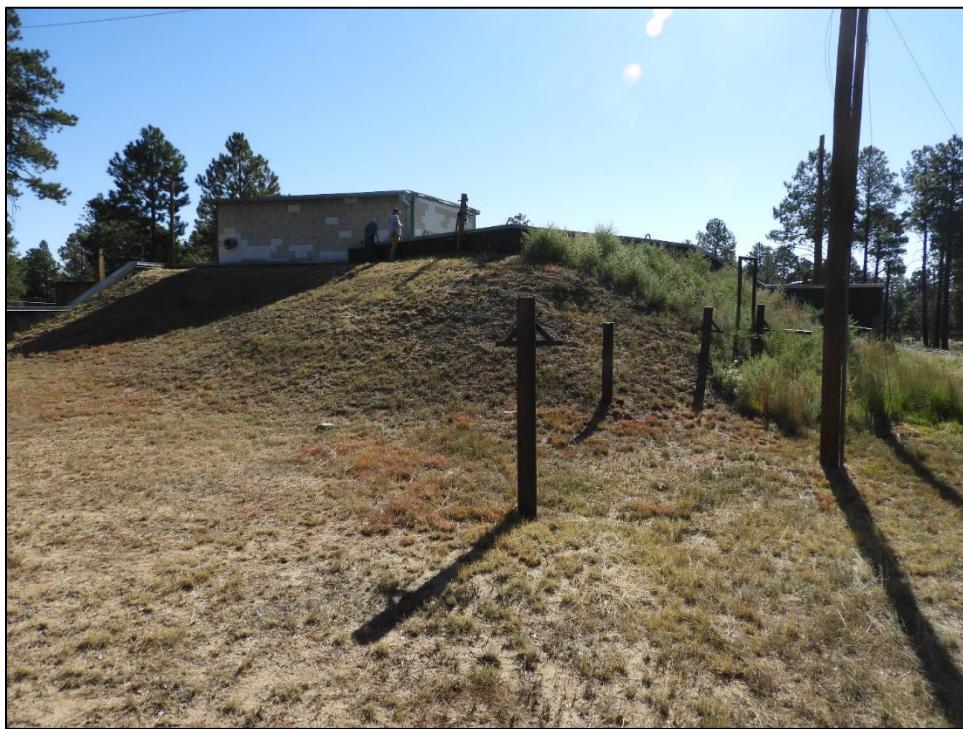
Figure 133. The west facing slope directly behind 16-0516 and 16-0517 after cutting.

Figure 134. A comparison of the berm with cut areas and uncut areas.

Erosion is minimal, therefore, reseeding with native grass seed is in order. Routine grass cutting should be performed sporadically to allow grasses time to seed out once they take hold. Larger shrubs and weeds should be taken out more routinely than the grass is cut back to help native grasses thrive.

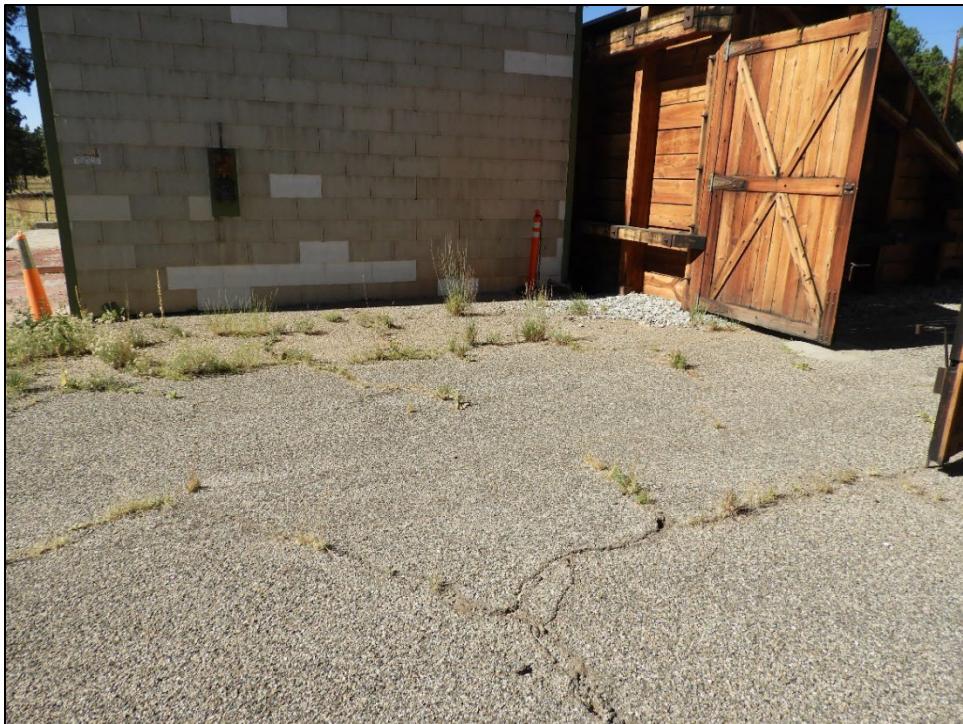
Currently rainwater and snowmelt drain toward critical architectural elements. The entrance road into the complex drains to the base of the north elevation of 16-0516. Drainage from the south portion of the central parking area of the complex drains to the Hubbelite pad of 16-0519 and 16-0520. Drainage from the central parking area and the concrete pad immediately east of 16-0517 has contributed to significant deterioration of the concrete pad. There are low spots within the concrete pad that hold rain and snow/ice. These areas drain directly to the double doors on the east elevation. The threshold for the double doors is not high enough and does not make contact with the bottom of the doors in order to help stop and redirect flowing water away from entering the building. The dip in front of the doors also allows moisture in the form of rainwater puddles and snow and ice to build up. Subsequently, melt runoff is directed under the doors and into the building. Wood at the base of the doors show evidence of moisture damage.

Figure 135. This portion of the central area drains directly to the north wall of 16-0516.

Recommendations include removing the deteriorated asphalt topping from the site and re-contouring the parking area to drain away from critical architectural elements. Topping the parking area should consist of gravel that helps absorb and slow drainage away from the site. Care should be taken to retain the depression feature in the center of the asphalted area which is significant to the historic of the Manhattan Project. The concrete pad on the east side of 16-0517 should be replaced in areas of total deterioration only, with stable areas of the pad retained. The threshold under the double doors on the east elevation of 16-0517 should be preserved in place if possible.

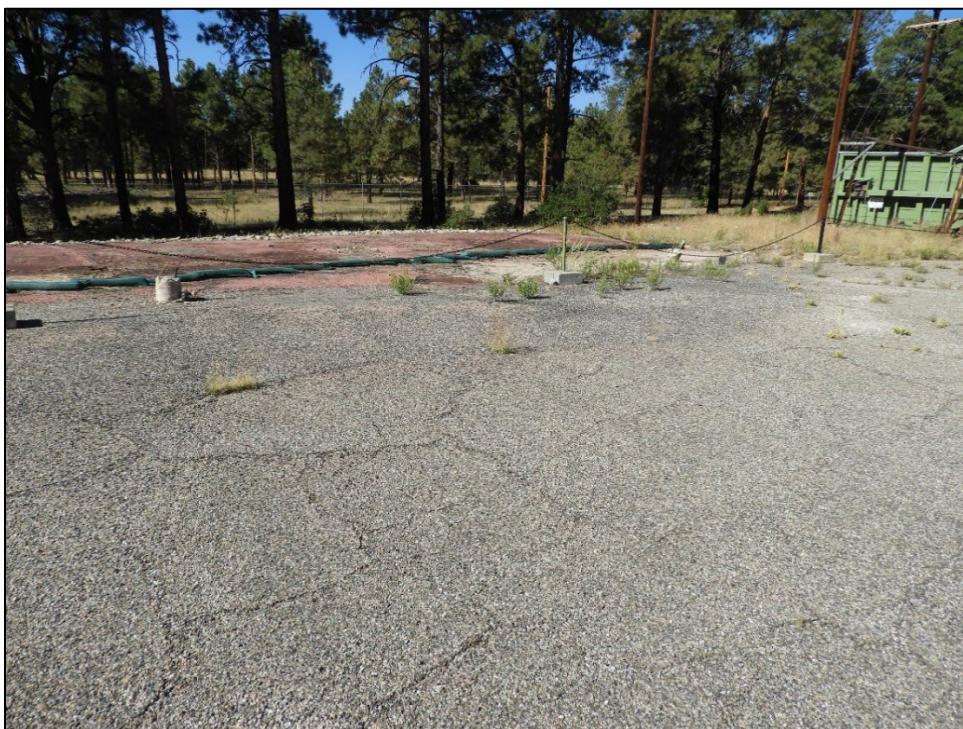
Figure 136. Drainage to the Hubbelite pad of 16-0519 and 16-0520 present significant preservation challenges.

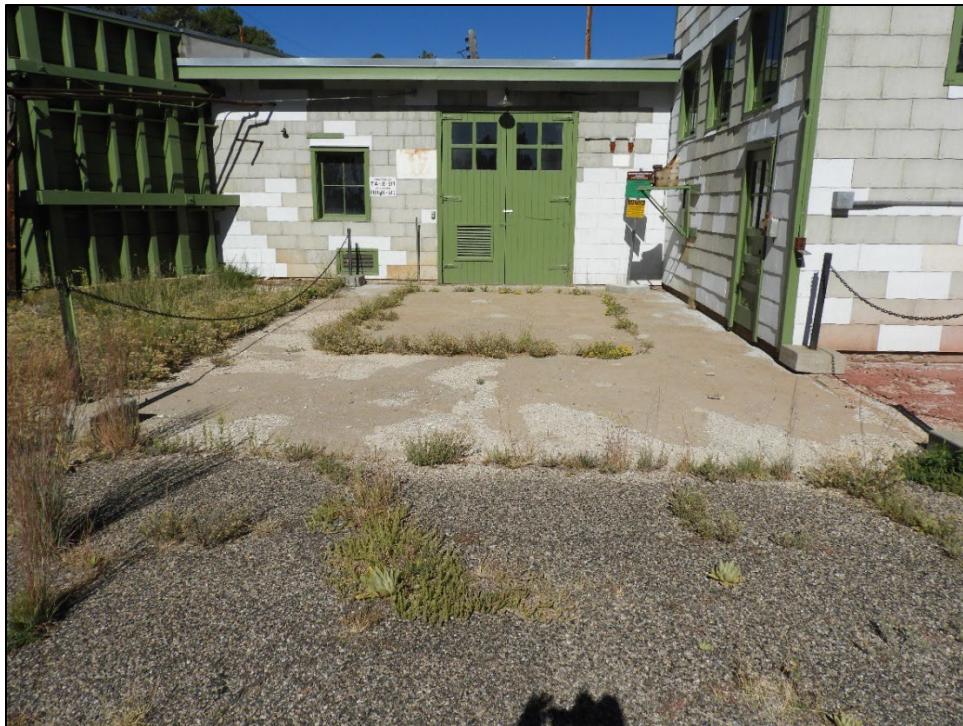
Figure 137. Water drains to the original concrete pad in front of 16-0517 and threatens the preservation of the doors and the interior of the building.

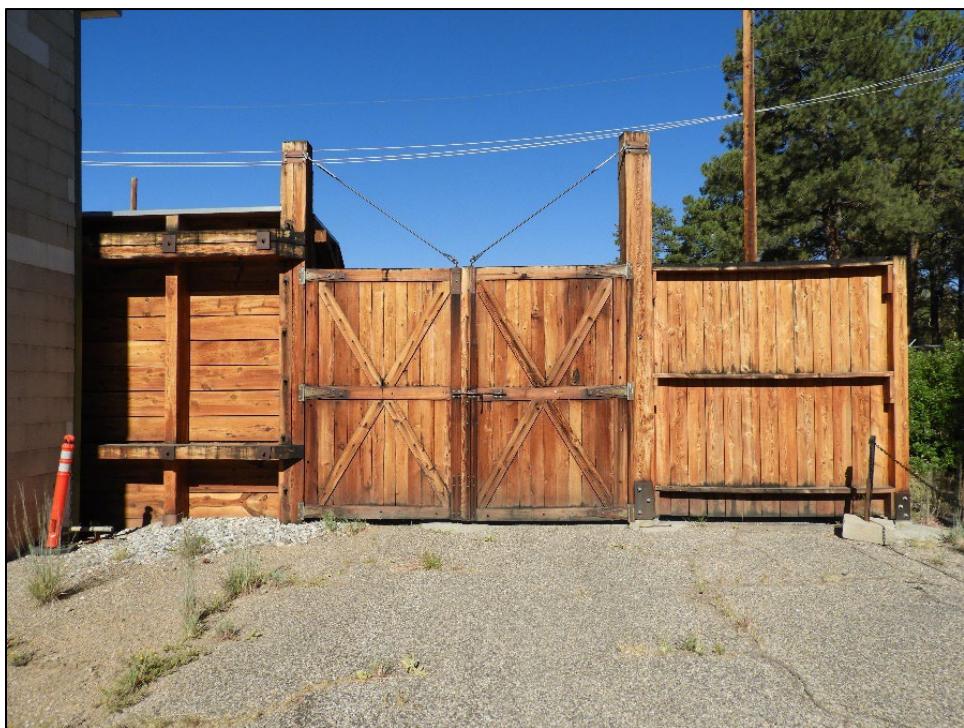
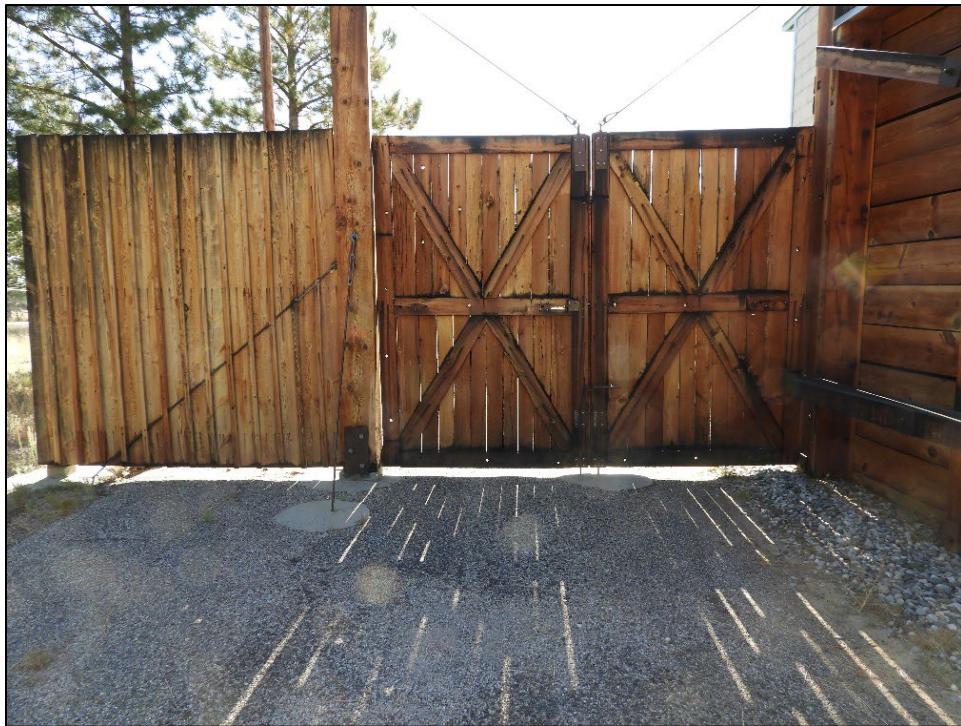
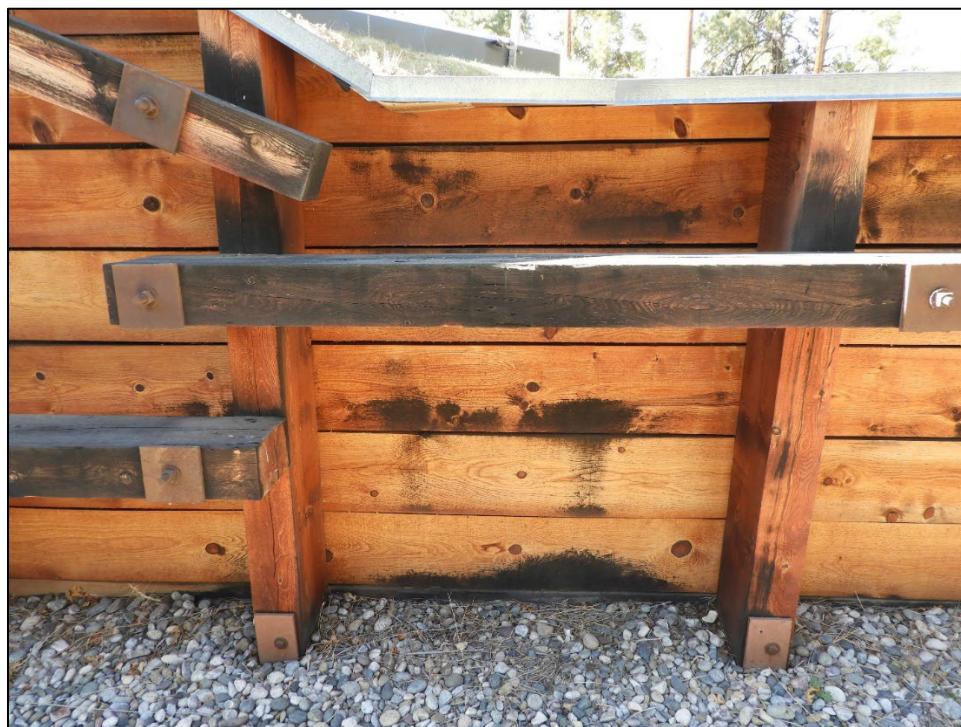
The biological growth amounts to a dark staining of the wooden elements used to reconstruct the gates leading into the V-Site complex. This staining results from the use of processed linseed oil prior to the present-day use of raw, unprocessed linseed oil. Processed (boiled) linseed oil promotes biological growth on wood and is common occurrence at other historical sites.

Figure 140. Exterior view of the gates and no-peep fence. Blackened areas on the wood represent biological growth.

Figure 141. Close-up of a section of the fence to highlight extent of biological growth.

Recommendations include the use of an appropriate biocide to kill the growth and return the wood to its natural finish. Unprocessed (raw) linseed oil should continue to be used for preservation purposes, however, biocide treatments should be considered every three to five years to not only improve appearance, but also preserve the wood which deteriorates faster where biological growth occurs.

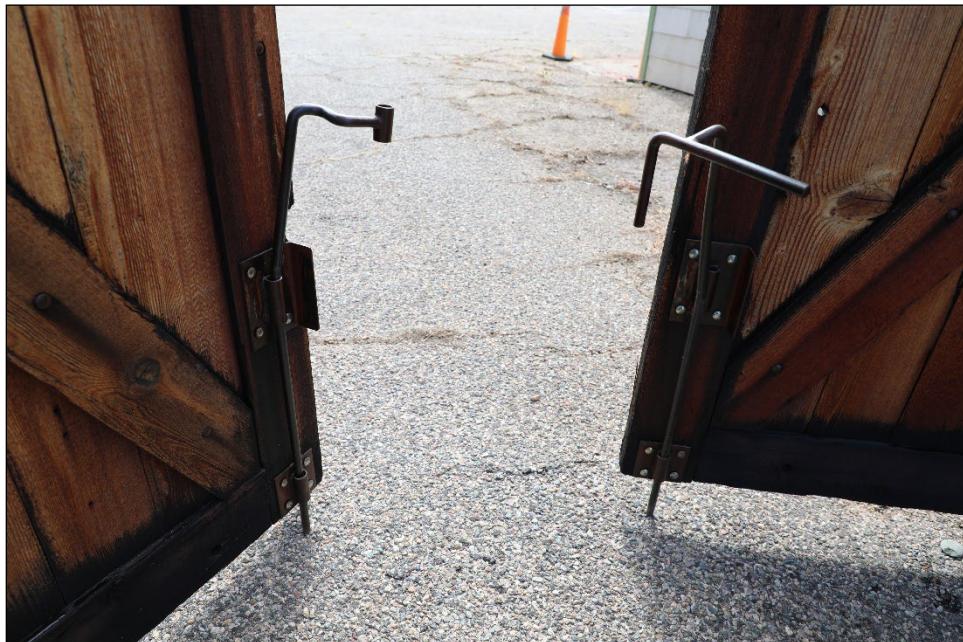
Figure 142. The metal rods that tie in both gate leaves when closed are no longer straight and functioning properly.

The pins will need to be straightened out to resume the appropriate closure function of both gate leaves.

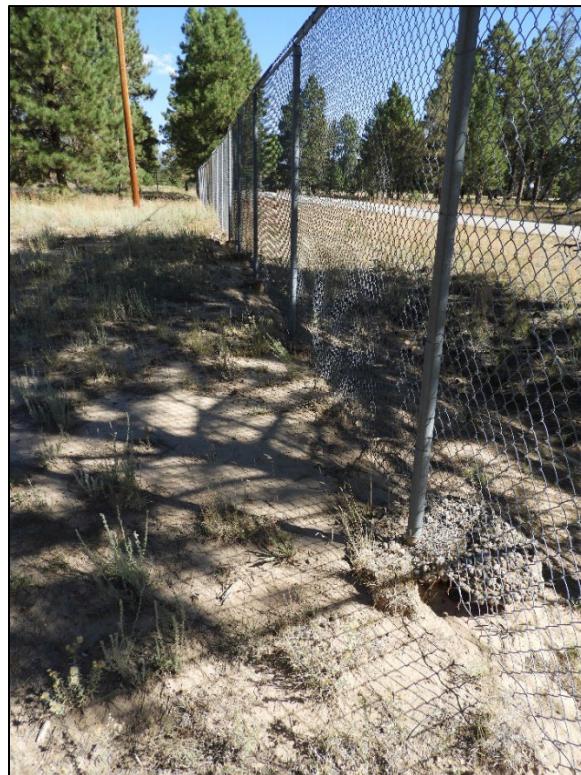
Larger erosional voids along the east perimeter fence allow wildlife access to the site which can, in turn, can cause damage to the buildings and the remaining building pads. A large tree fell on the fence causing significant damage (Figure 142).

Figure 143. Erosion at the base of the fence may cause the fence to topple in the future.

Fill in erosion areas and better direct water runoff. Care should be taken to not affect the nearby historic road bed only a couple feet away. Cut tree off fence and repair/replace section.

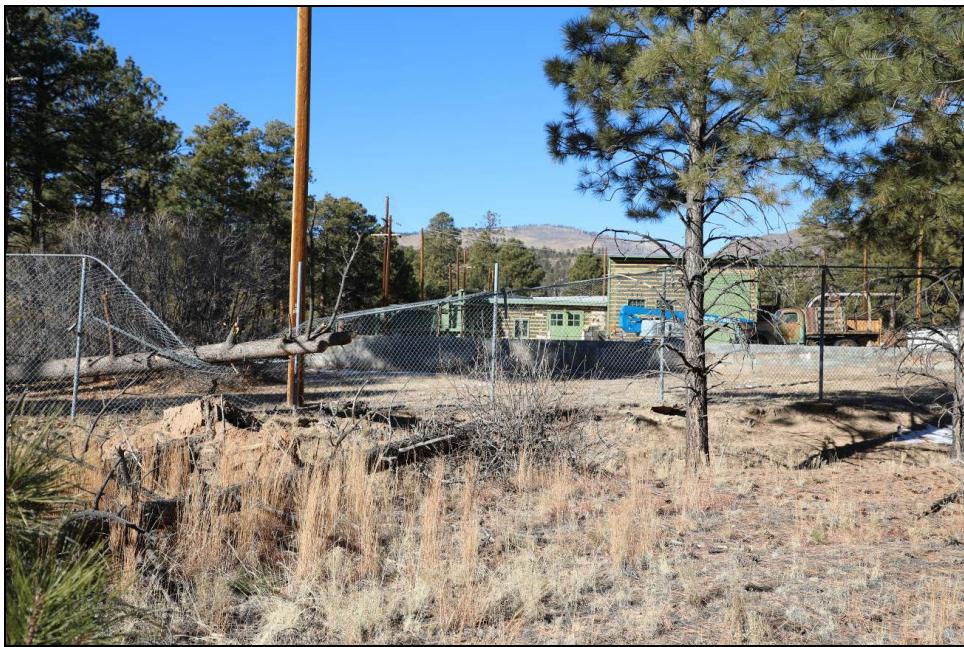
*Figure 144. A large tree fall caused considerable damage to the perimeter fence east of the V-Site complex.*

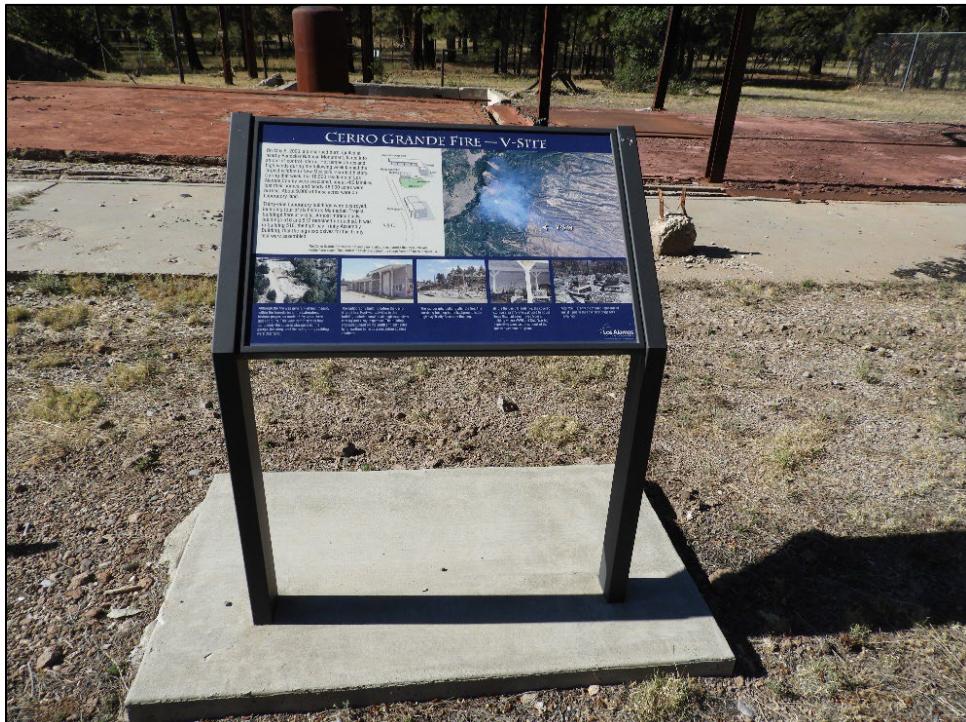
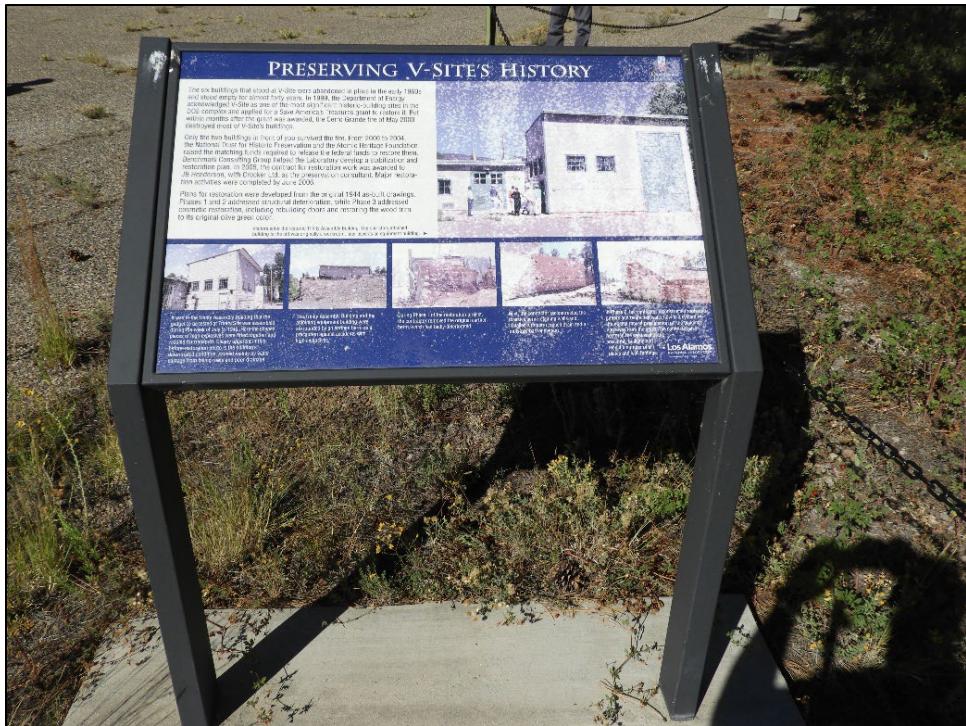
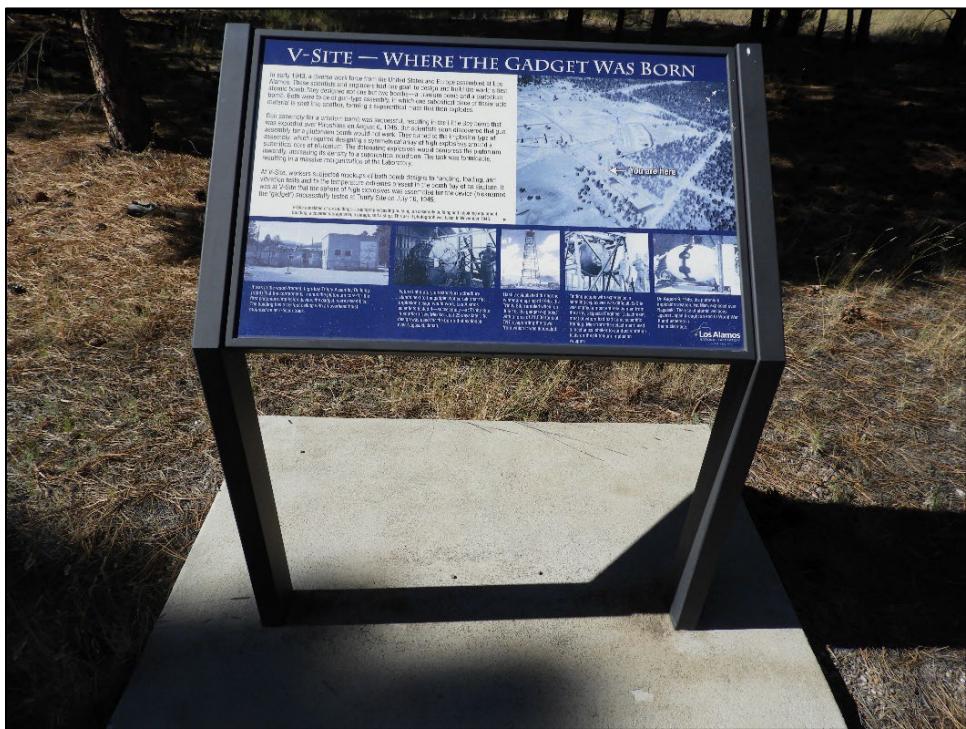
Interpretive panels are faded due to sun exposure. The metal stands remain in good and usable condition.

The stands are good condition. The interpretive insert panel should be replaced and possibly redesigned.

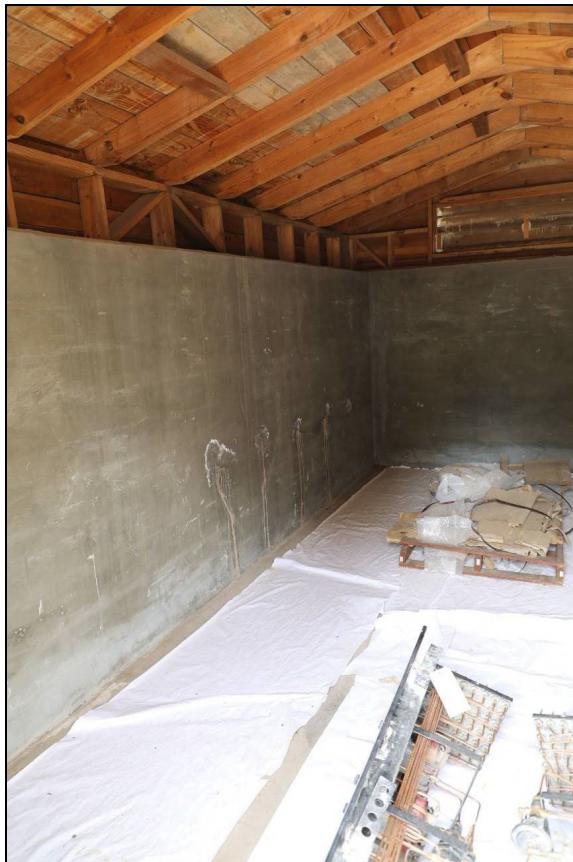
Rodent activity is evident inside the building. Insufficient seal of the entrance doors, concrete damage, and holes in transom vent screens contribute to this intrusion.

Figure 149. Rodent droppings can be seen on the freshly laid white paper.

Properly fitting door sweeps and replacement of transom vent screens will help to correct this issue. Any holes in the concrete can be temporarily filled with copper wool; however, once a more permanent concrete plan is developed, filling the voids with an approved concrete mix will be the most beneficial long-term solution.

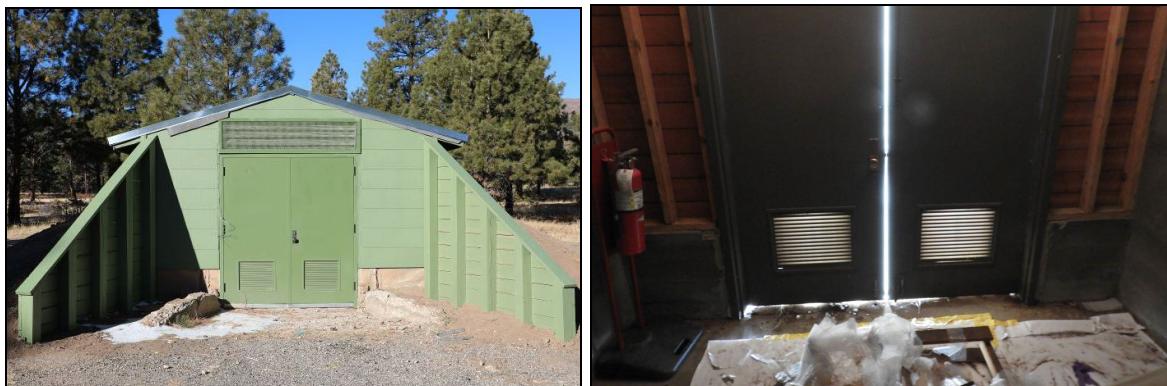
Figure 150. The non-original doors do not provide a proper fit to keep out pests.

Full replacement of both doors is recommended. Since neither door is original (or historic), door replacement with something closer to the originally designed doors will increase the historic character of the building while providing a better closure to keep out weather and pests.

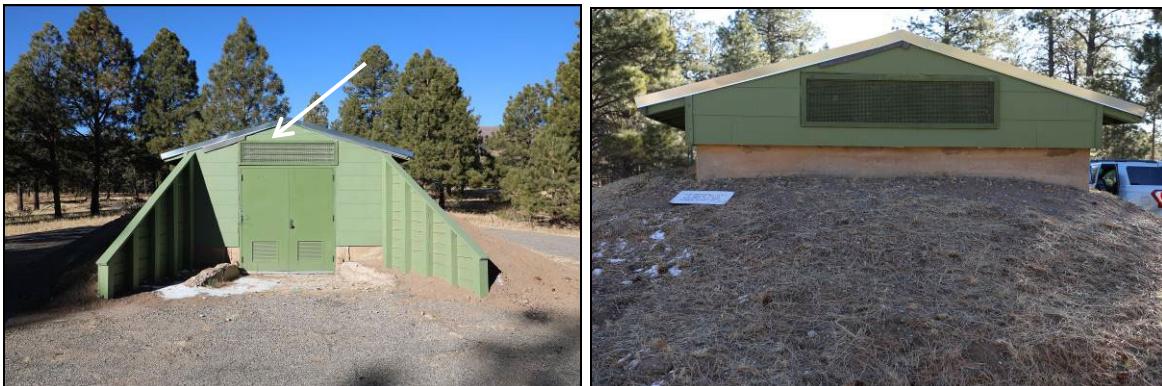
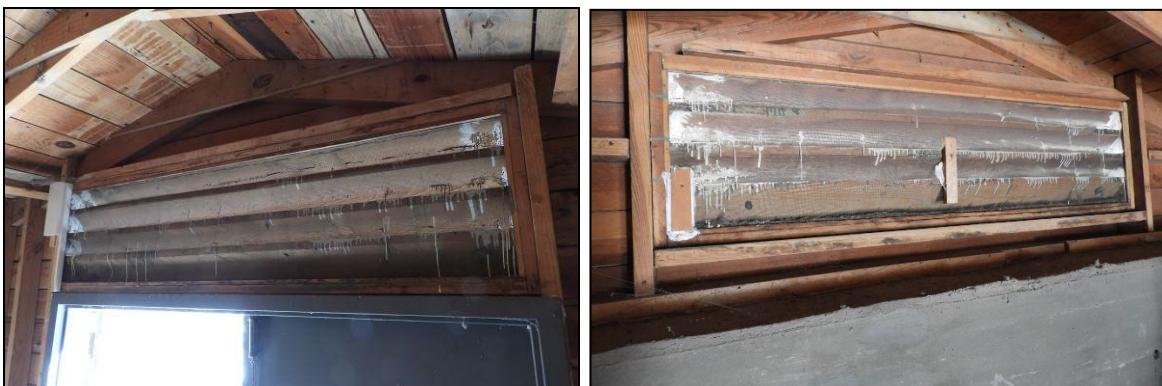
Figure 151. The metal grate over the louvered vents hides a prominent architectural feature.

Figure 152. The interior screens over the louvered vents require maintenance.

Carefully remove grates and perform any woodwork that may need to be done to the original louvers and protective screening.
