**Title:** Historic Buildings Report: Five-Year Preservation Planning for Manhattan Project National Historical Park Sites

# **Historic Buildings Report: Five-Year Preservation Planning for Manhattan Project National Historical Park Sites**

**Fiscal Years 2022 - 2026**

Historic Building Report No. 394  
Survey No. 1257

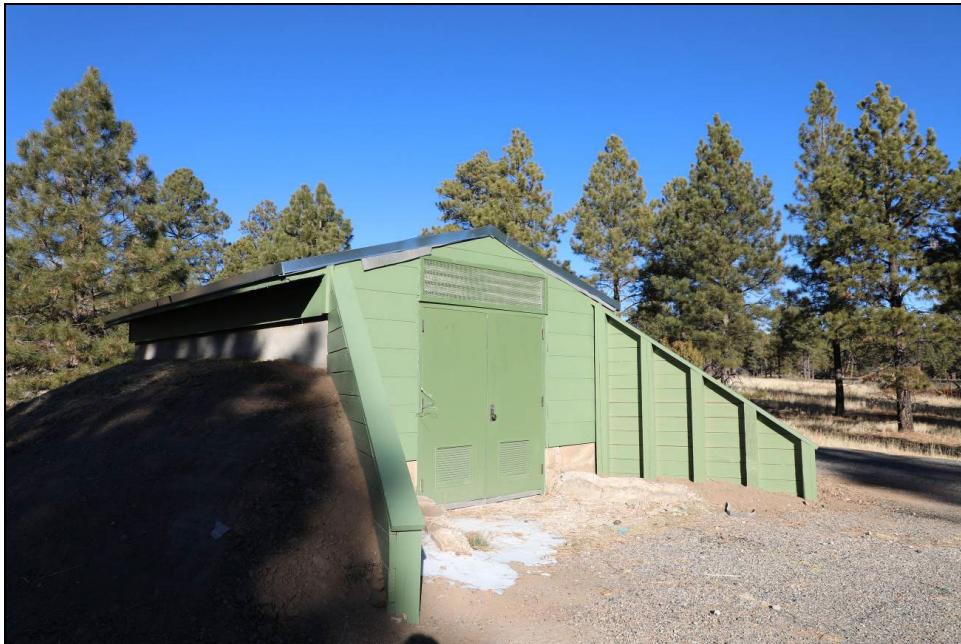
The current slope of the asphalt and concrete adjacent to the entrance doors allows moisture to pool close the base of the doors. This allows too much moisture to be near the building and risks moisture entering the building through the bottom of the doors. Much of the concrete deterioration to the entrance pad outside the double doors and the original wing wall foundations is likely attributable to this lack of positive grade and the resulting pooling of moisture.

Figure 153. Photo shows that moisture accumulates near the entrance and requires a way to drain away from the building.

The original concrete pad is likely irreparable and will need to be fully replaced following further investigation. Further investigation would include removal of the loose, deteriorated concrete on the surface to better analyze the structural stability of the underlying material. Preliminary investigations suggest that the pad is unfortunately not salvageable and that a new pad will need to be constructed.

The asphalt immediately adjacent to concrete pad should be removed to a distance consistent with keeping circular drive paved. A minor slope should be constructed leading away from the building's entrance and gravel should be laid down in its place. Asphalt accelerates sheet washing while gravel will help moisture to be soaked up by the ground during average rain fall and snow melt events.

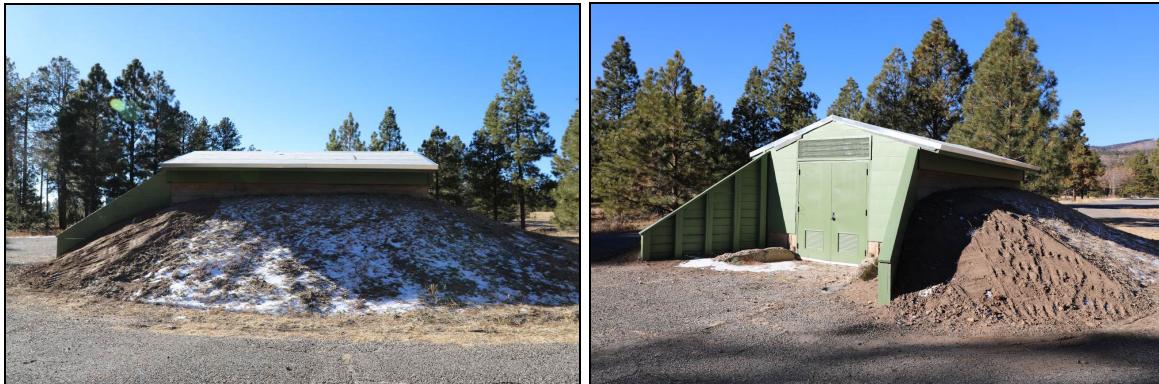
Recent work to install new wooden wing walls has placed loose soil in place of the vegetated berm around the rest of the building. The loose soil will erode away without some erosion control installed. Additionally, the vegetation around the rest of the berm is considerably sparse and could use some reinforcement to help keep erosion at minimum. The top of the berm around the building actually slopes to the building in most places. This directs water and snow melt to the building instead of away which is preferred.

*Figure 154. The berm requires new vegetation growth, especially in the front where the fill was just replaced.*

An approved matting and seeding of native grasses is preferred to help minimize erosion to the berm. A minimal amount of fill should be introduced to the top of the berm especially where the slope inclines toward the building. Reseeding should also occur to the introduced fill.

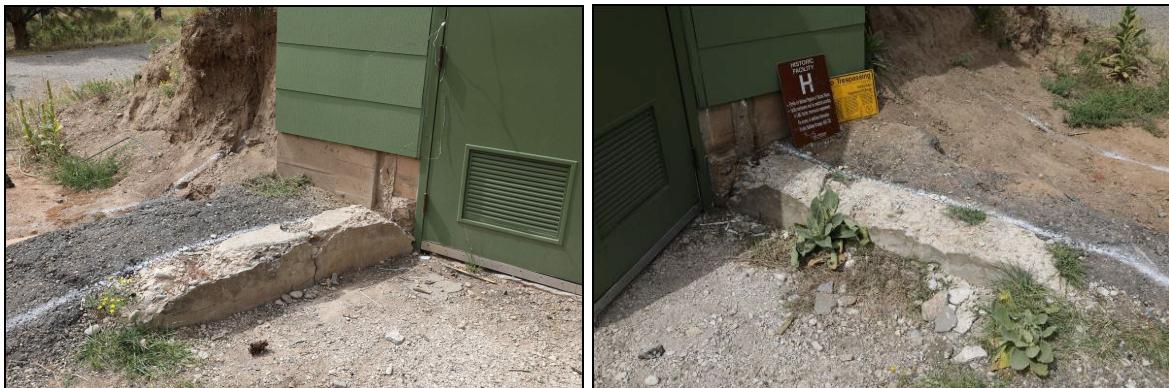
The original wing walls were closer to doors than the current wing walls. Re-establishment of the original wing wall locations will change the look of the front of the building closer to what it looked like during the Manhattan Project. The original wall foundations were constructed of concrete and are severely deteriorated. The original post holes in the foundations are still present and provide a good indicator for vertical support location.

Figure 155. The original wing wall foundations are in poor condition, but still exhibit the original post holes for the vertical support beams.

Extensive research will need to take place prior to on-the-ground work commencing. A plan for the extent of preservation versus reconstruction of the original concrete foundation will be produced once suitable mixtures have been identified. Additional documentation research will be needed to determine the construction design of the no-longer-extant wooden walls.

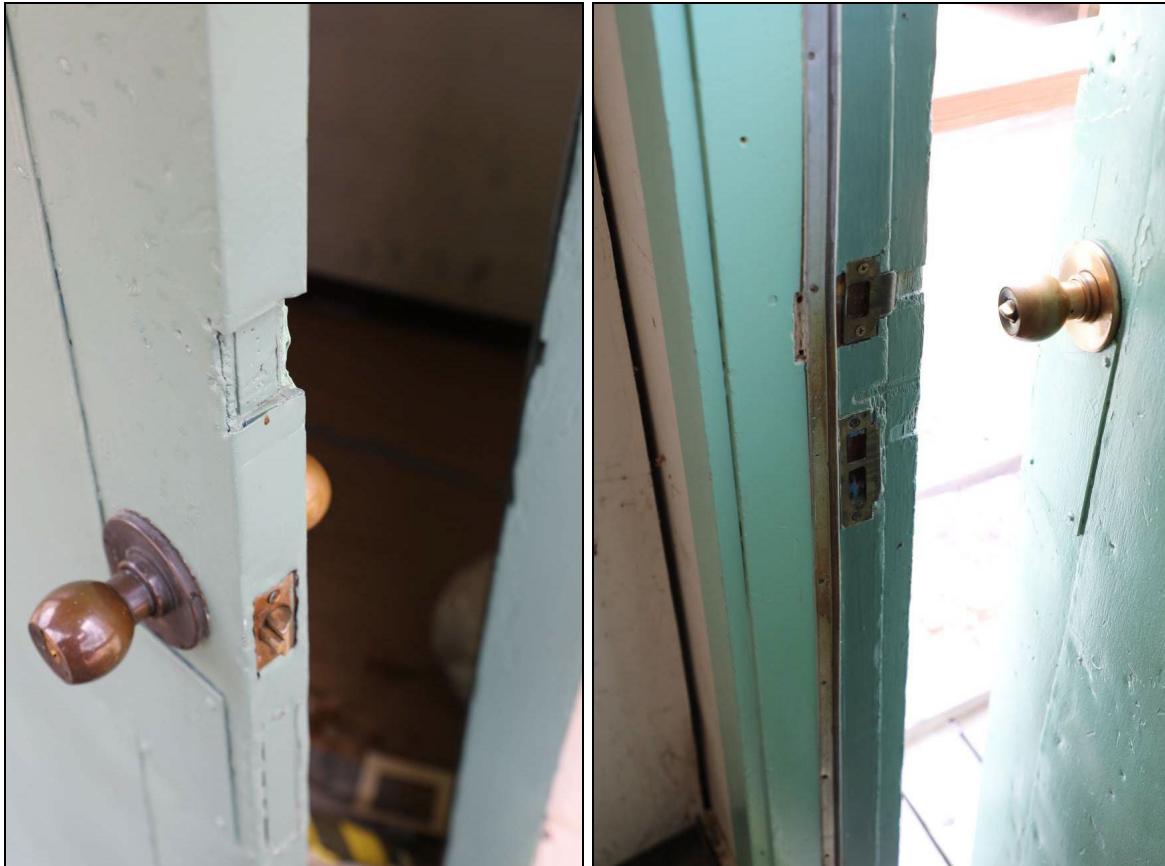
The turn handle and locking mechanism is a modern addition and is difficult to operate at times. The weather stripping and door sweep are in poor condition.

Basic maintenance should take place to the existing locking mechanism to ensure ease of operability. However, the mechanism may be replaced with a period-correct mechanism that utilizes the original locations as shown in the photos below. If this replacement occurs, Dutchman repairs will be needed to the frame and door where the existing equipment is removed, and in the original area to prep for a new system and to shore up any rotted or worn portions.

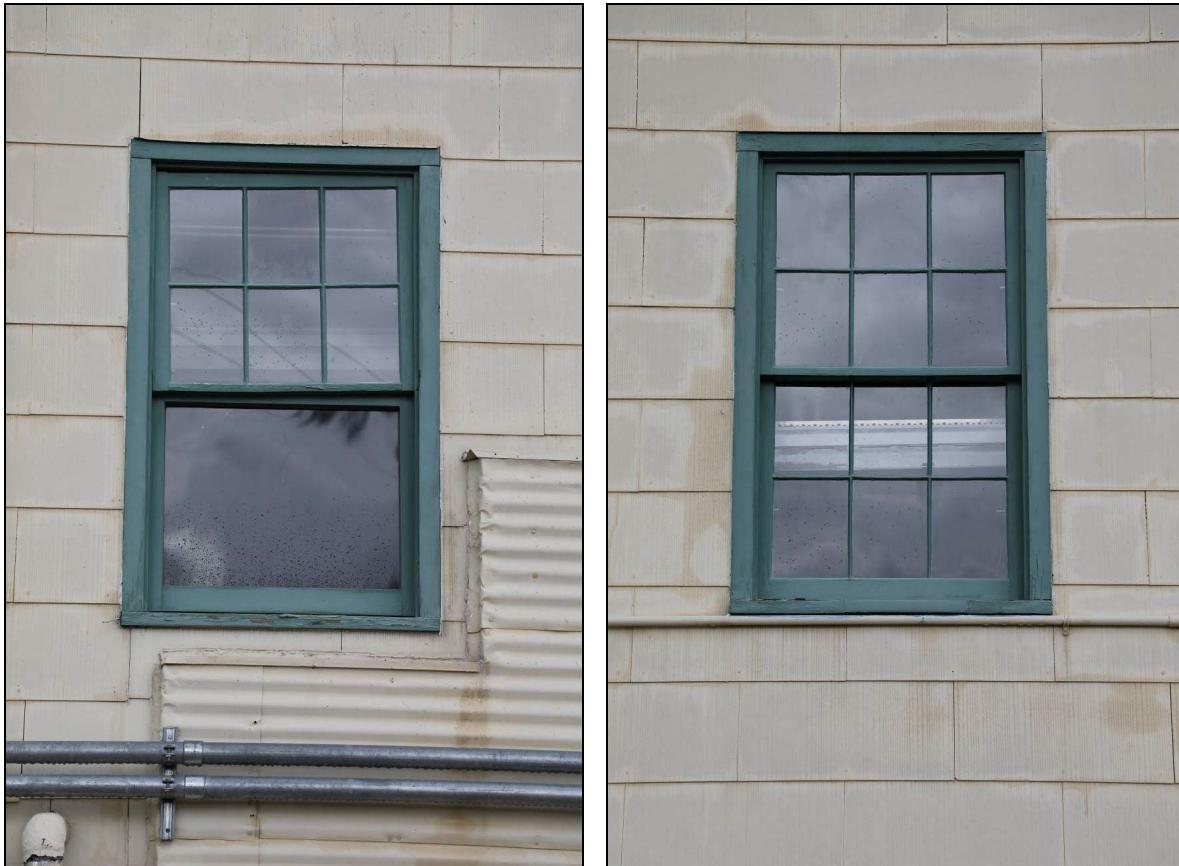
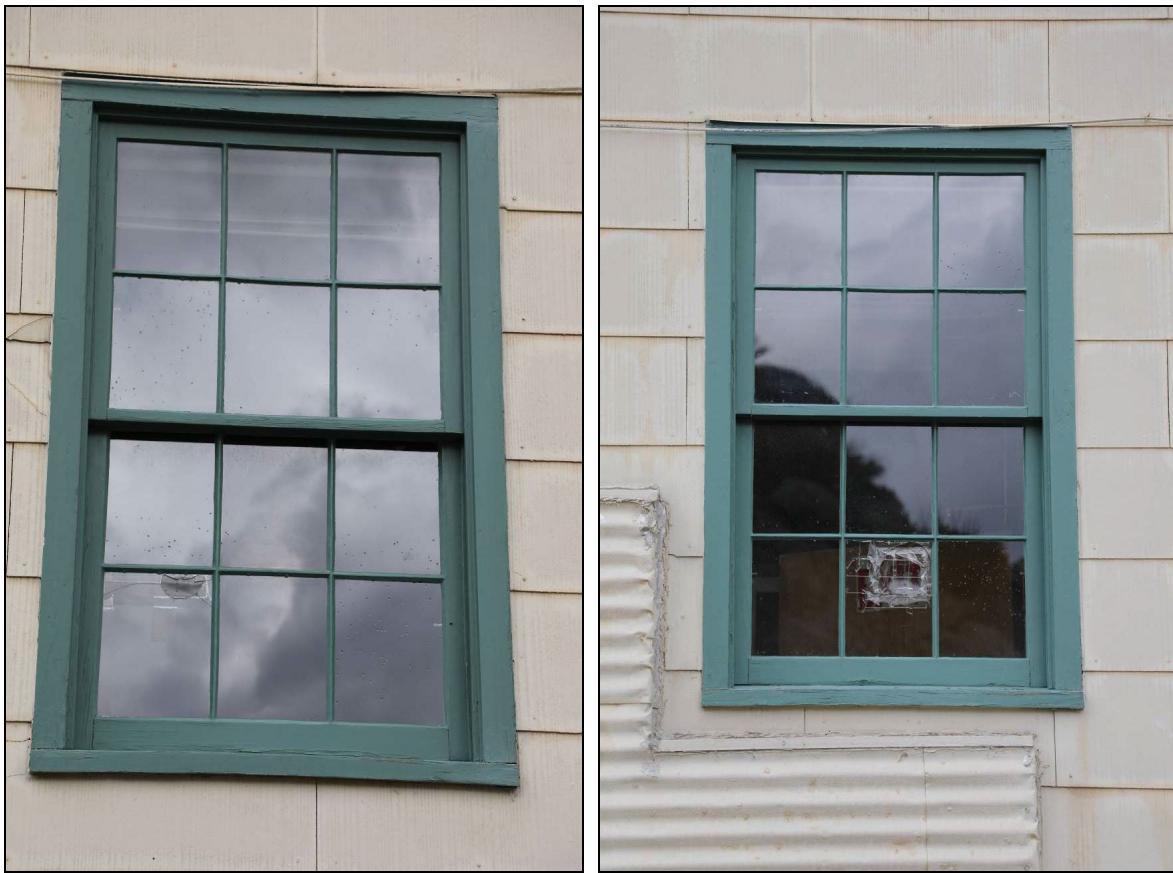
The 2018 repainting episode is beginning to fade; particularly on the east elevation which receives a greater concentration of sunlight. Paint flaking is occurring on the sills. The spring pins that hold up the upper sashes should be maintained. Two of the pins show signs of failure. Two glass panes are broken and the bottom sash of one window opening is missing.

Repainting of the sashes and frames should occur with the same color as used previously. The two failing spring pins should be repaired or replaced if repair is deemed unachievable, and the others checked for routine maintenance to maintain proper operability. The missing bottom sash (Figure 157) should be reconstructed to exact specifications as shown on original drawings or from using another sash as an example.

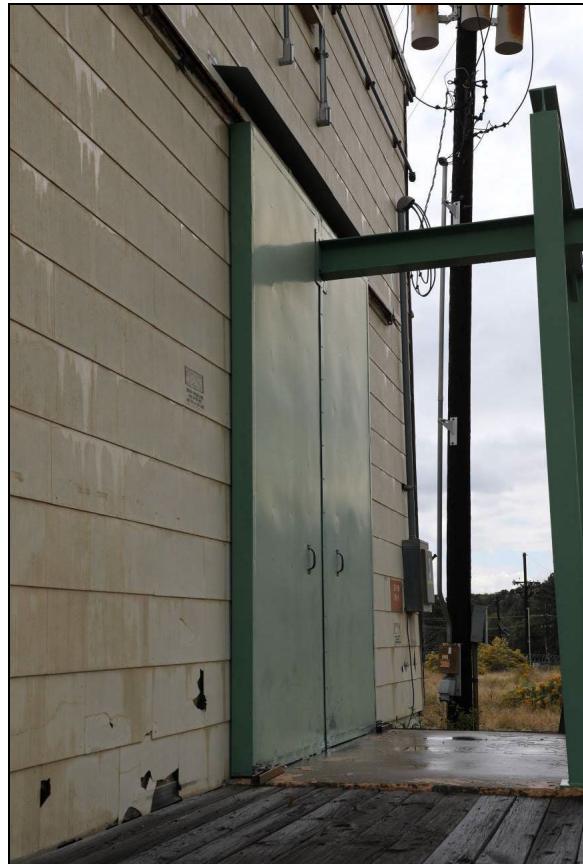
Figure 162. The large bay doors after a rain. Water was noticed to be leaking into the building from the top of the doors.

Readjustment of the existing drip edge is likely required; however the drip edge may not extend far enough out and may need to be reconstructed.

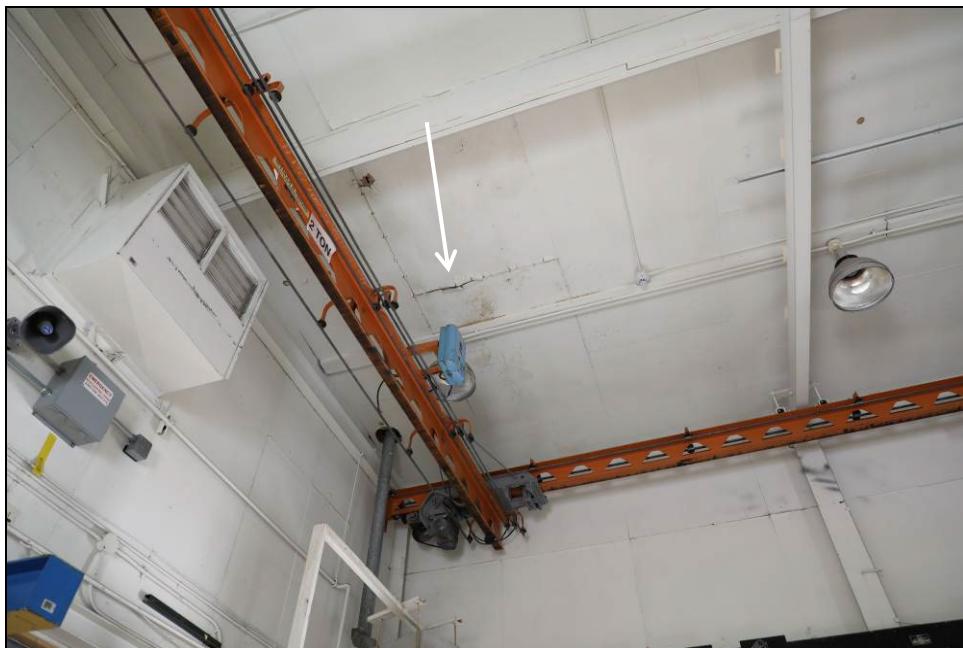
Plywood sheathing exhibits damage from a previous roof leak in four separate identified areas.

*Figure 163. Damage from a previous roof leak in the southwest corner of the building.*

Replacement of the plywood pieces should be undertaken. The entire piece should be removed instead of only cutting out the damaged area. An exact plywood cut should be inserted and painted to match the surrounding area.

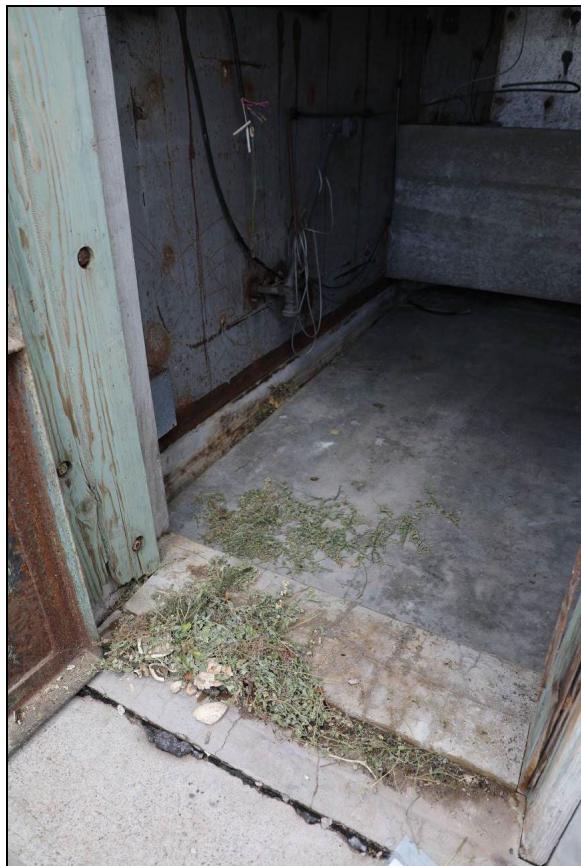
*Figure 167. Recently accumulated packrat nesting material near the entrance door.*

Routine cleaning will help prevent excessive accumulation of debris inside the building and sealing up entry points to the interior of the building, particularly around the door, will help prevent further incursions.

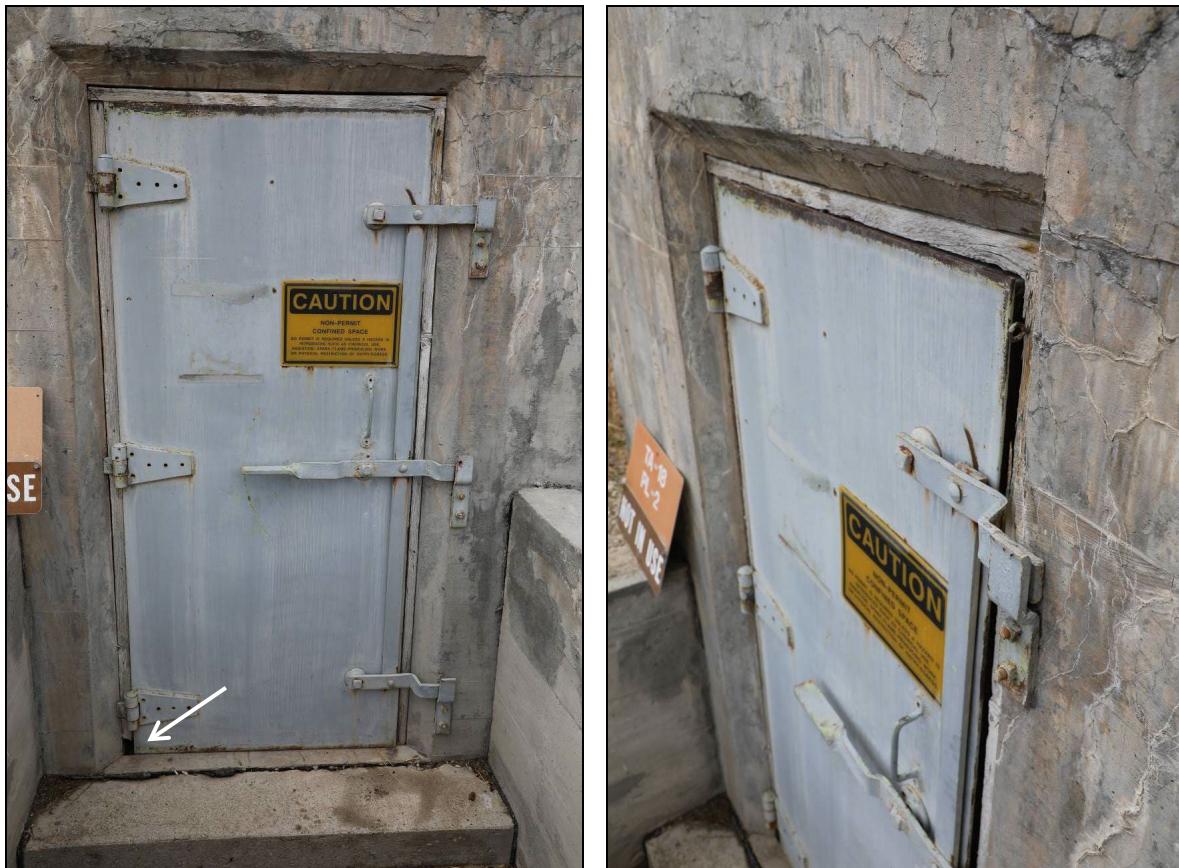
The wooden door frame exhibits deterioration from maintenance neglect and weathering. The seal to the door is no longer complete which allows access by pests. A larger hole is present at the base of the frame just under the bottom hinge.

Figure 168. Photos showing the condition of the entrance door frame.

A Dutchman repair should be made to the larger hole at the base of the frame to retain as much of the original frame as possible and the wood should be painted. Carpentry work around the edges may be needed in the interior if rodent activity persists after the initial Dutchman repair is complete.

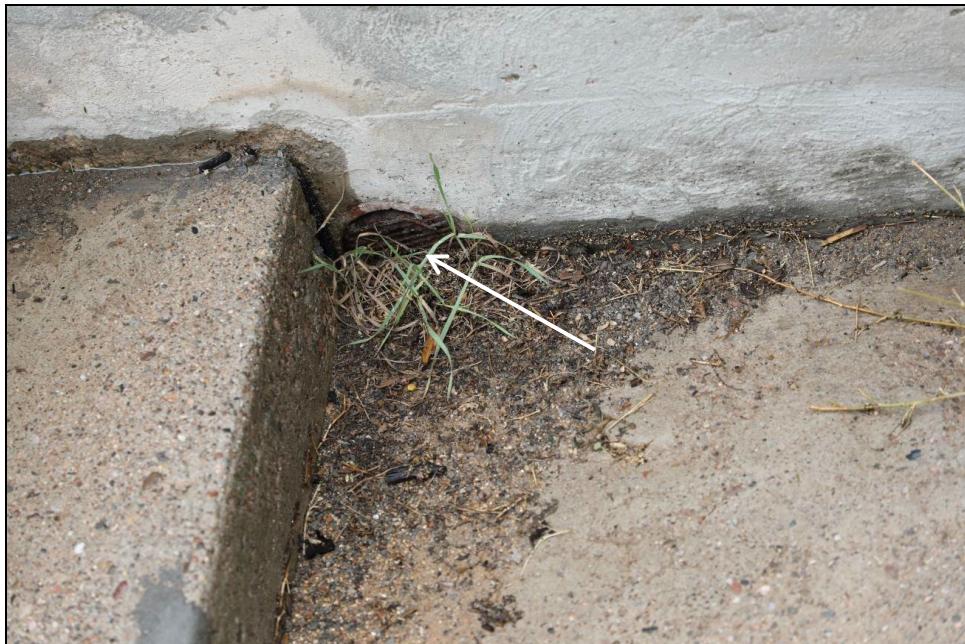
*Figure 170. Close-up view of the drain.*

Routine cleaning should occur to keep the drain operable.

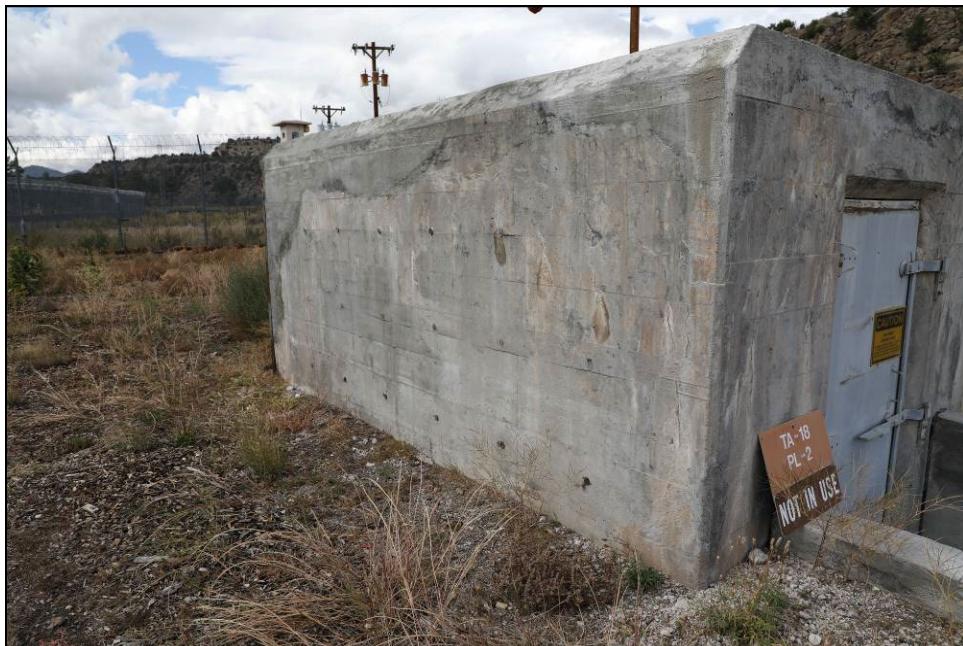
Soil moisture currently collects against the underground portion of the building. The other battleship bunker (18-0005) shows evidence of moisture seeping in through the concrete underground. While there is no evidence of this happening to this building, preventive maintenance should be considered.

*Figure 171. View of the ground surface up against the bunker.*

The installation of a French drain around the structure will help prevent damage that is occurring at the other battleship bunker. This work should be done in conjunction with 18-0005 to save time and money. Additionally, archeological monitoring will be required for the type of excavation that will be required to install a French drain system.

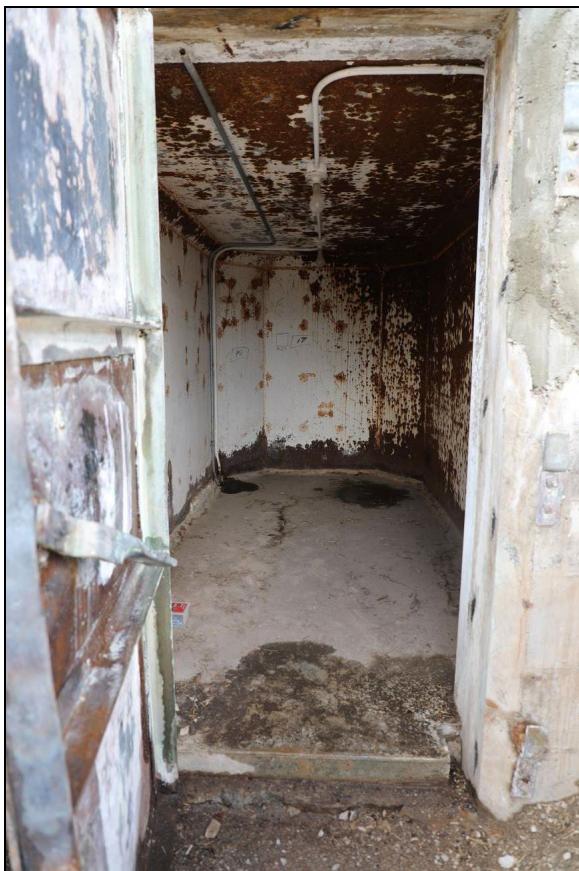
*Figure 173. Rodent droppings accumulate on the floor the building.*

Routine cleaning will help to keep rodent debris at minimal level. Further adjustment to the fit of the frame and the door may be required.

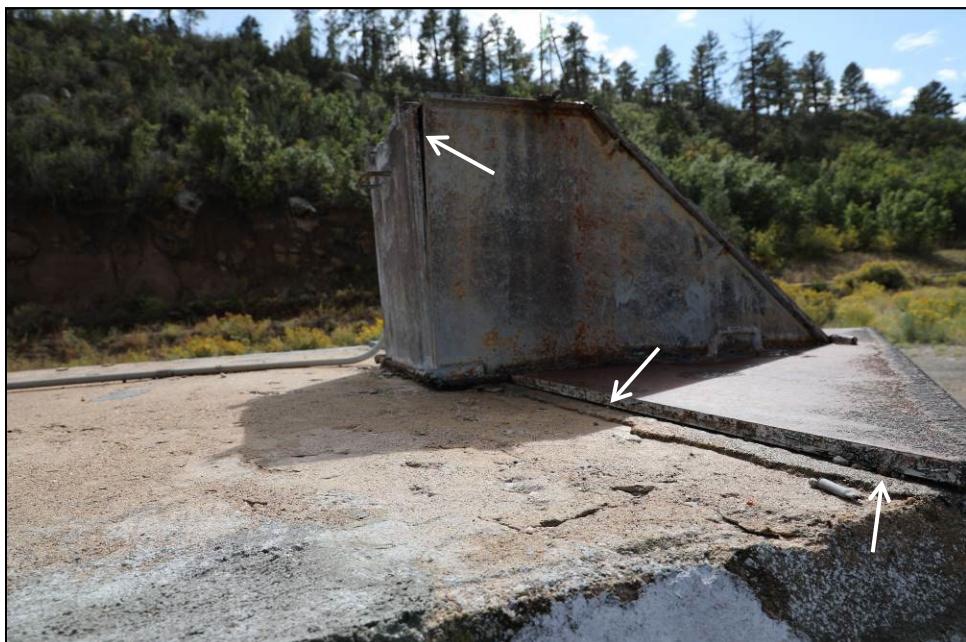
Roof leaks have been identified along the seams of the metal and the concrete towards the front of the structure (west elevation). The door to the metal box on top of the structure is slightly open and allows water to enter the inside of the box. Water has also been noted to pool on the southeast portion of the roof (Figure 173). No leaks, however, have been noted with this area though.

Figure 174. Photograph shows the areas where leaks have been identified.

An easily removable silicon seal can be applied temporarily along the metal-concrete seams. A long-term solution will likely require an approved concrete mix to be applied at the junction that does not allow moisture to pool at the seams.

The pooling in the southeast corner will require an approved concrete mix that builds up the area and effectively sheds to the edge.

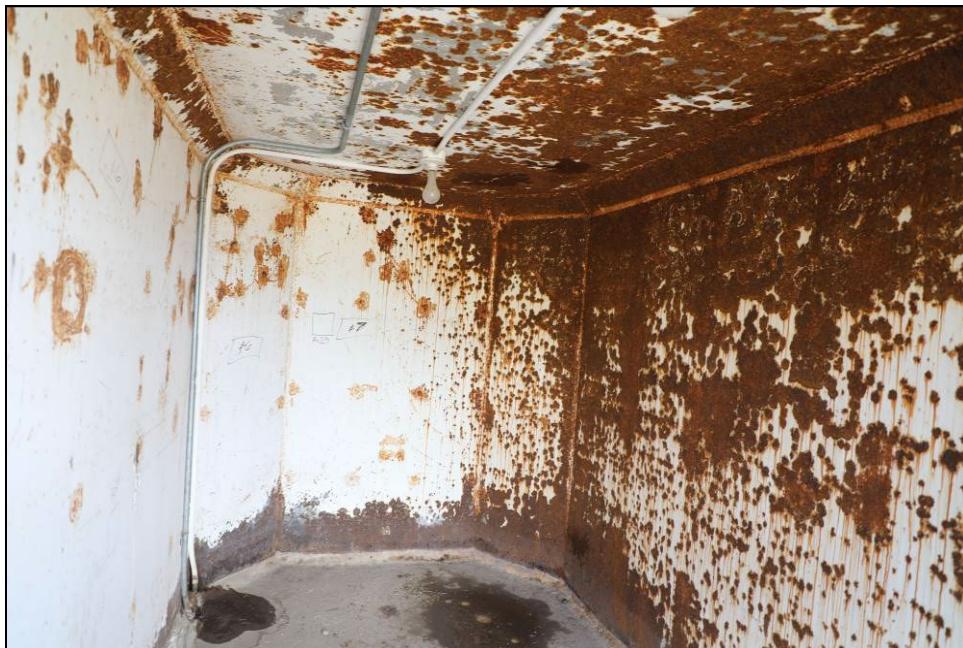
Figure 176. Rust is prevalent throughout the interior.

Further research should be conducted prior to work commencing that addresses the rust issue. An appropriate rust inhibitor will be needed prior to painting the interior. Covering up the problem will not solve it, and may even make it worse. The origin of the oxidation issue must be determined first – either something on the inside is producing the rust or moisture is coming in from the outside. Repainting may need to be held off until an appropriate rust inhibitor is selected and tested for a duration of time.

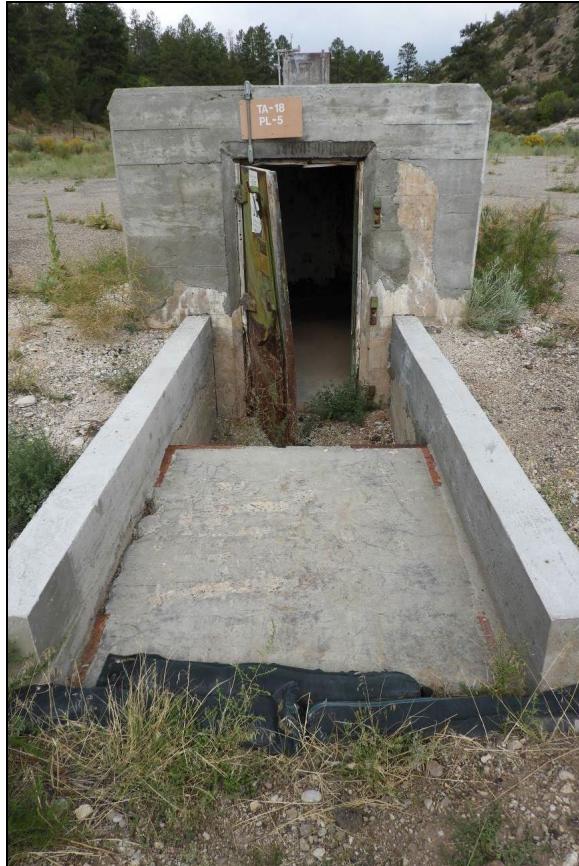
The stairs that once led to the door are no longer present. In place of the stairs is a formed concrete block. The distance of the drop from the concrete block or the adjacent side walls presents a safety hazard for personnel entering the building. The block is just resting in the old stairwell and does not seem to be tied in to the structure.

*Figure 177. The block is in-place of stairs and should be removed.*

While the concrete block does not appear to be tied in to anything, removal of the block should be done in a careful and deliberate manner to ensure that the original elements of the structure are not damaged. Once the block has been removed, stairs replicating the dimensions of the originals should be reconstructed.

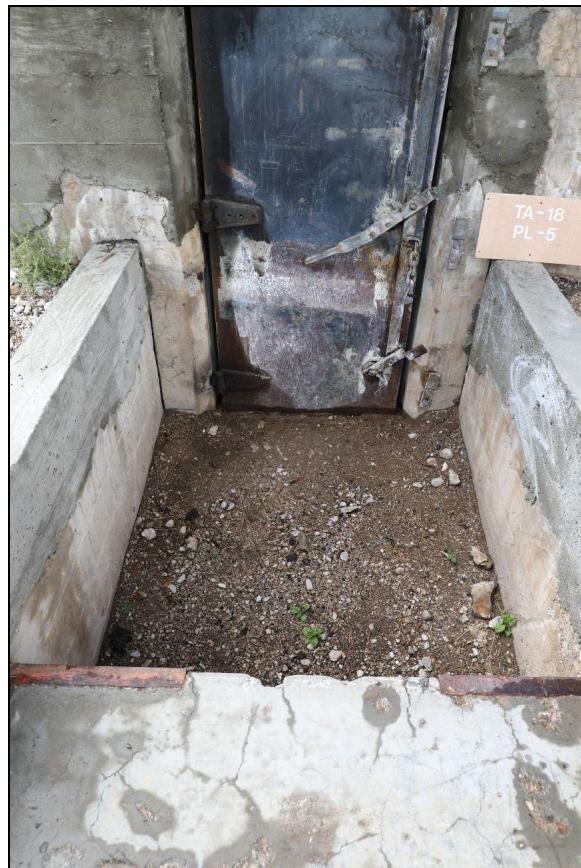
*Figure 178. Water has no way out of the stairwell.*

Debris should be shoveled out of the bottom of the stairwell and the drain cleared. Care should be taken to contour the bottom of the stairwell toward the drain and away from the door.

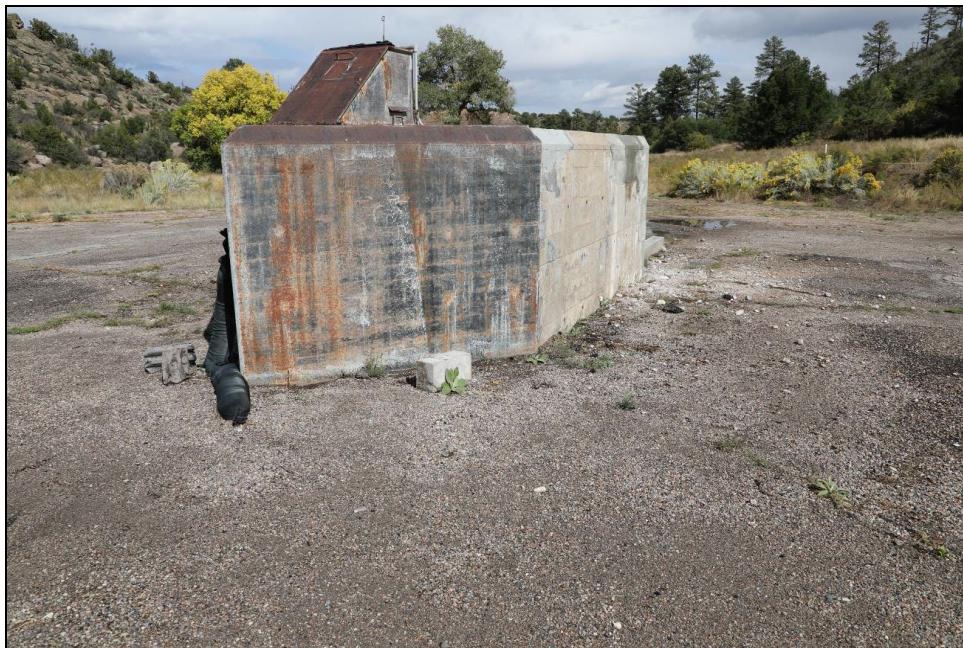
Asphalt currently surrounds each side of the structure. Some areas drain directly to the building and any moisture that gets trapped under the asphalt has a much more difficult time evaporating out of the soil. Water during rain events seeps its way into the building from underground and collects on the floor.

*Figure 179. Photograph showing the asphalt that runs right up against the building.*

The asphalt around the building should be removed. This will prevent sheet washing in the direction of the building and dramatically help to allow moisture to drain down and away. A gravel surface will offer a good replacement option to help with drainage of moisture and control muddy areas during rain and snow events. A French drain system around the building should also be installed to help with the side wall leaking that has been noted.

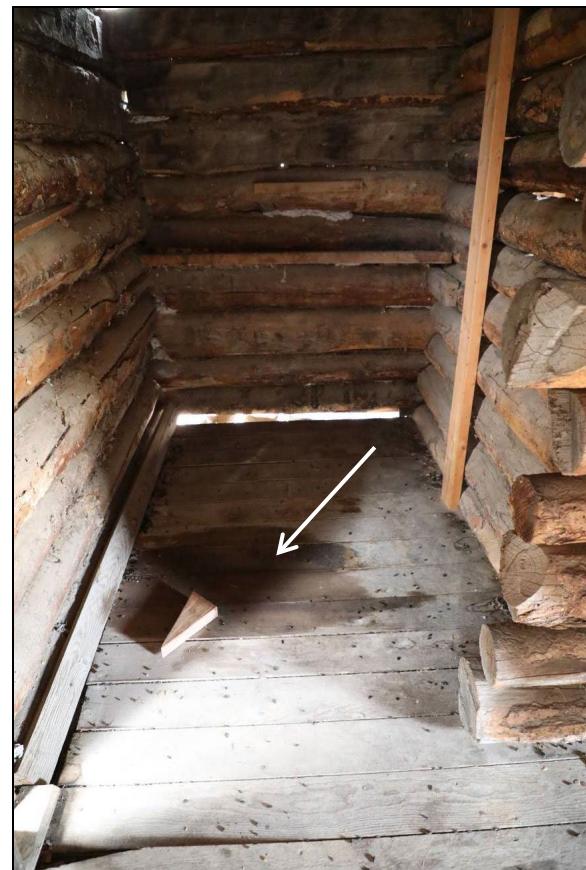
The roof leaks during rain events at a point somewhere near the southeast quadrant. Water from the leak collects on the floor near the east entrance door. Each rain or snow melt event will cause accelerated deterioration of the wooden floor as well as roof elements where the water is penetrating through.

Figure 181. Arrow points to evidence of an active roof leak.

A plan for a full roof repair should be developed and implemented. The existing corrugated metal should be retained along with the original plank decking. Appropriate materials such as marine grade plywood, additional planks, and roofing paper should be considered to upgrade the roof system between the metal and the original planks.

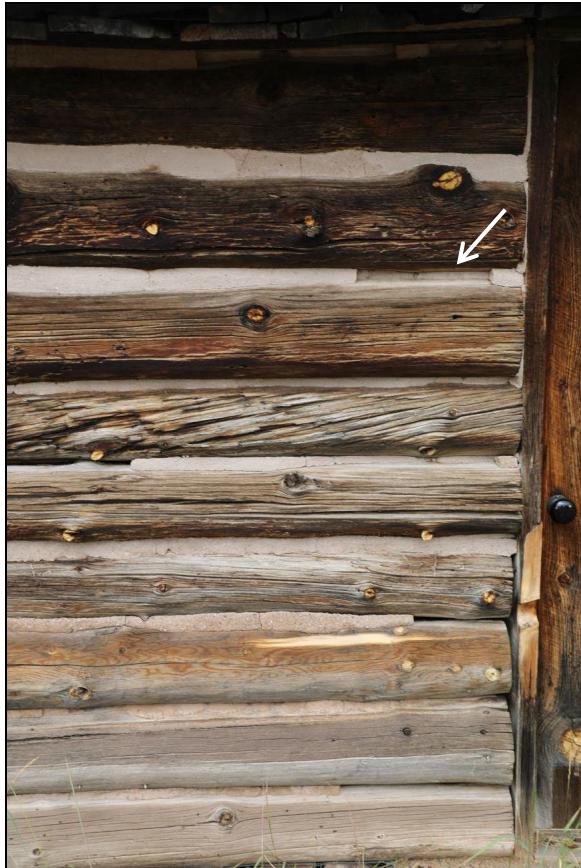
Redaubing of the log joints occurred in 2017. The work was expected to last five to seven years with minor repairs taking place every year or two. Voids are forming in the repair daubing which provides an avenue for pests and weather to enter the building.

Figure 183. Arrow points to missing daubing.

A temporary solution would be to perform patchwork with a lime-based earthen mortar that resembles the existing daubing in color and texture. Eventually, the existing daubing should be raked entirely and replaced on the interior and exterior.

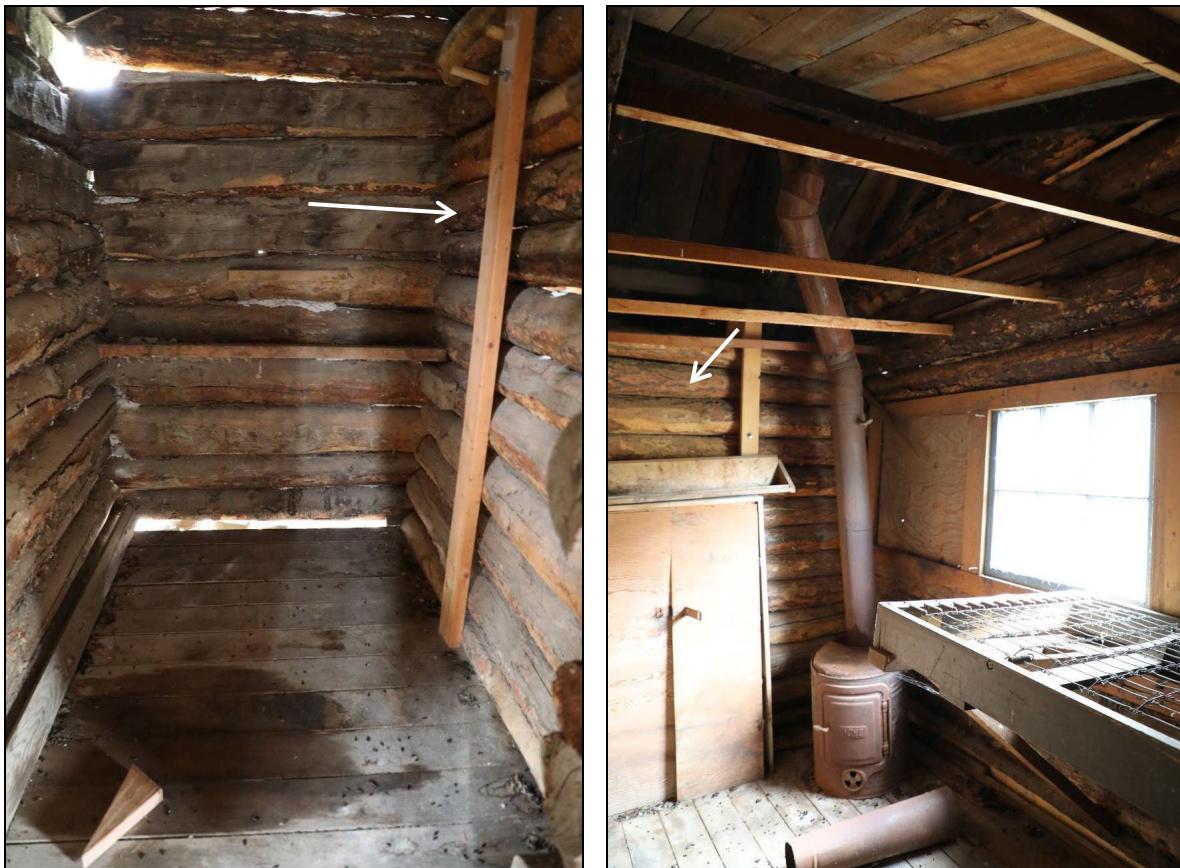
*Figure 185. Arrows point out the interior log wall.*

Bracing should be removed and logs should be pinned together at strategic locations using wood or fiberglass rods. An effort should also be made to tie in the log ends to the main structural walls of the cabin.

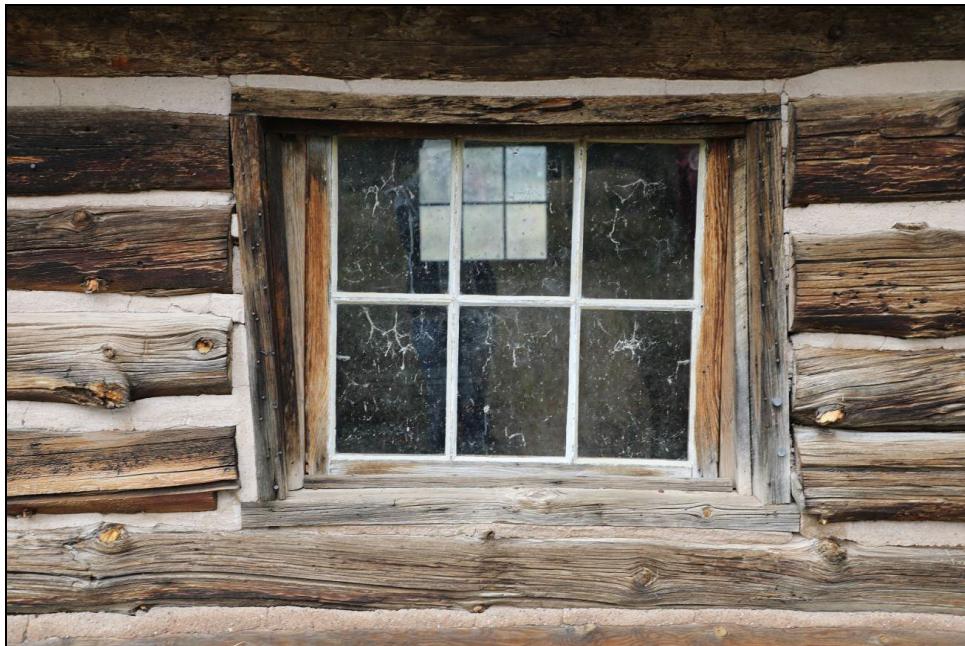
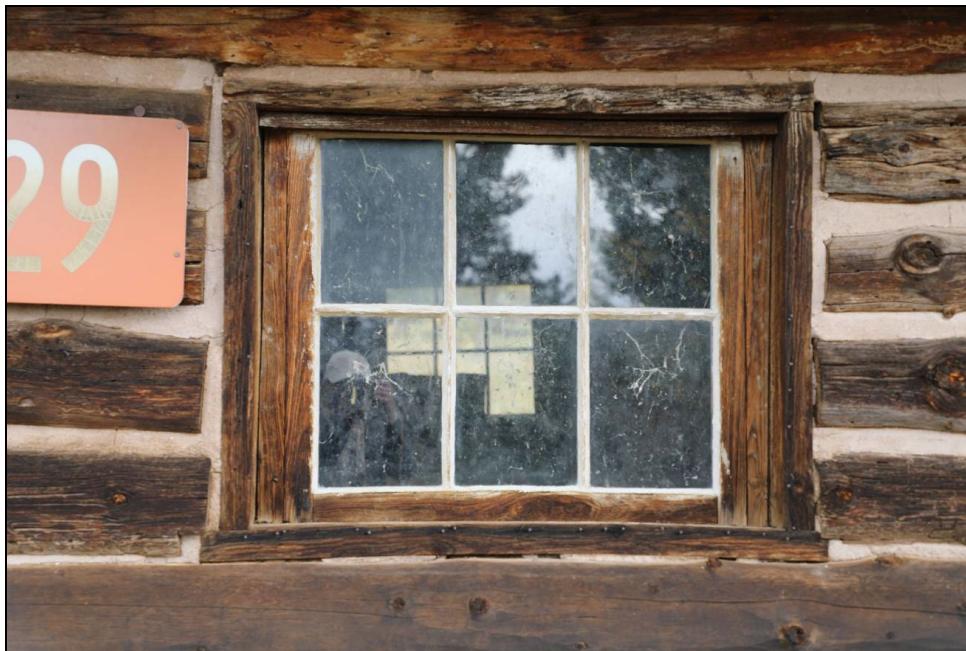
*Figure 186. The glass panes are dirty and full of spider webbing.*

Figure 187. Dirty glass present on the Pond Cabin windows.

Glass panes can be cleaned with a mild glass cleaner and light wiping.

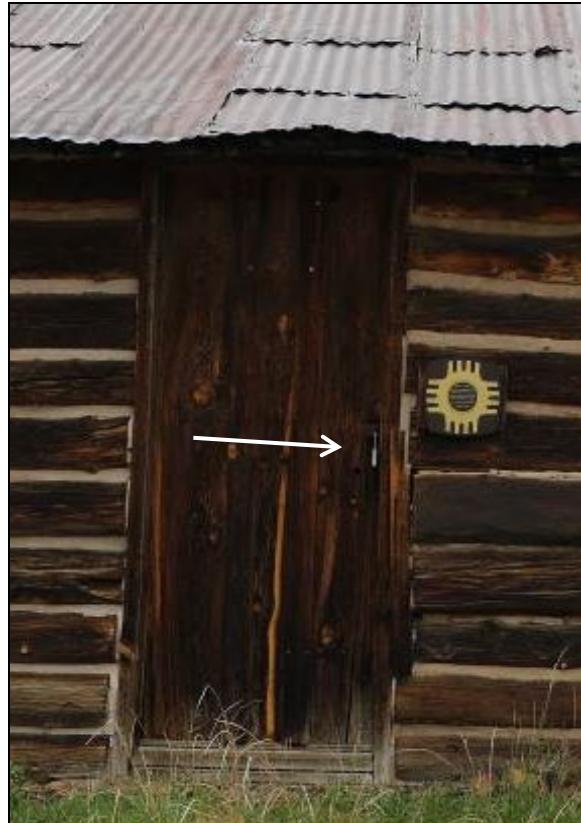
Figure 189. Arrow points to the current latching and locking device which is not sufficient...

A replica door knob and lock system similar to the one on the opposite door should be installed. The hardware on the other door is consistent with the knob that would have originally been on both doors. This treatment will give a more authentic look to the door and provide a better closure.

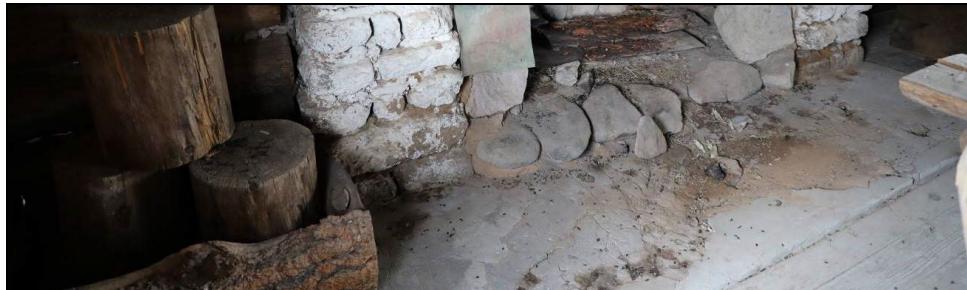
The hearth in front of the fireplace is experiencing moderate deterioration. Cracks have formed and pieces have broken away.

*Figure 192. Photograph shows the current condition of the hearth.*

An appropriate mortar mix must be selected that is relatively soft compared with original mix. A sacrificial parging is appropriate in this situation to approve the aesthetics, but to also protect the original material as gently as possible.

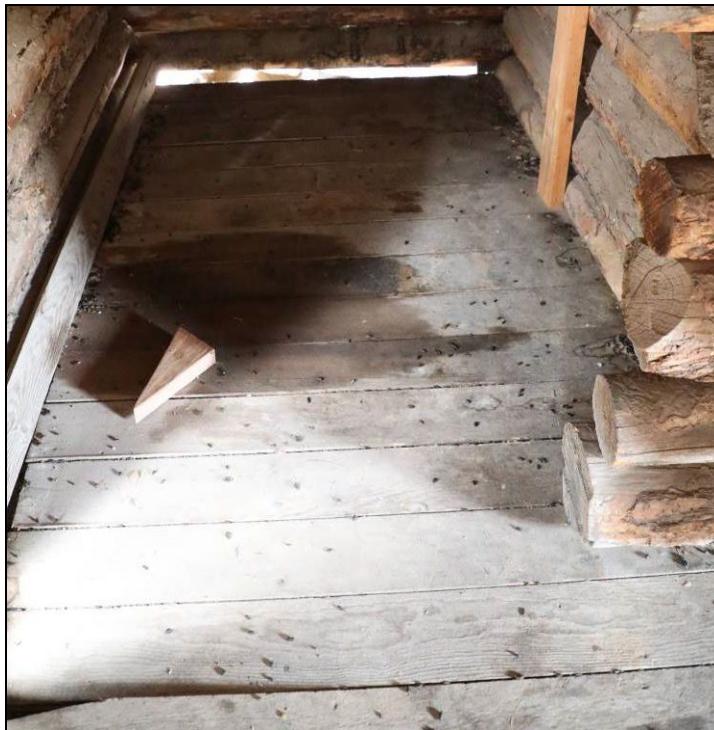
Figure 193. Photograph shows rodent droppings scattered across the floor.

Continued routine mitigation will help with the preservation of the building until a better seal for the entire building can be attained.

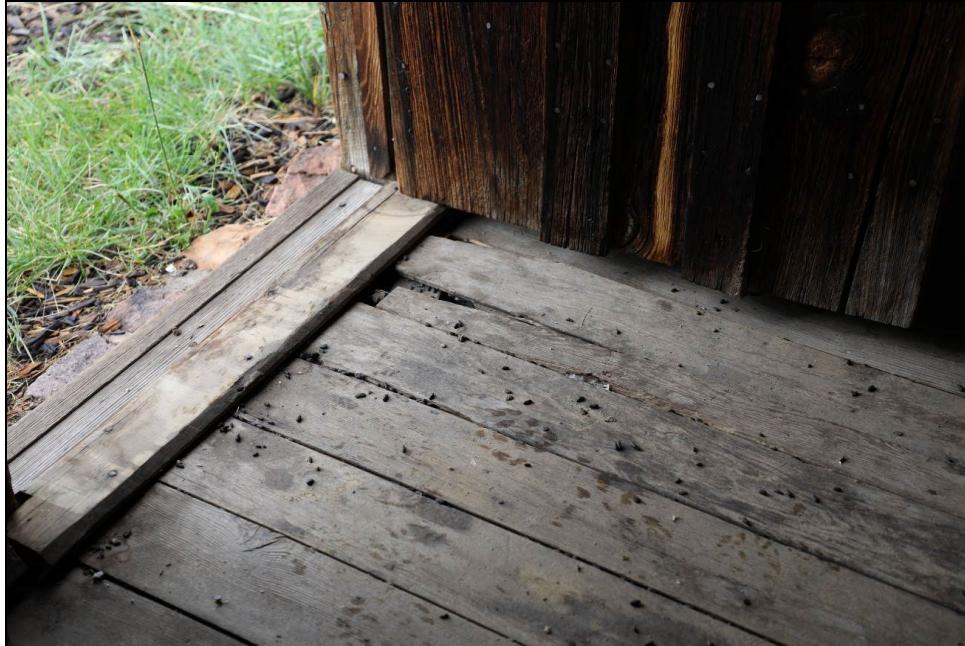
The floor needs significant repair in a few areas and especially along the edges. Rodents and other pests are allowed access through these areas that also provide a tripping hazard for individuals in the building.

*Figure 194. Photograph illustrates a typical section of flooring in need of repair.*

The floor may require lifting up in some areas to rejoin the floor slats with the underlying support system that was installed during a 1987 National Park Service treatment project.

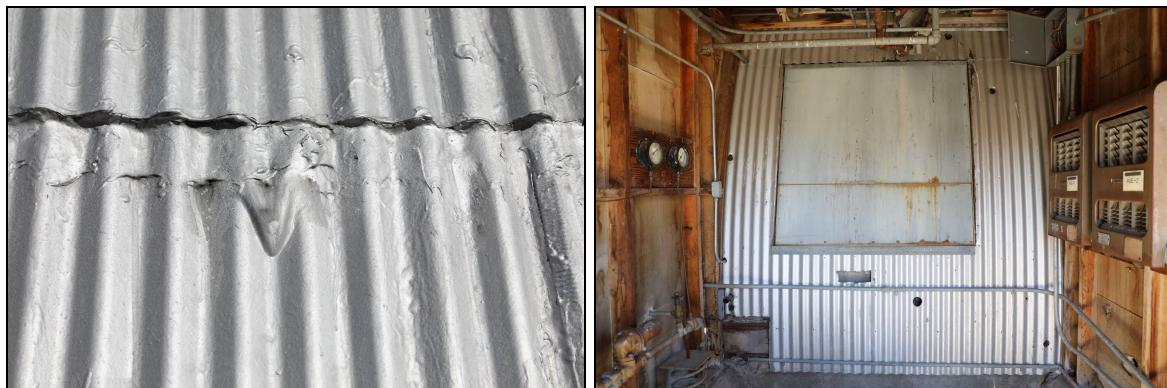
The aluminizer application currently on the outer shell of the Quonset Hut was applied in 2017 after leaks had formed and were wrecking havoc on the interior. The application serves its purpose and stopped the leaks, however, the goopy nature of the application is not attractive. Additionally, the sheen is too much and draws the eye in a negative sense.

Figure 197. The photo on the left gives an example of the state of the top coat, while the photo on the right shows an original finish section that will help with researching the correct application.

Removal of at least the top application is recommended prior applying a new material that will protect the building while providing a pleasing aesthetic quality. Abundant research will be required to select the correct material and protective measures will need to be taken during the removal process as underlying layers probably contain lead. Removal of the top coat should be completed using a chemical paint stripper in order to better contain any possible lead. Penetrations should be minimized and removed where possible, and patches should be determined to be either corrugated metal or some form of composite material.

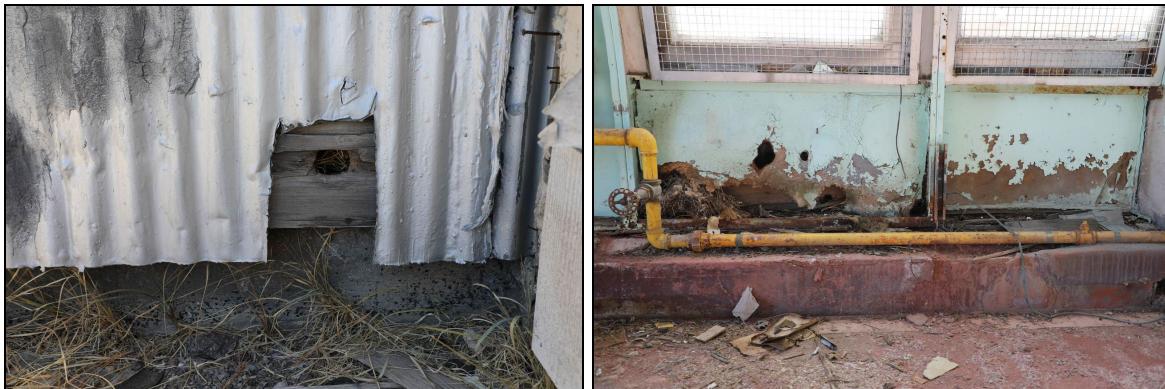
There are numerous holes (more than can be counted) that provide access between the exterior and the interior. The vast majority occur along the bottom portions of the building. Some represent old utility holes, while some are just from maintenance neglect and general structural deterioration.

*Figure 198. Just two examples of the types of holes found throughout the building.*

A temporary would be to patch the holes with copper wool packed tight in each one. Long term solution will vary per instance, but would generally involve a tedious patch with the same material that surrounds the hole.

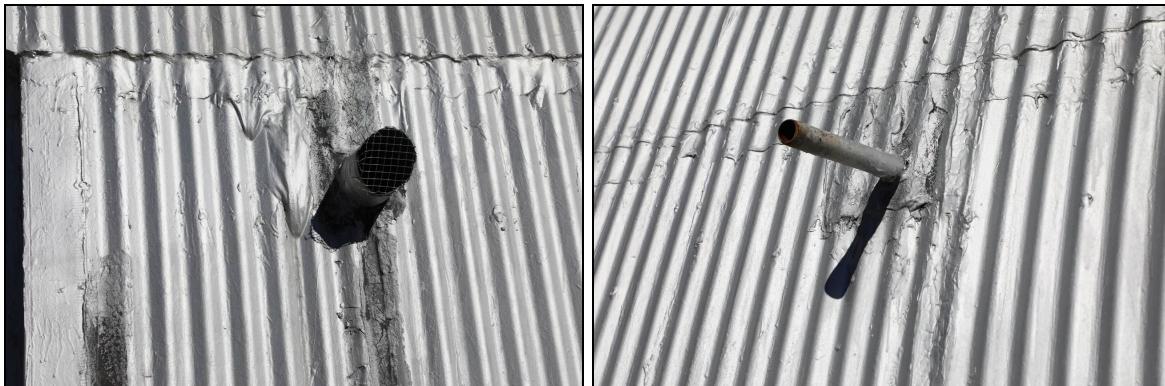
*Figure 199. Photo shows two examples of pipe ends needing new screen.*

Quarter-inch screen should be securely attached to the exterior opening of all exposed pipe ends.
