**Title:** Historic Buildings Report: Five-Year Preservation Planning for Manhattan Project National Historical Park Sites

# **Historic Buildings Report: Five-Year Preservation Planning for Manhattan Project National Historical Park Sites**

**Fiscal Years 2022 - 2026**

Historic Building Report No. 394  
Survey No. 1257

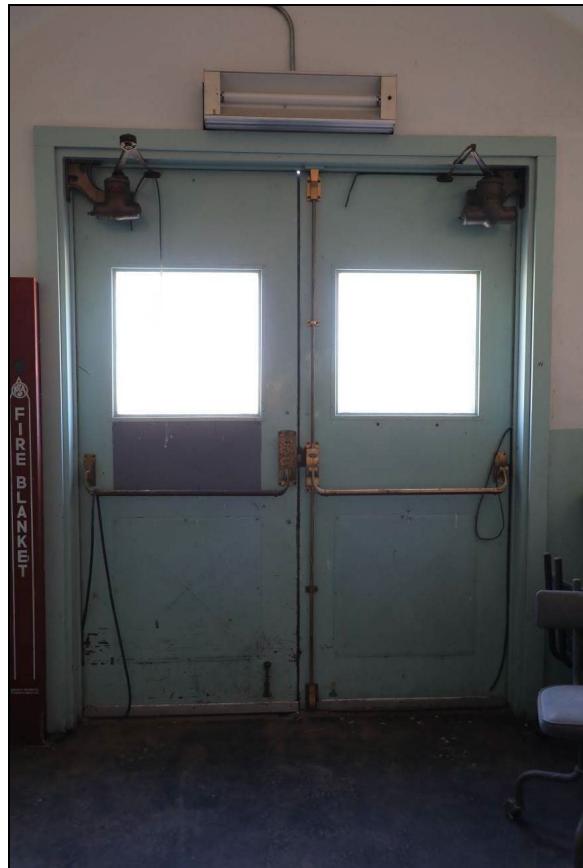
*Figure 200. Example of a door opening with some problems - repainting is needed, weather stripping is sagging, and the operability is problematic.*

Paint colors should be selected based upon historic buildings staff recommendations for each door. Door sweeps can be installed where needed. Operability will need to be dealt with on a case by case basis.

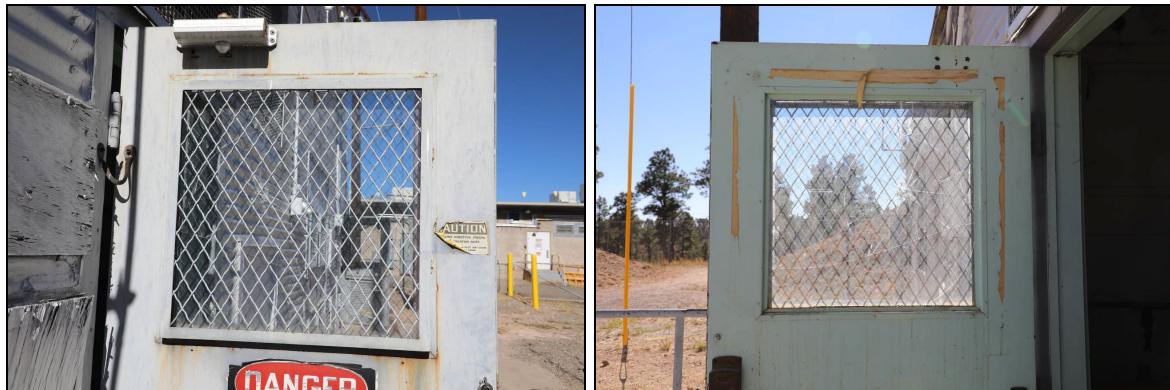
Figure 201. Photograph showing the shattered glass in the east elevation door.

Replace the shattered glass. Care will need to be taken since this is a metal-clad door with blast-prevention caging over the pane.

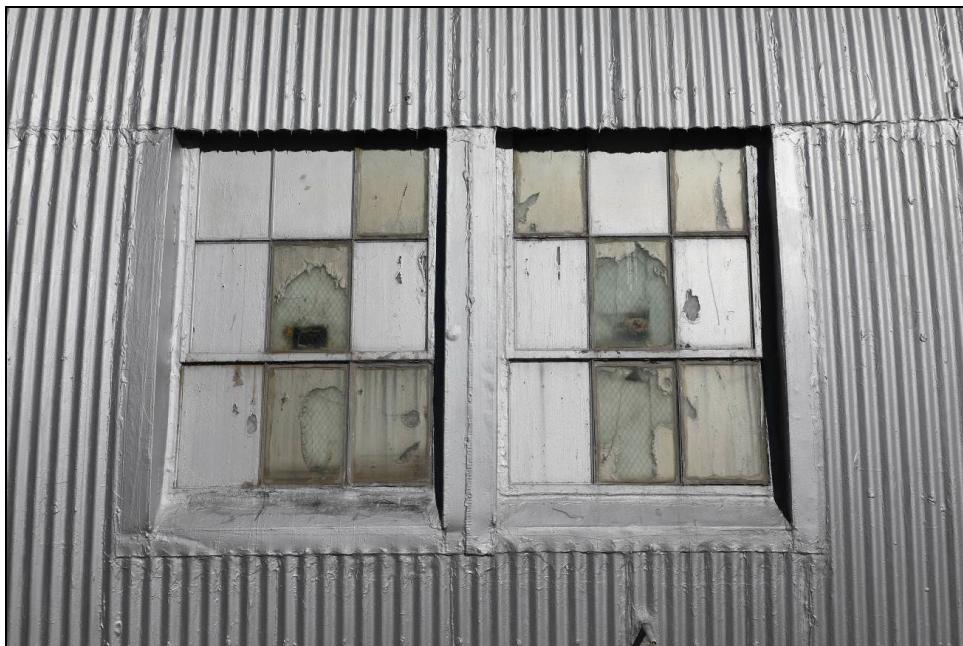
All metal window openings require extensive work. Glass panes require intensive cleaning and in some cases removal and replacement with a historically accurate pane. Panes and frames have been aluminized over.

*Figure 202. An example of metal windows requiring preservation work.*

A metal window specialist will be required to develop a detailed preservation maintenance plan.

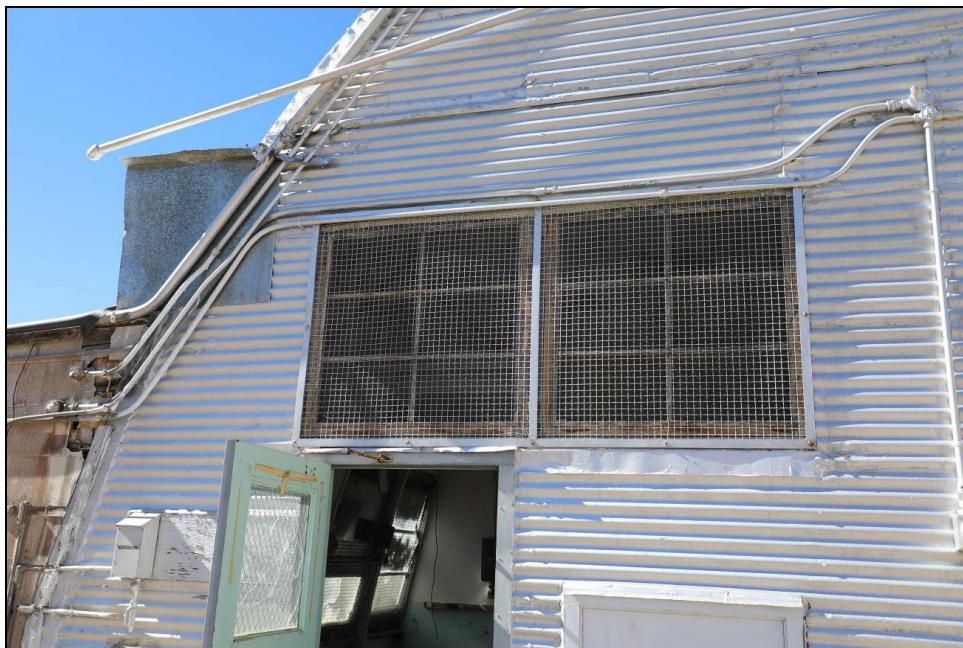
*Figure 203. The window opening above consists of only screen material.*

Screen requires a repair to prevent pests from accessing the interior of the building. Additional research is required to determine the appropriateness of fabricating and installing window sashes with the correct number of lites per sash.

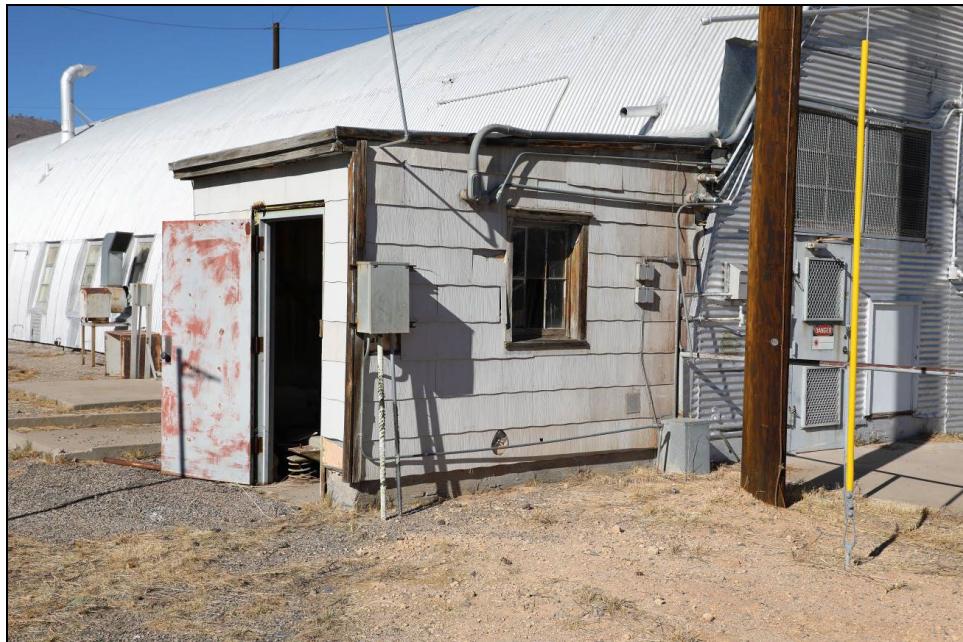
The eaves around the utility annex are severely weathered and deteriorating. Painting does not look to have occurred in many years.

*Figure 205. The eaves above the door can be seen here as weathered and lacking paint.*

Replace the eaves with new wood cut the exact specification required to replicate the original. Paint should be an approved color.

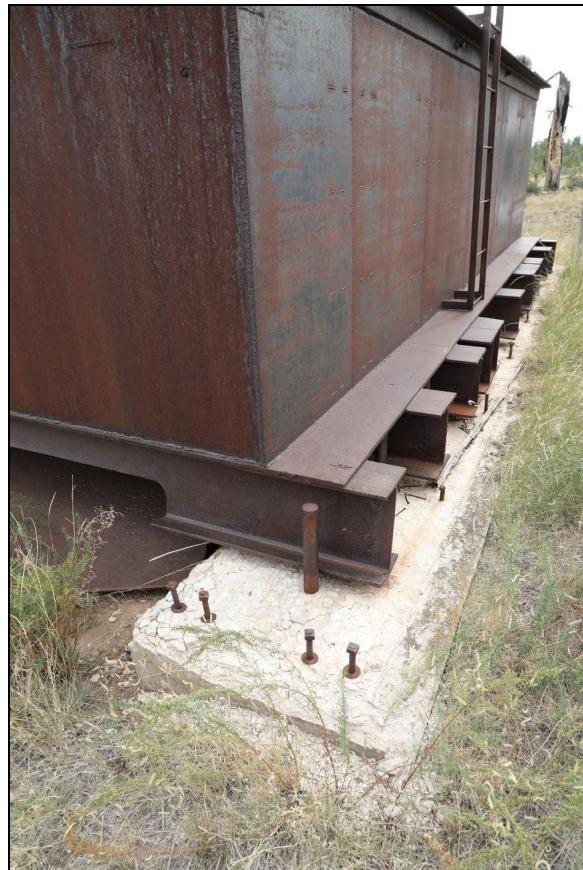
The concrete foundation is crumbling to much the same effect as all the other Manhattan Project concrete structures. Corners and edges are particularly bad.

*Figure 209. The concrete foundation is in poor condition - especially near the corners and edges.*

Significant research is needed to come up with a solution. Reconstruction is not recommended in this particular instance; however, putting a stop to active deterioration of the concrete should be strived for.

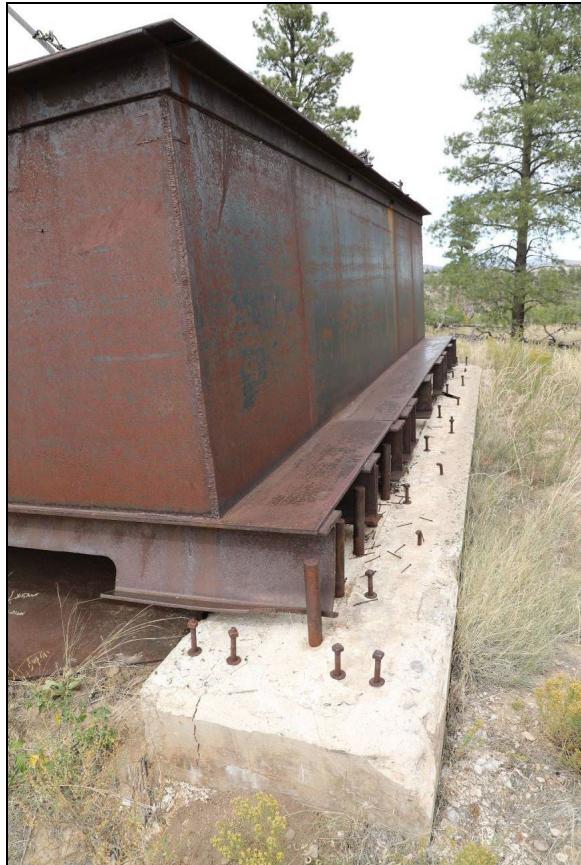
Exposed rebar and anchor bolts have oxidized and consequently affect the structural stability of the concrete foundation.

*Figure 210. Oxidized metal that enters the interior of concrete often times has a detrimental effect on the preservation of the concrete.*

A treatment solution will need to be developed to halt corrosion. There are several techniques available, however, further research and consultation with subject matter experts is warranted.

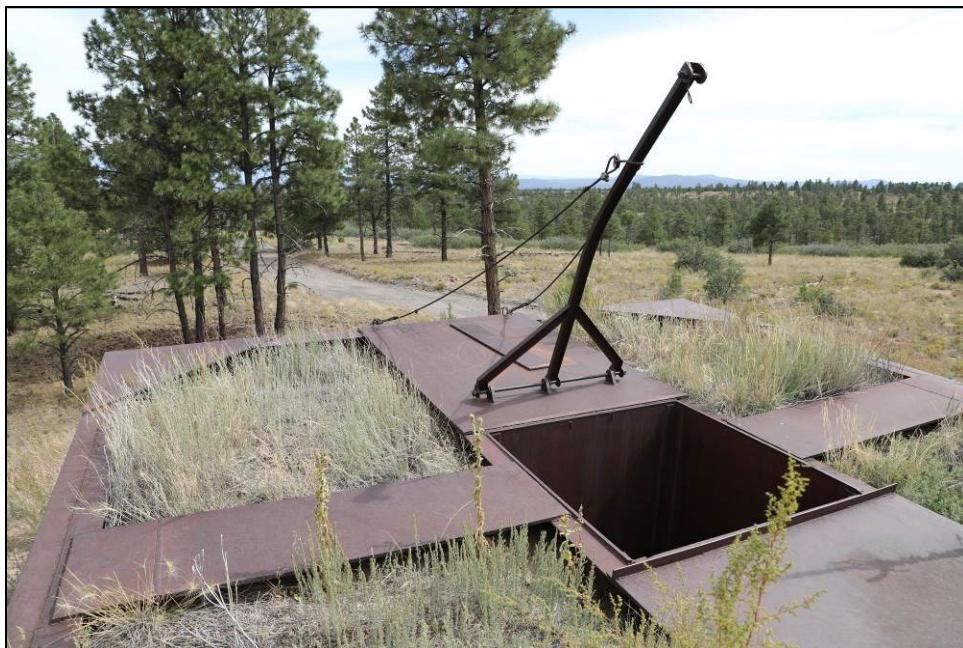
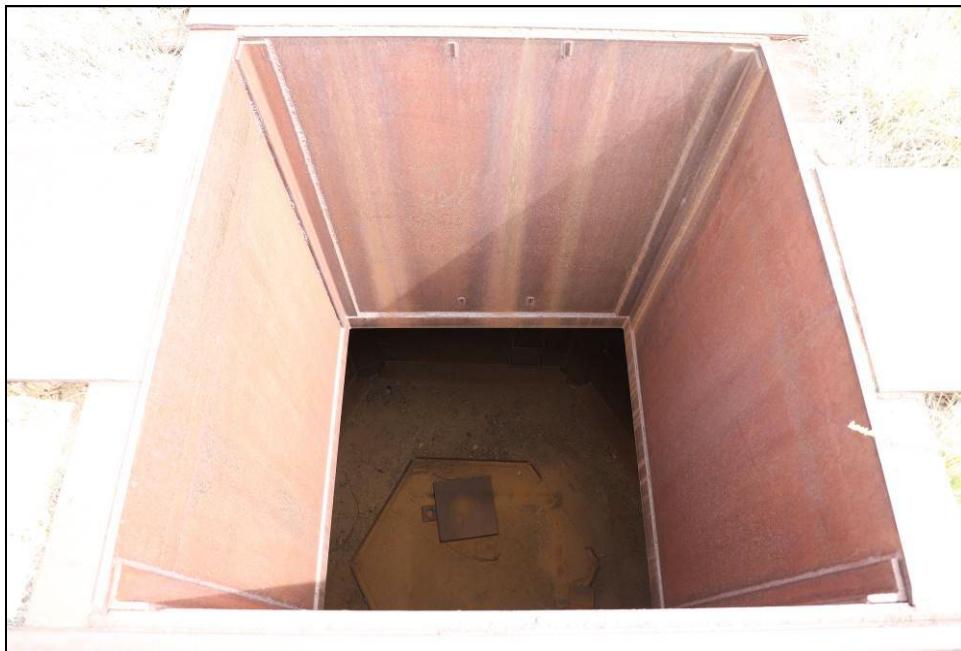
A large opening at the top center of the structure remains exposed. The opening allows in water and possibly animals. A skunk carcass was recently noted at the bottom. It is likely that the skunk fell into the structure from the top opening or one of the side openings and could not escape. Pooling water has also been noted and most likely entered through the top during rain and snow events. The top of the structure can be accessed by a welded-on ladder, so the opening also represents a fall hazard for individuals on top.

Figure 211. Test were lowered into the square hole using the adjacent boom.

Figure 212. View looking from above into the square hole.

A steel-plate cover should be constructed to rest on top of the opening.

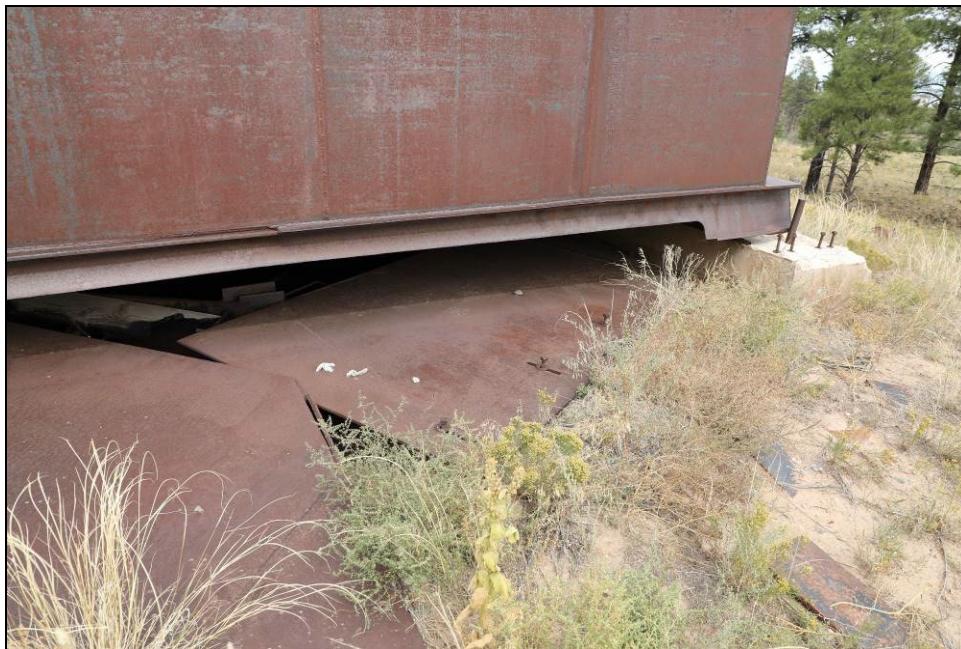
Figure 213. The side opening allow wildlife access to the bottom of the pit. This will be harder to close off compared with the top hole.

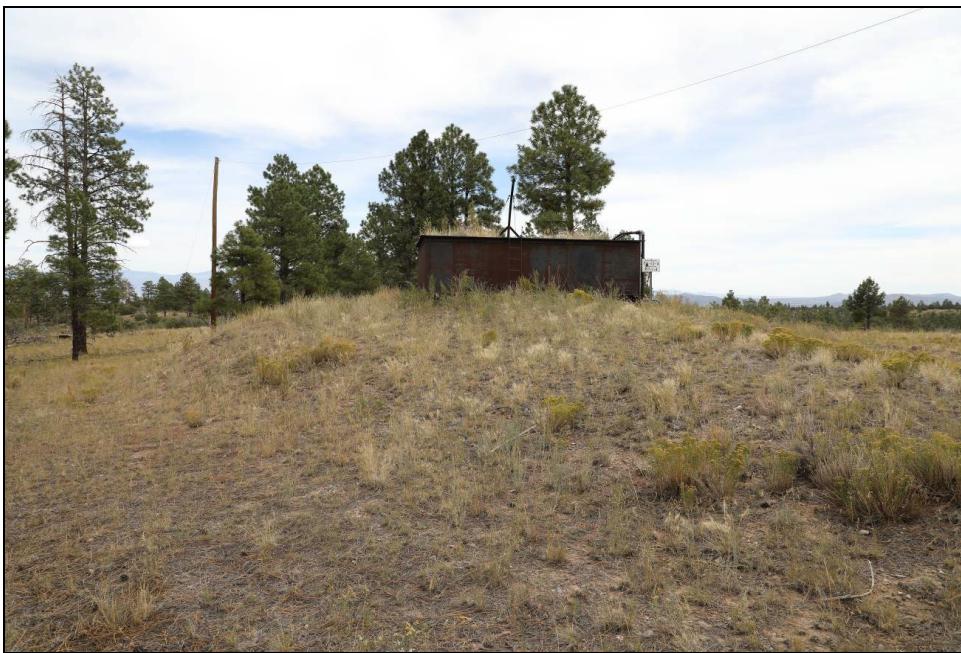
Figure 214. The historic roadbed skirts around the firing pit here at the left side of the photograph.

The historic roadbed should be brought back into use. The historic surface seems to have been compacted and perhaps lightly graveled during the time of use. The original path should be regraded as minimally as necessary and the surface compacted and graveled over. Gravel should be close in color to surrounding soil so as not to detract from the firing pit itself. Ponderosa pines have grown up along the eastern portion of the roadbed and will require removal. Asphalt paving is not recommended in an effort to retain as much of the historic character of the site as possible.
