Final Technical Report (FTR)

<i>a. Federal Agency</i>	Department of Energy	
<i>b. Award Number</i>	DE-EE0009378	
<i>c. Project Title</i>	Innovative Method for Welding in Generation 3 CSP to Enable Reliable Manufacturing of Solar Receivers to withstand Daily Cycling at Temperatures Above 700°C	
<i>d. Recipient Organization</i>	Electric Power Research Institute	
<i>e. Project Period</i>	<i>Start</i> : 03/01/2021	<i>End</i> : 08/31/2022
<i>f. Principal Investigator (PI)</i>	John Shingledecker Principal Technical Executive jshingledecker@epri.com 704-595-2619	
<i>g. Business Contact (BC)</i>	Cindy Colwell Government Contract Administrator ccolwell@epri.com 865-218-8109	
<i>h. Certifying Official (if different from the PI or BC)</i>

3.1.1: Characterization of Stress Relaxation Cracking Failures in 740H Weld Fabrications

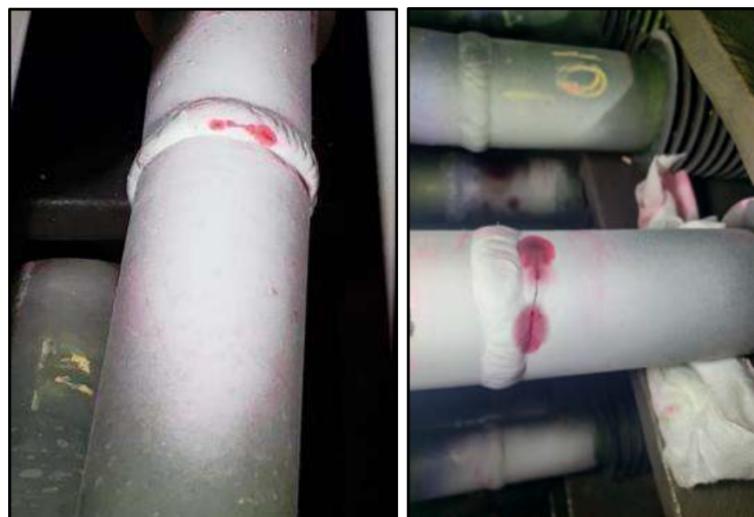
performed after the PWHT operation indicated 12 leaks in the tube-to-tube welds of the assembly. Figure 2 shows typical appearance of these leaked tubes after OD dye penetrant testing. Five of these twelve leaks were collected for metallographic investigations. Subsequent full volumetric inspection identified additional welds with cracks which did not result in pressure test leakage representing ~3% of the total tube-to-tube butt weld population.

Figure 2: Images showing the locations and appearance of the tube leak sites at the tube-to-tube welds after PWHT and hydrostatic testing.

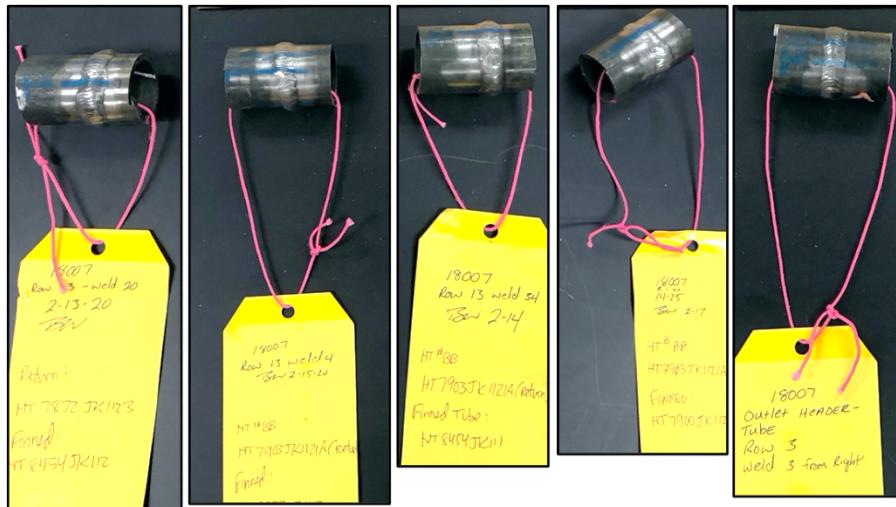
The five samples that were received from demonstration project #1 are shown in Figure 3. The obtained samples mainly consisted of sections with a tube-to-tube weld in the middle and small amounts of the tube parent materials on either side of the weld. The sample designation and the dimensions of the welded tubes of the 5 samples are

Figure 3: Images of the five as-received sections of the tube-to-tube welds where through wall leaks were identified. These sections were obtained for metallographic investigations

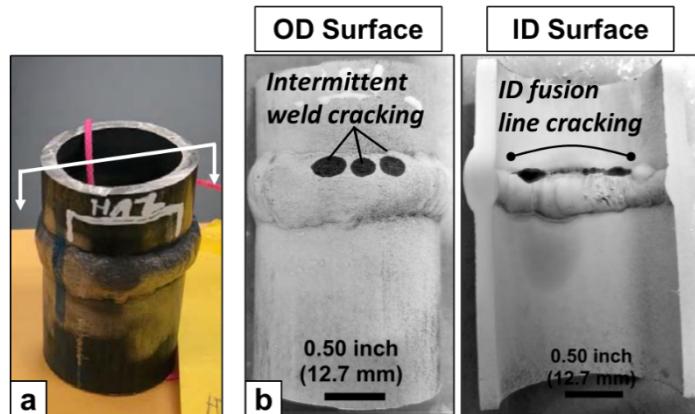
Failure investigation on these cracked samples was initiated by first performing an NDE evaluation. The tubes were first split along the tube length with precautions to avoid cutting into any of the marked locations with cracking as shown in Figure 4a. Liquid dye penetrant testing (LPT) was then done on both the ID and OD surfaces of the split tubes to determine the location and extent of cracking in these tubes. Figure 4b shows the through-wall crack in a split section of the tube in one of the samples as seen after LPT

at the OD and ID surfaces and Table 5 summarizes the observations from the LPT testing of the five tubes.

Figure 4: Images outlining a) how the obtained tube welds were sectioned axially and b) one example of OD and ID surface appearance indicating a through-wall crack after LPT.

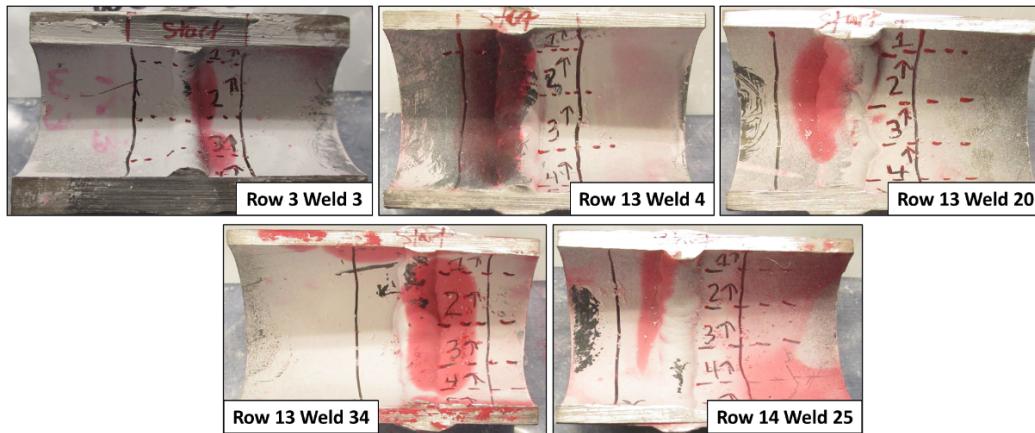
Following LPT testing, the tubes were marked for sectioning for sample preparation and metallographic examination. Multiple axial (lengthwise) sections were taken from each of the five tubes at the locations of the cracks to capture the initiation and propagation of the cracks. Figure 5 shows the locations where the tube sections were marked for sectioning. These sections were mounted and polished and examined in both etched and unetched conditions.

Figure 5: The sectioning locations for the five tubes near the sites with cracks.

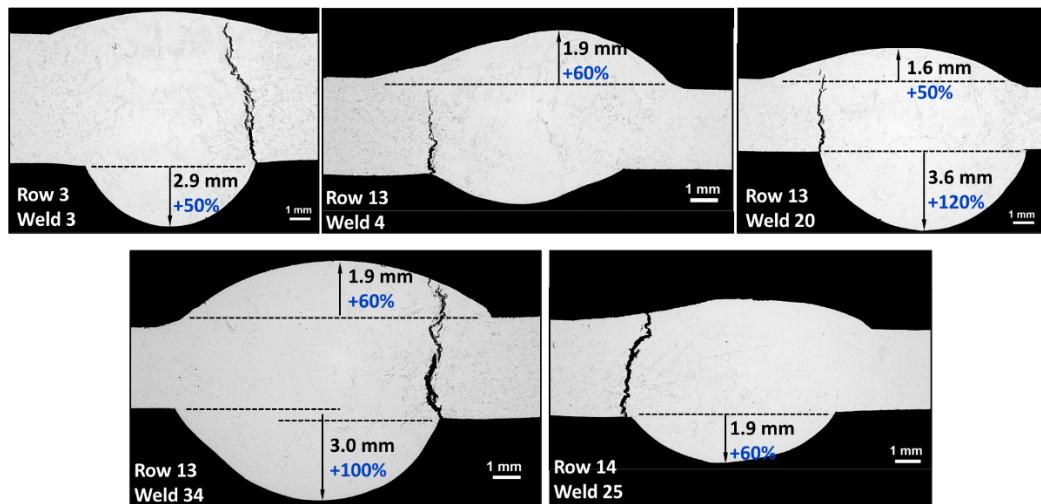
These images in Figure 6 also show that the main crack appears to have very little branching and there were no clear indications of secondary cracks surrounding the main crack. Initiation of the crack at or near the toe of the weld may further suggest that geometrical factors that increase local stress concentration, may play a part in the formation of these cracks. Figure 7 shows one representative weld cross section each from the five welded tubes. All these images show cracks originating at the toes of the welds. The images also show that all the welds had marked weld pushthrough at regions near cracking, sometimes even greater than the wall thickness for the tubes,

which could result in a significant build-up of residual stresses at the toes of the welds. These findings also highlight the variability in quality of workmanship in making these welds. Additionally, it is also interesting to note that cracks were present at only one of the weld toes at the ID in each of the five samples. Another important observation from cross sectional images was that there is no clear association of crack formation with the wall thickness of the tubes and, in multiple instances, cracking in the weld was on the tube with higher wall thickness. This suggests a local stress concentration because if strain was uniformly distributed across the weldment, the thinner sections would be expected to have higher stresses and the thicker sections lower stresses, resulting in failure on the thinner tube.

Figure 7: Images outlining the sectioning locations for the five tubes near the sites with cracks.

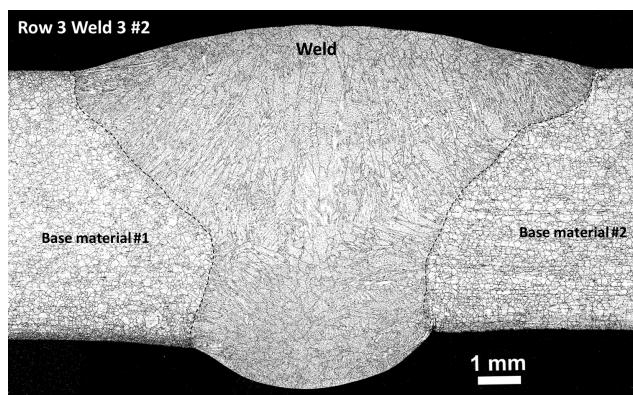
The grain structure of the tubes was revealed by etching the polished surfaces and Figure 8 shows a representative etched cross section as imaged using a light optical microscope. The etched microstructure of the welds primarily shows an equiaxed grain structure in both the base materials and a typical columnar and equiaxed dendritic microstructure within the weld.

Figure 8: Typical etched microstructure of the welded tubes when observed using a light optical microscope.

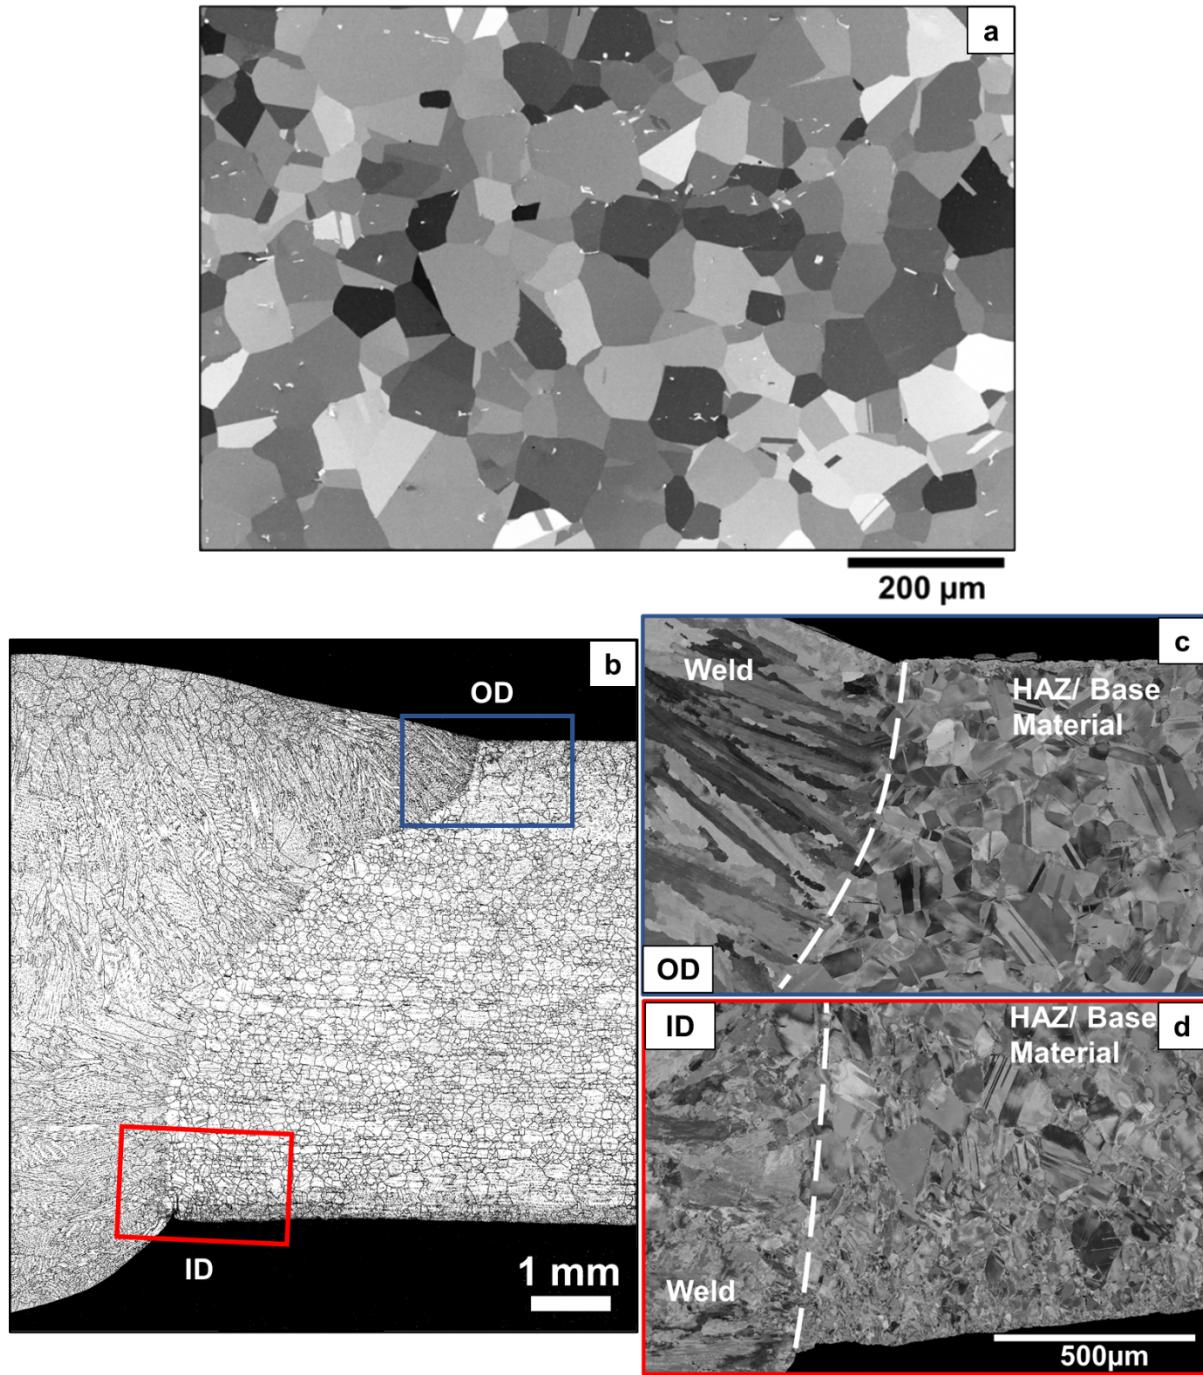
When analyzing the microstructure of a sample in unetched condition using the BSE imaging mode of an SEM, the grain structure of the metal can be distinctly visualized by increasing the contrast of an image. In such an imaging method, individual grains in the material will be evident even in unetched condition and, typically, each grain will have a unique greyscale contrast compared to its surrounding grains. This greyscale value is based on the amount of backscattered electron signal reaching the detector from that grain and is dependent on the orientation of that grain. Adjacent grains can hence be differentiated based on differences in their greyscale values due to differences in their relative orientations. As an example, Figure 13a shows a BSE image of the microstructure from an unetched austenitic stainless steel. In this image, the grain structure of the steel is clearly evident because of the differences in the greyscale contrast between adjacent grains. This method of imaging is known as imaging using electron channeling contrast. Similar images were taken from cross sections of one of the cracked tube-to-tube weld samples. Figure 13c and Figure 13d show BSE SEM images from the OD and ID regions of the weld cross section Row 3 Weld 3 #2 and Figure 13b shows the locations where these images were obtained from in a macro image. From these images, the grain structure near the tube OD shows equiaxed grains with twins. However, Figure 13d obtained from the region near the weld ID toe, the microstructure shows significant non-uniform distribution of greyscale coloration and the distinction between the grains cannot be made clearly. This non-uniform greyscale color distribution is typically seen in microstructure of material systems with strain within the matrices.

Figure 13: (a) unetched 'strain-free' austenitic stainless steel and (b-d) representative BSE images from the OD and ID regions of a weld cross section sample Row 3 Weld 3 #2.

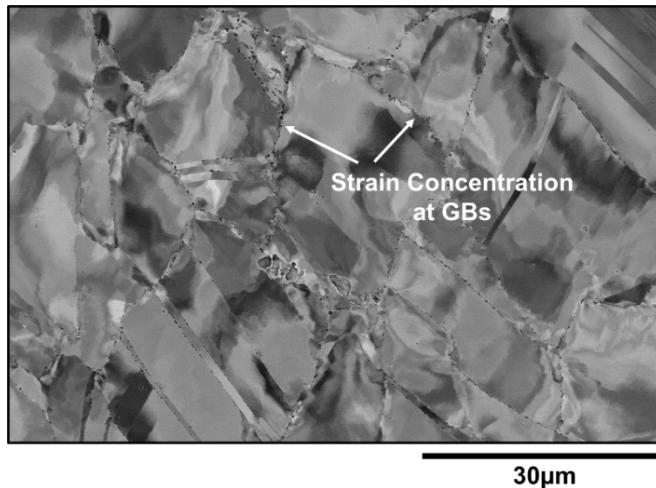
This phenomenon is further emphasized in Figure 14, which is a higher magnification image of the microstructure at the ID region of one cross section from weld Row 3 Weld 3. In this image the non-uniform greyscale coloration both within the grains and at the grain boundaries is evident and is more pronounced at the grain boundaries. These

observations suggest concentration of strain at the grain boundaries of the microstructure at the ID regions of the tube sections.

Figure 14: Higher magnification BSE images from the ID region of a weld cross section from sample Row 3 Weld 3 #2.

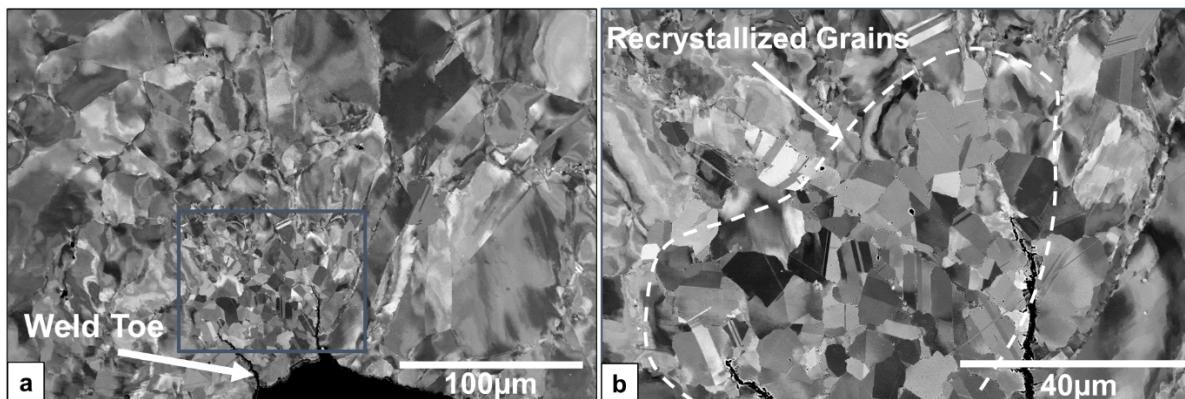
The microstructure near the toes of the weld with cracking also showed indication of strain in the matrix as is evident in Figure 15a taken from sample Row 3 Weld 3 #1. Furthermore, when the microstructure was analyzed at higher magnification, there was evidence of formation of fine grains ($<10\mu\text{m}$) right at the weld toe within a region marked in Figure 15b. These grains also have a relatively more uniform greyscale coloration compared to the surrounding matrix, which suggested that the grains had relatively lower strain than the matrix surrounding it. This combination of smaller grain sizes along with lower strain within this zone of fine grain indicated that these were recrystallized grains that have formed at the weld toe. These observations further suggest that the weld toes were regions with significant stress concentration resulting in local strain accumulation at the matrix to the extent that recrystallization phenomenon may also occur at these regions.

Figure 15: BSE a) low magnification and b) higher magnification of grains near the ID weld toe of a weld cross section from sample Row 3 Weld 3 #1.

All the above findings were from cross-sections #1 and #2 of the weld Row 3 Weld 3. In these cross-sections, there was no evidence of a crack at the weld toe, although from images Figure 15a and Figure 16b, the weld toes of these sections do seem to have some discontinuities which may have further contributed to increase in local stress concentration. From these analyses, there is clear evidence to suggest that just ahead of the crack initiation site, there is significant build-up of residual stress at the weld toes and, in some instances, the resulting strain on the matrix after welding is sufficiently high to result in recrystallization phenomenon occurring at the weld toe during PWHT. Furthermore, such transformations result in rearrangement/ annihilation of dislocations and grain boundary motion, which could result in the formation of PFZs at these sites.

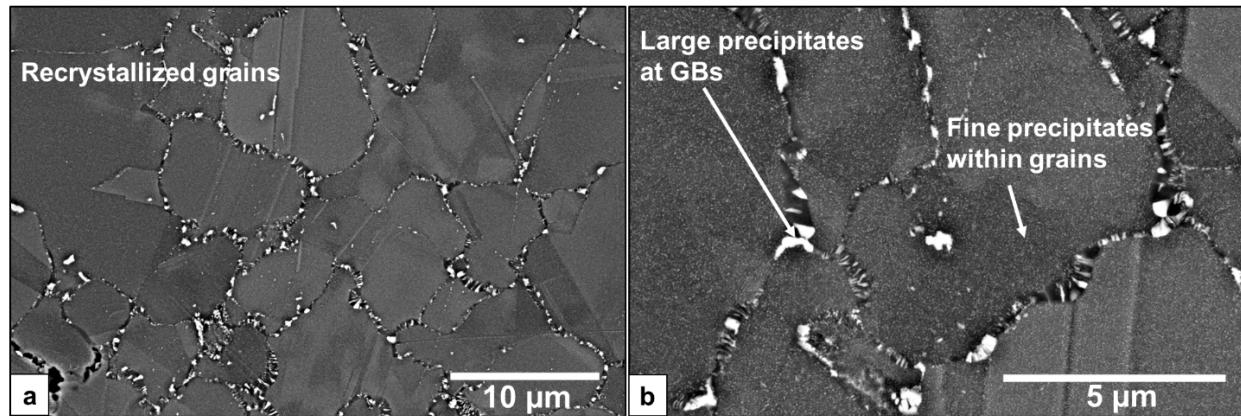
Figure 17: BSE a) lower magnification and b) higher magnification images of etched grains near the ID weld toe of a weld cross section from sample Row 3 Weld 3 #2 showing various precipitate features.

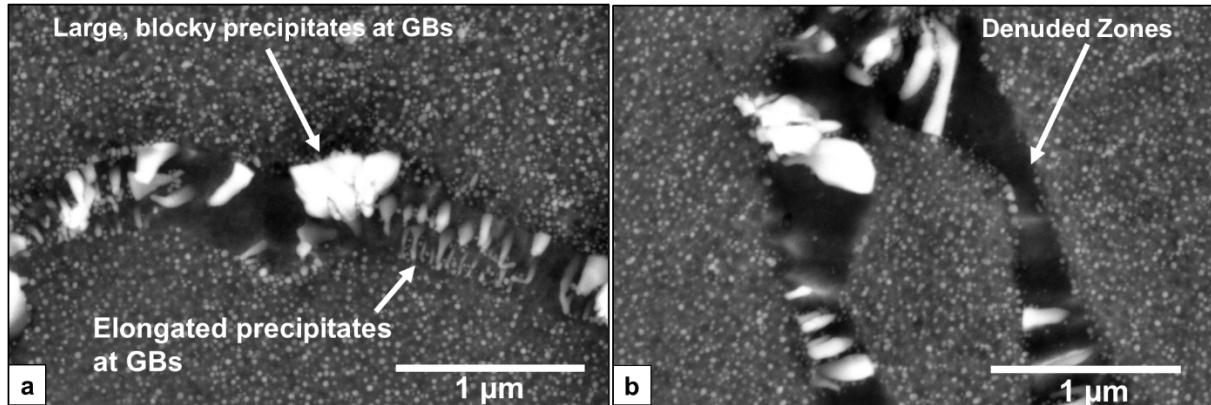
The boundaries showed different precipitate structures, which include large and blocky precipitates that appear bright in BSE images and thin, elongated precipitates that appear to be growing away from the grain boundaries and into the matrix of the grain, as highlighted in Figure 18a. Such formations of elongated precipitates are also called *discontinuous coarsening* or *discontinuous precipitation* due to the spaces between the elongated precipitates. Additionally, at these grain boundaries, there were clear regions where there were no precipitates (either large or fine). Such locations that are free from precipitates are termed *denuded zones* or *precipitate free zones* (PFZ) and have been known to form in the weld metal of 740H welds [14, 15]. However, this is first known study where their formation in the base material has been observed during fabrication of a component.

Figure 18: BSE images of etched grains near the ID weld toe of a weld cross section from sample Row 3 Weld 3 #2 showing various precipitate features at the boundary and formation of precipitate free zones.

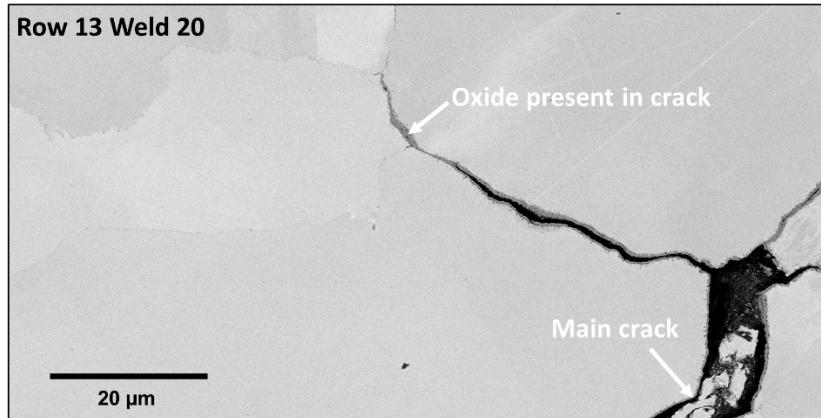
Additionally, the cracks formed on all the five welds contained a surface oxide scale within the crack openings. This finding is highlighted in Figure 25 as one example. Formation of such a scale suggests that cracking must have occurred immediately after the start of PWHT stage of fabrication as NDE evaluation of the welds after the welding operation did not indicate presence of any cracks.

Figure 25: BSE images of grain boundary regions highlighting the presence of oxide scales in grain boundaries

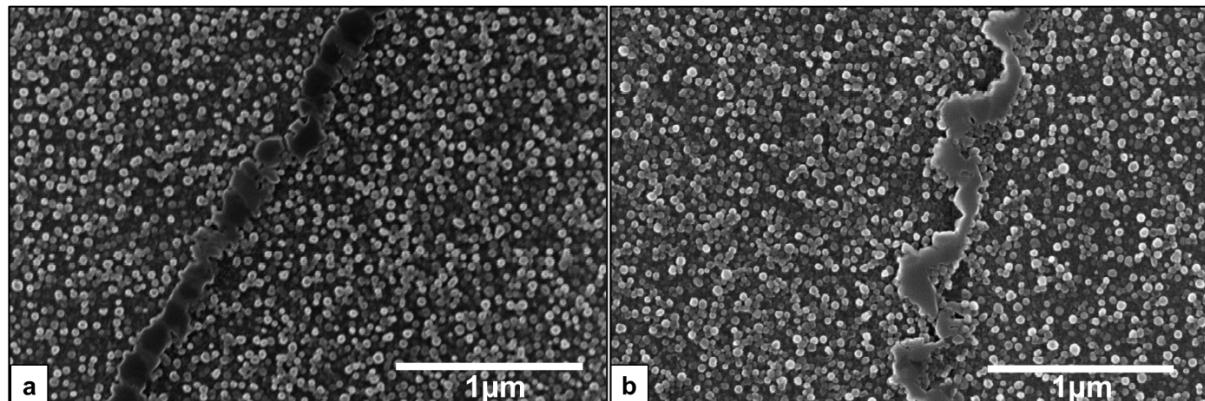
The grain boundary sites that showed discontinuous precipitate structure formation along with denuded grain boundary regions were studied with the help of a transmission electron microscope (TEM). The sample cross-section Row 14 Weld 2 #1 shown in Figure 20 was chosen as the sample for TEM studies. To primarily establish the precipitate structures formed in a normal grain boundary that did not show any discontinuous precipitation or grain boundary denuded zone formation, a TEM sample was first obtained from a grain boundary present in the non-cracked tube in the weld. Such a representative grain boundary region for baseline TEM analysis was identified and typical appearance of such boundaries are shown in Figure 26 where the grain boundaries have complete grain boundary coverage by precipitates.

Figure 26: BSE images of grain boundary regions on the non-cracked tube of the weld Row 14 Weld 25 #1 showing complete grain boundary coverage by precipitate structures

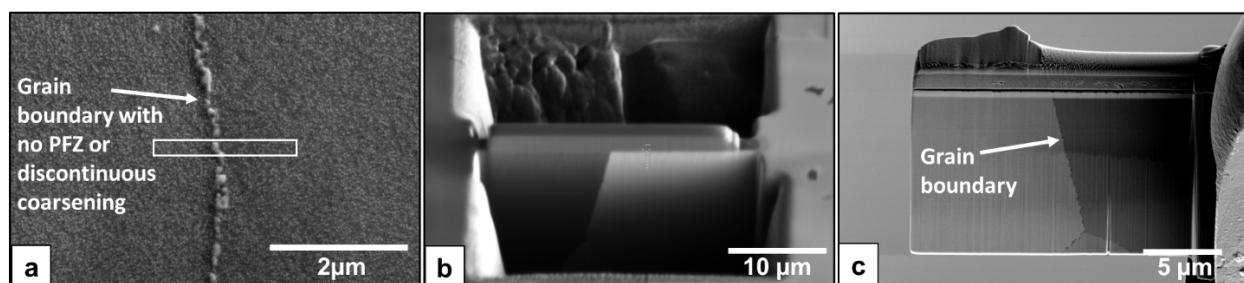
One such grain boundary was chosen and is shown in Figure 27a and marked in this image with a white rectangle is the location from which a TEM sample was extracted from this boundary. Sample extraction was performed using a focused ion beam (FIB) milling operation where the surrounding material is first milled away by a trenching operation as shown in Figure 27b. This sample is then lifted out of the substrate material and attached to a TEM sample holder as shown in Figure 27c. In this TEM sample, the grain boundary that was targeted for analysis was found to be extending

Figure 27: a) BSE images of grain boundary region where TEM sample was extracted, b) FIB trenching operation around area of interest during TEM sample preparation and c) the final TEM sample obtained after sample lift-off from the substrate and attaching to TEM sample holder.

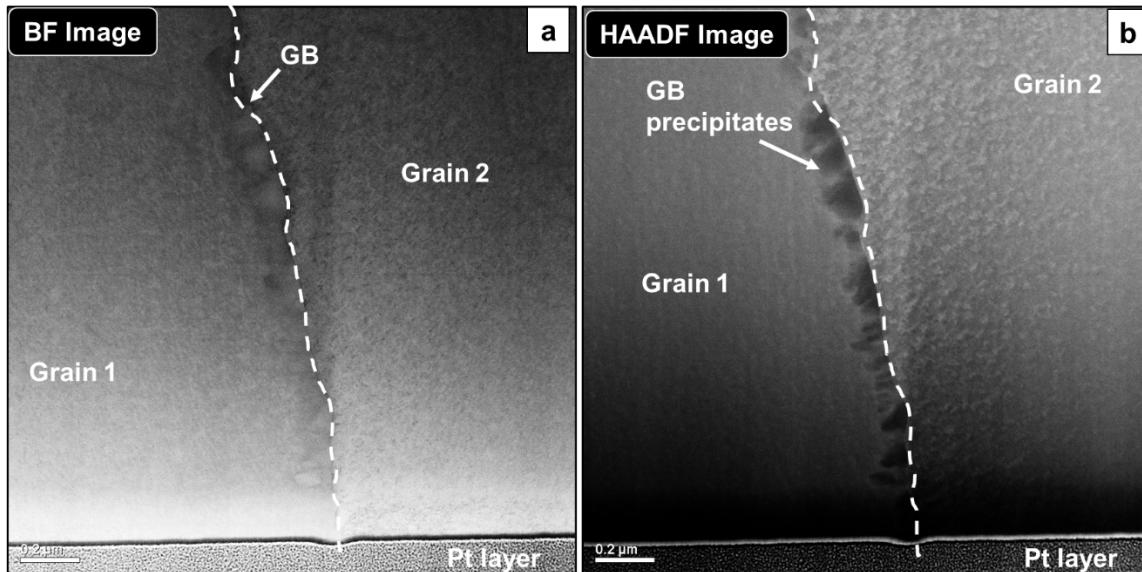
Figure 28 shows a low-magnification bright field (BF) and high angled annular dark field (HAADF) images of the extracted TEM sample. The grain boundary precipitates are visible as dark features along the grain boundary (dotted line) in Figure 28b. From these images, it is evident that the boundary shown in Figure 27a continues to show complete grain boundary coverage even within the sample. To identify the precipitates, present along the grain boundary, energy dispersive spectroscopy (EDS) analysis was performed in the scanning operation mode called scanning TEM mode or STEM mode.

Figure 28: a) Bright field (BF) and b) high angle annular dark field (HAADF) image of the TEM sample cross section showing grain boundary and precipitate features in the middle of the sample.

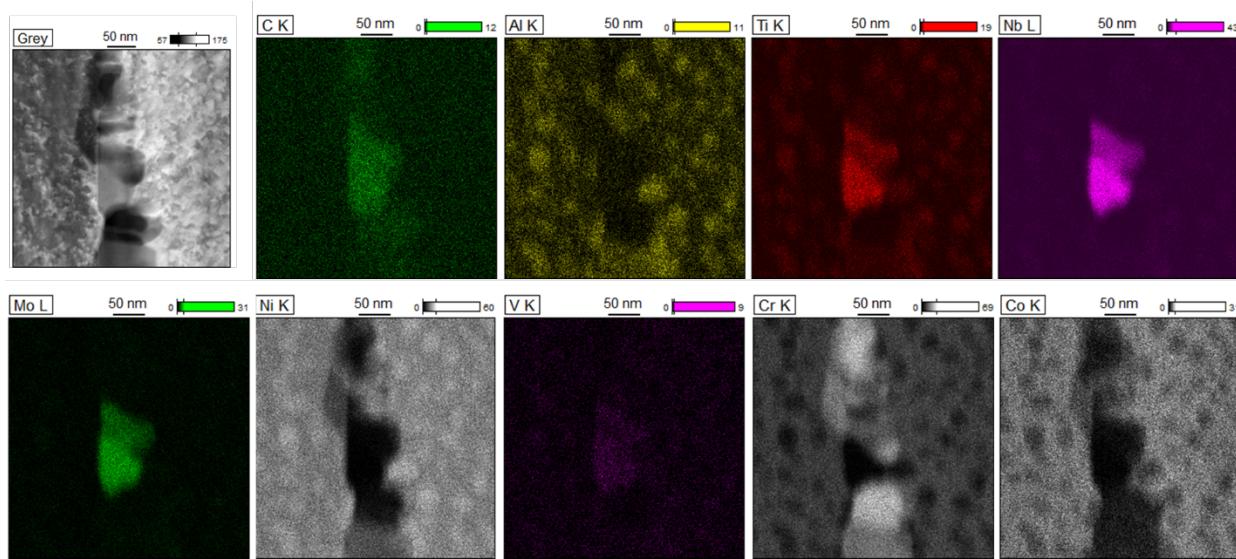
1. The matrix surrounding the grain boundary consists of many Al, Ti and Ni rich circular regions which correspond to the fine γ' precipitates in the matrix.
2. The Cr and C distribution map suggests that the grain boundary primarily consists of regions of Cr and C enrichment, which most likely are $M_{23}C_6$ carbides.
3. There is small region in the middle of the scanned area which is enriched in C, Ti, Nb, Mo and V. This element enrichment profile suggests that this feature is a MX type precipitate.

Figure 29: SEM-EDS results showing the intensity maps of different elements at a grain boundary area

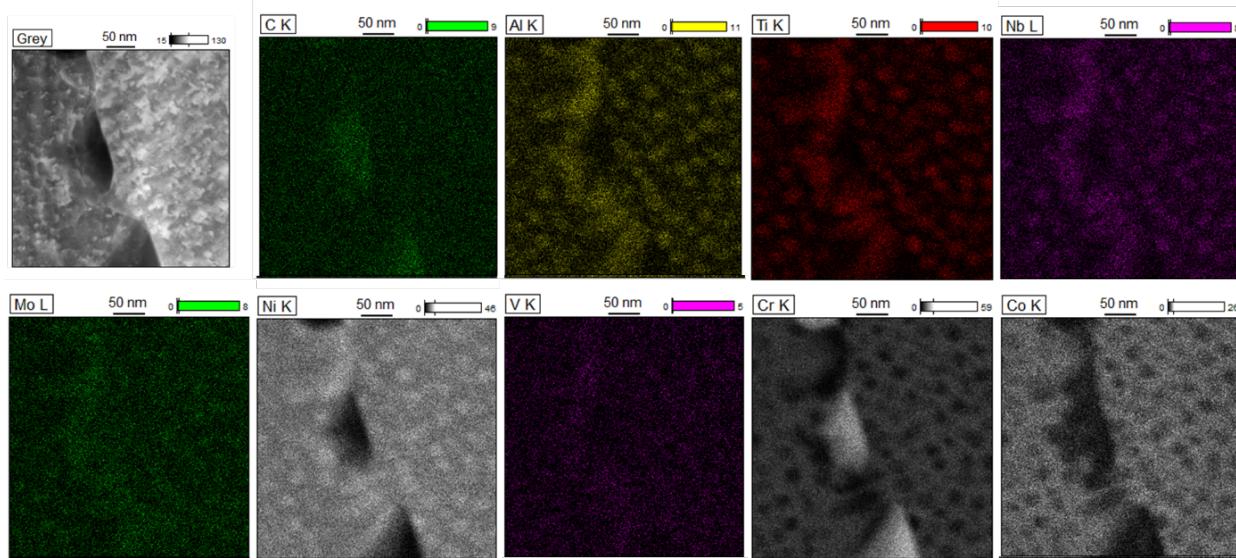
Results from EDS analysis of the second grain boundary region (Figure 30) suggests shows that, in this area, the grain boundary shows two distinct precipitate types. The first is enriched in Al, Ti, Nb and Ni, suggesting that the boundary has a continuous coverage of γ' precipitates. The second set of precipitates show enrichment in Cr and C, indicating $M_{23}C_6$ type precipitates. Results from additional analyses consisting of line EDS scans are shown in the Appendix. From these results, a typical grain boundary in 740H alloy should primarily consist of $M_{23}C_6$ carbides, MX-type carbides and γ' precipitates.

Figure 30: SEM-EDS results showing the intensity maps of different elements at a grain boundary area.

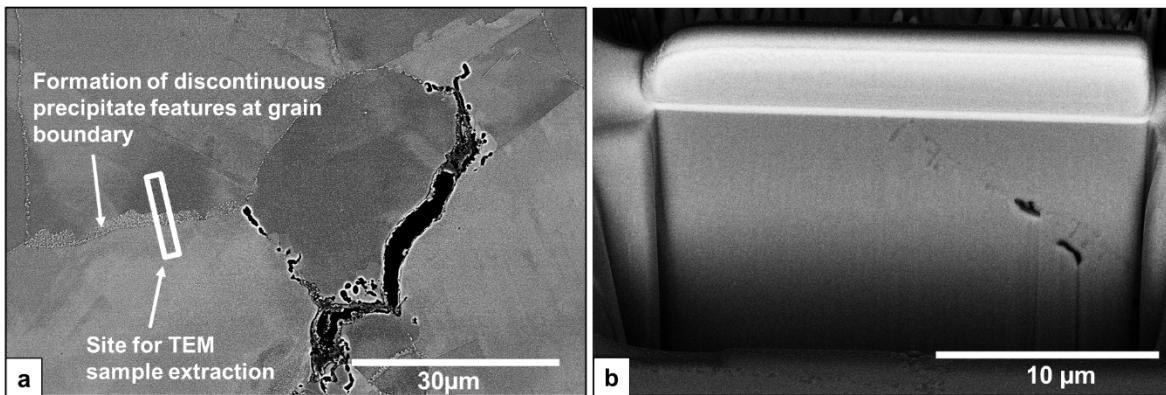
After establishing the baseline characteristics of grain boundary precipitates at boundary regions without PFZs or discontinuous coarsening, a TEM sample was next extracted from the boundary regions of the tube that had exhibited cracking. A region of the grain boundary was identified and is shown in Figure 31a. This site also shown in Figure 31b consisted of a region showing discontinuous coarsening located just ahead of a crack tip. This boundary exhibited coarse and elongated precipitates along with PFZ. Figure 31b shows the trenching operation being conducted using FIB to separate

Figure 31: a) BSE image showing the region where the TEM sample was removed and b) trenching operation being performed before the extraction of TEM sample.

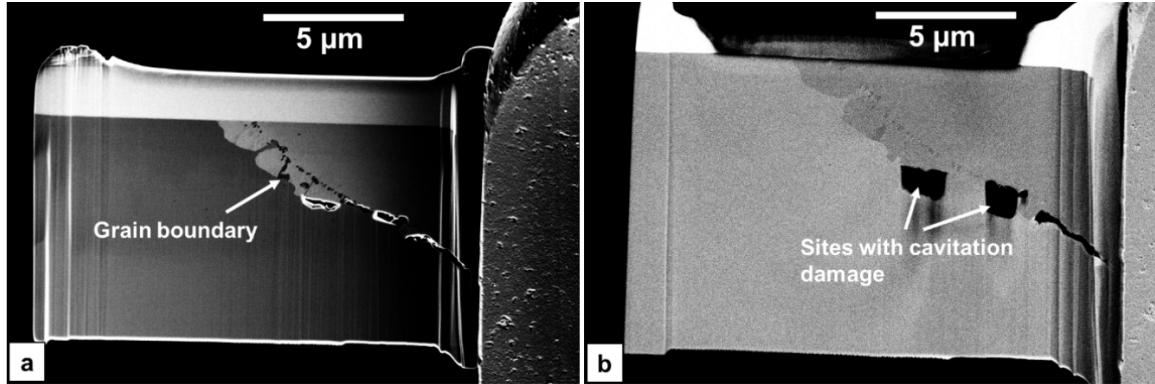
the region of interest from the surrounding matrix and Figure 32 shows SE and BSE SEM images of the extracted TEM sample after the final FIB thinning process. In these images it can be observed that the FIB milled grain boundary starts at the middle of the top portion of the sample but the boundary curves and ends on the side of the sample. In the Figure 32b, regions with cavitation damage at the grain boundary region also be seen.

Figure 32: SE and BSE image of the final TEM sample showing grain boundary features and cavitation damage.

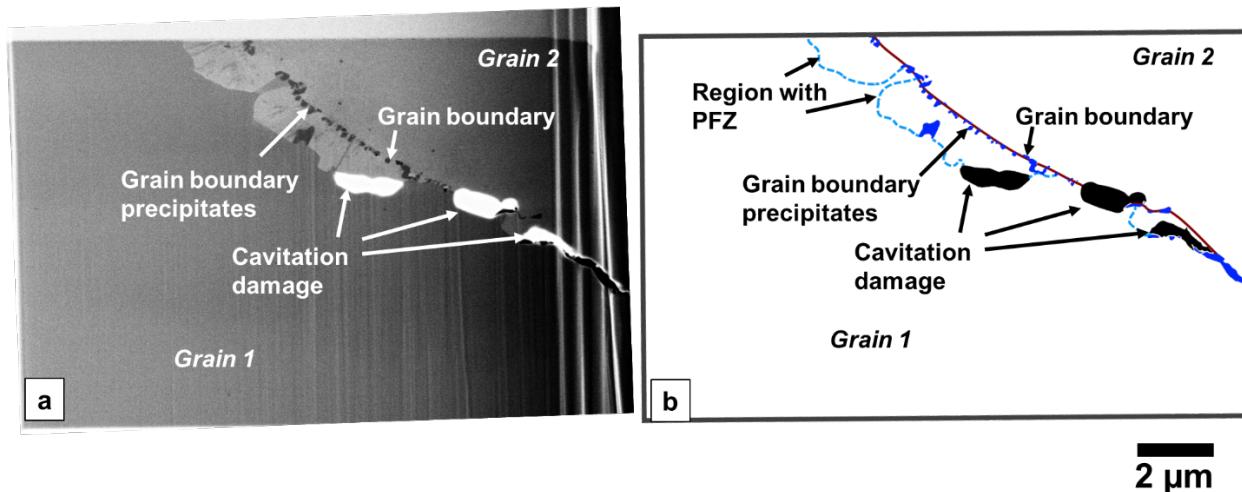
Figure 33a shows a BSE image of the extracted sample at a higher magnification and Figure 33b is a schematic created to show the various features of interest in this sample. In the BSE image, there are two main regions which differing grey scale contrast. These two regions are two adjacent grains (labeled Grain 1 and Grain 2) and their color difference is because of the difference electron channeling contrast between the two grains. In the schematic, the two grains in the TEM sample are divided by a solid blue line in the schematic, which is the original grain boundary. The blocky blue features on this boundary are the grain boundary precipitates and the cavitation damage sites are highlighted as black regions. From the grain boundary and growing

into Grain 1 are regions that have the same contrast as Grain 2 in Figure 33a. These are PFZs which may also have some elongated precipitates associated with discontinuous coarsening. To establish the characteristics of the grain boundary, multiple EDS line scans were performed to determine the distribution of various alloying elements.

Figure 33: a) BSE image of TEM sample and b) schematic of various features in TEM sample.

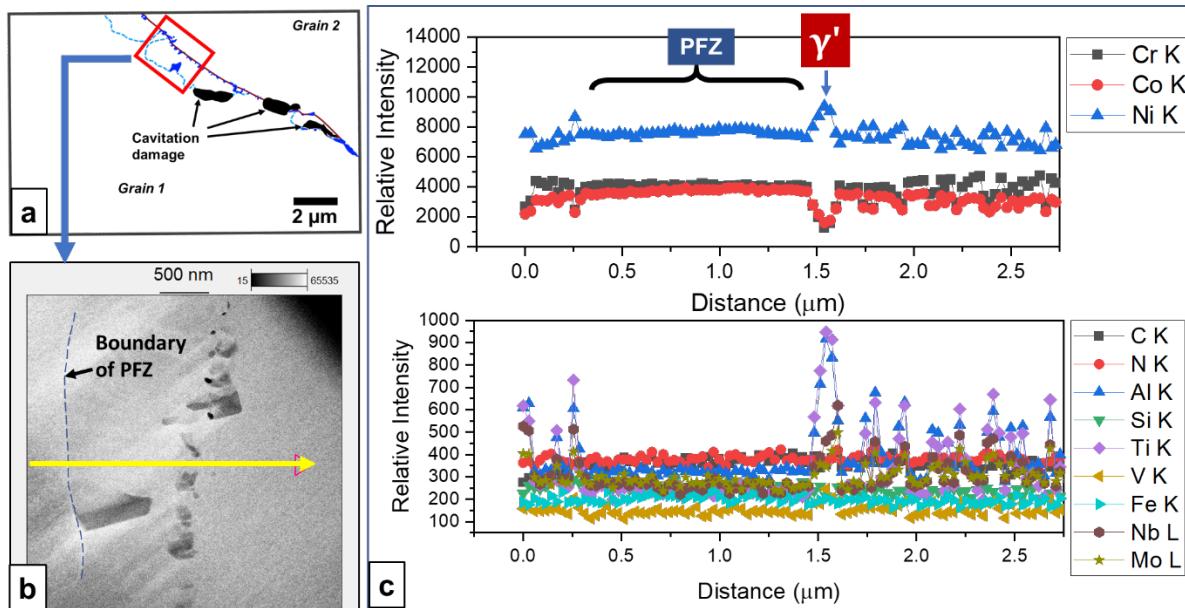
Figure 34a shows the region (red rectangle) of the TEM sample that was selected for EDS line scan and the magnified image of this region is shown in Figure 34b. An EDS line scan performed in this area has been highlighted by a yellow line and the line scan starts from inside a region in Grain 1, transitions through a region that is believed to be a PFZ, goes over the precipitates at the original grain boundary and ends at a region inside Grain 2. The variation in the intensity of various alloying elements along this line were plotted in the graphs shown in Figure 34c. At the beginning portion of the scan, where the X-rays signals are being generated from Grain 1 (between the regions 0 to 0.25 μm in the x-axis of graphs), there is variation in the Ni, Al, Ti and Nb. These variations represent the fine γ' precipitates present in the matrix of Grain 1. The region between ~0.25 to ~1.5 μm in the graph corresponds to the region which is believed to be the PFZ and in this region there is no change in the relative peak intensities of various alloying elements suggesting that this area is indeed free from any detectable precipitates. As the line scan reaches the grain boundary region (at ~1.5 μm), there is a sharp increase in the intensity of elements Ni, Ti, Al, which corresponds well with a grain boundary γ' precipitate. Upon careful observation of the line scan signal data, there is a further increase in Nb and Mo intensities right adjacent to the γ' particle, perhaps corresponding with a small MX particle present right next to the γ' precipitates. From the region ~1.6 μm to 2.75 μm in the x-axis of the graph, there is a regular increase in peak intensities of elements Ni, Al, Ti and Nb, which is associated with the fine γ' precipitates within the matrix of Grain 2. This analysis confirms that area that is believed to be the PFZ is indeed free from precipitates and hence a denuded zone. This zone is ~1.25 μm thick at the region of the scan.

Figure 34: a) Location of line EDS analysis in schematic, b) the region where line EDS was performed and graphs showing distribution of peak intensity of various elements along the line scan.

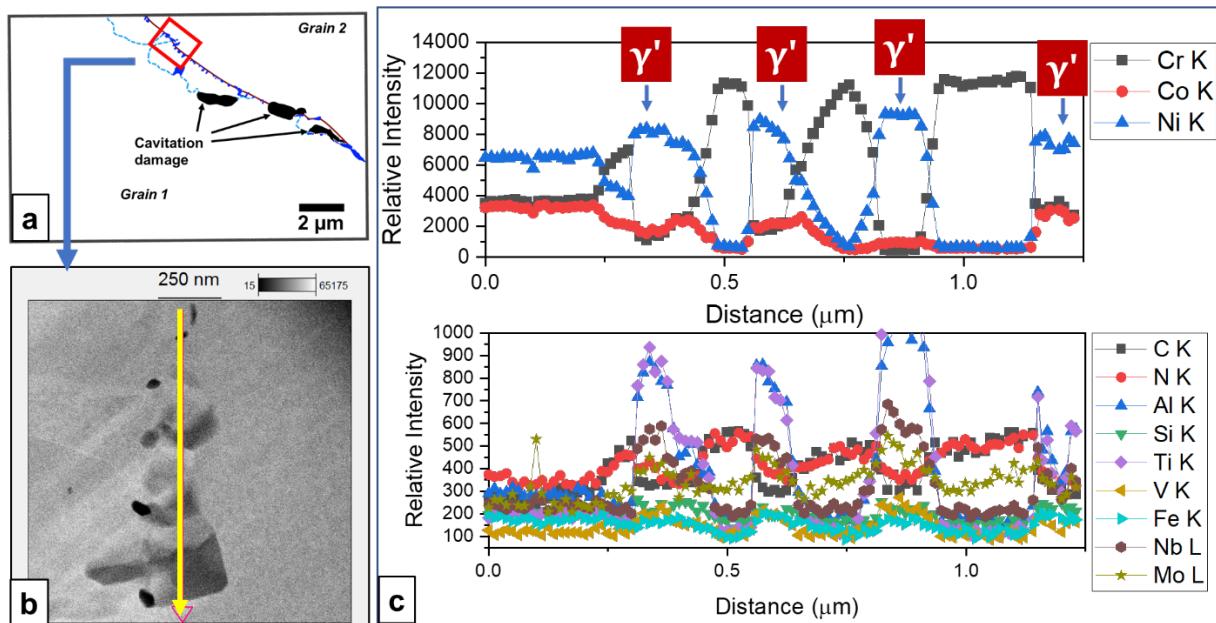
Similar analysis was performed a second grain boundary region as marked on Figure 35a and the magnified image from this area is shown in Figure 35b. A line scan was performed at this site as indicated in the image Figure 35b, with an intent to understand grain boundary precipitate structure. At the beginning of the scan, there is no relative change in the peak intensities of the different elements as shown in Figure 35c. suggesting that the scan was initiated at a PFZ region. When the electron beam is traversing over the grain boundary precipitates, the obtained elemental intensities are present between ~ 0.25 μm to ~ 1.25 μm region of the x-axis. In this region, there appears to be an alternate arrangement of Ni, Ti, Al and Cr, C regions. This suggests that at this grain boundary site has alternate arrangement of γ' and M_{23}C_6 carbides, similar to the precipitate structure seen in the TEM sample from the non-cracked tube of the weld discussed in Figure 30. Results from addition line scans are provided in the Appendix.

Figure 35: a) Location of line EDS analysis in schematic, b) the region where line EDS was performed and graphs showing distribution of peak intensity of various elements along the line scan.

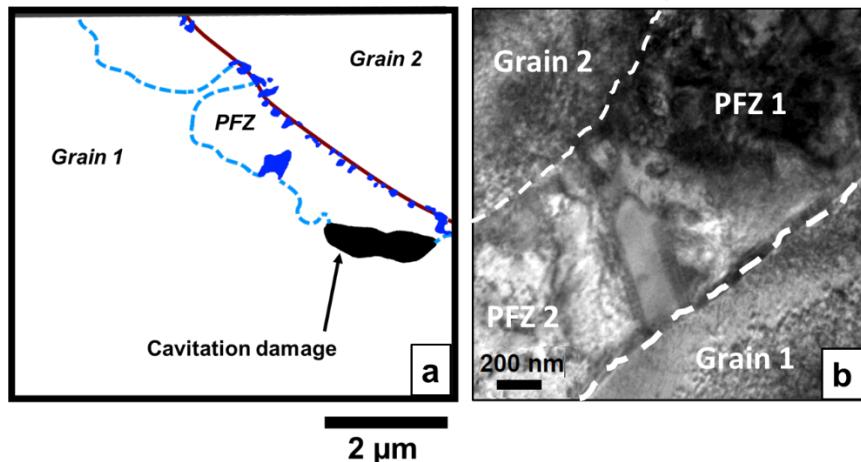
Figure 36a shows the schematic of the three regions of interest: Grain 1, Grain 2 and PFZ. These three regions are highlighted in a HAADF image in Figure 36b and diffraction patterns were obtained from four locations of this image: Grain 1, Grain 2, PFZ 1 and PFZ 2. These patterns taken along the [112] zone axis are shown in Figure 37. From this image the diffraction pattern from the matrix of Grain 2 matches the patterns from PFZ1 and PFZ2. This analysis suggested that the zone with the discontinuous precipitates was a region that formed from the growth of Grain 2 and is not a newly formed grain.

Figure 36: a) Schematic showing different regions in TEM sample and b) high magnification HAADF image showing three regions from where SAED patterns were obtained.

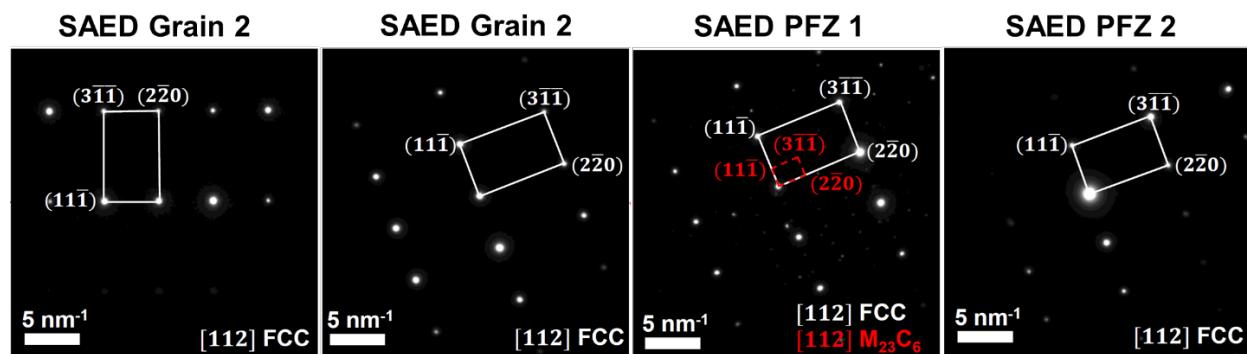
Figure 37: SAED patterns obtained from different regions of the TEM sample shown in Figure 36.

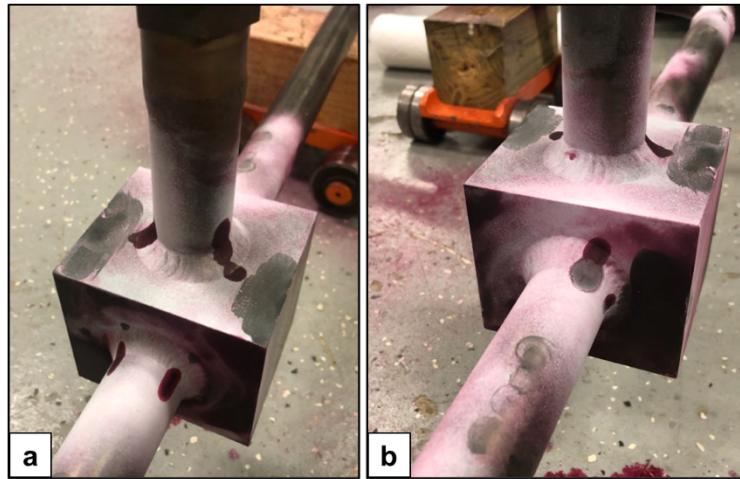
During the operation of the system at a pressure of ~200 psi, multiple audible leaks were noted from this instrumented tee block. In-situ LP testing revealed external surface breaking cracks in all the three socket welds. Figure 39 shows the appearance of these welds after in-situ LPT testing at the test facility. This leaked tee was provided to EPRI for analysis of the weld cracks and was included in the field failure analysis program of this project.

Figure 39: Images showing the 740H instrumentation tee block after in-situ LP testing at test facility.

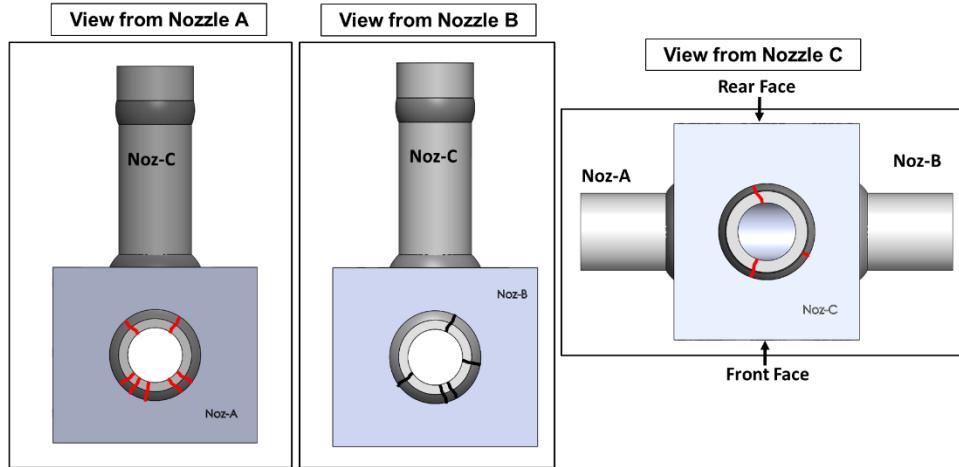
Visual inspection of the provided welds showed clear surface breaking cracks and the observed cracks were documented in a schematic shown in Figure 41. The weld on Nozzle A is found to have 7 through-wall cracks, one on Nozzle B had 5 cracks and the one on Nozzle C had 3 cracks.

Figure 41: Schematic showing the number and locations of various cracks detected in the instrumented tee.

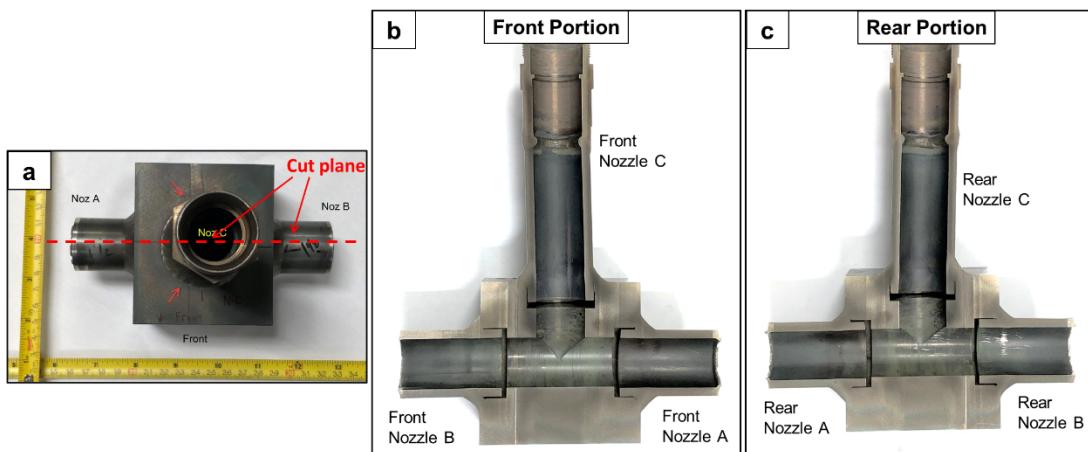
The instrumentation tee block was then sectioned through a plane running through the centers of the three nozzles as shown in Figure 42a and the interiors of the two obtained sections are shown in Figure 42b and Figure 42c. LP testing of the interior surfaces showed multiple interior cracks. Subsequent to LP testing the blocks were machined for metallographic preparation and small sections of the nozzles and the 740H forged block were cut for complete composition analysis.

Figure 42: a) Sectioning scheme of the instrumentation tee and b), c) the resulting two sectioned pieces of the tee block.

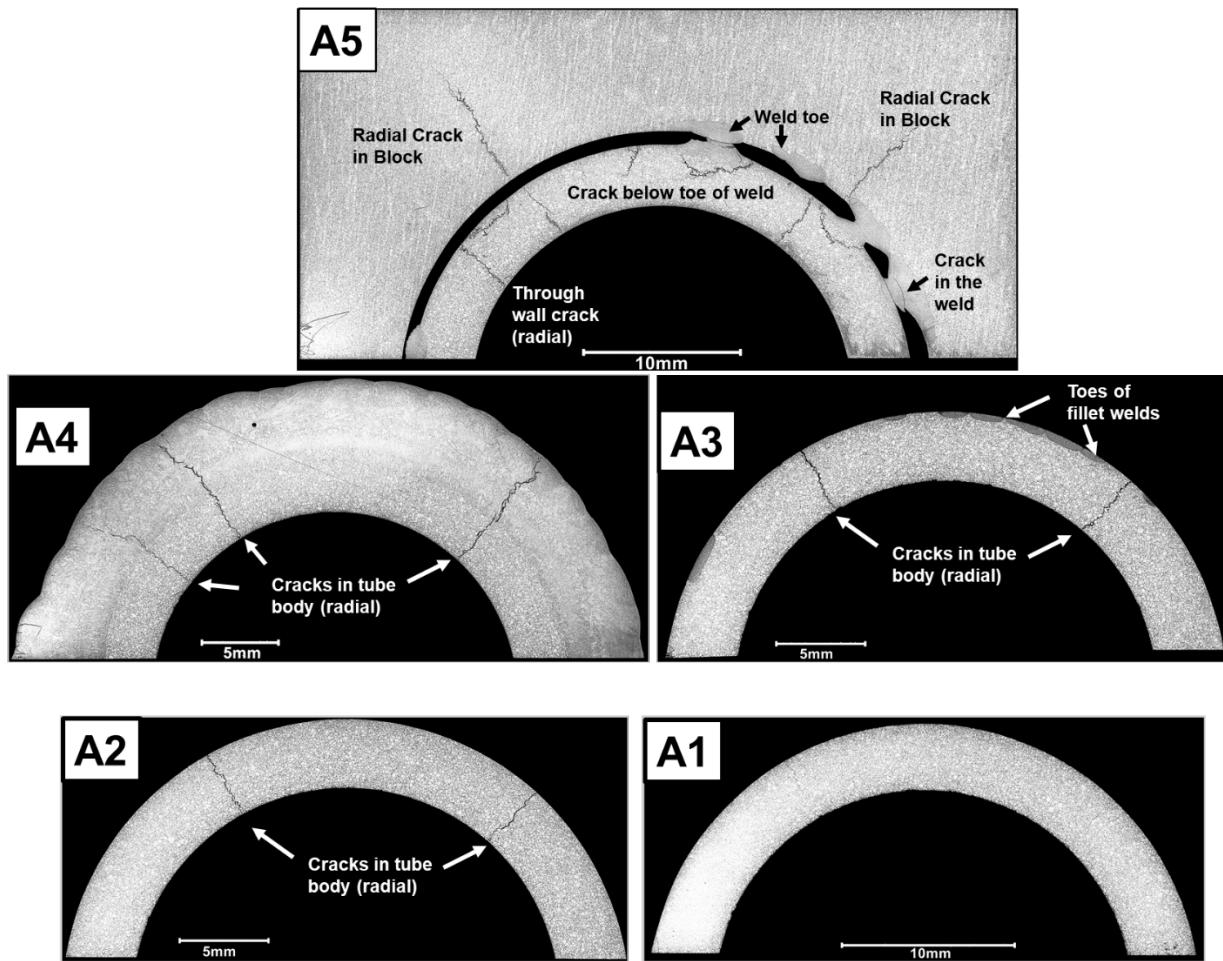
Macro images of the etched cross sections from Nozzle A (labeled A1 to A5) are shown in Figure 44. The section A5 was through both the forged body and tube and the forged body is evident in the outside of the tube cross-section. In this section, some portions of the toes of the fillet welds were also evident. Section A4 was through the fillet weld and the tube and the weld portion of the sectioning area is evident from a wavy nature of the outer diameter of the cross section. Sections A3 through A5 were all through the tube body only, although in A3, small portions of the fillet weld toes were still evident.

From the etched image of section A5, both the tube and forged body show equiaxed grain structure. Also in this section, multiple cracks both in the body of the tube and in the forged body are evident. Most importantly, the cracks in the forged body were radial with respect to the center of the tube. There were radial through-wall cracks through the tube body too but evidence of multiple cracks within the body of the tube but forming immediately below the toe of the welds were also evident in this cross-section. Figure 45 shows magnified macro images of some of the cracks observed in the cross section A-5. Figure 45a is an image with representative cracks observed in the tube body showing both radial cracks and cracks formed below weld toes. Both these types of cracks were intergranular in formation.

Figure 44: Macro images of the 5 cross-sections from Nozzle A.
