Final Technical Report (FTR)

<i>a. Federal Agency</i>	Department of Energy	
<i>b. Award Number</i>	DE-EE0009378	
<i>c. Project Title</i>	Innovative Method for Welding in Generation 3 CSP to Enable Reliable Manufacturing of Solar Receivers to withstand Daily Cycling at Temperatures Above 700°C	
<i>d. Recipient Organization</i>	Electric Power Research Institute	
<i>e. Project Period</i>	<i>Start</i> : 03/01/2021	<i>End</i> : 08/31/2022
<i>f. Principal Investigator (PI)</i>	John Shingledecker Principal Technical Executive jshingledecker@epri.com 704-595-2619	
<i>g. Business Contact (BC)</i>	Cindy Colwell Government Contract Administrator ccolwell@epri.com 865-218-8109	
<i>h. Certifying Official (if different from the PI or BC)</i>

3.1.1: Characterization of Stress Relaxation Cracking Failures in 740H Weld Fabrications

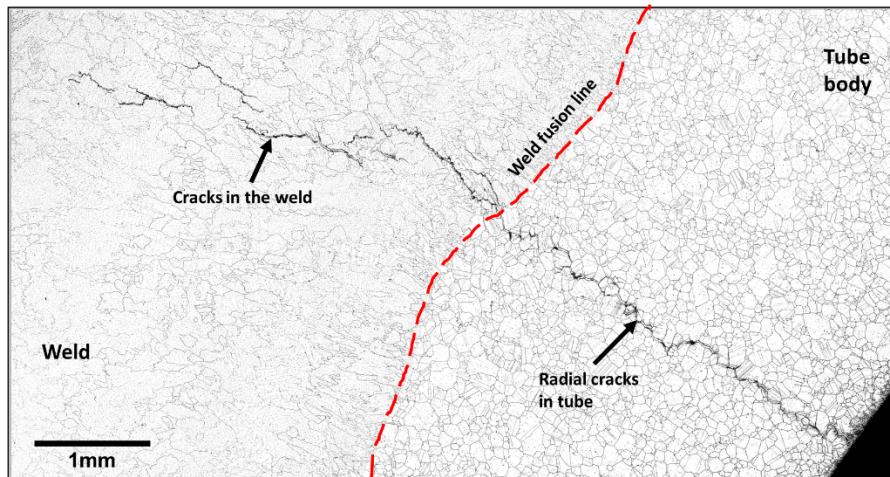
Figure 46 is a magnified image of one of the radial cracks in the sample cross-section A4. This image has a portion of the fillet weld on the left of the image and the tube body on the right of the image separated by the marked weld fusion line. There is a radial crack traversing through the body of the tube and transitioning into the weld. Once again, the crack clearly appears to be intergranular within the tube body and continued to have grown in an intergranular manner.

Figure 46: Image of a radial crack from the section A4

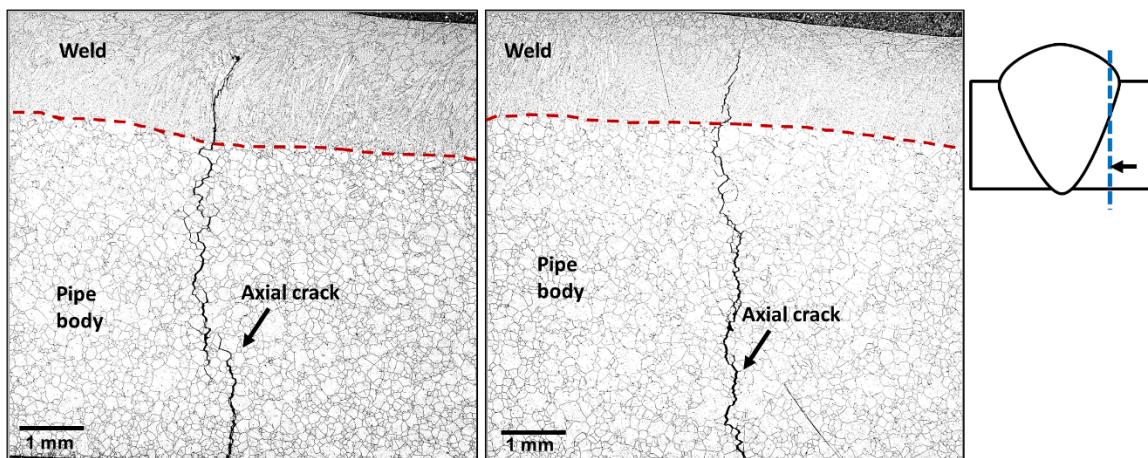
Figure 51 shows the two macro images of the etched surfaces of the samples which were sectioned through the axial cracks. In these images, the growth direction of the cracks is out of viewing plane. Furthermore, from the way these samples were sectioned, a portion of the girth weld close to the OD regions of the weld were retained as marked in the macro images. The sectioning plan to obtain such images is highlighted in the schematic on the right of Figure 51 using a blue dotted line. What is evident from these images is that microstructure of the pipe consists of equiaxed grains and that the cracks formed are once again intergranular. The origin of the cracks, which were most likely located near the ID toe of the weld, is not captured in these cross sections. It is also evident that at these sections, the cracks extend into the weld metal region and are ~ 90% of the way through the section thickness and do not appear to stop at the weld fusion boundary. Similar to the observations from the samples evaluated in the previous two demonstration projects, the cracks formed are sharp with minimal branching or significant amount of secondary cracks surrounding the main crack.

Figure 51: Macro image of cross-sections of two axial cracks. Schematic on the right shows the sectioning plane of the sample with respect to the weld.

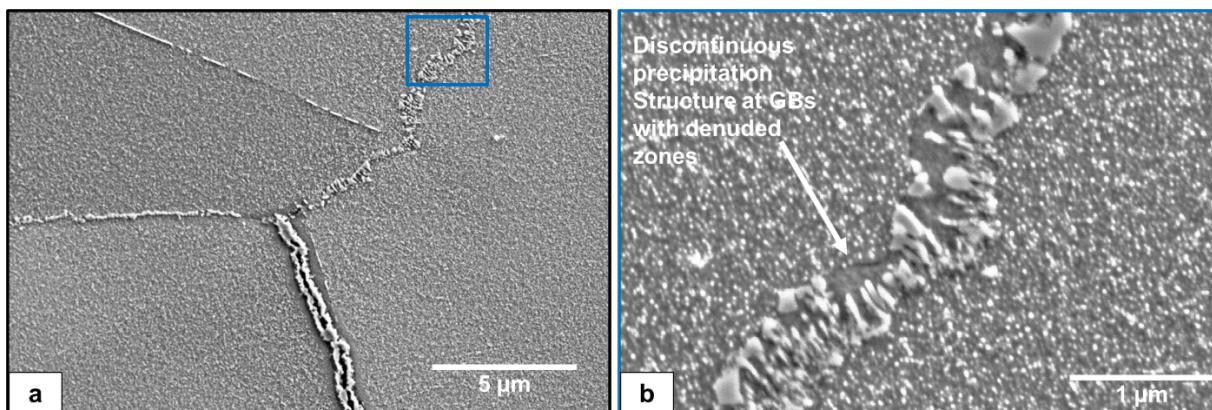
Figure 52a. It can be seen in Figure 52b that the tip of the crack has stopped at a triple point and on one side of the crack is a boundary that exhibits discontinuous coarsening, whereas the other boundary appears to be a normal boundary with a nearly 100% grain boundary coverage by precipitates and no clear indications of discontinuous precipitation or denuded zone formation. The presence of what appears to be an oxide scale is also evident within this crack. The formation of discontinuous precipitates in the adjacent grain boundary is further emphasized in Figure 53 with a higher magnification image of this grain boundary formation. What is immediately evident is that the region with discontinuous coarsening also has formations of PFZs.

Figure 53: a) Image from Figure 52b marked with a location on a grain boundary and b) higher magnification image of the grain boundary at the marked location in Figure 53a.

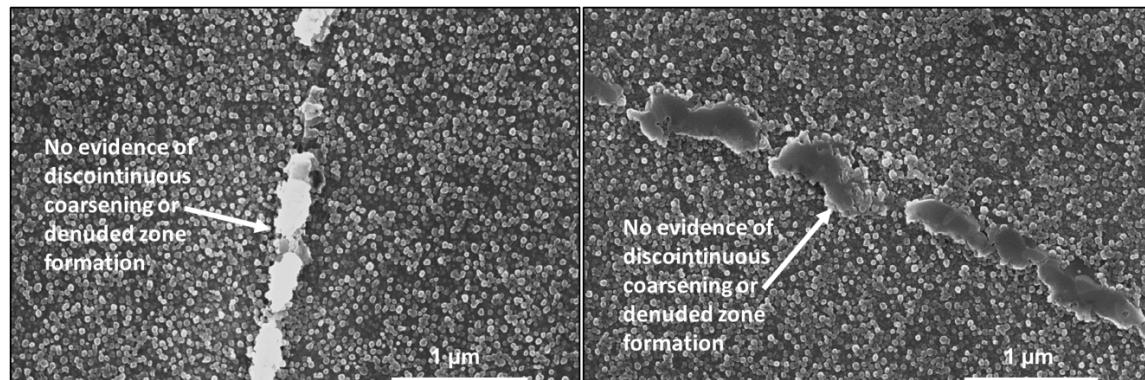
A few grains away from the main branch of the crack however, the grain boundary features do not show any evidence of discontinuous coarsening. An example to highlight this observation is shown in Figure 55 where two grain boundaries removed from the main crack and their precipitation characteristics are shown.

Figure 55: Appearance of grain boundaries away from the cracked region showing complete coverage of boundaries with precipitates.

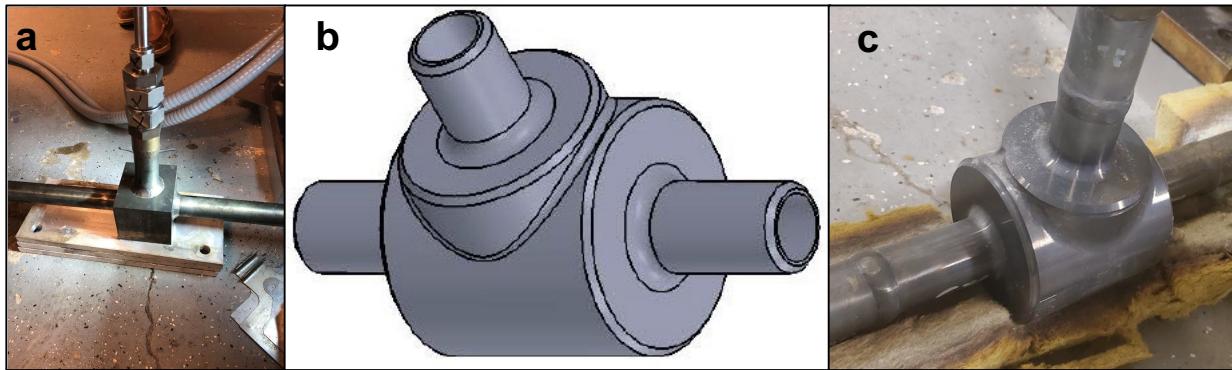
Figure 56. Original instrument 'block tee' design (a), a re-designed contoured tee(b), and the final fabricated tee which did not show any cracking (c).

4. Block fittings, intersections or valves must be avoided.

It is relatively commonplace to procure block forgings that are subsequently machined into fittings, intersections or valves with minimal OD machining or contouring. Figure 56(a) shows a different view of the component from demonstration project #2. While a detailed model was not constructed, it is likely the large block tee piece acted as a heat-sink during welding thus requiring the welder to compensate with excessive heat input. Additionally, the non-symmetric shape of a thin tube into a solid block likely led to additional stresses upon cooling. Figure 5(b) shows an improved design where OD machining provided a more uniform circumferential thickness and eliminated the socket weld in favor of a full penetration butt weld. Figure 56(c) shows the completed new instrument attachment which did not crack after PWHT and is now in-operation.

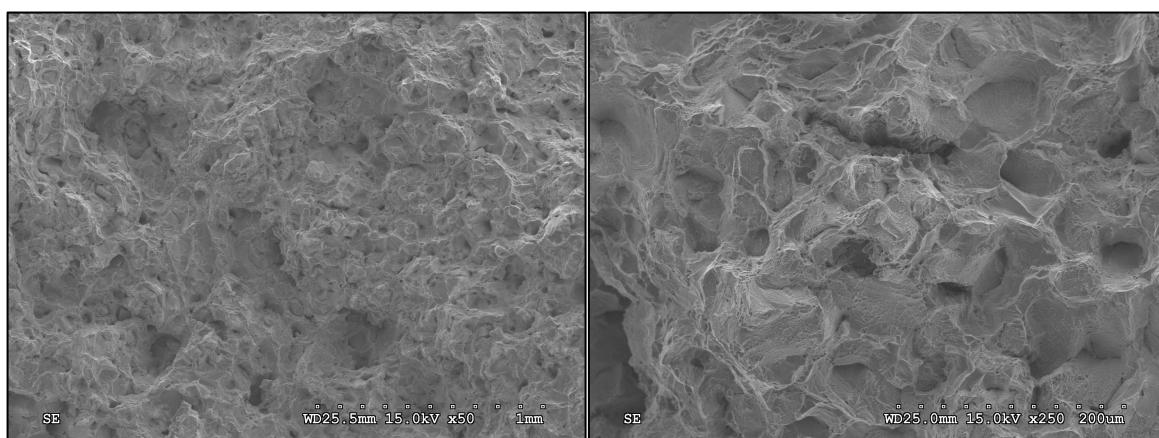
fracture modes of the tensile samples that are shown in Figures 65 through 76. At 700°C, Heats A and B show microvoid coalescence (MVC) whereas Heat C shows some evidence of intergranular fracture that is reminiscent of SRxC. At 800°C, all heats show intergranular fracture, but Heat B (with the highest tensile ductility) also shows significant amounts of ductile microvoid coalescence. Heats A and B exhibit all microvoid coalescence at 900°C, whereas Heat C exhibits some intergranular fracture. All the heats fail by microvoid coalescence at 1000°C.

Figure 67. Fracture surfaces from Heat C tensile tested at 700°C.

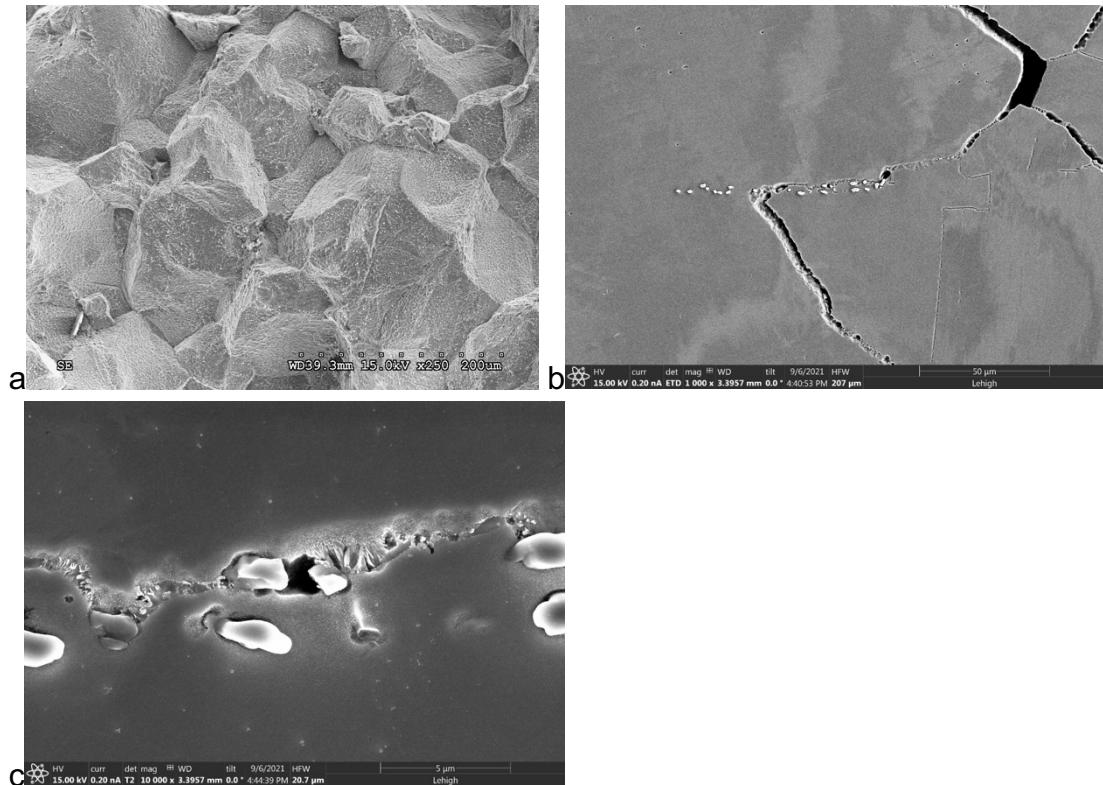
Figure 85 shows typical fracture features associated with the failures from this test. The results shown as an example are from Heat C that was tested at 4.75% strain that failed after about 1.5 hours at the PWHT of 800°C. The failed surface exhibits intergranular fracture in which microvoid coalescence is confined to the grain boundaries (Figure 85a). The SEM photomicrographs shown in Figures 85b and 85c were acquired on a cross sectional sample from areas of secondary grain boundary cracking just below the fracture surface. The cracking is associated with precipitate-free zones along the grain boundaries. Thus, failure occurs due to localized plastic deformation of the soft zone along the grain boundaries associated with the precipitate-free zone, which accurately simulates the changes in grain boundaries observed from the service failures.

Figure 85. Examples of SEM characterization of typical fracture features associated with the failures from Heat C that was tested at 4.75% strain that failed after about 1.5 hours at the PWHT of 800 °C, including (a) the fracture face, (b) a cross-sectional image of typical grain boundary cracks, and (c) confirmation of PFZs associated with the observed cracking

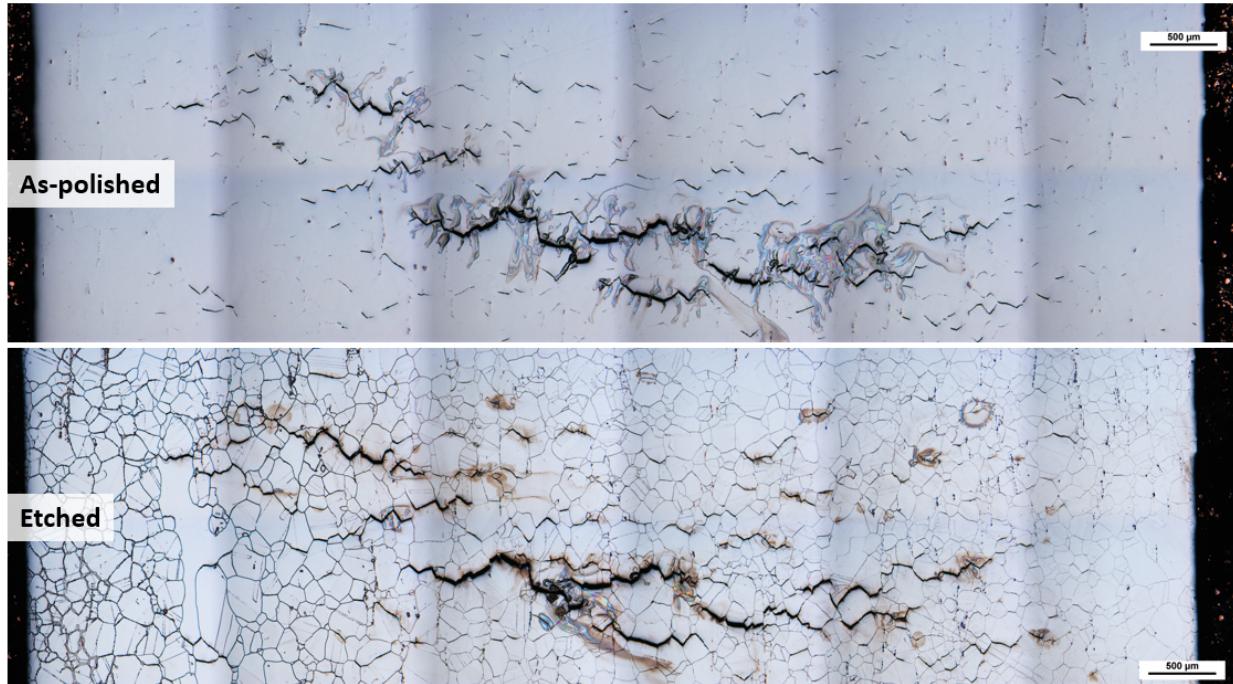
Figure 86 shows LOM cross-sectional images from Heat C in which the sample was given 2% plastic strain and tested for eight hours at 800 °C but was not pulled to failure after the test (this sample did not fracture after eight hours at 800°C). Although the sample did not fail during the test, there is obviously extensive crack initiation after eight hours at the PWHT temperature. This demonstrates that the failure time and/or lack of failure during the test cannot be used alone as an indicator of SRxC susceptibility.

Figure 86. LOM cross-sectional images from Heat C in which the sample was given 2% plastic strain and tested for eight hours at 800°C, but was not pulled to failure after the test (this sample did not fracture after eight hours at 800°C).

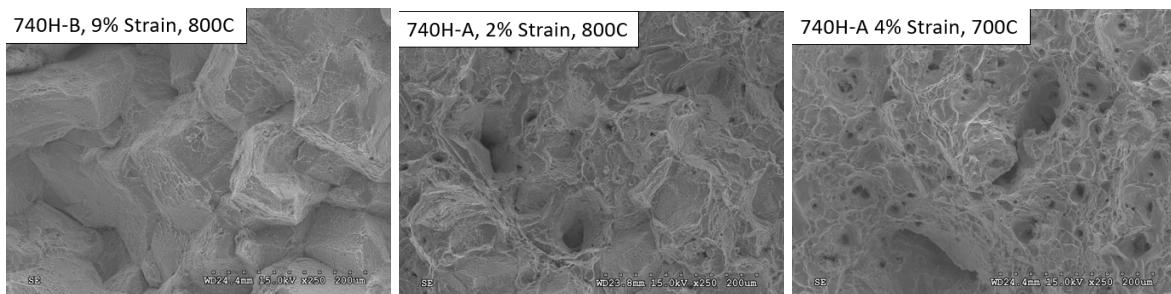
Figure 87. Different types of fracture modes observed in this work. Left – Type II, Middle – Type III, Right – Type IV.

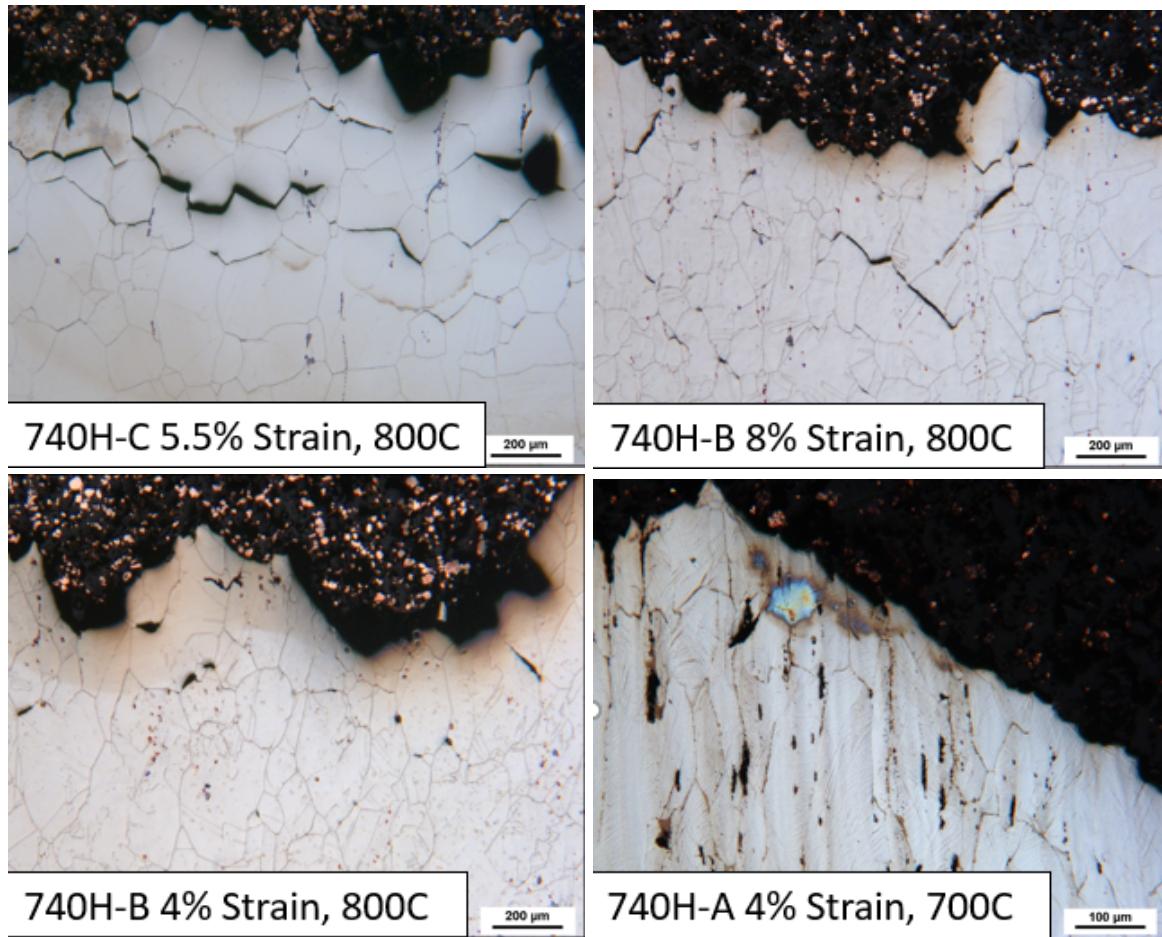
Figure 88. Different types of subsurface cracking modes observed in this work. Top Left – Type I, Top Right – Type II, Bottom Left – Type III, Bottom Right – Type IV

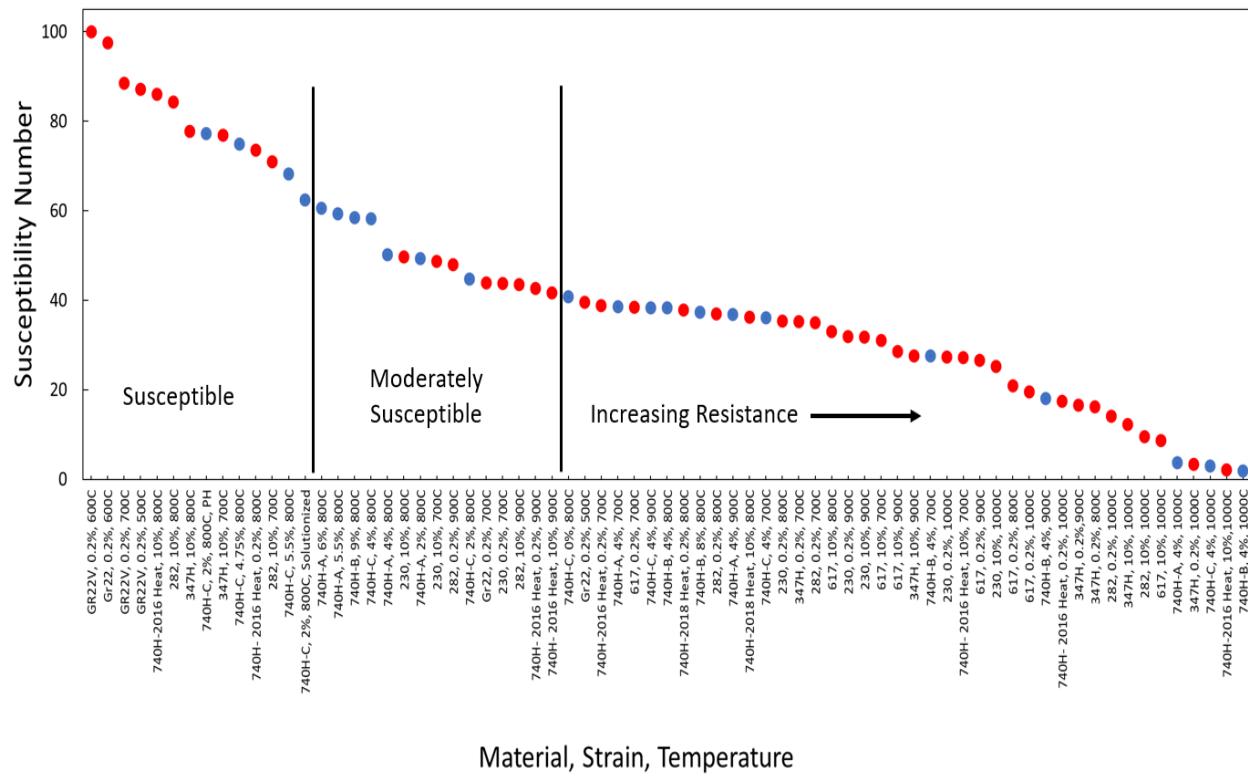
Figure 89. Susceptibility Numbers for different alloys, PWHT temperatures, and plastic strain values. The red data points are from recent SRxC test results conducted for a very wide range of alloys, PWHT temperatures, and plastic strain levels, while the blue data points are for tests conducted in this project.

In terms of heat-to-heat variations, Heat C from this study and Heat 2016 from the previous study were each highly susceptible to SRxC. Note that, of the five heats of alloy 740H considered, only these two alloys are in the “Susceptible” range in Figure 89, and these heats only fall within this range when tested at 800°C. The variation in SRxC susceptibility from the different heats can be associated with prior thermal/deformation treatments and/or composition. The influence of plastic strain has already been

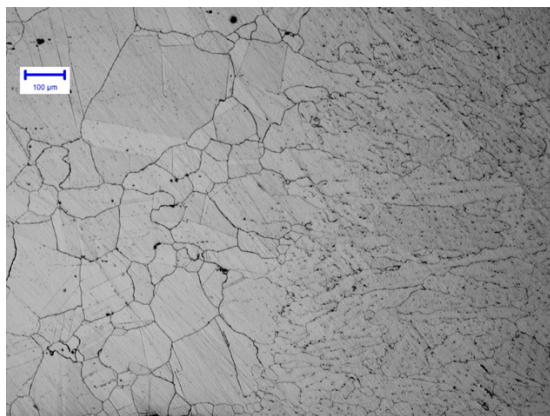
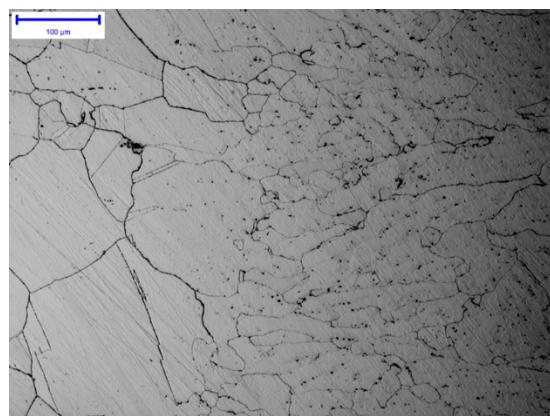
The completed weldments were radiographed at Mistras Group lab in South Point Ohio to their internal procedure 100-RT-001, Rev 20 which is compliant with ASME B&PV Code Section V Article 2. No indications were found. After radiography, transverse sections were cut for metallographic examination. At least four and as many as seven sections were examined for evidence of microcracks or grain boundary creep voids. Apart from scattered minor solidification porosity in the fusion zone, no cracks or voids were seen in any of the weld joint combinations. Representative micrographs from the various plates are shown in Figures 92-95.

Figure 92. no strain weldment

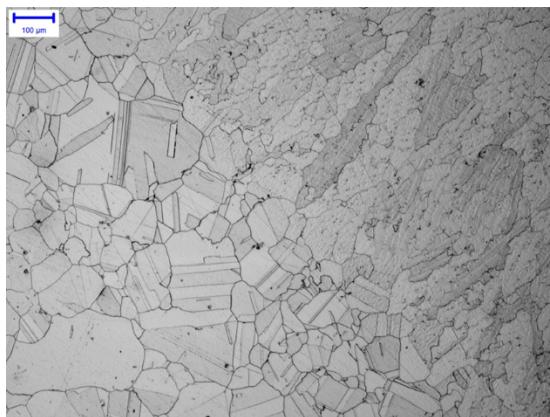
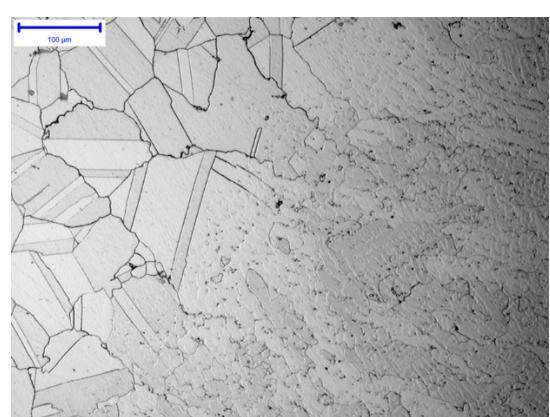
Figure 93. 5% strain to no strain weldment

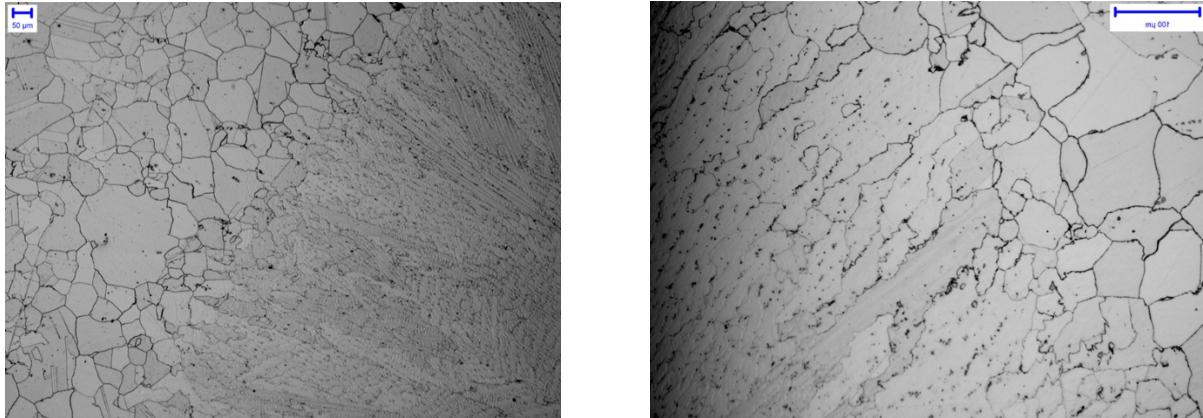
Figure 94. 10% strain to no strain weldment

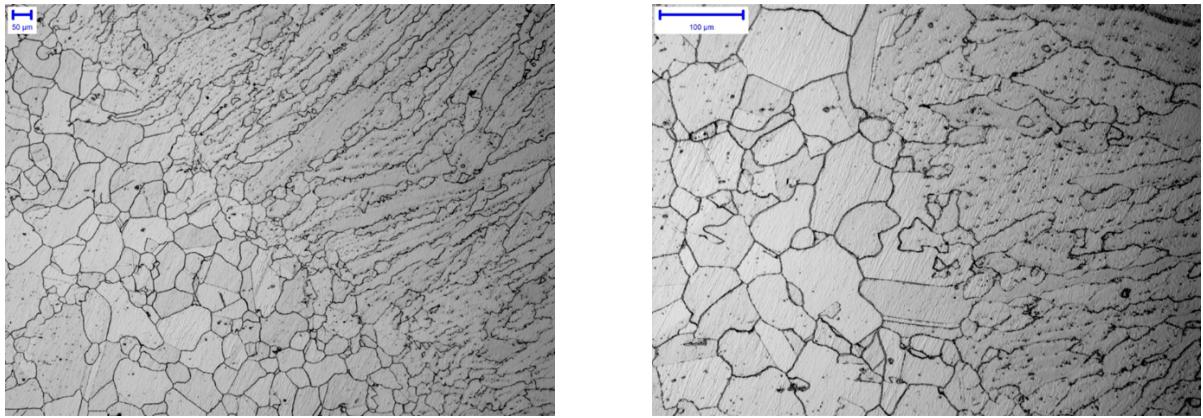
Figure 95. 10% strain to 10% strain weldment.

The failure to generate stress relaxation cracking, especially in the 10% strained plates, was unexpected and puzzling. Assessment of failed field welds where cold strain was present, laboratory Gleeble simulations (Task 2) and cold bending studies (Task 1) have all shown that cold strain in alloy 740H promotes cracking in thermal cycles by a strain aging mechanism. In this work there may have been some mitigating factors such as the cold rolling strain being compressive and uniform across the plate thickness. Welding the plates to the strongback was necessary to prevent extreme warpage that was experienced on an initial trial. However, that may have served to keep the residual stress compressive until it was able to relax. Additionally, this heat was found to perform better (moderate susceptibility at the PWHT temperature) in the Task 2 work. This trial did not provide the desired cracking evidence, but the negative result does not negate the premise that localized cold strain in conjunction with geometric stress concentrations and welding flaws are the drivers of stress relief cracking in alloy 740H weldments. The work shows the challenge in creating a universal SRxC laboratory test method.

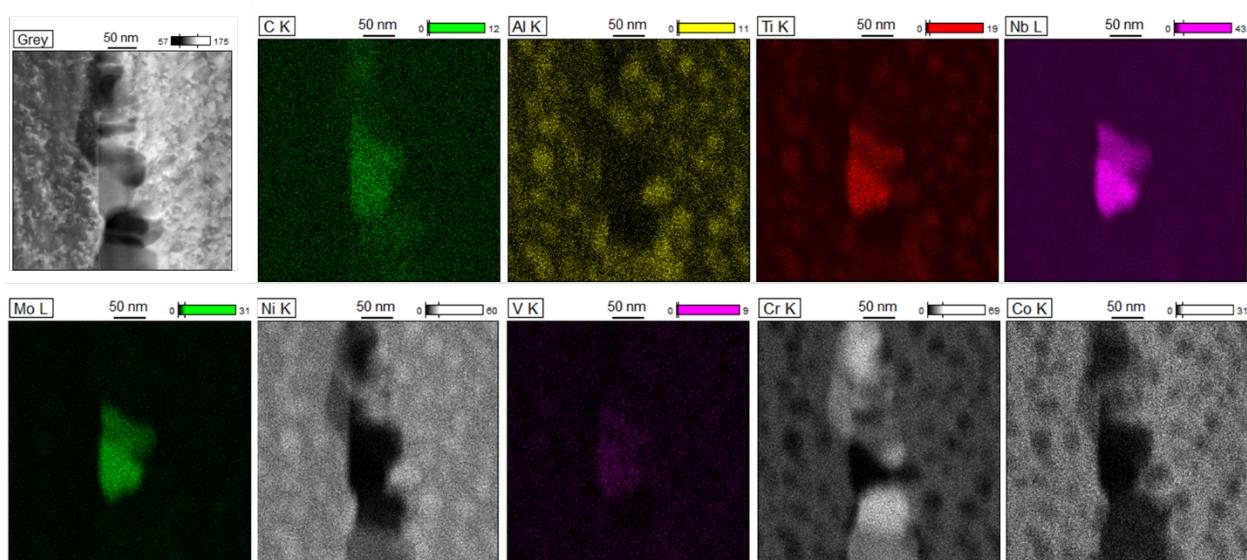
Figure A6: Results showing the distribution of various alloying elements from STEM EDS mapping done at a grain boundary region that is farther away from cracking site of sample Row 14 Weld 25 showing complete grain boundary coverage by precipitates.

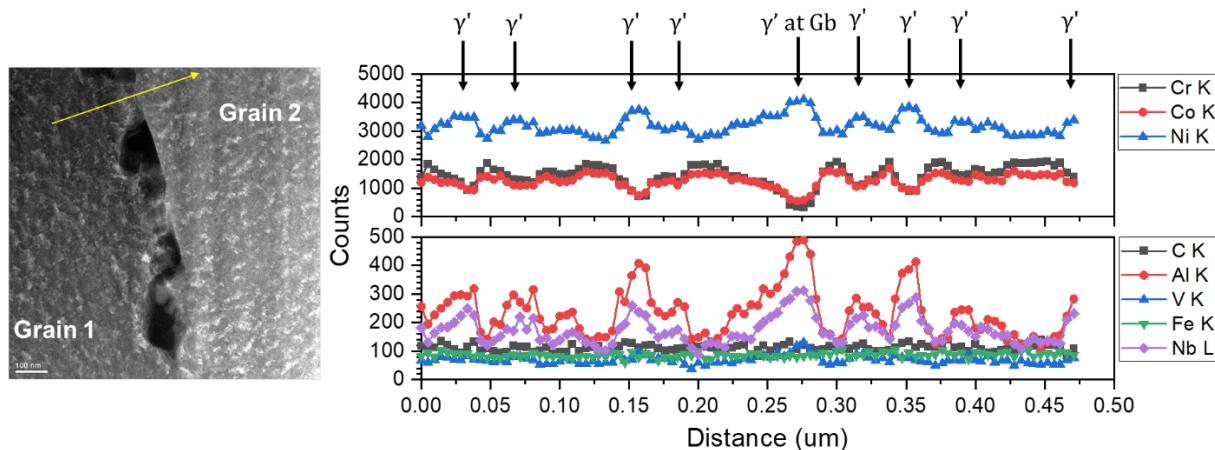
Figure A7: STEM-EDS line scan made across a grain boundary precipitate feature in a TEM sample obtained from a region farther away from location of crack in sample Row 14 Weld 25.

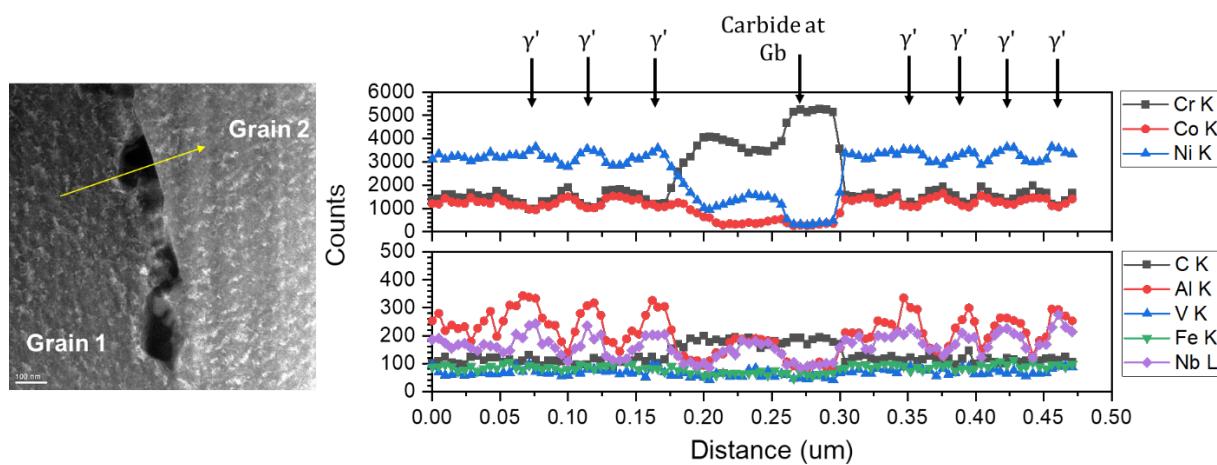
Figure A8: STEM-EDS line scan made across a grain boundary precipitate feature in a TEM sample obtained from a region farther away from location of crack in sample Row 14 Weld 25.

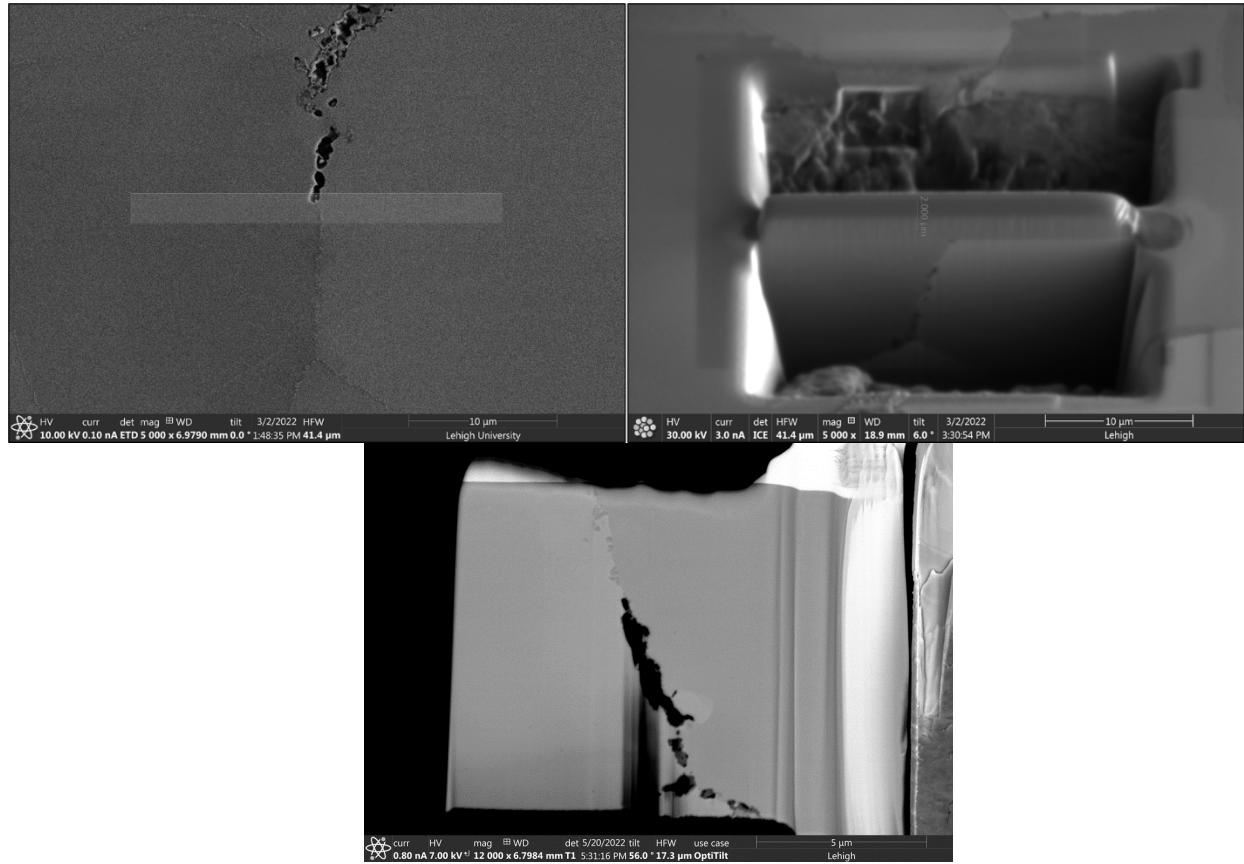
Figure A9: SEM images showing the extraction of a TEM sample for analysis from a grain boundary region immediately ahead of an intergranular crack.

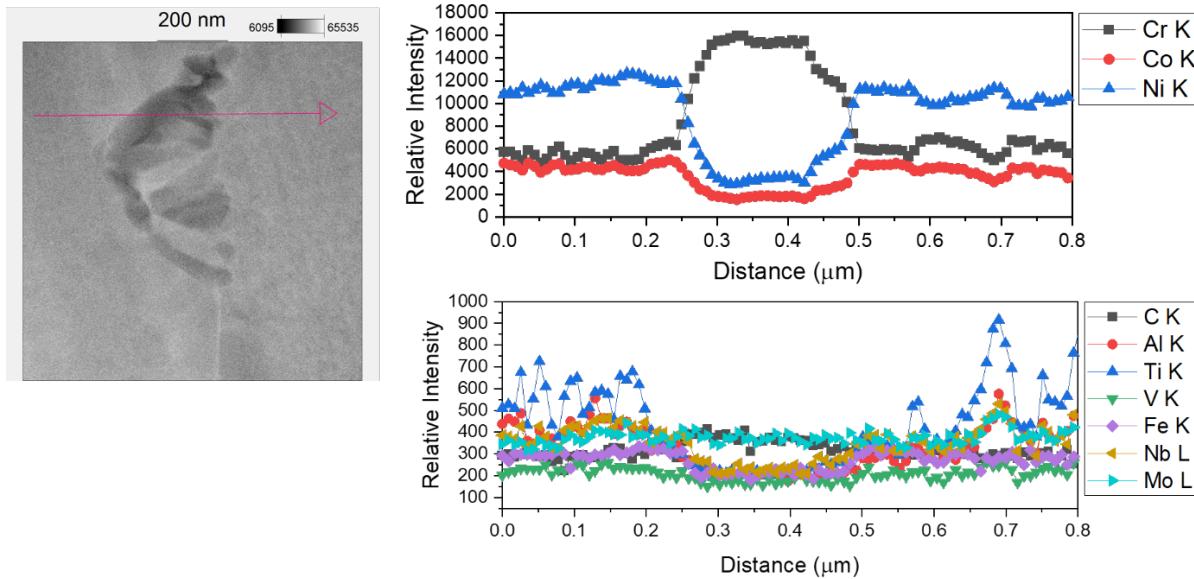
Figure A10: STEM-EDS line scan made across precipitate features in the TEM sample showing in Figure A7.

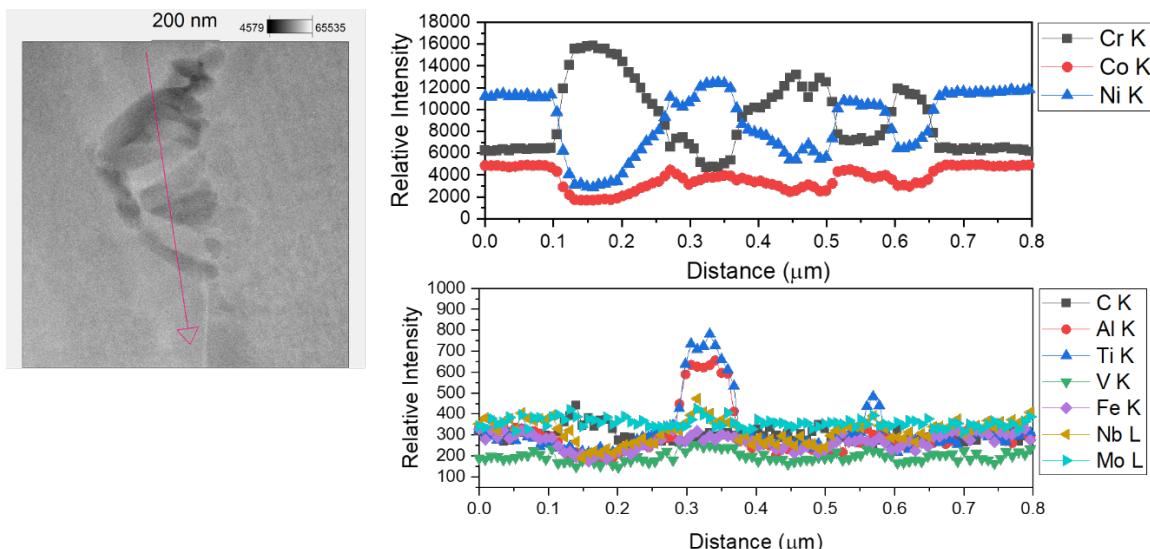
Figure A11: STEM-EDS line scan made across precipitate features in the TEM sample showing in Figure A7.

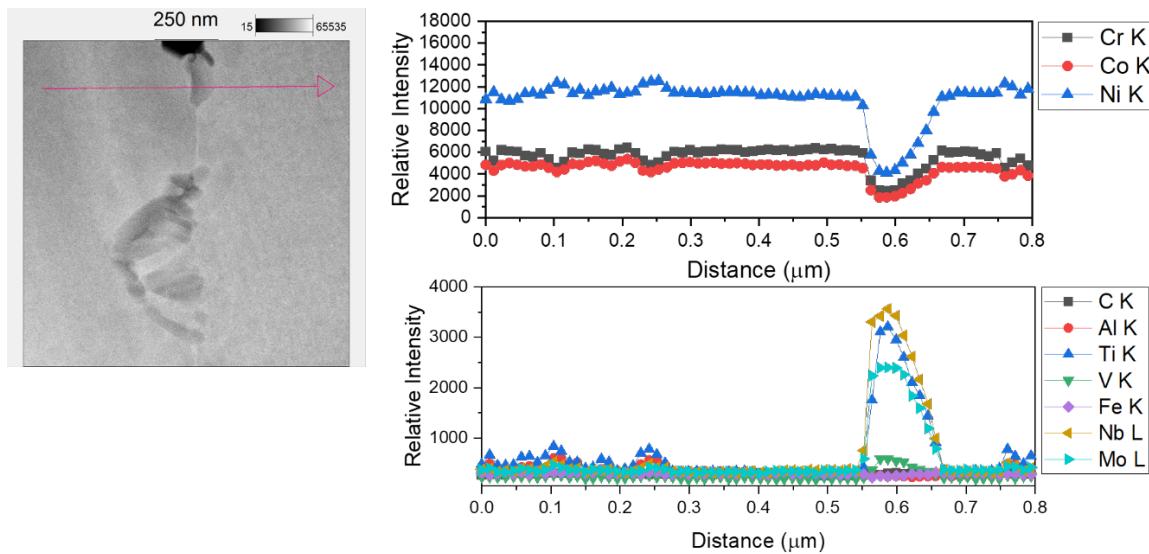
Figure A12: STEM-EDS line scan made across precipitate features in the TEM sample showing in Figure A7.

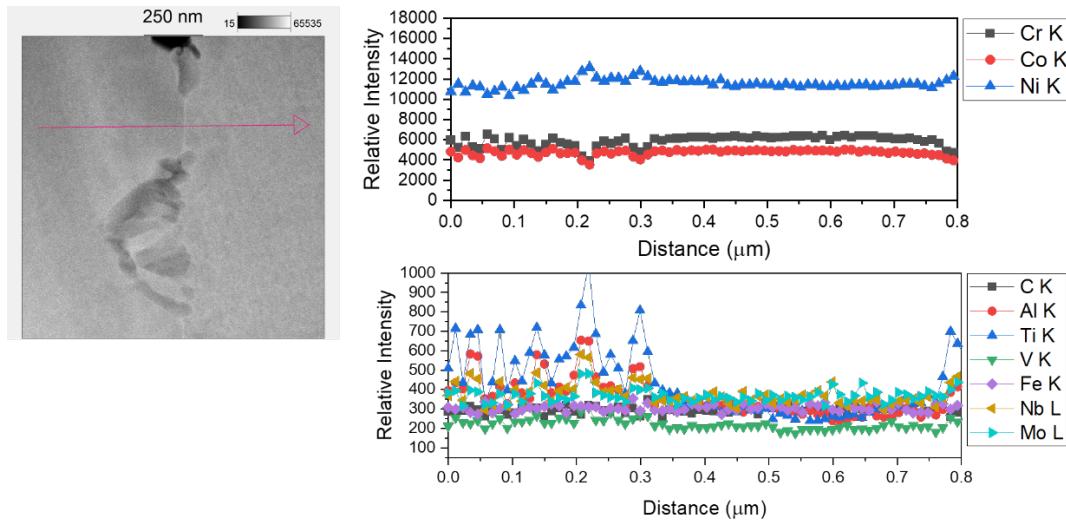
Figure A13: STEM-EDS line scan made across precipitate features in the TEM sample showing in Figure A7.

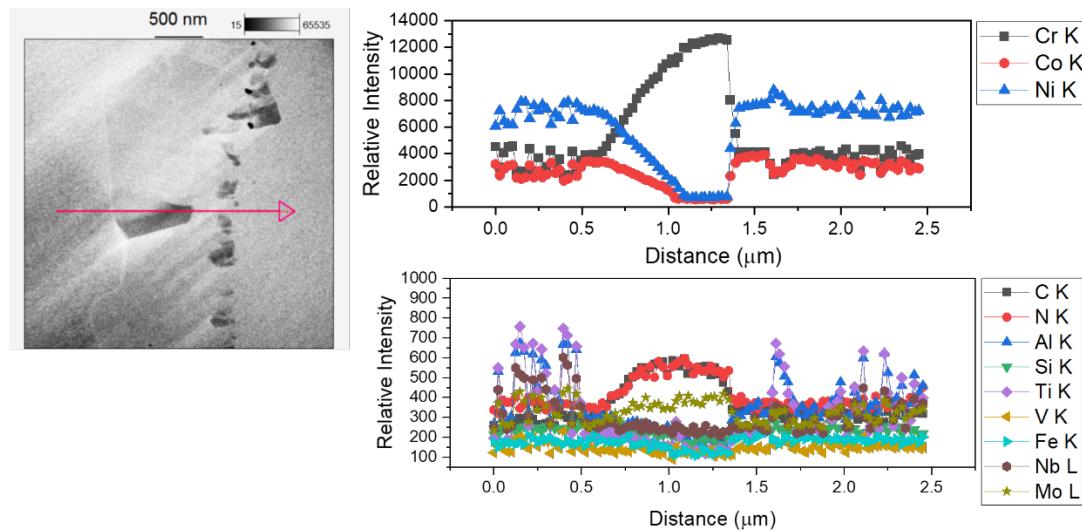
Figure A13: STEM-EDS line scan made across precipitate features in the second TEM sample from sample Row 14 Weld 25.
