ANL/ESD/TM-105

**Contamination Source Review for Building E3613,
Edgewood Area, Aberdeen Proving Ground, Maryland**

**Energy Systems Division
Argonne National Laboratory**

September 1995

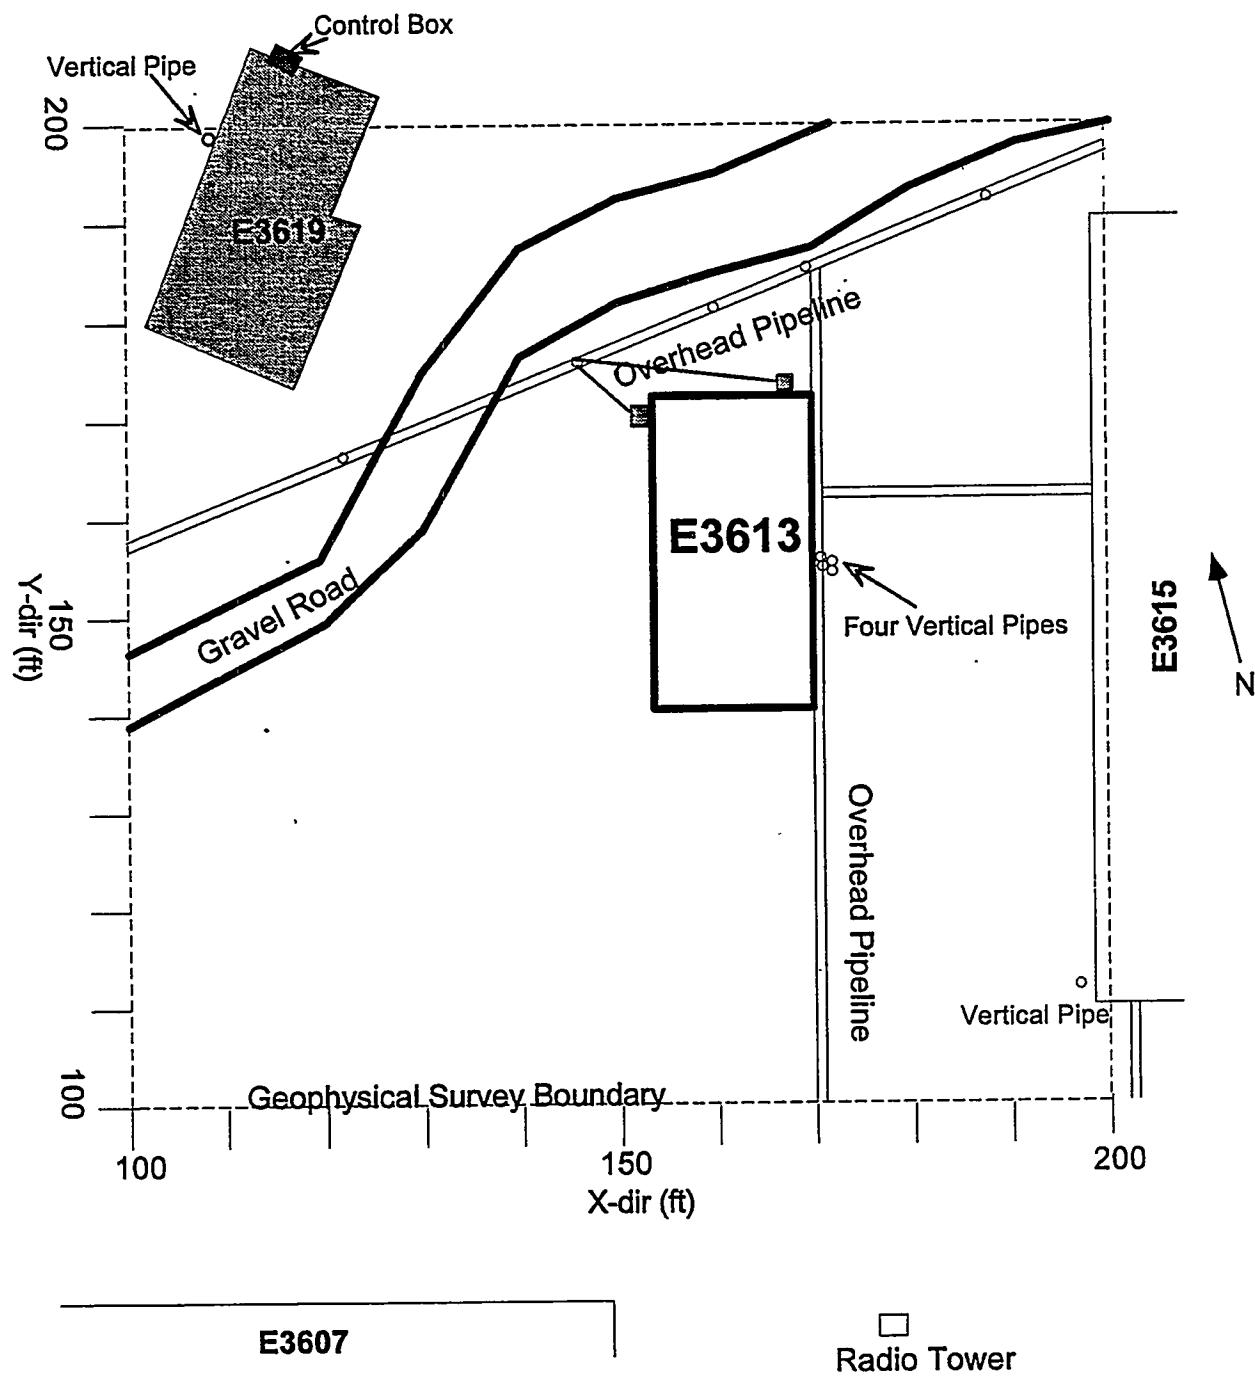
FIGURE 2 Detailed Location Map of Building E3613

As discussed earlier, a strong EMF positive is observed south of E3619 (Figure 6) that correlates with both conductivity and magnetic observations. EMF highs on the northwest corner of the foundation of E3619 match the locations of a control box and a vertical pipe (Figure 2). A magnetic high (Figure 3) is also observed near the EM-61 anomaly (Figure 6) along the eastern edge of the foundation.

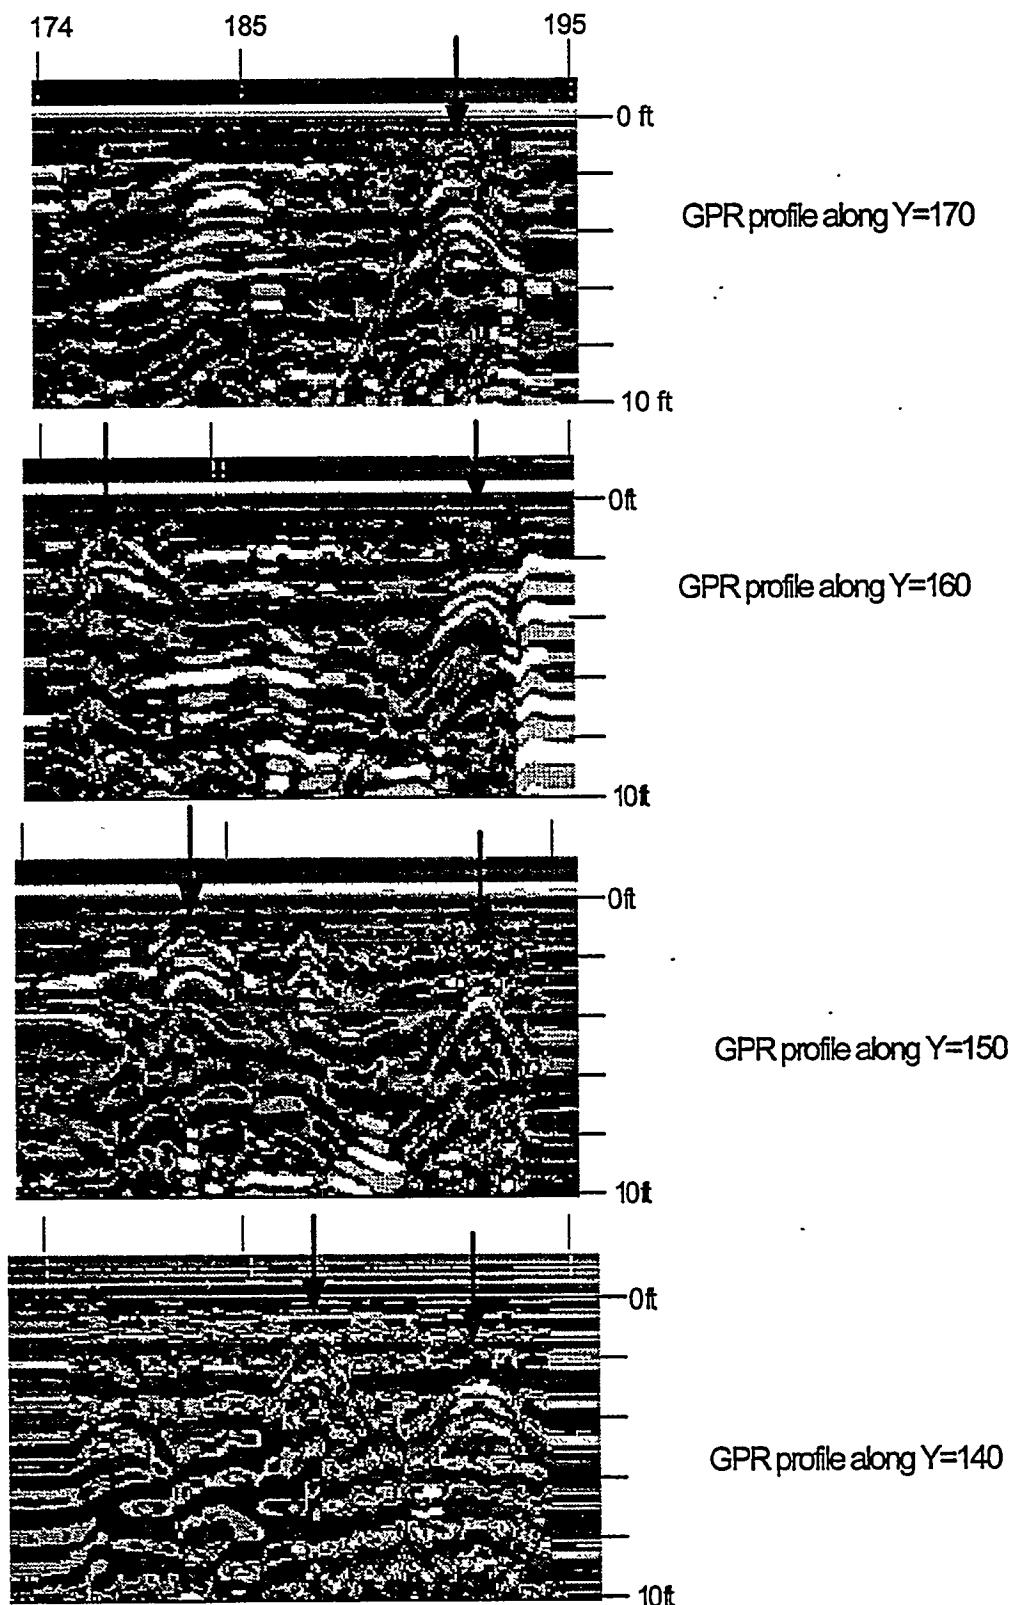
FIGURE 7 Ground Radar Images along Transects Parallel to the X-Axis between Buildings E3615 and E3613 (Arrows show two sets of observed anomalies. The maximum penetration depth is estimated at 7 ft.)

Southeasterly-trending EMF highs are located between buildings E3613 and E3615, south of the east-west-trending overhead steam pipe. Hyperbolic GPR anomalies are also detected along a similar trend on EW transects (Figure 7). The EMF positive parallel to and just west of 3615 correlates with a series of hyperbolic GPR anomalies (Figure 7), suggesting a possible buried metallic pipe at this location.

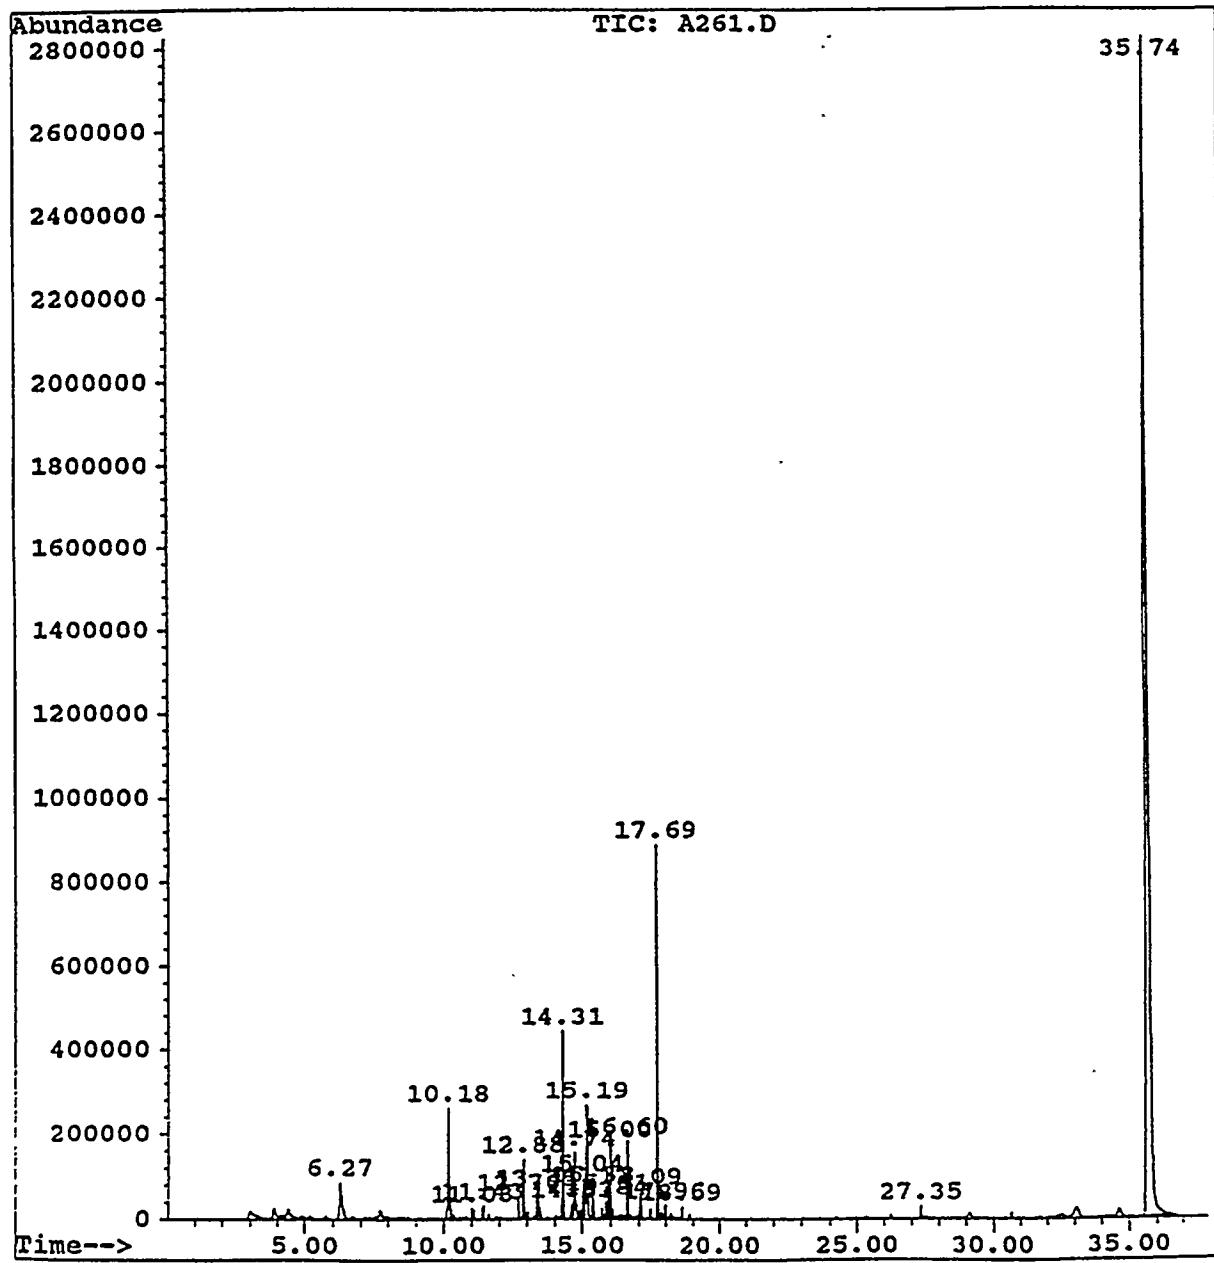
File : A:\A261.D
Operator : lar
Acquired : 19 Nov 94 2:10 pm using AcqMethod PILOT
Instrument : 5972 - In
Sample Name: 261(47) E3613 north rm, 9:10-11:10 200mL/min
Misc Info : start, 200mL/min end,facing north, north wal
Vial Number: 1

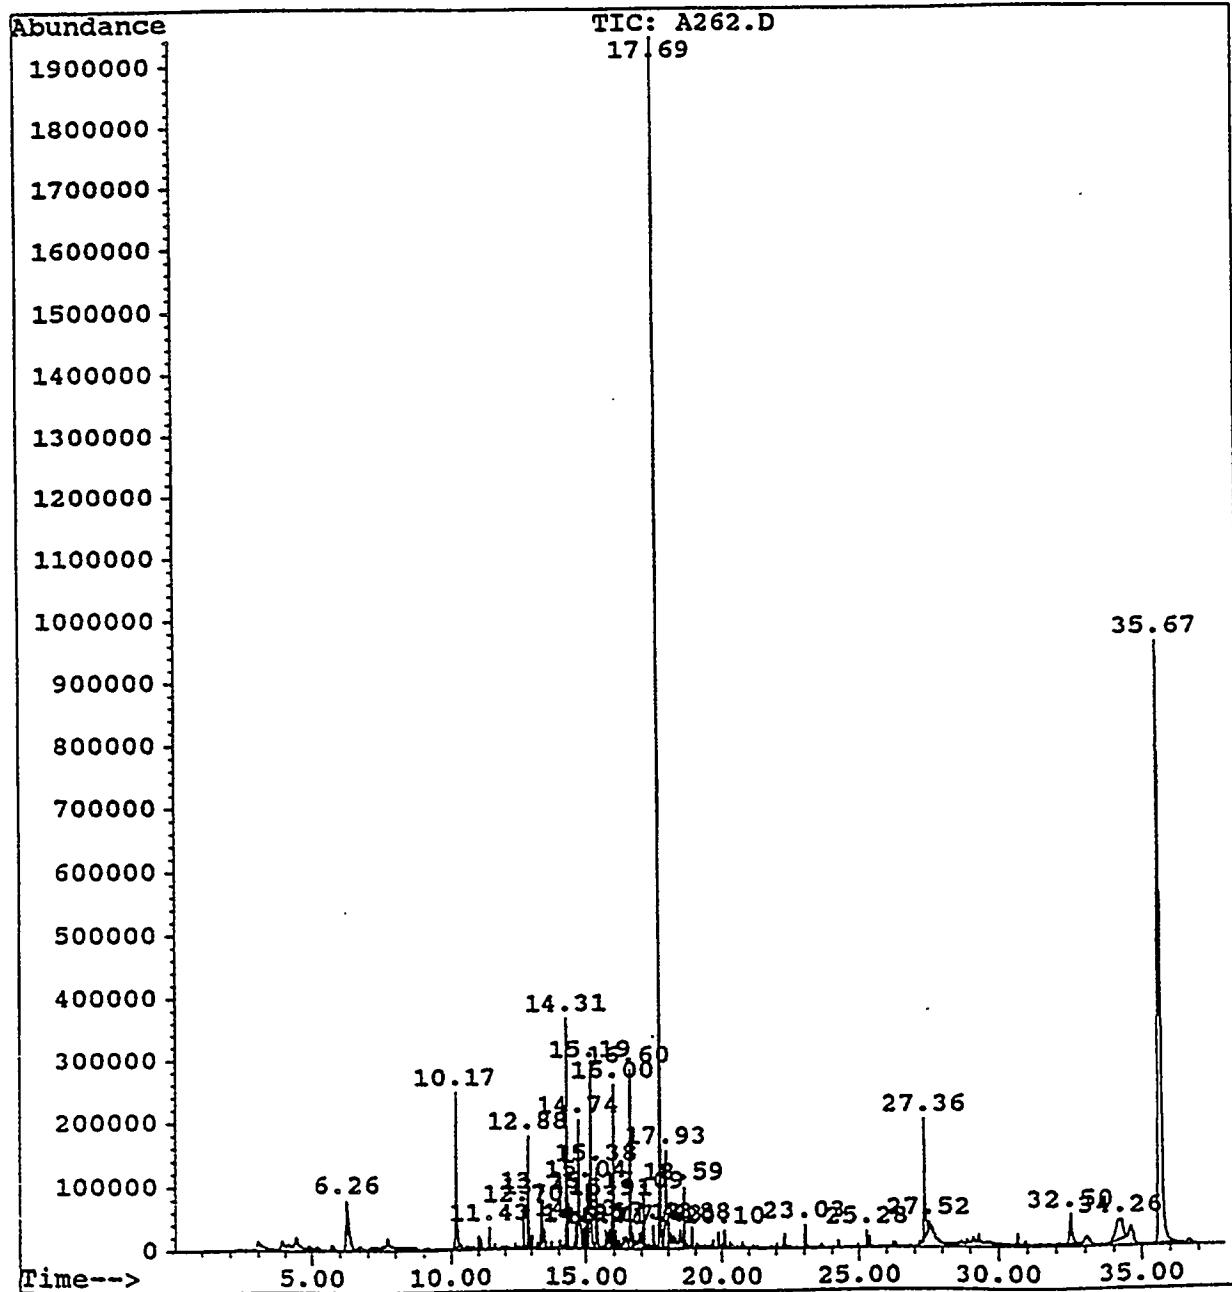
File : A:\A262.D
Operator : lar
Acquired : 19 Nov 94 3:02 pm using AcqMethod PILOT
Instrument : 5972 - In
Sample Name: 262(52) E3613 south rm, 9:10-11:10 200mL/min
Misc Info : start, 200mL/min end,facing north, north wal
Vial Number: 1

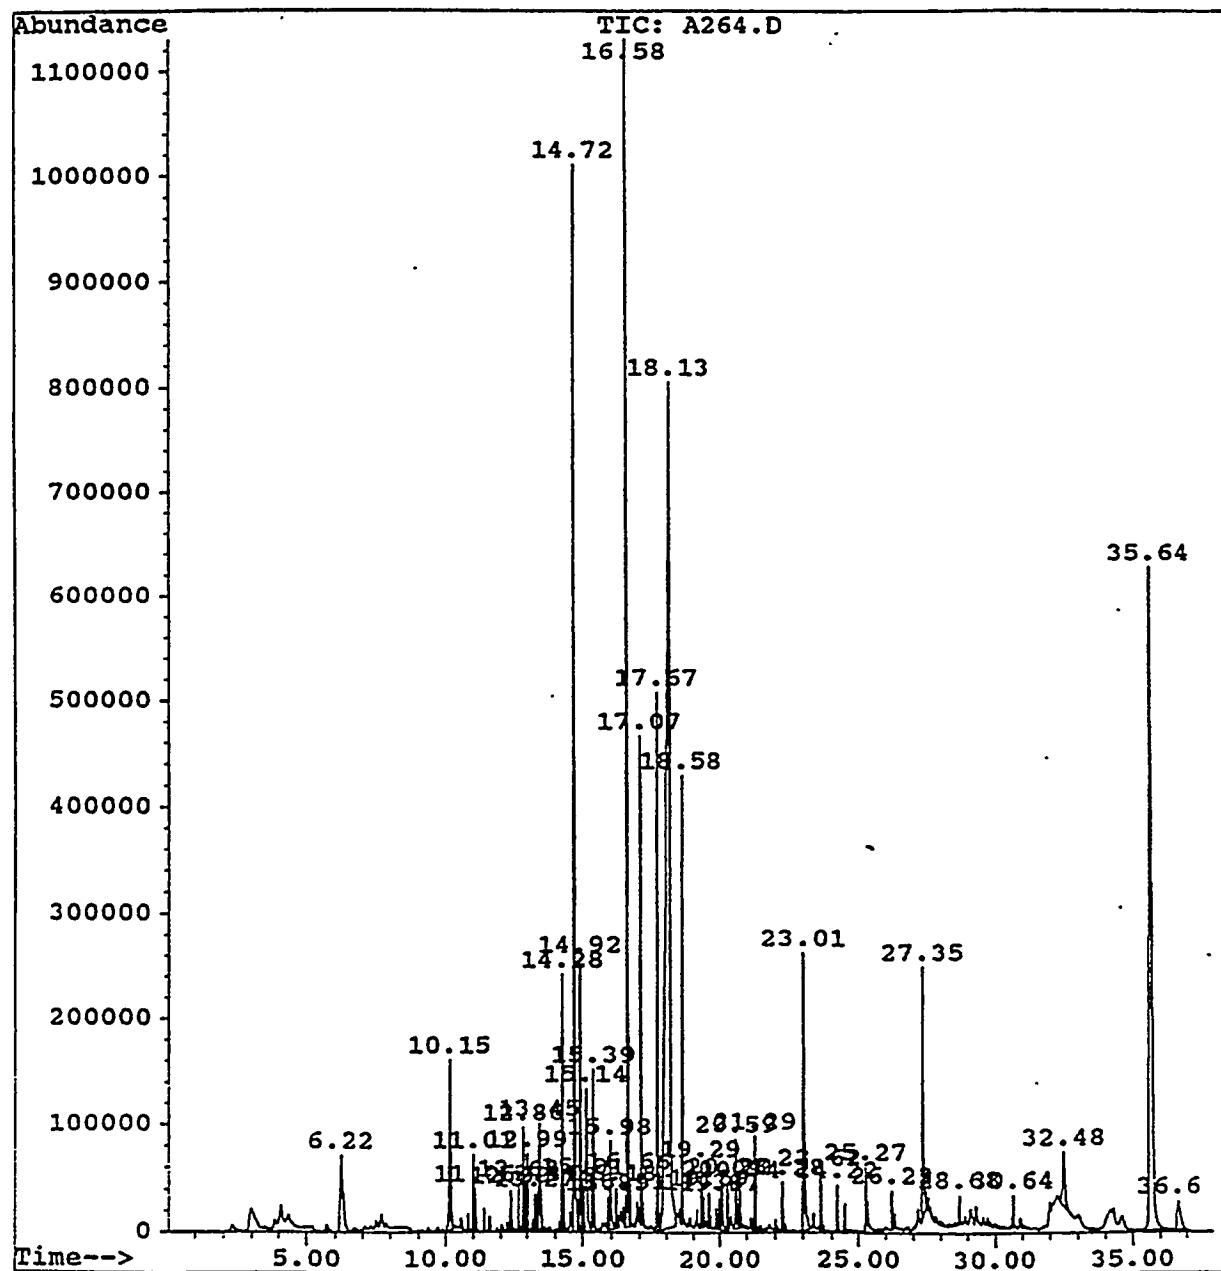
File : A:\A264.D
Operator : lar
Acquired : 19 Nov 94 4:40 pm using AcqMethod PILOT
Instrument : 5972 - In
Sample Name: 264(43) E3613 downwind, 9:20-11:20 200mL/min
Misc Info : start, 200mL/min end, facing SW, SE
Vial Number: 1

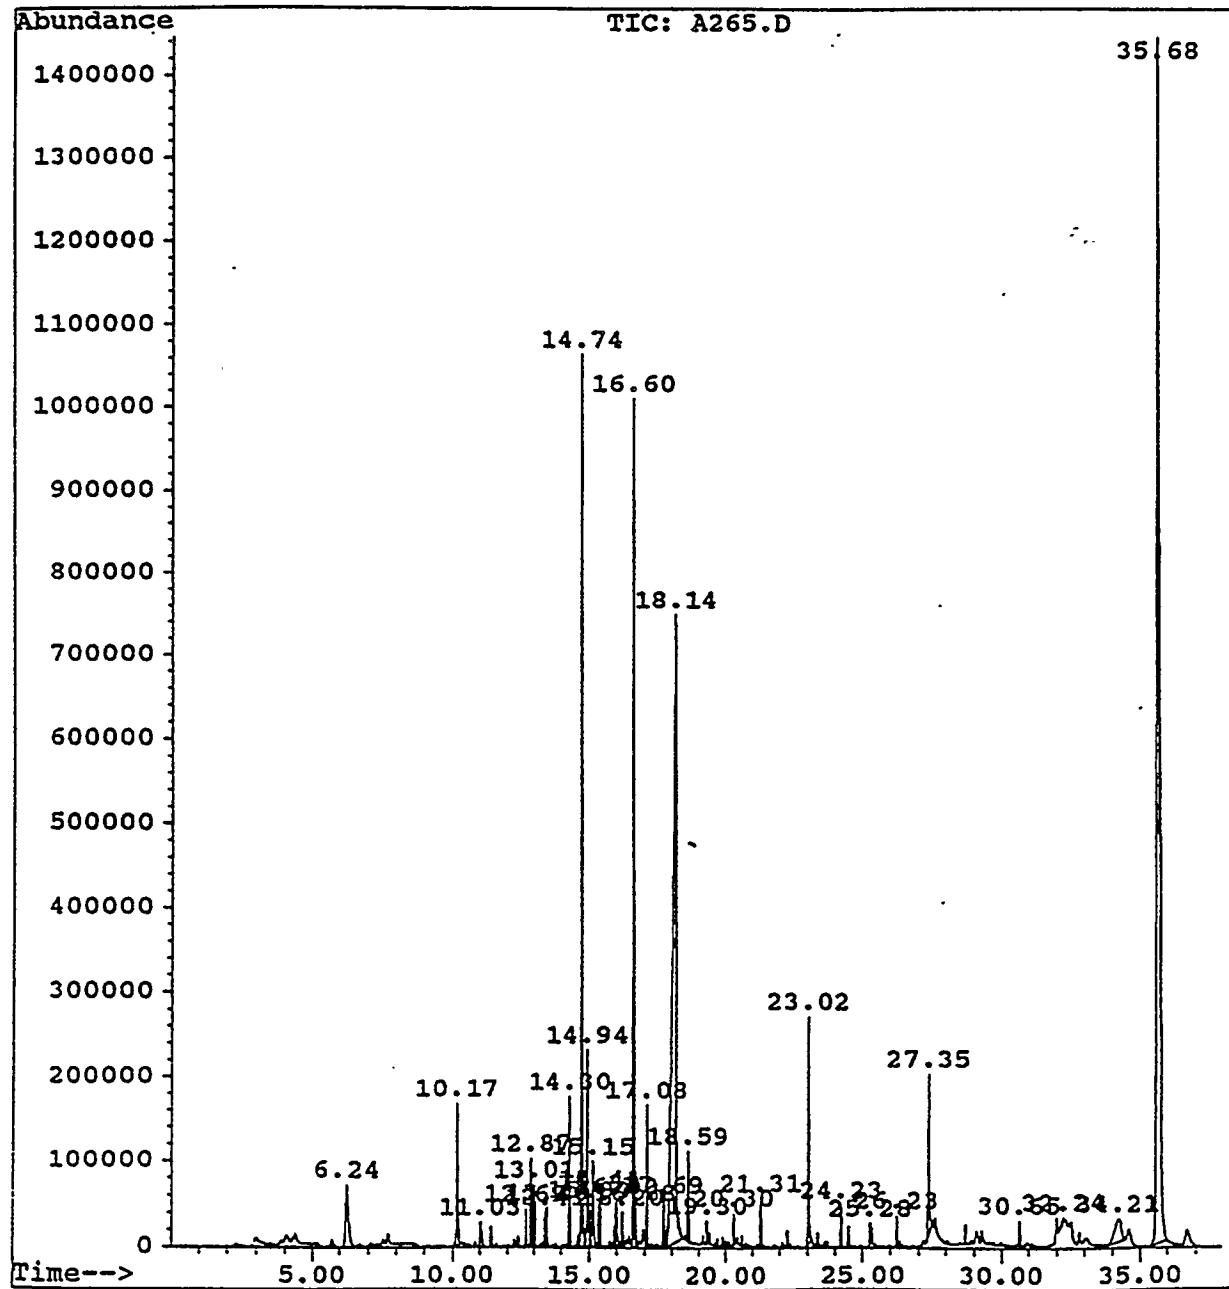
File : A:\A265.D
Operator : lar
Acquired : 19 Nov 94 3:51 pm using AcqMethod PILOT
Instrument : 5972 - In
Sample Name: 265(45) E3613 upwind, 9:10-11:10 200mL/min
Misc Info : start, 200mL/min end, facing SW, SW
Vial Number: 1
