**Contamination Source Review for Building E3642,
Edgewood Area, Aberdeen Proving Ground, Maryland**

M.N. Booher, D.P. O'Reilly, A.K Draugelis, J. Rueda, and R.E. Zimmerman

September 1995

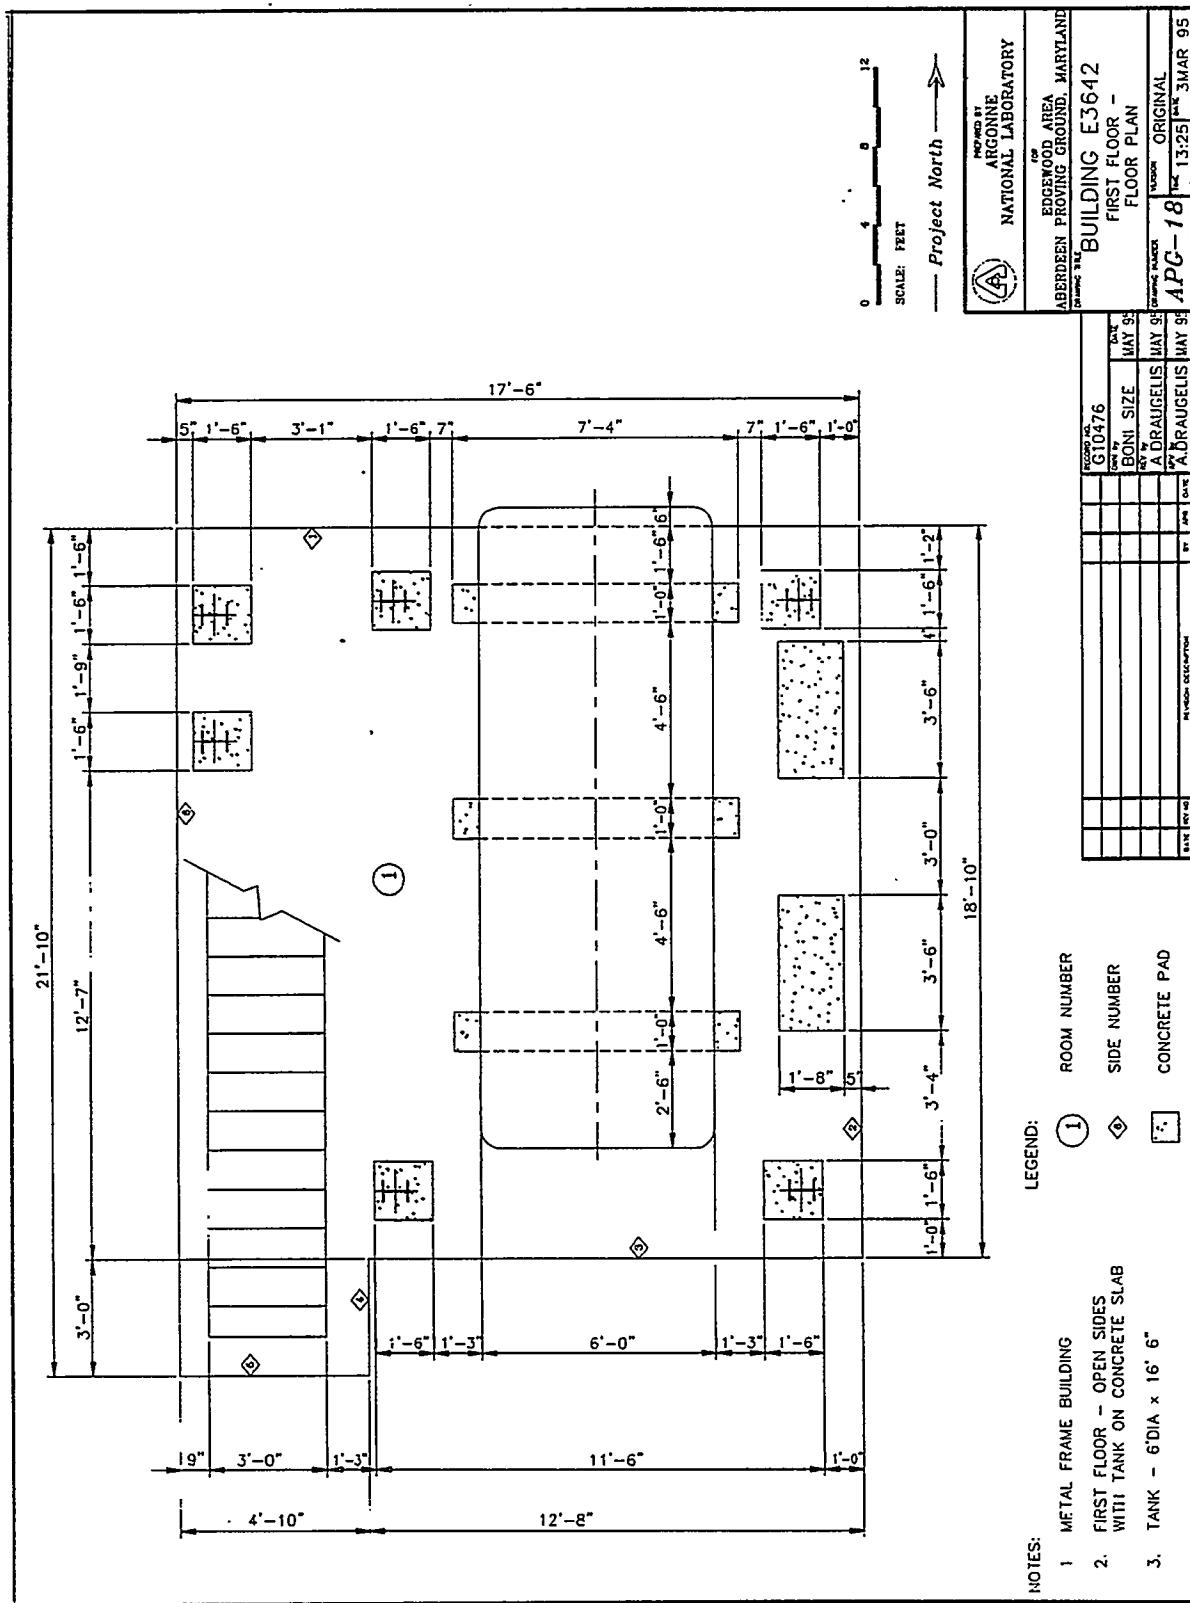
FIGURE 3 Building E3642 First Floor — Floor Plan

The north exterior elevation of Building E3642 measures 17 ft 6 in. long. The second-floor structure measures 11 ft 6 in. long (excluding the staircase) (Figures 3 and 4).

Along the east exterior elevation of Building E3642, the first floor measures 18 ft 10 in. long. The second floor is 15 ft 2 in. long (Figures 3 and 4).

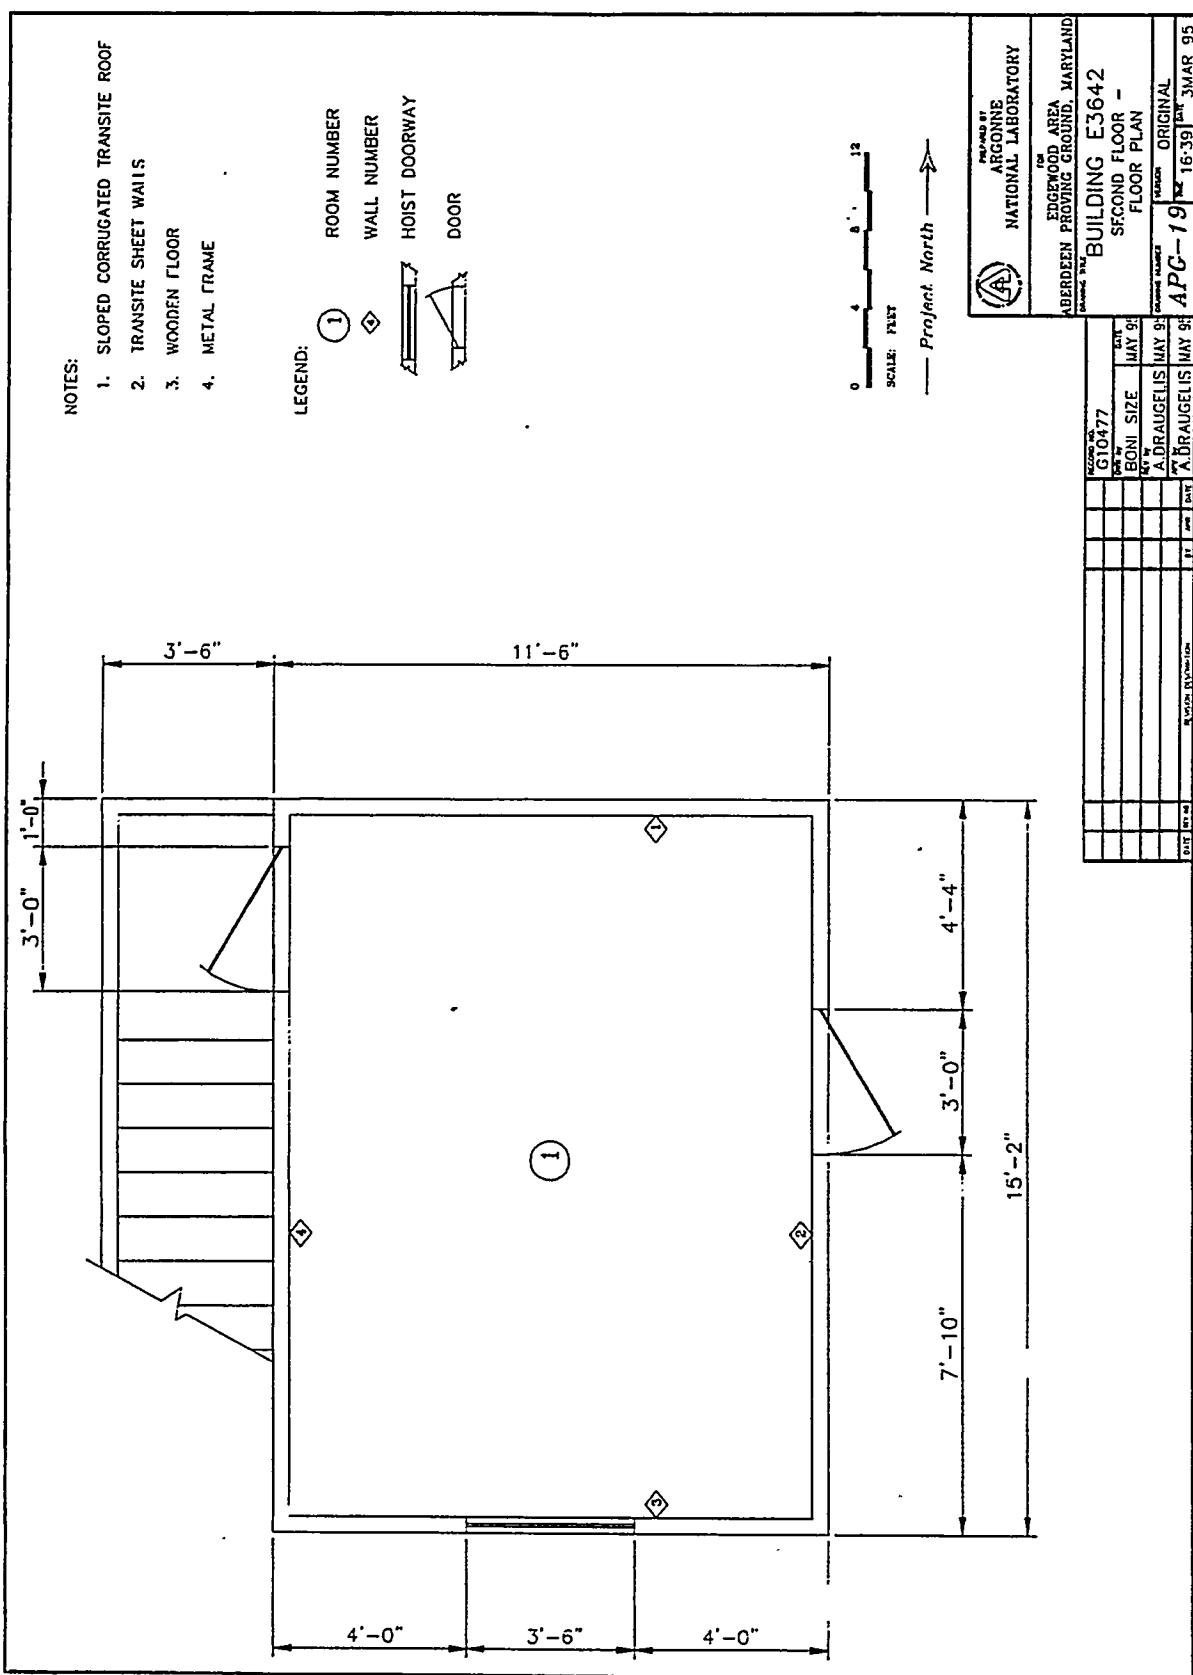
FIGURE 4 Building E3642 Second Floor — Floor Plan

The south exterior elevation of Building E3642 measures 17 ft 6 in. long. The second floor structure measures 11 ft 6 in. long (Figures 3 and 4).

The first floor on the west exterior elevation of Building E3642 measures 18 ft 10 in. long. The second floor is 15 ft 2 in. long (Figures 3 and 4).
