**Contamination Source Review for Building E2370,  
Edgewood Area, Aberdeen Proving Ground, Maryland**

## **Contamination Source Review for Building E2370, Edgewood Area, Aberdeen Proving Ground, Maryland**

D.P. O'Reilly, M.A. Glennon, A.K. Draugelis, J..Rueda, and R.E. Zimmerman

September 1995

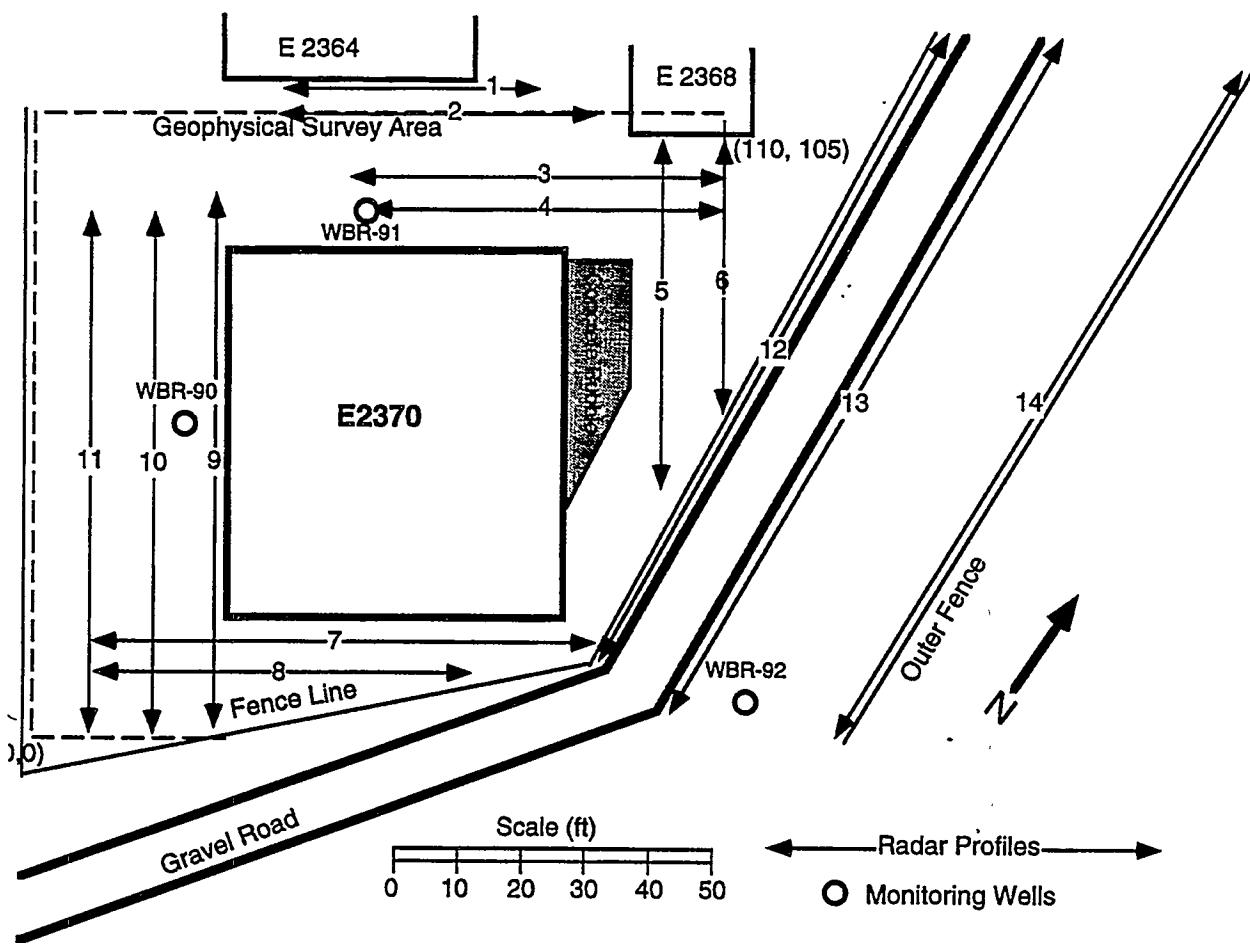
FIGURE 5 Locations of Ground-Penetrating-Radar Profiles

GPR transects were run over the survey area surrounding Building E2370 along east-west and north-south transects spaced 10 ft apart where possible. The locations of GPR lines are shown in the Figure 5 and are also listed in the Attachment, where the lines are numbered in sequence, along with the beginning and ending positions relative to the grid survey. Without verification by another technique or by passing the antenna over an object of known depth, characteristics of radar anomalies may only be inferred. However, where anomalies are also seen with magnetic or resistivity profiling, a diagnostic interpretation of the radar anomaly is possible.
