**Contamination Source Review for Building E3163,  
Edgewood Area, Aberdeen Proving Ground, Maryland**

## **Contamination Source Review for Building E3163, Edgewood Area, Aberdeen Proving Ground, Maryland**

A.K. Draugelis, K.L. Muir-Ploense, M.A. Glennon, J. Rueda, and R.E. Zimmerman

September 1995

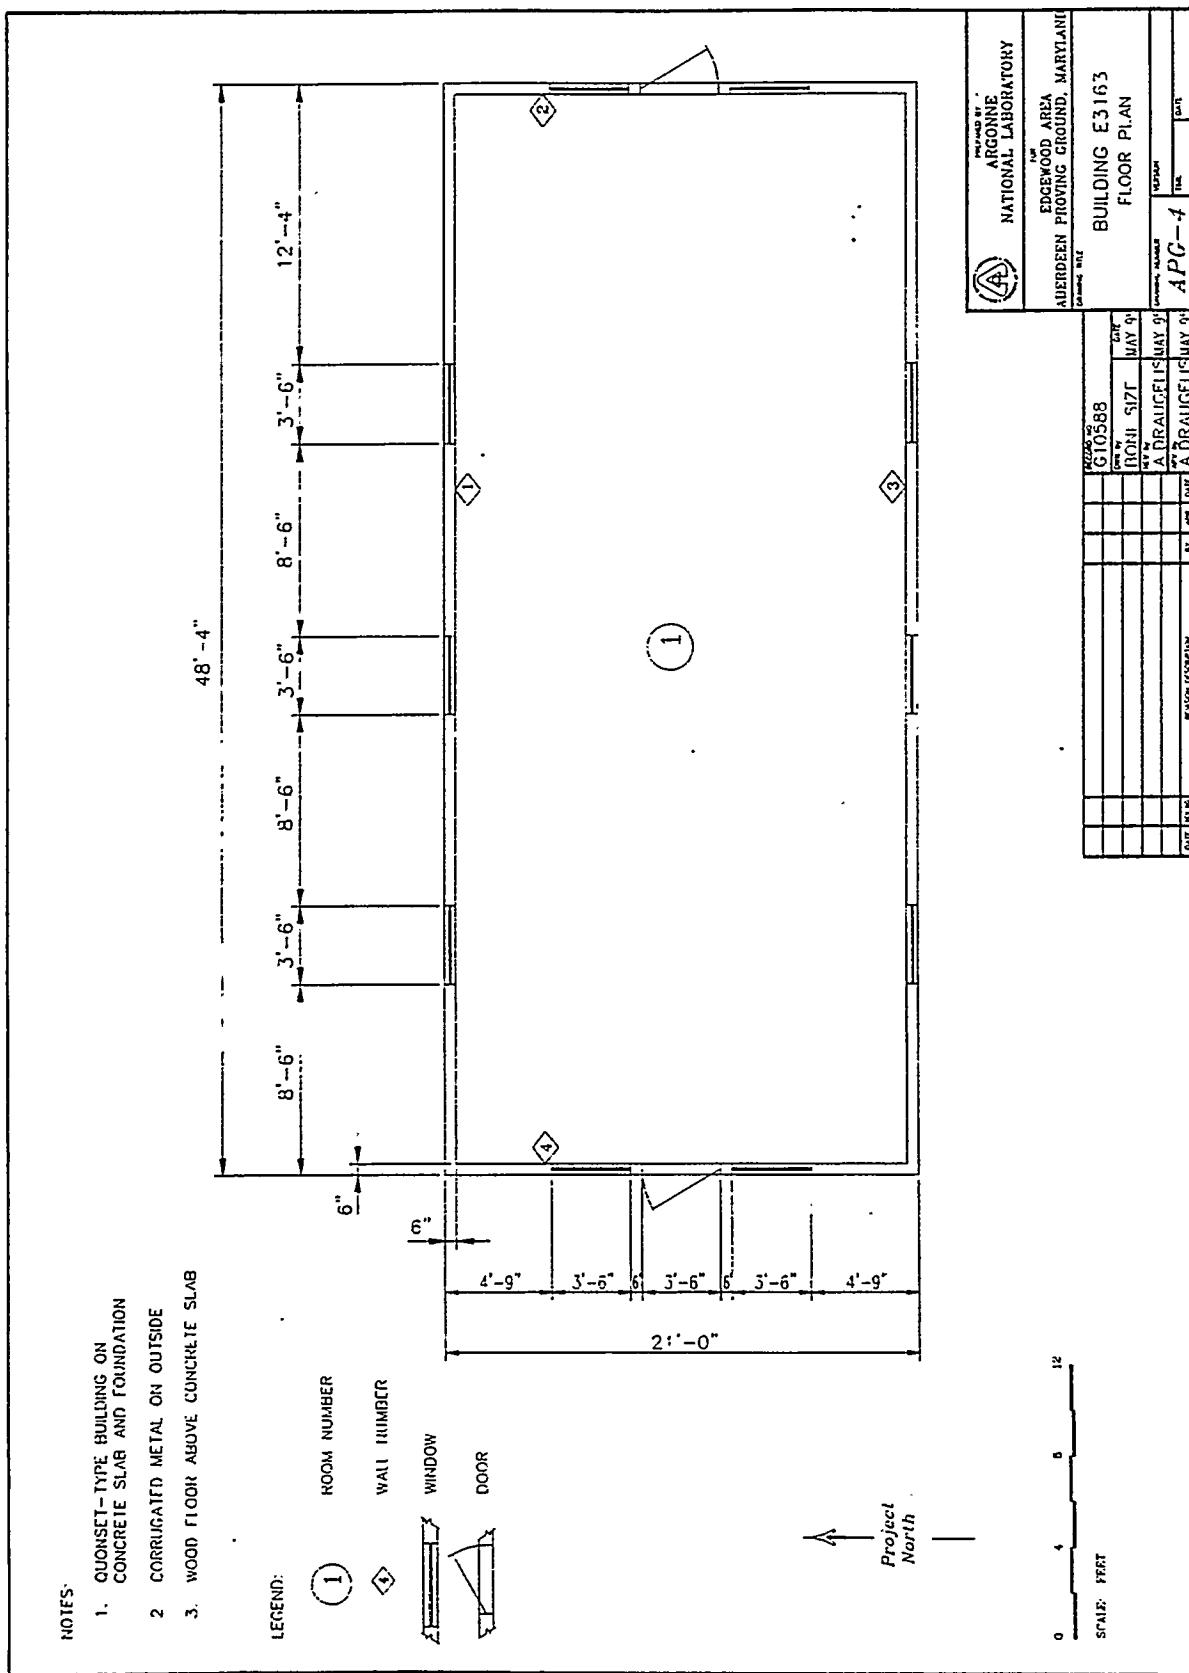
FIGURE 3 Building E3163 Floor Plan

Because of a lack of building maintenance, the north elevation shows signs of deterioration and weathering. Oxidized metals were observed at the time of this investigation.

Because of a lack of building maintenance, the east elevation shows signs of deterioration and weathering. Oxidized metals were observed at the time of the investigation.

Because of a lack of building maintenance, the south elevation shows signs of deterioration and weathering. Oxidized metals were observed at the time of the investigation.

Because of a lack of building maintenance, the west elevation shows signs of deterioration and weathering. Oxidized metals were observed at the time of the investigation.

The walls of the room, which coincide with the exterior and interior walls of the building, are 6 in. thick. The exterior is covered with corrugated sheet metal and the interior with particle board. The interior walls are damaged.

Building E3163 has a wooden floor that is damaged and in poor condition. There is evidence to suggest that the floor of this building was modified.

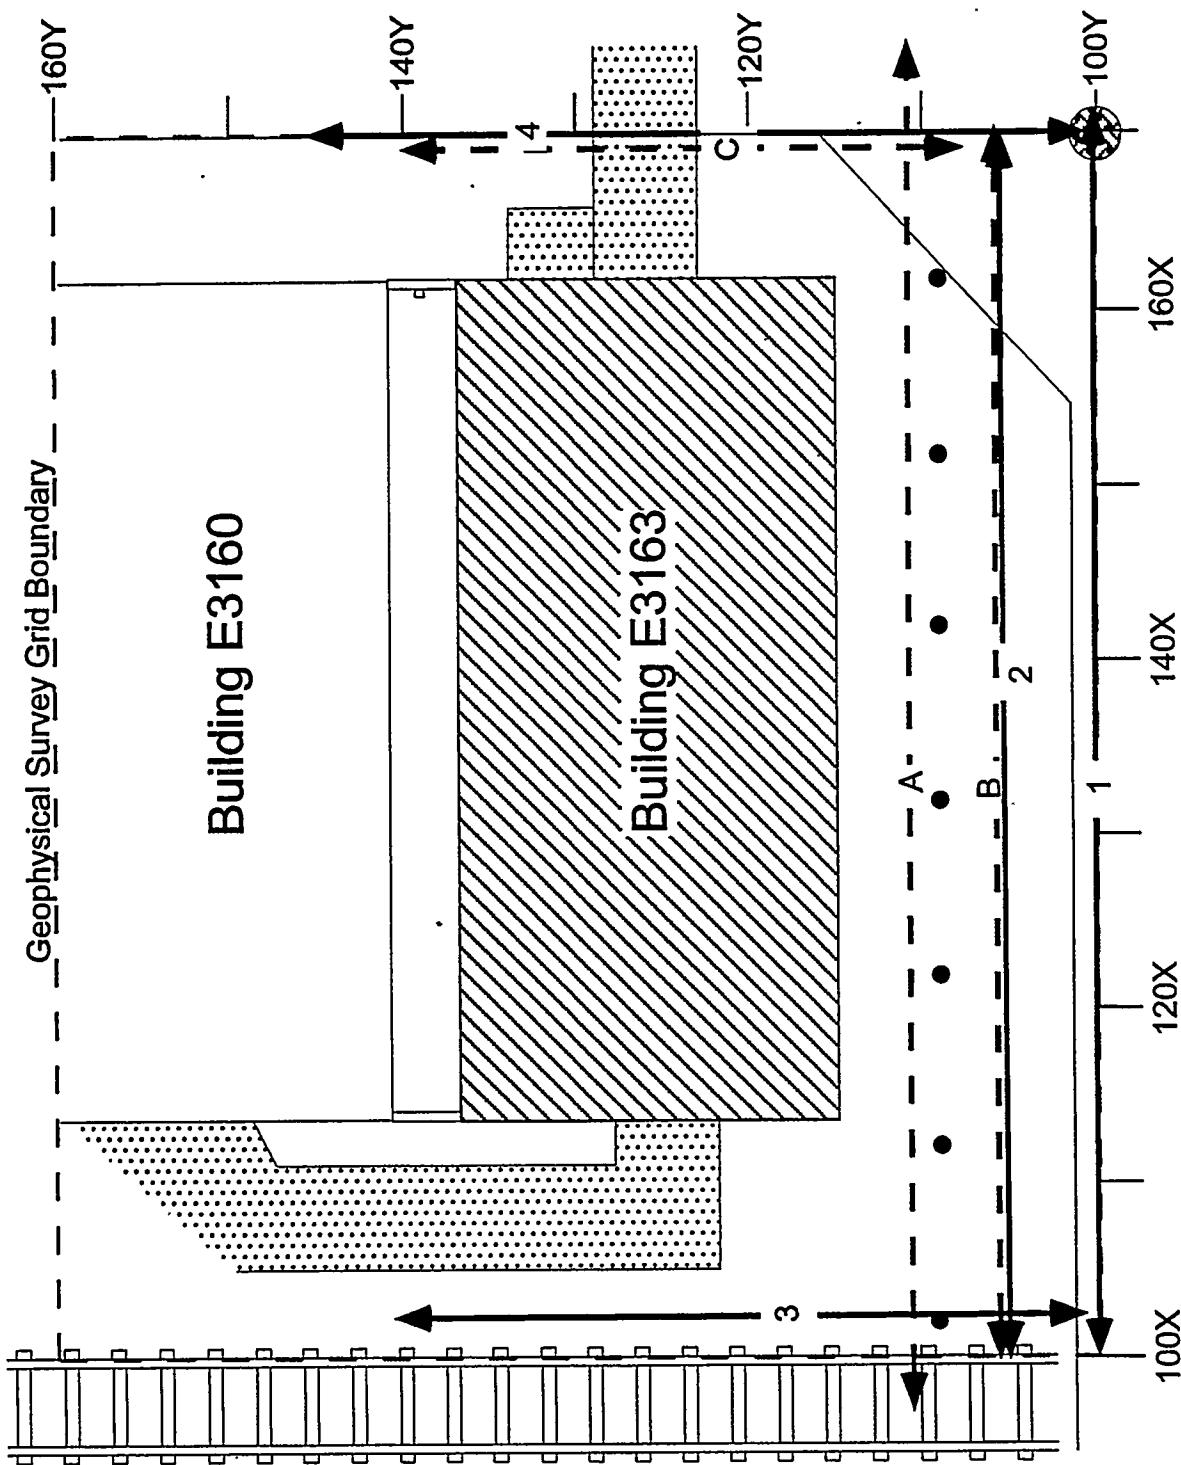
FIGURE 3 Location of GPR and EM-61 profiles conducted near E3163

Four GPR profiles were conducted in the vicinity of E3163 (Figure 3). Along X=103 (Figure 5), two shallow hyperbolas are detected at Y=103 and Y=133. The sources of these anomalies are unknown. Along the same profile, strong reflections are observed at depths greater than about 6 ft near Y=108, which may be sourced by subsurface disturbances associated with the nearby metal pole. The strong reflections along X=170 between Y=122 and 128 can be attributed to the concrete slab (Figure 6). However, along the same profile, similar reflections are also detected between Y=128 and Y=140 that can not be associated with that structure. Along Y=100 and Y=105, shallow hyperbolas are detected at X=150. The sources of these anomalies are unknown.

Interference from metal poles located along Y=110 probably cause the EMF positive anomalies along profile A (Figures 3 and 4). Deep GPR reflections are detected at (103, 108) which could also be sourced by subsurface disturbances associated with a metal pole.
