Printed Wiring Assemblies (PWA) and Counterfeit Detection using Non-Destructive X-ray CT Analysis

Sandia National Labs/Computer Science R&D

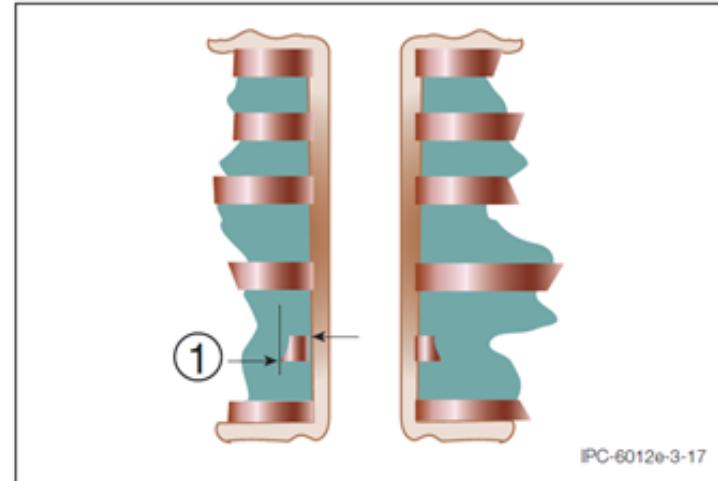
Figure 3-17 Annular Ring Measurement (Internal)

Note 1. Measurement of internal annular ring.

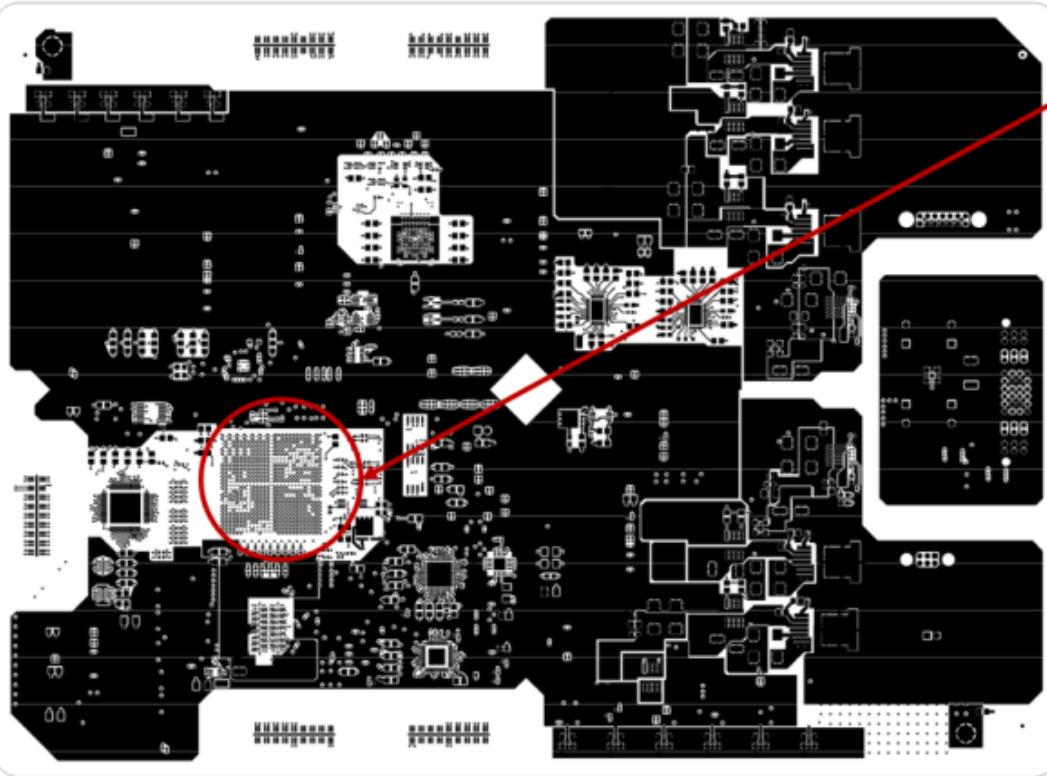
FPGA is the region of interest

High density drilled via's through the board provide details on annular ring information for Class 3 PCB inspection.
